WELCOME TO JOURNEY
RISK MANAGEMENT
(JRM) STUDY USING
ARTIFICIAL
INTELLIGENCE (AI)
FOR IOCL TRICHY
TERMINAL

IOCL TIRCHY TERMINAL (10.7753, 78.8368) TO VIMA ENTERPRISES, ,(11.077525 , 79.580841) TOTAL DISTANCE - 107KM

Welcome to the Journey Risk Management Study

for VIMA ENTERPRISES,,

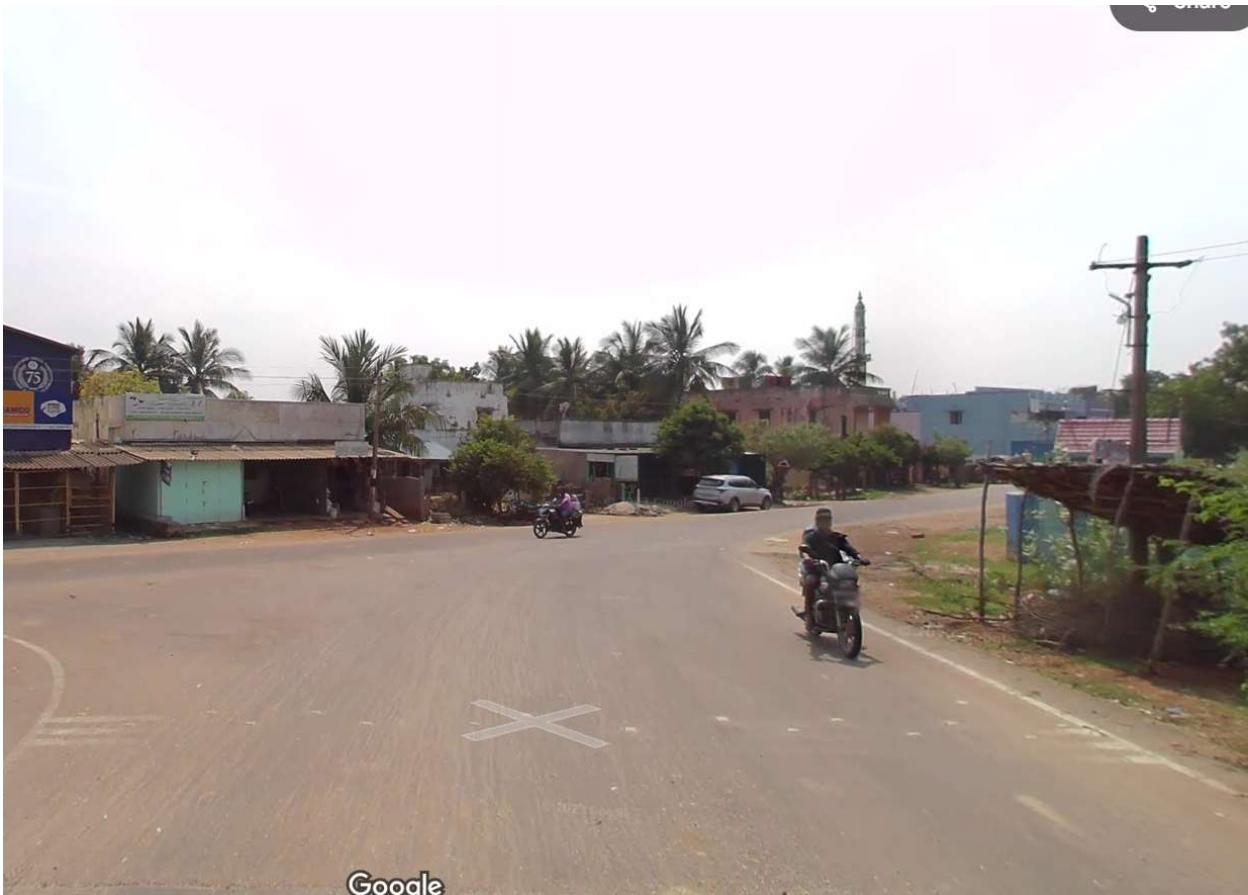
IMAGE: SHARP TURN RISK LEVEL: - MEDIUM, COORDI 10.758262863684411, 78.83351425048

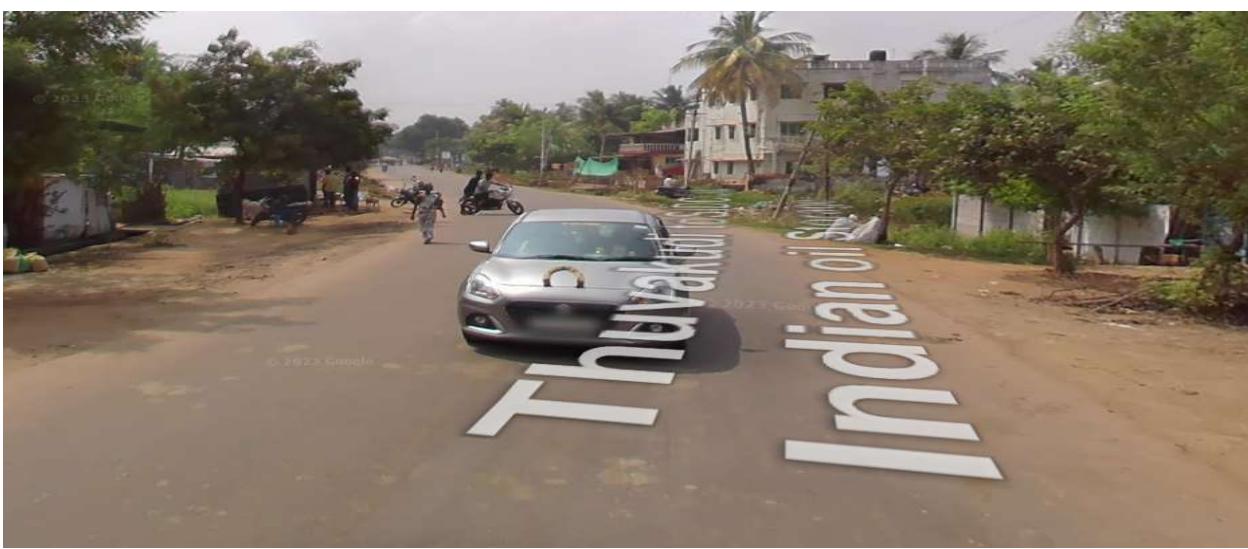
IMAGE: SHARP TURN RISK LEVEL: - MEDIUM, COORDI 10.755557510143007, 78.82964043768688

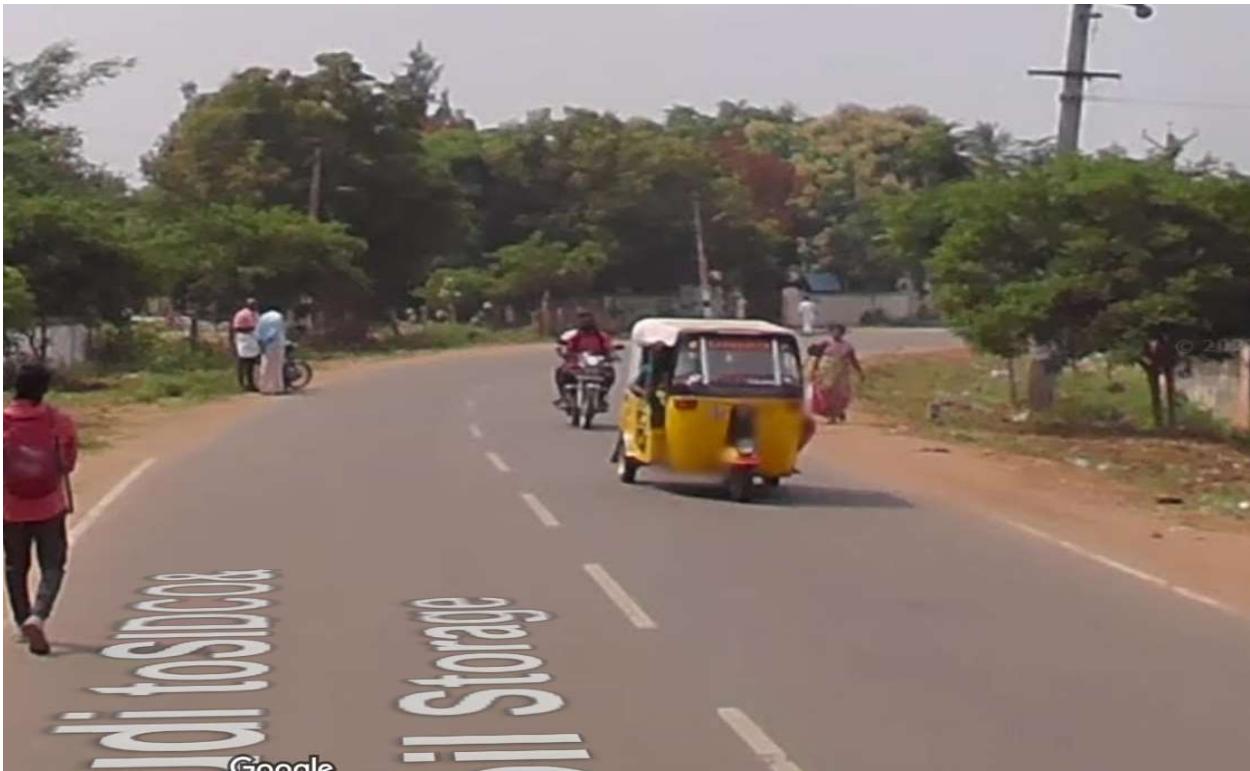
IMAGE: SHARP TURN RISK LEVEL: - MEDIUM, COORDI 10.752134298790681, 78.82718013759803

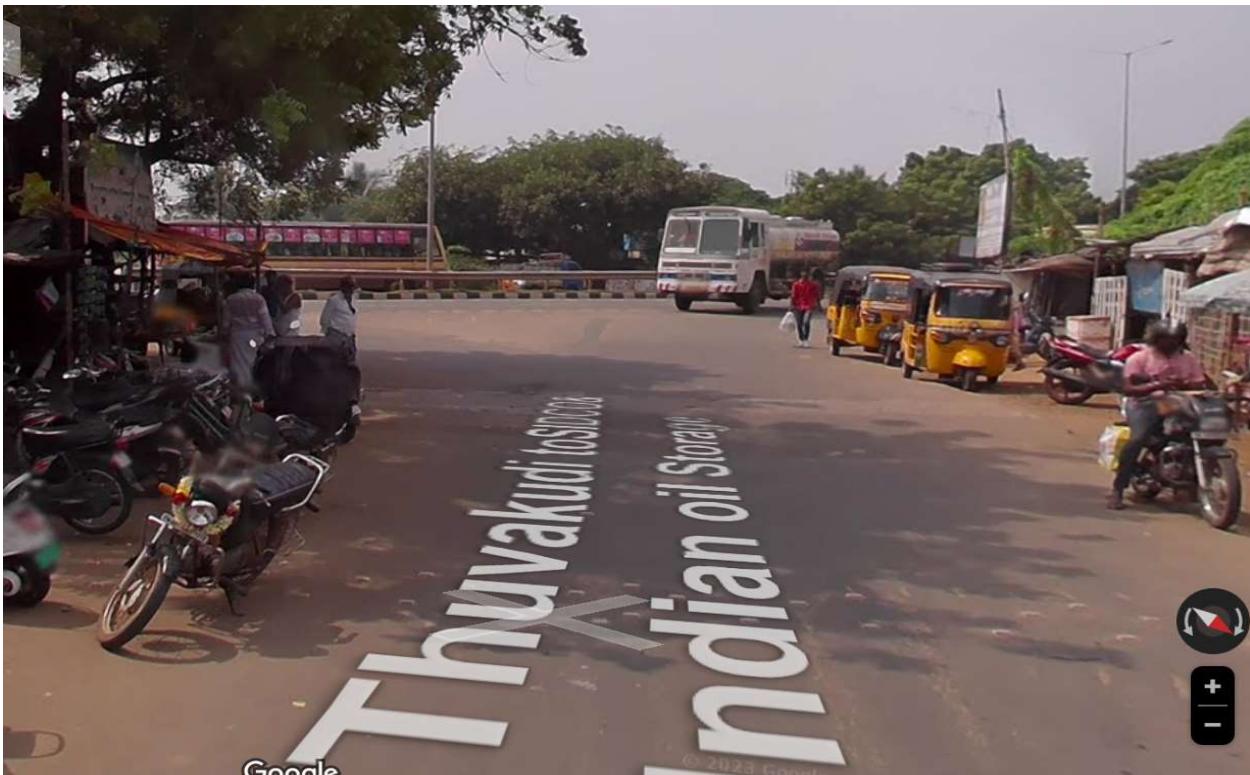
IMAGE: SHARP TURN RISK LEVEL: - MEDIUM, COORDI 10.75124649331893, 78.8252916438317

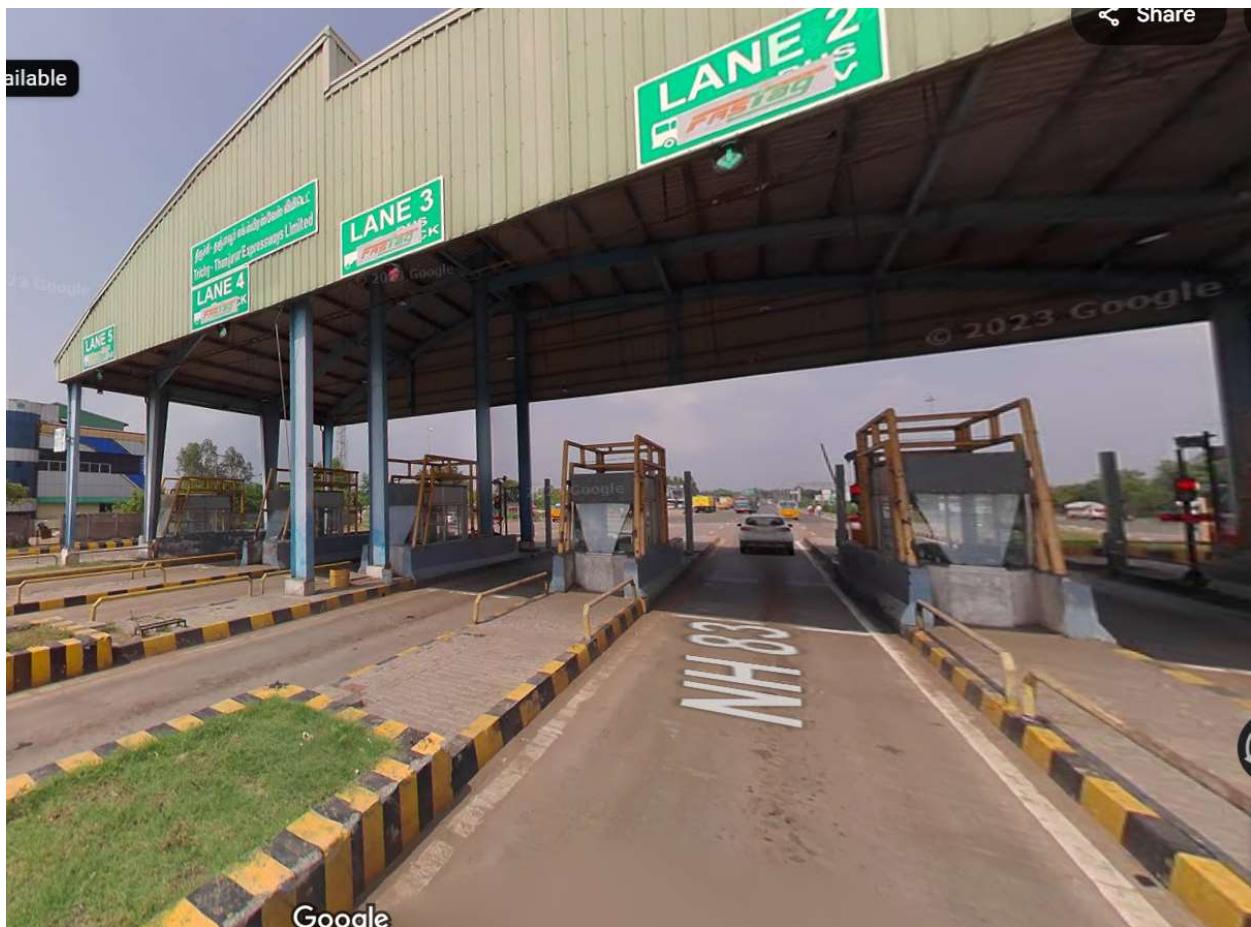
IMAGE: SHARP TURN RISK LEVEL: - MEDIUM, COORDI 10.744321179303157, 78.83417370199756

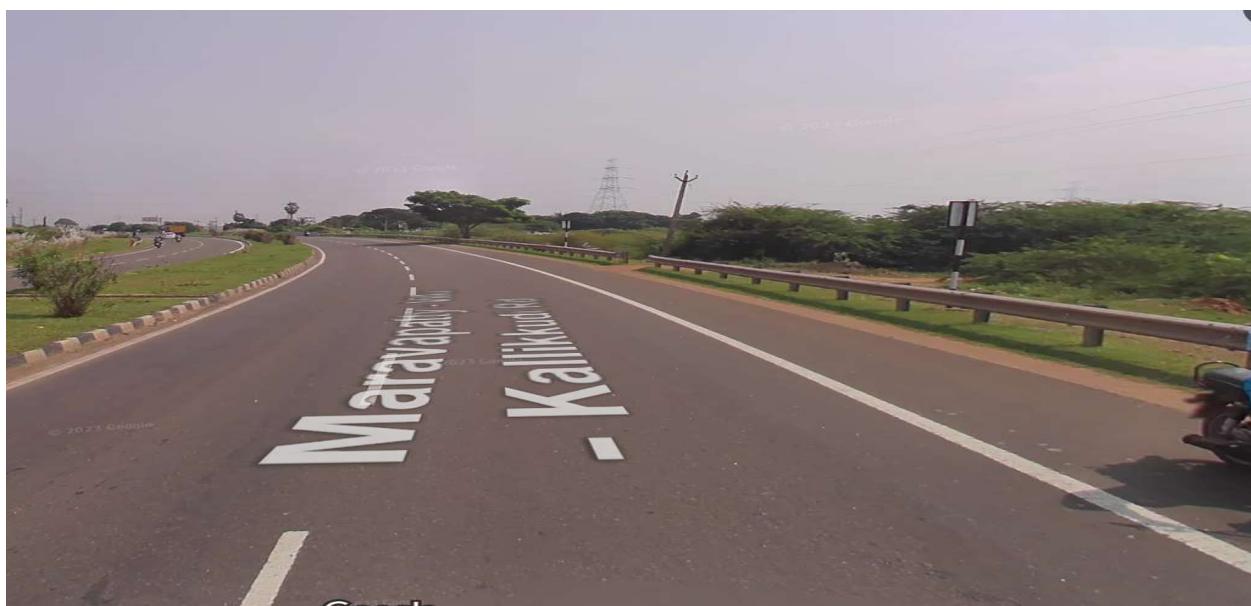
IMAGE: SHARP TURN RISK LEVEL: - MEDIUM, COORDI 10.739248384583261, 78.8381029124365

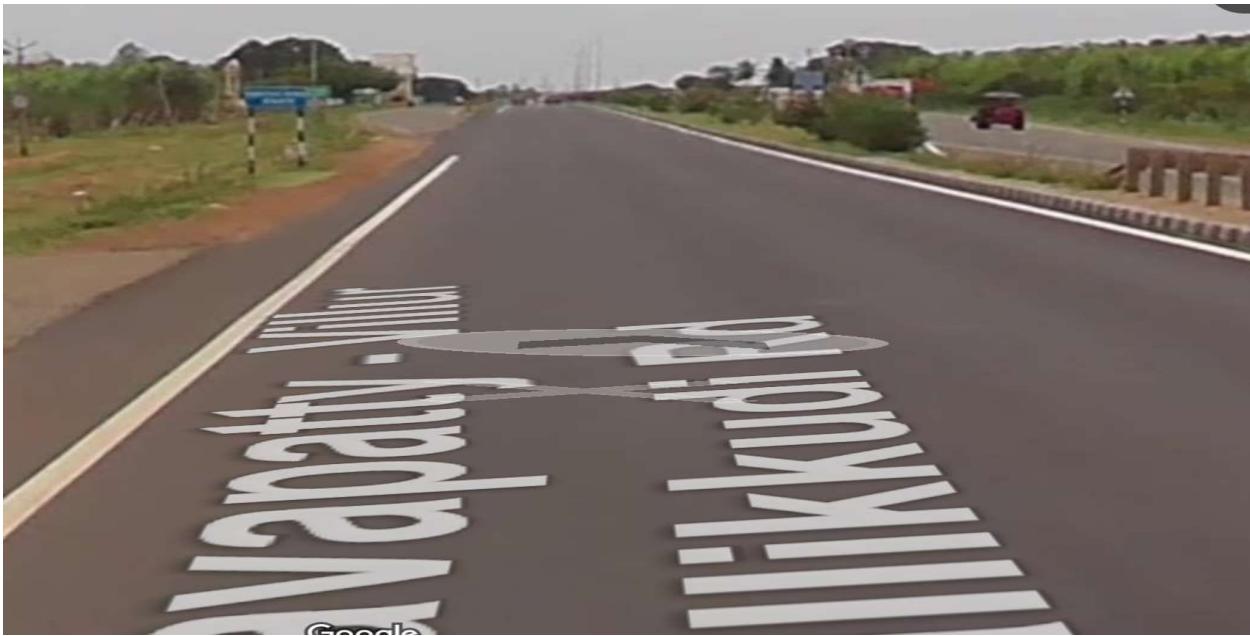
IMAGE: SHARP TURN RISK LEVEL: - MEDIUM, COORDI 10.729351757363672, 78.9111983896726

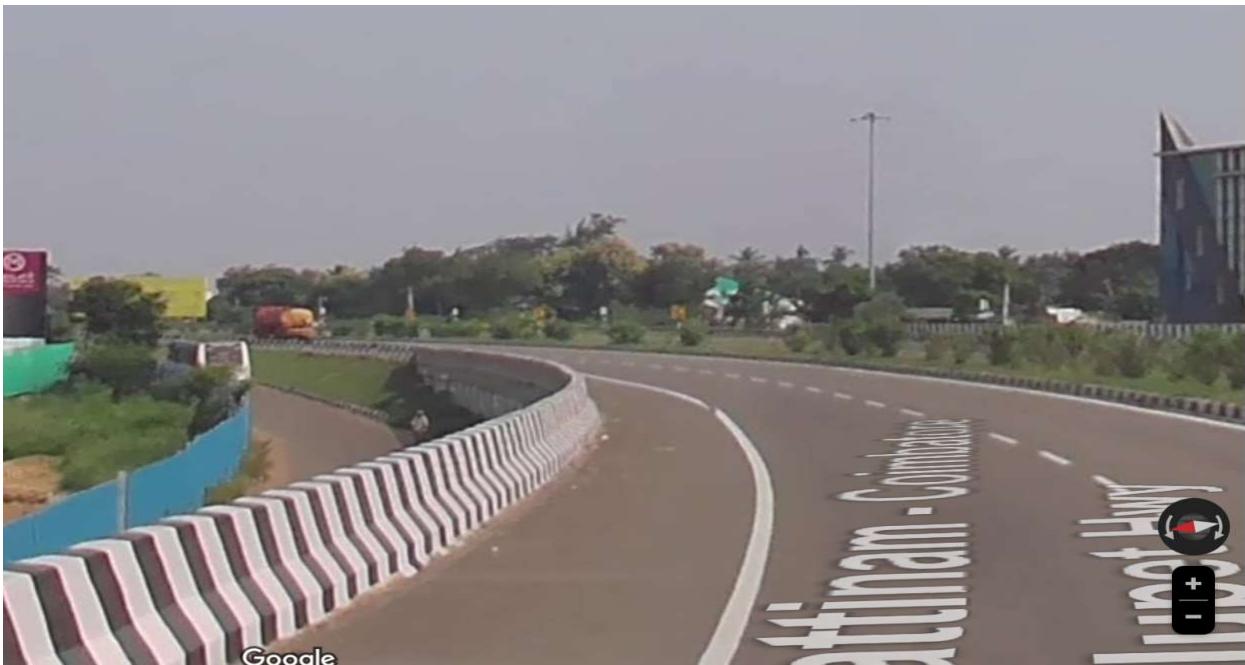
IMAGE: SHARP TURN RISK LEVEL: - MEDIUM, COORDI 10.722889017911928, 79.0708448272496

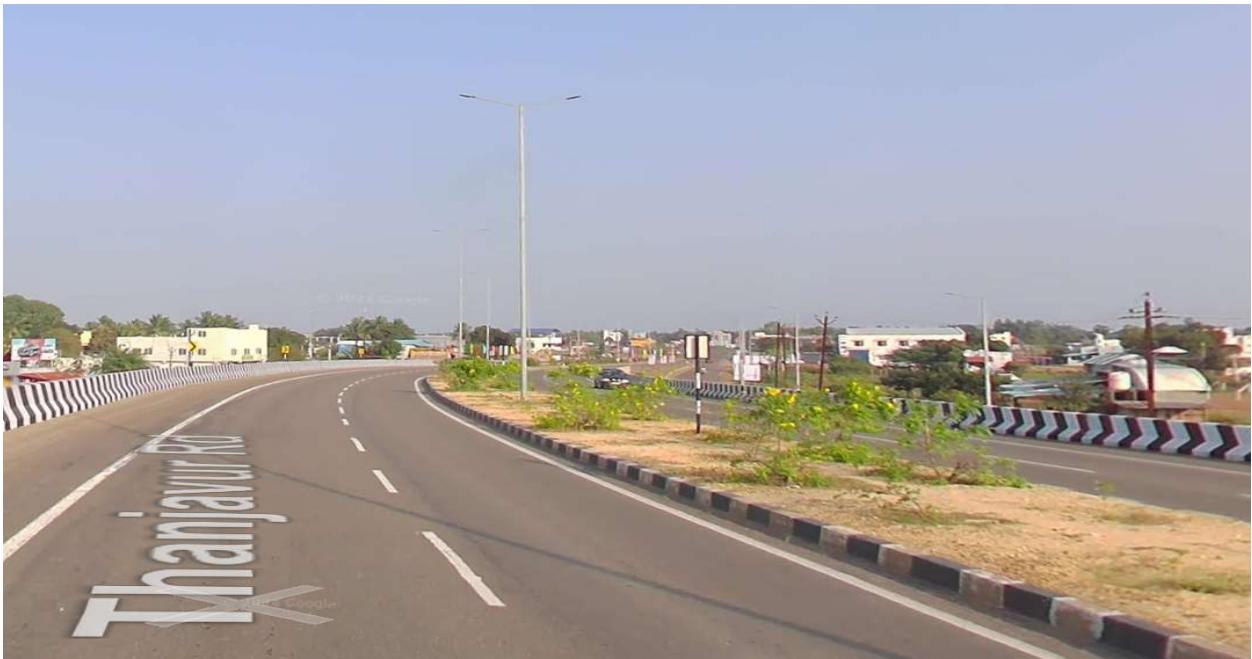
IMAGE: SHARP TURN RISK LEVEL: - MEDIUM, COORDI 10.737039321922905, 79.10617598879925

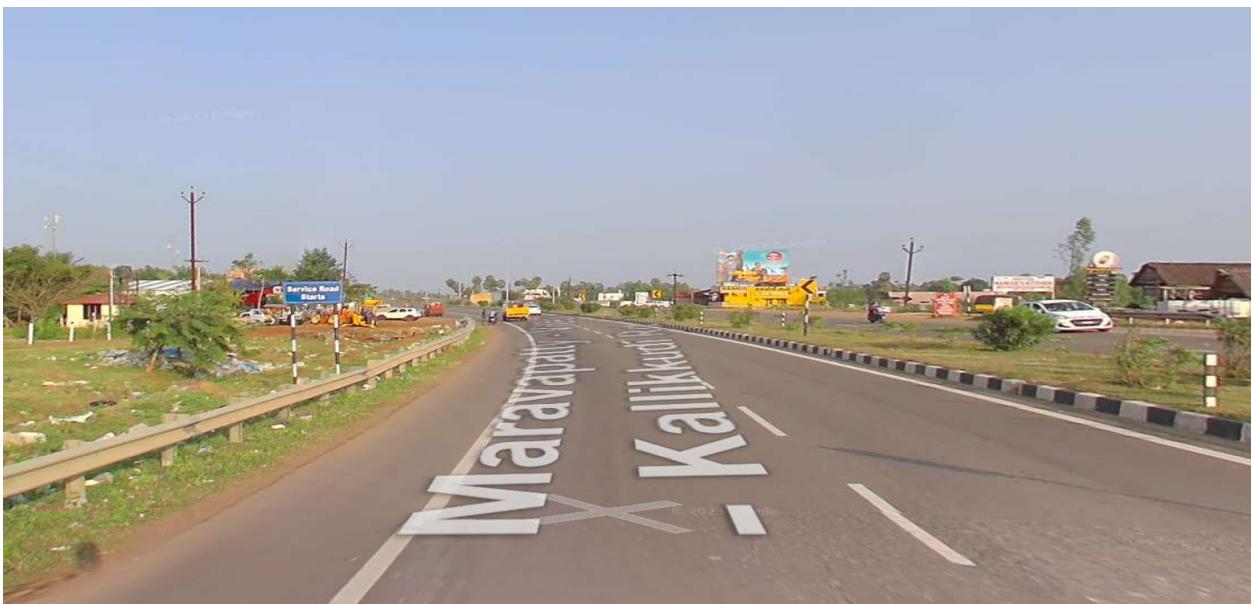
IMAGE: SHARP TURN RISK LEVEL: - MEDIUM, COORDI 0.736059554306644, 79.11087033763184

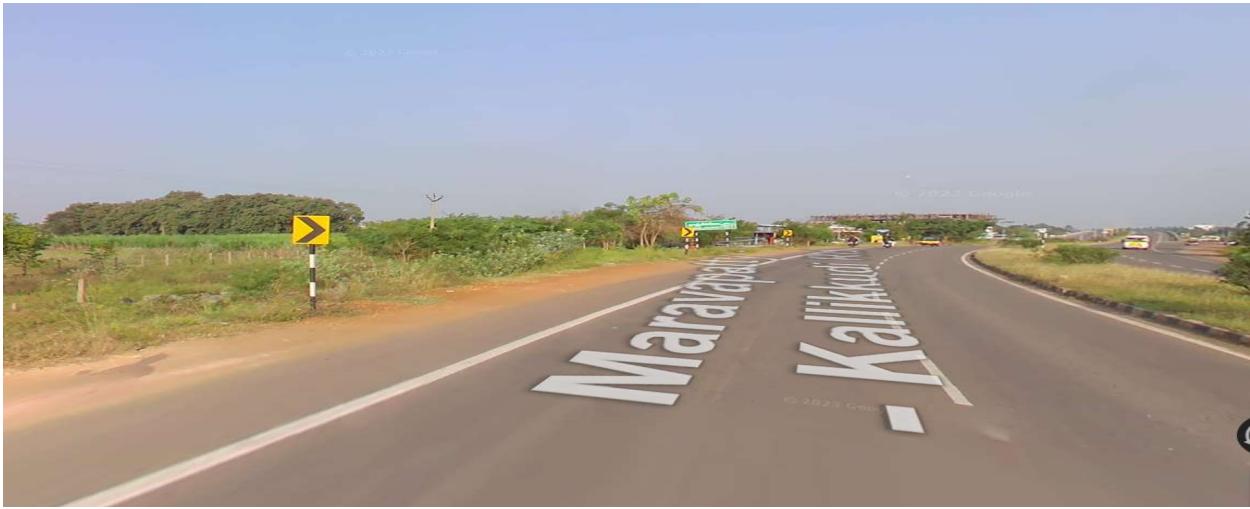
IMAGE: SHARP TURN RISK LEVEL: - MEDIUM, COORDI 10.742887598886316, 79.1339170990376

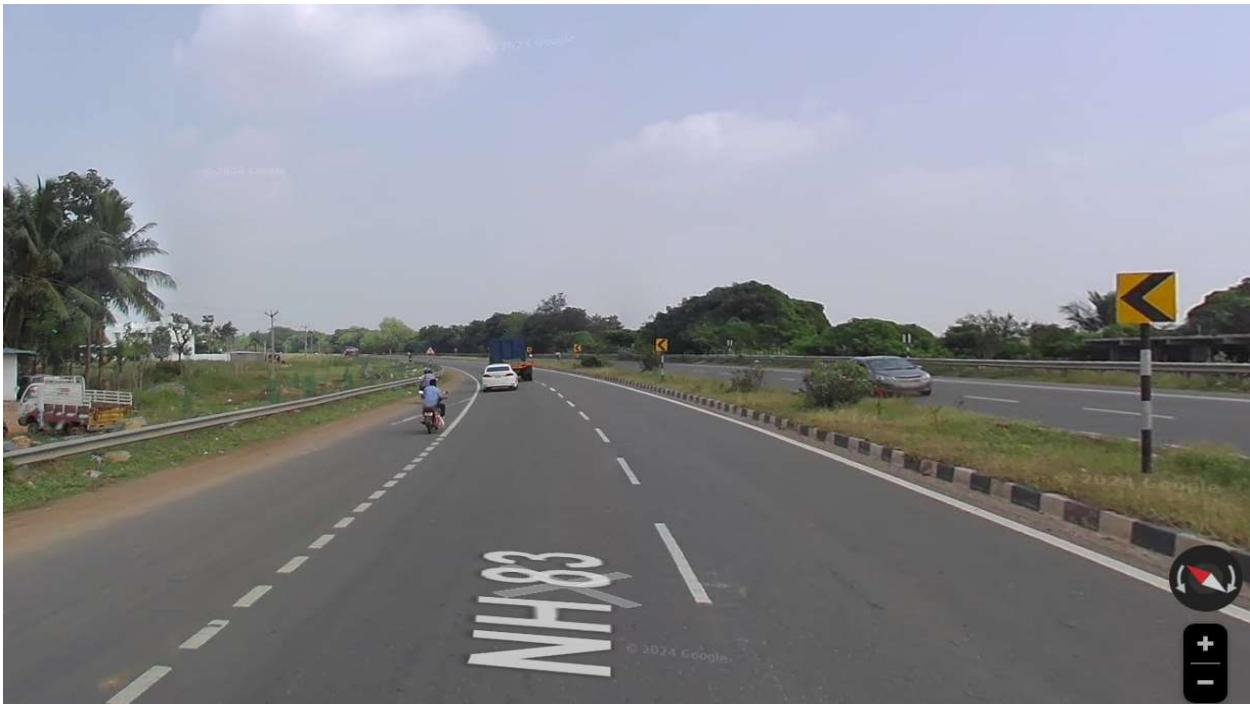
IMAGE: SHARP TURN RISK LEVEL: - MEDIUM, COORDI 10.743106188872718, 79.14359127001919

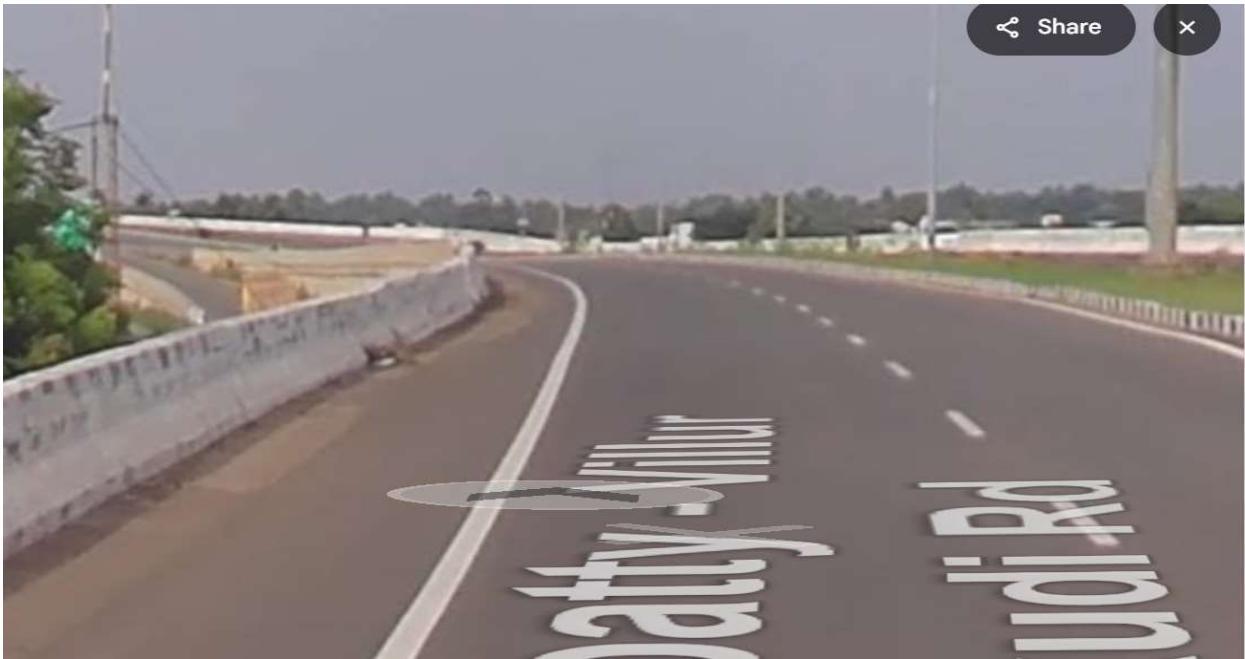
IMAGE: SHARP TURN RISK LEVEL: - MEDIUM, COORDI 10.767849216068843, 79.16395199458142

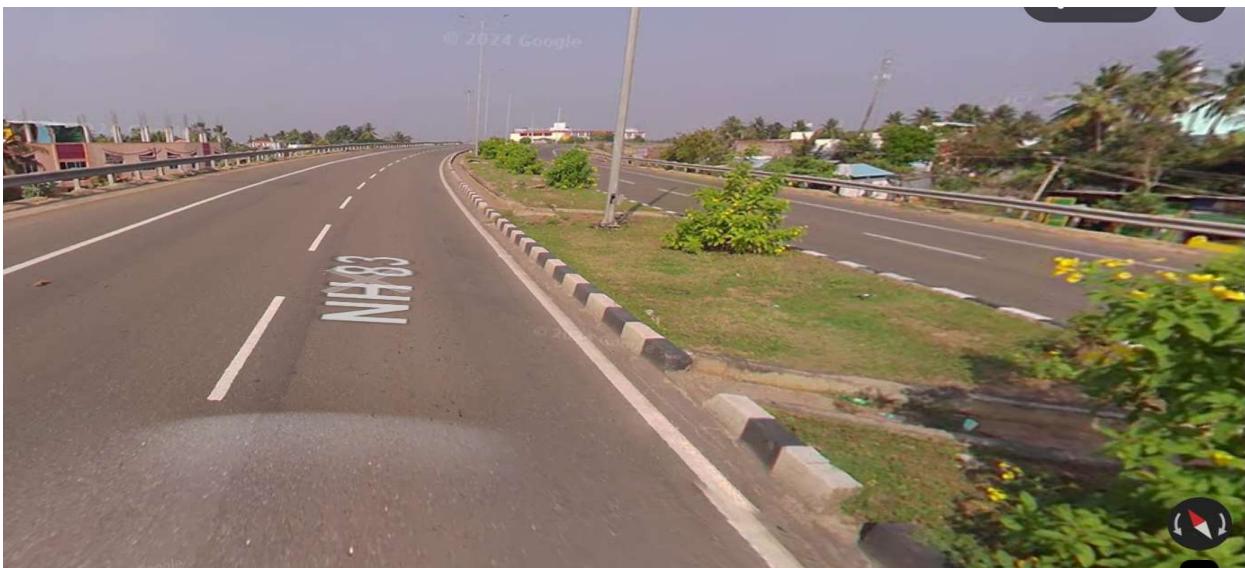
IMAGE: SHARP TURN RISK LEVEL: - MEDIUM, COORDI 10.779145184533025, 79.16673243634816

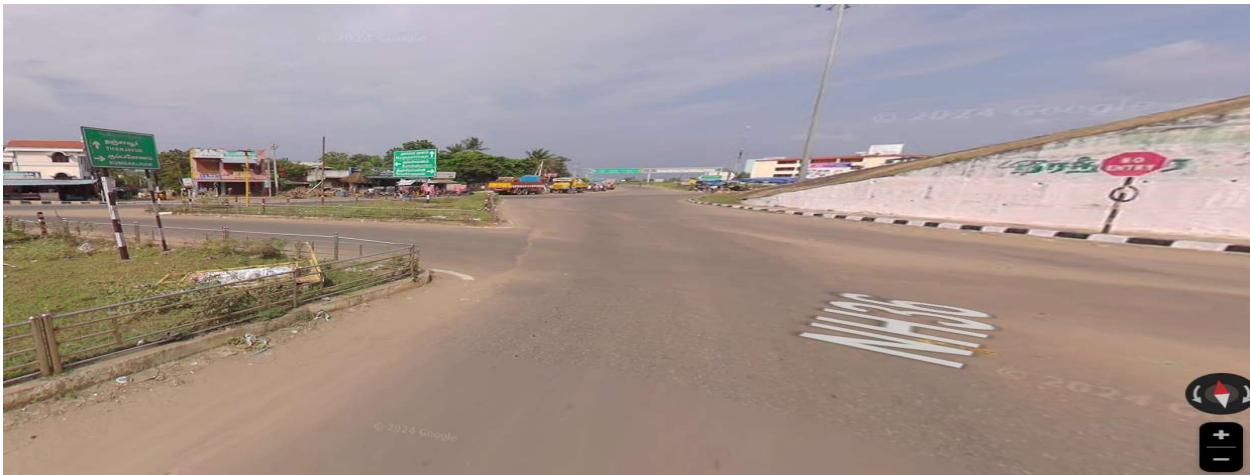
IMAGE: SHARP TURN RISK LEVEL: -MEDIUM, COORDI 10.780213541873538, 79.16759987567329

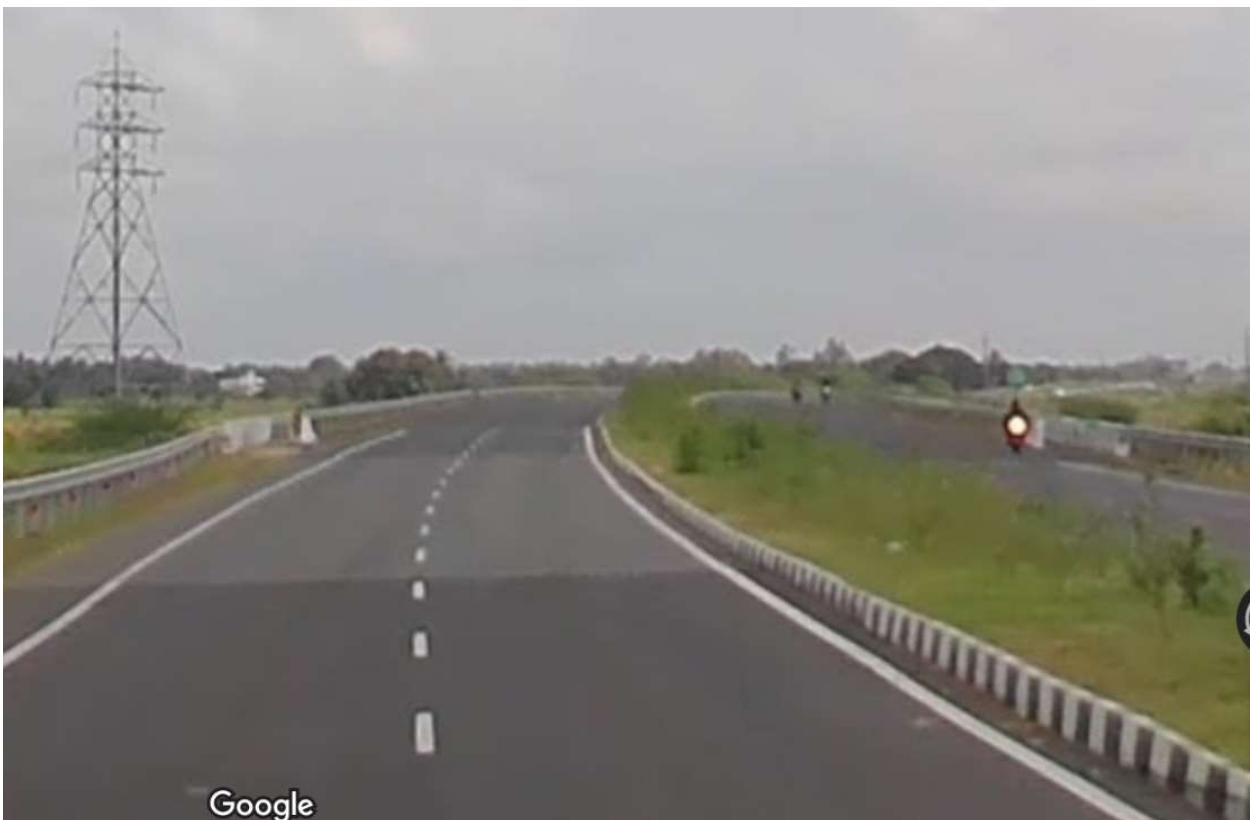
IMAGE: SHARP TURN RISK LEVEL: - BLIND SPOT , COORDI 10.82458958339195, 79.18257335314436

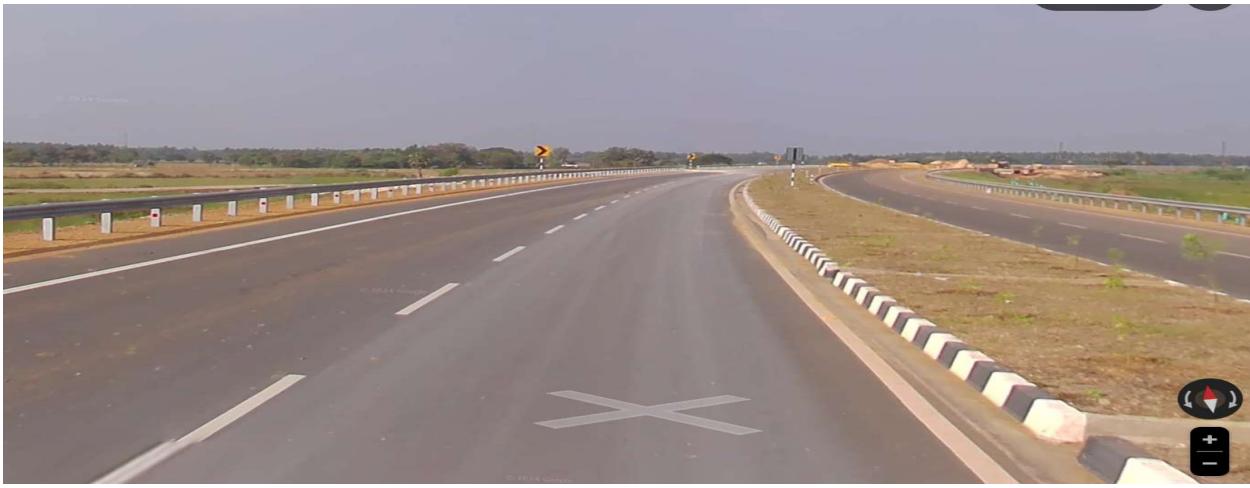
IMAGE: SHARP TURN RISK LEVEL: -MEDIUM, COORDI 10.86521583767493, 79.19284161784364

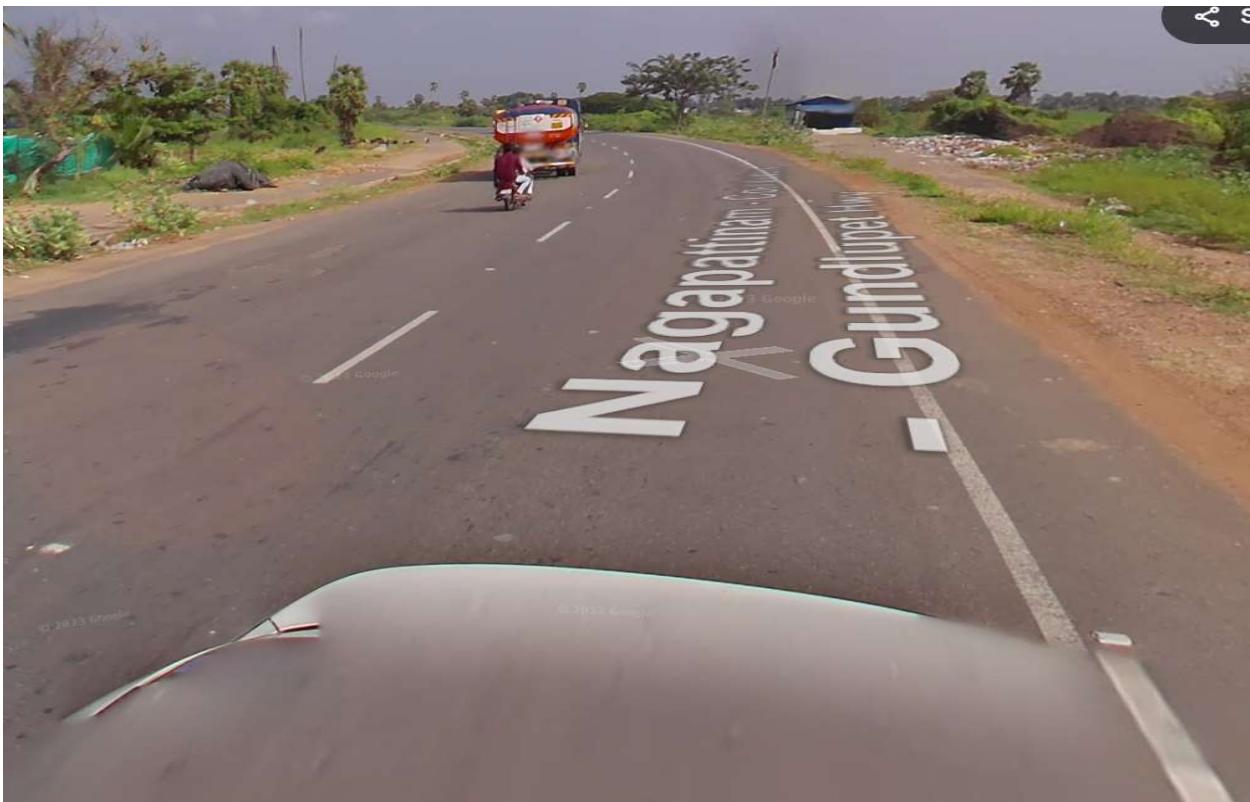
IMAGE: SHARP TURN RISK LEVEL: -MEDIUM, COORDI 10.78264888430246, 79.19827687817182

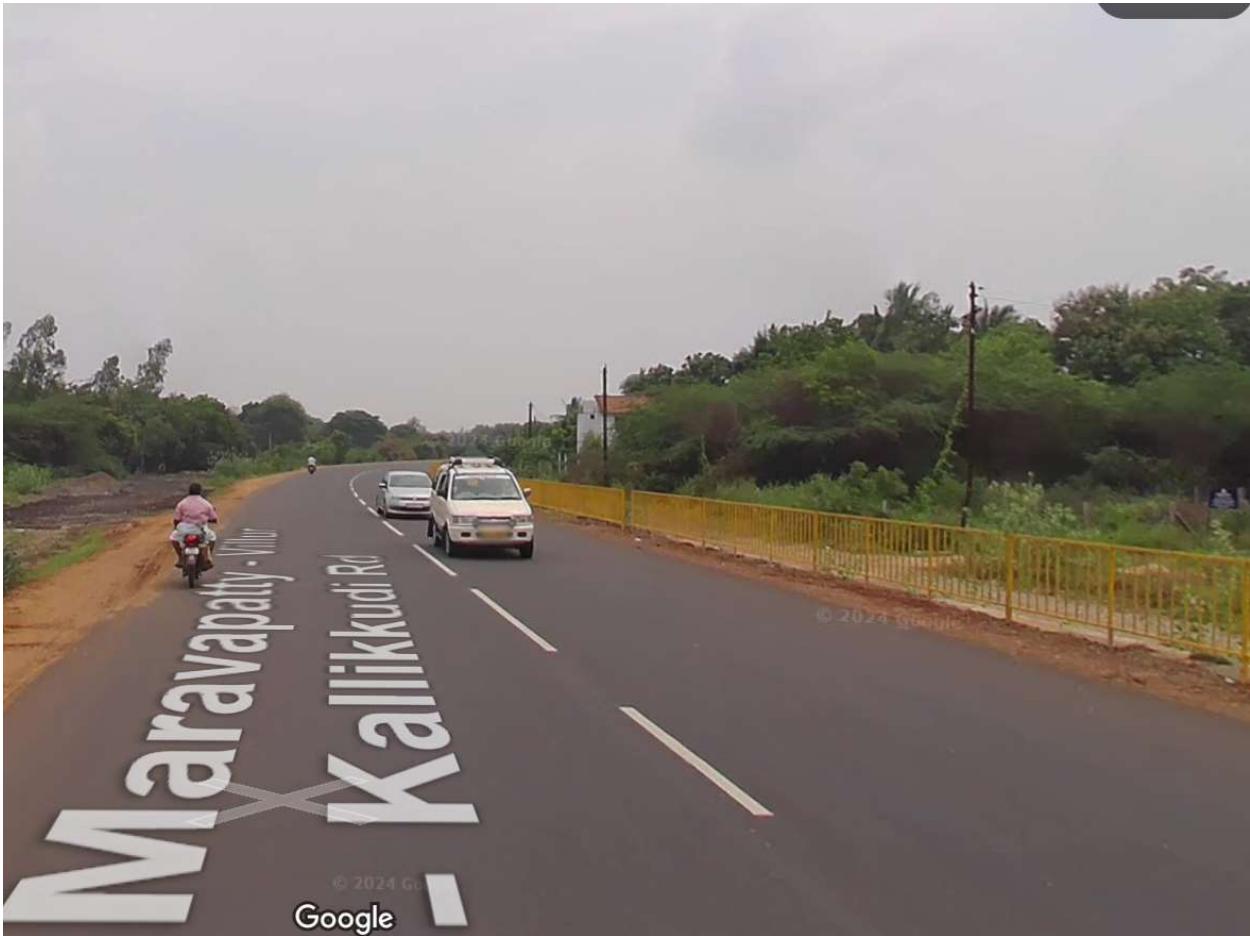
IMAGE: SHARP TURN RISK LEVEL: -MEDIUM, COORDI 10.780416257312543, 79.2379448355477

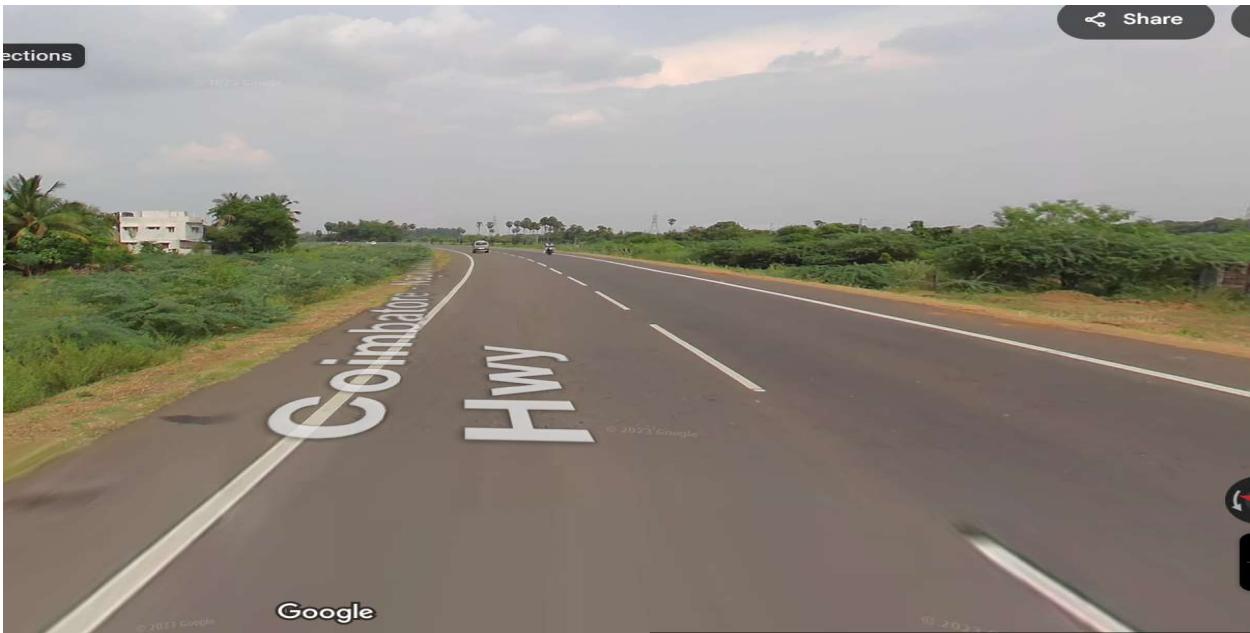
IMAGE: SHARP TURN RISK LEVEL: -MEDIUM , COORDI 10.777589957207995, 79.25308715211956

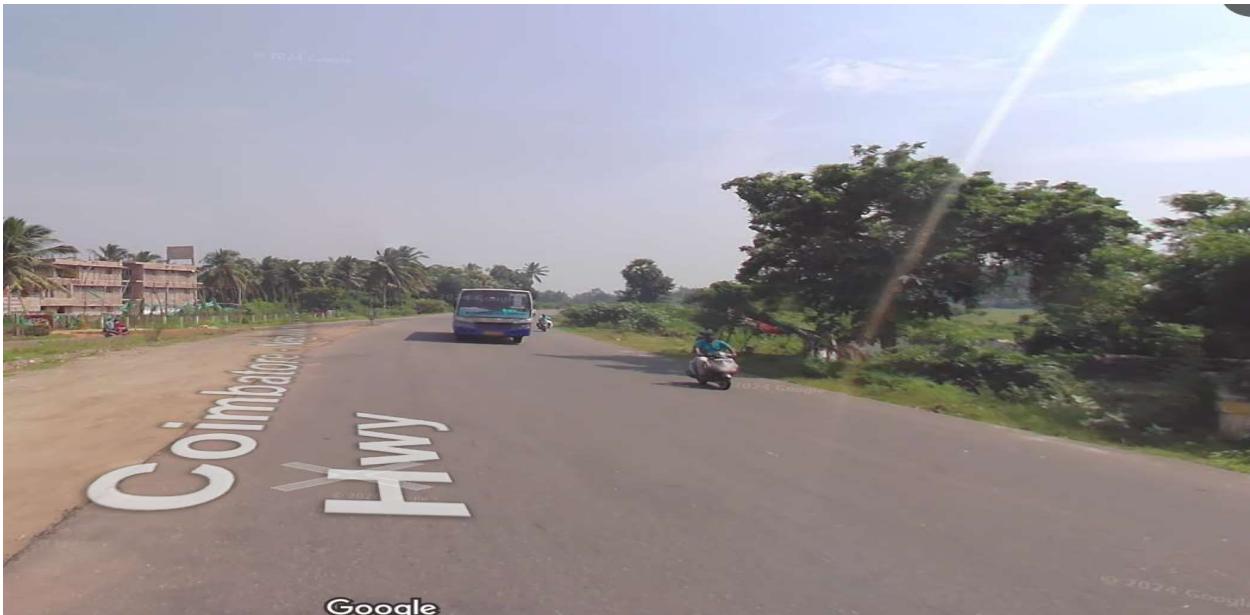
IMAGE: SHARP TURN RISK LEVEL: -MEDIUM, COORDI 10.780076298248042, 79.25832468636311

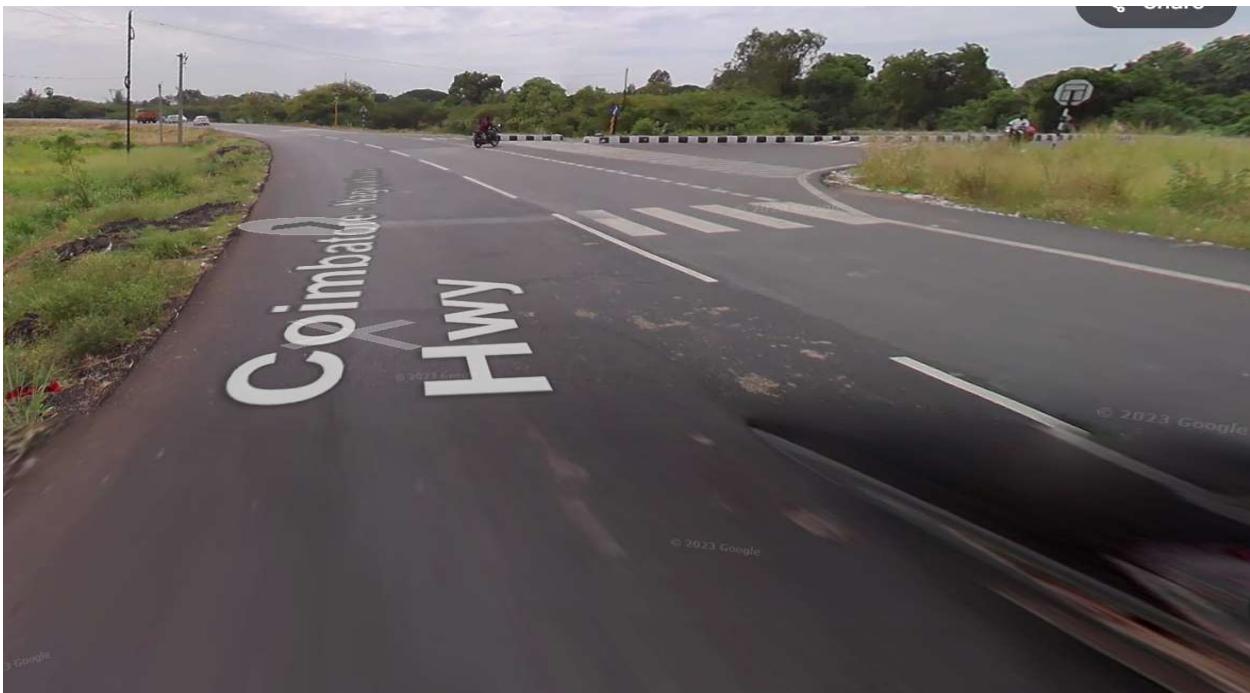
IMAGE: SHARP TURN RISK LEVEL: -MEDIUM , COORDI 10.780647803864088, 79.26569120395301

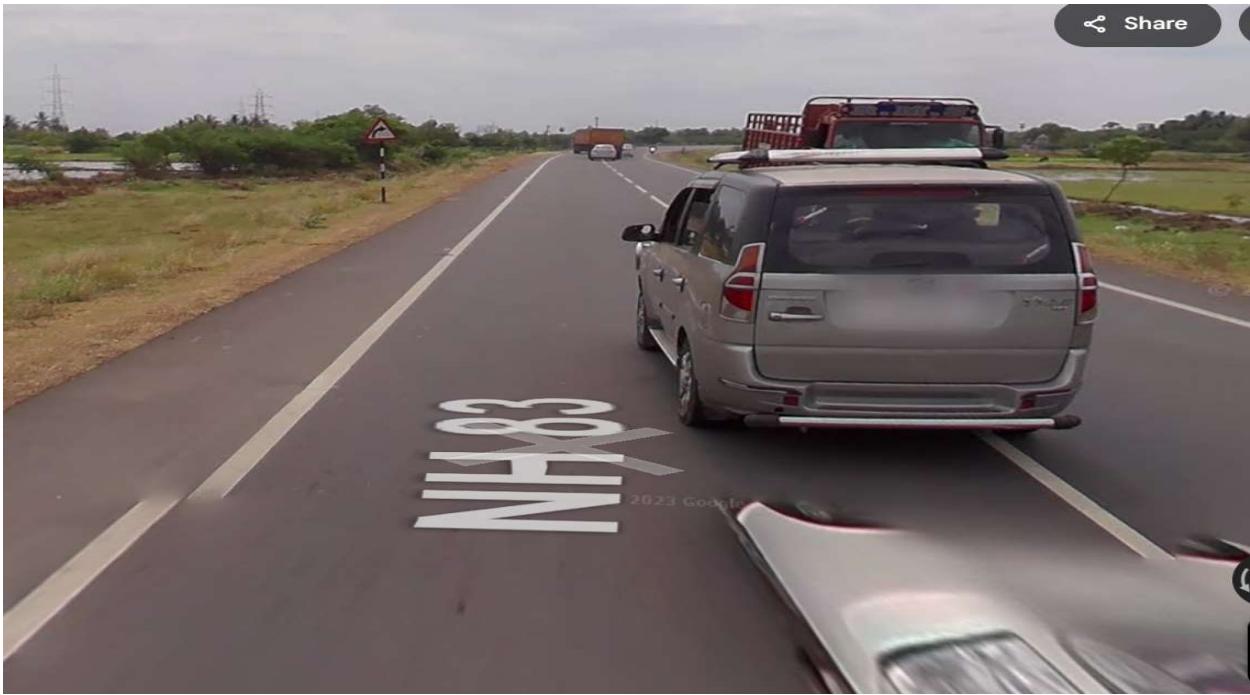
IMAGE: SHARP TURN RISK LEVEL: -MEDIUM, COORDI 10.790174840169144, 79.27781013069385

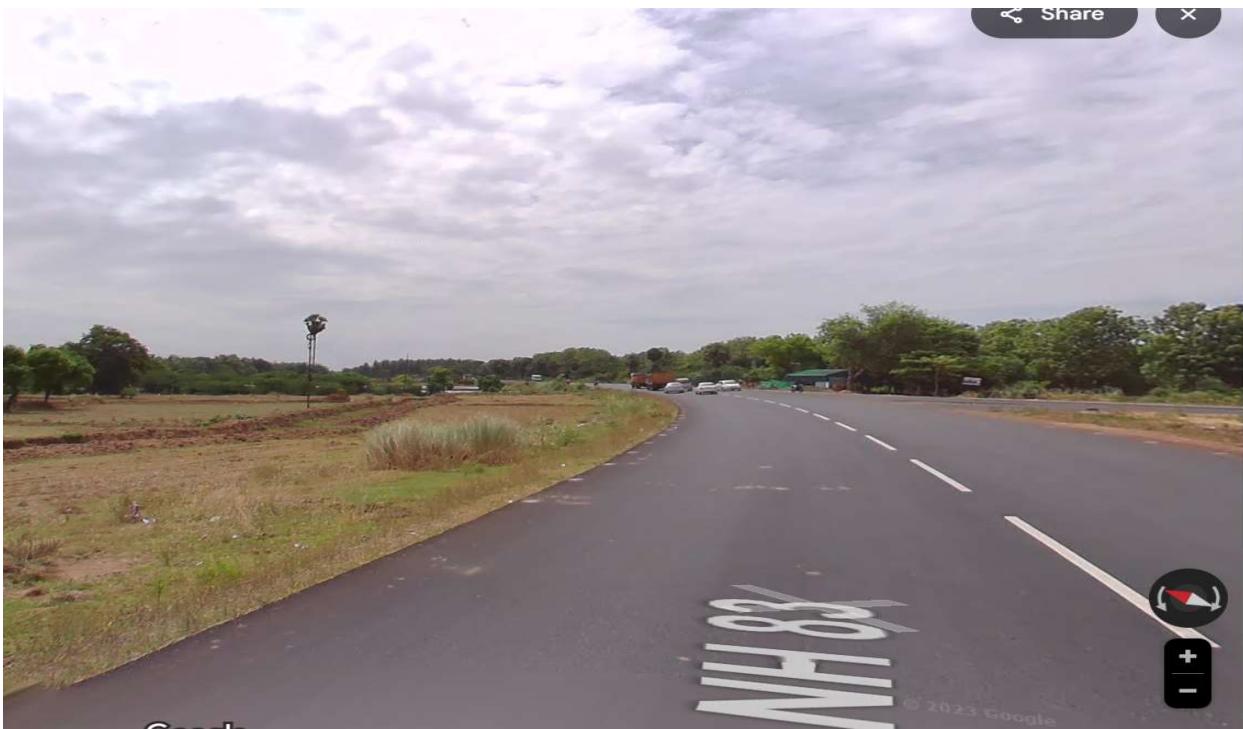
IMAGE: SHARP TURN RISK LEVEL: - MEDIUM , COORDI 10.78849870678751, 79.28802397538799

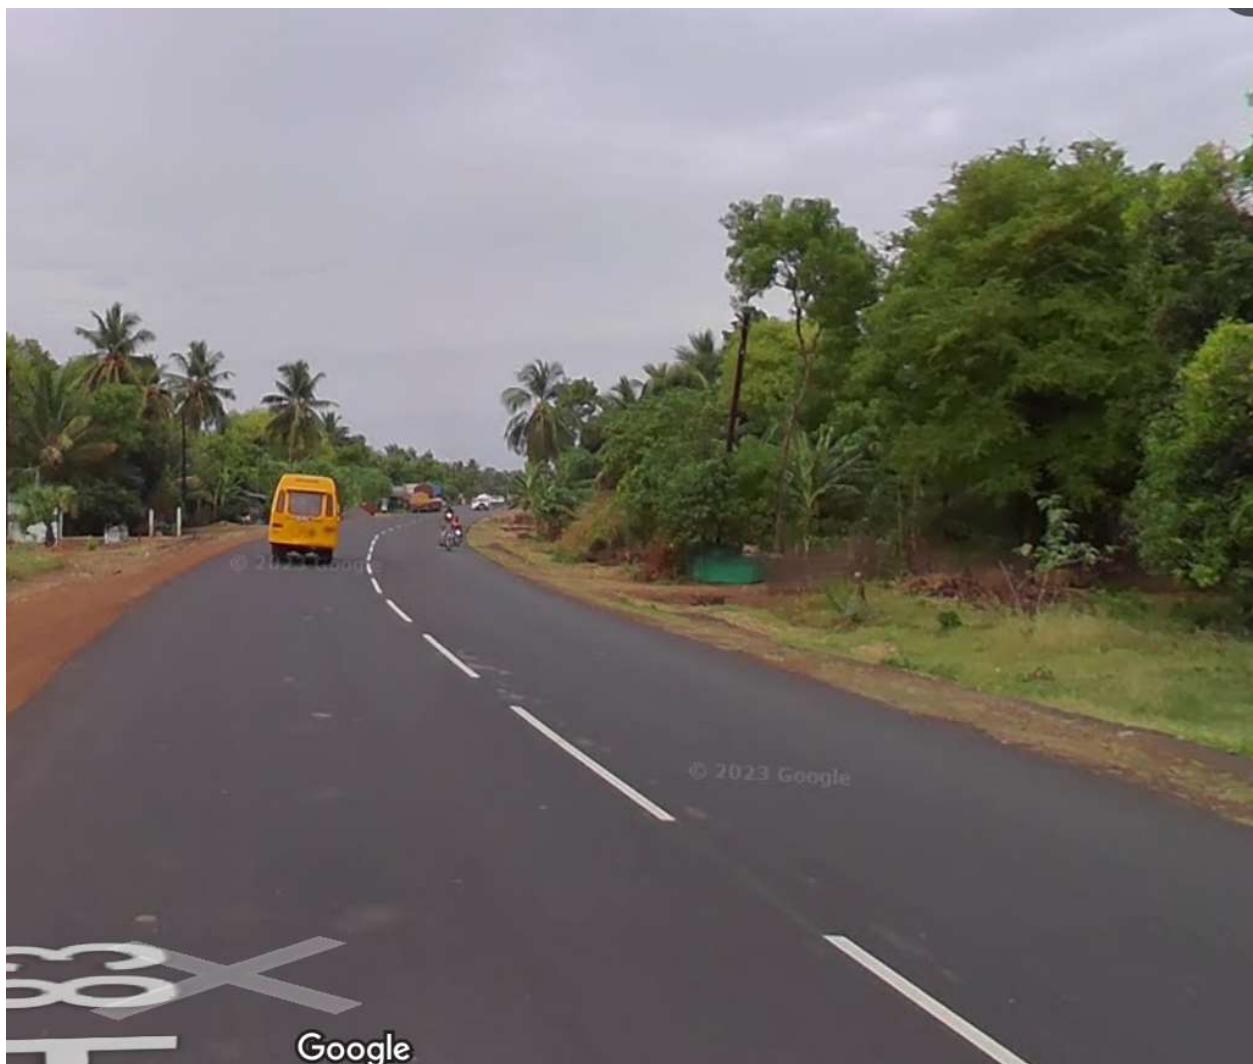
IMAGE: SHARP TURN RISK LEVEL: - BLIND SPOT , COORDI 10.790446113920844, 79.29450581645645
