WELCOME TO JOURNEY
RISK MANAGEMENT
(JRM) STUDY USING
ARTIFICIAL
INTELLIGENCE (AI)
FOR IOCL TRICHY
TERMINAL

IOCL TIRCHY TERMINAL (10.7753, 78.8368) TO VIMA ENTERPRISES, ,(11.077525 , 79.580841) TOTAL DISTANCE - 107KM

Welcome to the Journey Risk Management Study

for VIMA ENTERPRISES,,

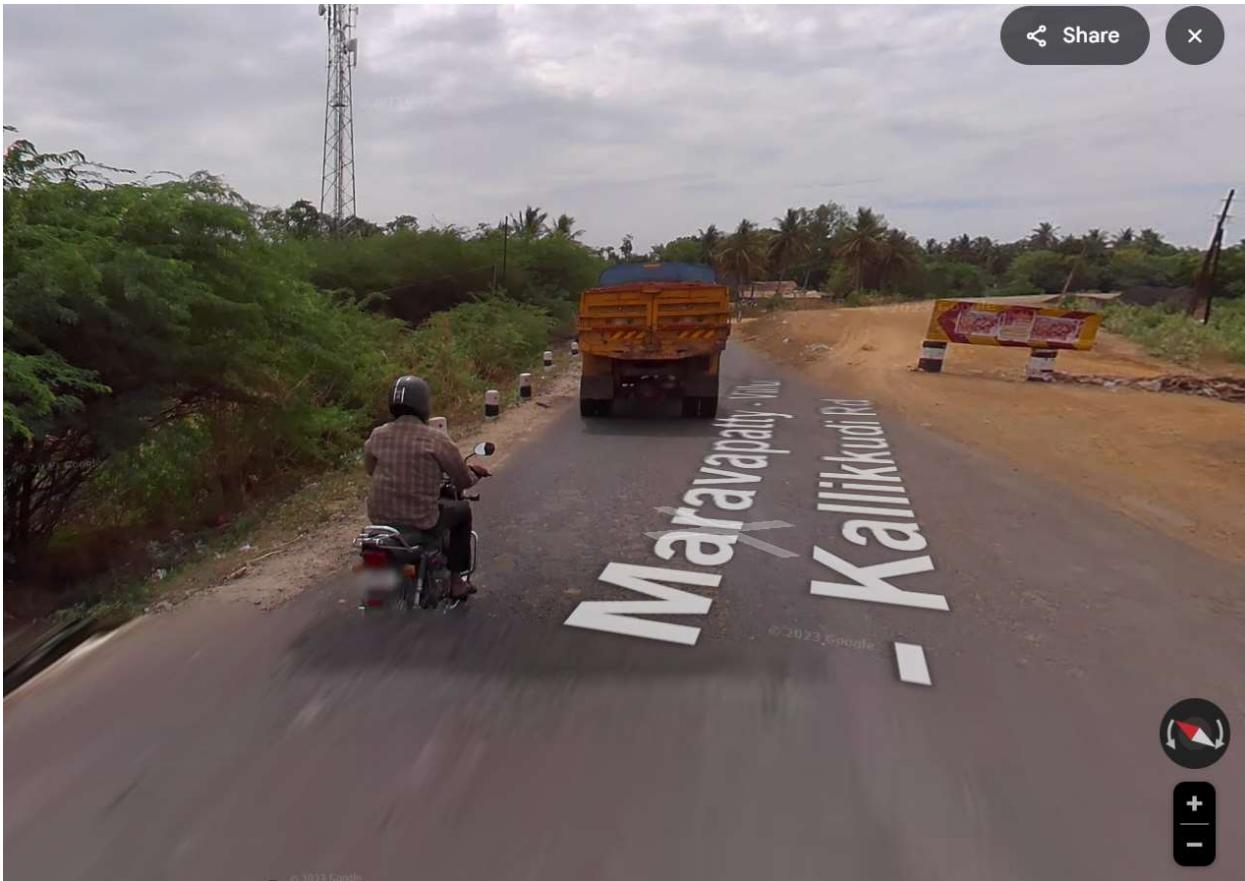
IMAGE: SHARP TURN RISK LEVEL: -MEDIUM, COORDI 10.792380219077335, 79.30826986447208

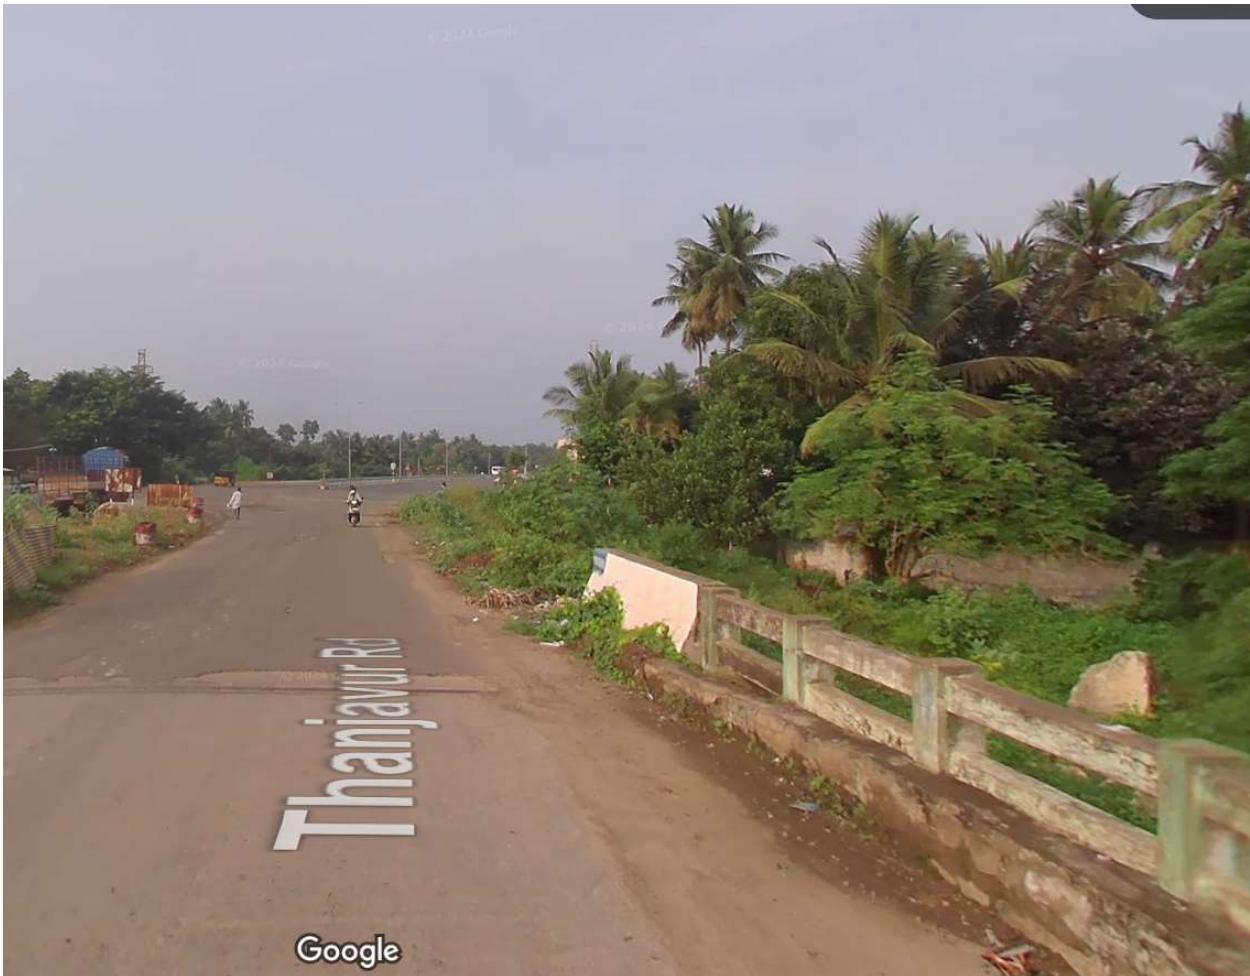
IMAGE: SHARP TURN RISK LEVEL:-MEDIUM, COORDI 10.982267525456553, 79.38847428720712

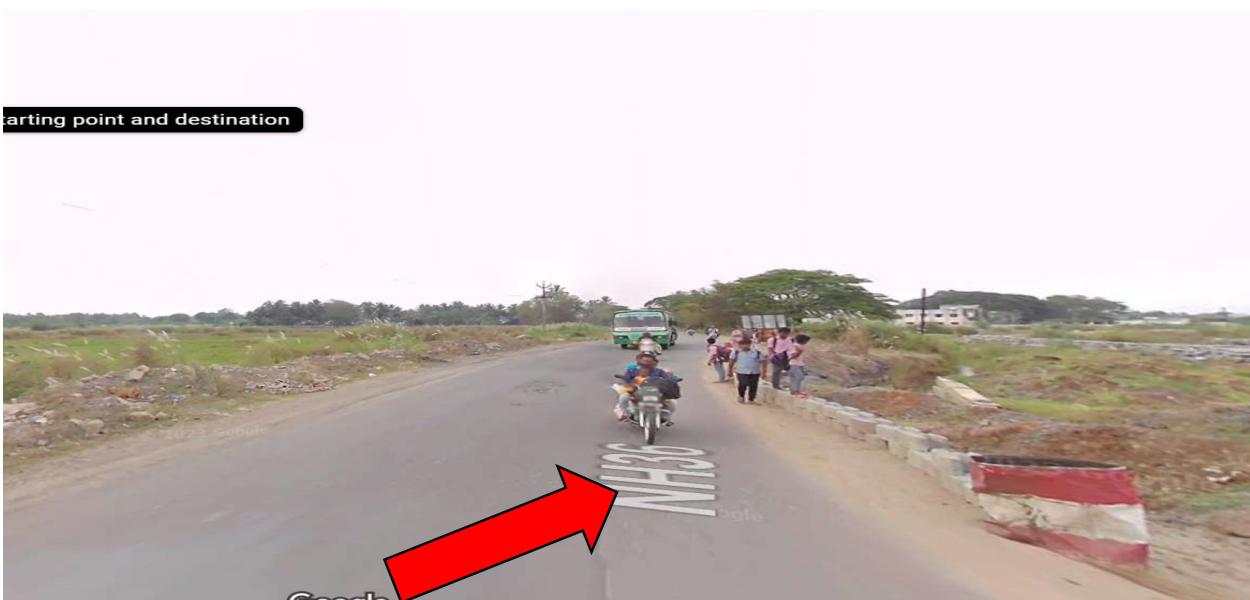
IMAGE: SHARP TURN RISK LEVEL: -MEDIUM, COORDI 11.043156034155047, 79.41068071798952

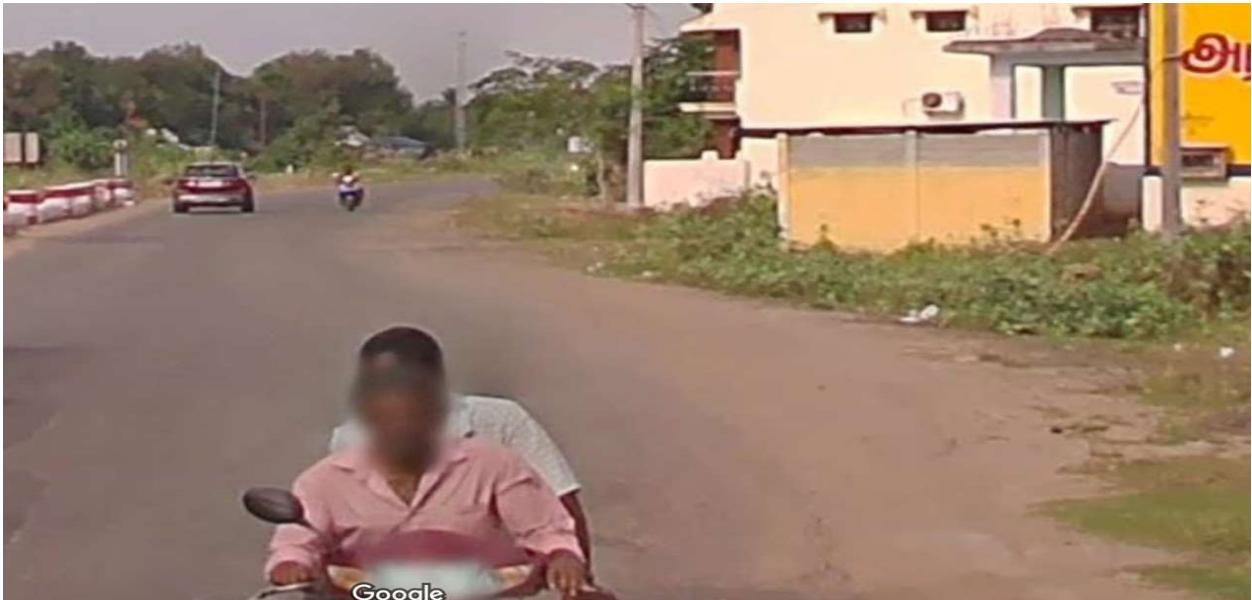
IMAGE: SHARP TURN RISK LEVEL: -MEDIUM, COORDI 11.061145786719607, 79.41817304645129

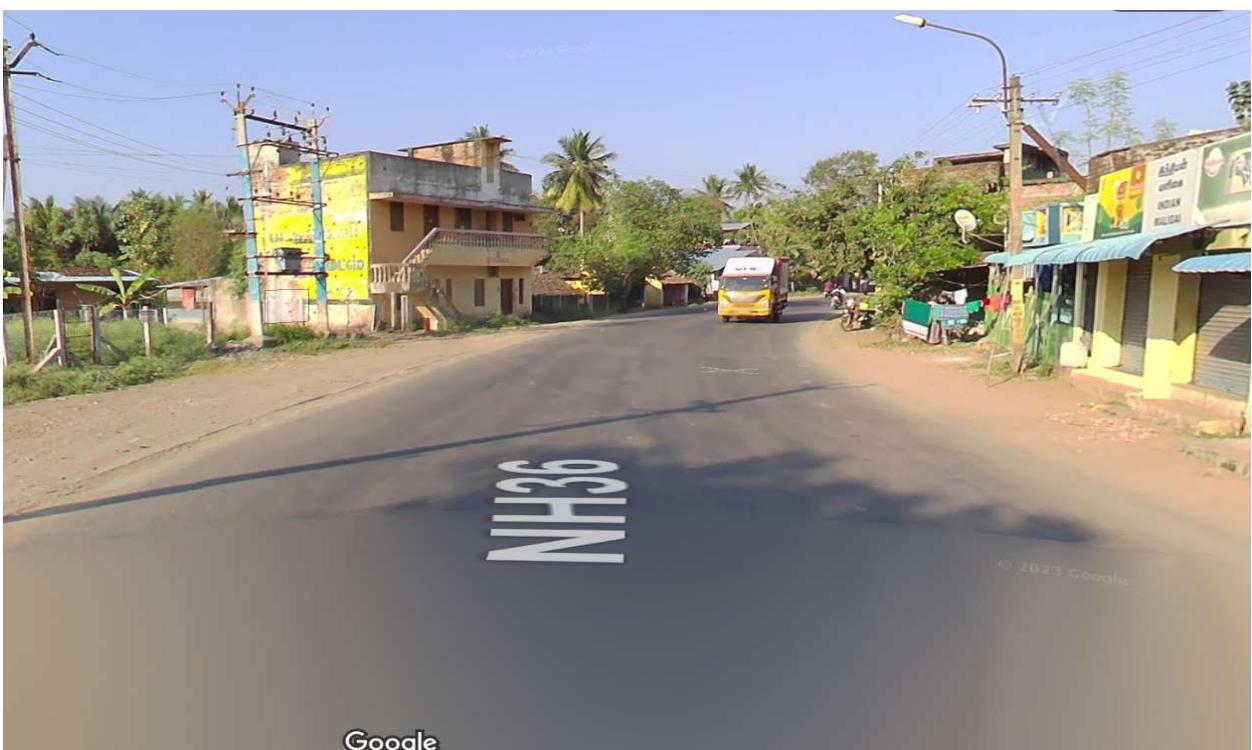
IMAGE: SHARP TURN RISK LEVEL: -MEDIUM, COORDI 11.089025354462414, 79.45051529795313

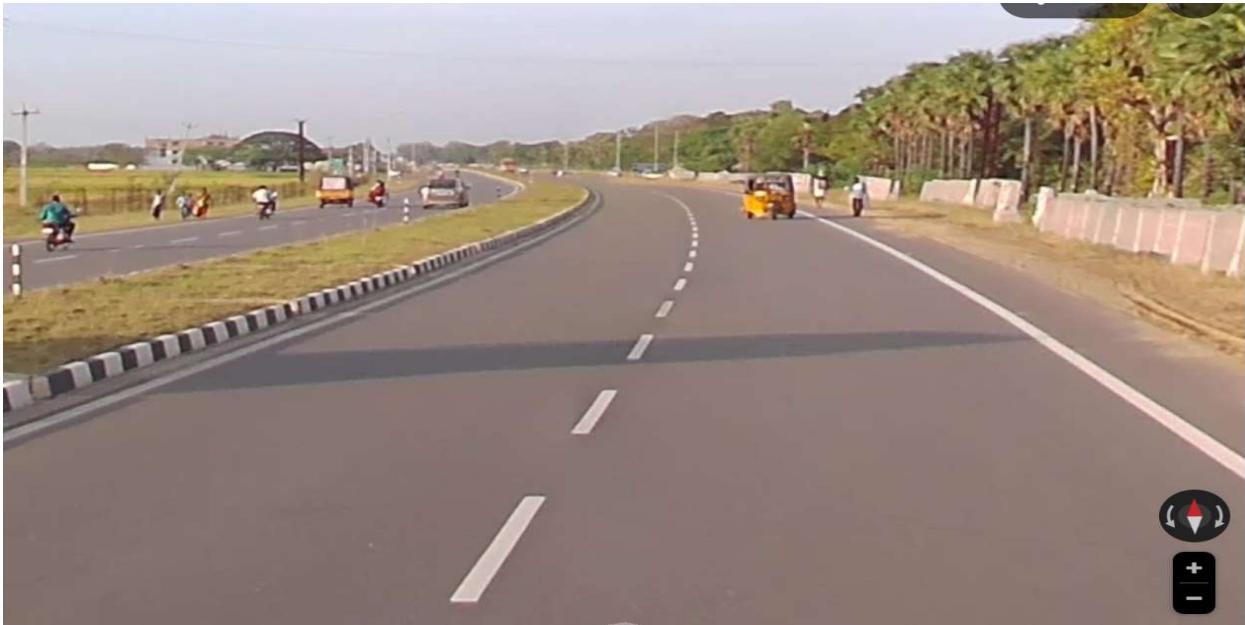
IMAGE: SHARP TURN RISK LEVEL: -MEDIUM, COORDI 11.010559991808481, 79.40771232610331

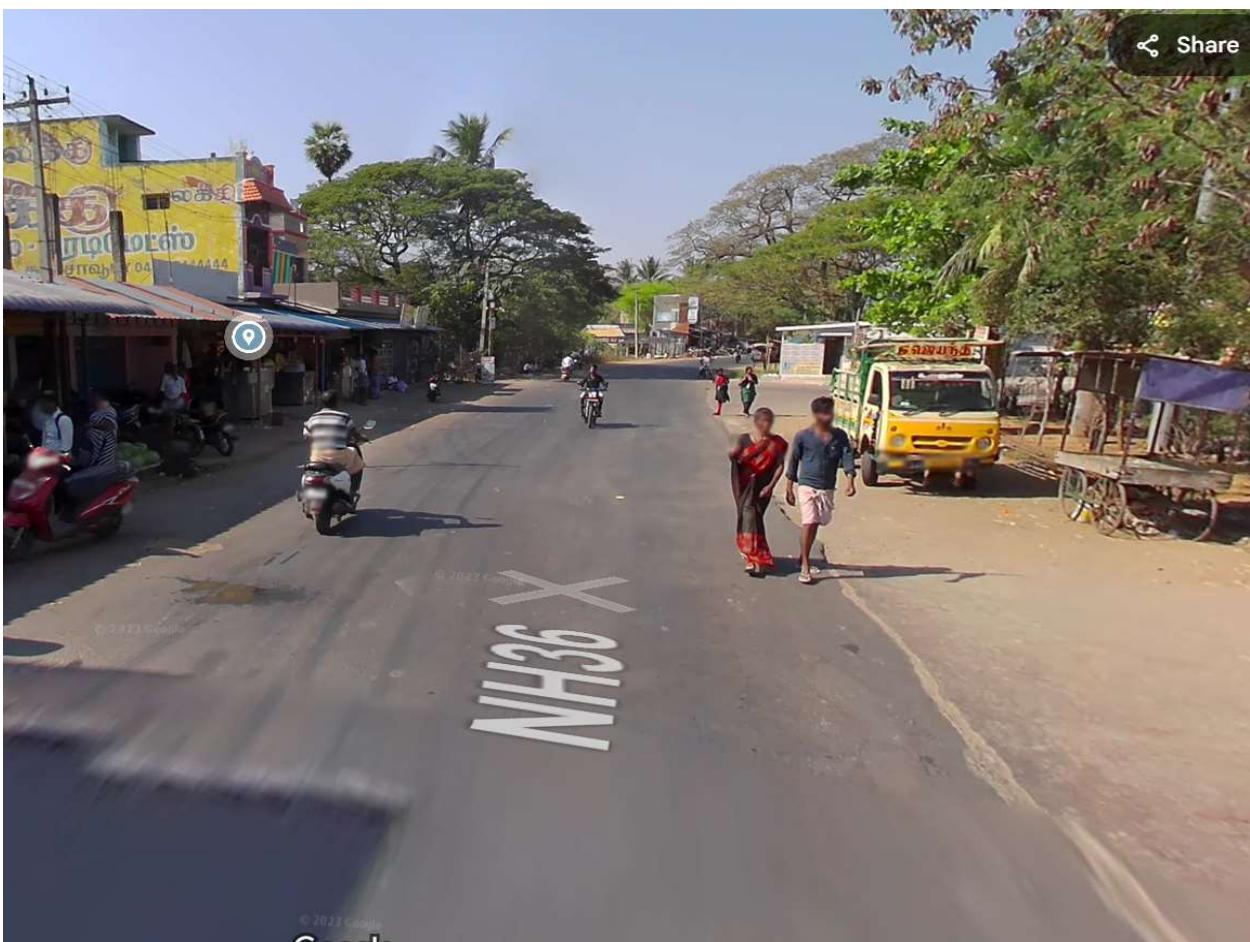
IMAGE: SHARP TURN RISK LEVEL: -MEDIUM, COORDI 11.094631280176856, 79.45314082348497

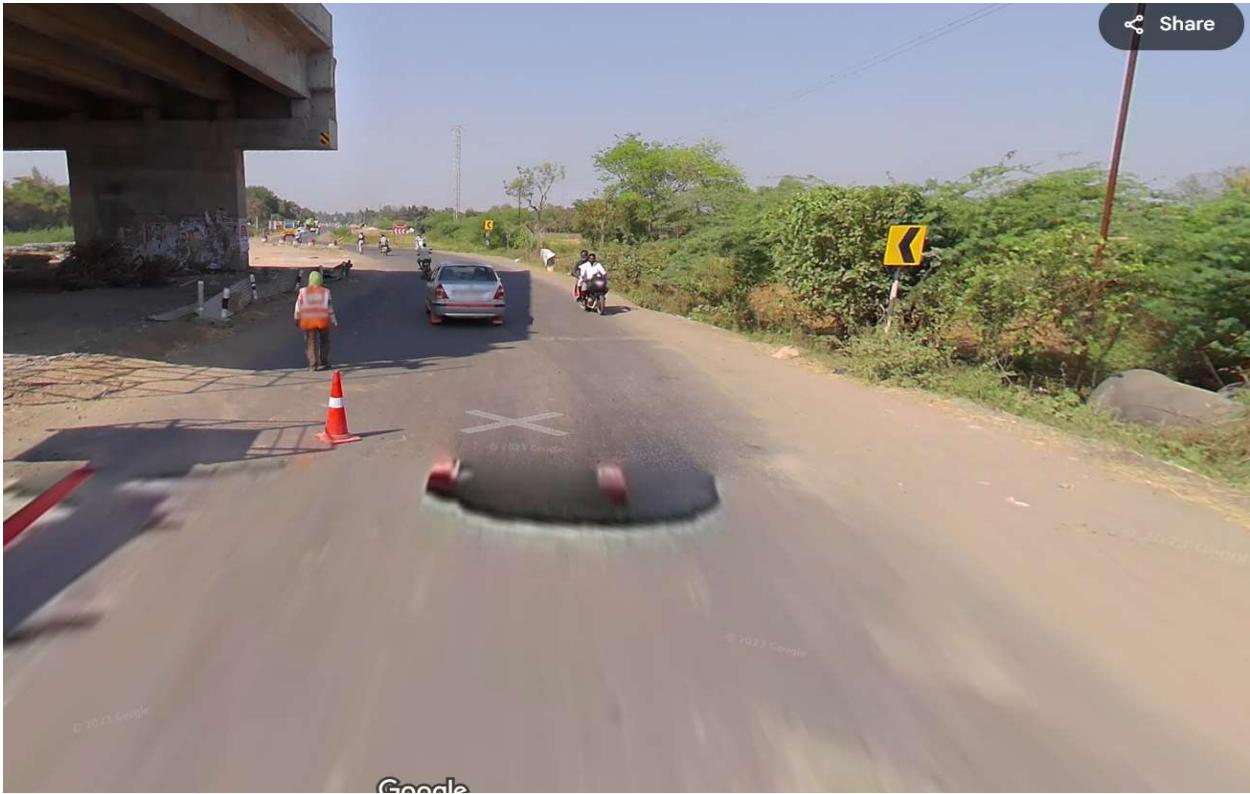
IMAGE: SHARP TURN RISK LEVEL: -MEDIUM, COORDI 11.102290448291411, 79.45459760924864

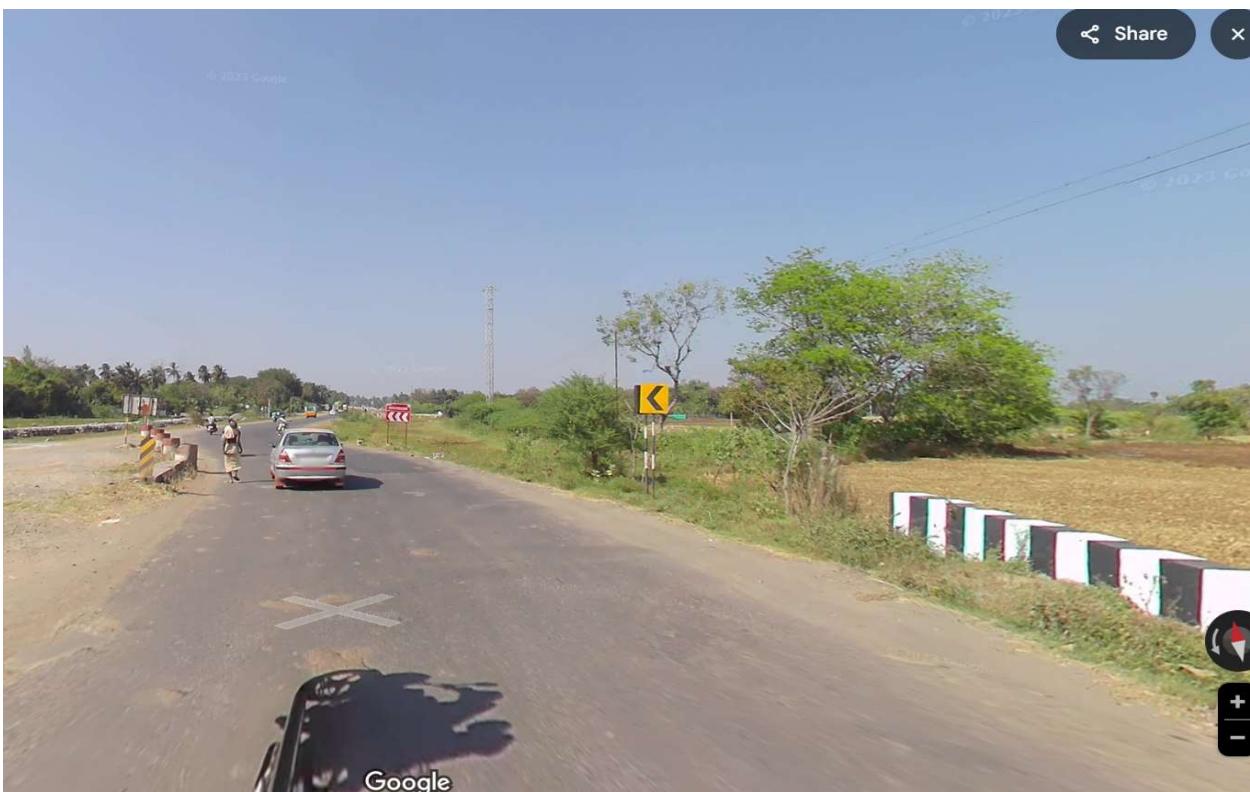
IMAGE: SHARP TURN RISK LEVEL: - MEDIUM , COORDI 11.102580198227484, 79.45436398783474

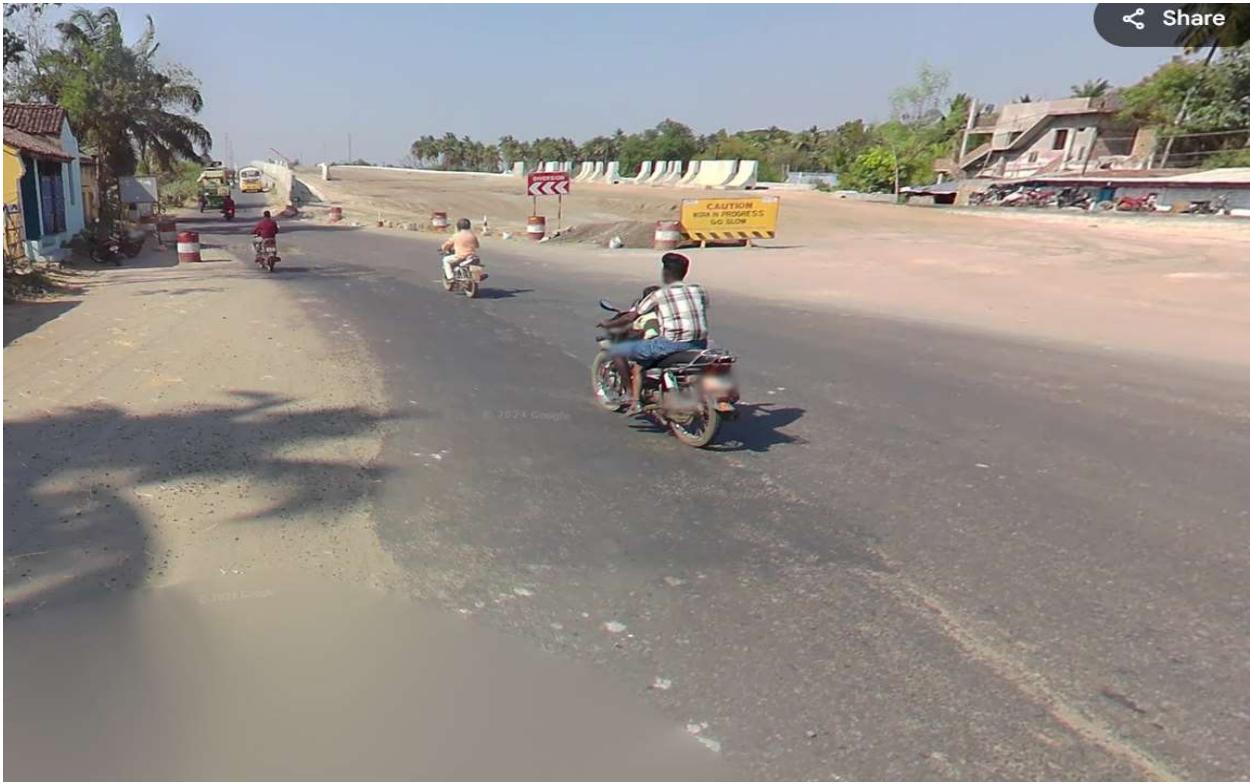
IMAGE: SHARP TURN RISK LEVEL: - MEDIUM, COORDI 11.109026489562, 79.45561762346365

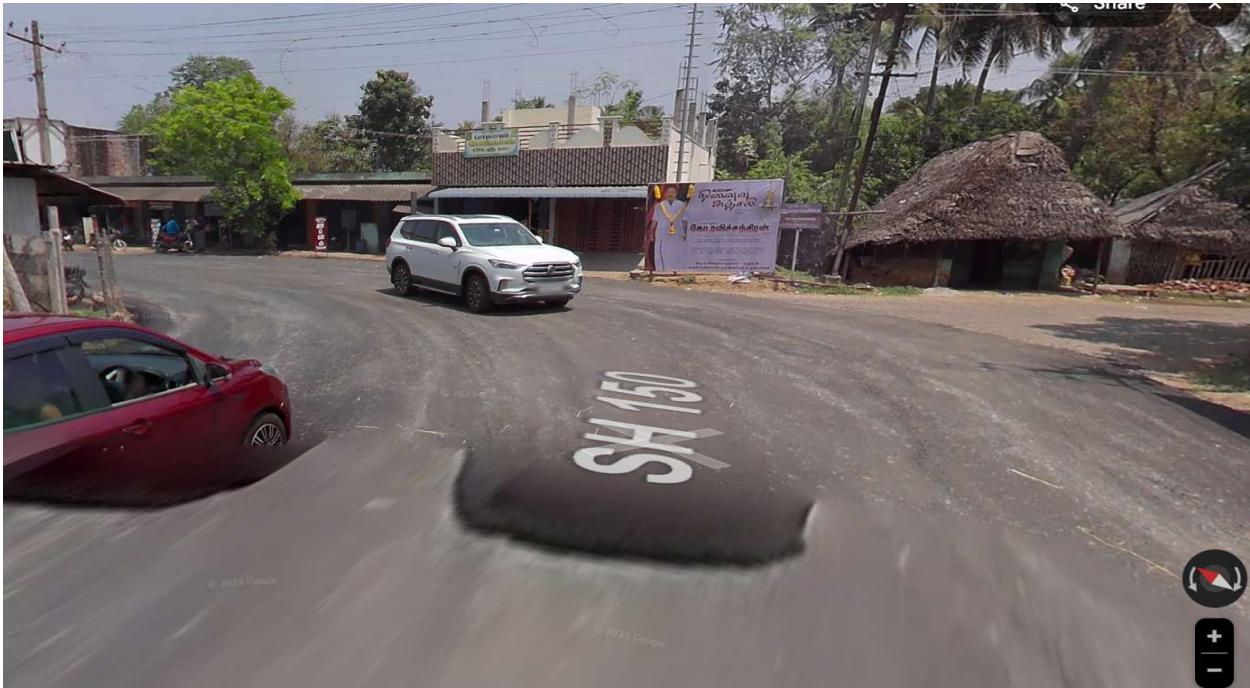
IMAGE: BLIND SPOT RISK LEVEL: - BLIND SPOT , COORDI 11.114605442799302, 79.4730874193487

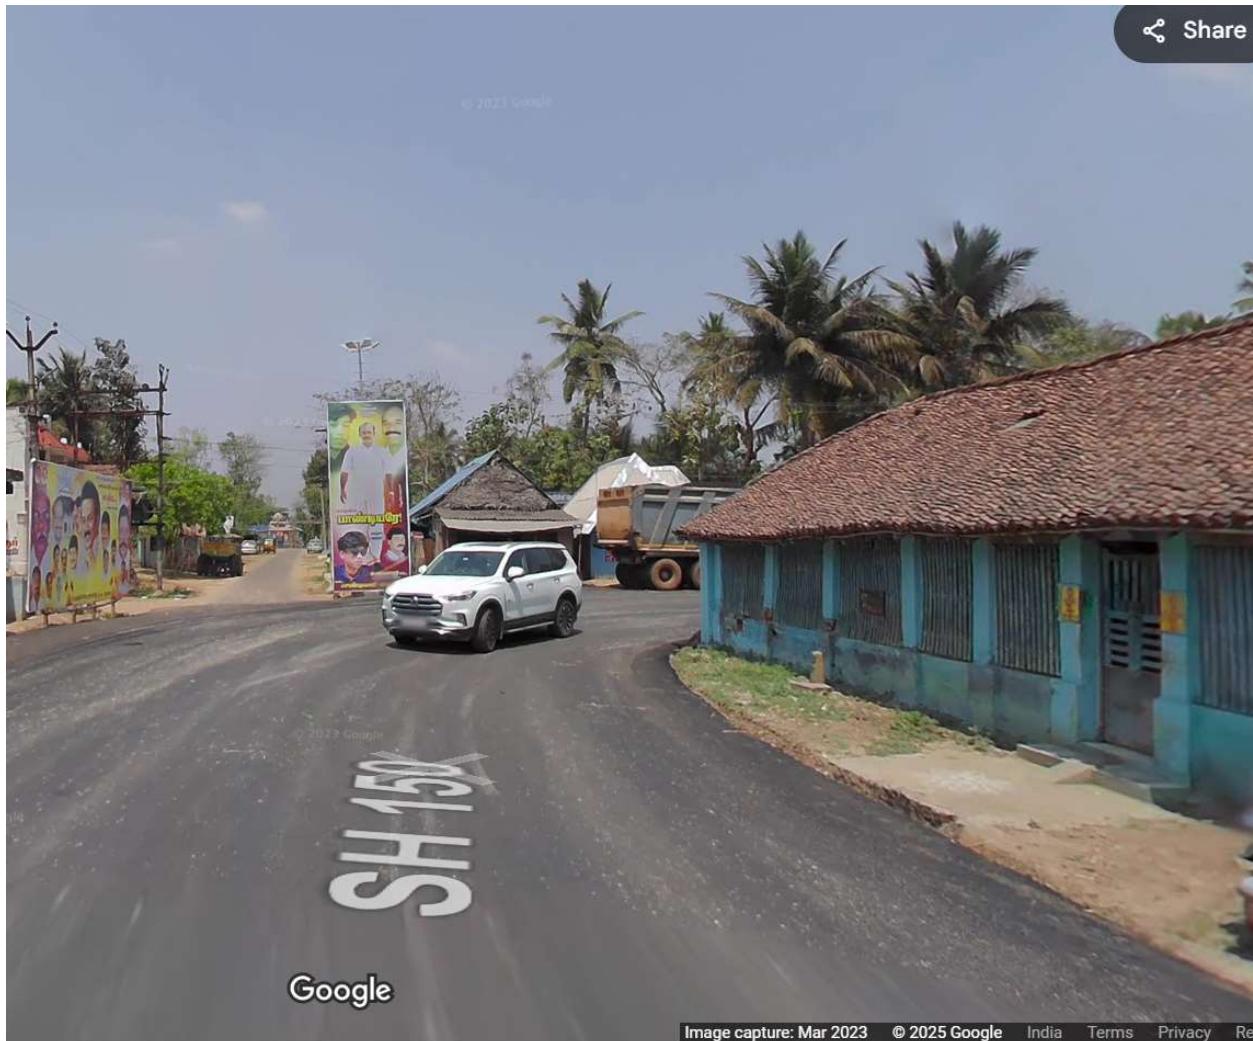
IMAGE: BLIND SPOT RISK LEVEL: - MEDIUM , COORDI 11.107452006056978, 79.47308553839483

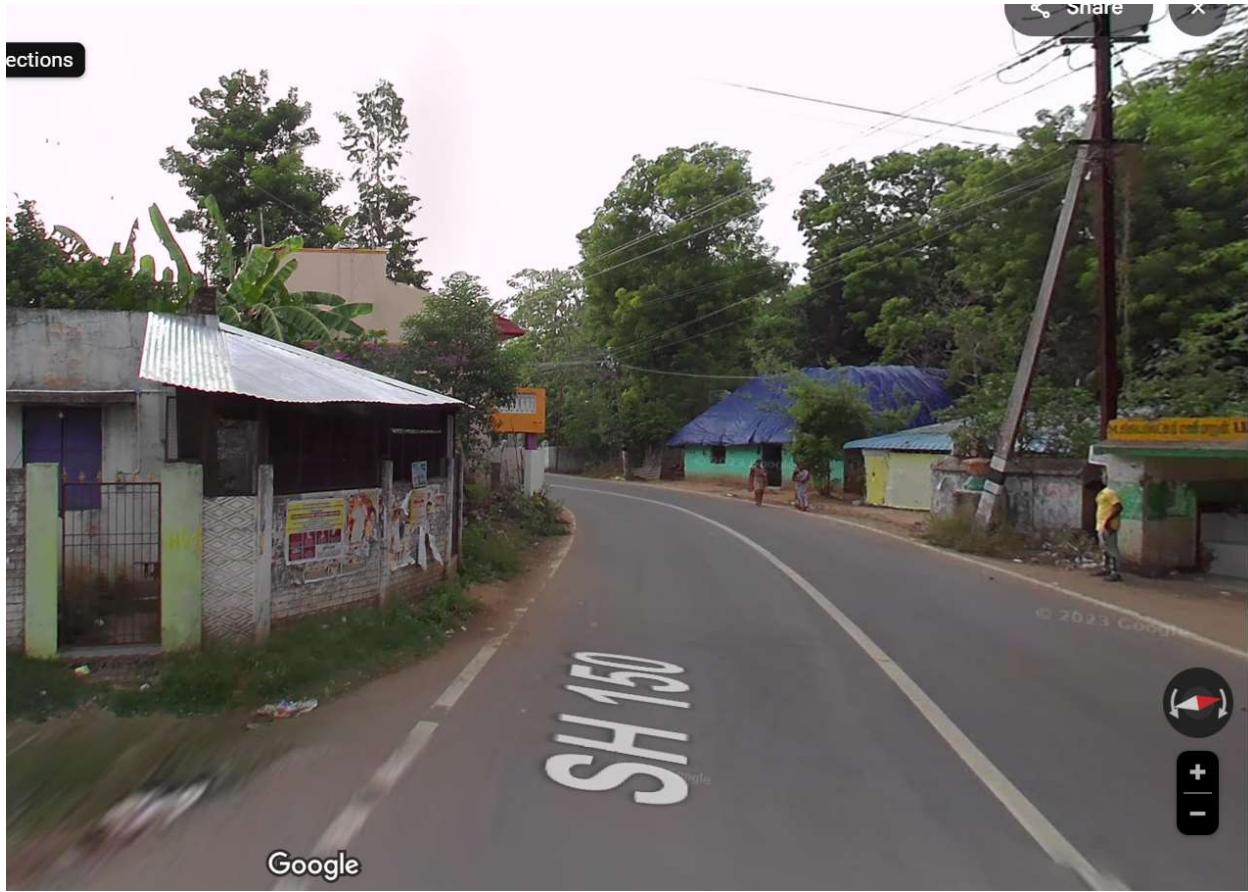
IMAGE: BLIND SPOT RISK LEVEL: - MEDIUM , COORDI 11.107542743095205, 79.47322081396807

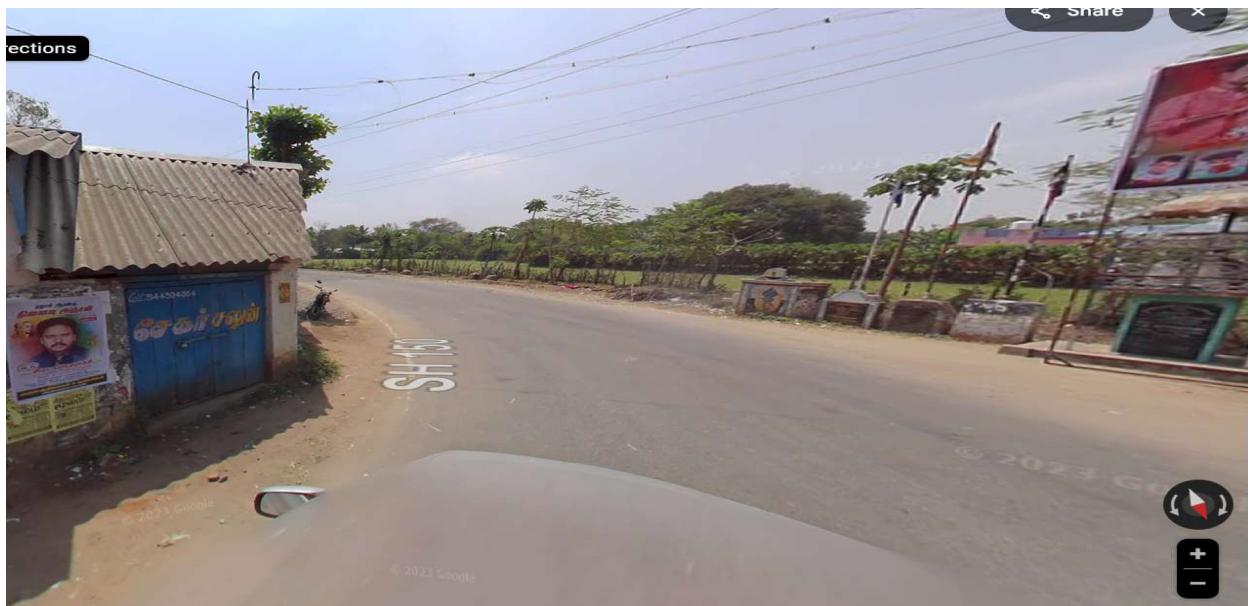
IMAGE: SHARP TURN RISK LEVEL: - MEDIUM , COORDI 11.118252267733796, 79.48887816812439

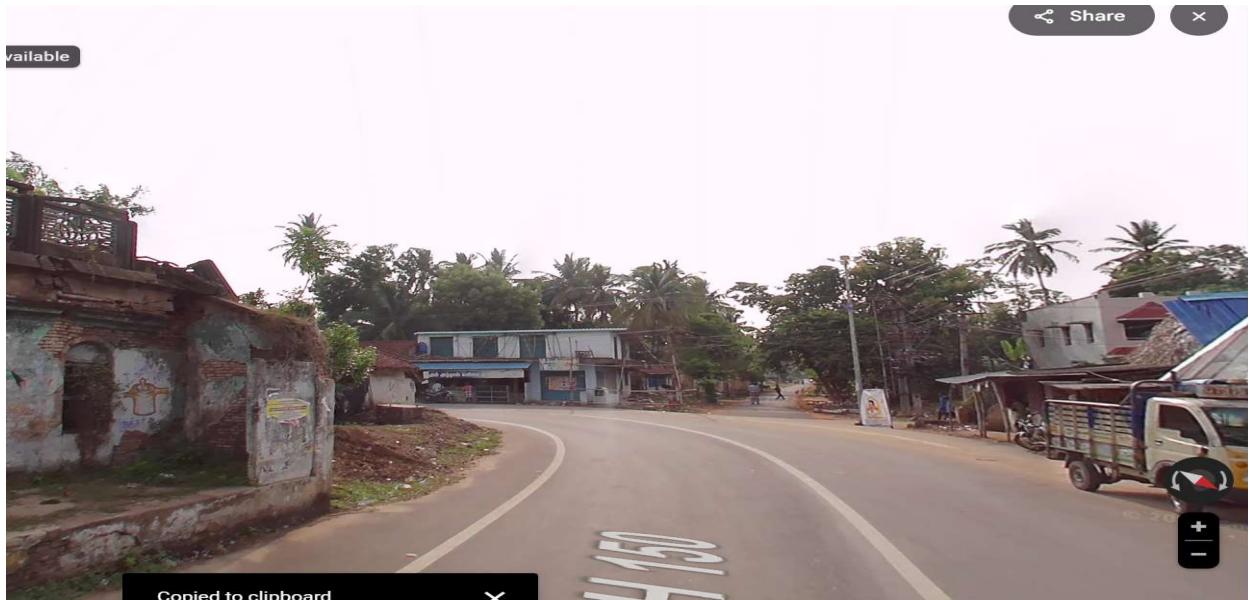
IMAGE: BLIND SPOT RISK LEVEL: - MEDIUM , COORDI 11.11690577242187, 79.48493616584861

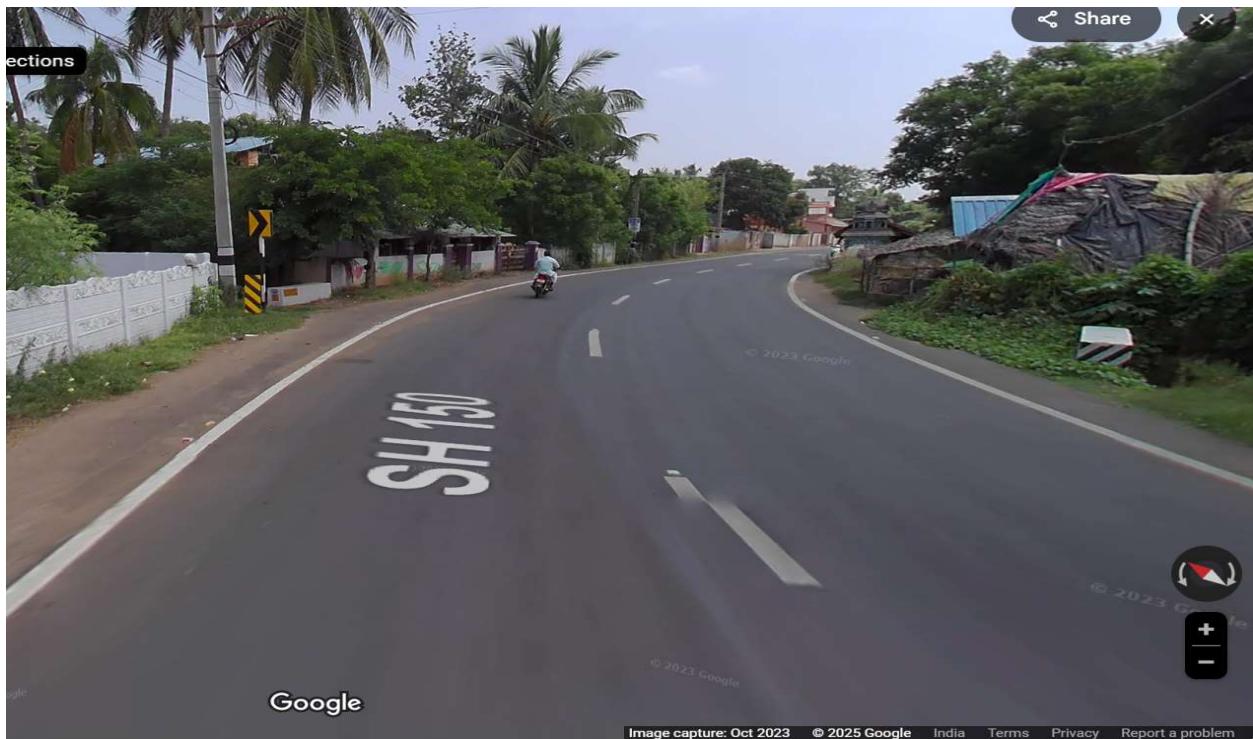
IMAGE: SHARP TURN RISK LEVEL: - MEDIUM , COORDI 11.120969699668045, 79.4955822164653

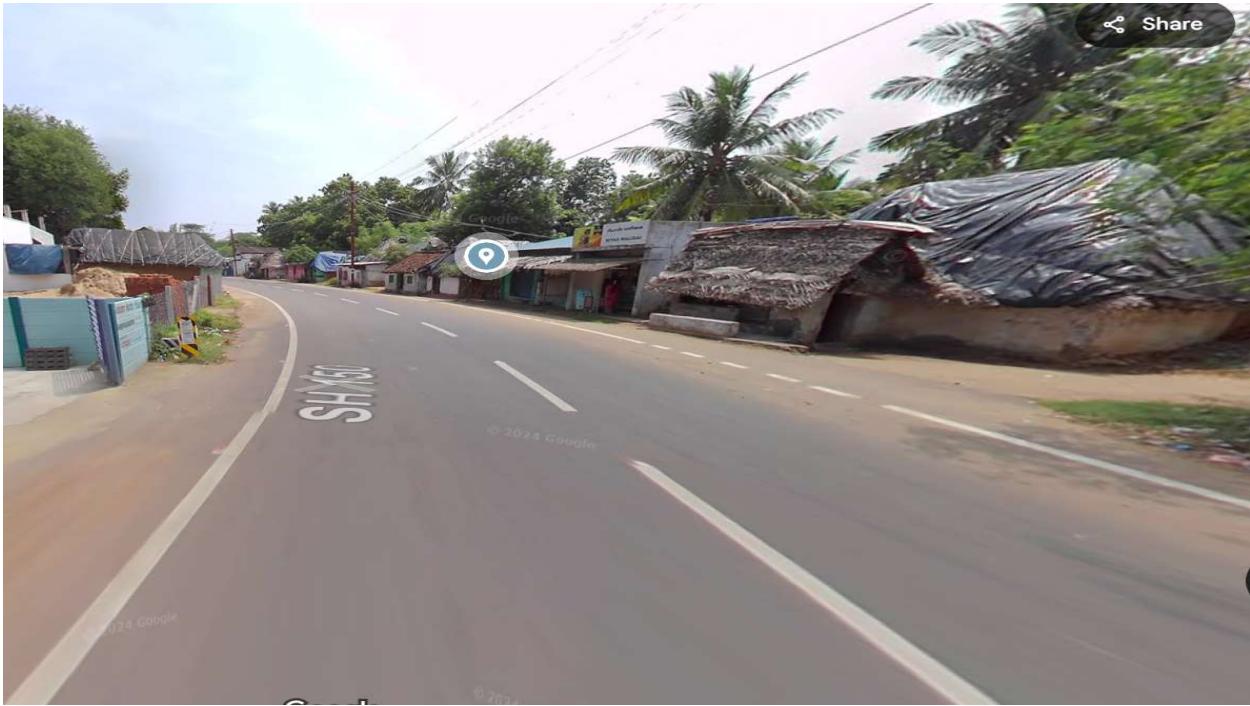
IMAGE: SHARP TURN RISK LEVEL: - MEDIUM , COORDI 11.121260123249073, 79.50289274295069

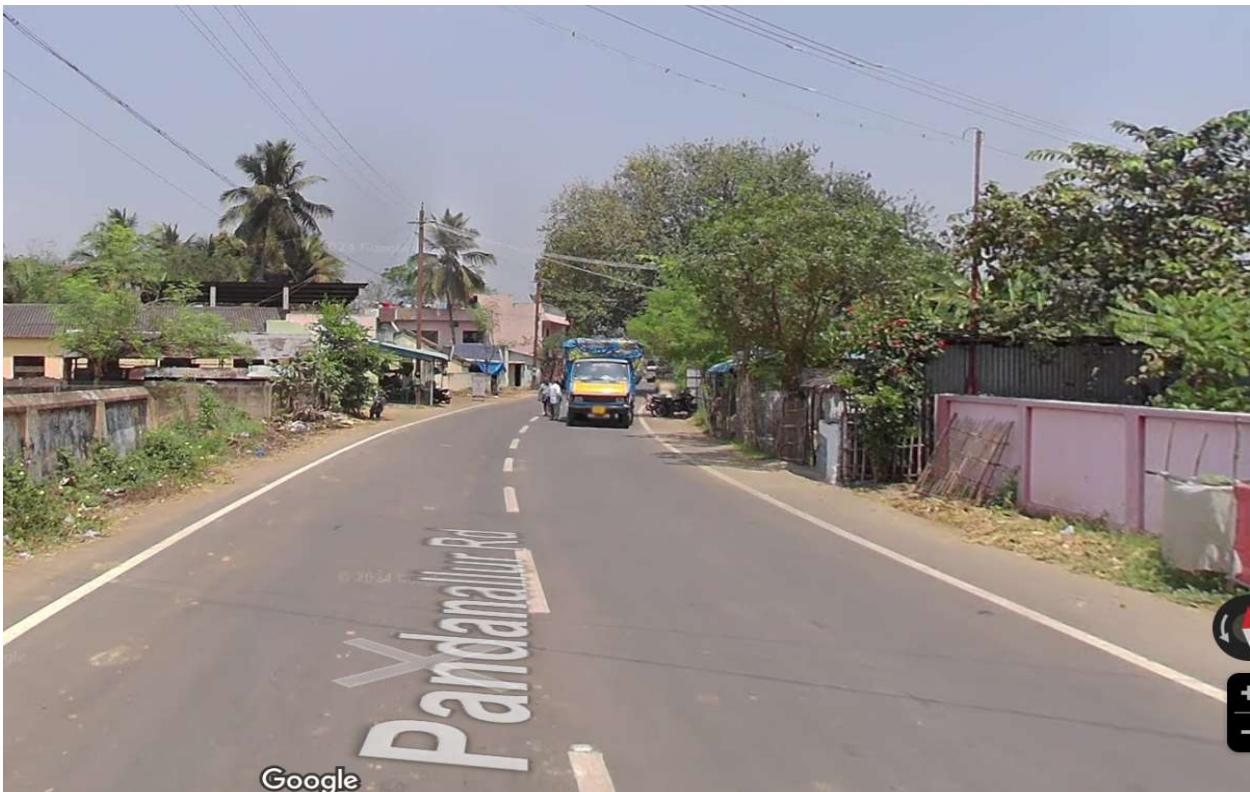
IMAGE: SHARP TURN RISK LEVEL: - MEDIUM, COORDI 11.132333657850268, 79.5160507624041
