JOURNEY RISK MANAGEMENT (JRM) STUDY

IOCL Coimbatore Terminal to Sri Ramakrishna Yarn Carrier

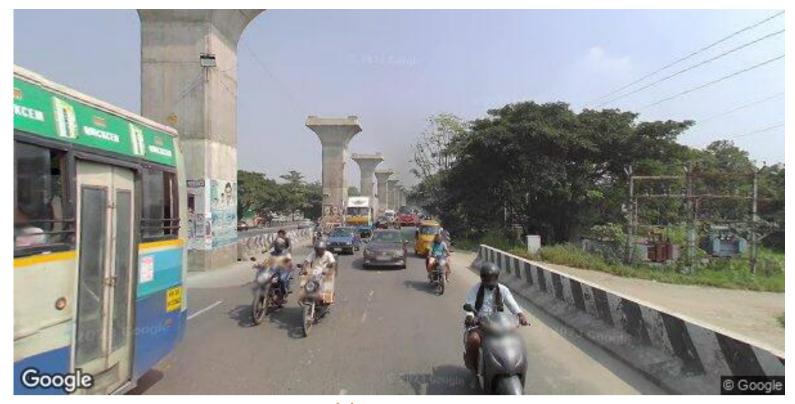
Coordinates: 11.0269486, 77.0222809

Risk Type: U-Turn
Risk Level: High
Speed Limit: 10 KM/Hr

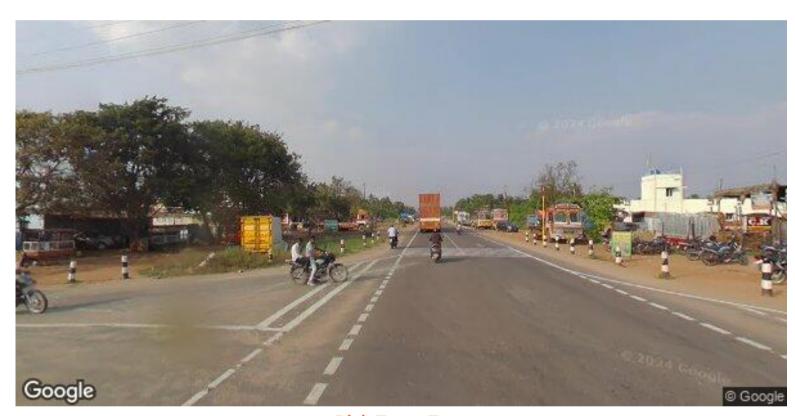
Risk Type: Turn
Risk Level: High
Speed Limit: 15 KM/Hr
Coordinates: 11.03211, 77.07640

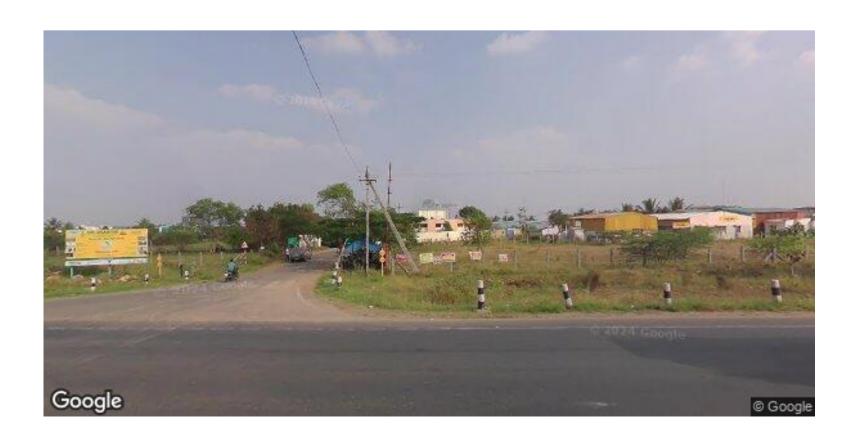
Coordinates: 11.05129, 77.07919

Risk Type: Turn
Risk Level: High
Speed Limit: 15 KM/Hr

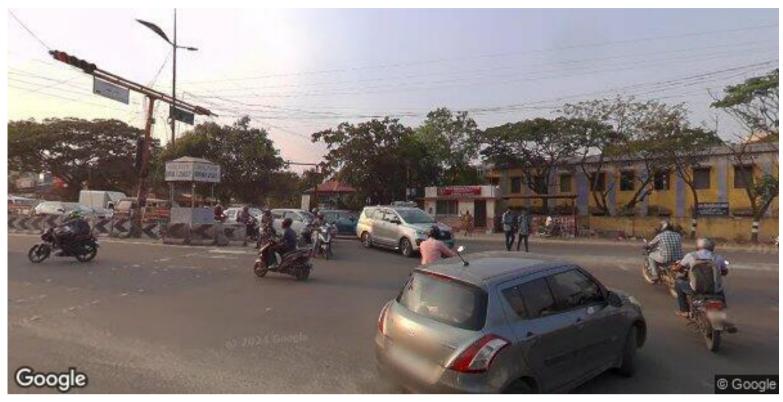
Coordinates: 11.05529, 77.06566

Risk Type: Turn
Risk Level: High
Speed Limit: 15 KM/Hr

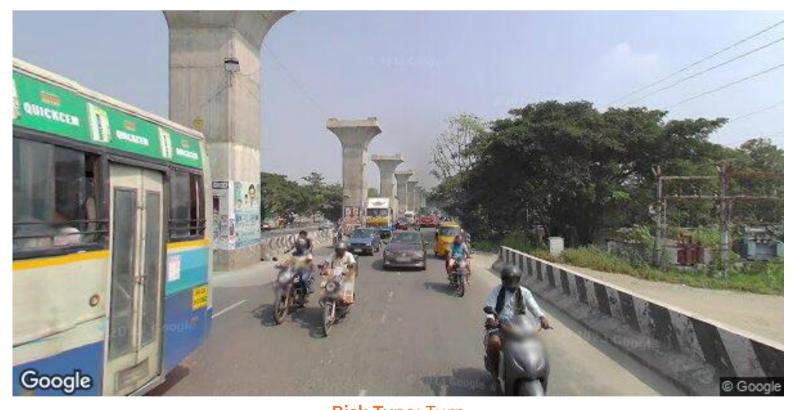
Coordinates: 11.02695, 77.02228

Risk Type: Turn
Risk Level: High
Speed Limit: 15 KM/Hr

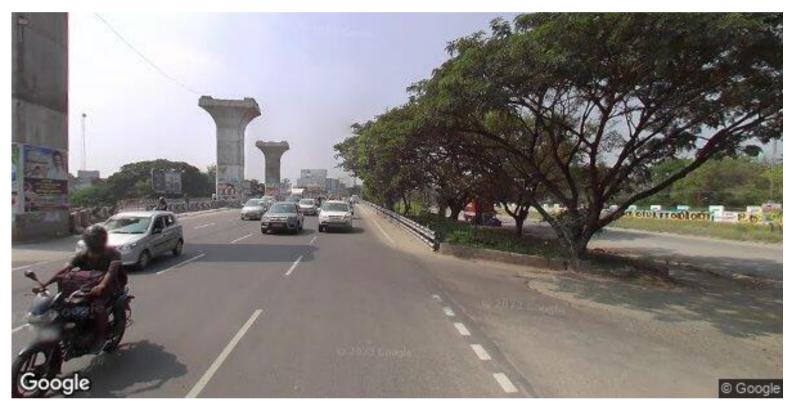
Risk Type: Turn
Risk Level: High
Speed Limit: 15 KM/Hr
Coordinates: 11.02730, 77.02265

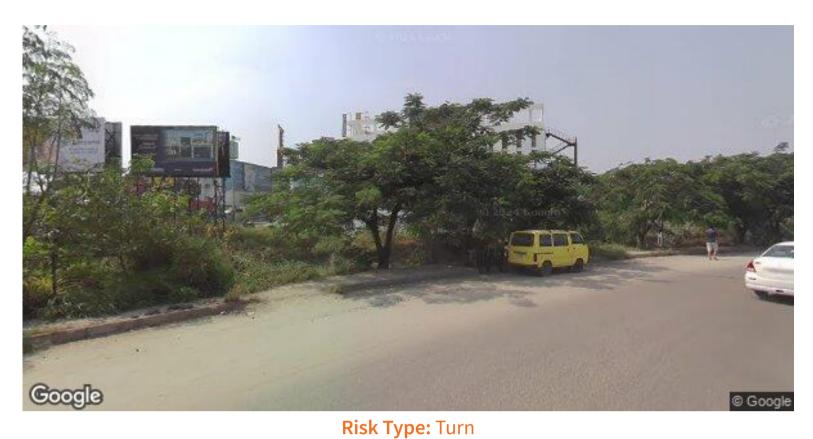
Risk Level: Medium
Speed Limit: 30 KM/Hr
Coordinates: 11.02698, 77.02121

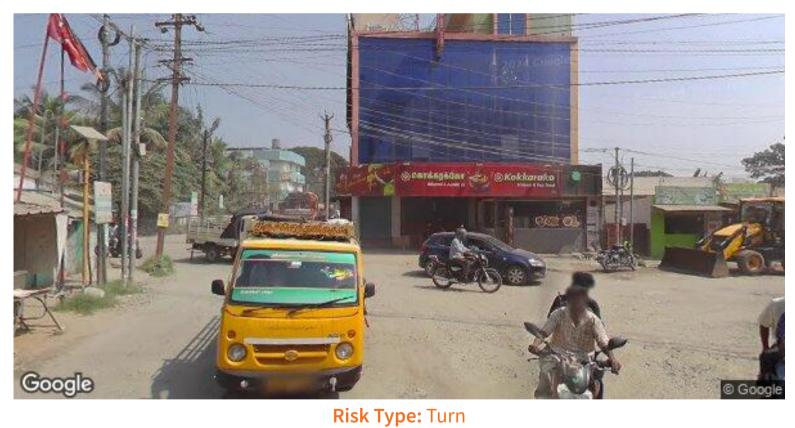
Risk Level: High
Speed Limit: 15 KM/Hr
Coordinates: 11.03822, 77.01471

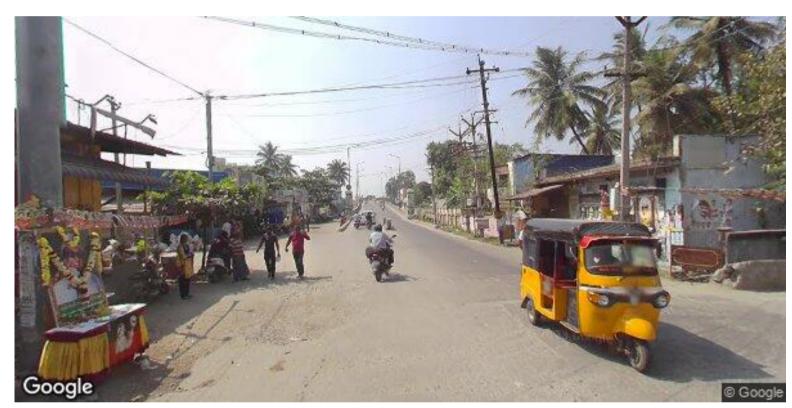
Risk Type: Blind Spot
Risk Level: Blind Spot
Speed Limit: 10 KM/Hr
Coordinates: 11.03460, 77.00456

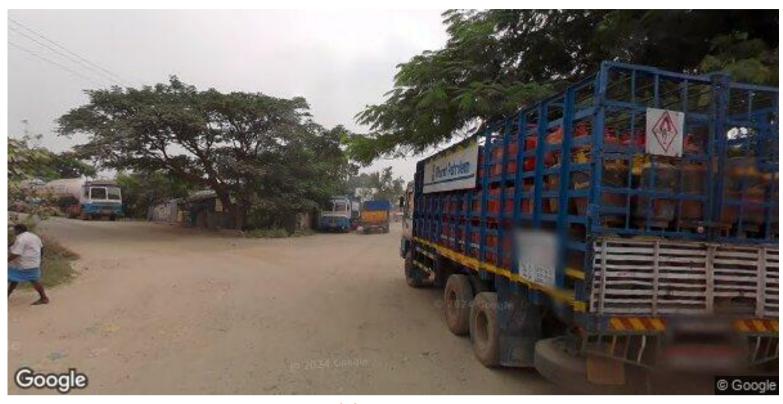
Risk Type: Turn
Risk Level: High
Speed Limit: 15 KM/Hr
Coordinates: 11.03892, 76.99666

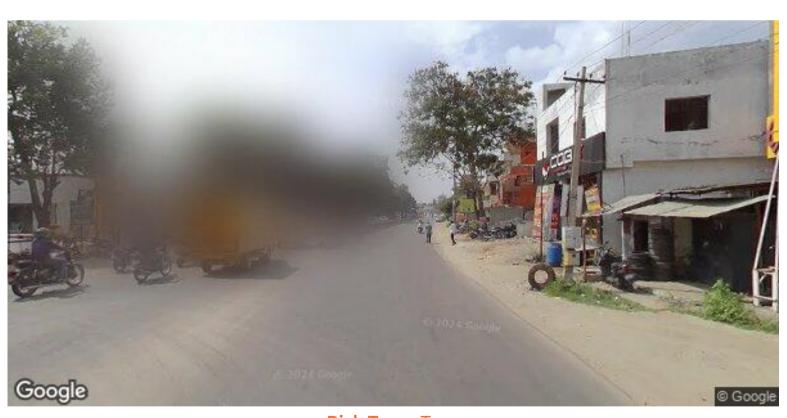
Risk Type: Turn
Risk Level: High
Speed Limit: 15 KM/Hr
Coordinates: 11.04686, 76.98809

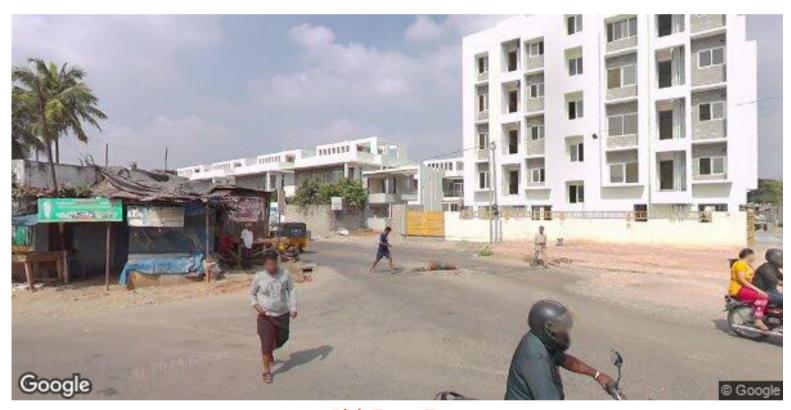
Risk Type: Turn
Risk Level: Medium
Speed Limit: 30 KM/Hr
Coordinates: 11.05138, 76.99143

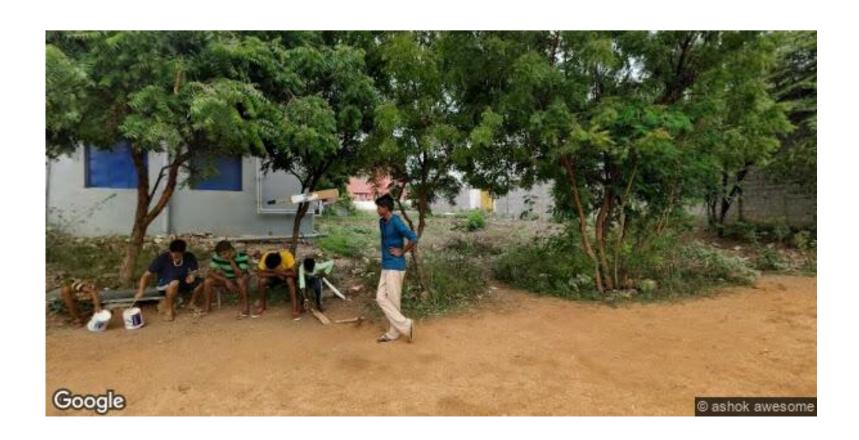
Coordinates: 11.05189, 76.99137

Risk Type: Turn
Risk Level: High
Speed Limit: 15 KM/Hr
