JOURNEY RISK MANAGEMENT (JRM) STUDY

Salem Terminal To SHREE SARATHAMBAL AGENCIES

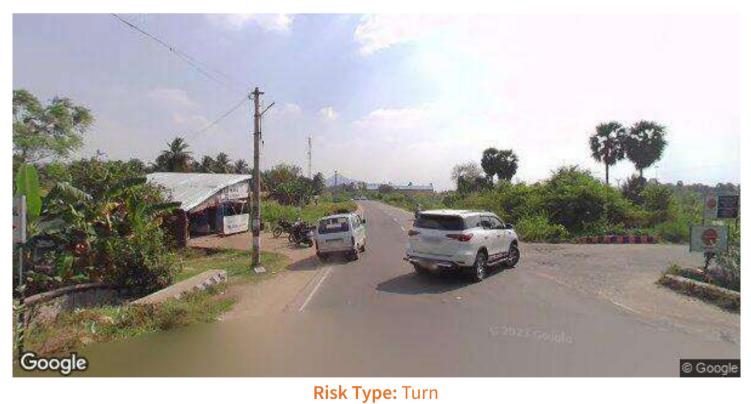
Risk Type: Turn
Risk Level: High
Speed Limit: 15 KM/Hr
Coordinates: 11.44029, 77.87544

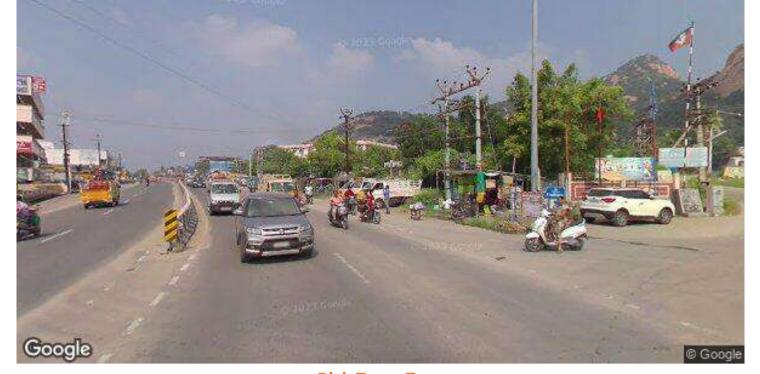
Risk Type: Turn
Risk Level: Medium
Speed Limit: 30 KM/Hr
Coordinates: 11.39671, 77.88878

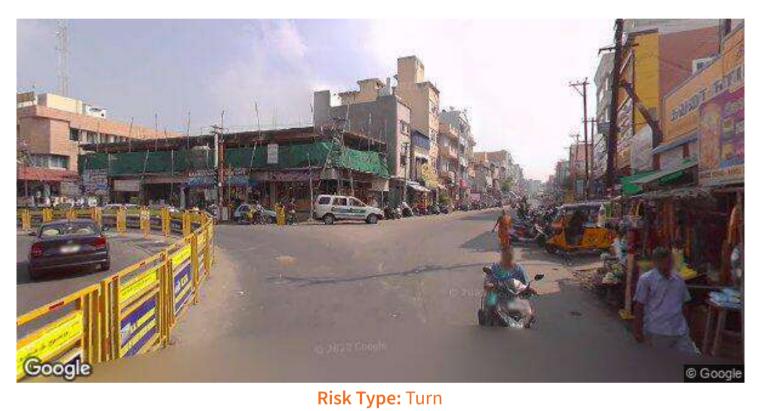
Risk Level: High
Speed Limit: 15 KM/Hr
Coordinates: 11.37862, 77.89488

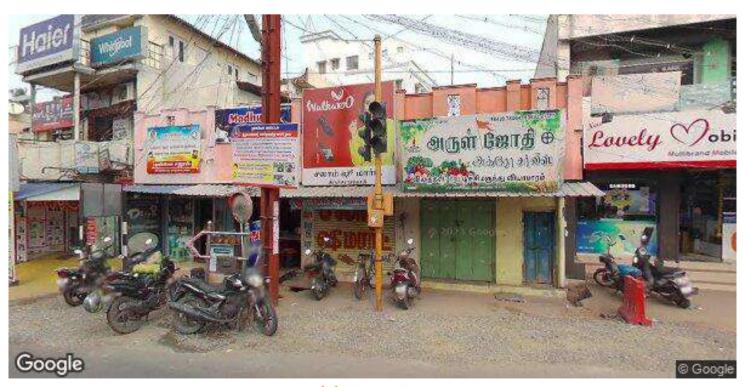
Risk Type: Turn Risk Level: High Speed Limit: 15 KM/Hr Coordinates: 11.37850, 77.89453

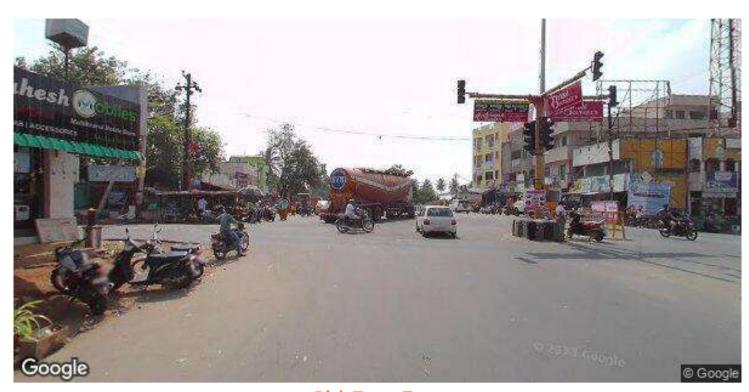
Risk Type: Turn
Risk Level: Medium
Speed Limit: 30 KM/Hr
Coordinates: 11.36616, 77.88885

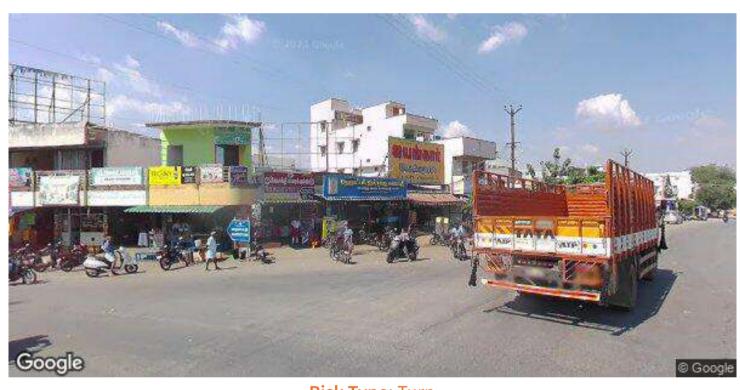
Risk Type: Turn
Risk Level: Medium
Speed Limit: 30 KM/Hr
Coordinates: 11.36602, 77.88875

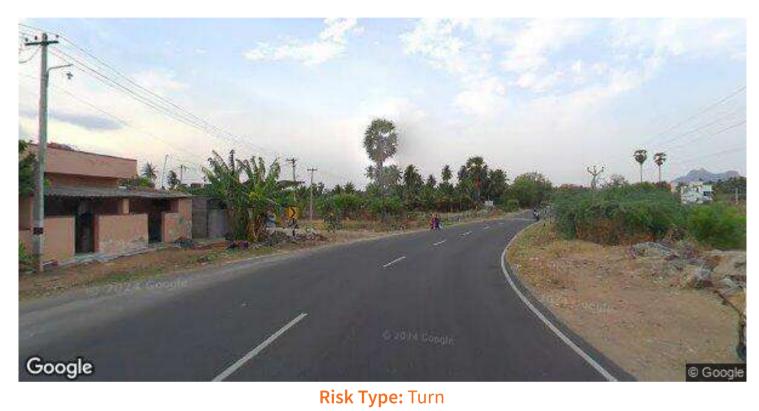
Risk Level: Medium
Speed Limit: 30 KM/Hr
Coordinates: 11.33882, 77.86218

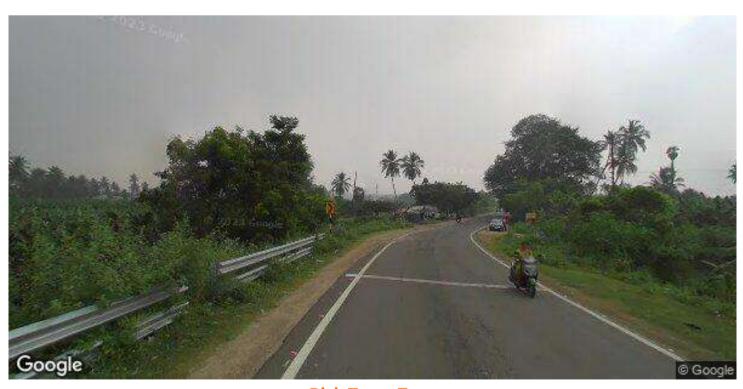
Risk Type: Turn
Risk Level: Medium

Speed Limit: 30 KM/Hr Coordinates: 11.31118, 77.77139

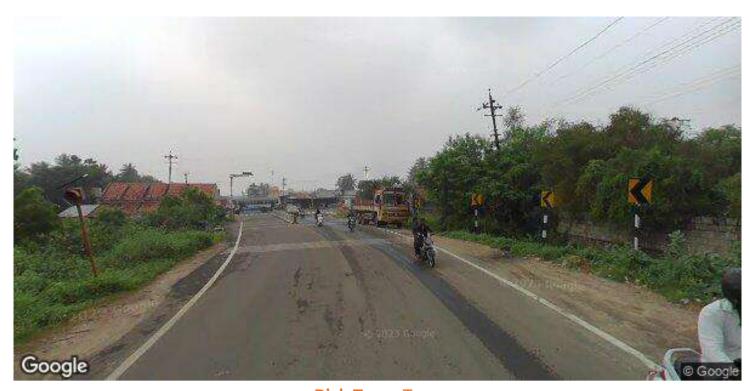
Risk Type: Turn
Risk Level: Medium
Speed Limit: 30 KM/Hr
Coordinates: 11.30970, 77.76705

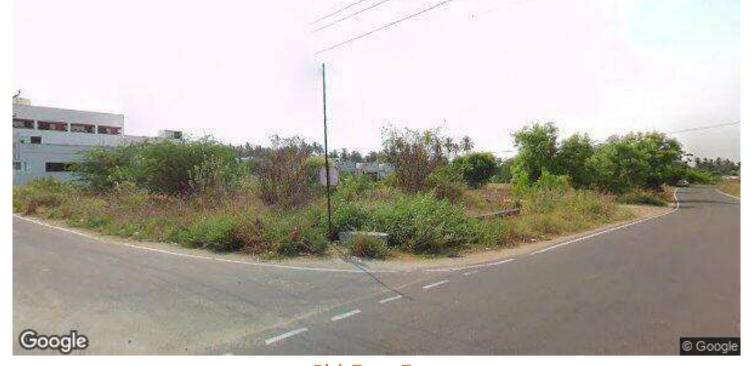
Risk Type: Turn
Risk Level: High
Speed Limit: 15 KM/Hr
Coordinates: 11.29133, 77.74660

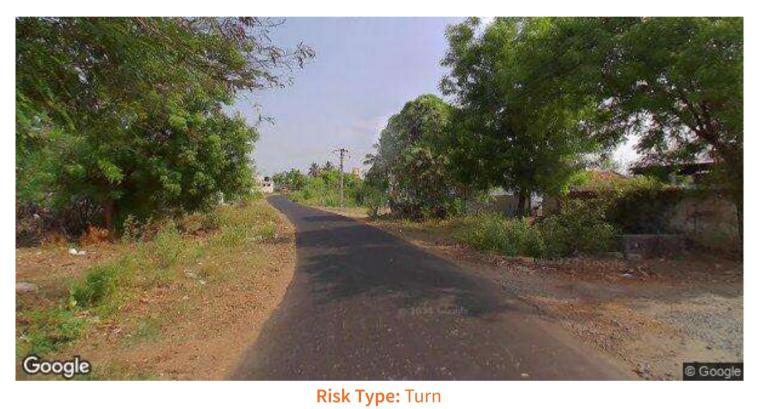
Risk Level: Medium
Speed Limit: 30 KM/Hr
Coordinates: 11.28844, 77.74319

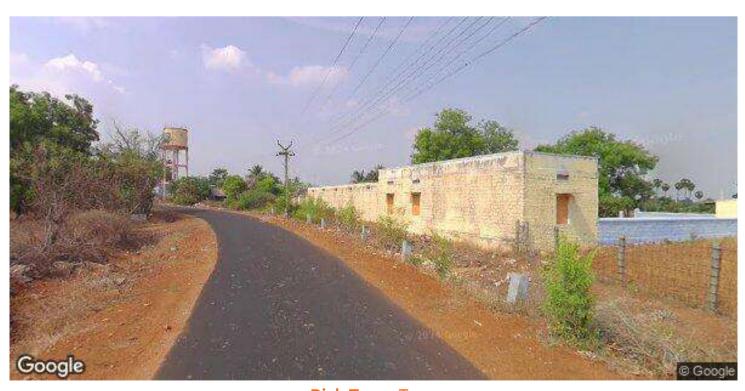
Risk Type: Turn
Risk Level: Medium

Speed Limit: 30 KM/Hr Coordinates: 11.28558, 77.74271

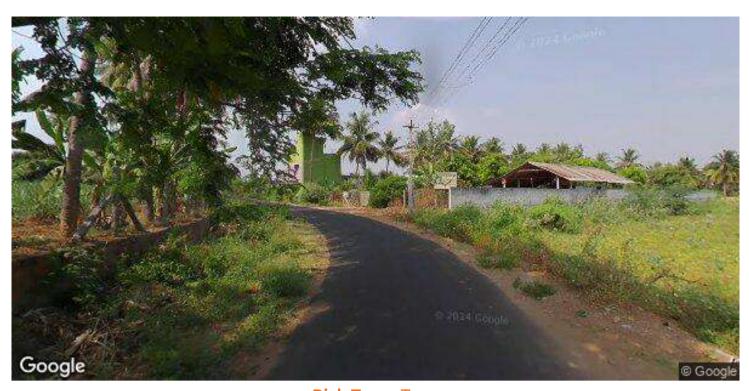
Risk Type: Turn
Risk Level: Medium
Speed Limit: 30 KM/Hr
Coordinates: 11.27326, 77.72991

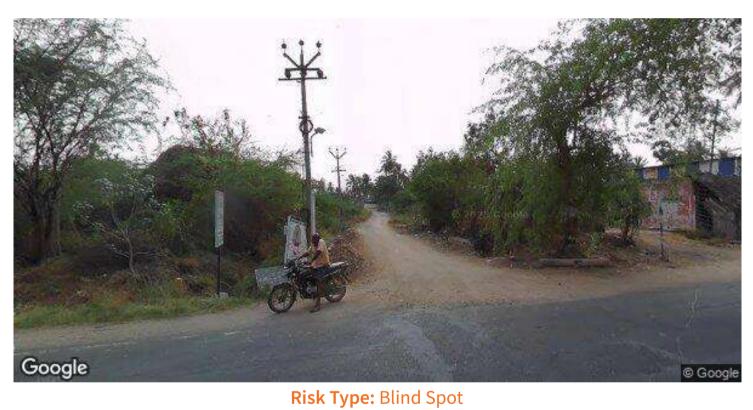
Risk Level: Blind Spot
Speed Limit: 10 KM/Hr
Coordinates: 11.27330, 77.72711

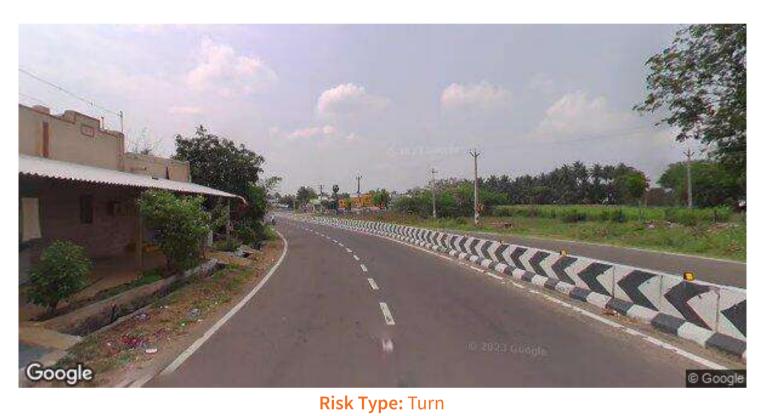
Risk Level: Medium
Speed Limit: 30 KM/Hr
Coordinates: 11.22387, 77.71385

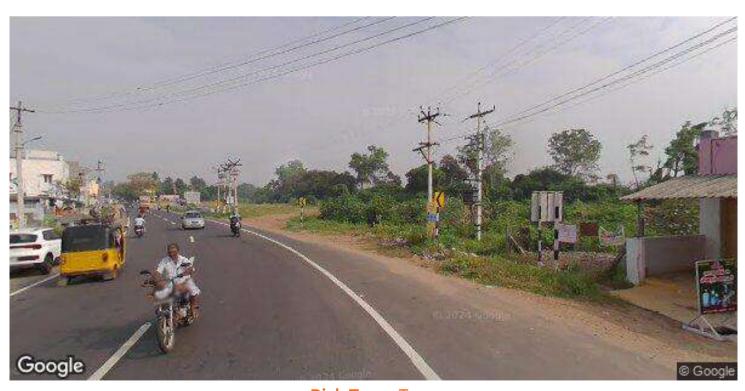
Risk Type: Turn
Risk Level: Medium

Speed Limit: 30 KM/Hr Coordinates: 11.16078, 77.70122

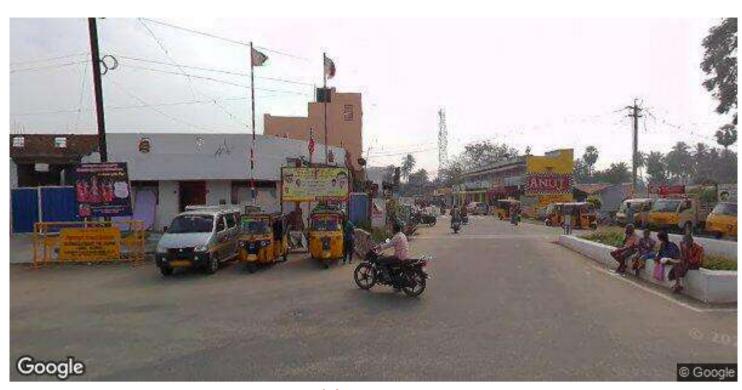
Risk Type: Turn
Risk Level: Medium
Speed Limit: 30 KM/Hr
Coordinates: 11.15953, 77.70067

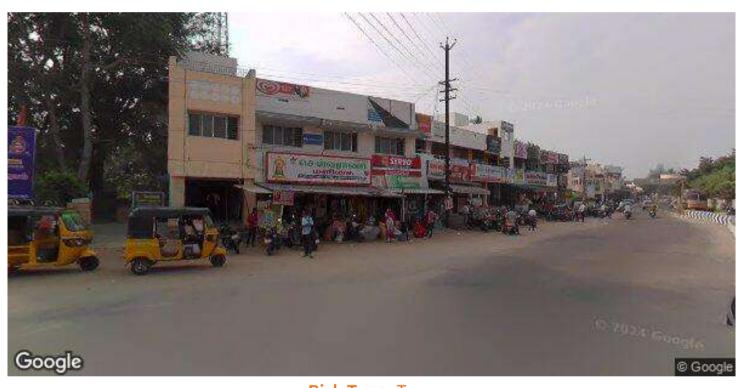
Risk Type: Turn
Risk Level: High
Speed Limit: 15 KM/Hr
Coordinates: 11.15944, 77.70068

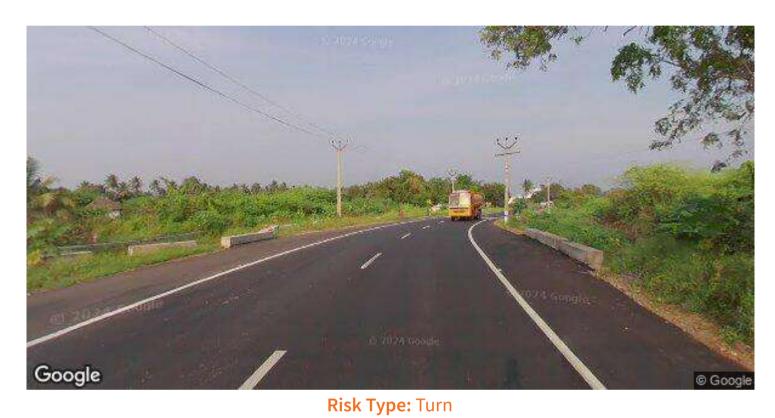
Risk Level: Medium
Speed Limit: 30 KM/Hr
Coordinates: 11.11740, 77.67198

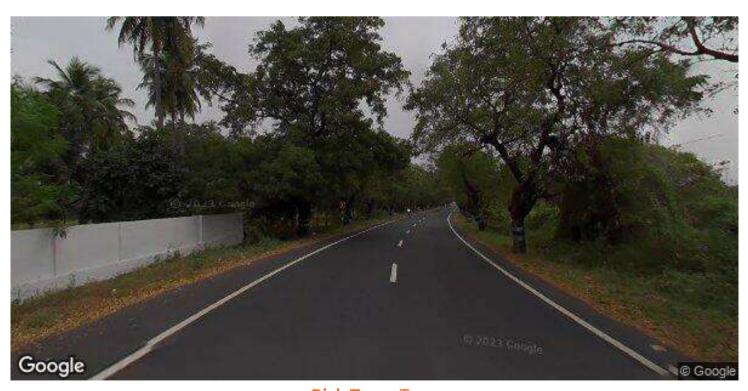
Risk Type: Turn
Risk Level: Medium

Speed Limit: 30 KM/Hr Coordinates: 11.10481, 77.67060

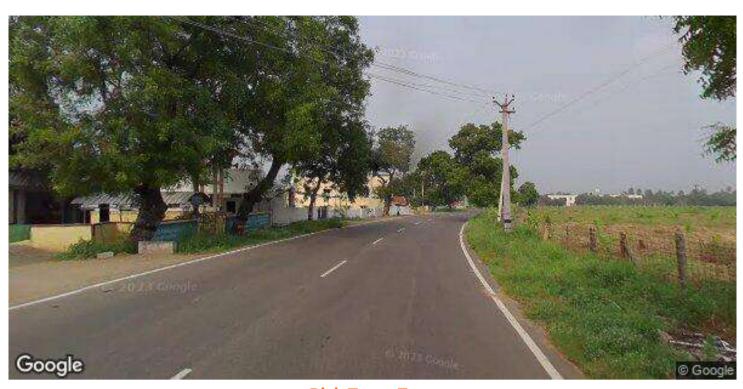
Risk Type: Turn
Risk Level: Medium
Speed Limit: 30 KM/Hr
Coordinates: 11.09509, 77.66612

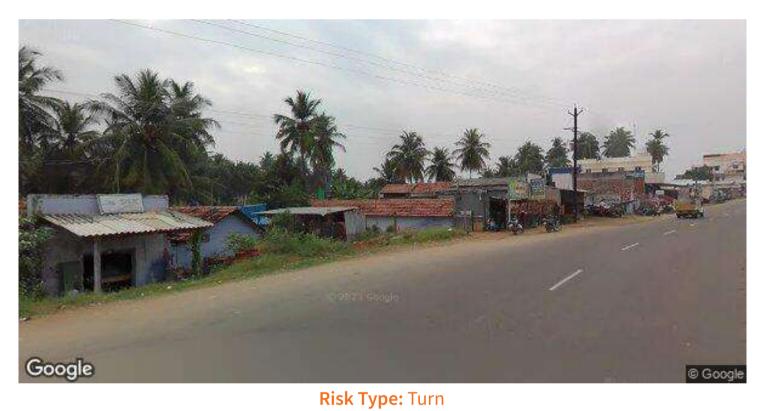
Risk Level: Medium
Speed Limit: 30 KM/Hr
Coordinates: 11.08730, 77.66436

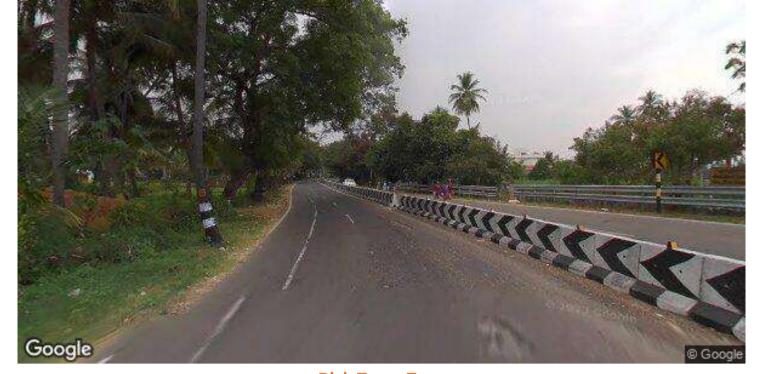
Risk Type: Turn
Risk Level: Medium
Speed Limit: 30 KM/Hr
Coordinates: 11.08282, 77.65837

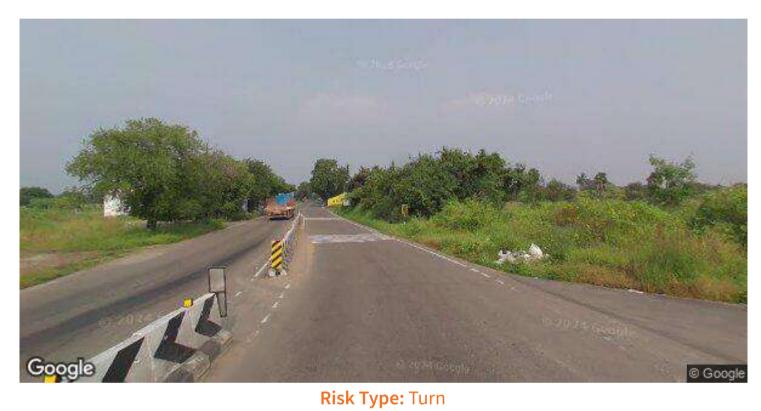
Risk Level: High
Speed Limit: 15 KM/Hr
Coordinates: 11.06189, 77.63943
