JOURNEY RISK MANAGEMENT (JRM) STUDY

Salem Terminal To SREE PERIYANAYAHI AMMAN & CO

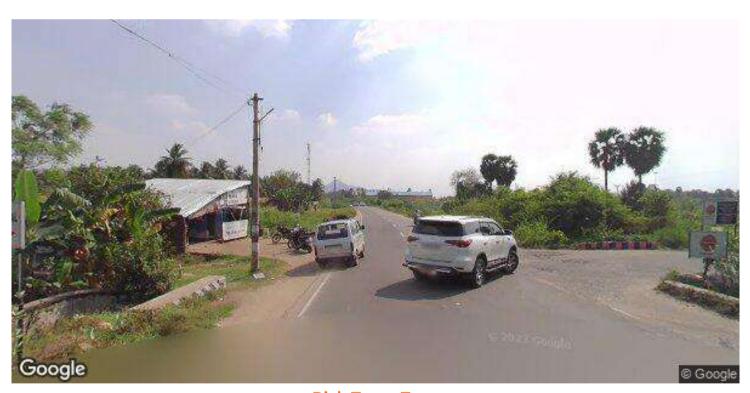
Risk Type: Turn
Risk Level: High
Speed Limit: 15 KM/Hr
Coordinates: 11.44029, 77.87544

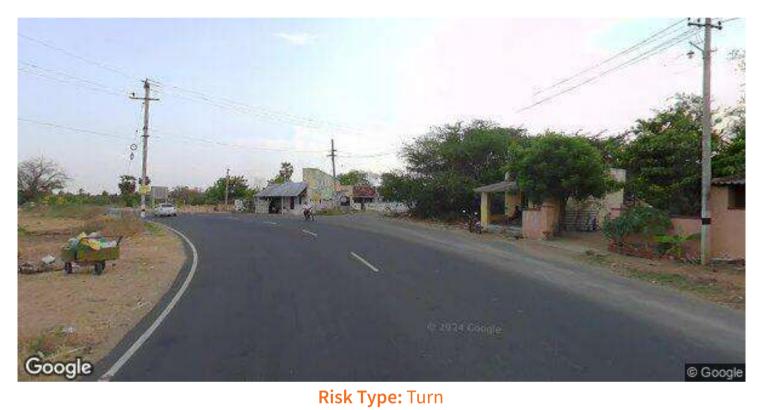
Risk Level: Medium
Speed Limit: 30 KM/Hr
Coordinates: 11.33894, 77.86224

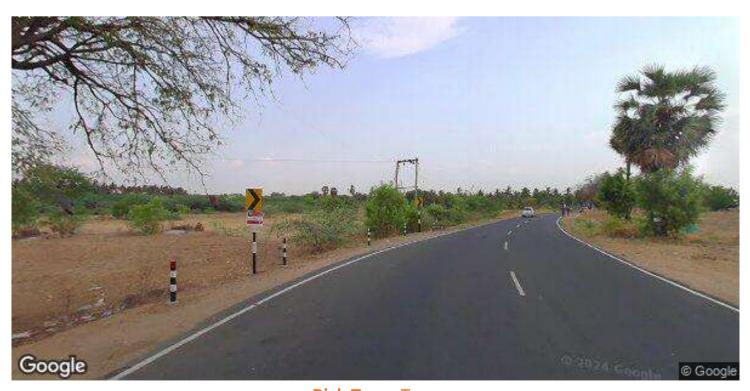
Risk Type: Turn
Risk Level: Medium

Speed Limit: 30 KM/Hr Coordinates: 11.33794, 77.86235

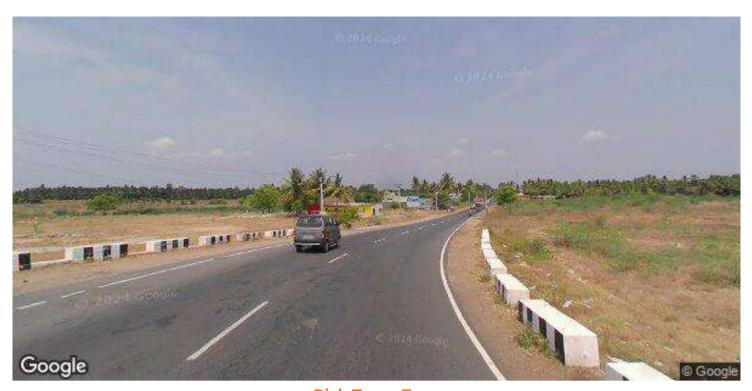
Risk Type: Turn
Risk Level: Medium
Speed Limit: 30 KM/Hr
Coordinates: 11.31749, 77.84251

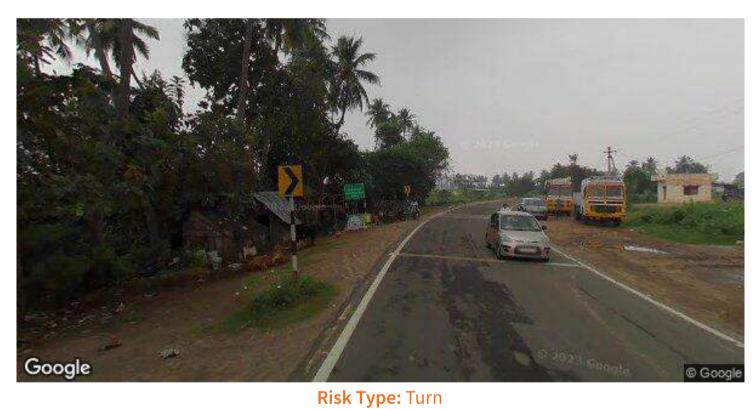
Risk Level: Medium
Speed Limit: 30 KM/Hr
Coordinates: 11.30952, 77.77617

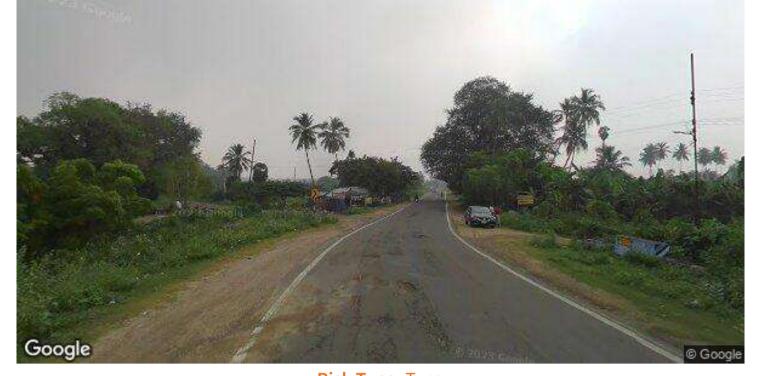
Risk Type: Turn
Risk Level: Medium
Speed Limit: 30 KM/Hr
Coordinates: 11.31116, 77.77158

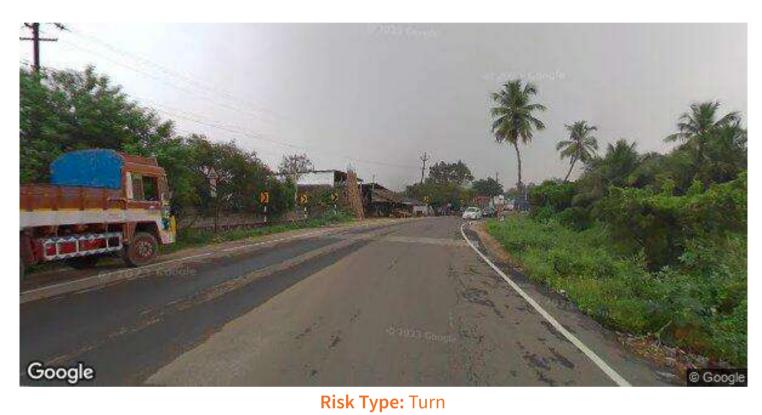
Risk Level: Medium
Speed Limit: 30 KM/Hr
Coordinates: 11.30949, 77.76682

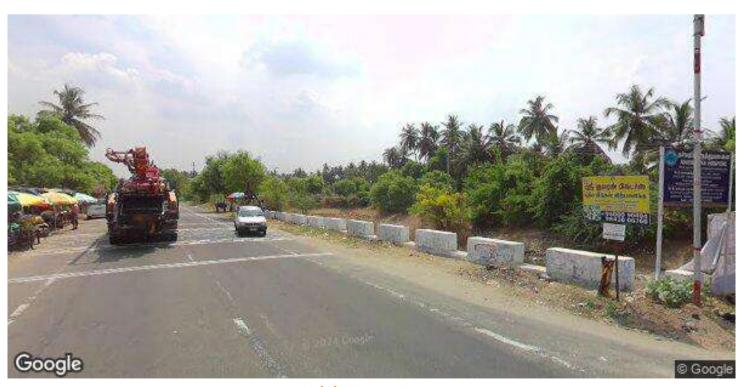
Risk Type: Turn Risk Level: High

Speed Limit: 15 KM/Hr Coordinates: 11.29490, 77.74685

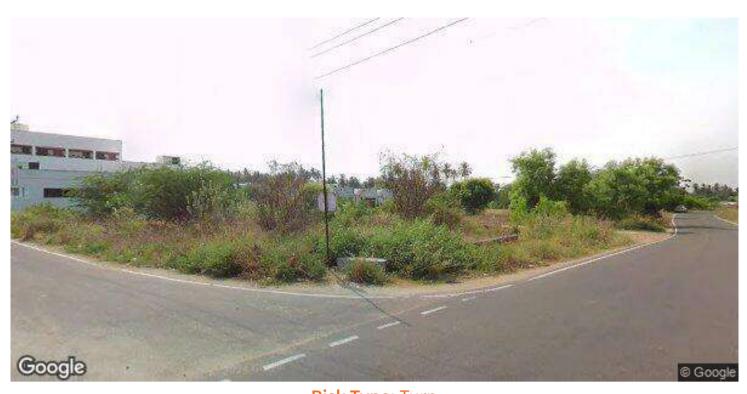
Risk Type: Turn
Risk Level: High
Speed Limit: 15 KM/Hr
Coordinates: 11.29133, 77.74660

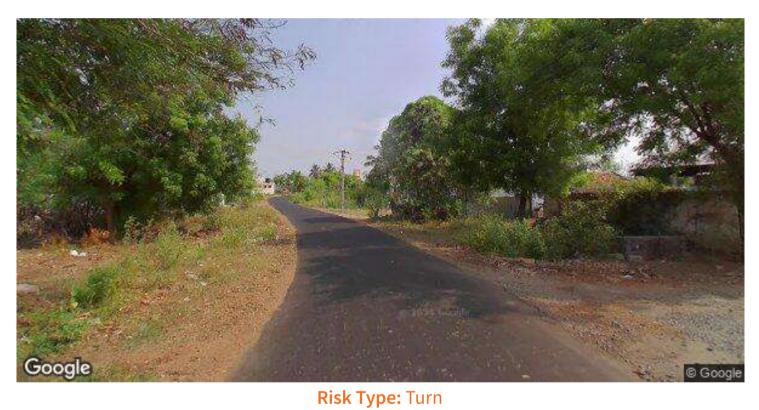
Risk Level: Medium
Speed Limit: 30 KM/Hr
Coordinates: 11.28844, 77.74319

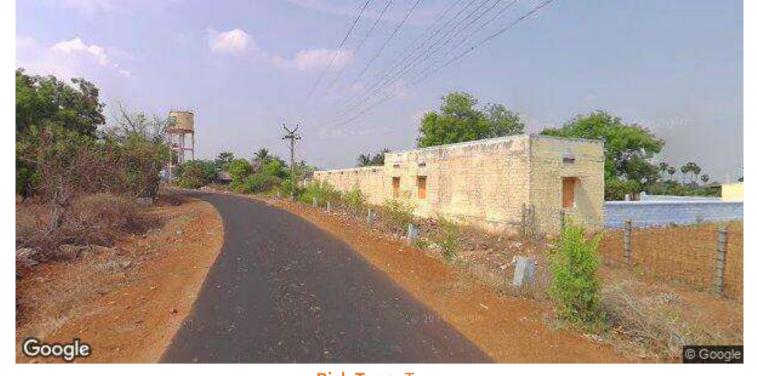
Risk Type: Turn
Risk Level: Medium
Speed Limit: 30 KM/Hr
Coordinates: 11.28558, 77.74271

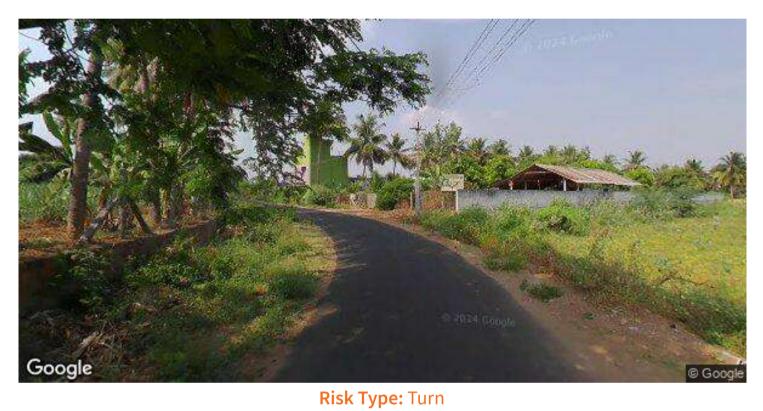
Risk Level: Medium
Speed Limit: 30 KM/Hr
Coordinates: 11.27326, 77.72991

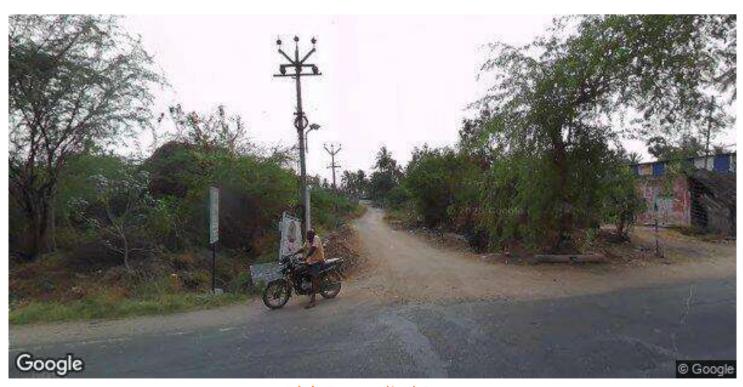
Risk Type: Blind Spot Risk Level: Blind Spot Speed Limit: 10 KM/Hr Coordinates: 11.27330, 77.72711

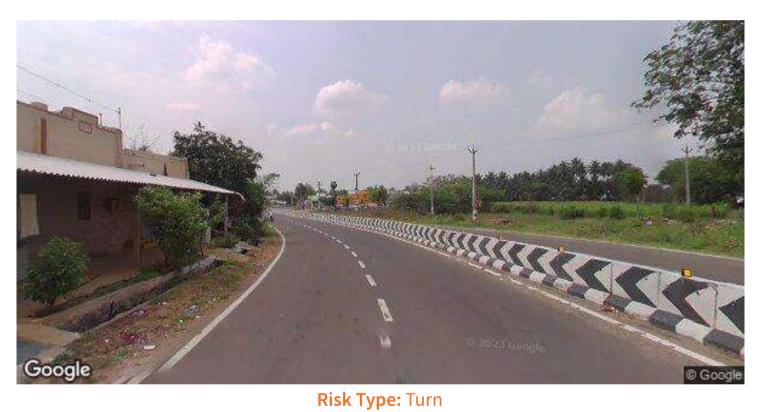
Risk Level: Medium
Speed Limit: 30 KM/Hr
Coordinates: 11.22387, 77.71385

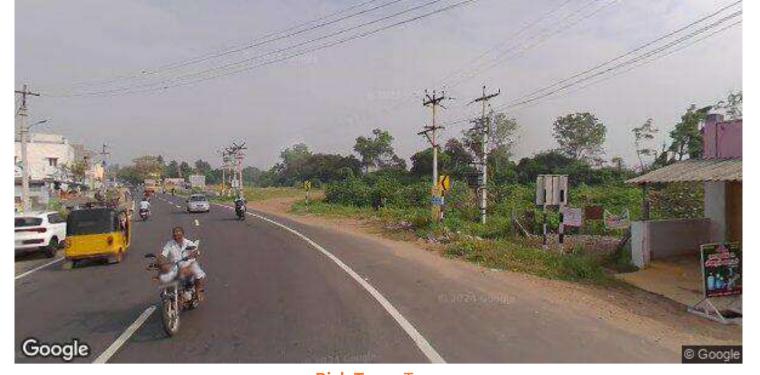
Risk Type: Turn Risk Level: Medium **Speed Limit:** 30 KM/Hr **Coordinates:** 11.16078, 77.70122

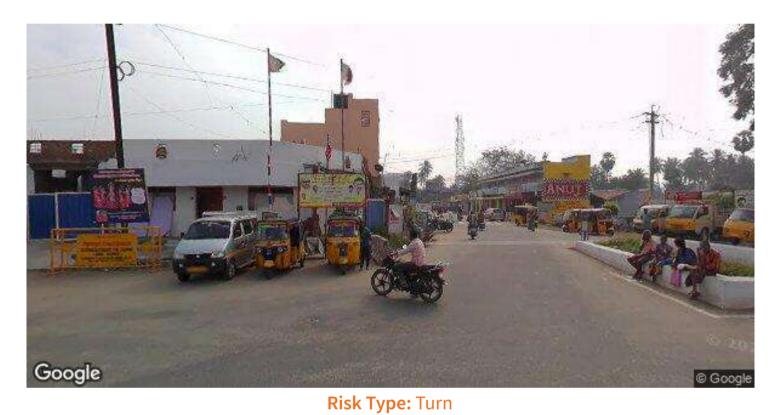
Risk Level: Medium **Speed Limit:** 30 KM/Hr **Coordinates:** 11.15953, 77.70067

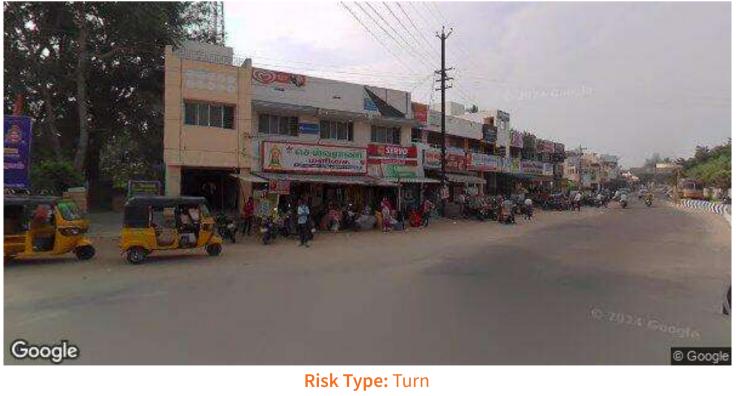
Risk Type: Turn Risk Level: High

Speed Limit: 15 KM/Hr Coordinates: 11.15944, 77.70068

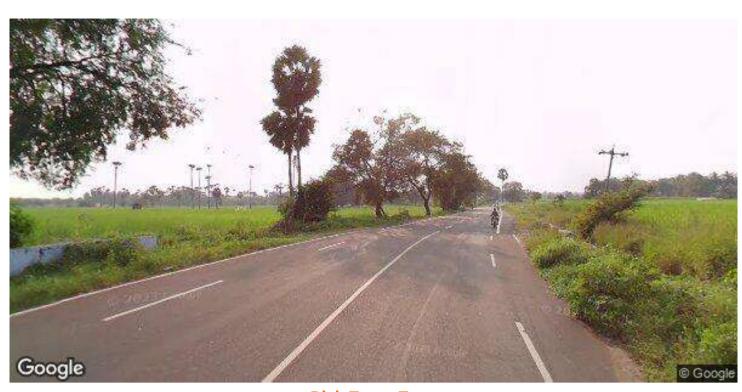
Risk Type: Turn
Risk Level: Medium
Speed Limit: 30 KM/Hr
Coordinates: 11.11918, 77.67766

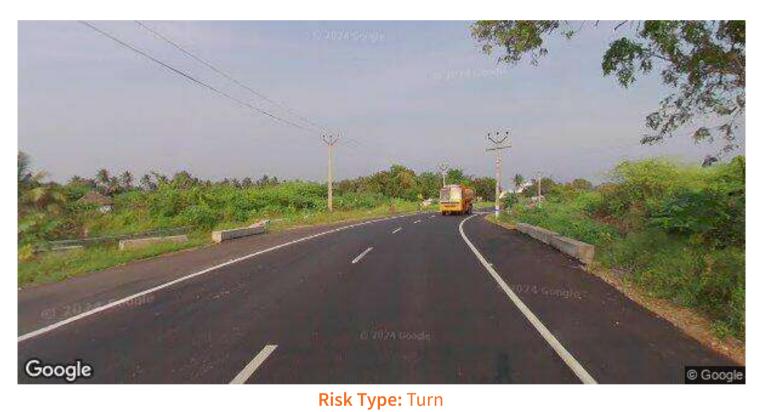
Risk Level: Medium
Speed Limit: 30 KM/Hr
Coordinates: 11.11740, 77.67198

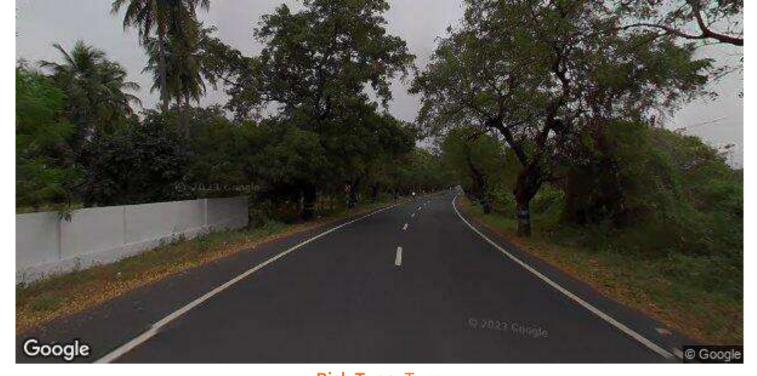
Risk Type: Turn
Risk Level: Medium
Speed Limit: 30 KM/Hr
Coordinates: 11.10481, 77.67060

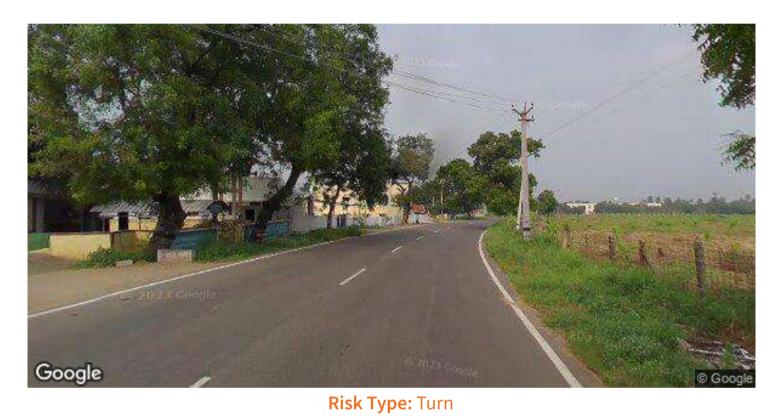
Risk Level: Medium
Speed Limit: 30 KM/Hr
Coordinates: 11.09509, 77.66612

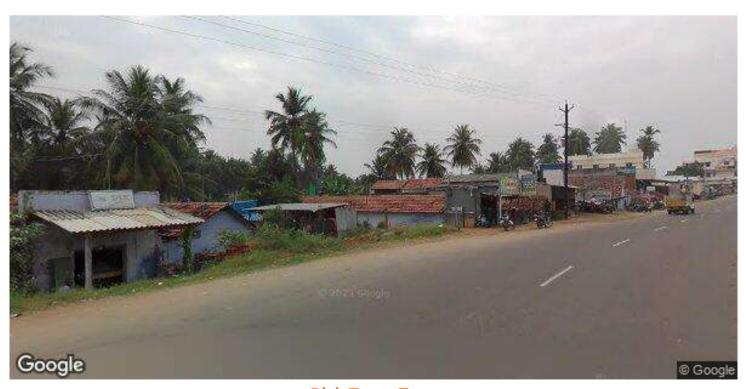
Risk Type: Turn
Risk Level: Medium

Speed Limit: 30 KM/Hr Coordinates: 11.08730, 77.66436

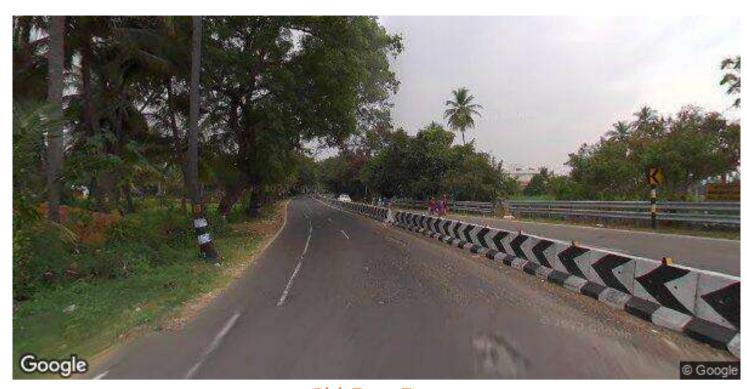
Risk Type: Turn
Risk Level: Medium
Speed Limit: 30 KM/Hr
Coordinates: 11.08282, 77.65837

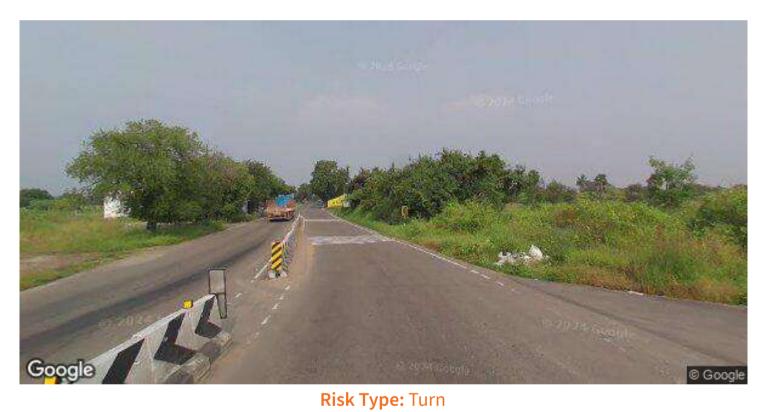
Risk Level: Medium
Speed Limit: 30 KM/Hr
Coordinates: 11.06189, 77.63943

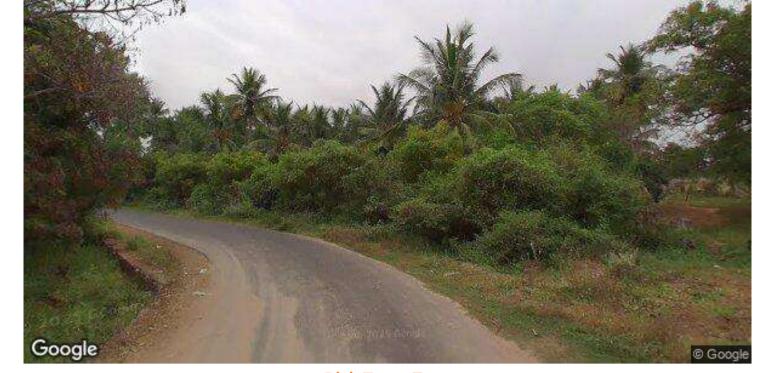
Risk Type: Turn
Risk Level: High
Speed Limit: 15 KM/Hr

Coordinates: 11.05548, 77.63958
