# JOURNEY RISK MANAGEMENT (JRM) STUDY

#### Salem Terminal To SHREE CHANDIKA AGENCIES

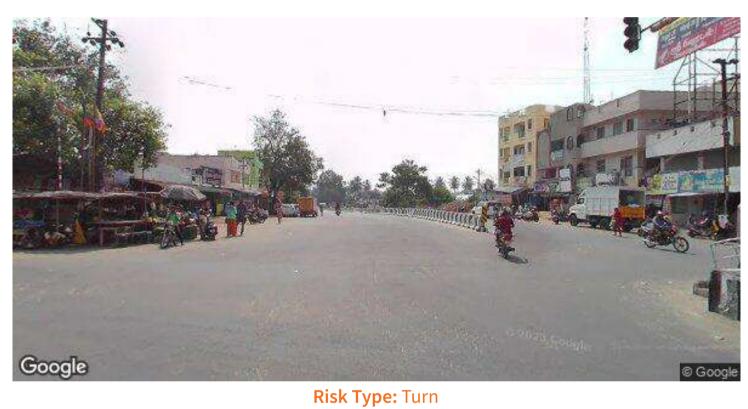
Risk Level: High
Speed Limit: 15 KM/Hr
Coordinates: 11.36604, 77.88887

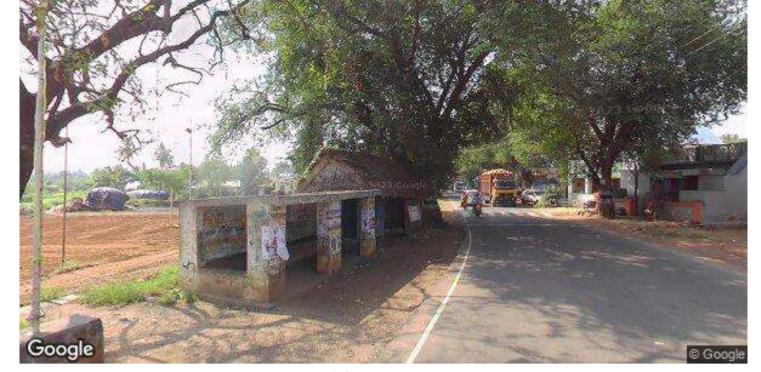
Risk Type: Turn
Risk Level: Medium
Speed Limit: 30 KM/Hr
Coordinates: 11.34632, 77.86836

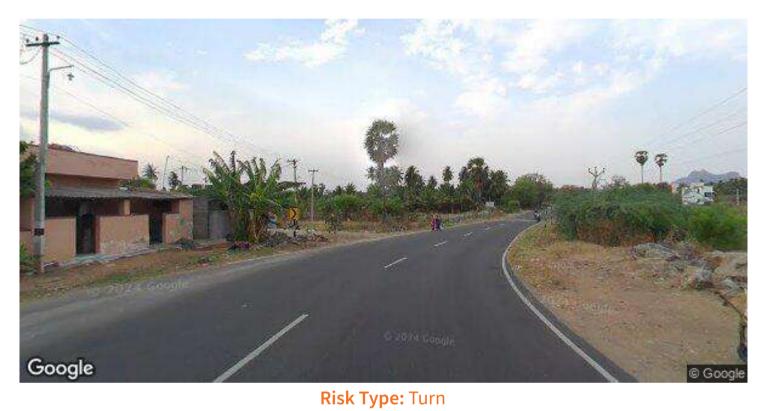
Risk Level: Medium
Speed Limit: 30 KM/Hr
Coordinates: 11.33882, 77.86218

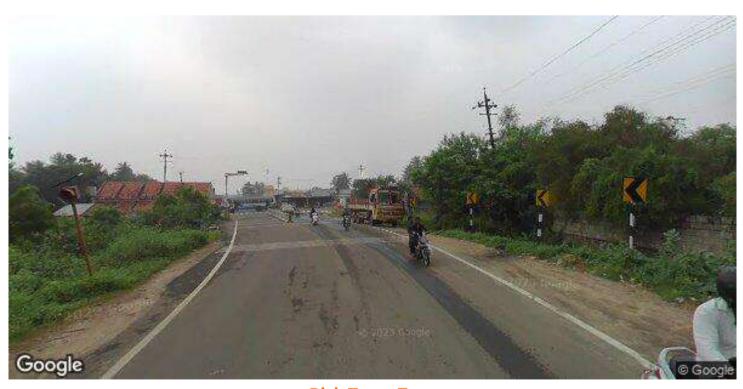
Risk Type: Turn
Risk Level: Medium

Speed Limit: 30 KM/Hr Coordinates: 11.30970, 77.76705

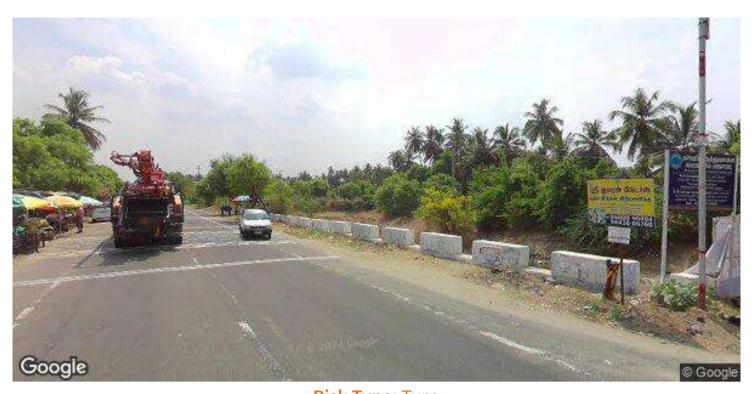
Risk Type: Turn
Risk Level: High
Speed Limit: 15 KM/Hr
Coordinates: 11.29490, 77.74685

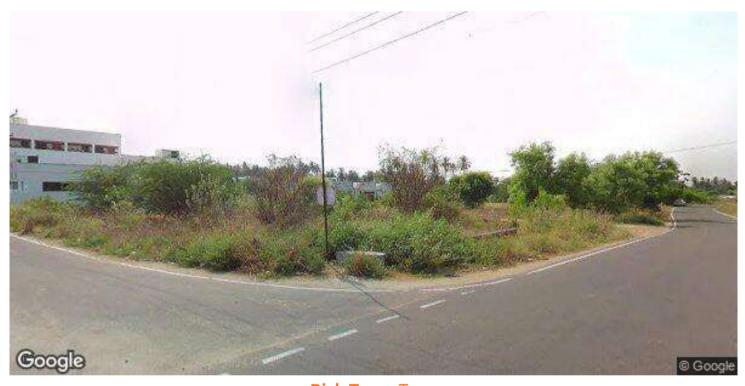
Risk Type: Turn
Risk Level: High
Speed Limit: 15 KM/Hr

**Coordinates:** 11.29133, 77.74660

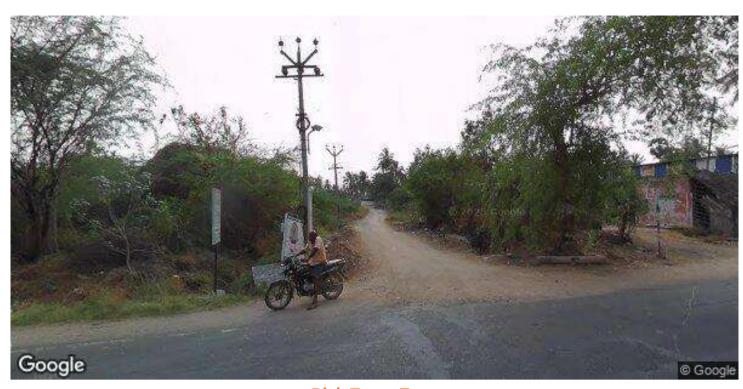
Risk Type: Turn
Risk Level: High
Speed Limit: 15 KM/Hr
Coordinates: 11.27330, 77.72711

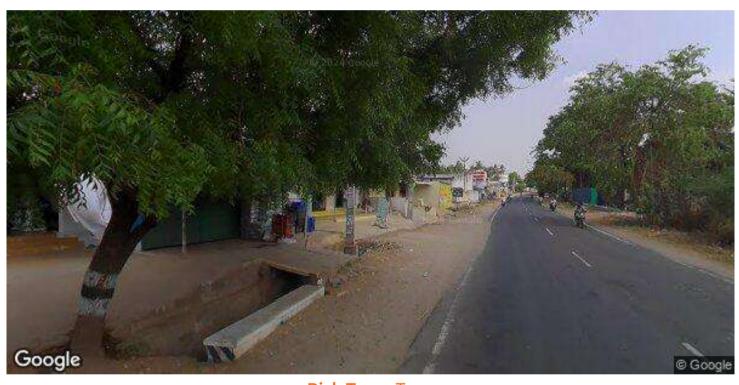
Risk Type: Turn
Risk Level: Medium
Speed Limit: 30 KM/Hr
Coordinates: 11.27322, 77.72706

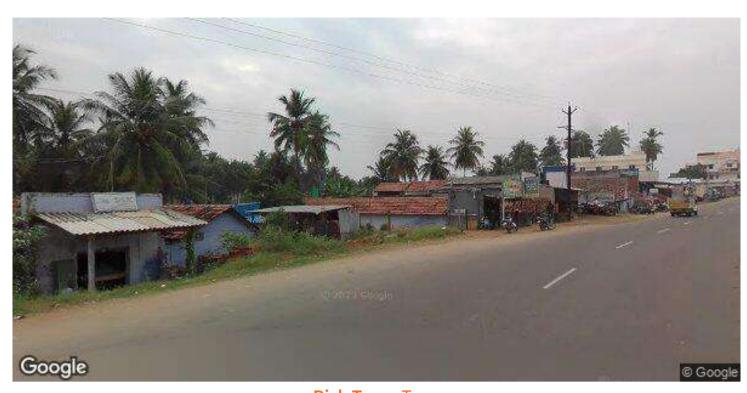
Risk Type: Turn
Risk Level: Medium
Speed Limit: 30 KM/Hr
Coordinates: 11.08730, 77.66436

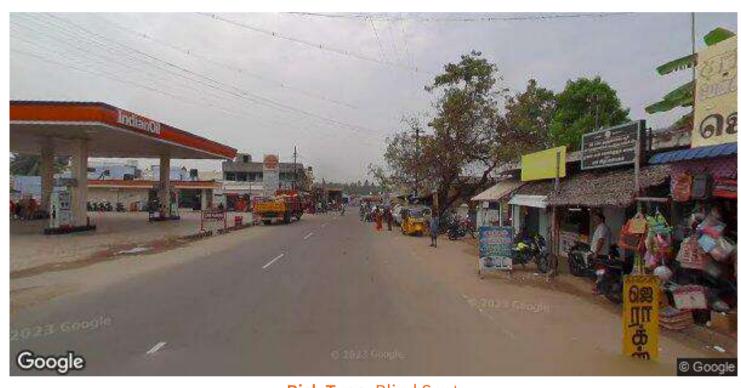
Risk Type: Blind Spot
Risk Level: Blind Spot
Speed Limit: 10 KM/Hr
Coordinates: 11.08565, 77.66268
