JOURNEY RISK MANAGEMENT (JRM) STUDY

IOCL Coimbatore Terminal to Kevi Petroleum

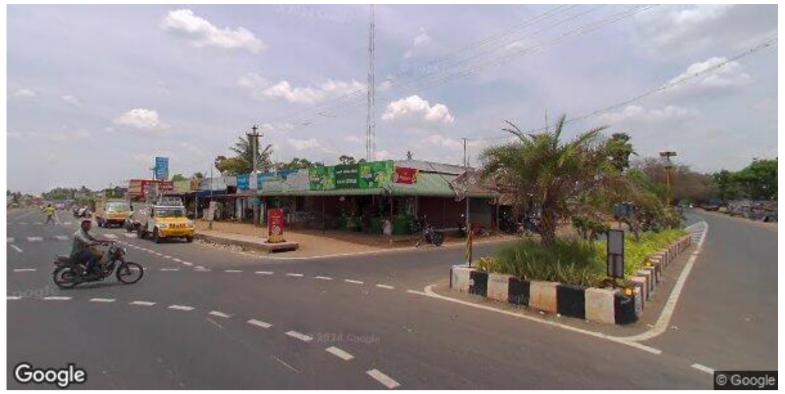
Risk Type: Roundabout
Risk Level: High
Speed Limit: 15 KM/Hr
Coordinates: 10.68968, 76.91155

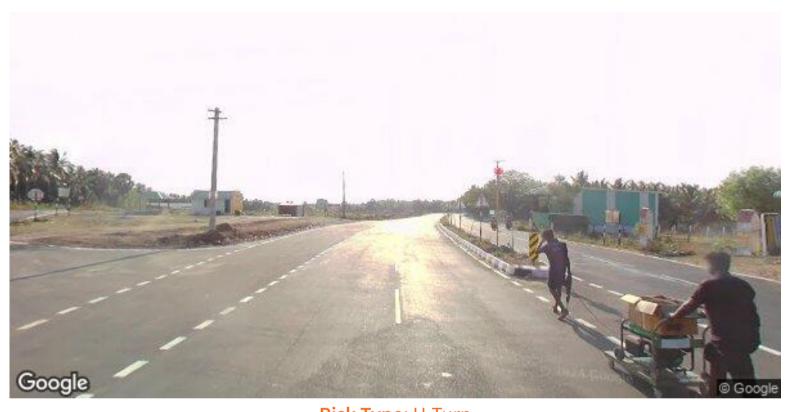
Risk Type: U-Turn
Risk Level: High
Speed Limit: 10 KM/Hr
Coordinates: 10.6914007, 76.9028769

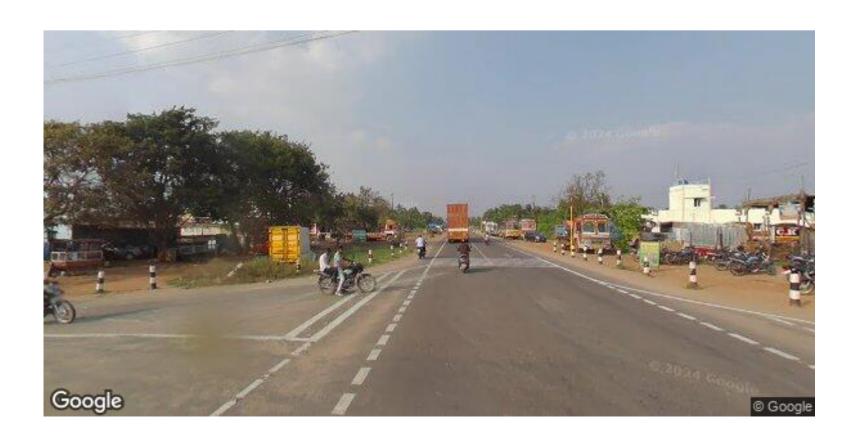
Coordinates: 11.03211, 77.07640

Risk Type: Blind Spot
Risk Level: Blind Spot
Speed Limit: 10 KM/Hr

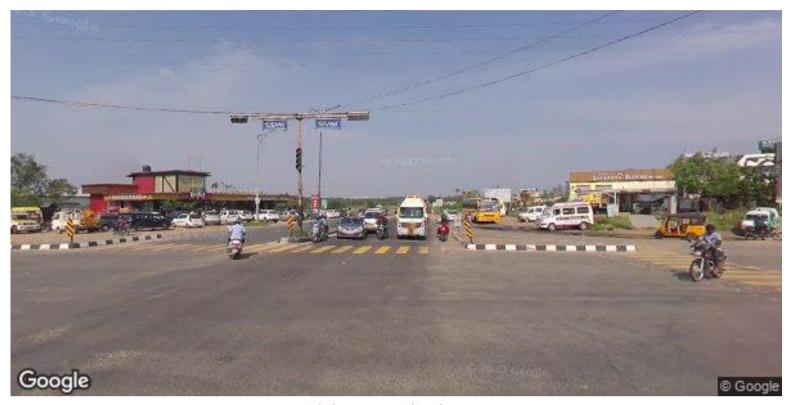
Risk Type: Blind Spot
Risk Level: Blind Spot
Speed Limit: 10 KM/Hr
Coordinates: 10.91785, 76.98617

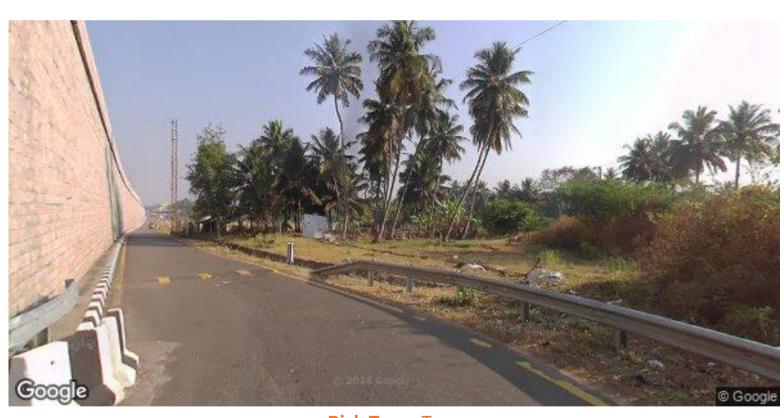
Risk Type: Turn
Risk Level: Medium
Speed Limit: 30 KM/Hr
Coordinates: 10.76126, 77.01934

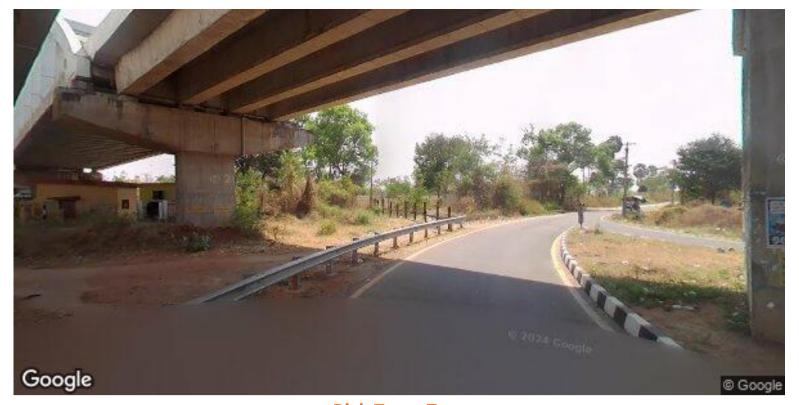
Risk Type: Turn
Risk Level: Medium
Speed Limit: 30 KM/Hr
Coordinates: 10.76105, 77.01924

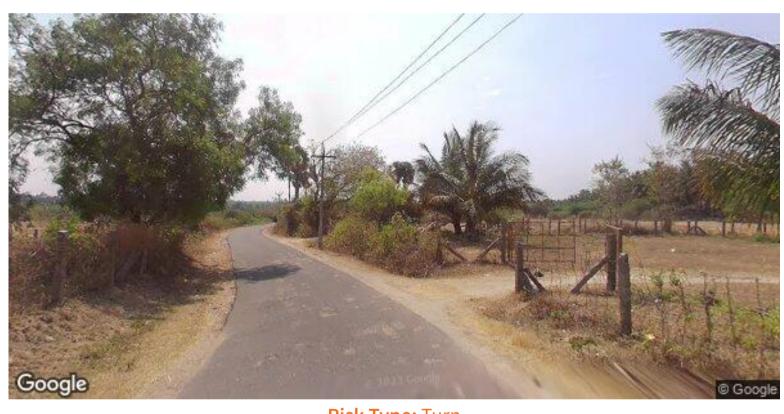
Risk Type: Turn
Risk Level: Medium
Speed Limit: 30 KM/Hr
Coordinates: 10.76064, 77.01722

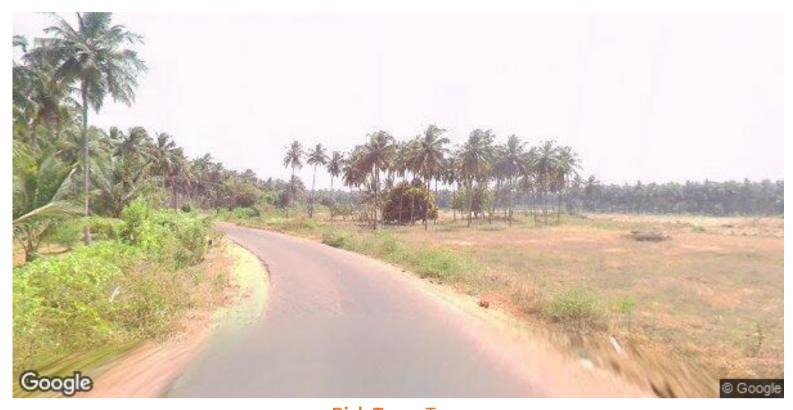
Risk Type: Turn
Risk Level: Medium
Speed Limit: 30 KM/Hr
Coordinates: 10.75911, 77.01183

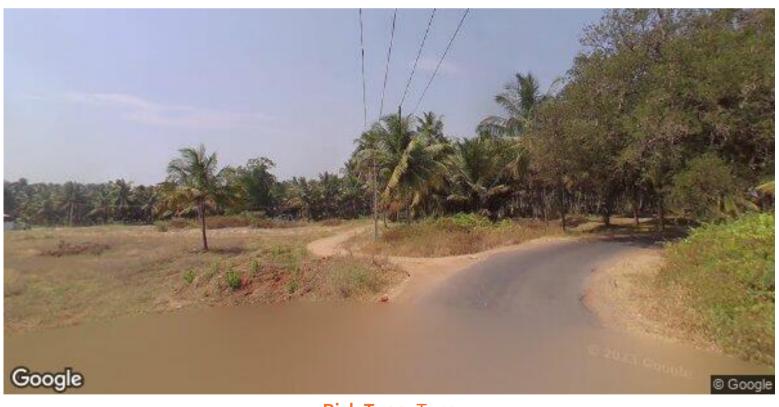
Risk Type: Turn
Risk Level: Medium
Speed Limit: 30 KM/Hr
Coordinates: 10.75897, 77.01181

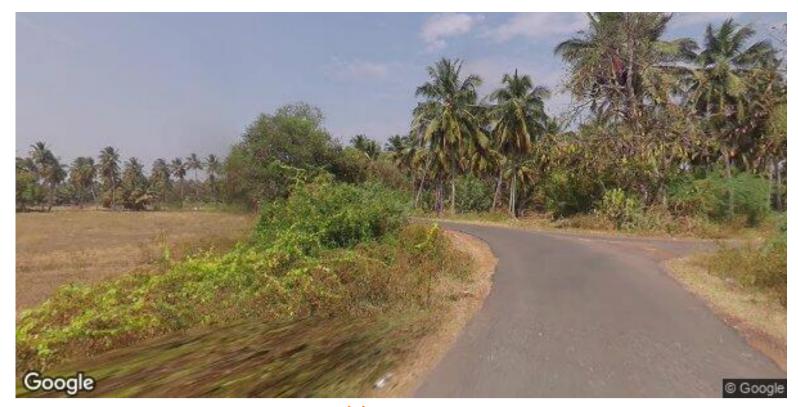
Risk Type: Turn
Risk Level: Medium
Speed Limit: 30 KM/Hr
Coordinates: 10.75677, 77.01162

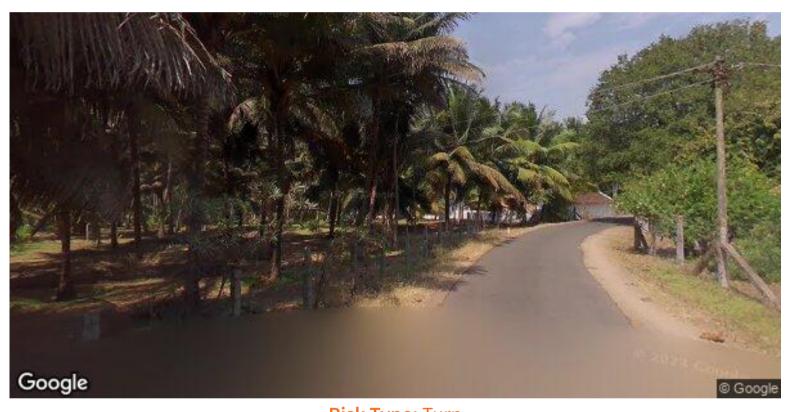
Risk Type: Turn
Risk Level: Medium
Speed Limit: 30 KM/Hr
Coordinates: 10.75580, 77.00744

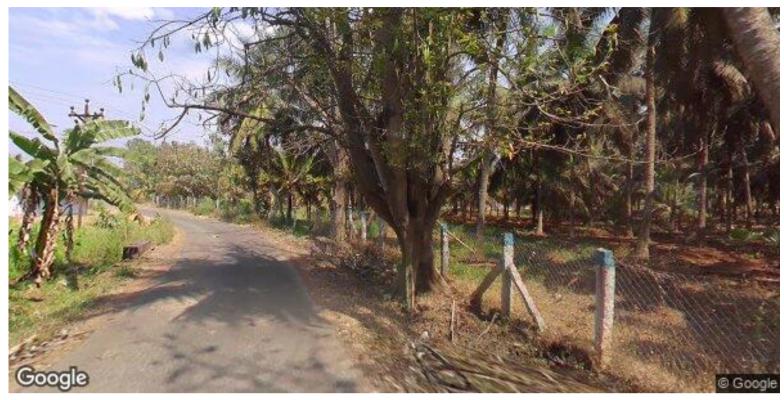
Risk Type: Turn
Risk Level: Medium
Speed Limit: 30 KM/Hr
Coordinates: 10.75230, 76.99966

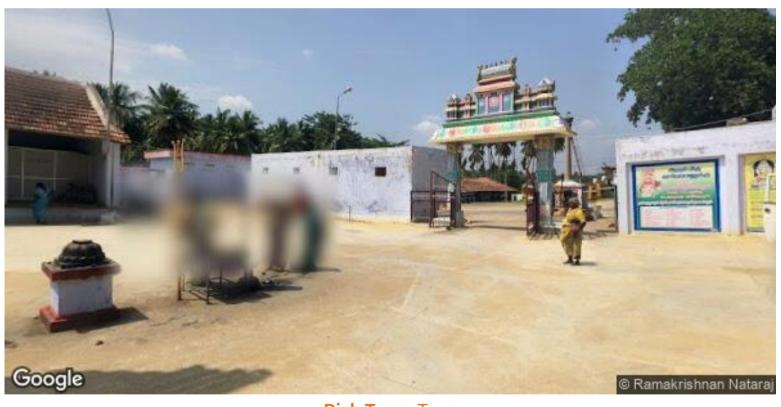
Risk Type: Turn
Risk Level: High
Speed Limit: 15 KM/Hr
Coordinates: 10.75039, 76.99445

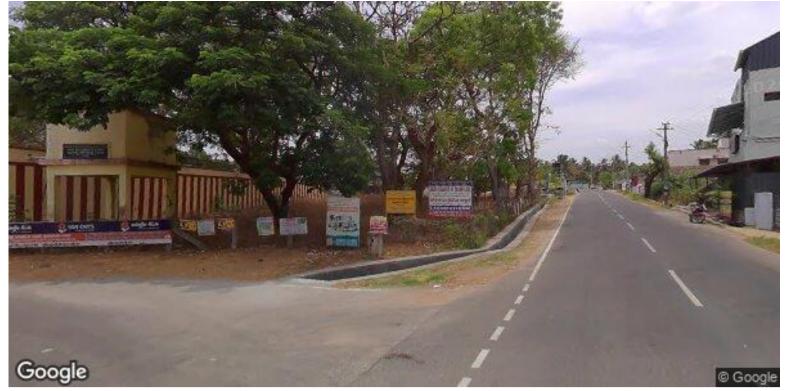
Coordinates: 10.74949, 76.99419

Risk Type: Blind Spot Risk Level: Blind Spot Speed Limit: 10 KM/Hr

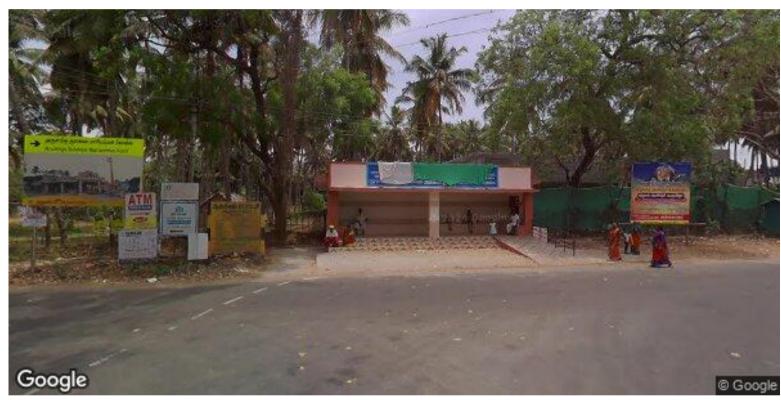
Coordinates: 10.75015, 76.99326

Risk Type: Turn
Risk Level: High
Speed Limit: 15 KM/Hr

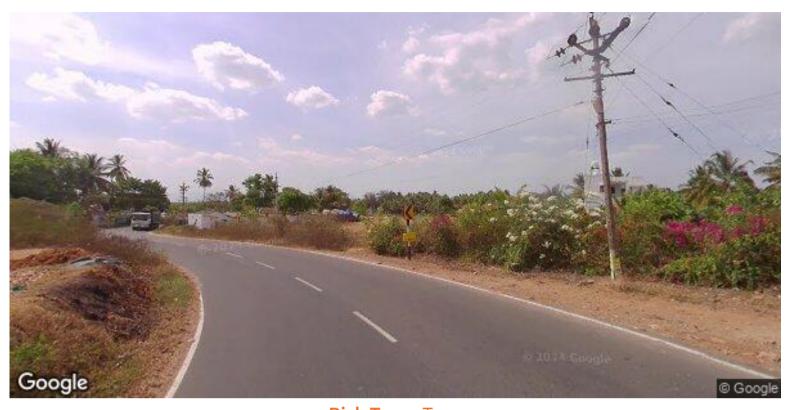
Risk Type: Turn
Risk Level: Medium
Speed Limit: 30 KM/Hr
Coordinates: 10.74138, 76.98754

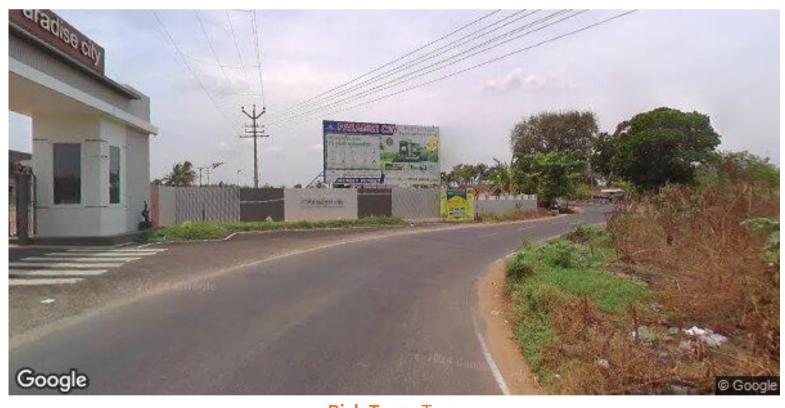
Risk Type: Turn
Risk Level: Medium
Speed Limit: 30 KM/Hr
Coordinates: 10.74071, 76.98762

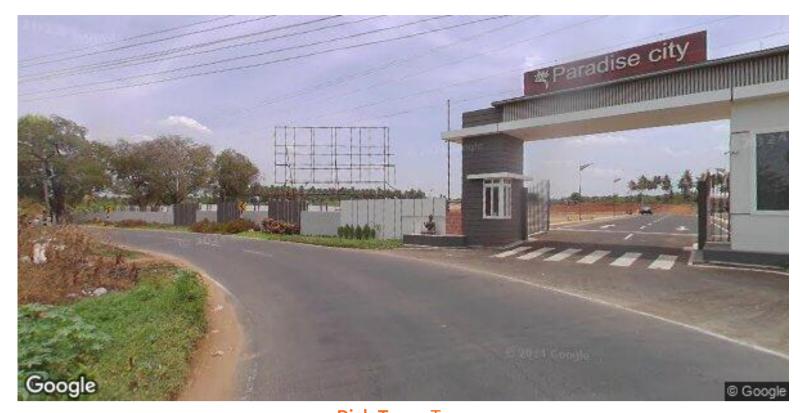
Risk Type: Turn
Risk Level: Medium
Speed Limit: 30 KM/Hr
Coordinates: 10.74058, 76.98756

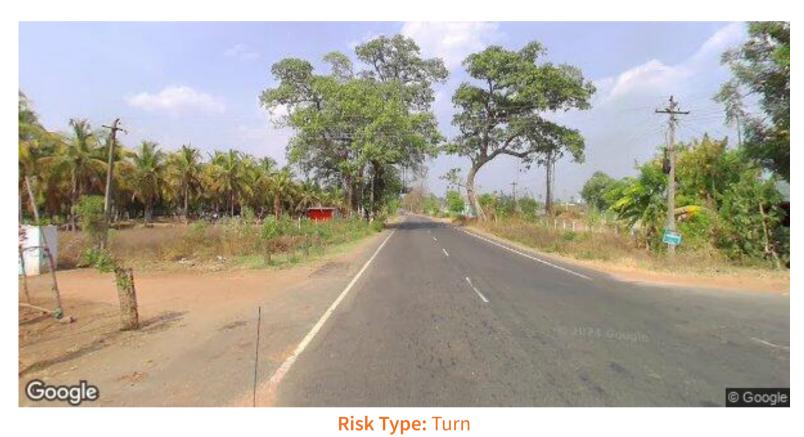
Risk Level: High
Speed Limit: 15 KM/Hr
Coordinates: 10.72397, 76.91777

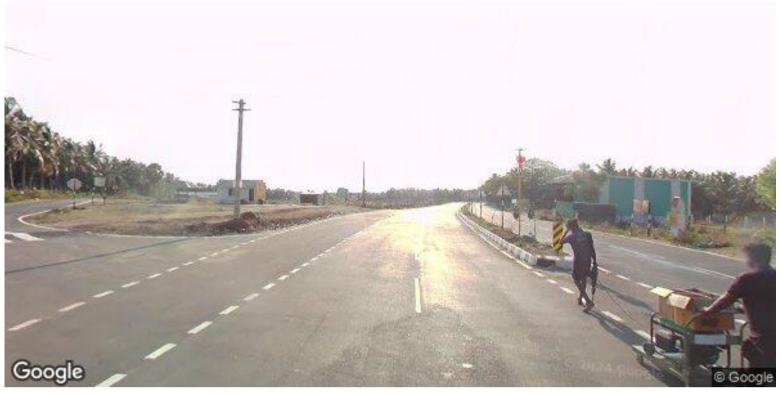
Coordinates: 10.69140, 76.90288

Risk Type: Blind Spot Risk Level: Blind Spot Speed Limit: 10 KM/Hr
