# JOURNEY RISK MANAGEMENT (JRM) STUDY

#### **IOCL Coimbatore Terminal to AVT Auto Feeds**

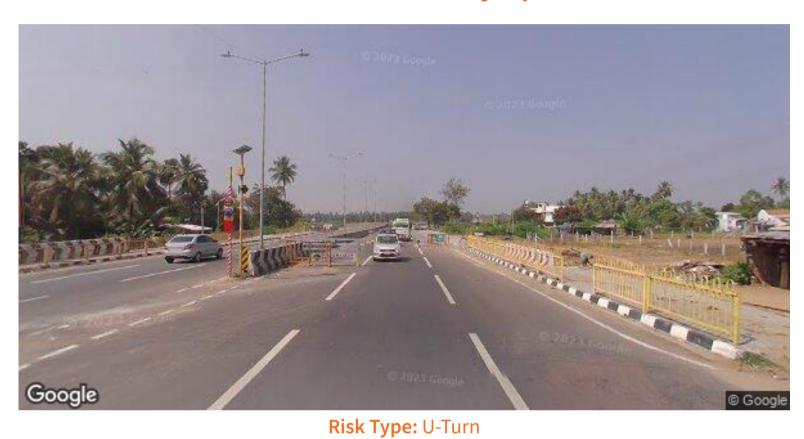
**Coordinates:** 10.716839, 77.5398277

Risk Level: High
Speed Limit: 10 KM/Hr

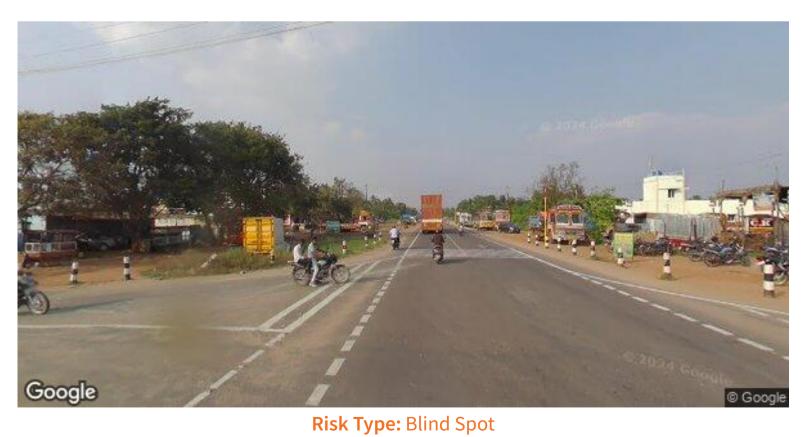
**Coordinates:** 11.03211, 77.07640

Risk Level: Blind Spot
Speed Limit: 10 KM/Hr

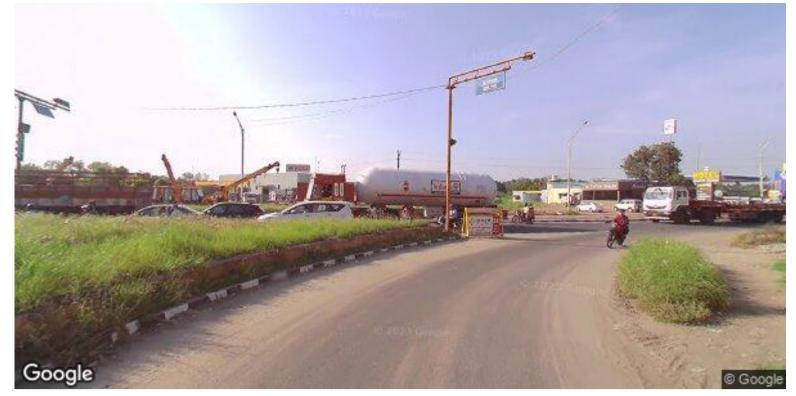
**Coordinates:** 11.00778, 77.07085

Risk Type: Blind Spot Risk Level: Blind Spot Speed Limit: 10 KM/Hr

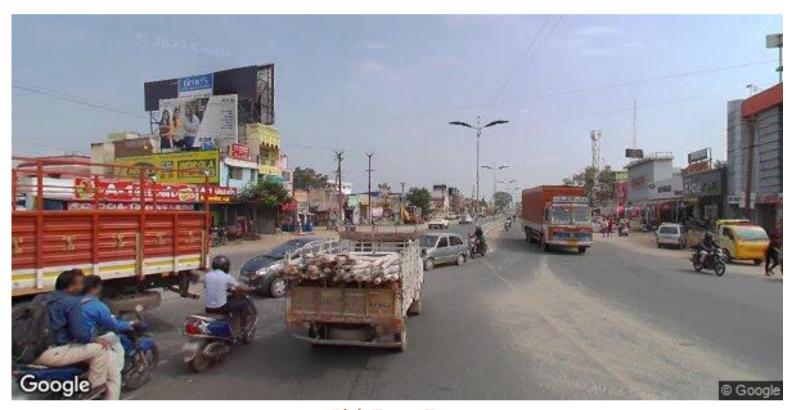
Risk Type: Turn
Risk Level: Medium
Speed Limit: 30 KM/Hr
Coordinates: 11.02774, 77.12761

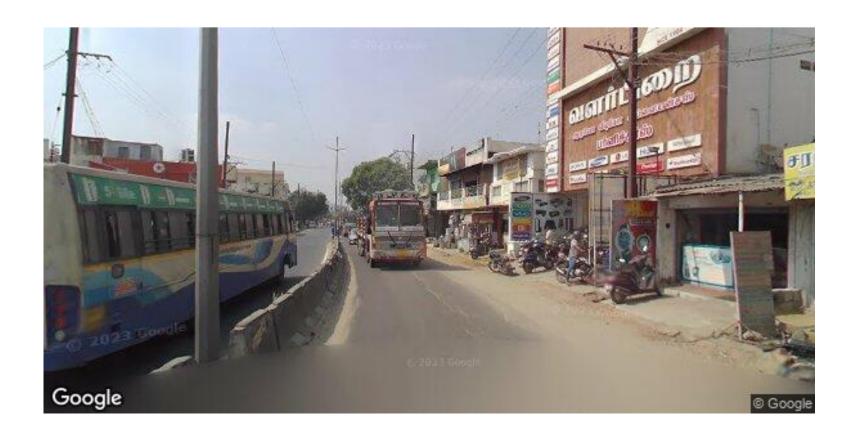
**Coordinates:** 10.99570, 77.28153

Risk Type: Turn
Risk Level: Medium
Speed Limit: 30 KM/Hr

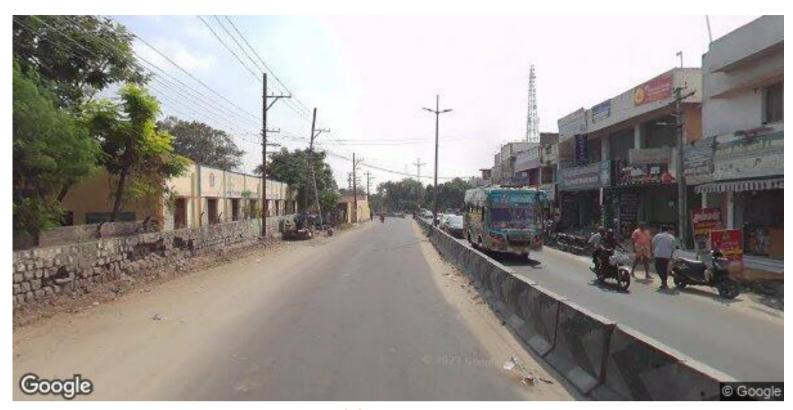
**Coordinates:** 10.99535, 77.28179

Risk Type: Turn
Risk Level: Medium
Speed Limit: 30 KM/Hr

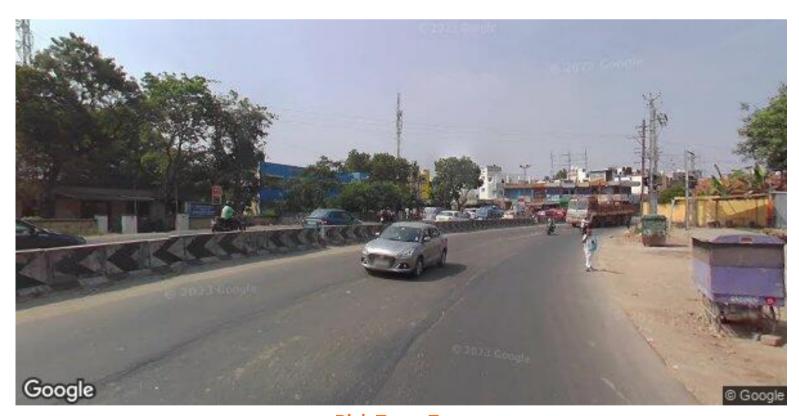
**Coordinates:** 10.99416, 77.28200

Risk Type: Turn
Risk Level: High
Speed Limit: 15 KM/Hr

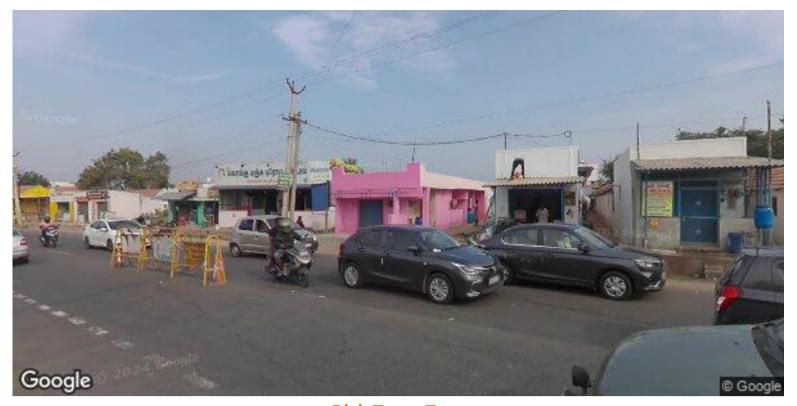
Risk Type: Turn
Risk Level: Medium
Speed Limit: 30 KM/Hr
Coordinates: 10.99304, 77.29585

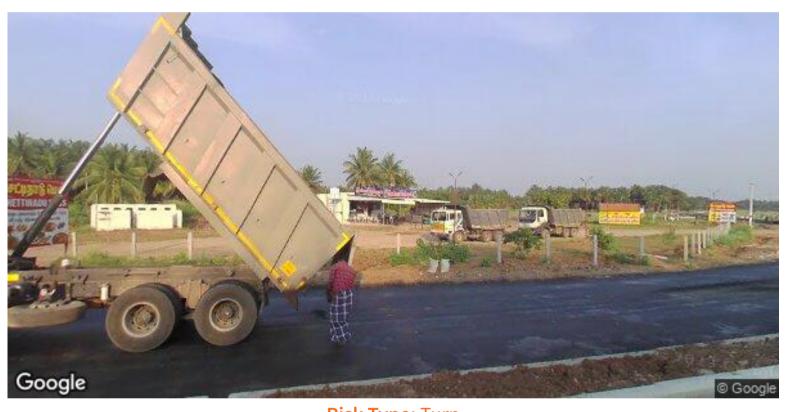
Risk Type: Turn
Risk Level: Medium
Speed Limit: 30 KM/Hr
Coordinates: 10.88226, 77.36219

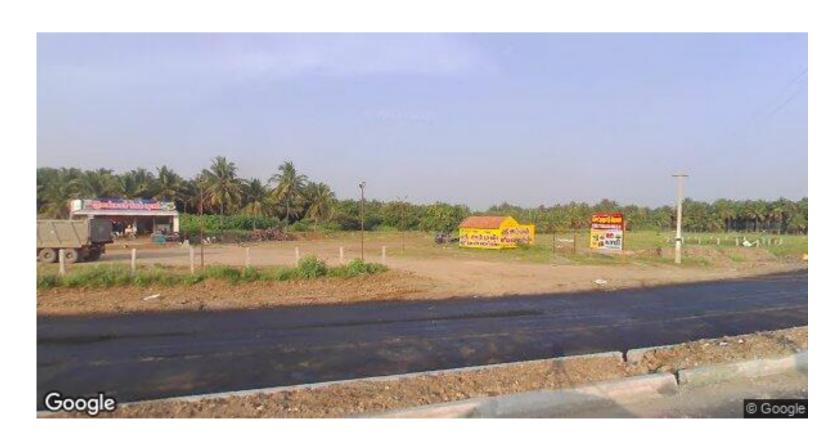
**Coordinates:** 10.88198, 77.36259

Risk Type: Turn
Risk Level: Medium
Speed Limit: 30 KM/Hr

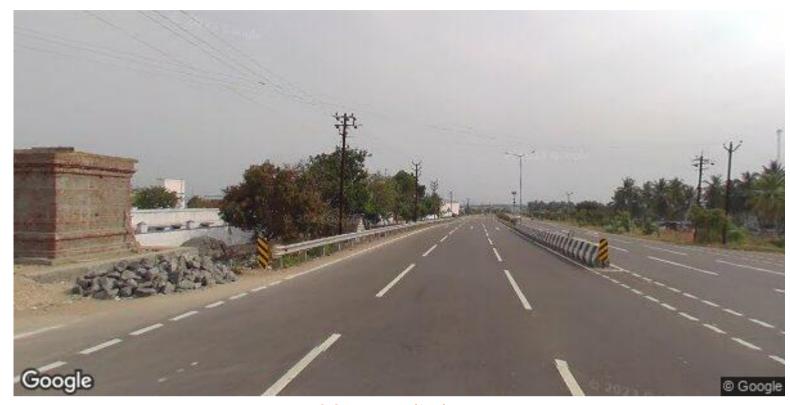
**Coordinates:** 10.84231, 77.47133

Risk Type: Blind Spot Risk Level: Blind Spot Speed Limit: 10 KM/Hr

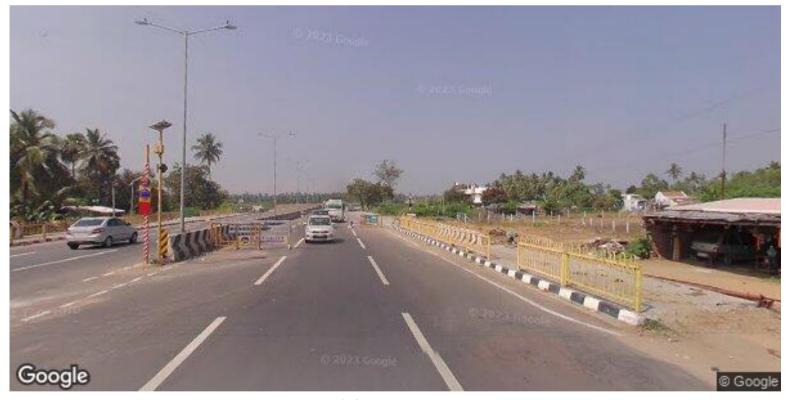
**Coordinates:** 10.71684, 77.53983

Risk Type: Turn
Risk Level: High
Speed Limit: 15 KM/Hr

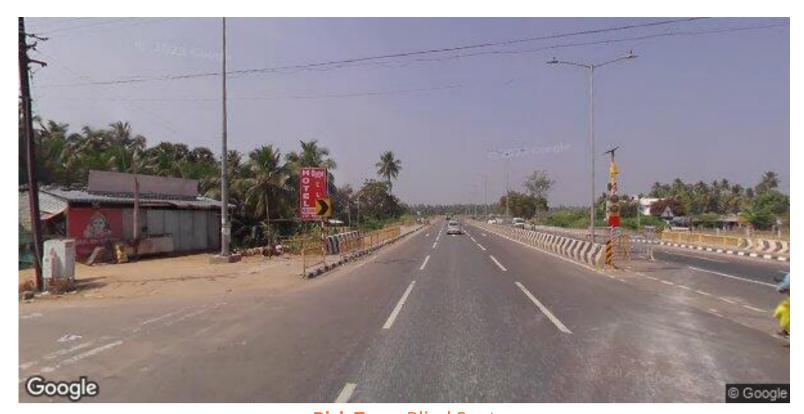
**Coordinates:** 10.71672, 77.53985

Risk Type: Blind Spot Risk Level: Blind Spot Speed Limit: 10 KM/Hr
