# JOURNEY RISK MANAGEMENT (JRM) STUDY

# Salem Terminal To SHIVA MUTHUKUMAR PETROLEUMS

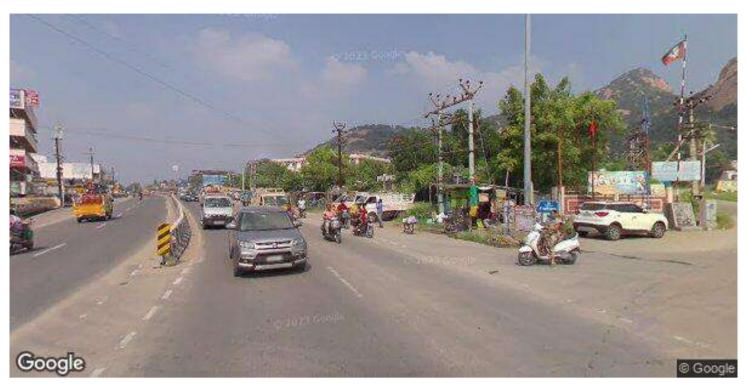
Risk Type: Turn
Risk Level: Medium
Speed Limit: 30 KM/Hr
Coordinates: 11.39671, 77.88878

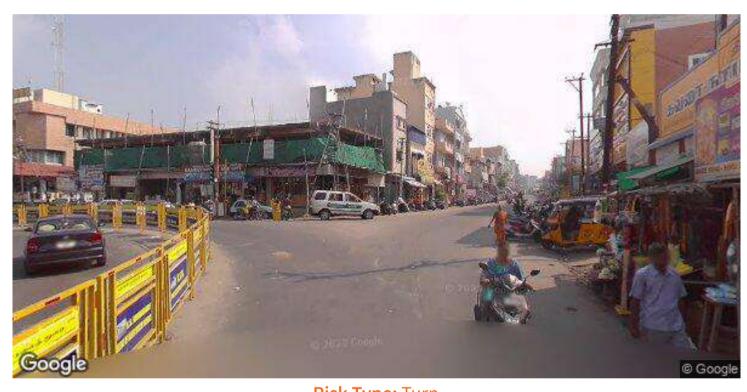
Risk Type: Turn
Risk Level: High
Speed Limit: 15 KM/Hr
Coordinates: 11.37862, 77.89488

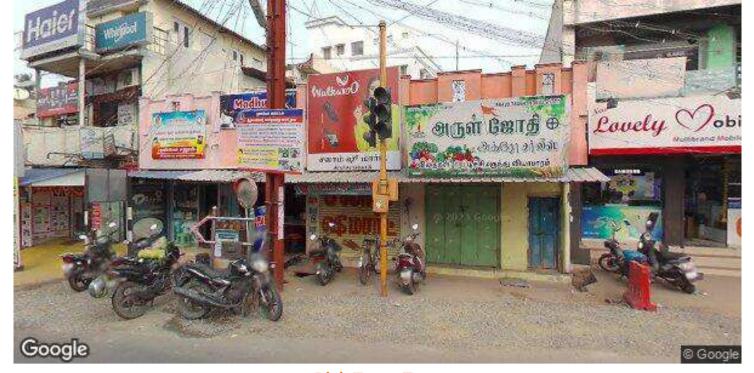
Risk Type: Turn
Risk Level: High
Speed Limit: 15 KM/Hr
Coordinates: 11.37850, 77.89453

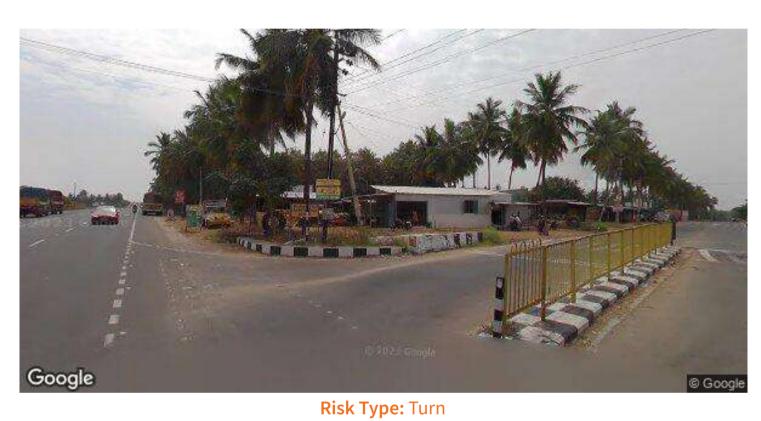
Risk Level: High
Speed Limit: 15 KM/Hr
Coordinates: 11.30859, 77.92918

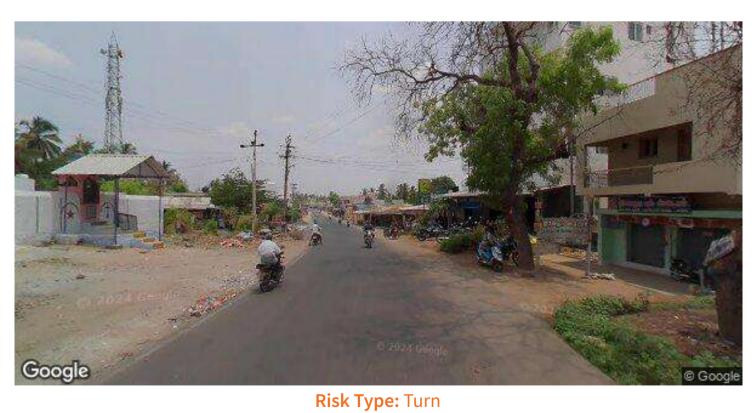
Risk Level: Medium

Speed Limit: 30 KM/Hr Coordinates: 11.24421, 77.87541

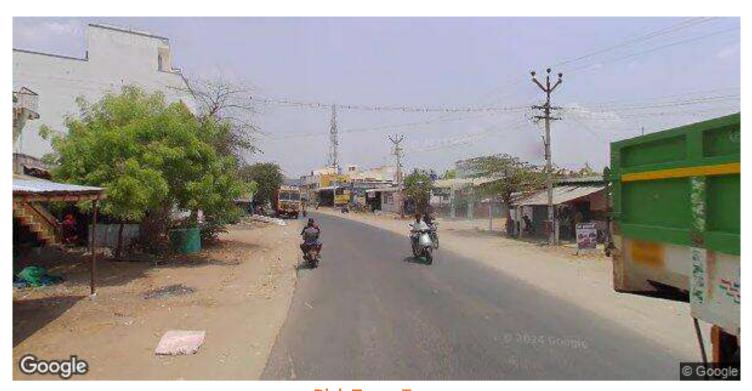
Risk Type: Turn
Risk Level: Medium
Speed Limit: 30 KM/Hr
Coordinates: 11.24192, 77.87363

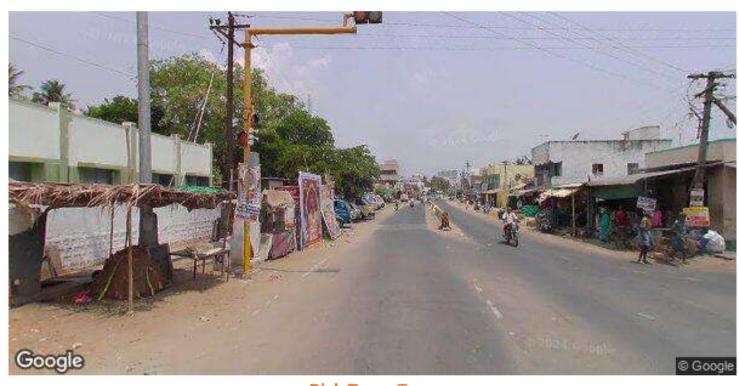
Risk Type: Turn
Risk Level: High
Speed Limit: 15 KM/Hr

**Coordinates:** 11.24001, 77.87368

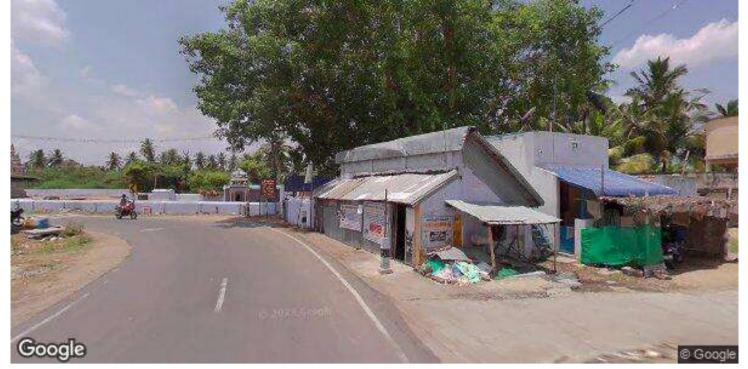
Risk Type: Turn
Risk Level: High
Speed Limit: 15 KM/Hr
Coordinates: 11.24061, 77.86899

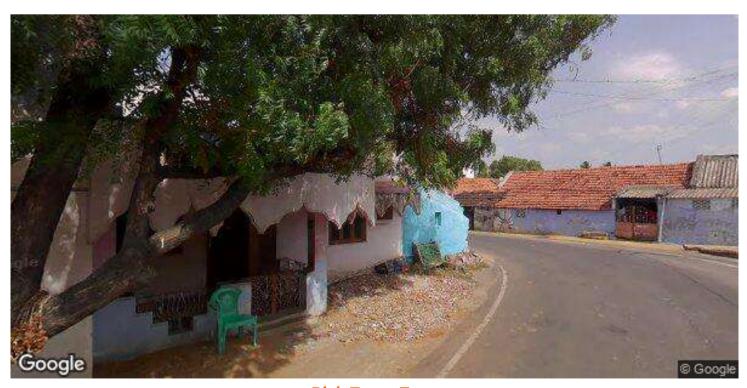
Risk Type: Turn Risk Level: High

Speed Limit: 15 KM/Hr Coordinates: 11.24166, 77.86845

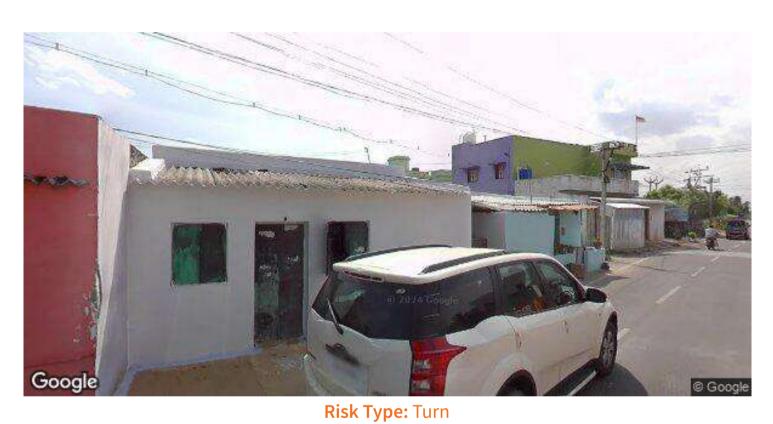
Risk Level: High
Speed Limit: 15 KM/Hr
Coordinates: 11.24250, 77.86784

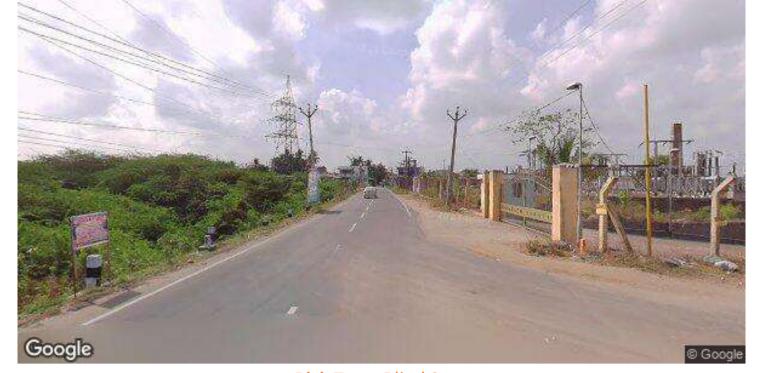
Risk Type: Blind Spot
Risk Level: Blind Spot
Speed Limit: 10 KM/Hr
Coordinates: 11.24384, 77.86689

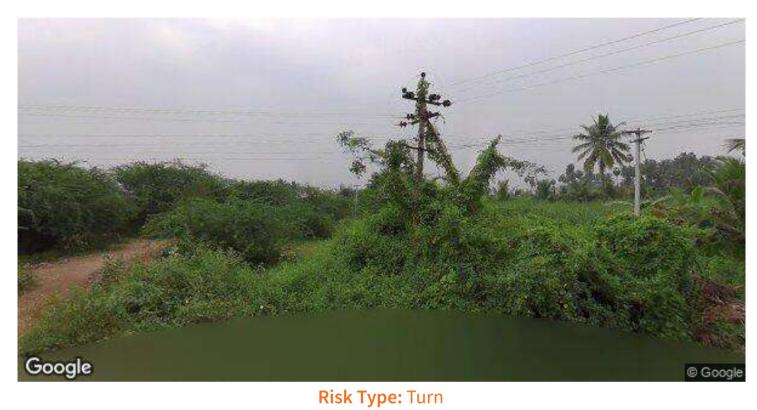
Risk Level: High
Speed Limit: 15 KM/Hr
Coordinates: 11.24100, 77.86026

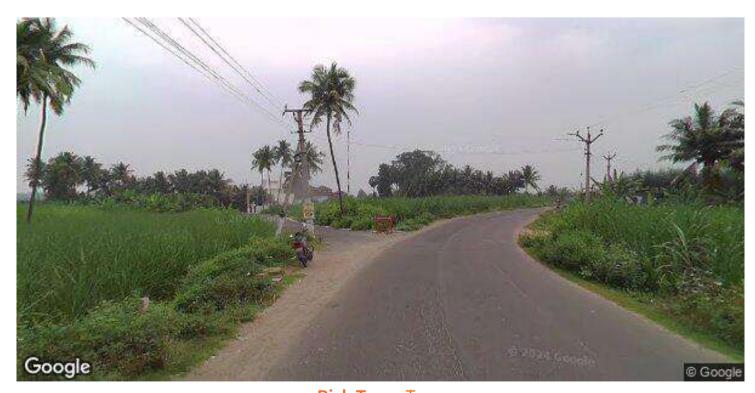
Risk Type: Turn
Risk Level: Medium

Speed Limit: 30 KM/Hr Coordinates: 11.24197, 77.85898

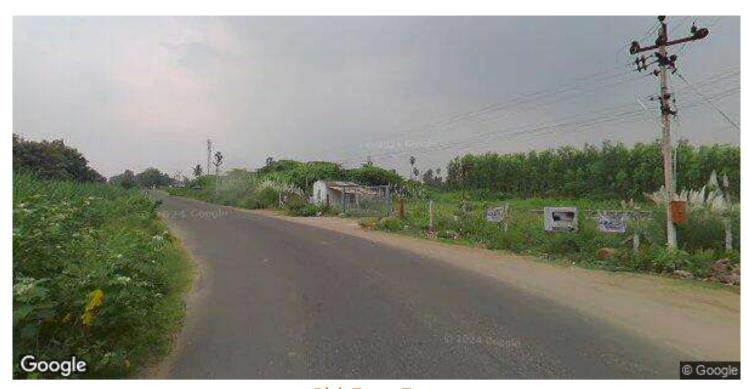
Risk Type: Turn
Risk Level: Medium
Speed Limit: 30 KM/Hr
Coordinates: 11.24199, 77.85864

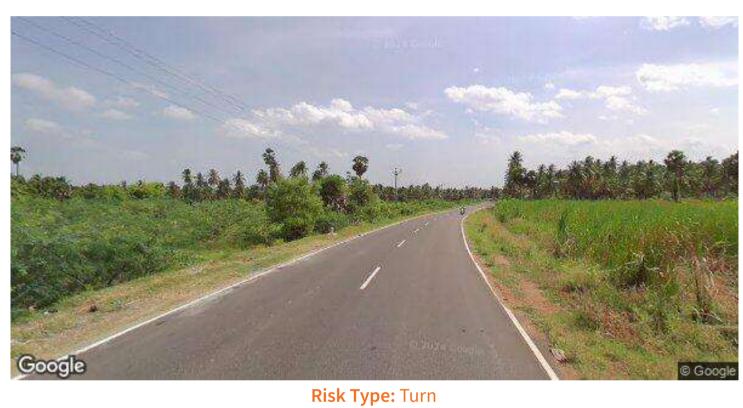
Risk Type. Turn
Risk Level: Medium
Speed Limit: 30 KM/Hr
Coordinates: 11.20921, 77.81149

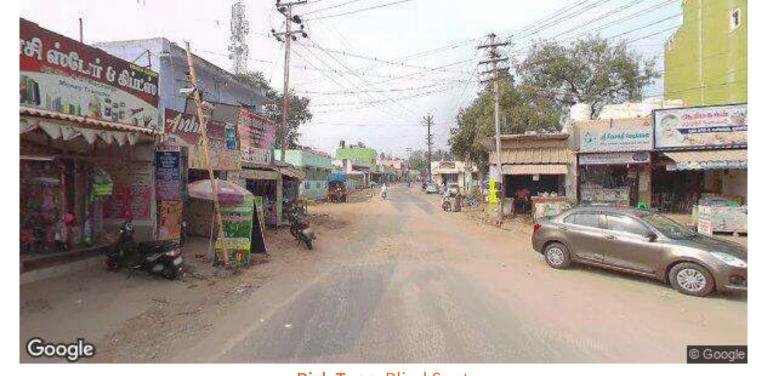
Risk Type: Blind Spot
Risk Level: Blind Spot
Speed Limit: 10 KM/Hr
Coordinates: 11.18856, 77.77110

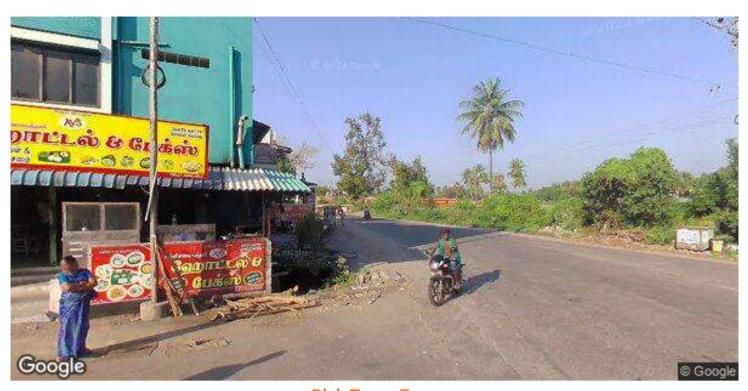
Risk Type: Turn
Risk Level: Medium
Speed Limit: 30 KM/Hr
Coordinates: 11.13679, 77.76533

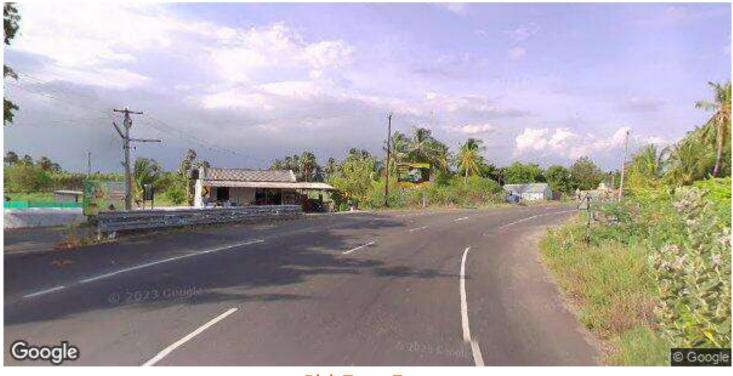
Risk Type: Turn Risk Level: High Speed Limit: 15 KM/Hr Coordinates: 10.98966, 77.72381

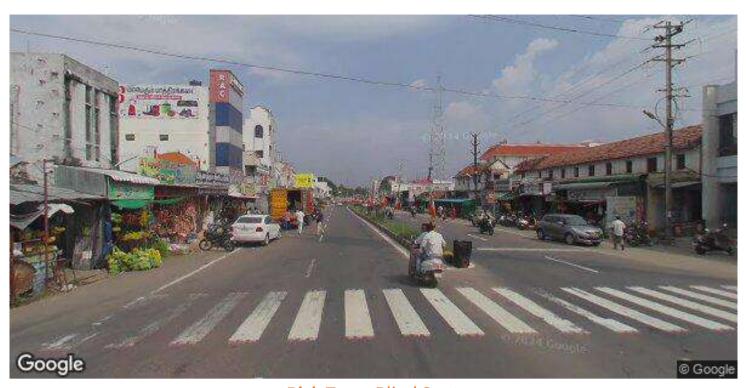
Risk Type: Blind Spot
Risk Level: Blind Spot
Speed Limit: 10 KM/Hr
Coordinates: 10.94597, 77.71319

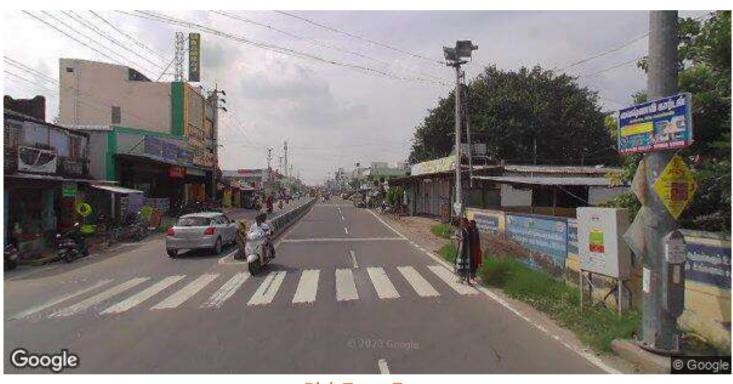
Risk Type: Turn
Risk Level: High
Speed Limit: 15 KM/Hr

**Coordinates:** 10.94571, 77.71574
