JOURNEY RISK MANAGEMENT (JRM) STUDY

Salem Terminal To SRI RAGAVENDRA ENERGY REFILLS

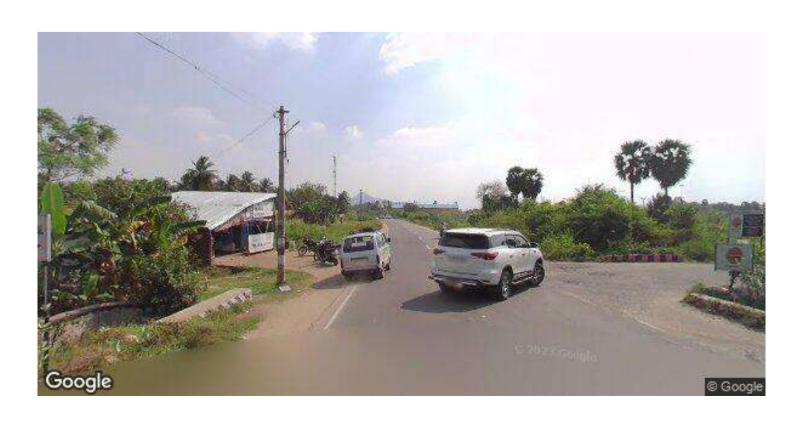
Risk Type: Turn
Risk Level: High
Speed Limit: 15 KM/Hr

Coordinates: 11.44029, 77.87544

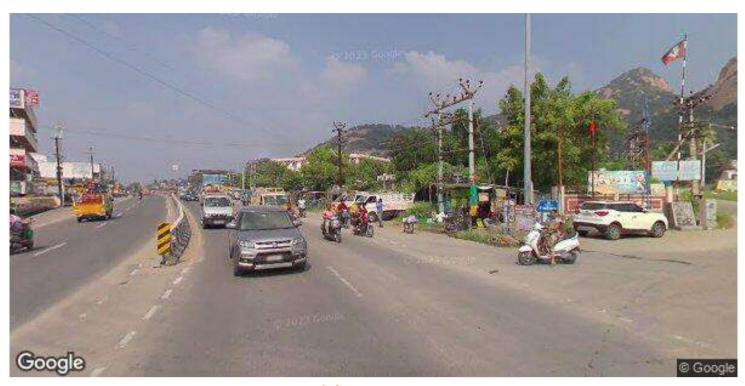
Risk Type: Turn
Risk Level: Medium
Speed Limit: 30 KM/Hr
Coordinates: 11.39671, 77.88878

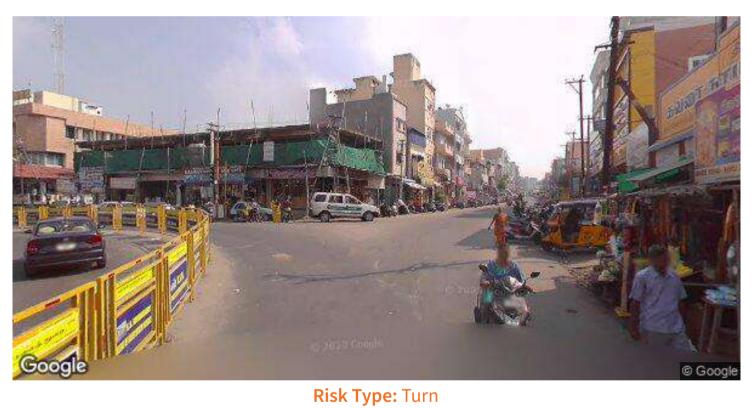
Risk Type: Turn
Risk Level: High
Speed Limit: 15 KM/Hr
Coordinates: 11.37862, 77.89488

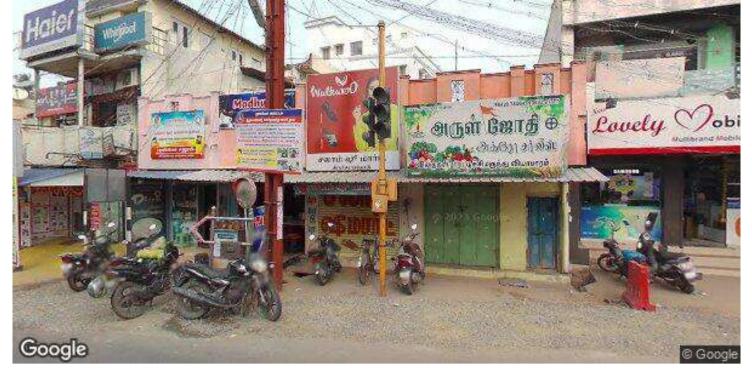
Risk Type: Turn
Risk Level: High
Speed Limit: 15 KM/Hr
Coordinates: 11.37850, 77.89453

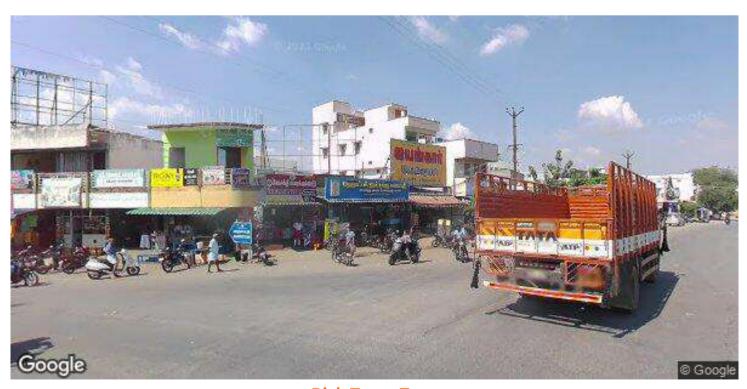
Risk Type: Turn
Risk Level: Medium

Speed Limit: 30 KM/Hr Coordinates: 11.36602, 77.88875

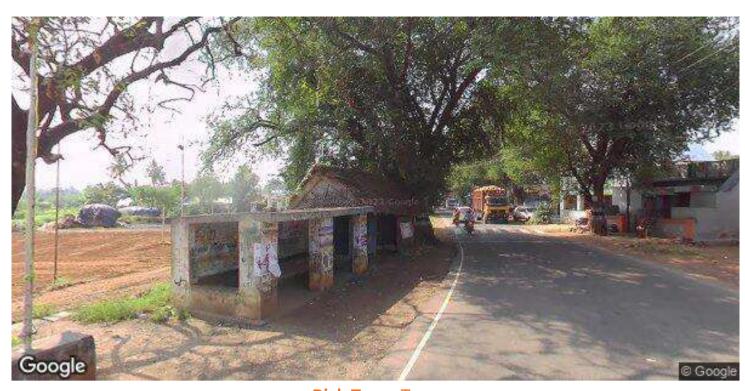
Risk Type: Turn
Risk Level: Medium
Speed Limit: 30 KM/Hr
Coordinates: 11.34632, 77.86836

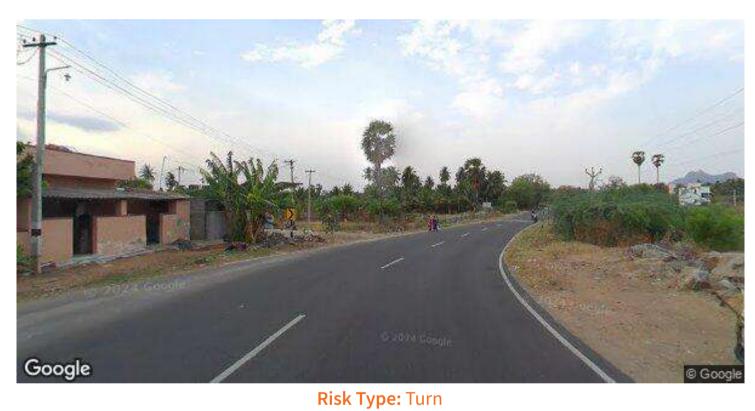
Risk Level: Medium
Speed Limit: 30 KM/Hr
Coordinates: 11.33882, 77.86218

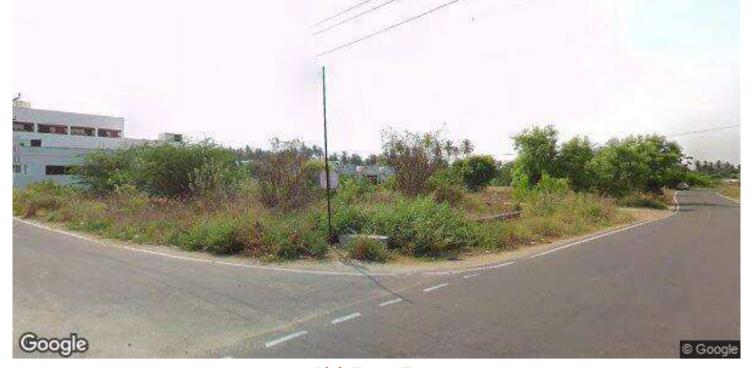
Risk Type: Turn
Risk Level: High
Speed Limit: 15 KM/Hr
Coordinates: 11.29133, 77.74660

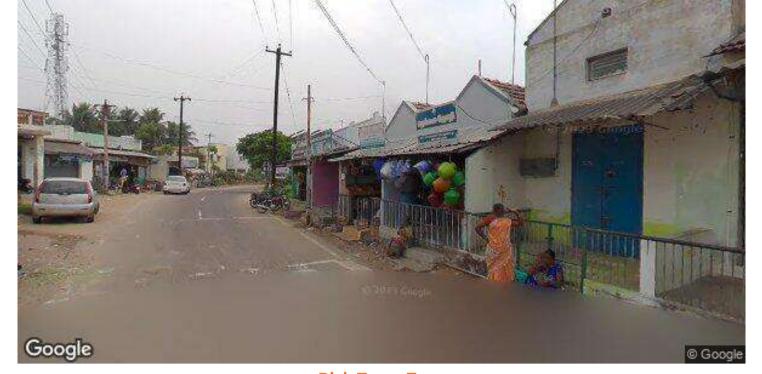
Risk Type: Turn
Risk Level: High
Speed Limit: 15 KM/Hr
Coordinates: 11.08484, 77.66195

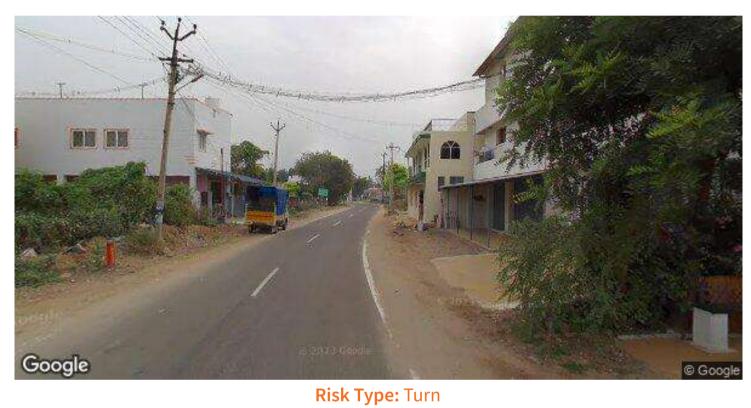
Risk Level: Medium
Speed Limit: 30 KM/Hr
Coordinates: 11.08433, 77.66212

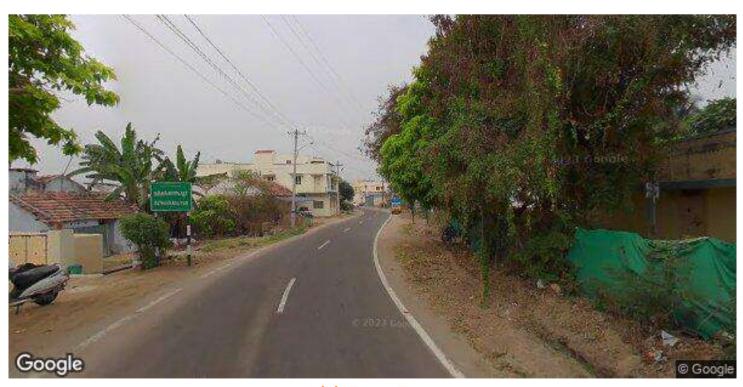
Risk Type: Turn Risk Level: High

Speed Limit: 15 KM/Hr Coordinates: 11.08365, 77.66202

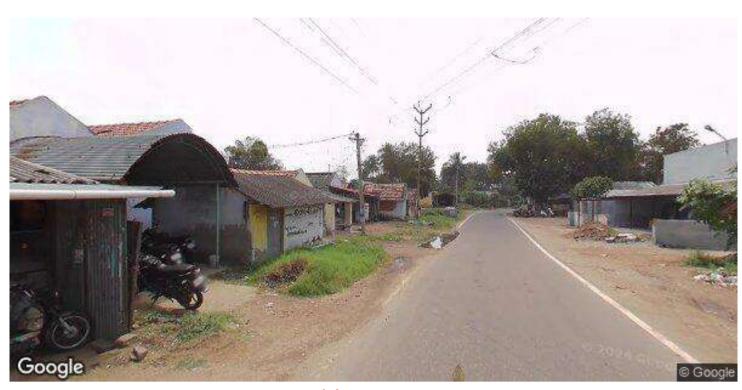
Risk Type: Turn
Risk Level: Medium
Speed Limit: 30 KM/Hr
Coordinates: 11.08010, 77.66431

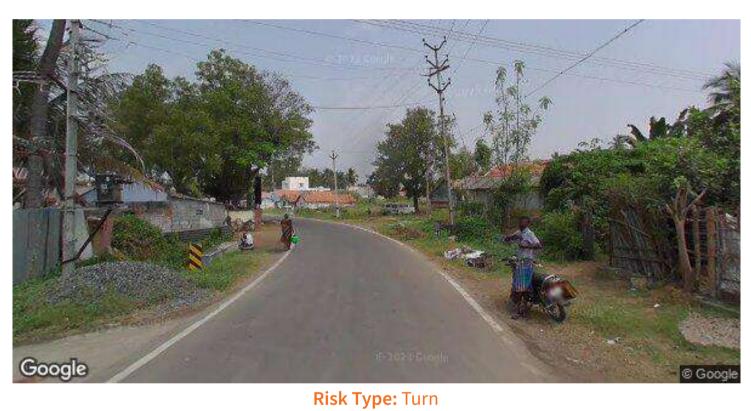
Risk Level: Medium
Speed Limit: 30 KM/Hr
Coordinates: 11.07926, 77.66416

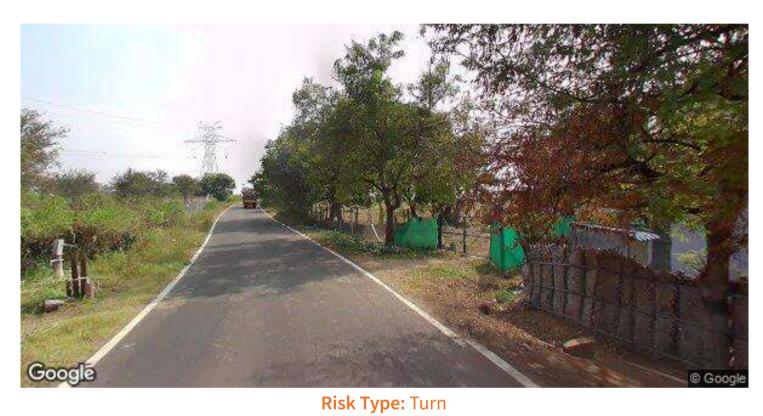
Risk Level: Medium
Speed Limit: 30 KM/Hr
Coordinates: 11.04802, 77.65982

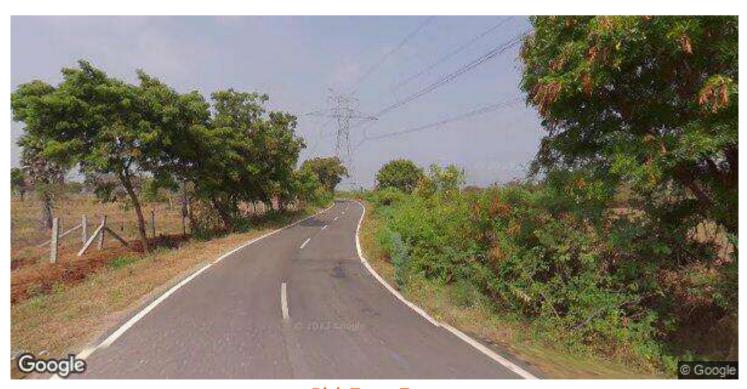
Risk Type: Turn
Risk Level: Medium

Speed Limit: 30 KM/Hr Coordinates: 11.04392, 77.65930

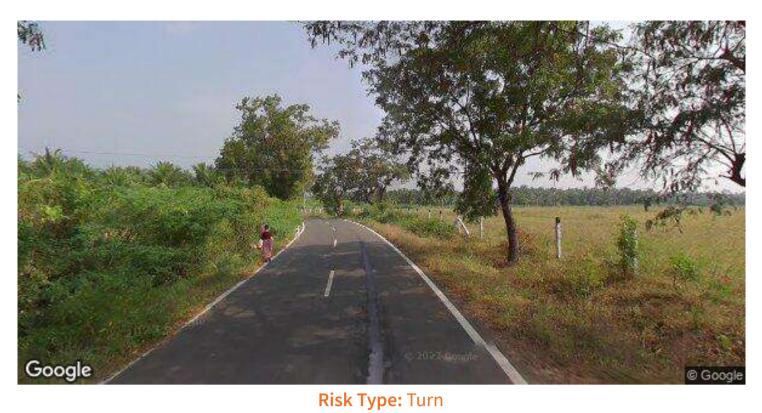
Risk Type: Turn
Risk Level: High
Speed Limit: 15 KM/Hr
Coordinates: 11.04364, 77.65937

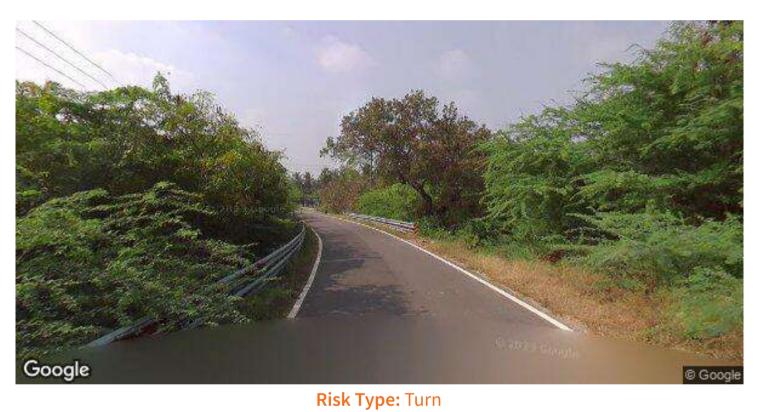
Risk Level: Medium
Speed Limit: 30 KM/Hr
Coordinates: 11.04257, 77.66142

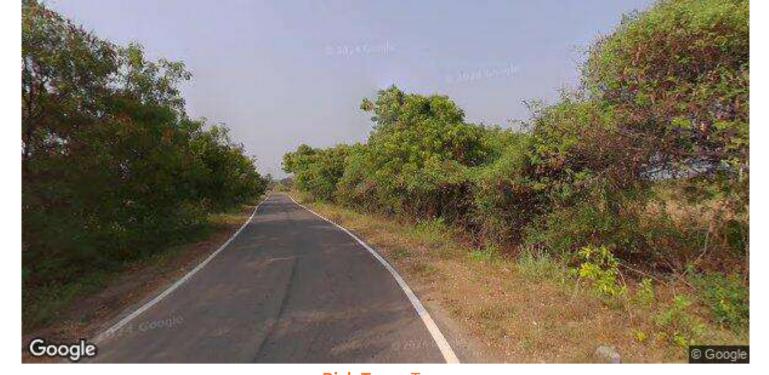
Risk Type: Turn
Risk Level: High
Speed Limit: 15 KM/Hr
Coordinates: 11.03742, 77.66229

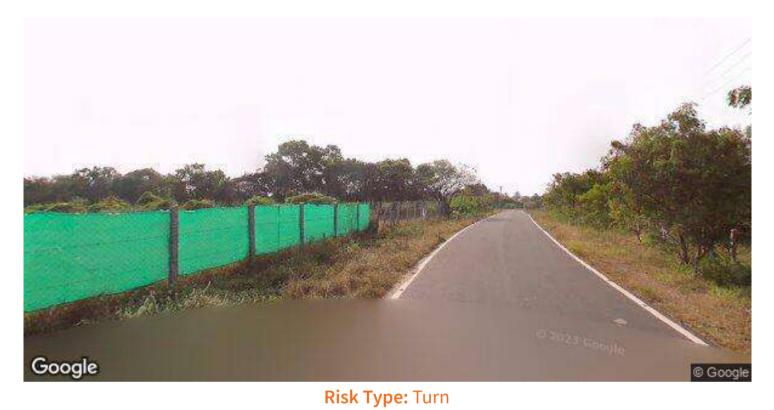
Risk Level: High
Speed Limit: 15 KM/Hr
Coordinates: 11.03726, 77.66214

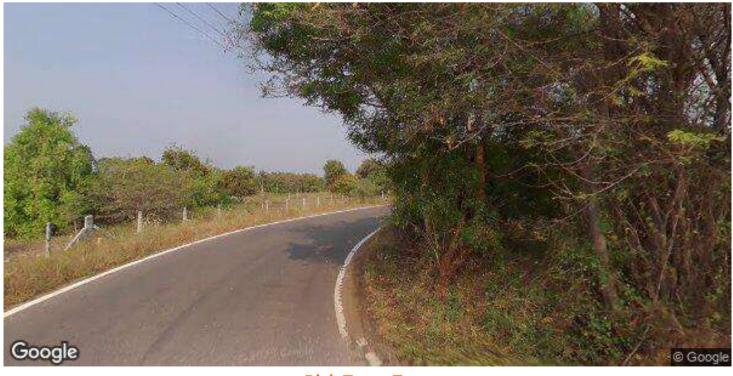
Risk Type: Turn Risk Level: High

Speed Limit: 15 KM/Hr Coordinates: 11.03732, 77.66105

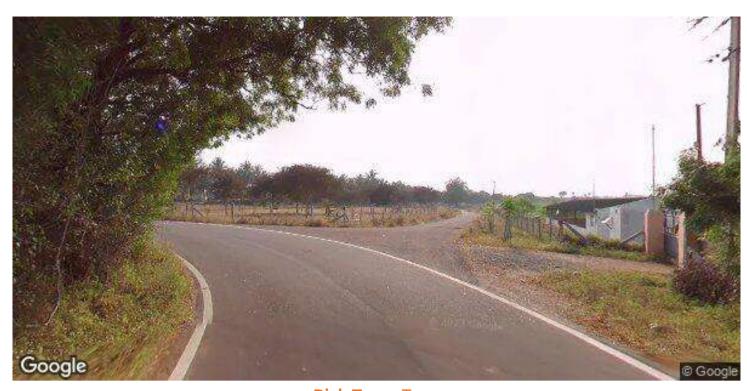
Risk Type: Turn
Risk Level: Medium
Speed Limit: 30 KM/Hr
Coordinates: 11.03580, 77.65957

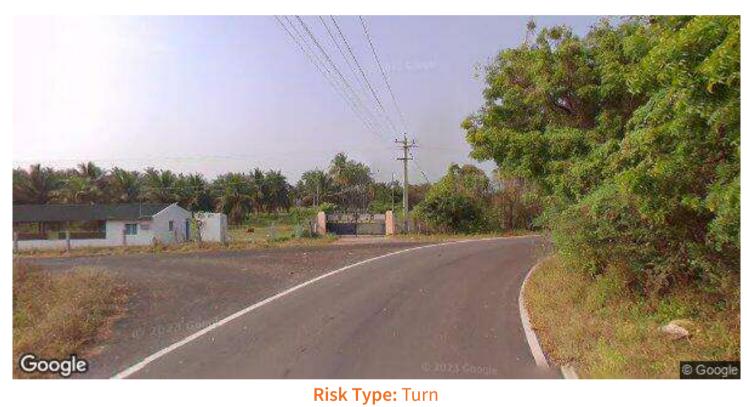
Risk Type: Turn
Risk Level: Medium
Speed Limit: 30 KM/Hr
Coordinates: 11.03559, 77.65949

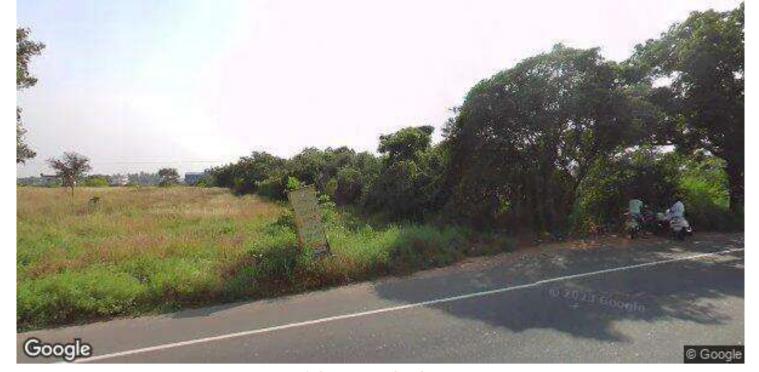
Risk Type: Blind Spot
Risk Level: Blind Spot
Speed Limit: 10 KM/Hr
Coordinates: 11.02383, 77.66081
