# JOURNEY RISK MANAGEMENT (JRM) STUDY

### **Salem Terminal To SHANTHI ENTERPRISES**

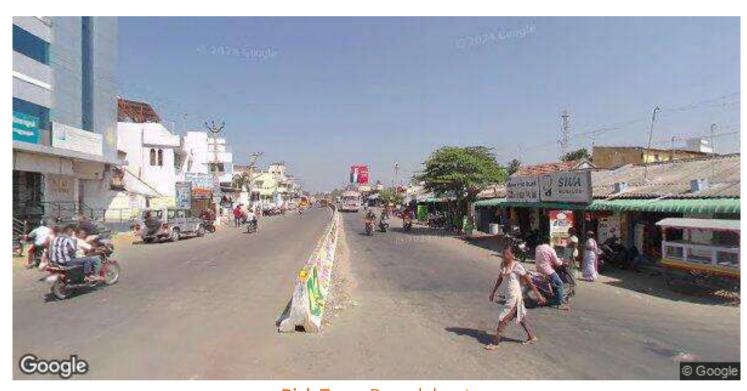
**Coordinates:** 11.37086, 77.74828

Risk Type: Roundabout
Risk Level: High

Speed Limit: 15 KM/Hr

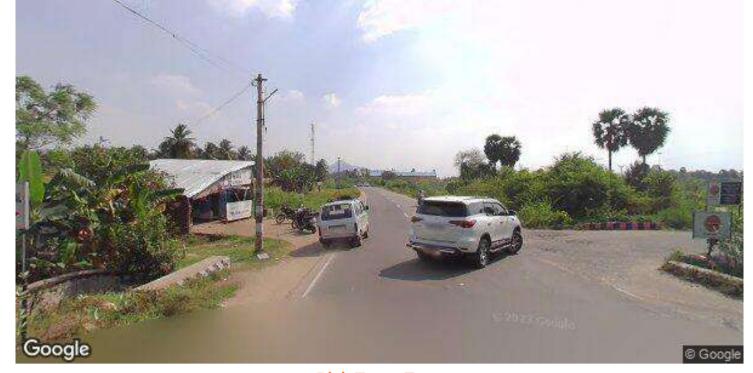
Risk Type: Turn
Risk Level: High
Speed Limit: 15 KM/Hr
Coordinates: 11.44029, 77.87544

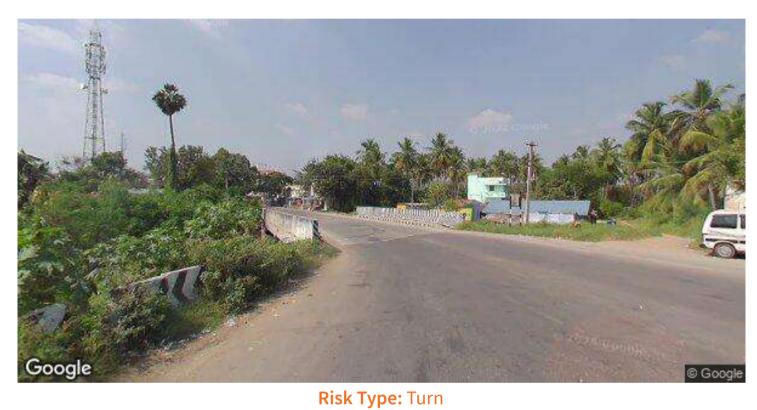
Risk Level: Medium
Speed Limit: 30 KM/Hr
Coordinates: 11.44893, 77.87413

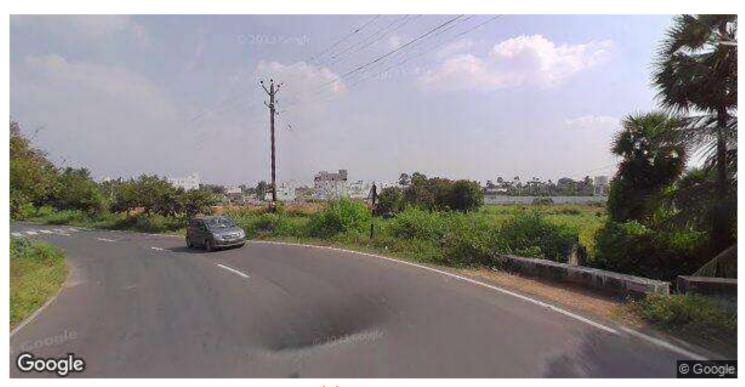
Risk Type: Turn Risk Level: High

Speed Limit: 15 KM/Hr Coordinates: 11.45350, 77.85700

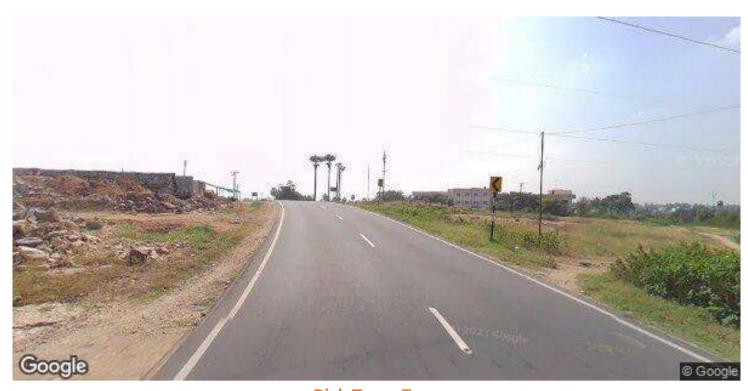
Risk Type: Turn
Risk Level: Medium
Speed Limit: 30 KM/Hr
Coordinates: 11.46046, 77.85037

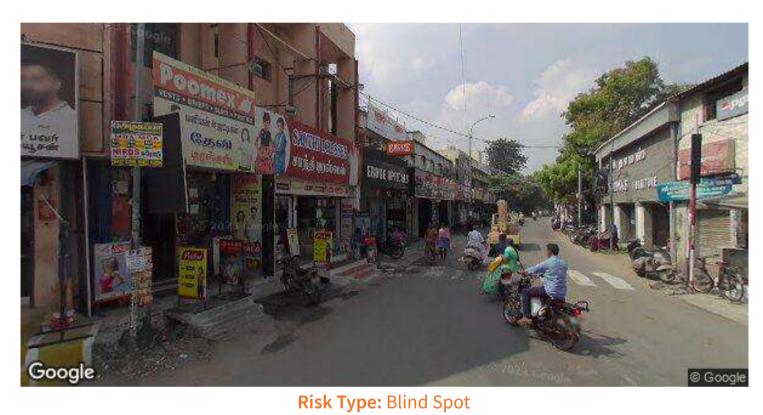
Risk Level: Blind Spot
Speed Limit: 10 KM/Hr
Coordinates: 11.33920, 77.72902

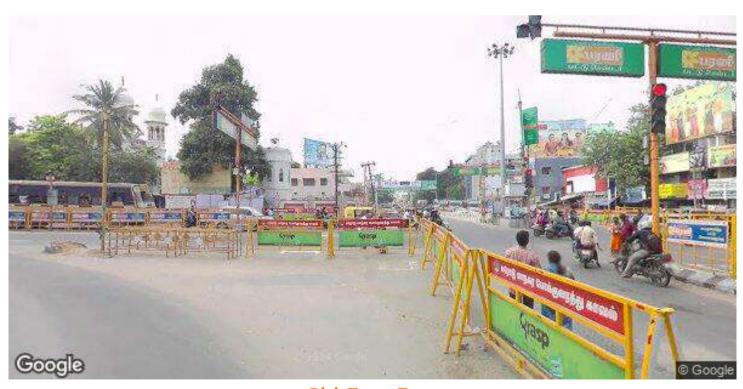
Risk Type: Turn
Risk Level: Medium

Speed Limit: 30 KM/Hr Coordinates: 11.33914, 77.72659

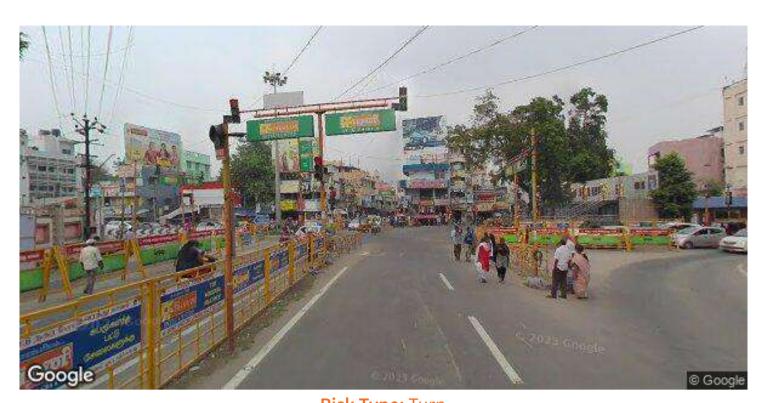
Risk Type: Turn
Risk Level: High
Speed Limit: 15 KM/Hr
Coordinates: 11.33890, 77.72637

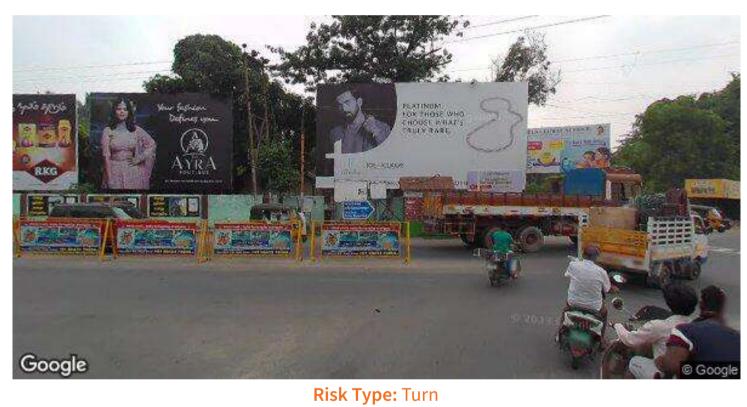
Risk Type: Turn
Risk Level: Medium
Speed Limit: 30 KM/Hr
Coordinates: 11.33092, 77.72748

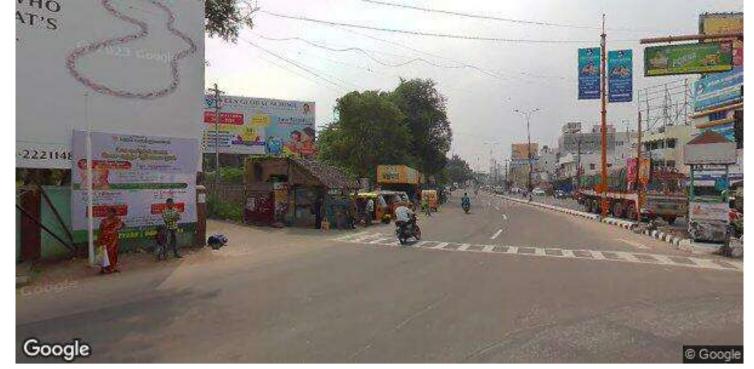
Risk Type: Turn
Risk Level: High
Speed Limit: 15 KM/Hr
Coordinates: 11.33085, 77.72744

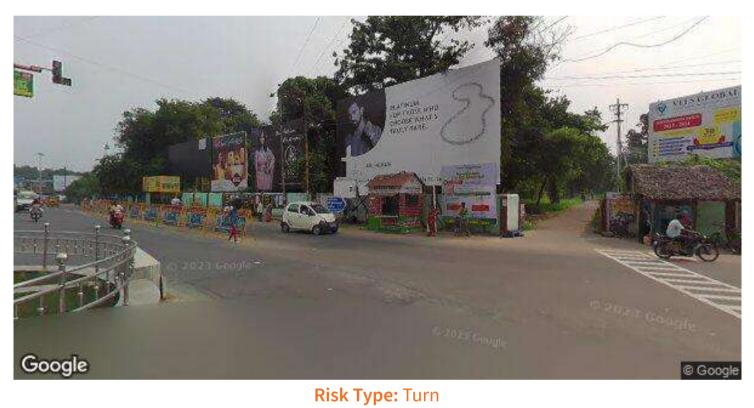
Risk Level: Medium
Speed Limit: 30 KM/Hr
Coordinates: 11.33085, 77.72730

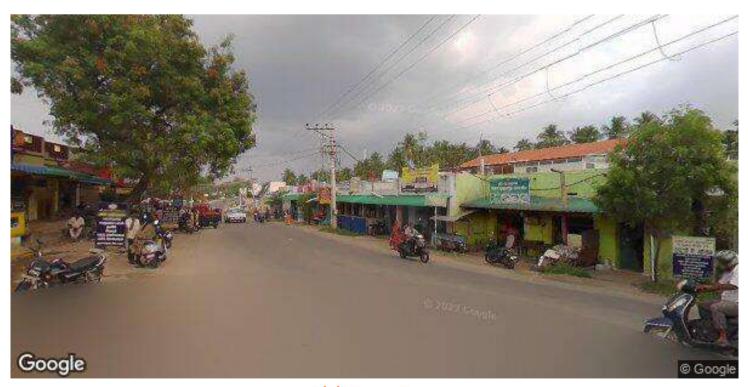
Risk Type: Turn Risk Level: High Speed Limit: 15 KM/Hr Coordinates: 11.31172, 77.70715

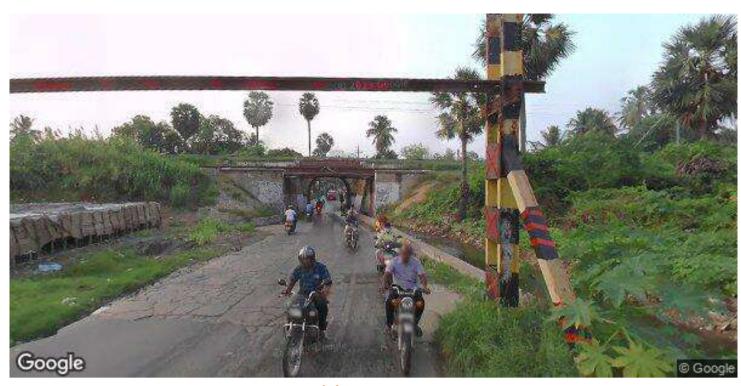
Risk Type: Turn
Risk Level: Medium
Speed Limit: 30 KM/Hr
Coordinates: 11.31052, 77.70780

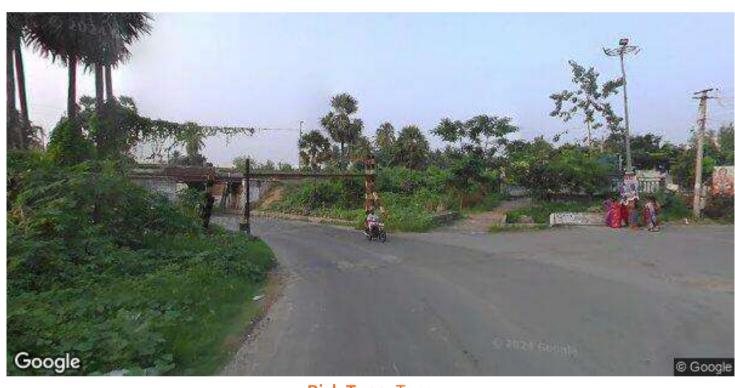
Risk Type: Turn
Risk Level: Medium
Speed Limit: 30 KM/Hr
Coordinates: 11.31034, 77.70783

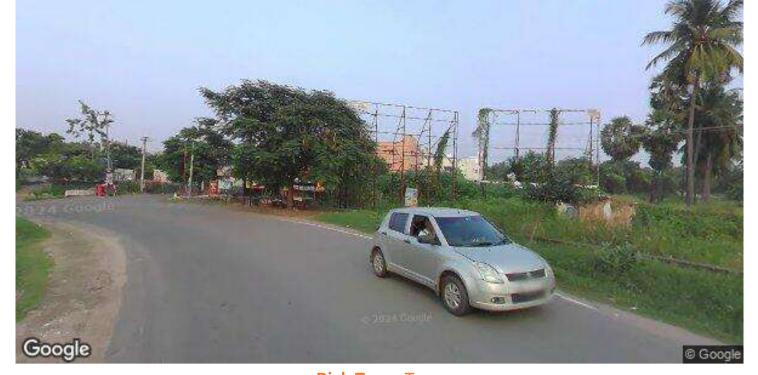
Risk Type: Turn
Risk Level: Medium
Speed Limit: 30 KM/Hr
Coordinates: 11.31008, 77.70768

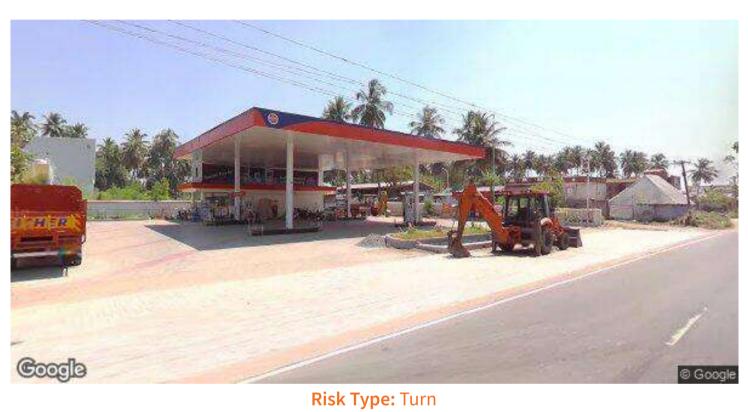
Risk Type: Turn
Risk Level: High
Speed Limit: 15 KM/Hr
Coordinates: 11.24215, 77.66407
