# JOURNEY RISK MANAGEMENT (JRM) STUDY

### **IOCL Coimbatore Terminal to Harsita Fuels**

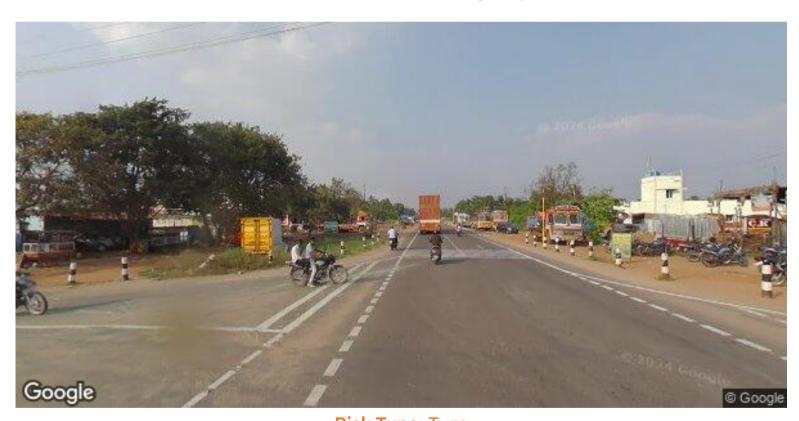
**Coordinates:** 11.03211, 77.07640

Risk Type: Turn Risk Level: High

Speed Limit: 15 KM/Hr

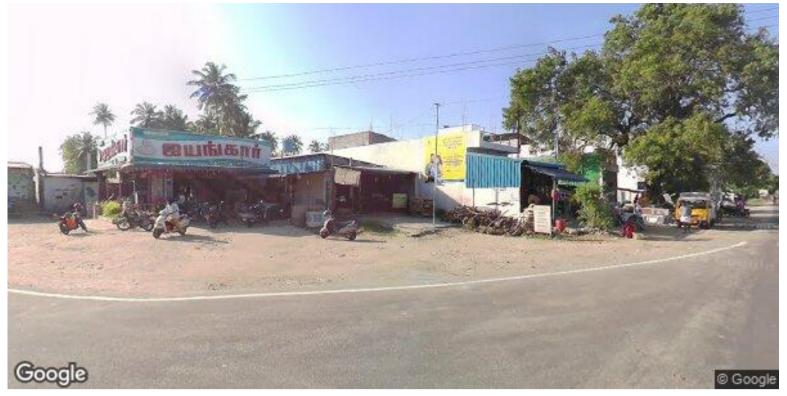
**Coordinates:** 11.20054, 77.42223

Risk Type: Blind Spot Risk Level: Blind Spot Speed Limit: 10 KM/Hr

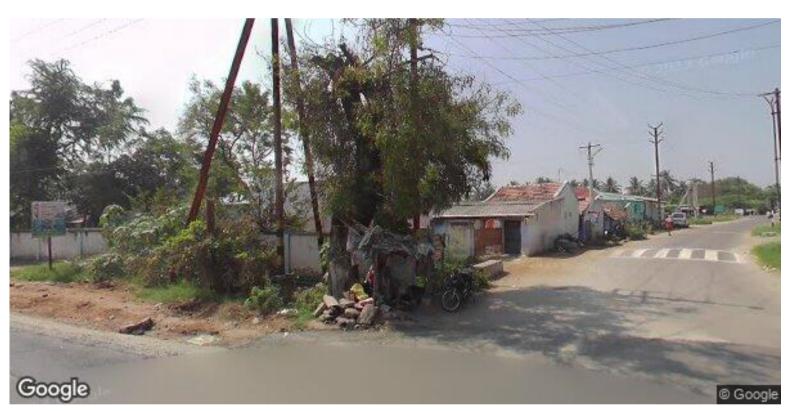
Risk Type: Blind Spot
Risk Level: Blind Spot
Speed Limit: 10 KM/Hr
Coordinates: 11.19748, 77.42349

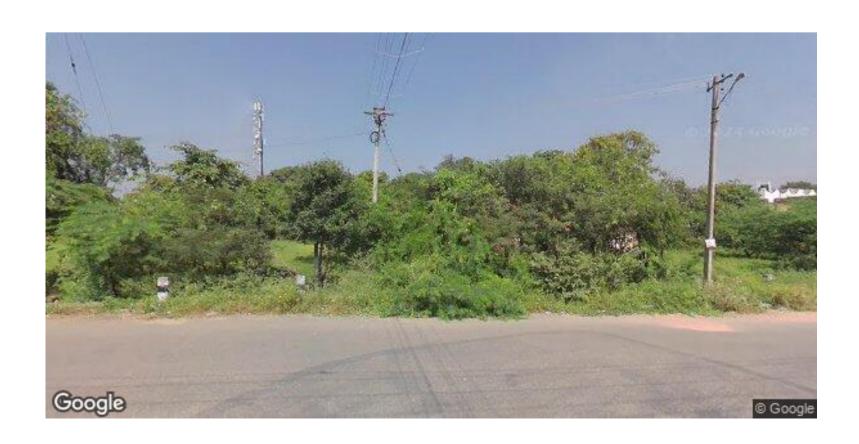
**Coordinates:** 11.19731, 77.42240

Risk Type: Turn
Risk Level: High
Speed Limit: 15 KM/Hr

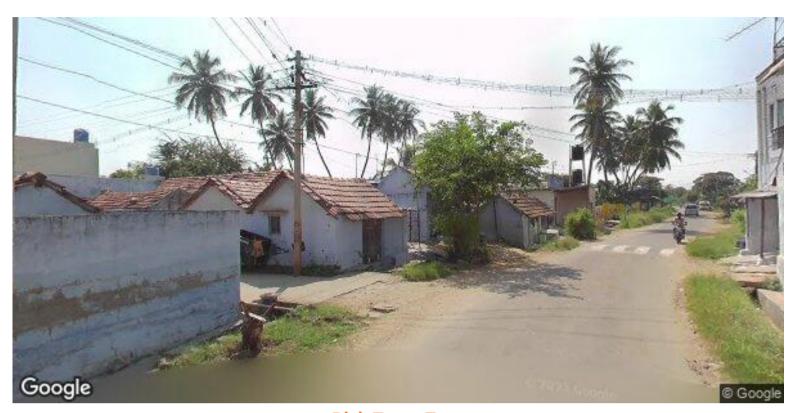
Risk Type: Turn
Risk Level: Medium
Speed Limit: 30 KM/Hr
Coordinates: 11.18019, 77.42391

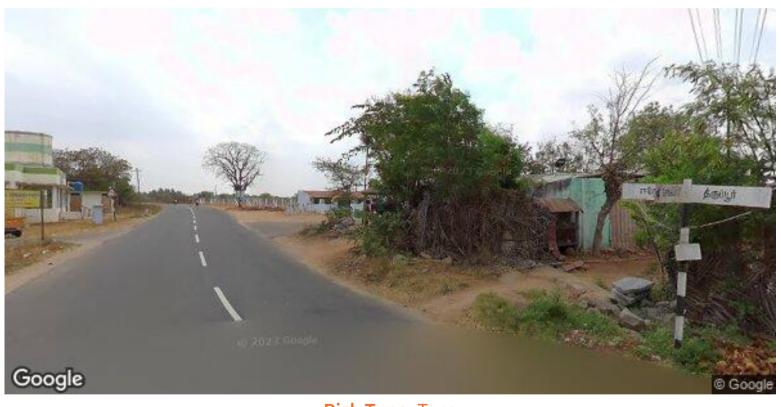
Risk Type: Turn
Risk Level: High
Speed Limit: 15 KM/Hr
Coordinates: 11.15926, 77.42054

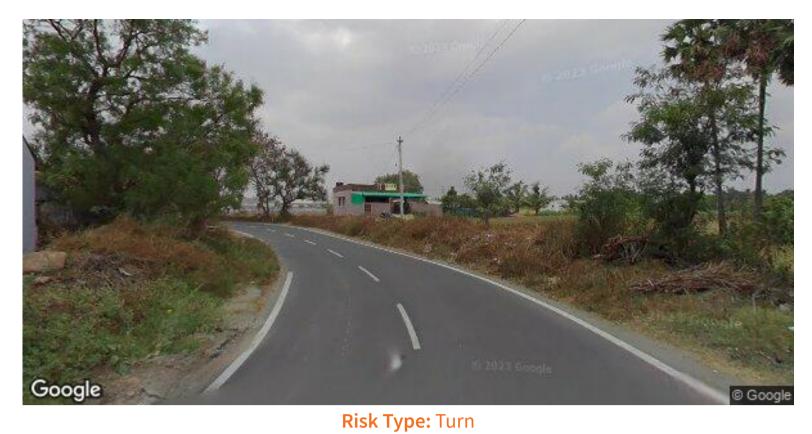
Risk Type: Turn
Risk Level: Medium
Speed Limit: 30 KM/Hr
Coordinates: 11.16000, 77.41801

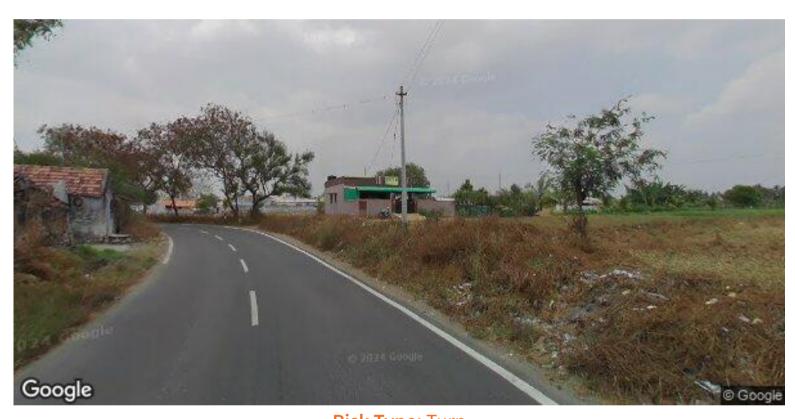
Risk Type: Turn
Risk Level: Medium
Speed Limit: 30 KM/Hr
Coordinates: 11.16005, 77.41791

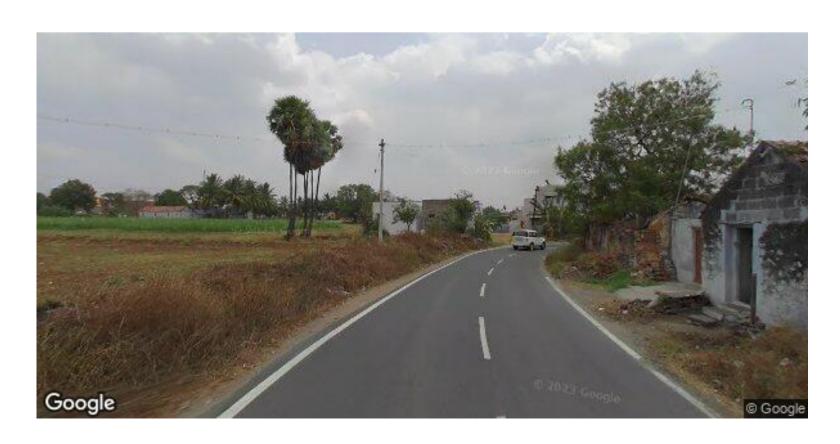
**Coordinates:** 11.16005, 77.41765

Risk Type: Turn
Risk Level: Medium
Speed Limit: 30 KM/Hr
