JOURNEY RISK MANAGEMENT (JRM) STUDY

IOCL Coimbatore Terminal to Tamilnadu Newsprint & Papers Ltd

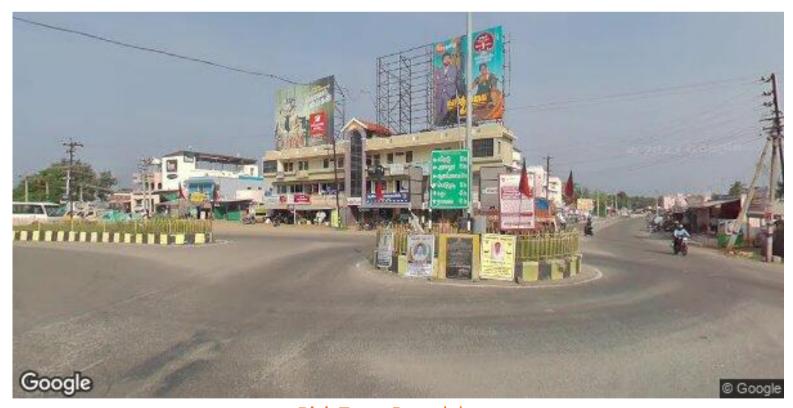
Coordinates: 11.04633, 77.73751

Risk Type: Roundabout
Risk Level: High

Speed Limit: 15 KM/Hr

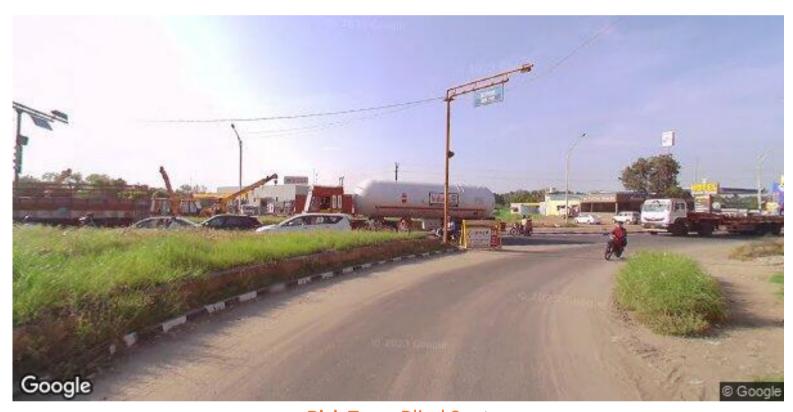
Coordinates: 11.00778, 77.07085

Risk Type: Blind Spot Risk Level: Blind Spot Speed Limit: 10 KM/Hr

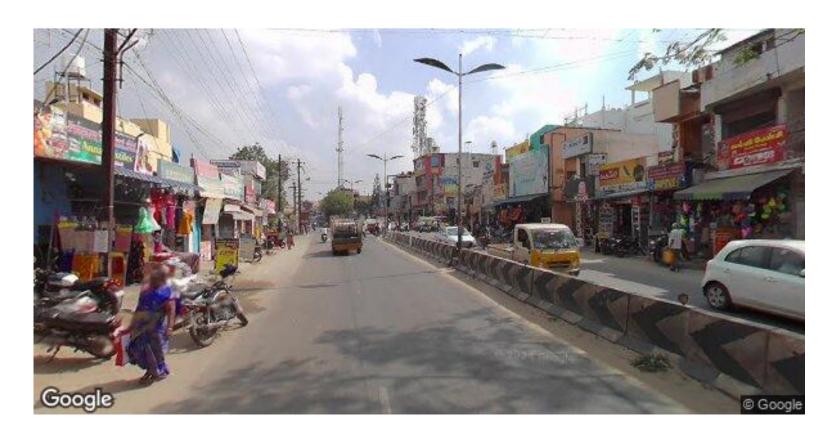
Coordinates: 11.02535, 77.12419

Risk Type: Turn
Risk Level: Medium
Speed Limit: 30 KM/Hr

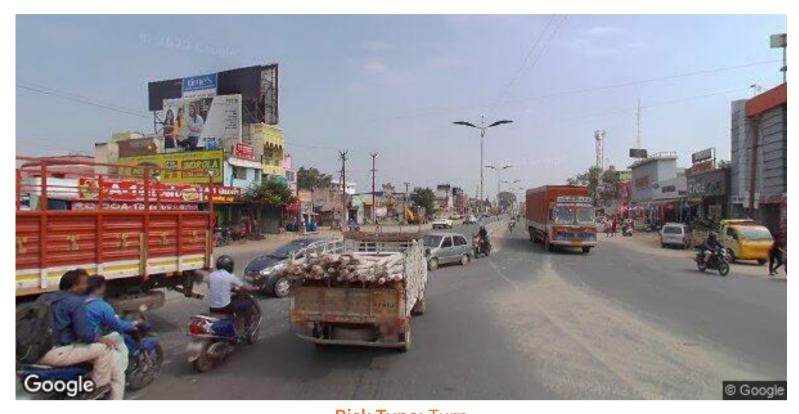
Risk Type: Turn
Risk Level: Medium
Speed Limit: 30 KM/Hr
Coordinates: 11.02774, 77.12761

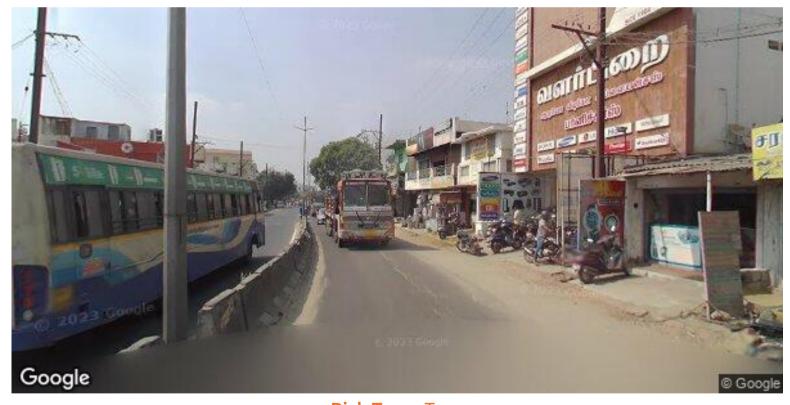
Risk Type: Turn
Risk Level: Medium
Speed Limit: 30 KM/Hr
Coordinates: 10.99570, 77.28153

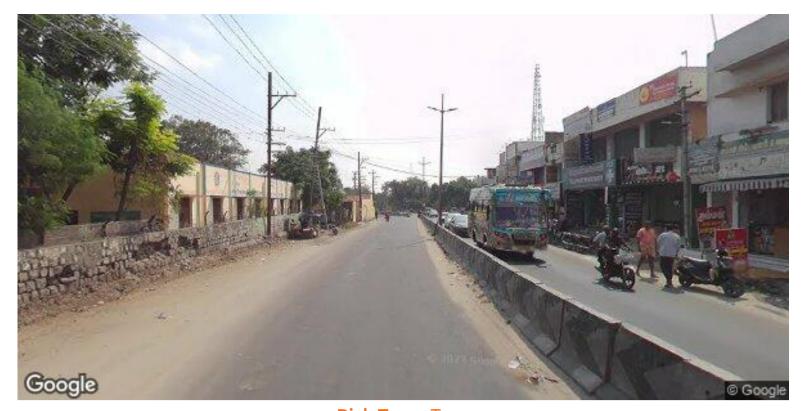
Coordinates: 10.99535, 77.28179

Risk Type: Turn
Risk Level: Medium
Speed Limit: 30 KM/Hr

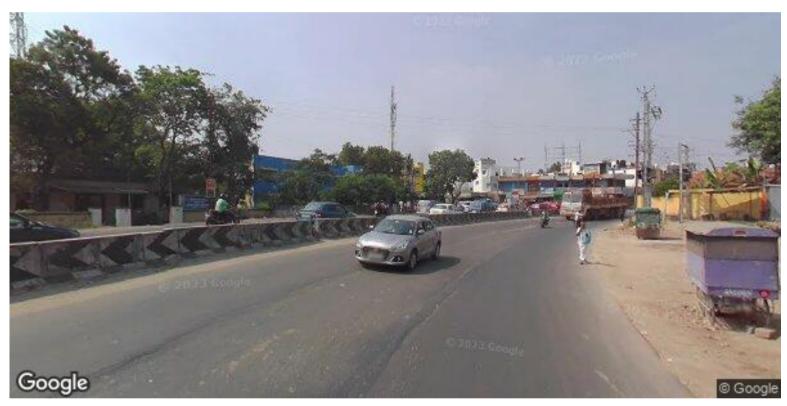
Coordinates: 10.99416, 77.28200

Risk Type: Turn
Risk Level: High
Speed Limit: 15 KM/Hr

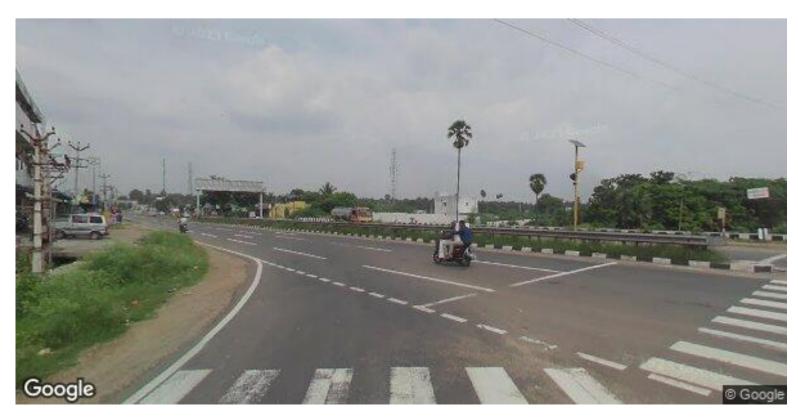
Coordinates: 10.96823, 77.42701

Risk Type: Turn
Risk Level: High
Speed Limit: 15 KM/Hr

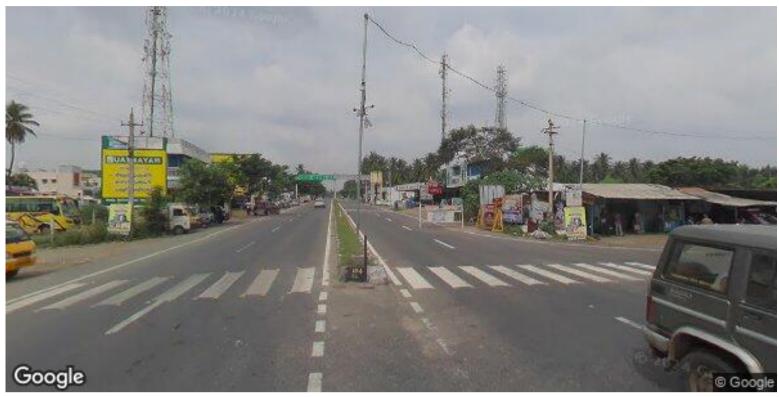
Coordinates: 10.97042, 77.42713

Risk Type: Turn
Risk Level: High
Speed Limit: 15 KM/Hr

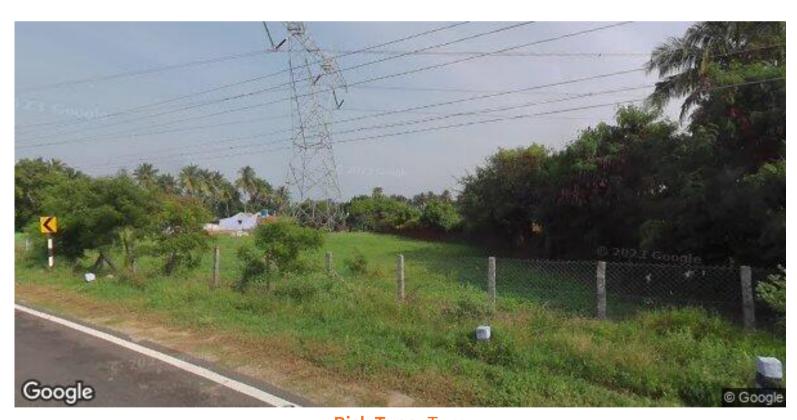
Coordinates: 11.01178, 77.61449

Risk Type: Turn
Risk Level: Medium
Speed Limit: 30 KM/Hr

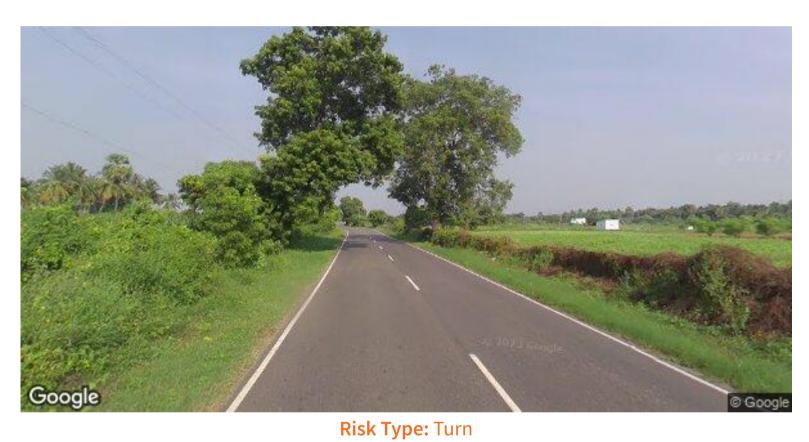
Risk Level: Medium
Speed Limit: 30 KM/Hr
Coordinates: 11.01704, 77.62328

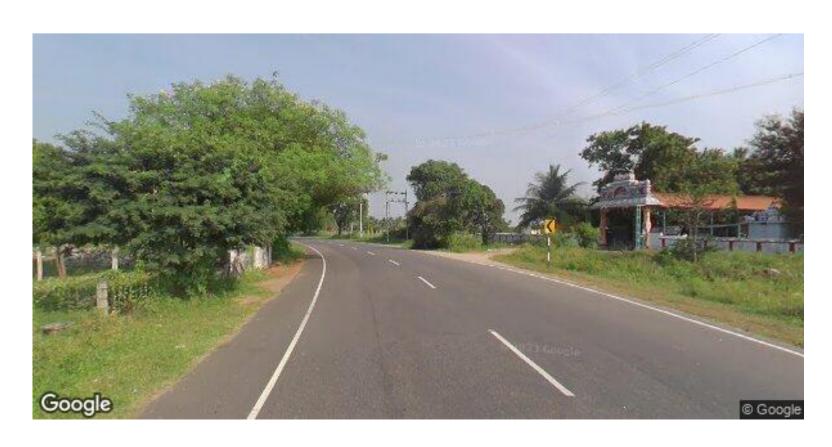
Coordinates: 11.01801, 77.63357

Risk Type: Turn
Risk Level: Medium
Speed Limit: 30 KM/Hr

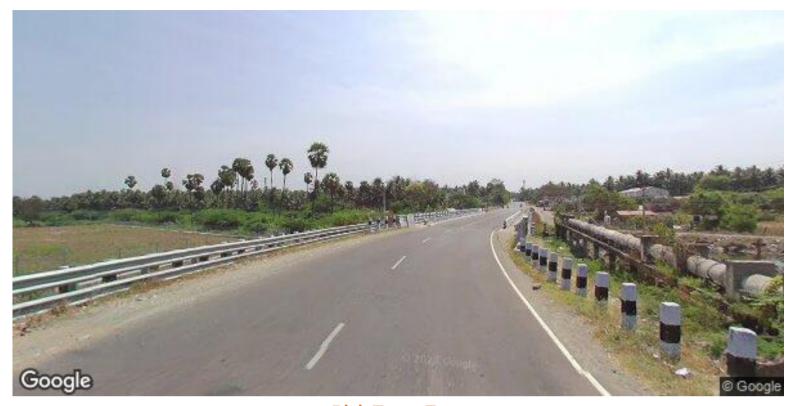
Coordinates: 11.05057, 77.74878

Risk Type: Turn
Risk Level: Medium
Speed Limit: 30 KM/Hr

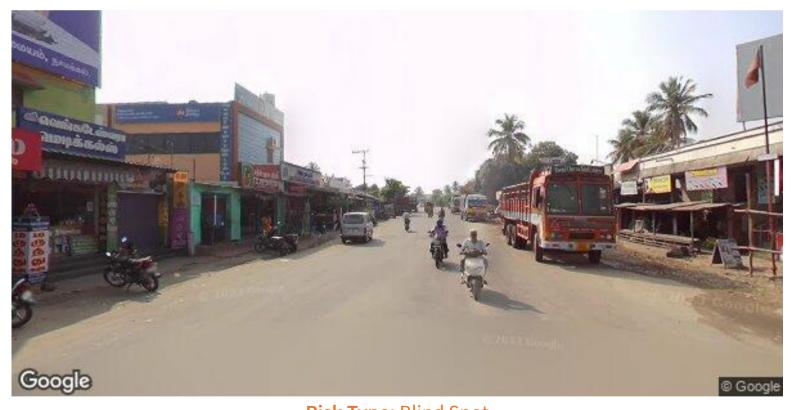
Coordinates: 11.08078, 77.86455

Risk Type: Blind Spot Risk Level: Blind Spot Speed Limit: 10 KM/Hr

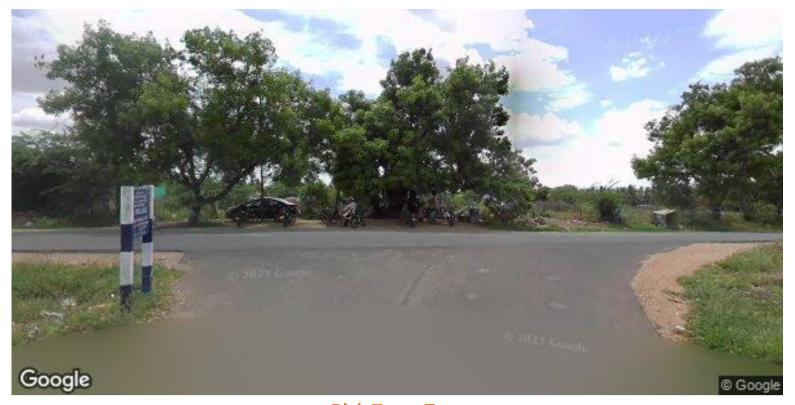
Risk Type: Turn
Risk Level: Medium
Speed Limit: 30 KM/Hr
Coordinates: 11.03600, 77.94381

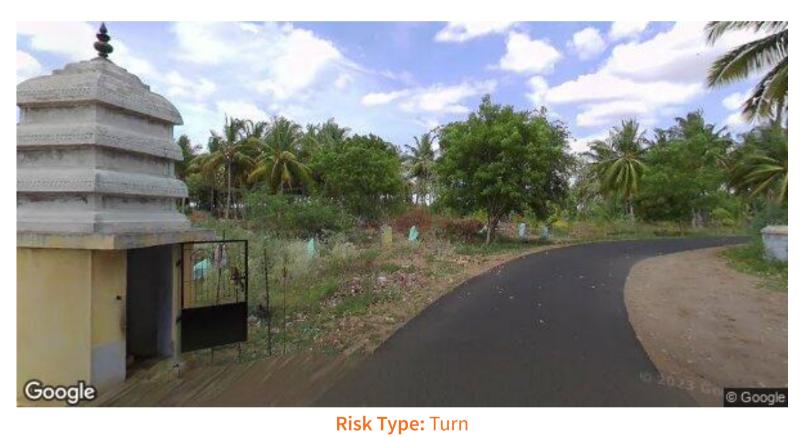
Risk Type: Turn
Risk Level: High
Speed Limit: 15 KM/Hr
Coordinates: 11.03611, 77.94602

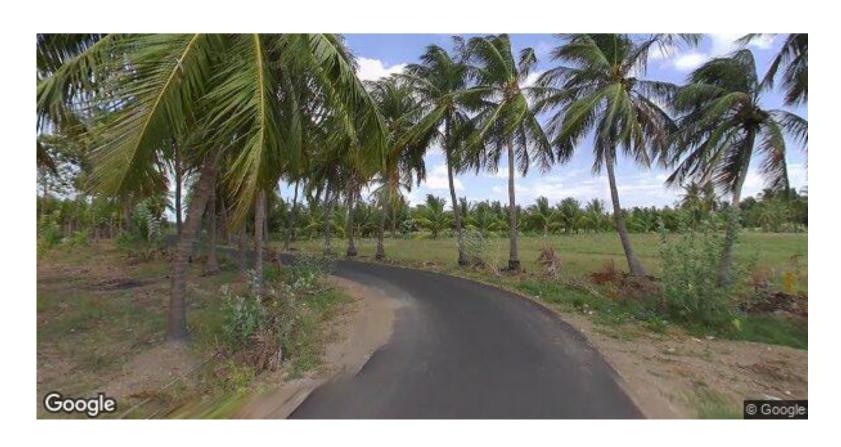
Coordinates: 11.03579, 77.94639

Risk Type: Turn
Risk Level: Medium
Speed Limit: 30 KM/Hr

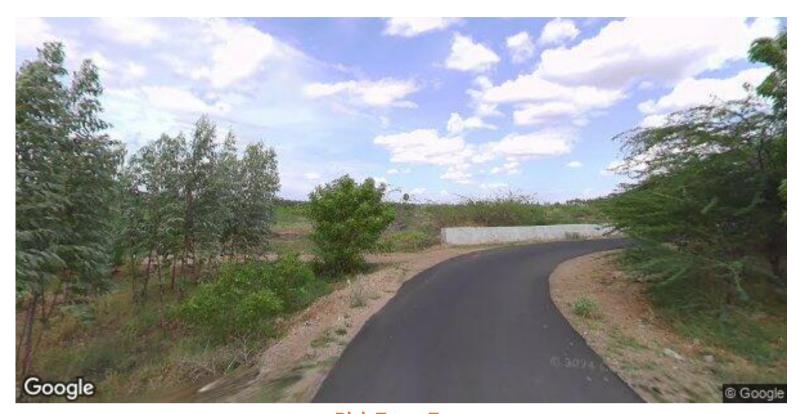
Coordinates: 11.03581, 77.94847

Risk Type: Turn
Risk Level: High
Speed Limit: 15 KM/Hr

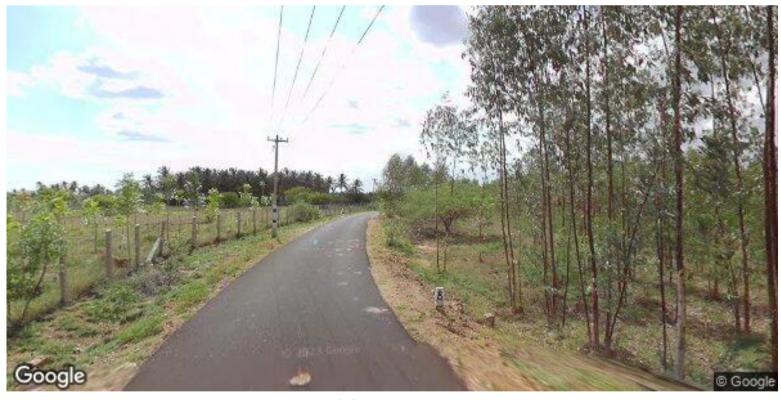
Coordinates: 11.03450, 77.95047

Risk Type: Turn
Risk Level: Medium
Speed Limit: 30 KM/Hr

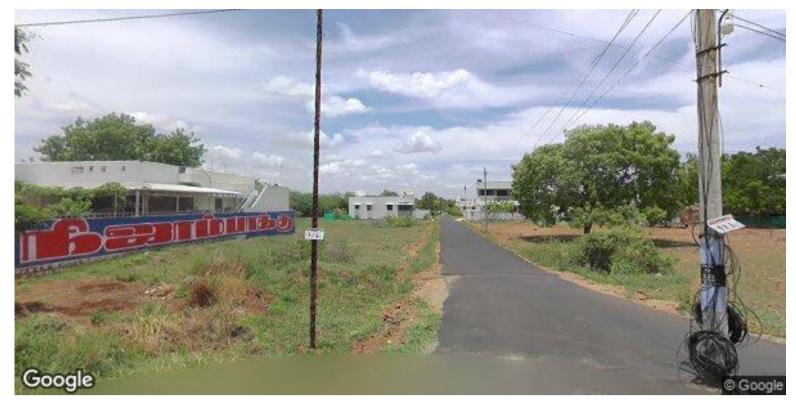
Risk Type: Blind Spot
Risk Level: Blind Spot
Speed Limit: 10 KM/Hr
Coordinates: 11.04051, 77.98977

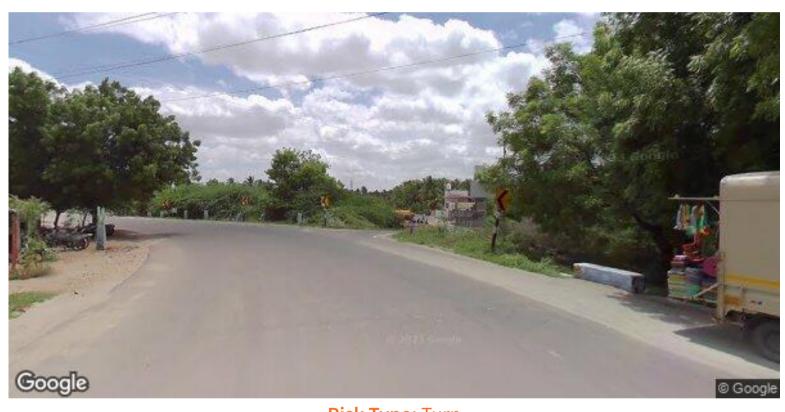
Risk Type: Turn
Risk Level: Medium
Speed Limit: 30 KM/Hr
Coordinates: 11.05169, 77.98844

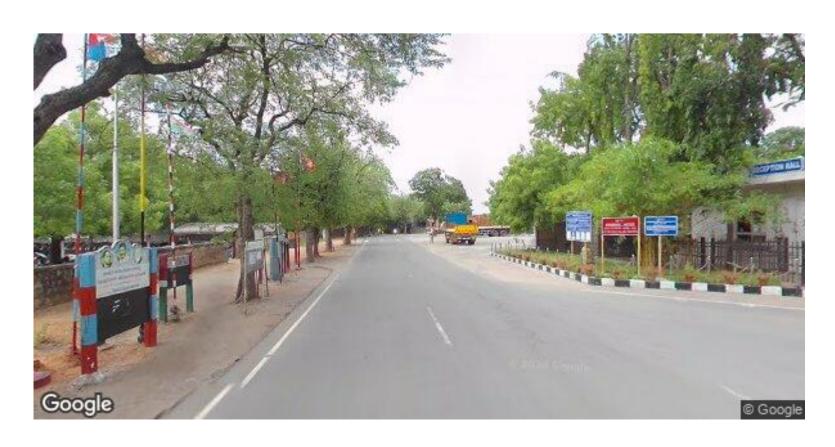
Coordinates: 11.05736, 77.99171

Risk Type: Blind Spot Risk Level: Blind Spot Speed Limit: 10 KM/Hr
