# JOURNEY RISK MANAGEMENT (JRM) STUDY

### **IOCL Coimbatore Terminal to TNSTC JTC Palani**

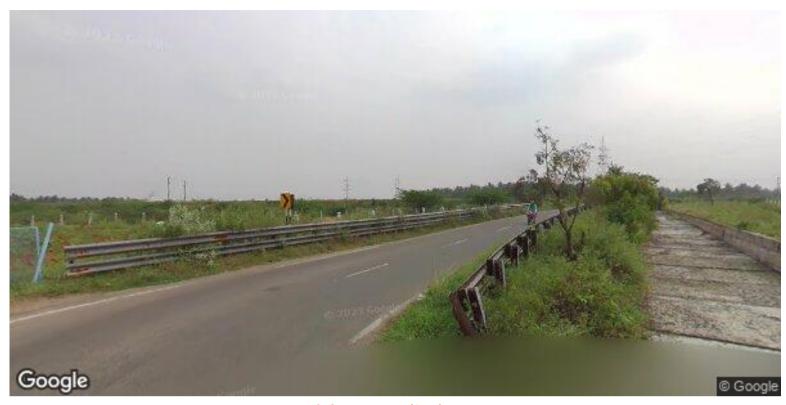
**Coordinates:** 11.03364, 77.08947

Risk Type: Blind Spot Risk Level: Blind Spot Speed Limit: 10 KM/Hr

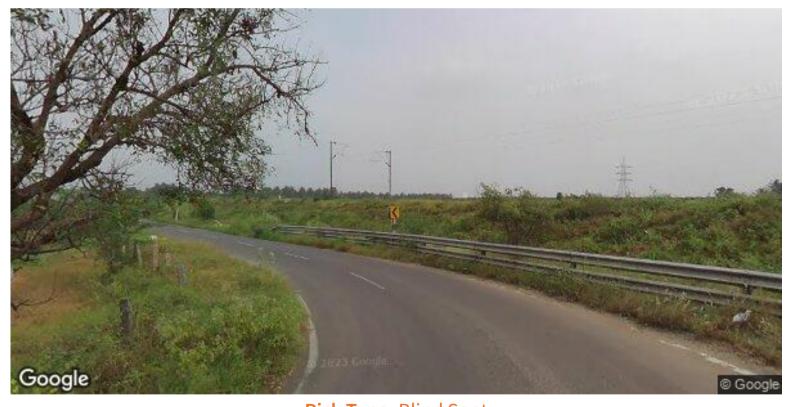
**Coordinates:** 11.03267, 77.08951

Risk Type: Blind Spot Risk Level: Blind Spot Speed Limit: 10 KM/Hr

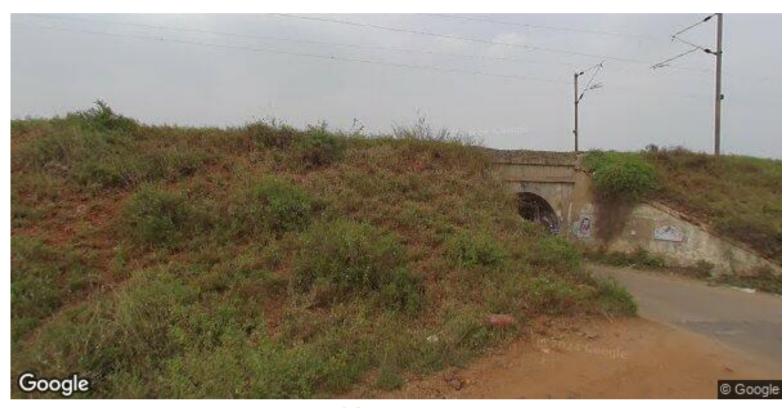
Risk Type: Turn
Risk Level: Medium
Speed Limit: 30 KM/Hr
Coordinates: 11.03521, 77.09439

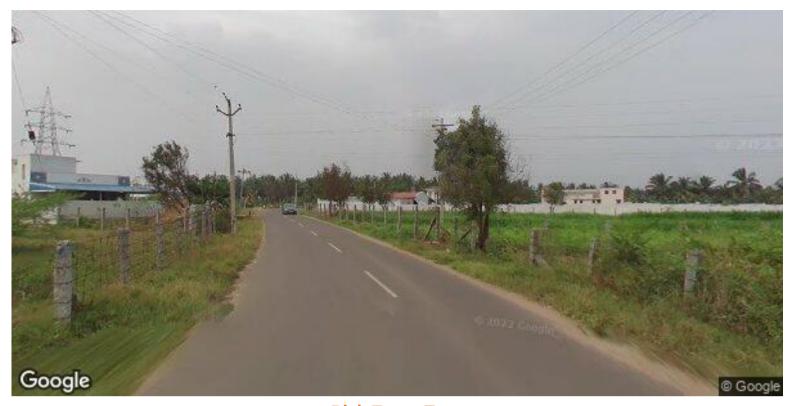
Risk Type: Turn
Risk Level: Medium
Speed Limit: 30 KM/Hr
Coordinates: 11.03057, 77.09537

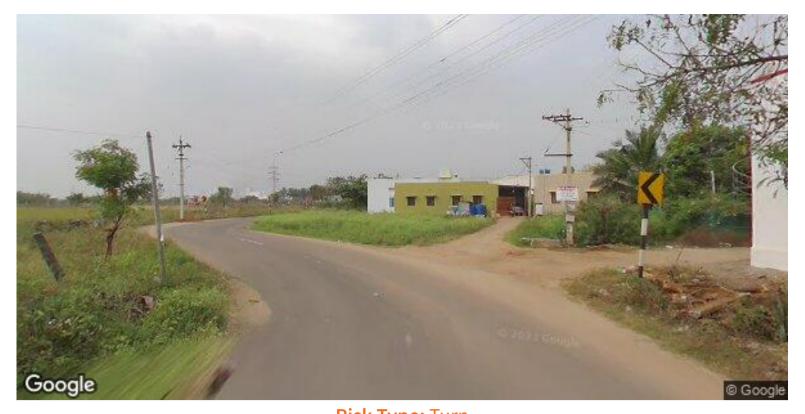
Risk Type: Turn
Risk Level: Medium
Speed Limit: 30 KM/Hr
Coordinates: 11.02927, 77.09595

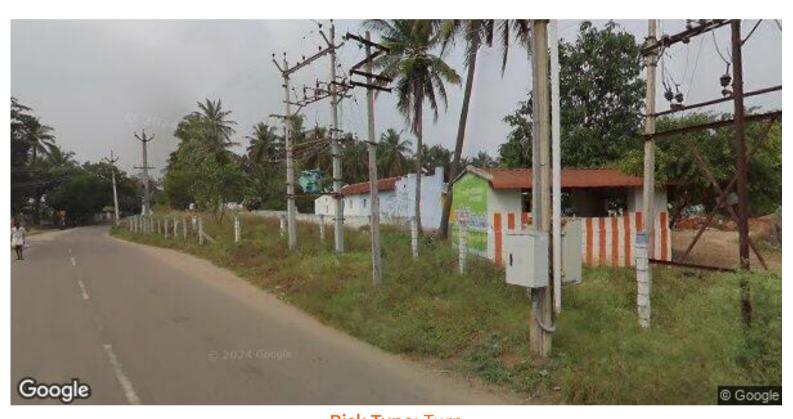
Risk Type: Turn
Risk Level: Medium
Speed Limit: 30 KM/Hr
Coordinates: 11.02777, 77.09694

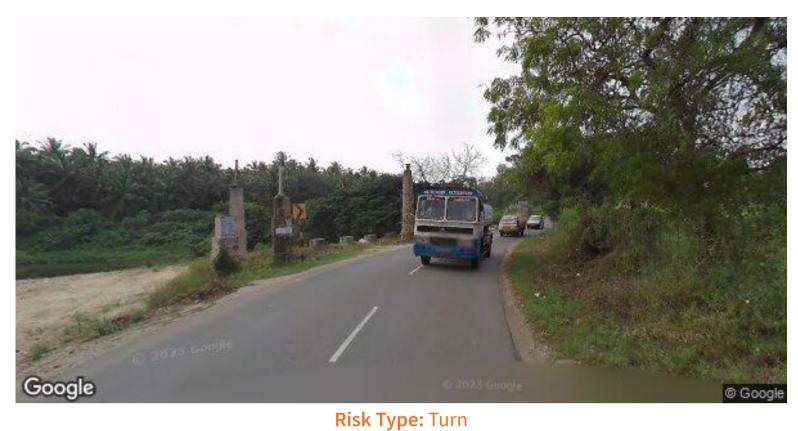
Risk Type: Turn
Risk Level: Medium
Speed Limit: 30 KM/Hr
Coordinates: 11.03323, 77.11422

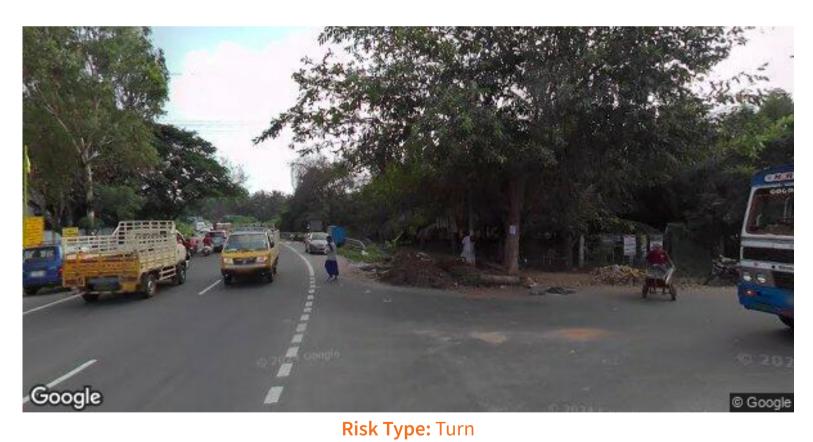
Risk Level: High
Speed Limit: 15 KM/Hr
Coordinates: 11.03352, 77.11509

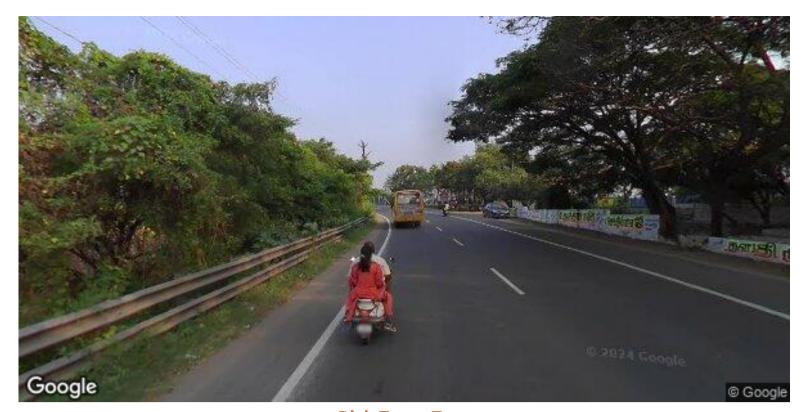
Risk Type: Turn
Risk Level: Medium
Speed Limit: 30 KM/Hr
Coordinates: 11.03154, 77.11673

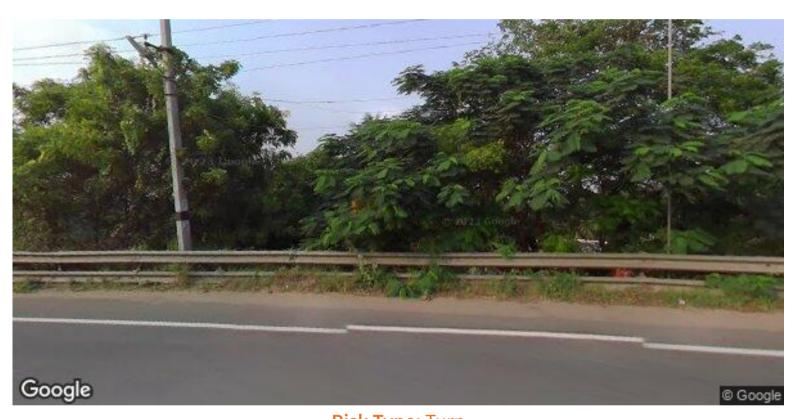
Risk Type: Turn
Risk Level: Medium
Speed Limit: 30 KM/Hr
Coordinates: 11.03146, 77.11854

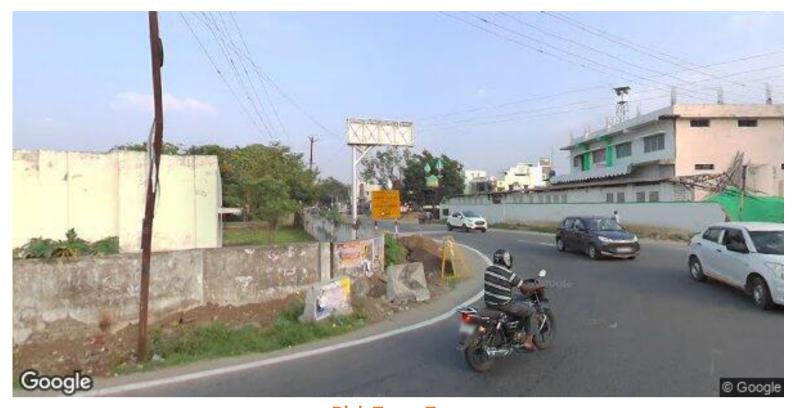
Risk Type: Turn
Risk Level: High
Speed Limit: 15 KM/Hr
Coordinates: 11.02928, 77.12212

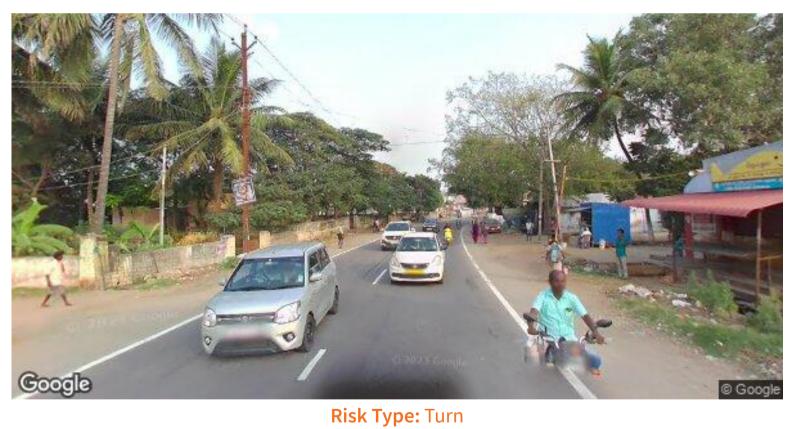
Risk Level: Medium
Speed Limit: 30 KM/Hr
Coordinates: 11.02950, 77.12393

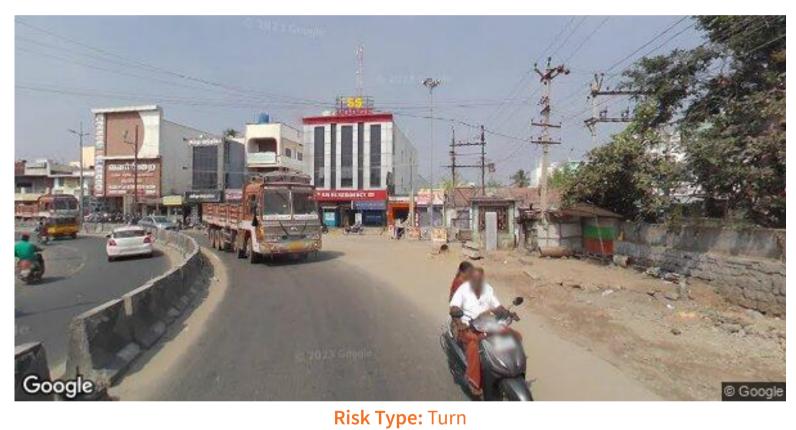
Risk Level: Medium
Speed Limit: 30 KM/Hr
Coordinates: 10.99541, 77.28179

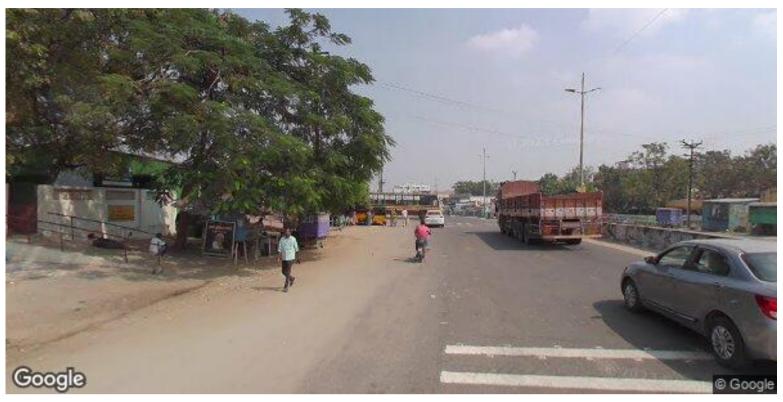
**Coordinates:** 10.99396, 77.28249

Risk Type: Turn
Risk Level: Medium
Speed Limit: 30 KM/Hr

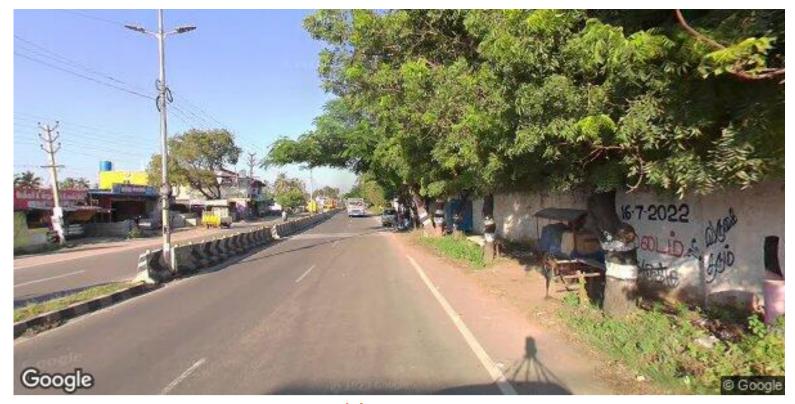
Risk Type: Turn
Risk Level: Medium
Speed Limit: 30 KM/Hr
Coordinates: 10.98129, 77.27944

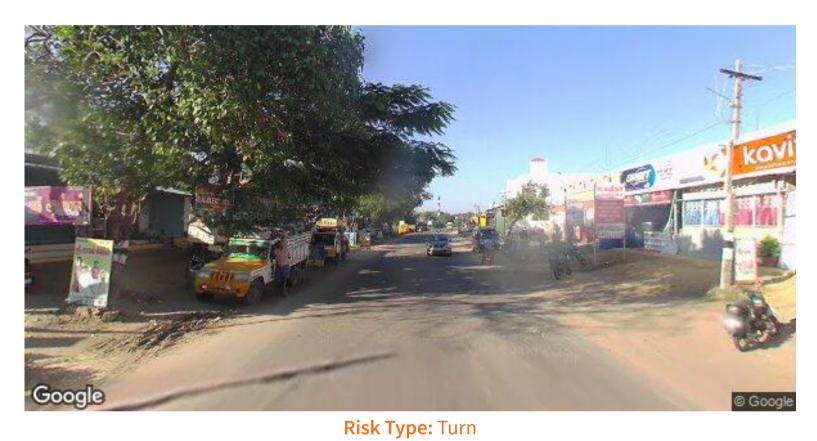
Risk Level: Medium
Speed Limit: 30 KM/Hr
Coordinates: 10.91573, 77.26608

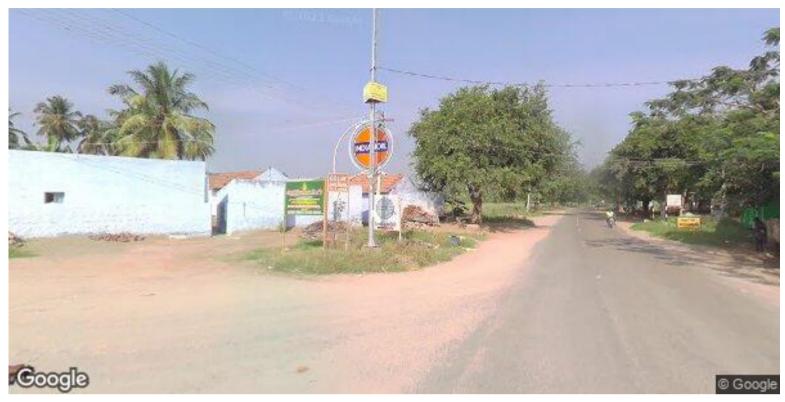
**Coordinates:** 10.62623, 77.33109

Risk Type: Turn
Risk Level: Medium
Speed Limit: 30 KM/Hr

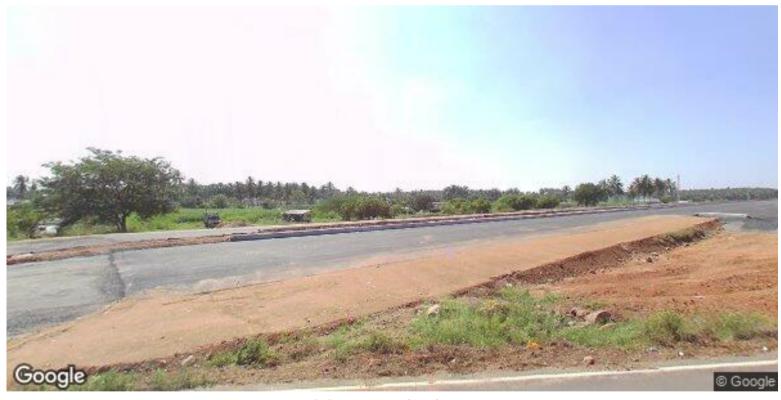
**Coordinates:** 10.56755, 77.36194

Risk Type: Blind Spot Risk Level: Blind Spot Speed Limit: 10 KM/Hr

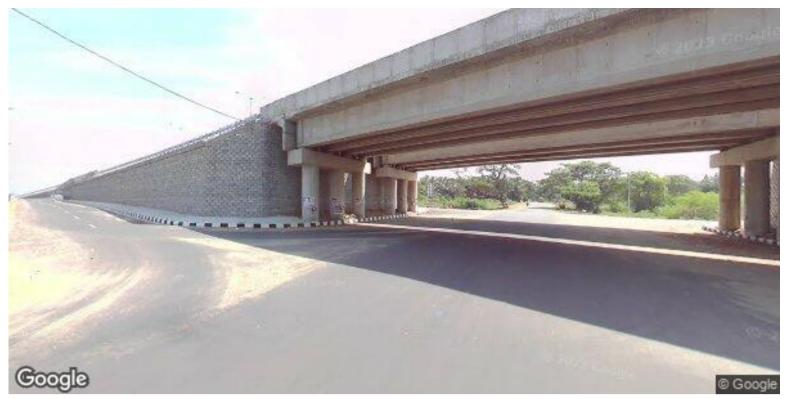
Risk Type: Turn
Risk Level: High
Speed Limit: 15 KM/Hr
Coordinates: 10.49126, 77.49541

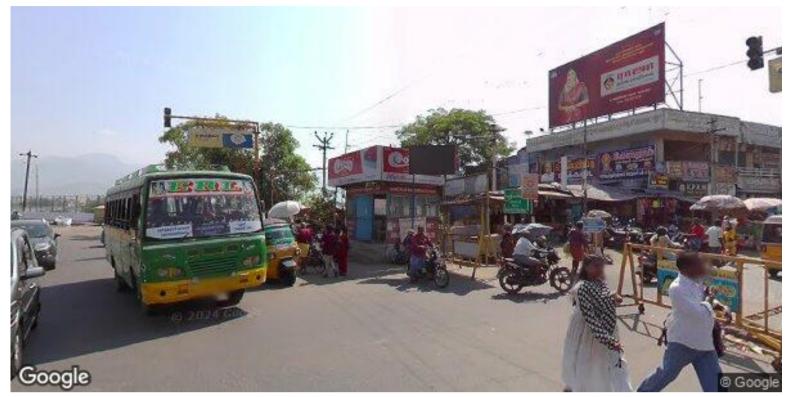
**Coordinates:** 10.45061, 77.51441

Risk Type: Turn
Risk Level: High
Speed Limit: 15 KM/Hr

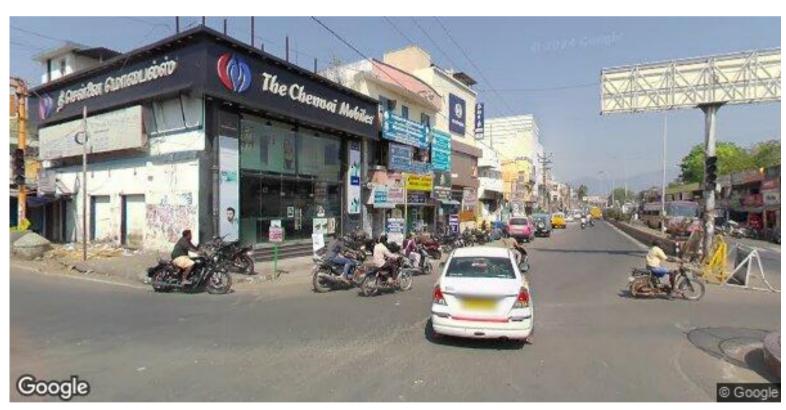
Risk Type: Turn
Risk Level: Medium
Speed Limit: 30 KM/Hr
Coordinates: 10.45063, 77.51446

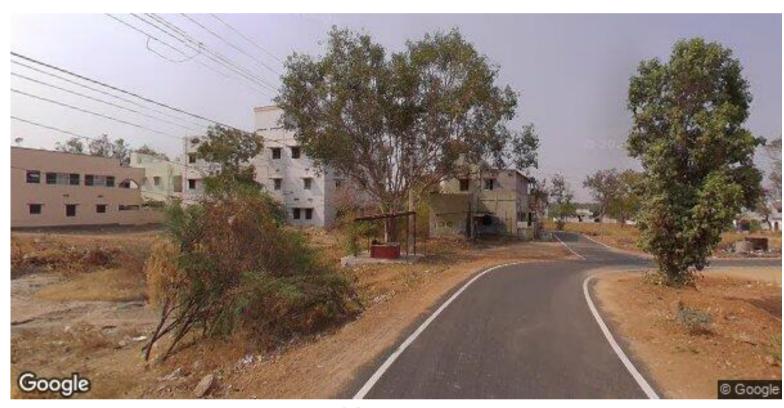
Risk Type: Turn
Risk Level: High
Speed Limit: 15 KM/Hr
Coordinates: 10.44980, 77.54030
