## JOURNEY RISK MANAGEMENT STUDY REPORT

**IOCL TIRCHY TERMINAL (10.7753, 78.8368) TO SIVAN ENTERPRISES  
(10.604934 , 78.417896), TOTAL DISTANCE -68.20 KM**

## **Welcome to the Journey Risk Management Study for Sivan Enterprises Agencies**

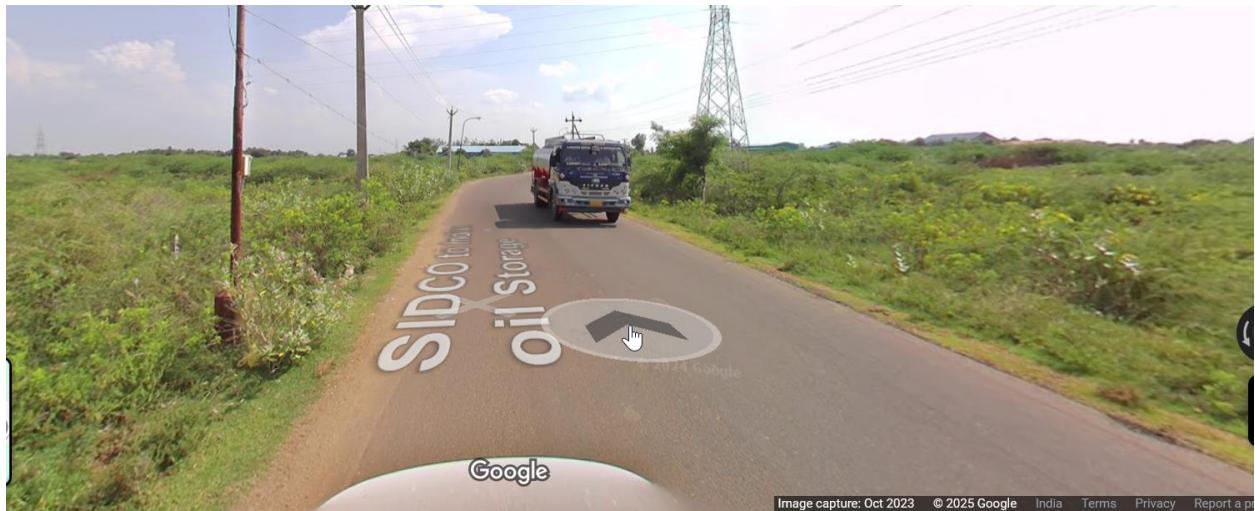
IMAGE: SHARP TURN RISK LEVEL:- MEDIUM, COORDI. 10.75826994715787, 78.83326651420096

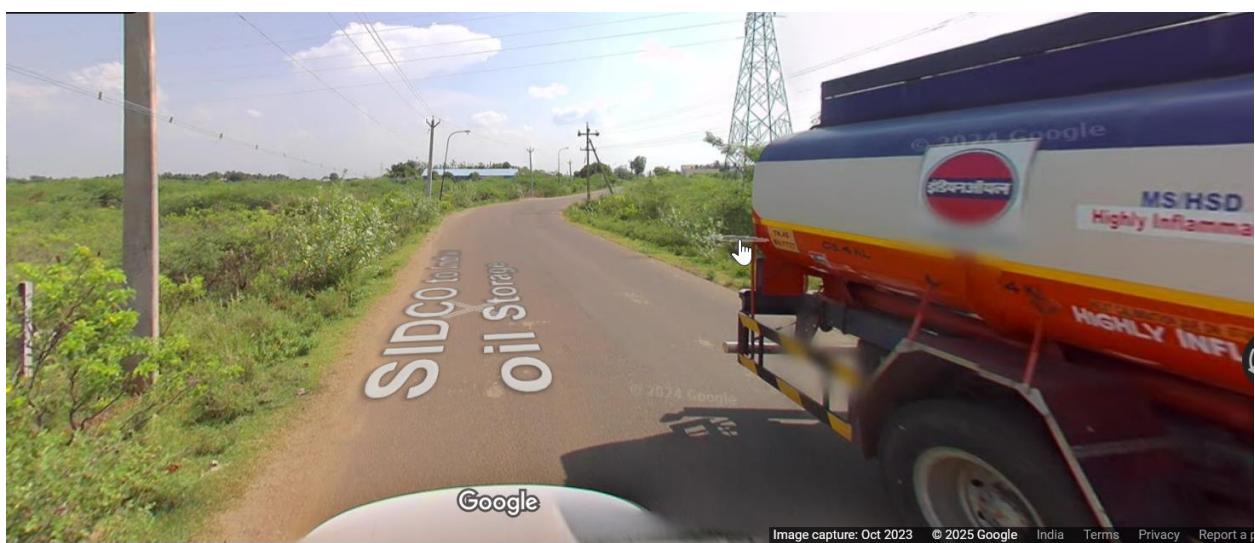
IMAGE: SHARP TURN RISK LEVEL: - MEDIUM, COORDI. 10.756715887788083, 78.83021887801165

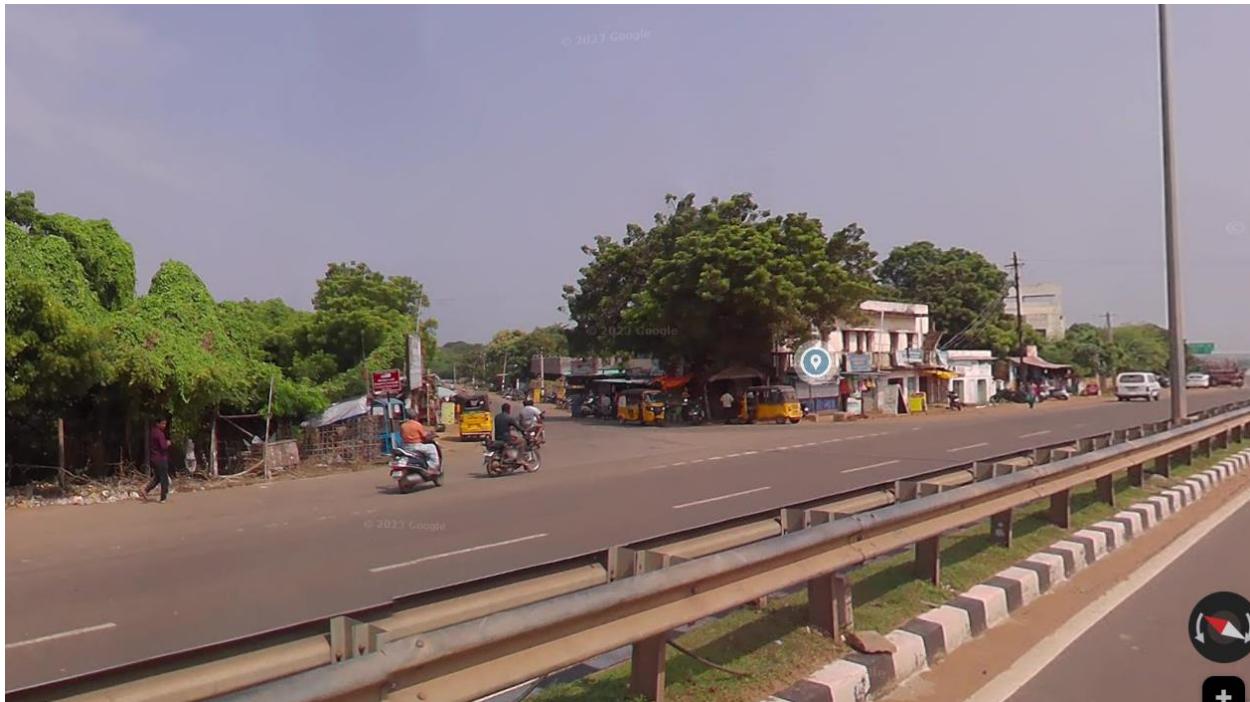
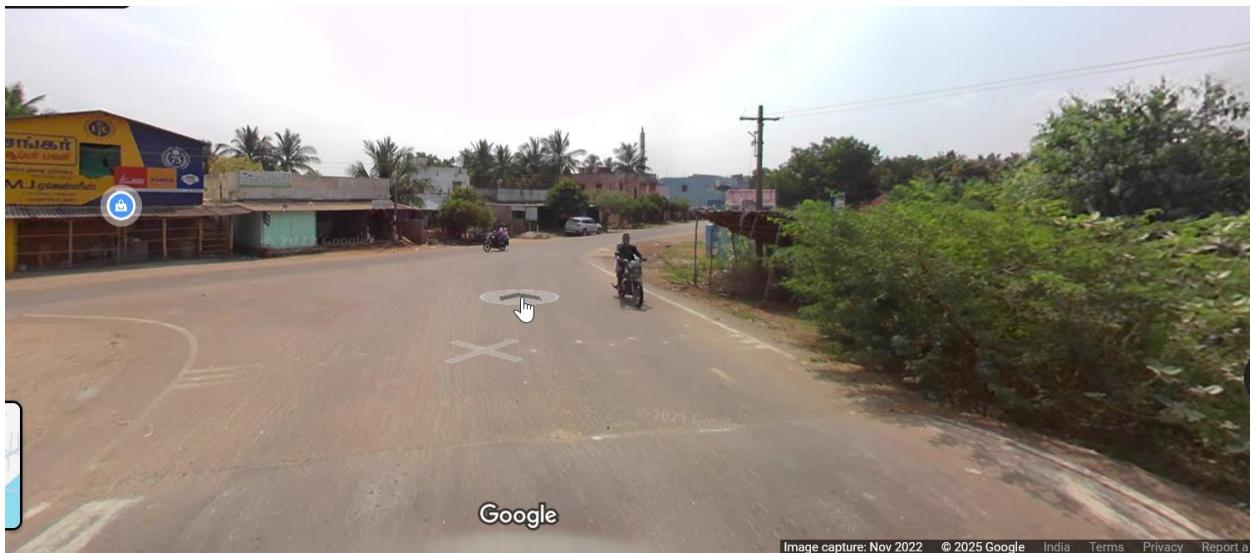
**IMAGE: SHARP TURN RISK LEVEL: - MEDIUM, COORDI. 10.751302465260789, 78.82527380728716**

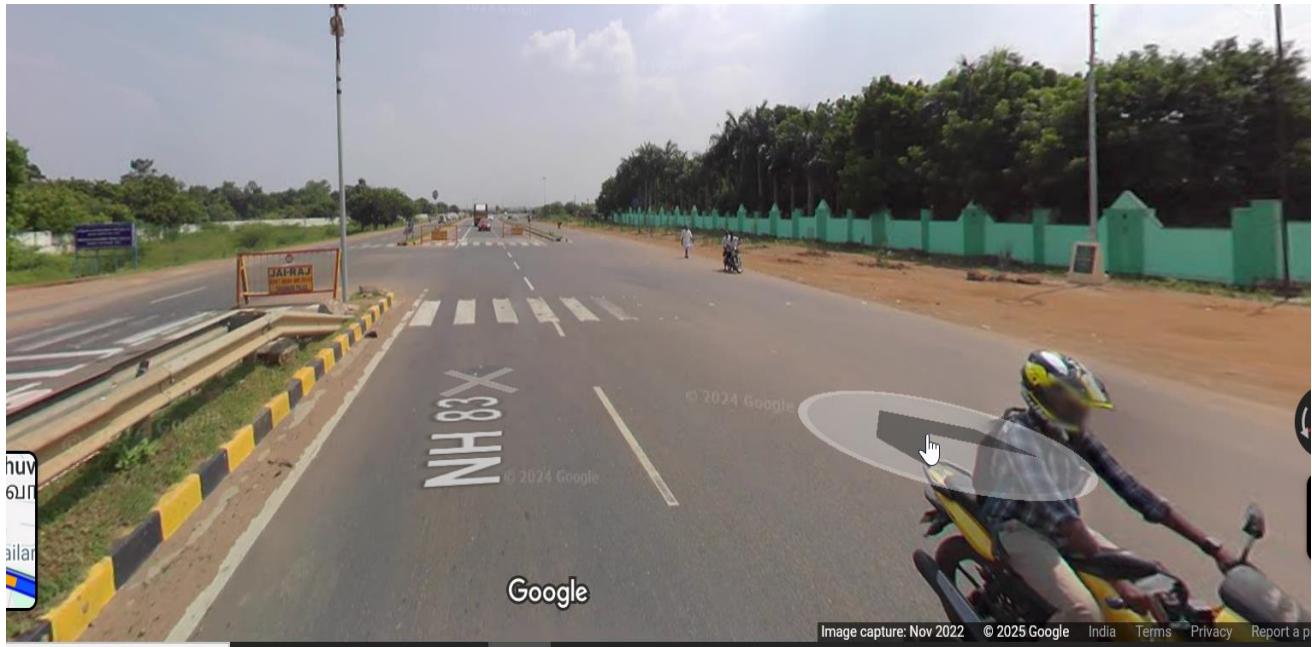
IMAGE: SHARP TURN RISK LEVEL: - MEDIUM, COORDI. 10.750307701965173, 78.82832678223028

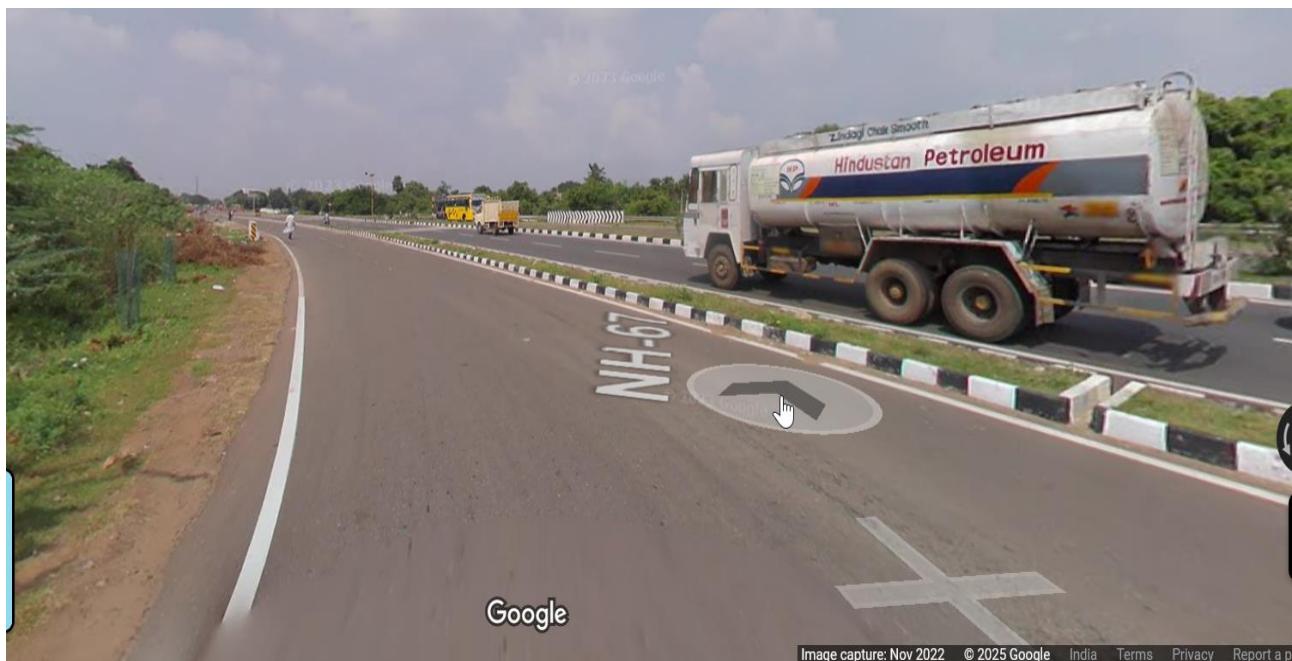
IMAGE: SHARP TURN RISK LEVEL: - MEDIUM, COORDI. 10.750307701965173, 78.82832678223028

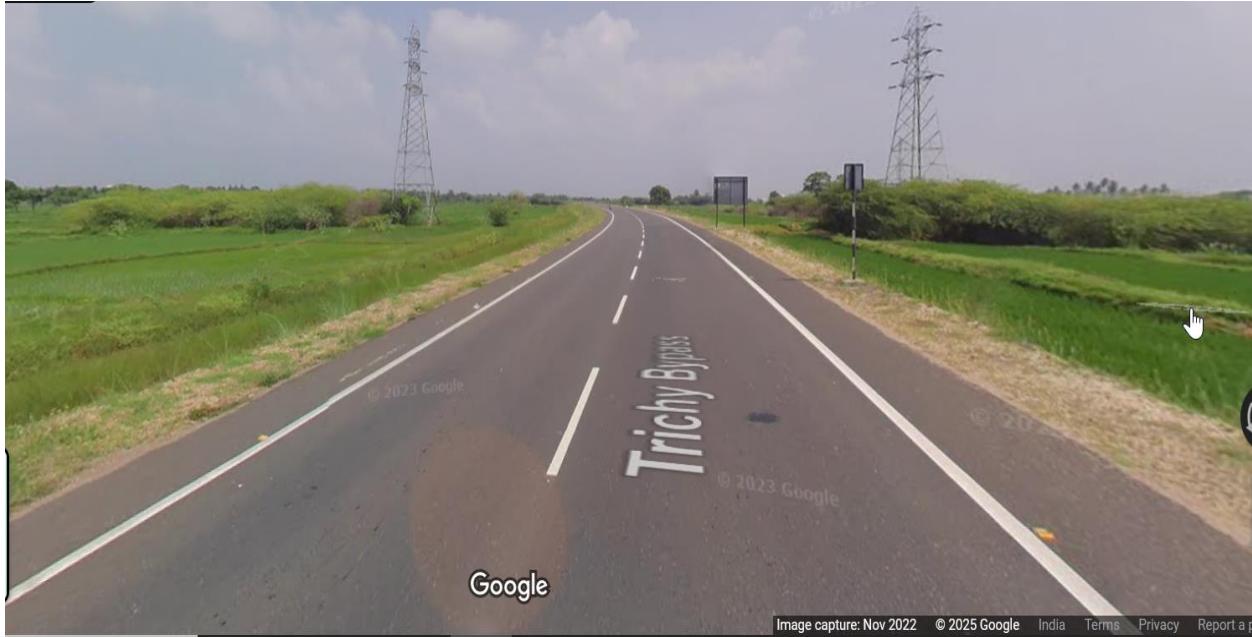
IMAGE: SHARP TURN RISK LEVEL: - MEDIUM, COORDI 10.730801241545027, 78.81876421912196

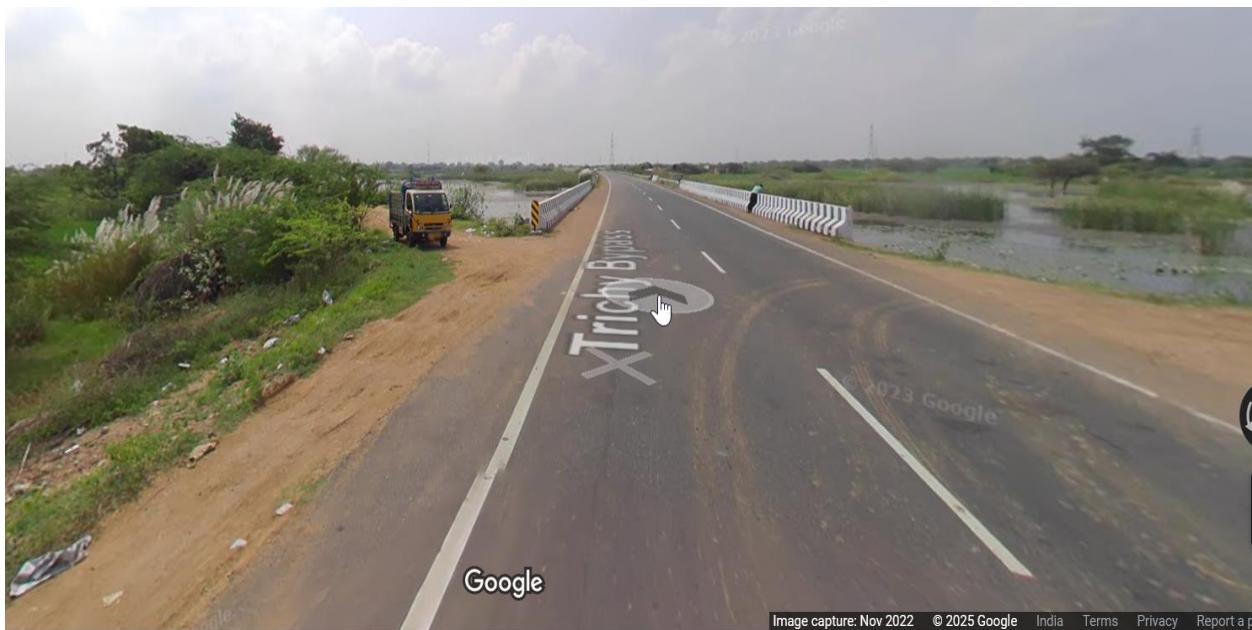
IMAGE: SHARP TURN RISK LEVEL: - MEDIUM, COORDI 10.707684883090641, 78.80790073860112

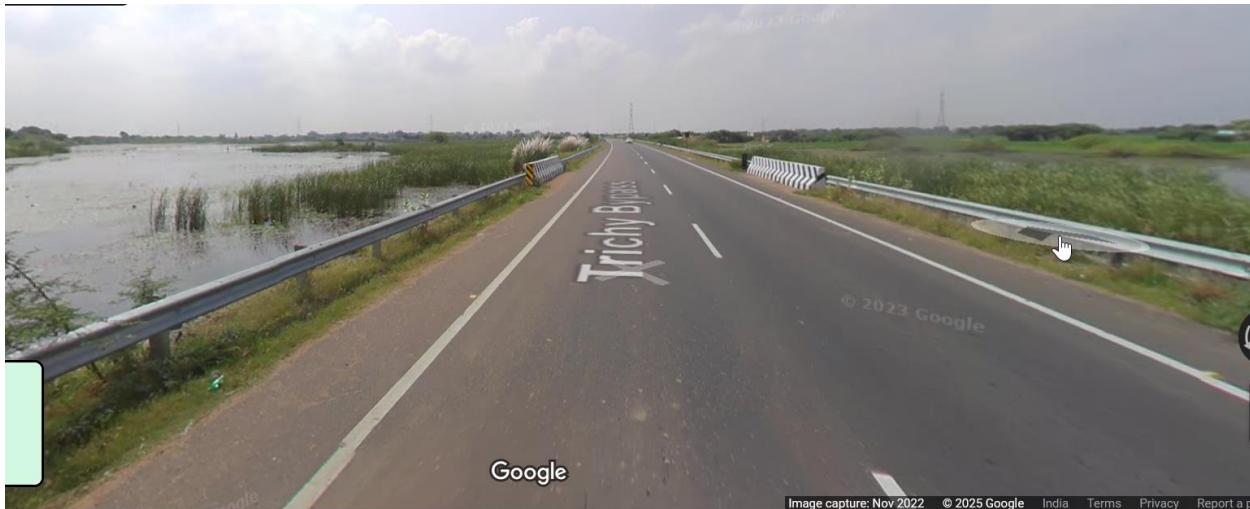
IMAGE: SHARP TURN RISK LEVEL: - MEDIUM, COORDI 10.692121284464921, 78.79367071643559

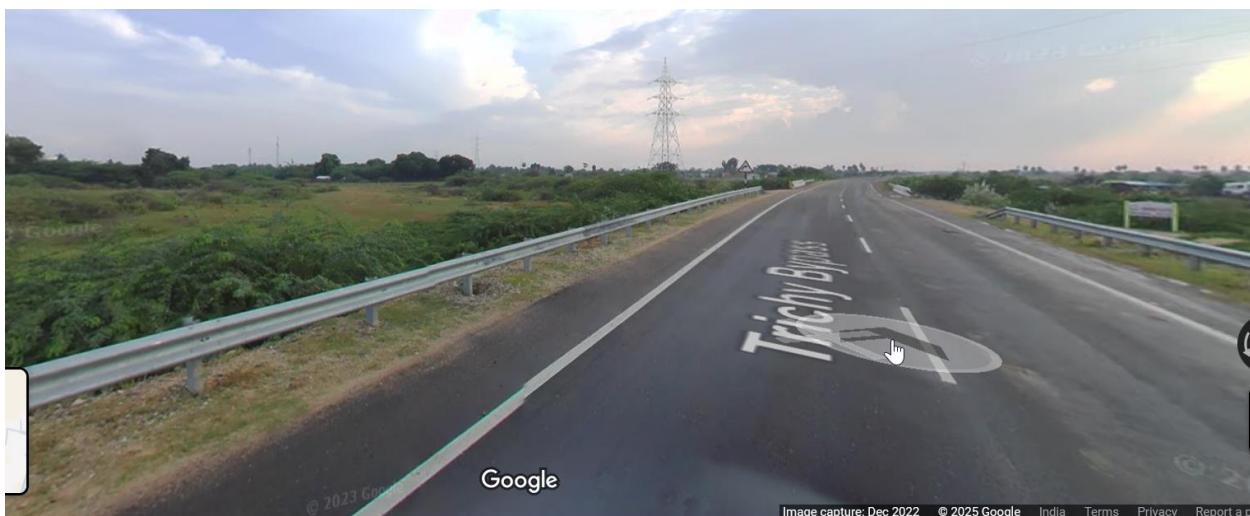
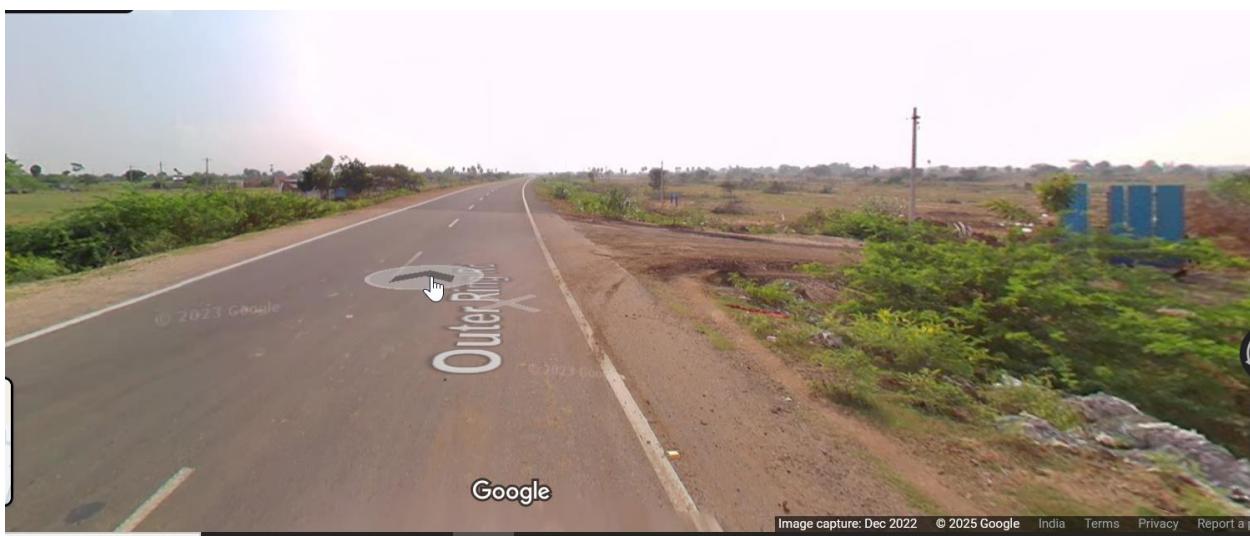
IMAGE: SHARP TURN RISK LEVEL: - MEDIUM, COORDI 10.701959474295487, 78.7318164898981

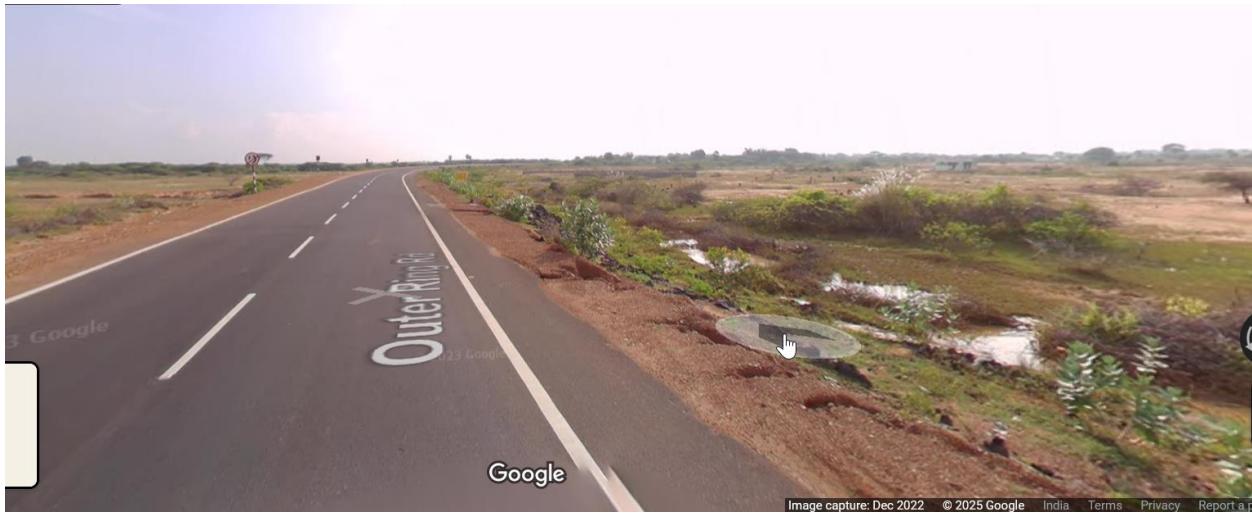
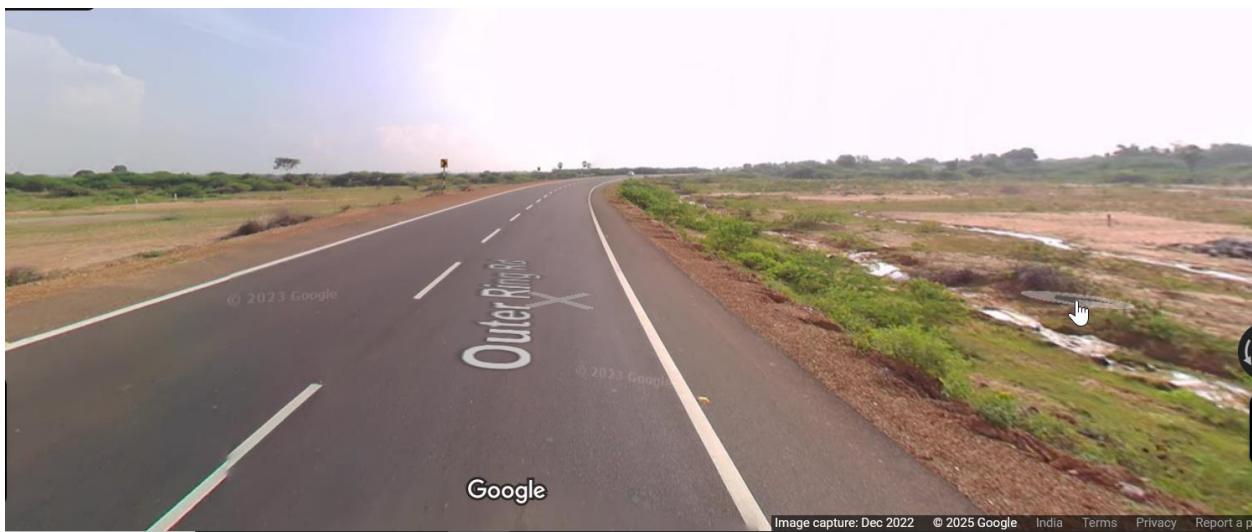
IMAGE: SHARP TURN RISK LEVEL: - MEDIUM, COORDI 10.697331232469807, 78.713823479486

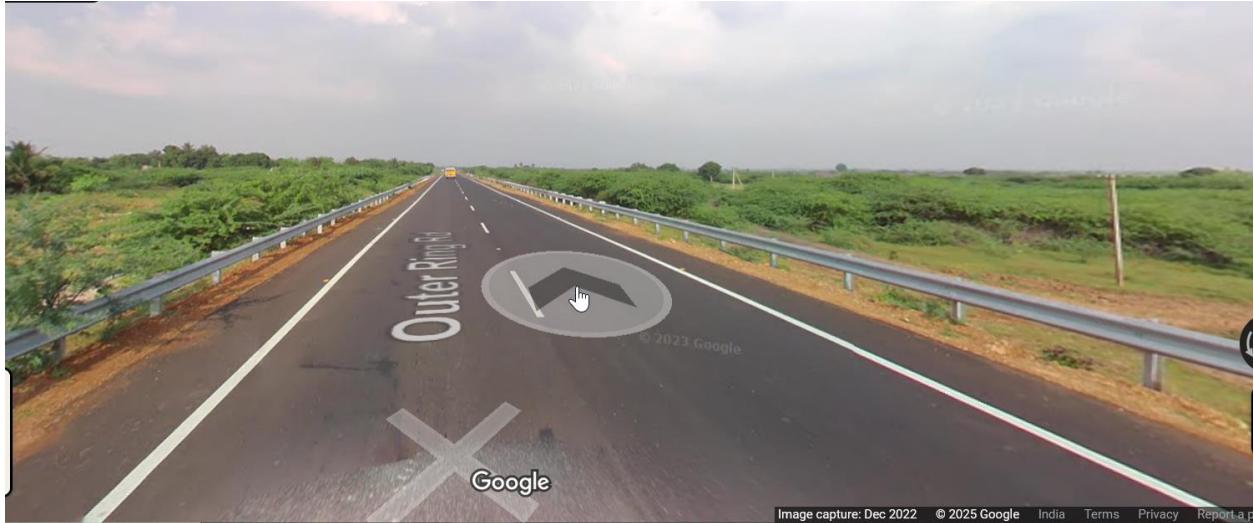
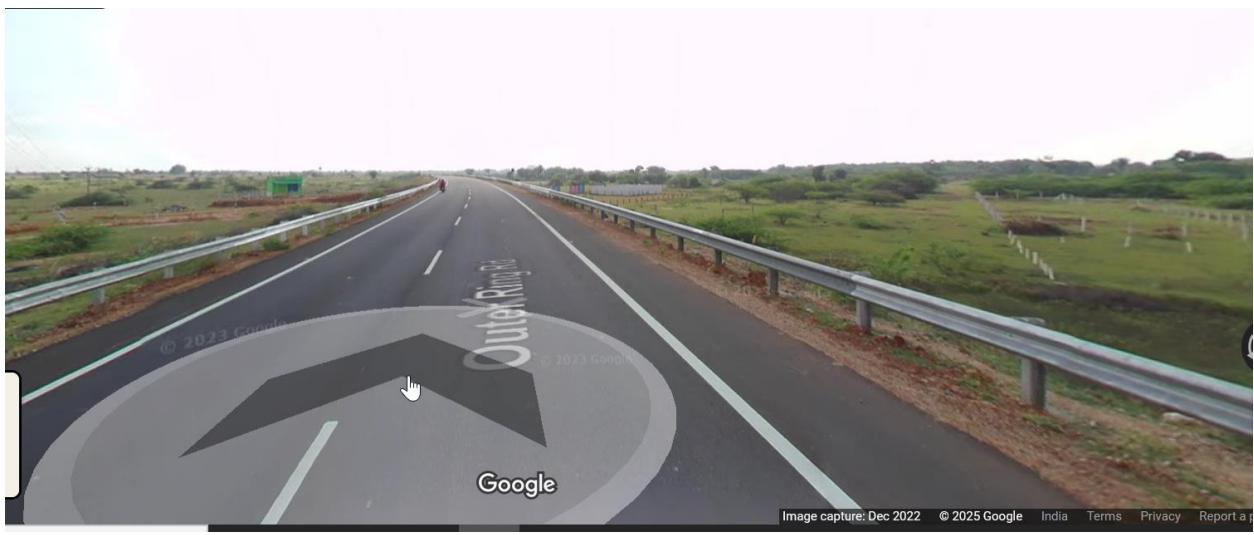
**IMAGE: SHARP TURN RISK LEVEL: - MEDIUM, COORDI 10.724409480793417, 78.68673230766052**

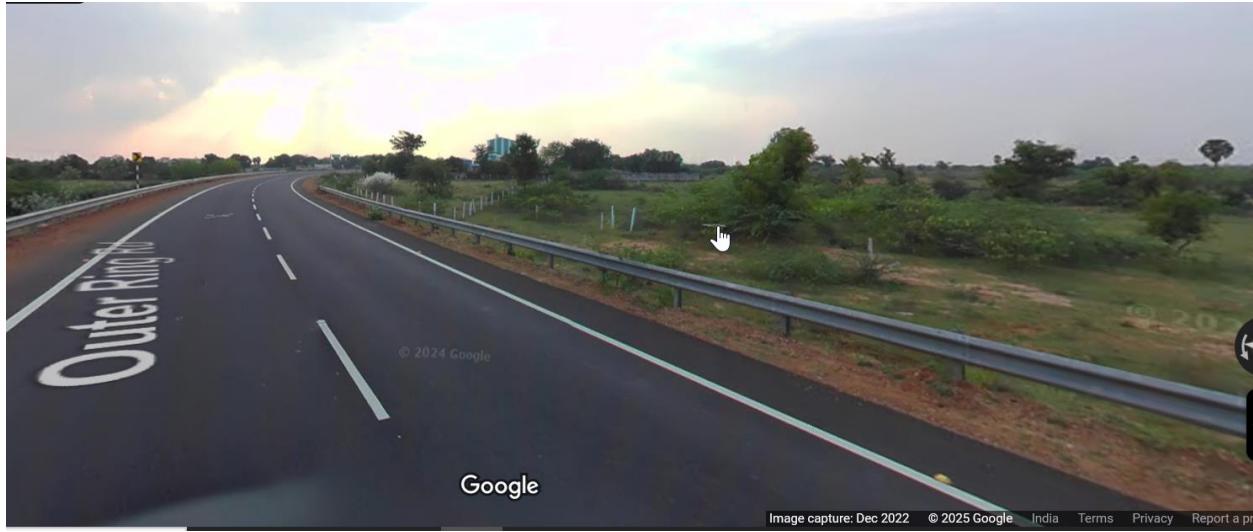
IMAGE: SHARP TURN RISK LEVEL: - MEDIUM, COORDI 10.73888374814383, 78.68225059068071

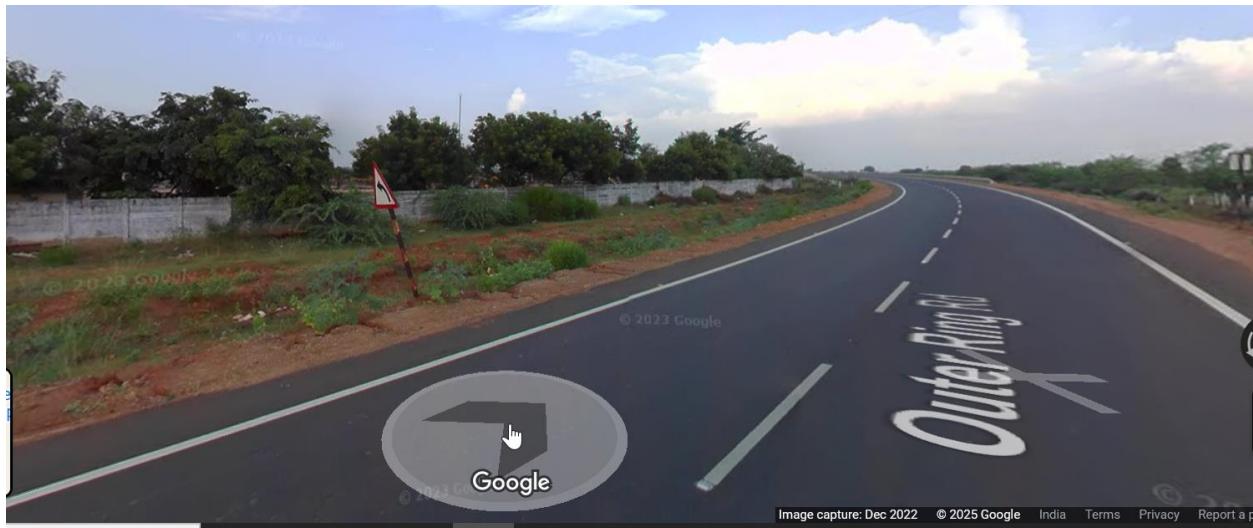
IMAGE: SHARP TURN RISK LEVEL: - MEDIUM, COORDI 10.742960945159615, 78.6798914362882

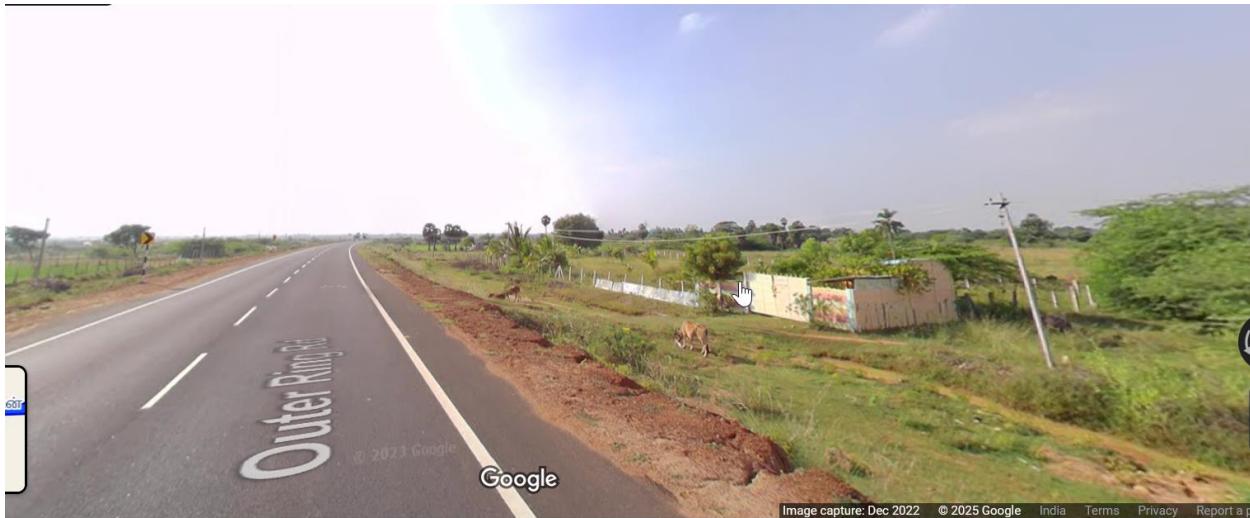
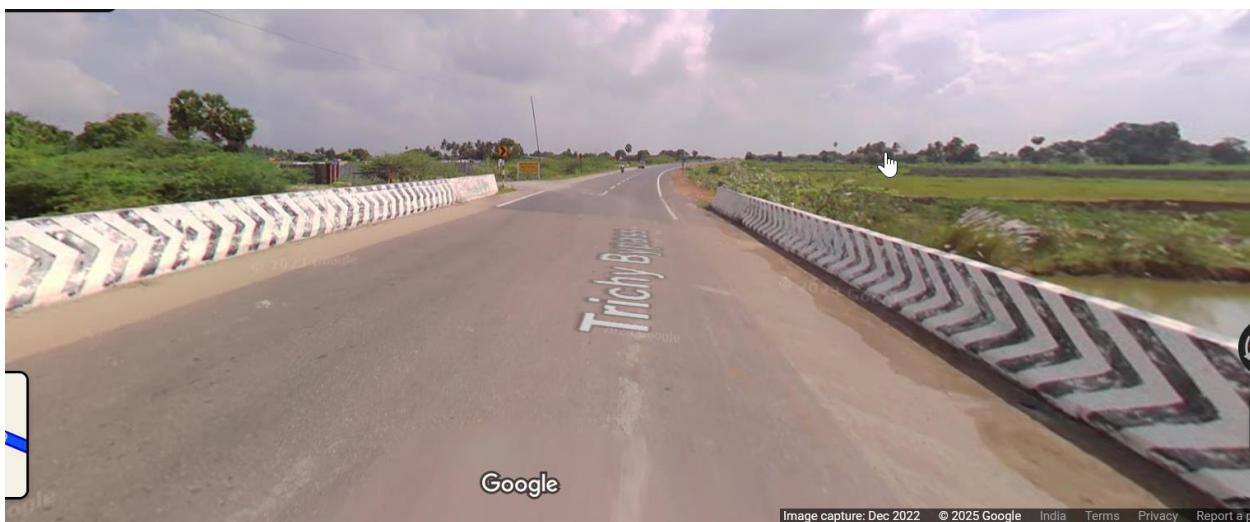
**IMAGE: SHARP TURN RISK LEVEL: - MEDIUM, COORDI 10.748042527178717, 78.67273590248926**

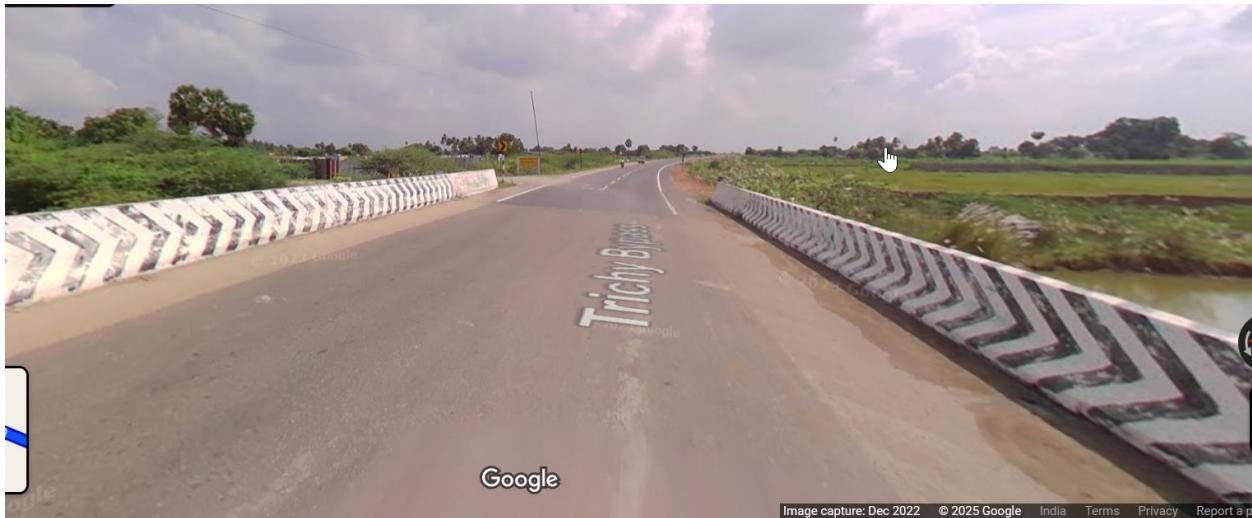
IMAGE: SHARP TURN RISK LEVEL: - MEDIUM, COORDI 10.75438694906606, 78.6662268755092

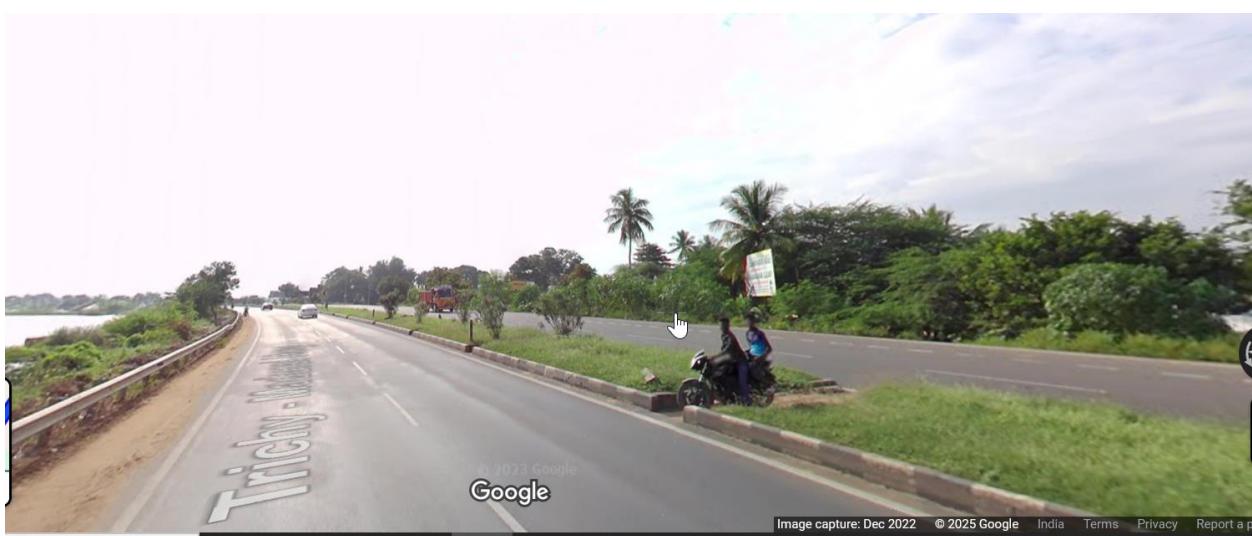
IMAGE: SHARP TURN RISK LEVEL: - MEDIUM, COORDI 10.759320830253554, 78.65977557378794

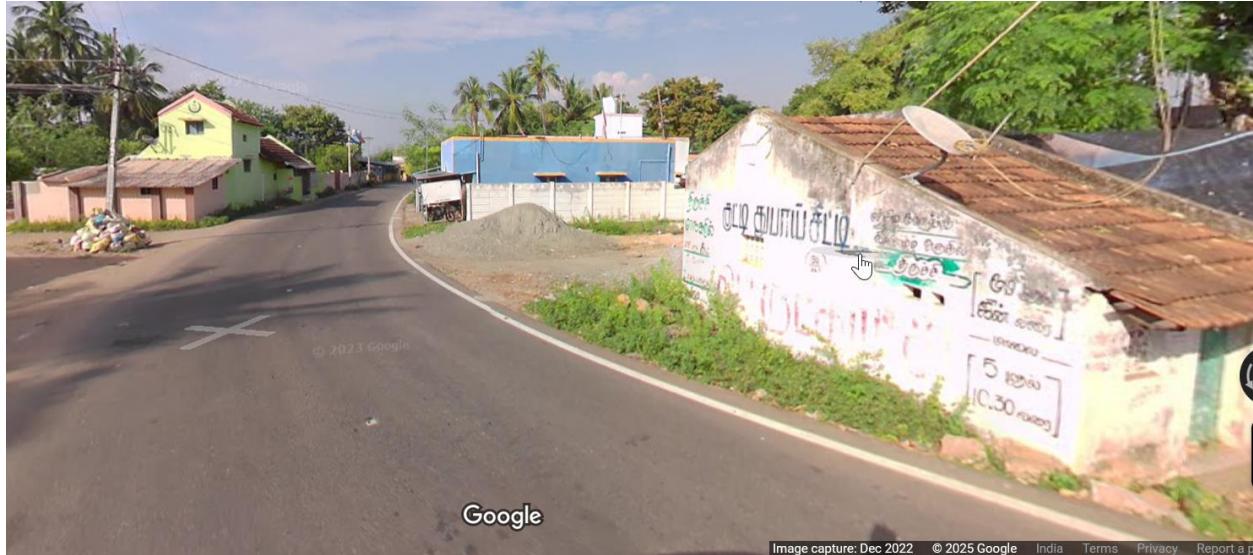
IMAGE: SHARP TURN RISK LEVEL: - HIGH, COORDI 10.728096799775422, 78.63174082151609

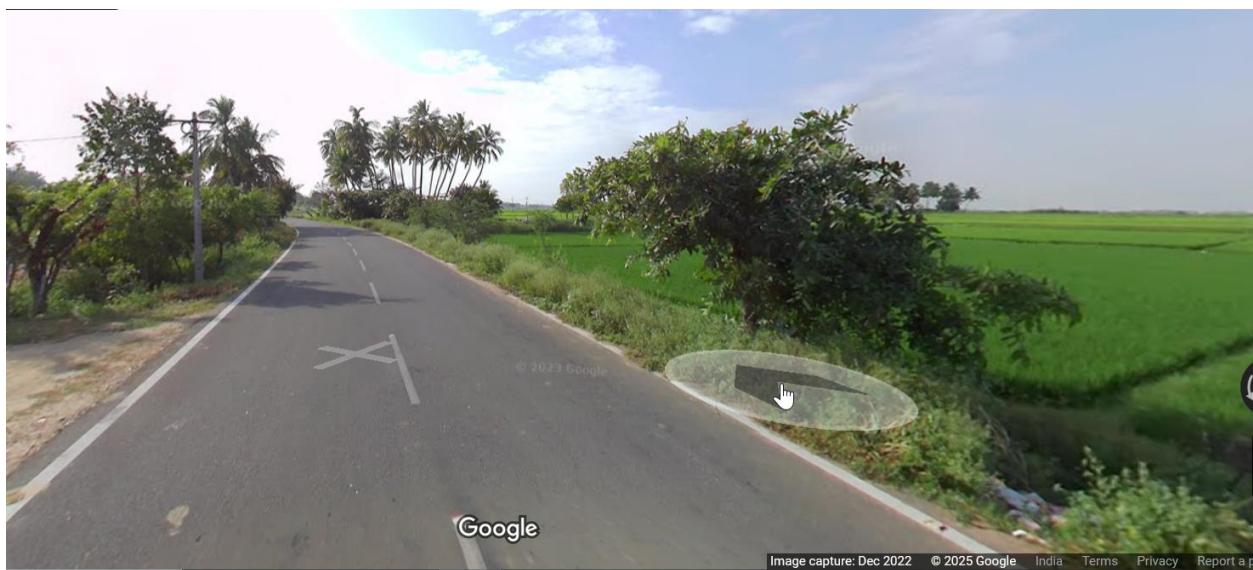
IMAGE: SHARP TURN RISK LEVEL: - MEDIUM, COORDI 10.736760846752857, 78.6345738723341

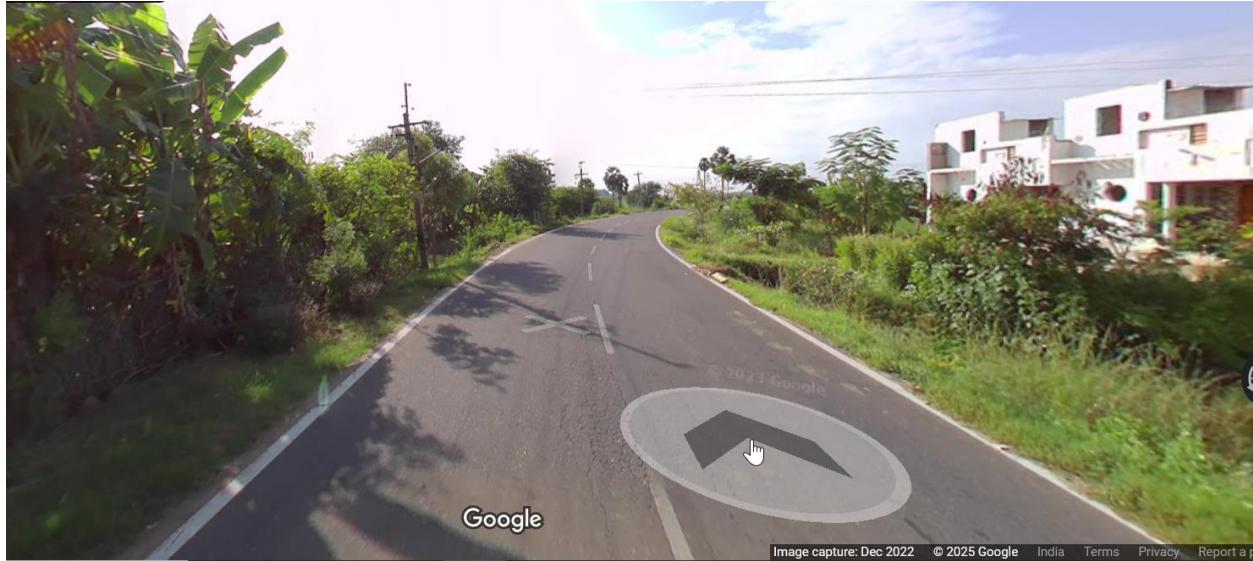
IMAGE: SHARP TURN RISK LEVEL: - MEDIUM, COORDI 10.739680081317179, 78.6344112428024

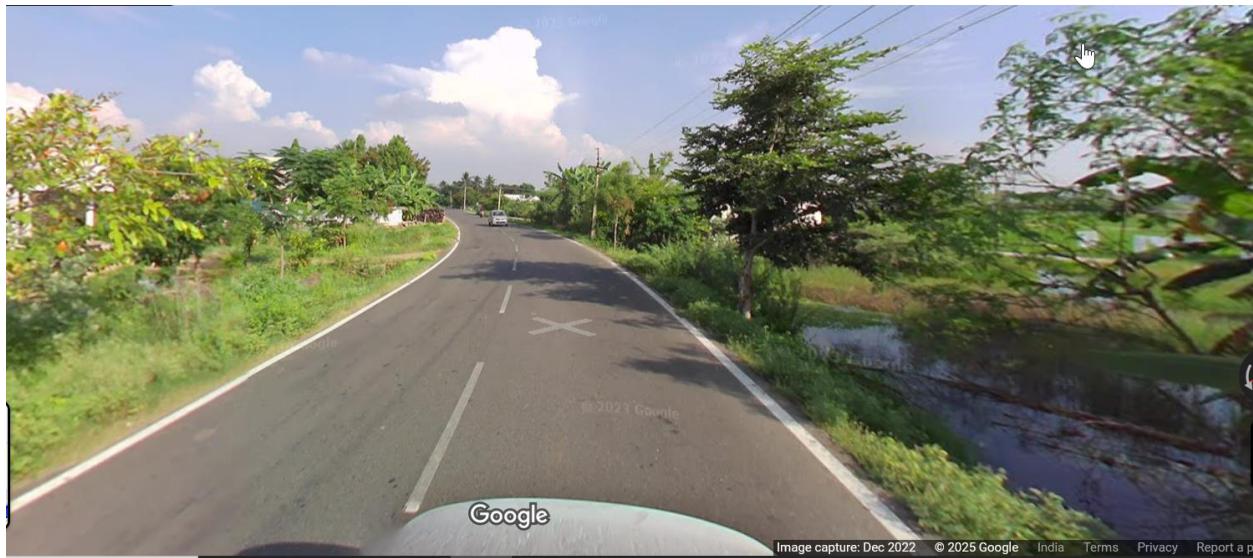
IMAGE: SHARP TURN RISK LEVEL: - MEDIUM, COORDI 10.74489823070153, 78.6333388938736

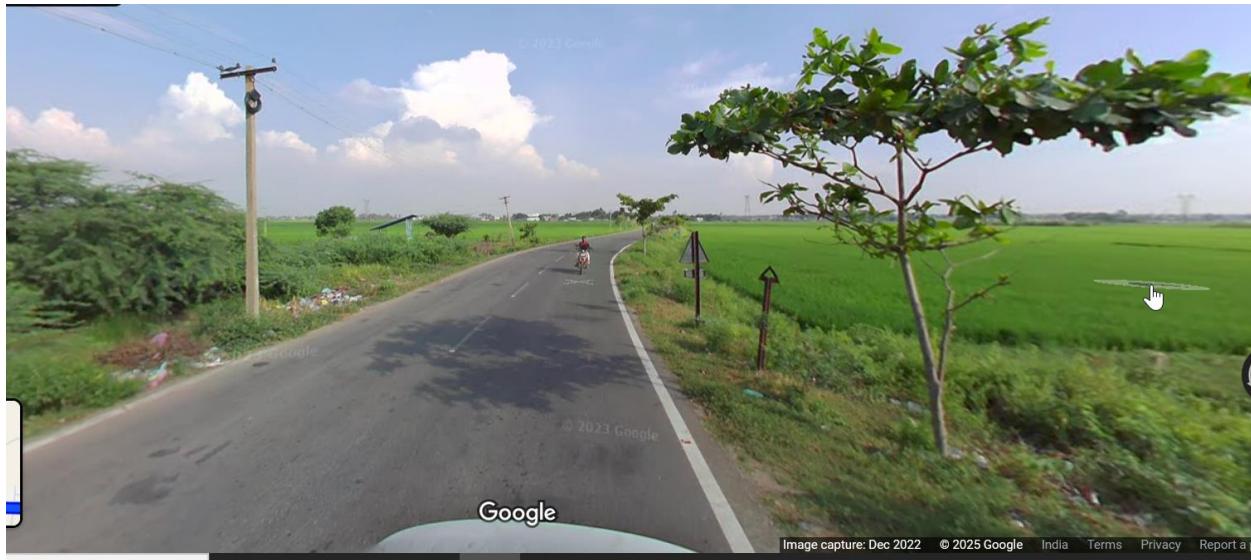
IMAGE: SHARP TURN RISK LEVEL: - MEDIUM, COORDI 10.744939218315286, 78.62975828065873

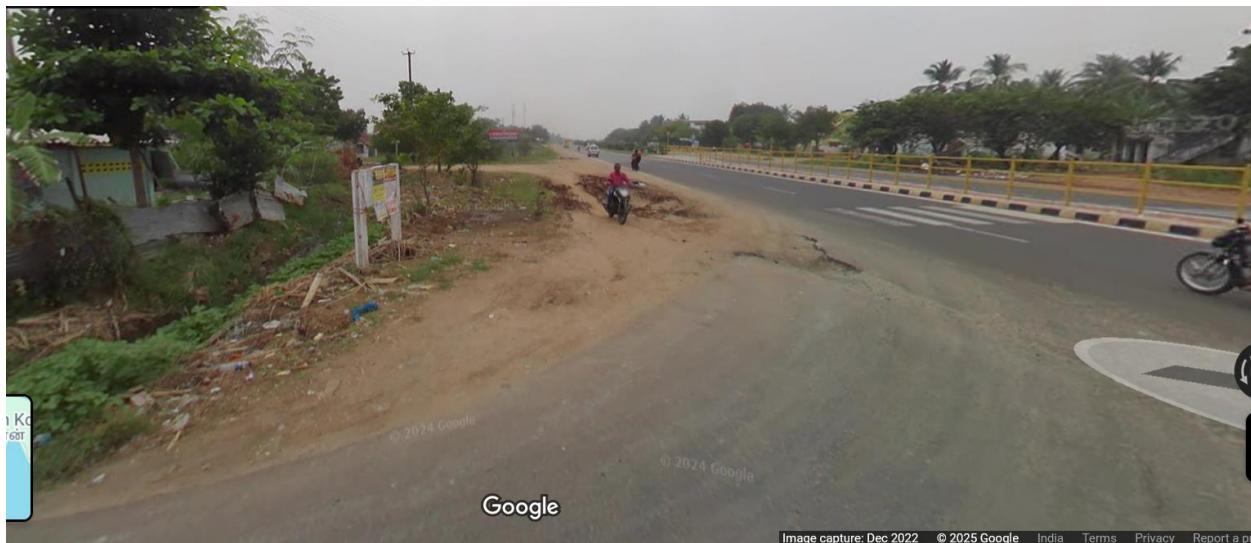
IMAGE: SHARP TURN RISK LEVEL: - MEDIUM, COORDI 10.747901176153153, 78.62016607394331

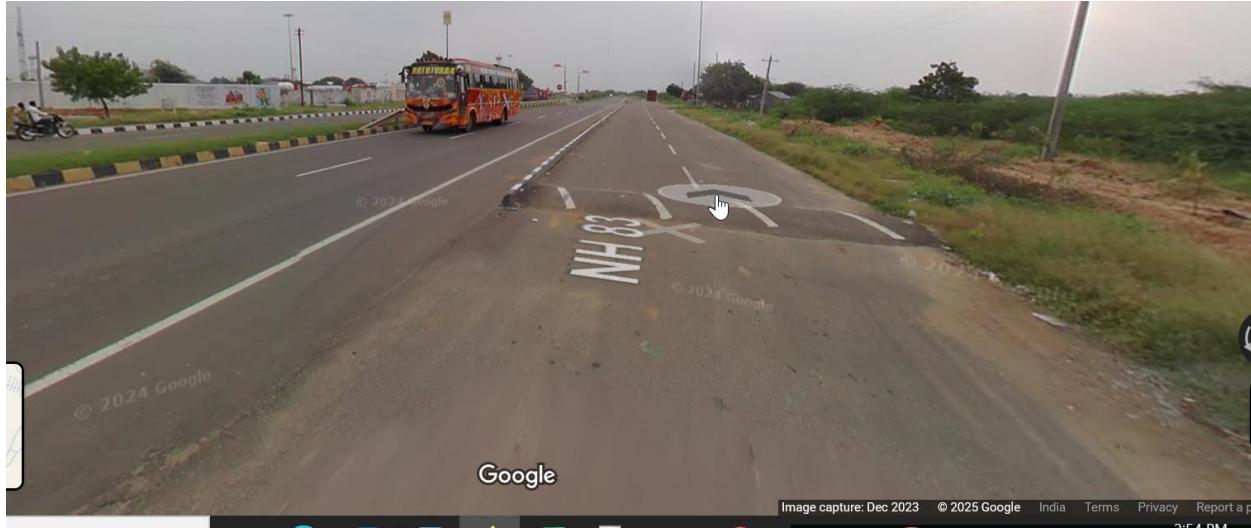
IMAGE: SHARP TURN RISK LEVEL: - MEDIUM, COORDI 10.751990126824074, 78.61266513520374

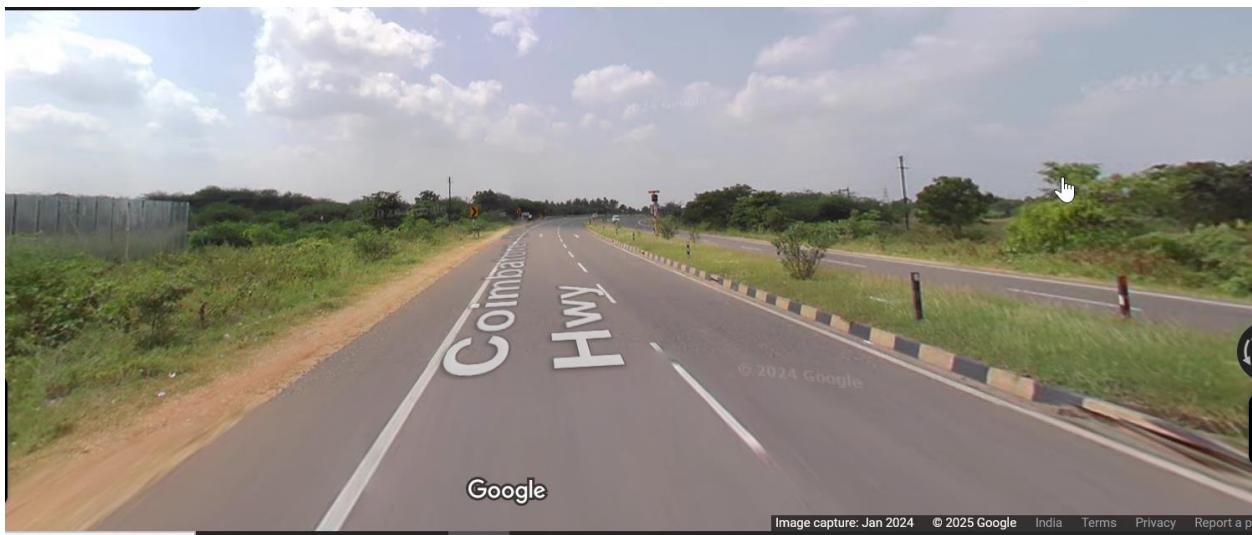
IMAGE: SHARP TURN RISK LEVEL: - MEDIUM, COORDI 10.645963337825492, 78.46627102916706

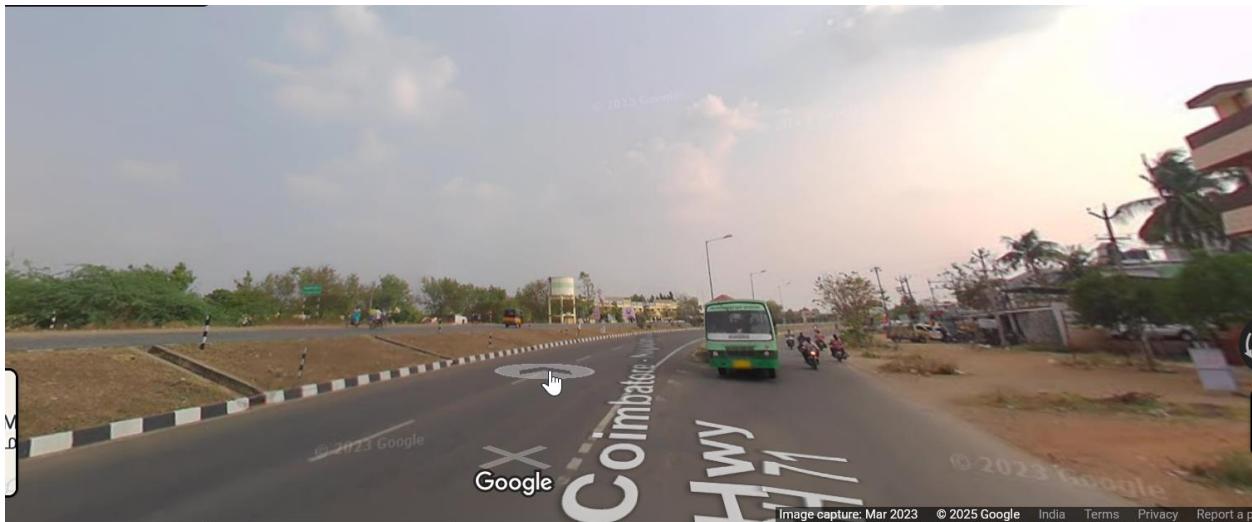
IMAGE: SHARP TURN RISK LEVEL: - MEDIUM, COORDI 10.625759253720217, 78.43227453528326

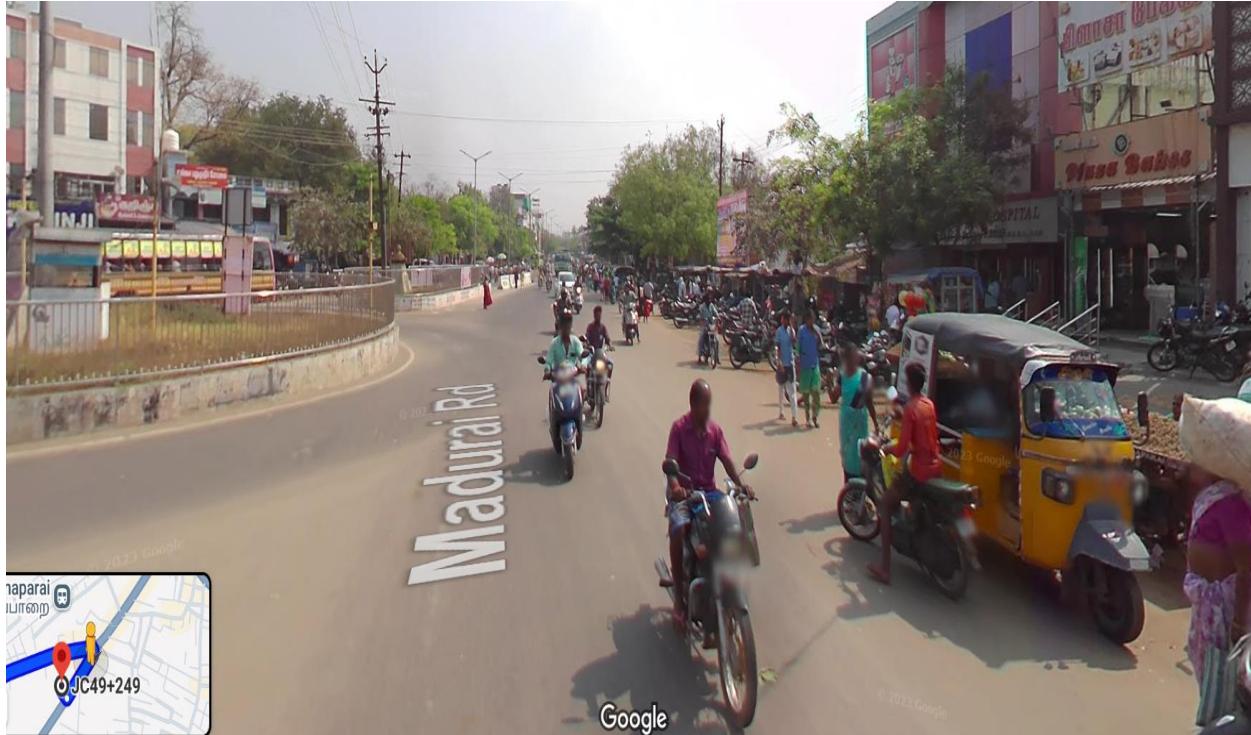
IMAGE: SHARP TURN RISK LEVEL: - MEDIUM, COORDI 10.605954802571658, 78.41892375775498
