JOURNEY RISK MANAGEMENT (JRM) STUDY

Salem Terminal To SREE BALAJI AGENCIES

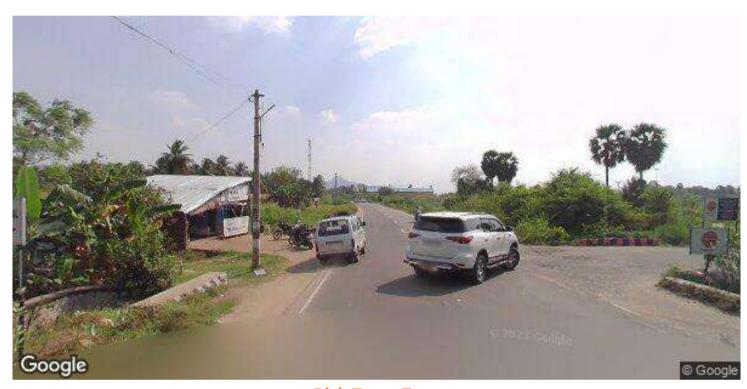
Risk Type: Turn
Risk Level: High
Speed Limit: 15 KM/Hr
Coordinates: 11.44029, 77.87544

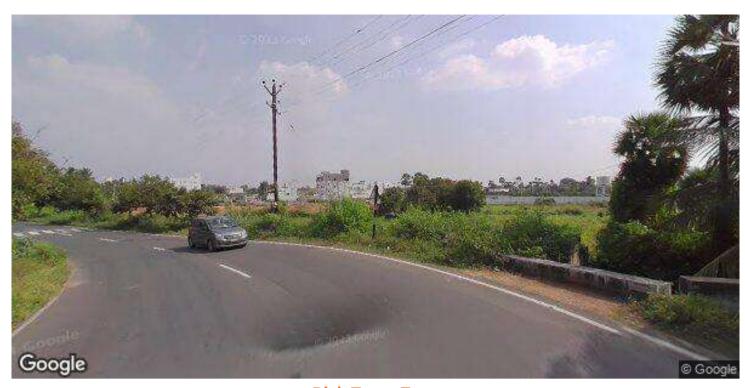
Risk Type: Turn
Risk Level: High
Speed Limit: 15 KM/Hr
Coordinates: 11.45350, 77.85700

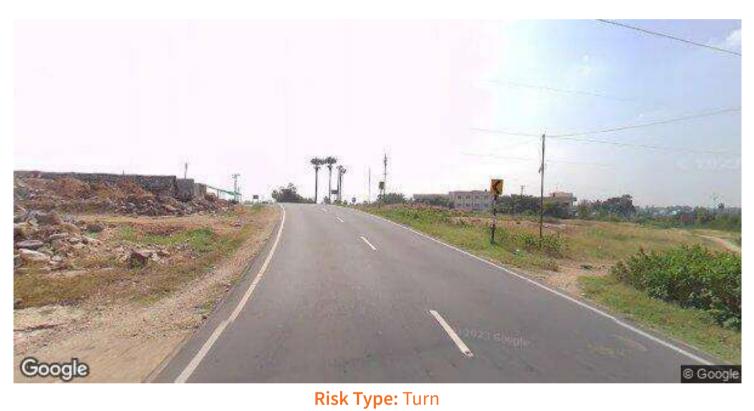
Risk Level: Medium
Speed Limit: 30 KM/Hr
Coordinates: 11.46046, 77.85037

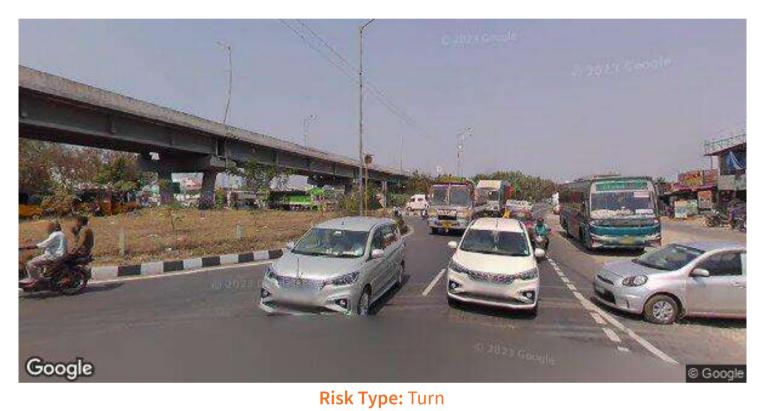
Risk Level: High
Speed Limit: 15 KM/Hr
Coordinates: 11.43001, 77.67575

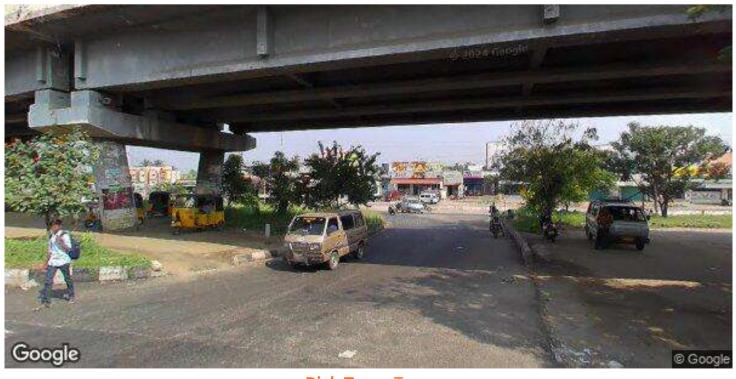
Risk Type: Turn
Risk Level: Medium

Speed Limit: 30 KM/Hr Coordinates: 11.43007, 77.67543

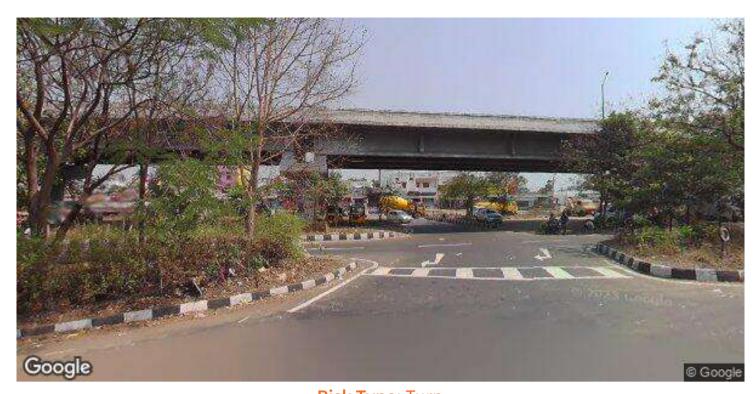
Risk Type: Turn
Risk Level: High
Speed Limit: 15 KM/Hr
Coordinates: 11.43026, 77.67525

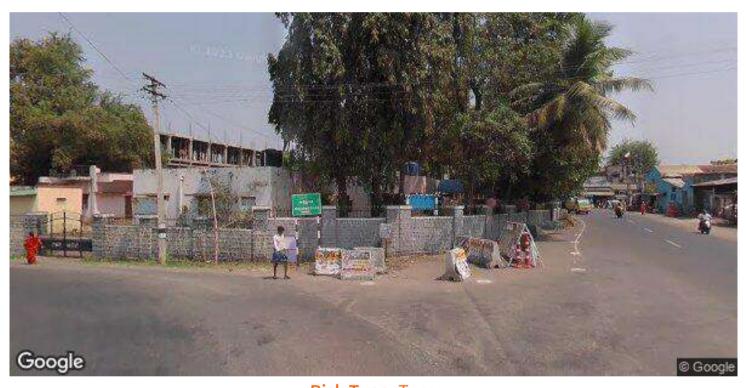
Risk Type: Turn
Risk Level: High
Speed Limit: 15 KM/Hr
Coordinates: 11.43864, 77.68225

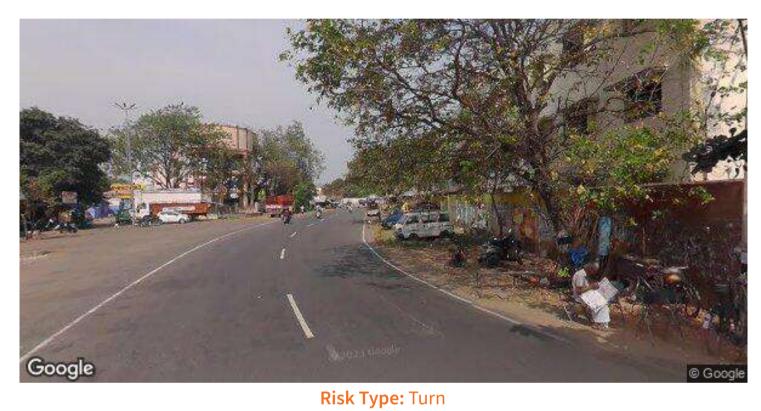
Risk Level: Medium
Speed Limit: 30 KM/Hr
Coordinates: 11.43997, 77.68198

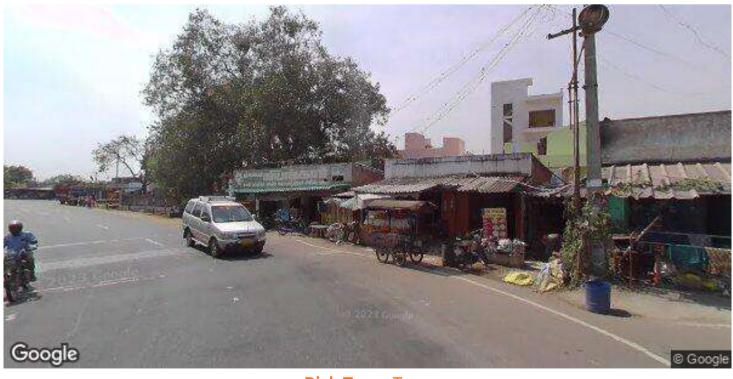
Risk Type: Turn Risk Level: High

Speed Limit: 15 KM/Hr Coordinates: 11.44105, 77.68187

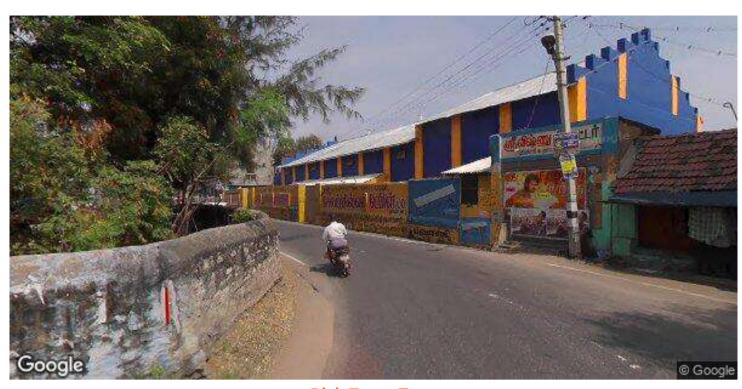
Risk Type: Turn
Risk Level: High
Speed Limit: 15 KM/Hr
Coordinates: 11.44119, 77.68217

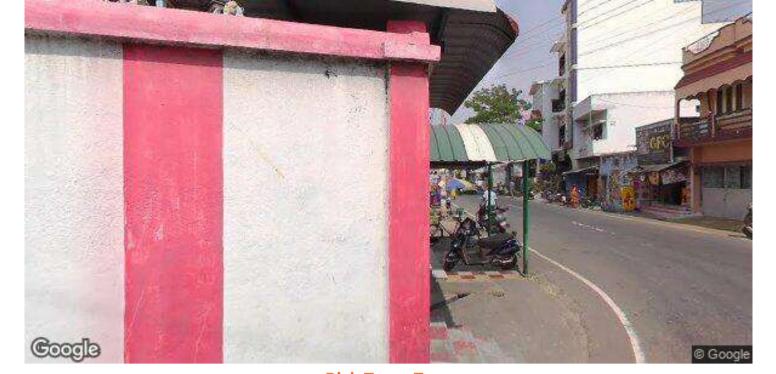
Risk Type: Turn
Risk Level: Medium
Speed Limit: 30 KM/Hr
Coordinates: 11.44298, 77.68272

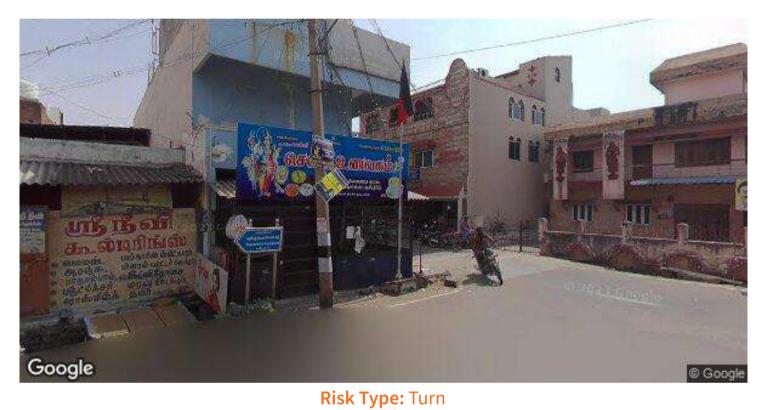
Risk Level: Medium
Speed Limit: 30 KM/Hr
Coordinates: 11.44305, 77.68277

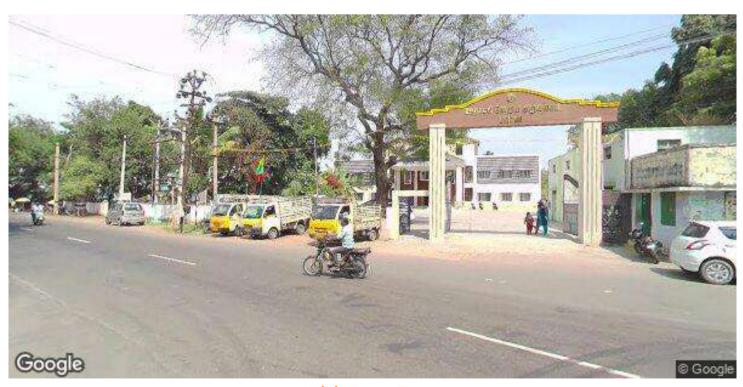
Risk Type: Turn Risk Level: High Speed Limit: 15 KM/Hr Coordinates: 11.44853, 77.68331

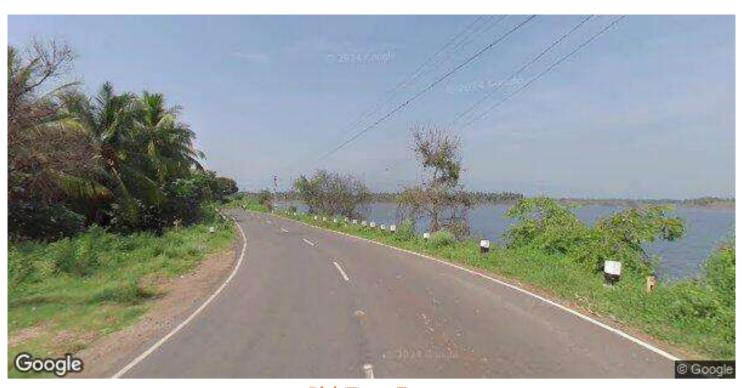
Risk Type: Turn
Risk Level: Medium
Speed Limit: 30 KM/Hr
Coordinates: 11.48124, 77.57031
