JOURNEY RISK MANAGEMENT (JRM) STUDY

IOCL Coimbatore Terminal to Kamalm Dheepam

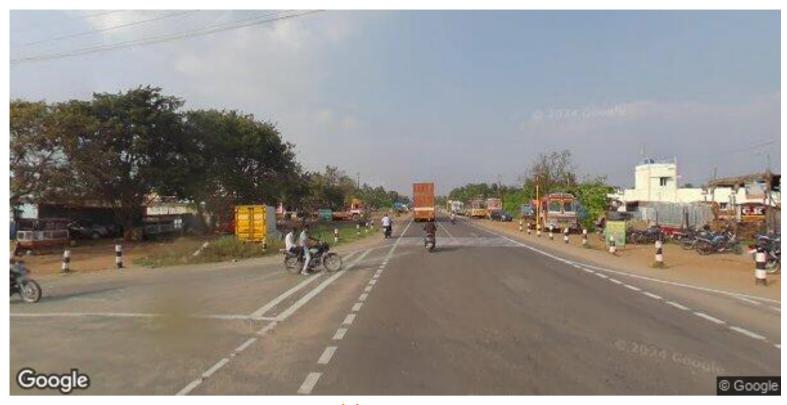
Coordinates: 11.03211, 77.07640

Risk Type: Turn
Risk Level: High
Speed Limit: 15 KM/Hr

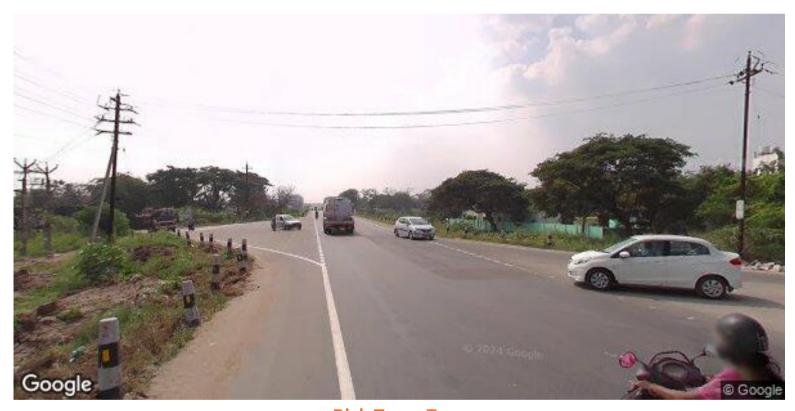
Coordinates: 11.05950, 77.08744

Risk Type: Turn
Risk Level: High
Speed Limit: 15 KM/Hr

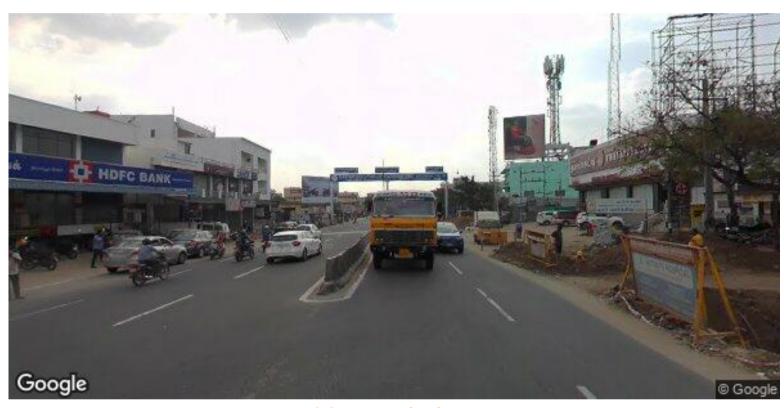
Risk Type: Blind Spot
Risk Level: Blind Spot
Speed Limit: 10 KM/Hr
Coordinates: 11.06138, 77.08700

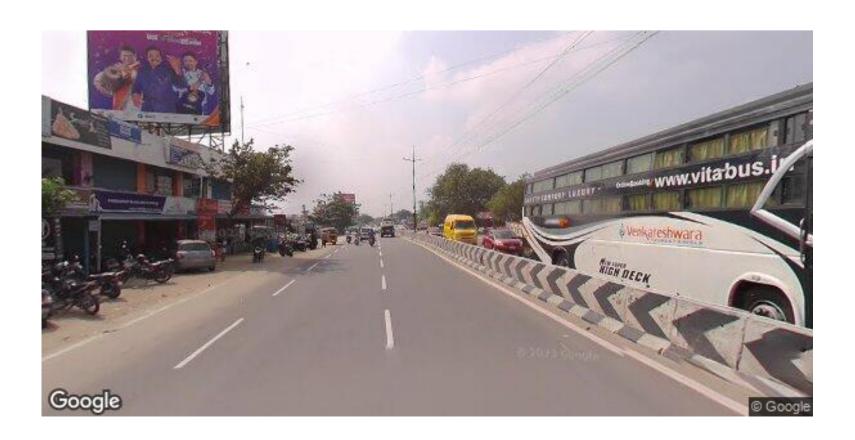
Coordinates: 11.06017, 77.08395

Risk Type: Blind Spot Risk Level: Blind Spot Speed Limit: 10 KM/Hr

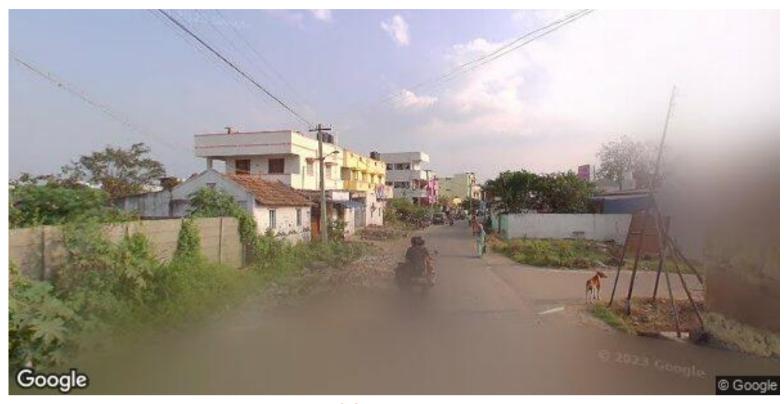
Coordinates: 11.06143, 77.08368

Risk Type: Turn
Risk Level: Medium
Speed Limit: 30 KM/Hr

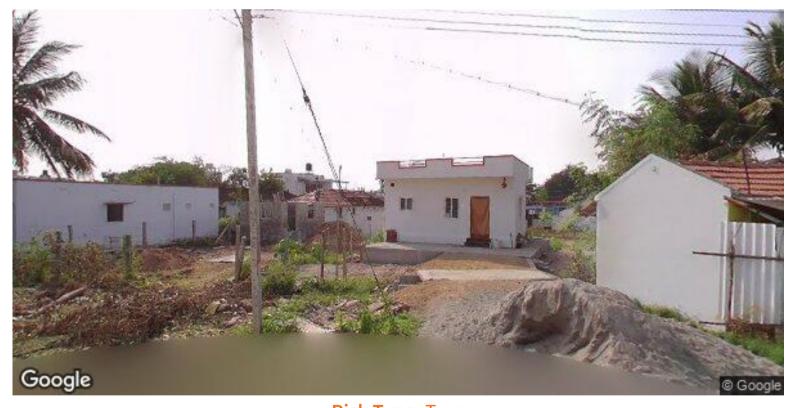
Coordinates: 11.09666, 77.07062

Risk Type: Turn
Risk Level: Medium
Speed Limit: 30 KM/Hr

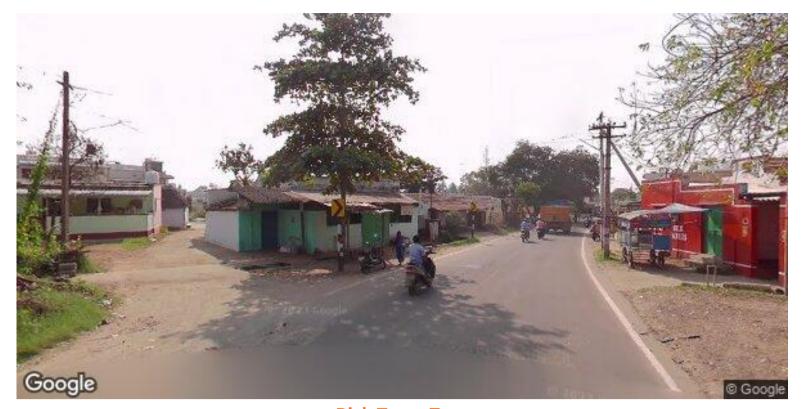
Risk Type: Turn
Risk Level: High
Speed Limit: 15 KM/Hr
Coordinates: 11.09692, 77.07032

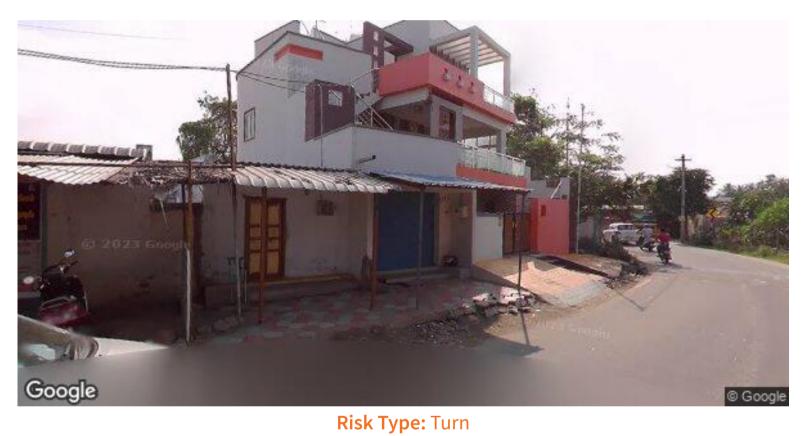
Risk Type: Turn
Risk Level: High
Speed Limit: 15 KM/Hr
Coordinates: 11.09692, 77.06915

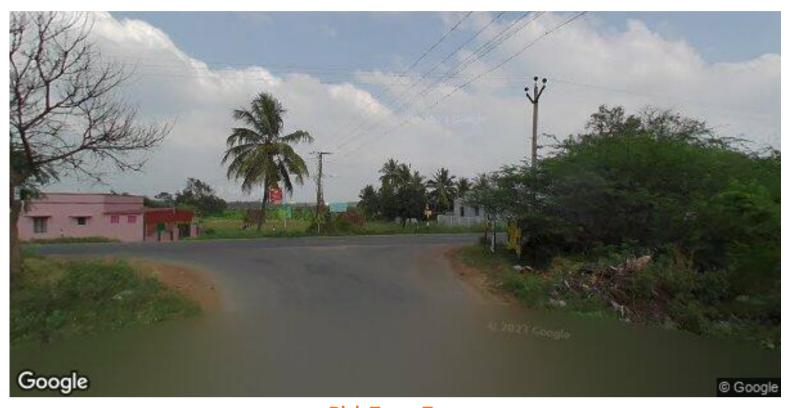
Risk Type: Turn
Risk Level: High
Speed Limit: 15 KM/Hr
Coordinates: 11.11518, 77.06798

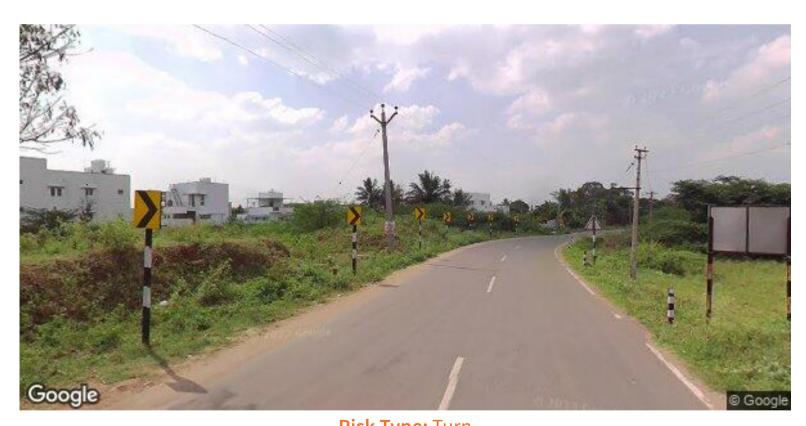
Risk Type: Turn
Risk Level: Medium
Speed Limit: 30 KM/Hr
Coordinates: 11.11530, 77.06781

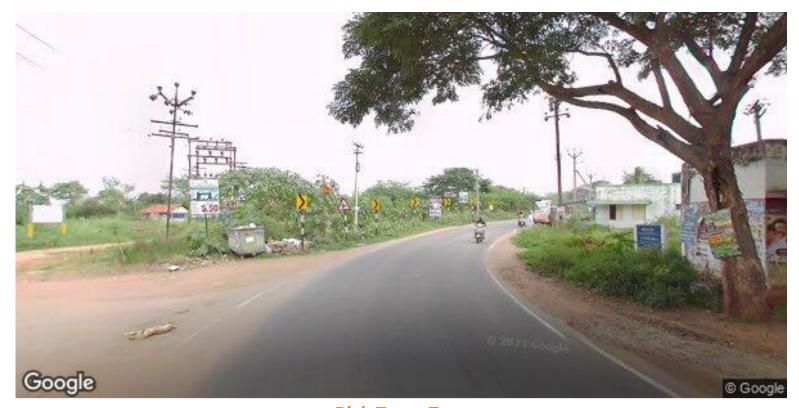
Risk Type: Turn
Risk Level: Medium
Speed Limit: 30 KM/Hr
Coordinates: 11.11570, 77.06566

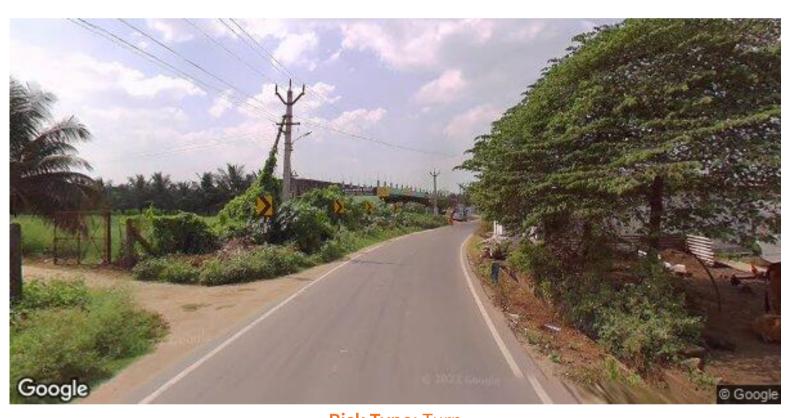
Risk Type: Turn
Risk Level: Medium
Speed Limit: 30 KM/Hr
Coordinates: 11.11520, 77.06462

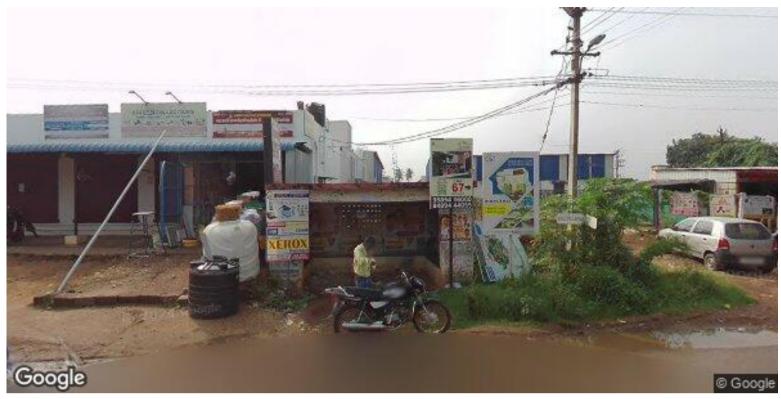
Coordinates: 11.11590, 77.04318

Risk Type: Blind Spot Risk Level: Blind Spot Speed Limit: 10 KM/Hr

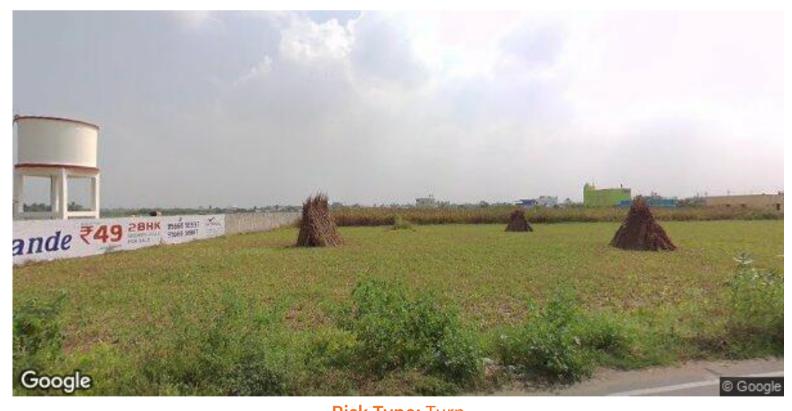
Coordinates: 11.12352, 77.04304

Risk Type: Turn
Risk Level: Medium
Speed Limit: 30 KM/Hr

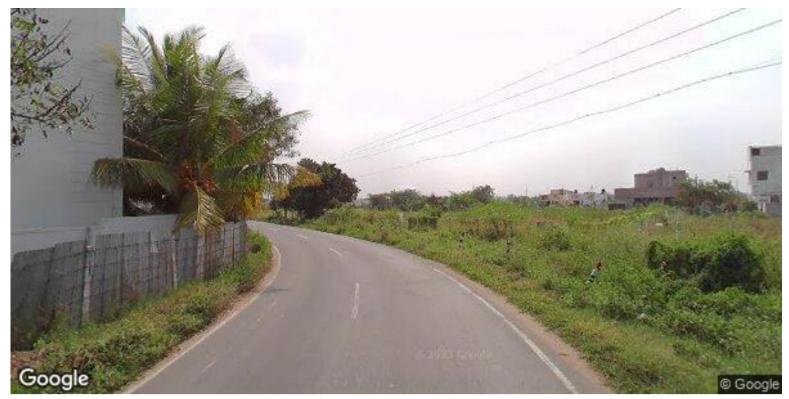
Coordinates: 11.12412, 77.04223

Risk Type: Turn
Risk Level: High
Speed Limit: 15 KM/Hr

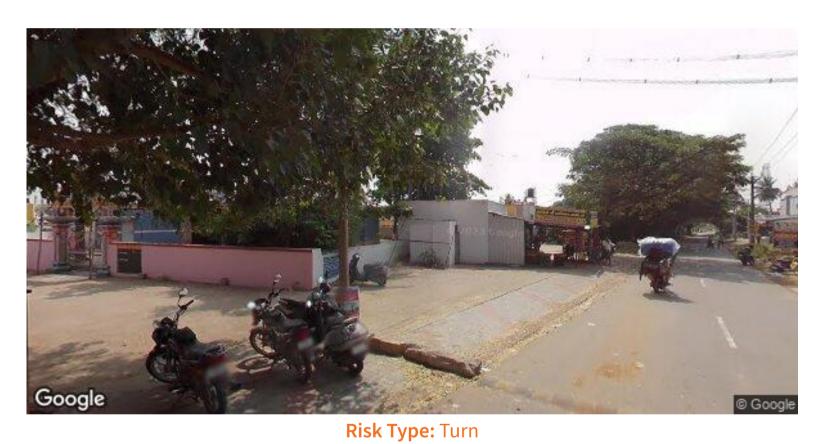
Risk Level: High
Speed Limit: 15 KM/Hr
Coordinates: 11.13276, 77.04239

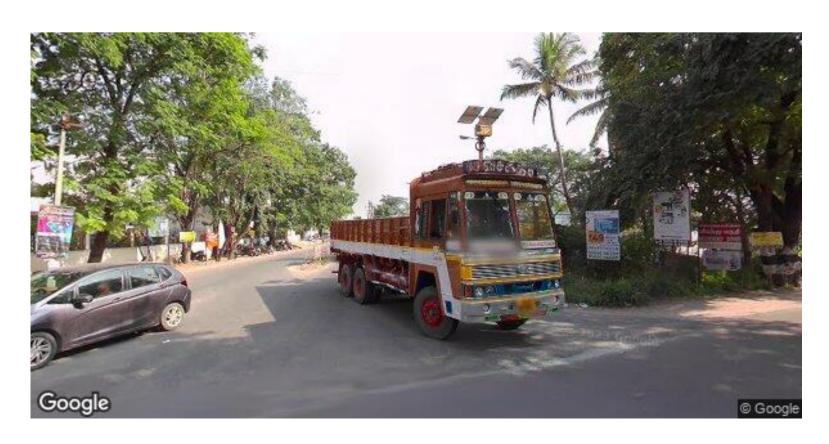
Coordinates: 11.13350, 77.03352

Risk Type: Turn
Risk Level: High
Speed Limit: 15 KM/Hr

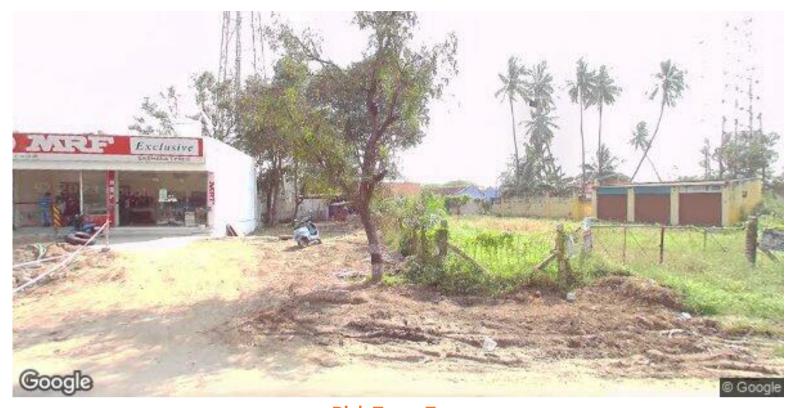
Risk Type: Turn
Risk Level: Medium
Speed Limit: 30 KM/Hr
Coordinates: 11.14129, 77.03688

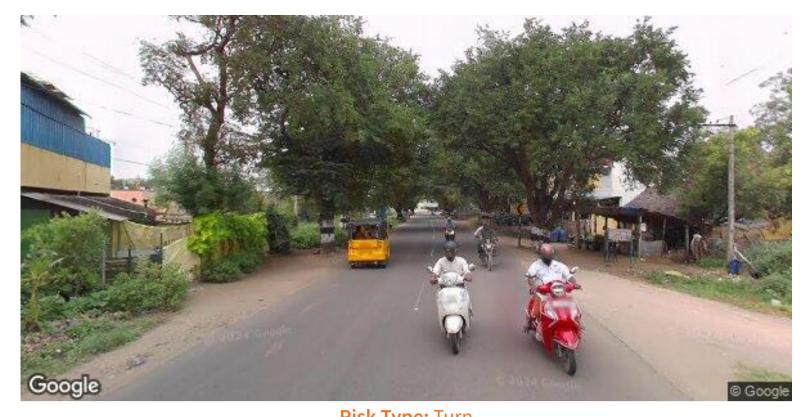
Risk Type: Turn
Risk Level: Medium
Speed Limit: 30 KM/Hr
Coordinates: 11.14358, 77.04115

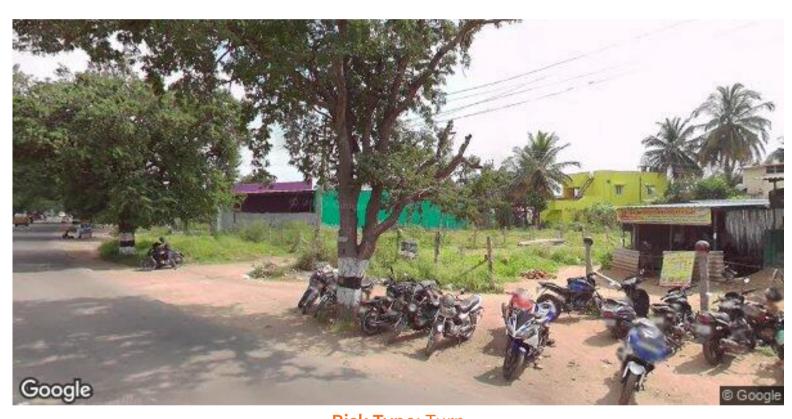
Risk Type: Turn
Risk Level: Medium
Speed Limit: 30 KM/Hr
Coordinates: 11.14496, 77.04160

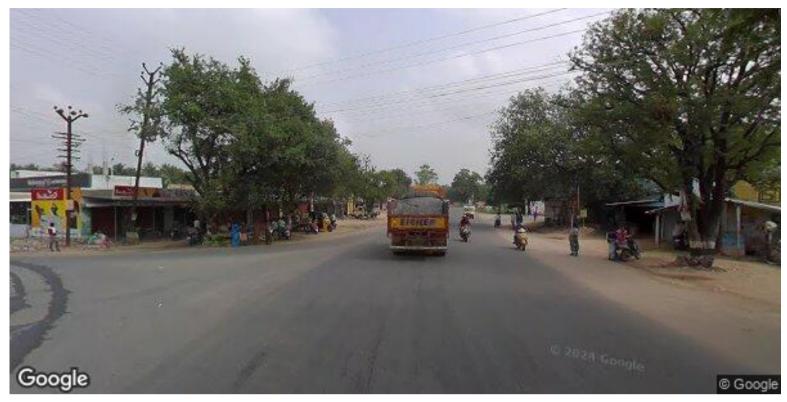
Coordinates: 11.20175, 77.07779

Risk Type: Turn
Risk Level: High
Speed Limit: 15 KM/Hr

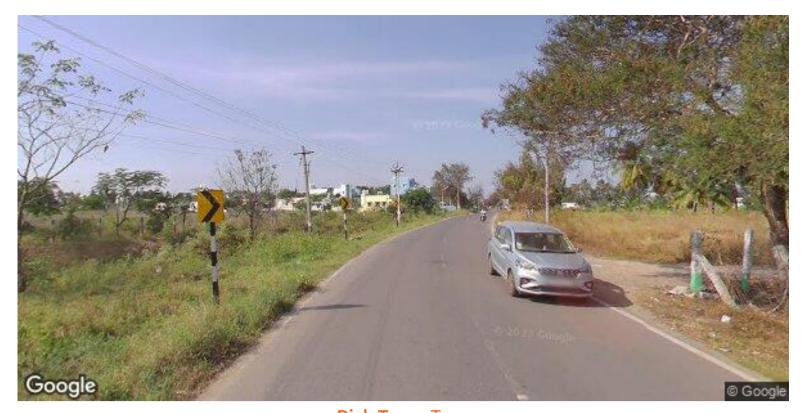
Risk Type: Turn
Risk Level: Medium
Speed Limit: 30 KM/Hr
Coordinates: 11.20448, 77.07523

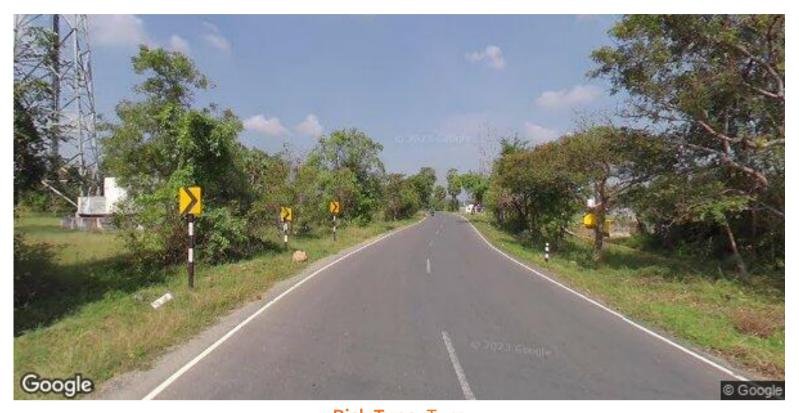
Risk Type: Turn
Risk Level: Medium
Speed Limit: 30 KM/Hr
Coordinates: 11.21306, 77.04025

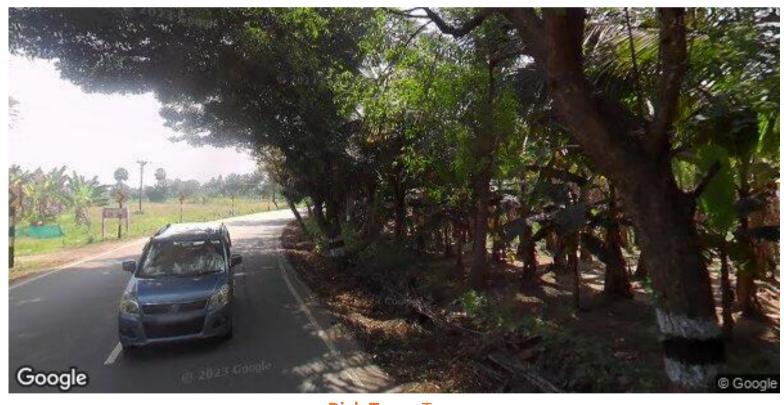
Risk Type: Turn
Risk Level: Medium
Speed Limit: 30 KM/Hr
Coordinates: 11.22203, 77.03364

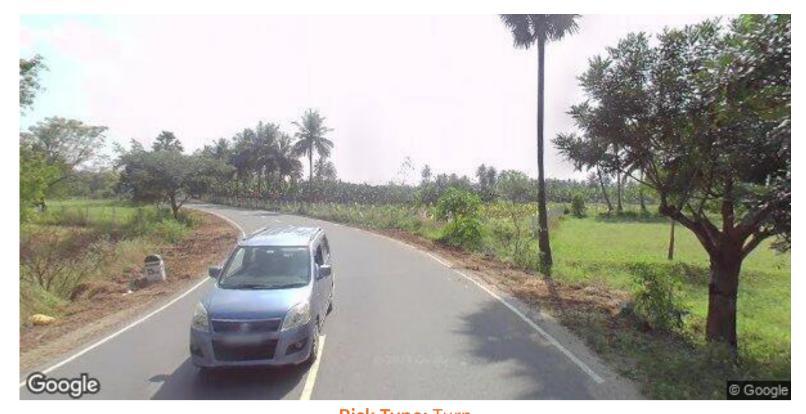
Risk Type: Turn
Risk Level: Medium
Speed Limit: 30 KM/Hr
Coordinates: 11.22255, 77.03183

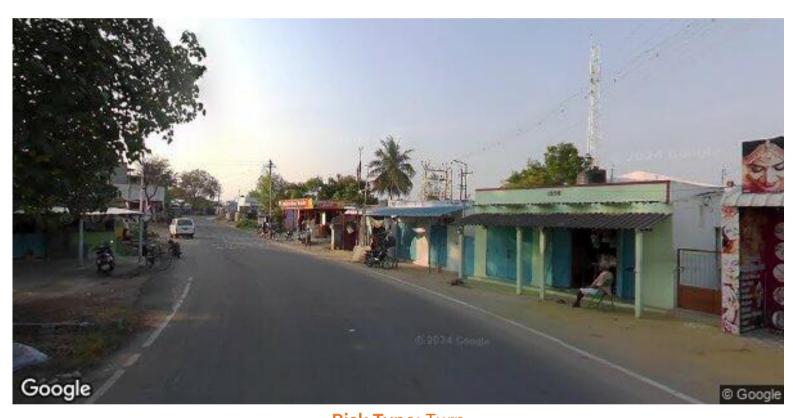
Risk Type: Turn
Risk Level: Medium
Speed Limit: 30 KM/Hr
Coordinates: 11.22810, 77.02928

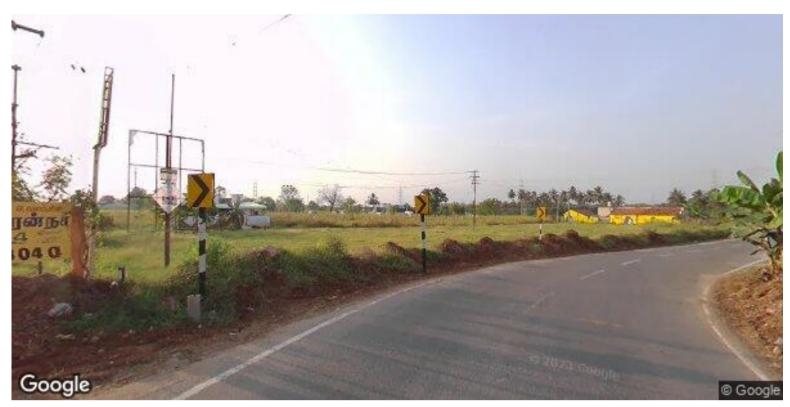
Coordinates: 11.22934, 77.02626

Risk Type: Turn
Risk Level: High
Speed Limit: 15 KM/Hr

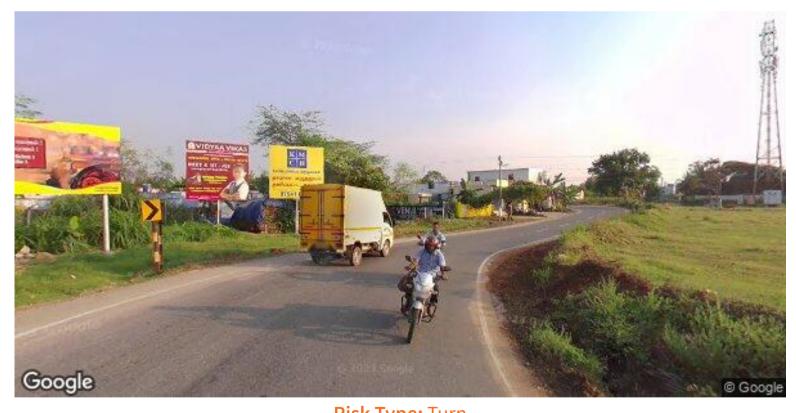
Coordinates: 11.23003, 77.02620

Risk Type: Turn
Risk Level: High
Speed Limit: 15 KM/Hr

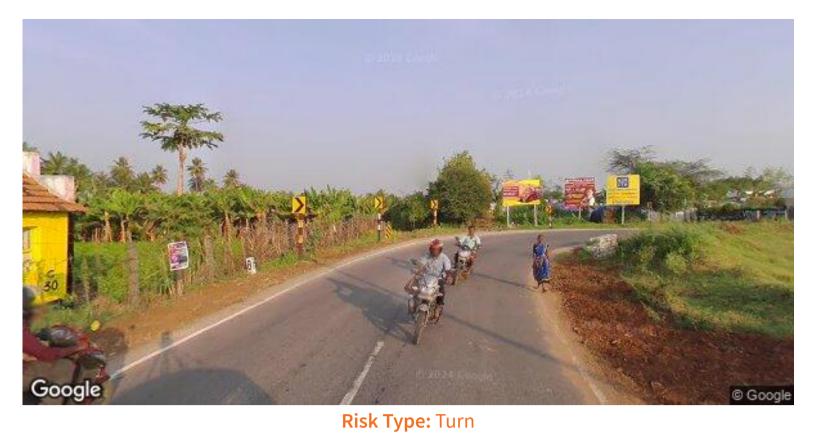
Risk Type: Turn
Risk Level: Medium
Speed Limit: 30 KM/Hr
Coordinates: 11.23015, 77.02603

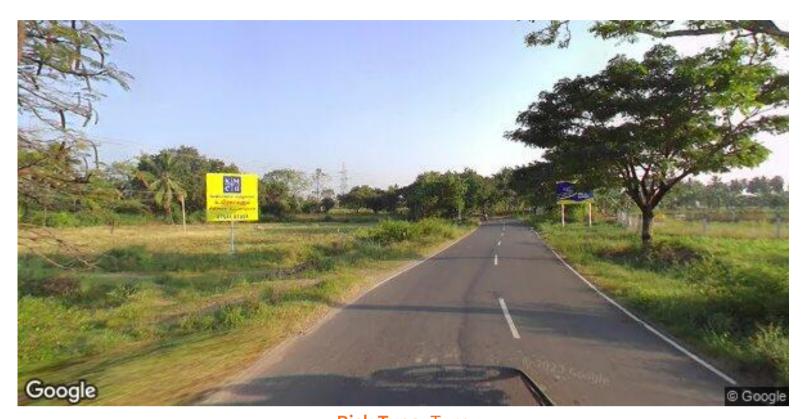
Risk Type: Turn
Risk Level: Medium
Speed Limit: 30 KM/Hr
Coordinates: 11.23245, 77.01340

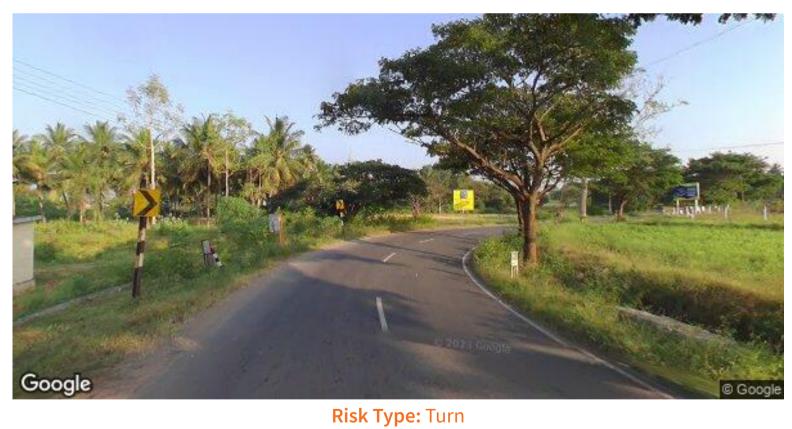
Risk Level: Medium
Speed Limit: 30 KM/Hr
Coordinates: 11.23262, 77.01320

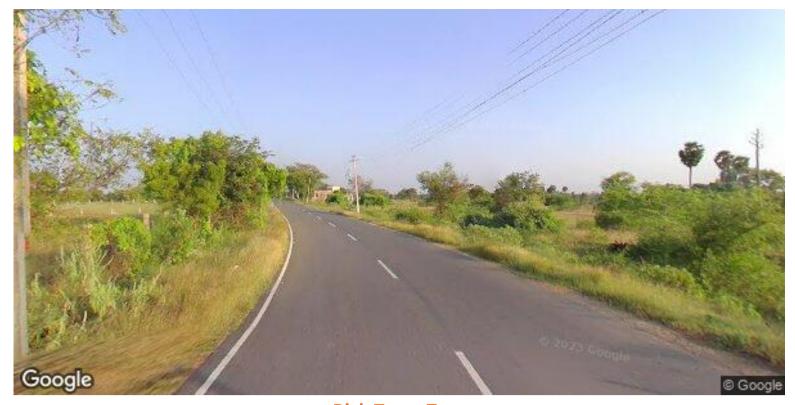
Risk Type: Turn
Risk Level: Medium
Speed Limit: 30 KM/Hr
Coordinates: 11.23454, 77.00623

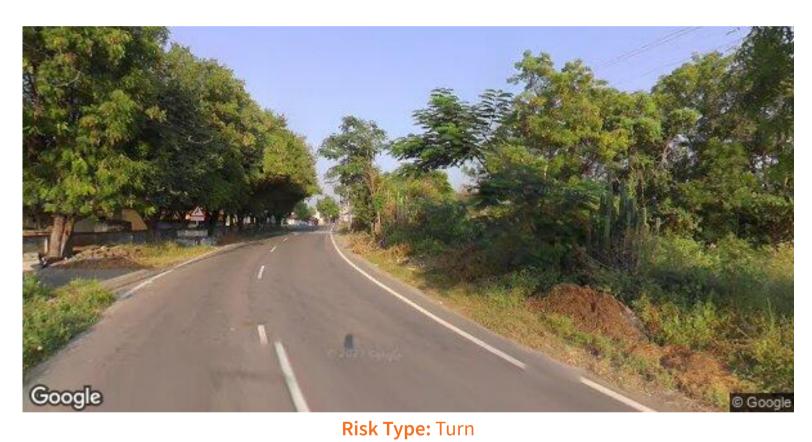
Risk Level: High
Speed Limit: 15 KM/Hr
Coordinates: 11.23791, 76.99529

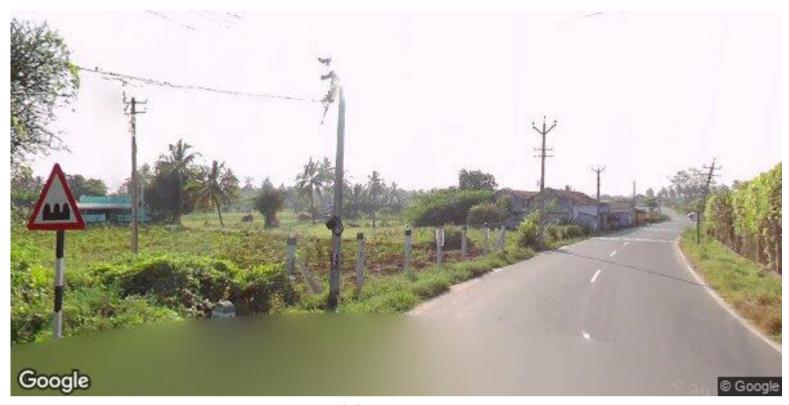
Coordinates: 11.23668, 76.99489

Risk Type: Turn
Risk Level: Medium
Speed Limit: 30 KM/Hr

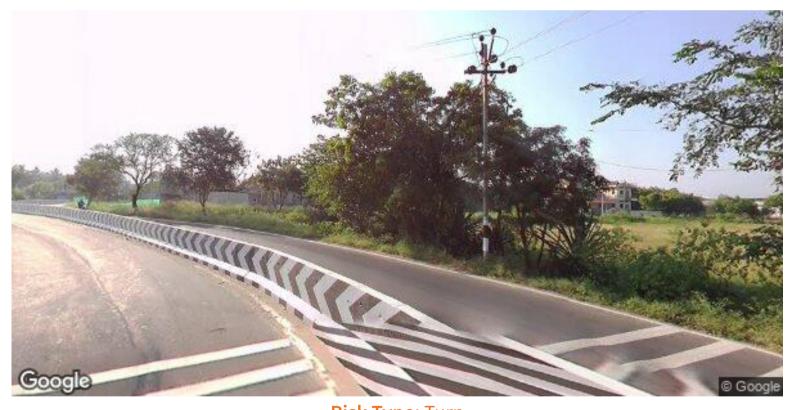
Risk Type: Turn
Risk Level: Medium
Speed Limit: 30 KM/Hr
Coordinates: 11.23685, 76.98811

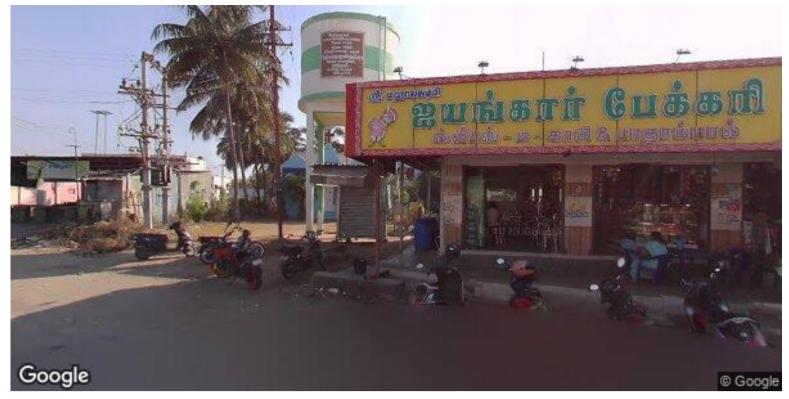
Risk Type: Turn
Risk Level: Medium
Speed Limit: 30 KM/Hr
Coordinates: 11.23511, 76.97752

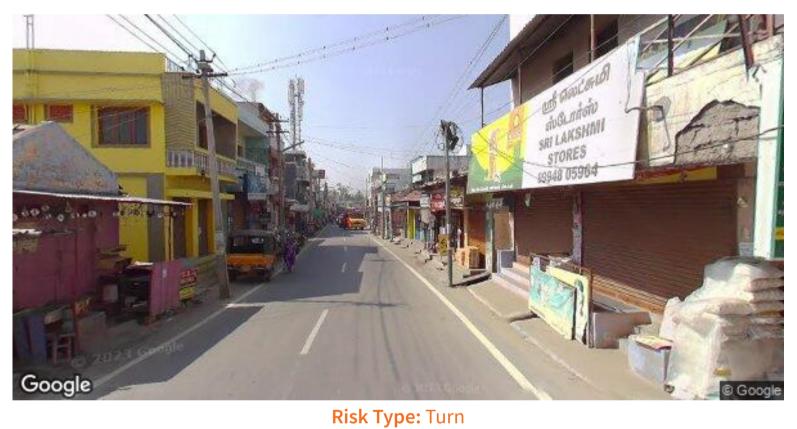
Risk Level: Medium
Speed Limit: 30 KM/Hr
Coordinates: 11.24041, 76.96162

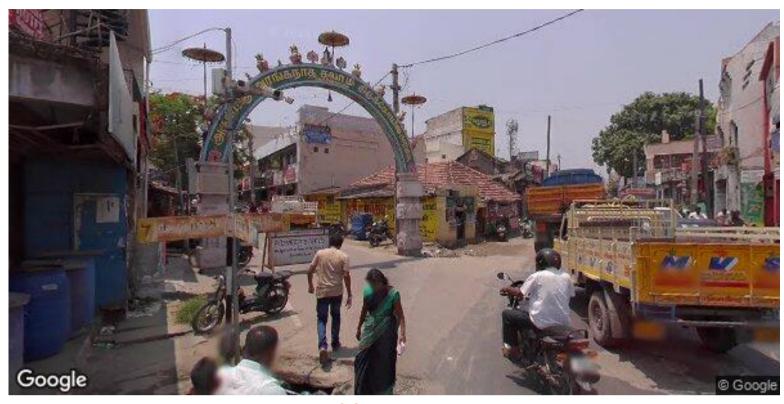
Risk Type: Turn
Risk Level: High
Speed Limit: 15 KM/Hr
Coordinates: 11.24280, 76.95869

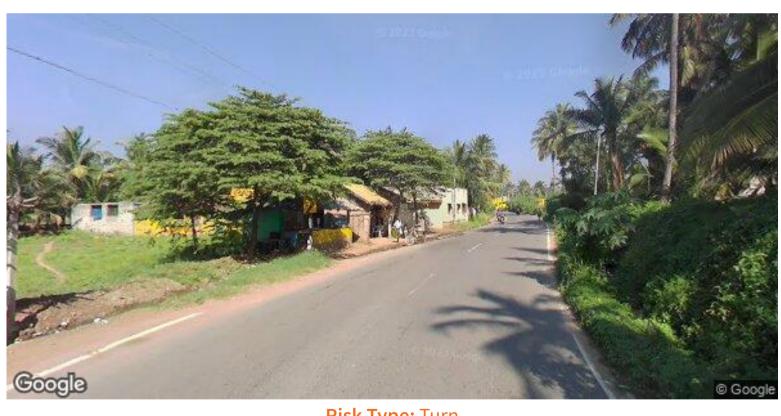
Risk Type: Turn
Risk Level: Medium
Speed Limit: 30 KM/Hr
Coordinates: 11.22018, 76.88621

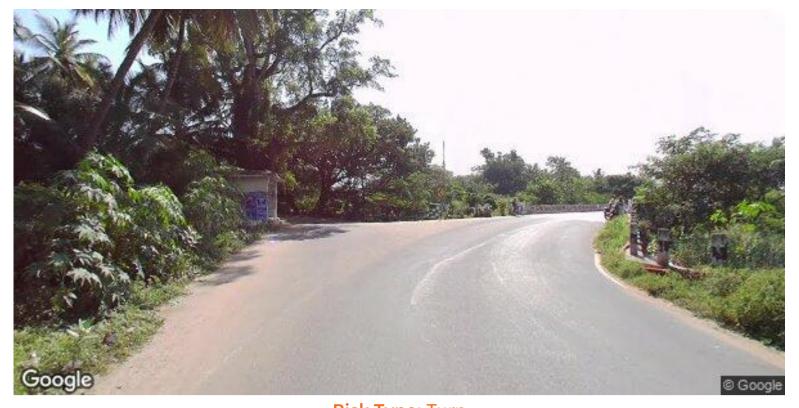
Risk Type: Turn
Risk Level: Medium
Speed Limit: 30 KM/Hr
Coordinates: 11.21975, 76.88588

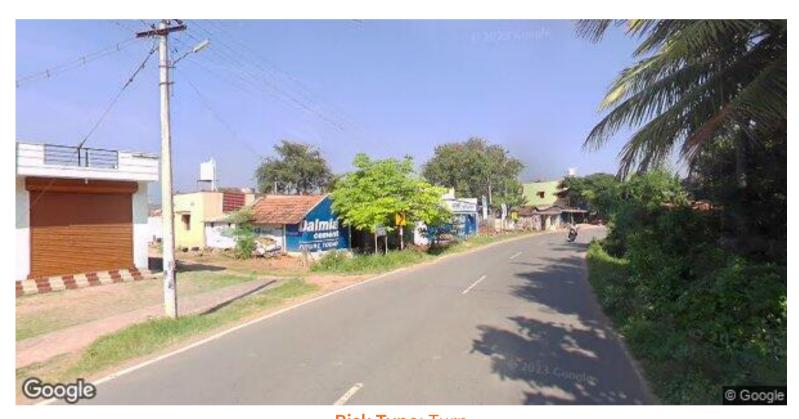
Risk Type: Turn
Risk Level: Medium
Speed Limit: 30 KM/Hr
Coordinates: 11.21903, 76.88284

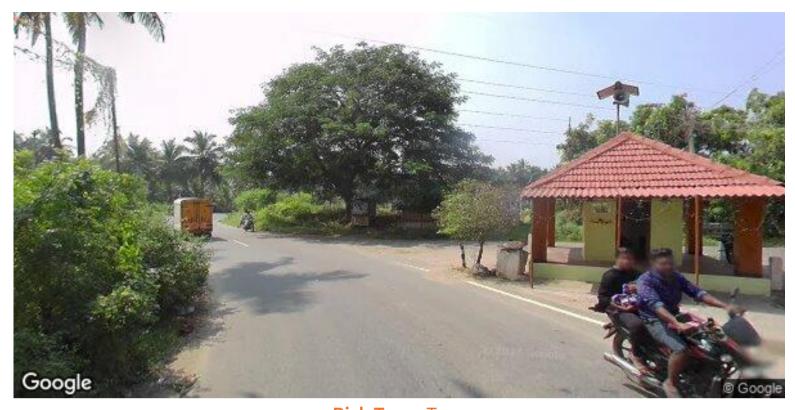
Risk Type: Turn
Risk Level: High
Speed Limit: 15 KM/Hr
Coordinates: 11.21340, 76.87481

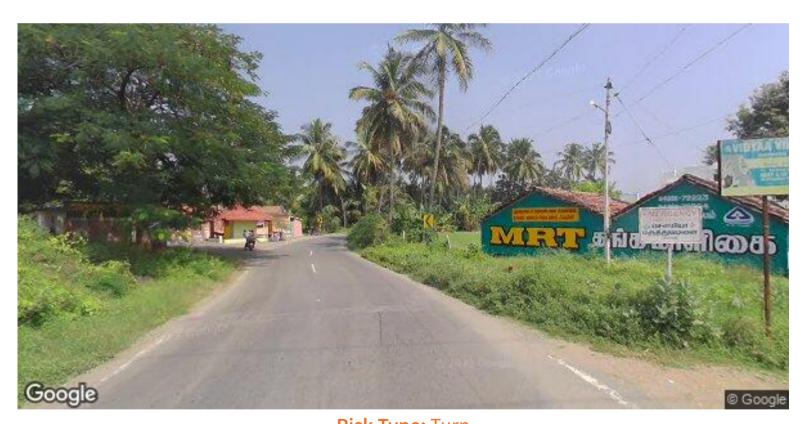
Risk Type: Turn
Risk Level: Medium
Speed Limit: 30 KM/Hr
Coordinates: 11.21304, 76.87461

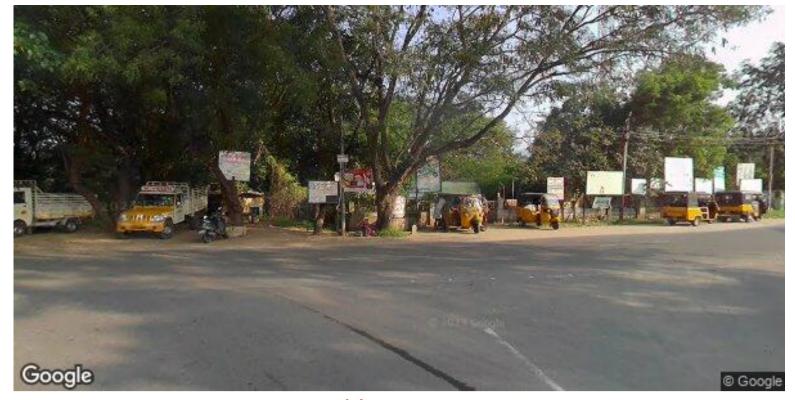
Risk Type: Turn
Risk Level: Medium
Speed Limit: 30 KM/Hr
Coordinates: 11.21061, 76.87074

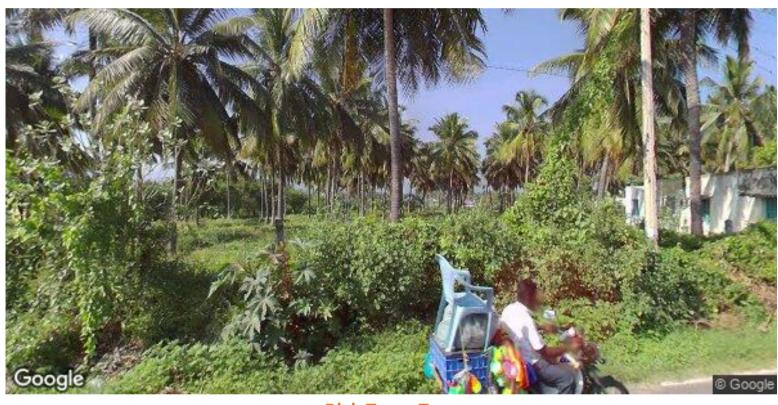
Coordinates: 11.20868, 76.86949

Risk Type: Turn
Risk Level: High
Speed Limit: 15 KM/Hr
