JOURNEY RISK MANAGEMENT (JRM) STUDY

Salem Terminal to SRI VENKATESHWARA AGENCIES

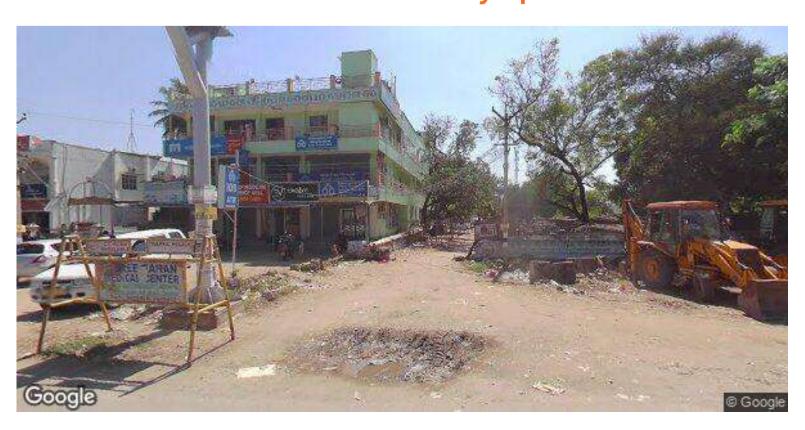
Coordinates: 11.2075731, 77.36051979999999

Risk Type: U-Turn
Risk Level: High
Speed Limit: 10 KM/Hr

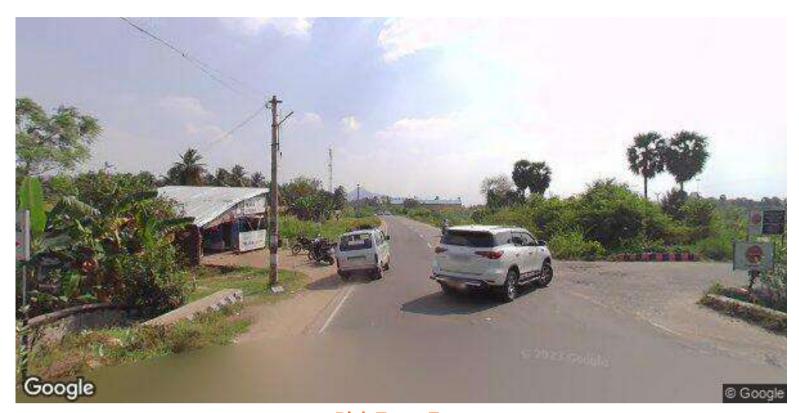
Coordinates: 11.44029, 77.87544

Risk Type: Turn
Risk Level: High
Speed Limit: 15 KM/Hr

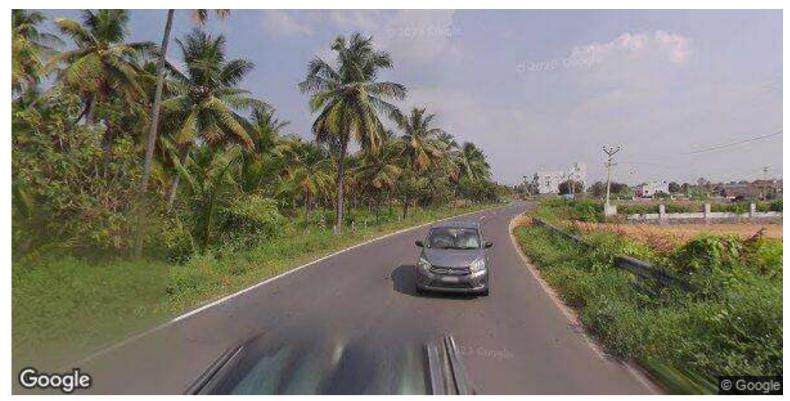
Coordinates: 11.45357, 77.85789

Risk Type: Turn
Risk Level: Medium
Speed Limit: 30 KM/Hr

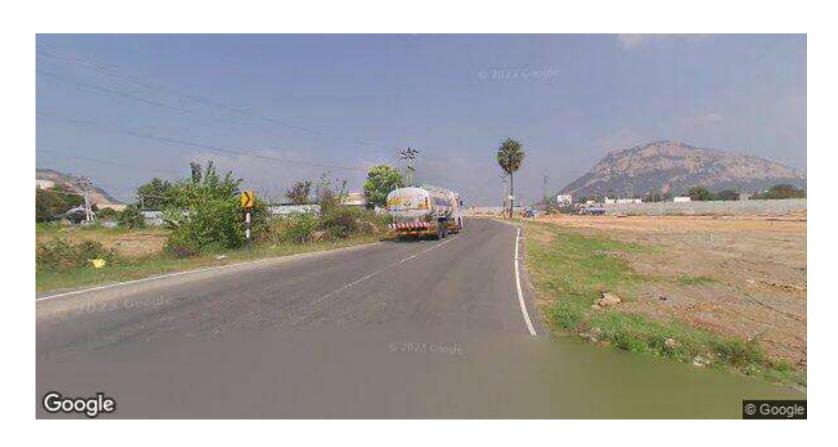
Coordinates: 11.45847, 77.85140

Risk Type: Turn
Risk Level: Medium
Speed Limit: 30 KM/Hr

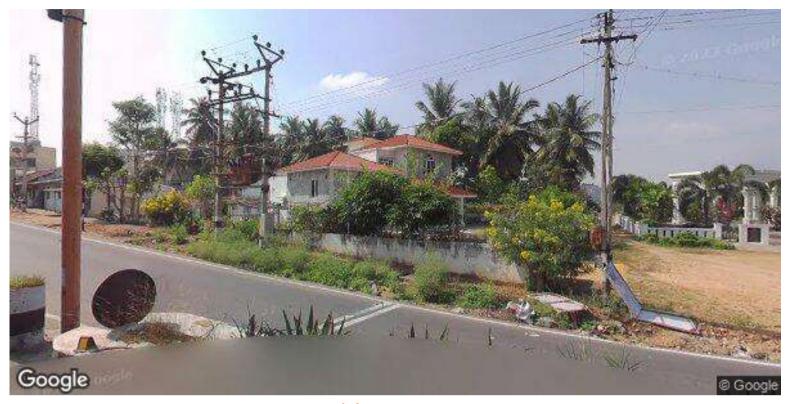
Coordinates: 11.46303, 77.84945

Risk Type: Turn
Risk Level: Medium
Speed Limit: 30 KM/Hr

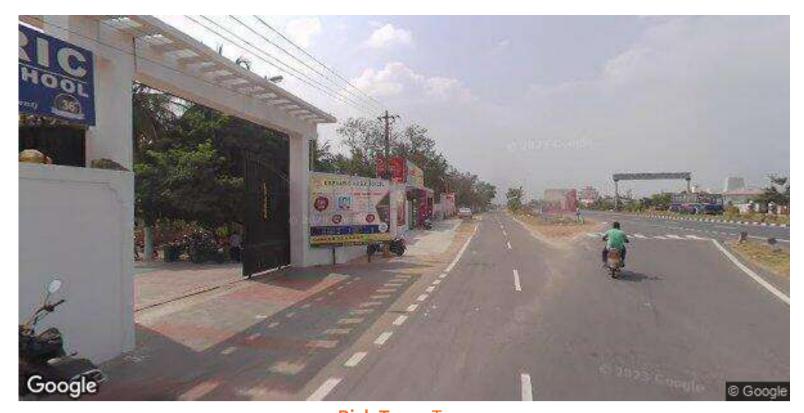
Risk Type: Turn
Risk Level: Medium
Speed Limit: 30 KM/Hr
Coordinates: 11.45509, 77.81383

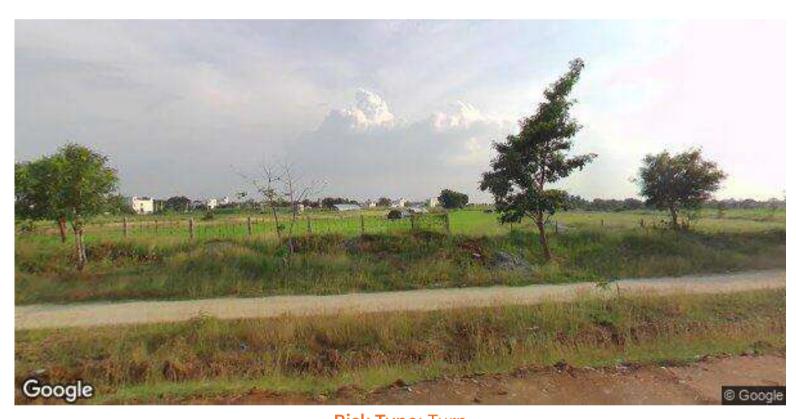
Risk Type: Turn
Risk Level: Medium
Speed Limit: 30 KM/Hr
Coordinates: 11.29288, 77.59029

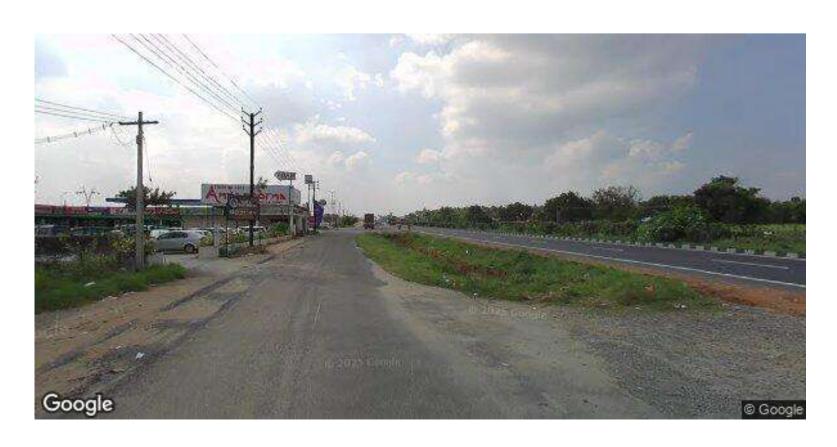
Coordinates: 11.29140, 77.58253

Risk Type: Turn
Risk Level: Medium
Speed Limit: 30 KM/Hr

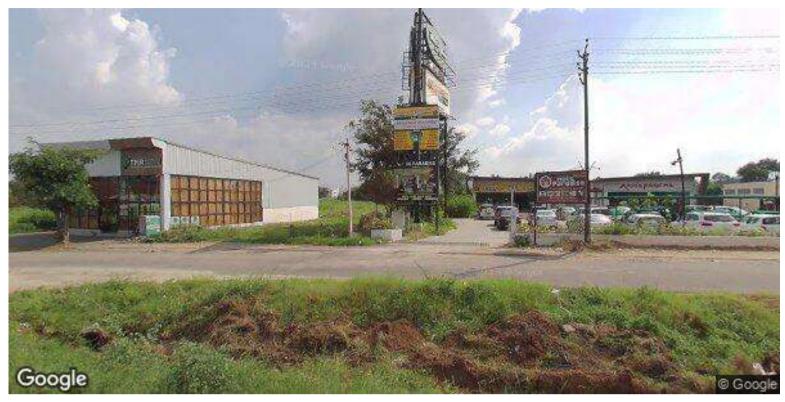
Risk Type: Turn
Risk Level: Medium
Speed Limit: 30 KM/Hr
Coordinates: 11.29154, 77.58236

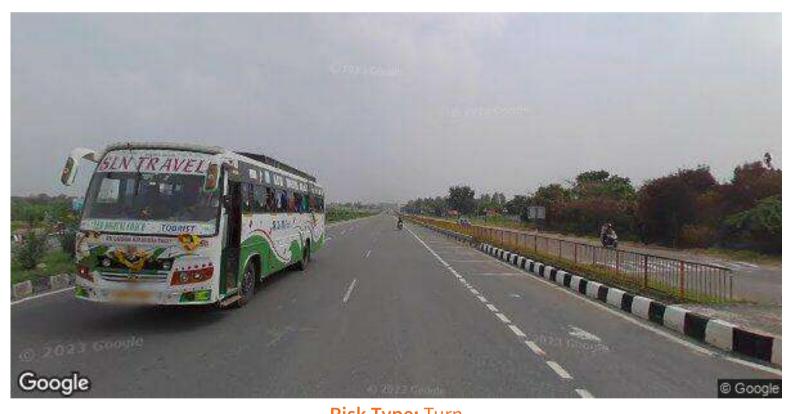
Risk Type: Turn
Risk Level: Medium
Speed Limit: 30 KM/Hr
Coordinates: 11.20682, 77.37703

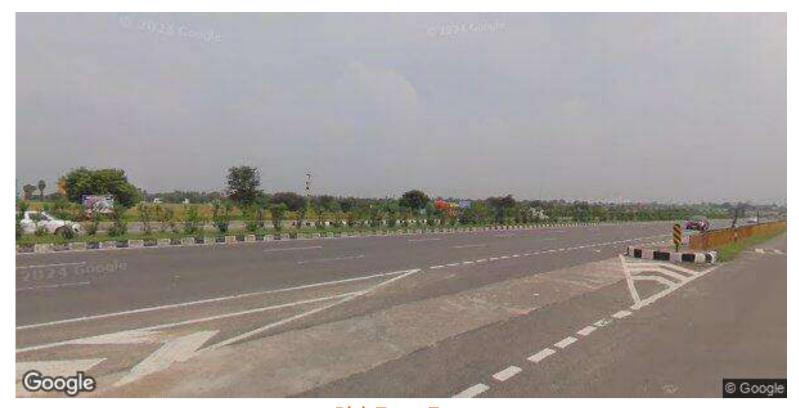
Risk Type: Turn
Risk Level: Medium
Speed Limit: 30 KM/Hr
Coordinates: 11.20668, 77.37686

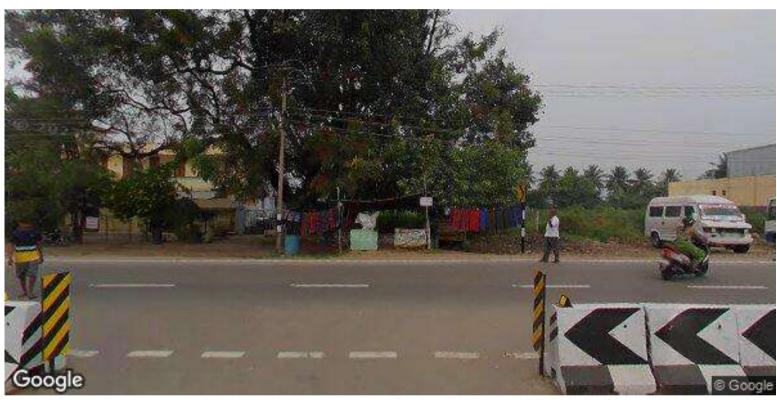
Coordinates: 11.20758, 77.36054

Risk Type: Blind Spot
Risk Level: Blind Spot
Speed Limit: 10 KM/Hr
