# JOURNEY RISK MANAGEMENT (JRM) STUDY

## IOCL Coimbatore Terminal to SUBHANITHI AGENCIES

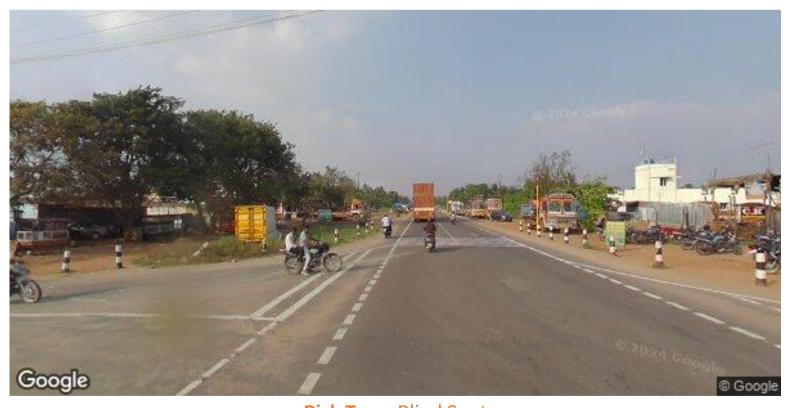
**Coordinates:** 11.03211, 77.07640

Risk Type: Blind Spot
Risk Level: Blind Spot
Speed Limit: 10 KM/Hr

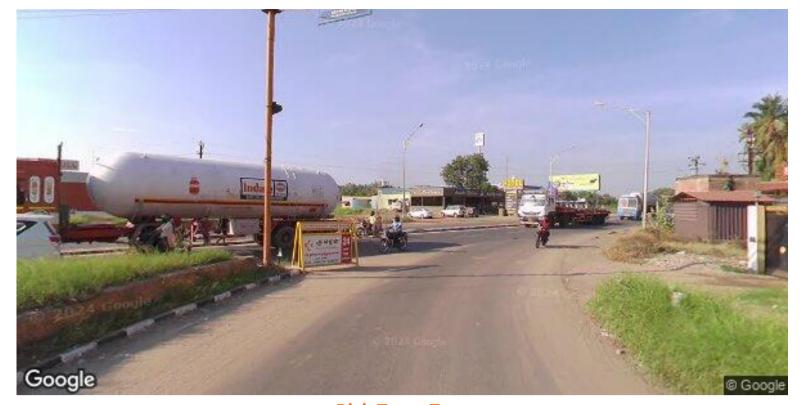
Risk Type: Turn
Risk Level: Medium
Speed Limit: 30 KM/Hr
Coordinates: 11.00787, 77.07082

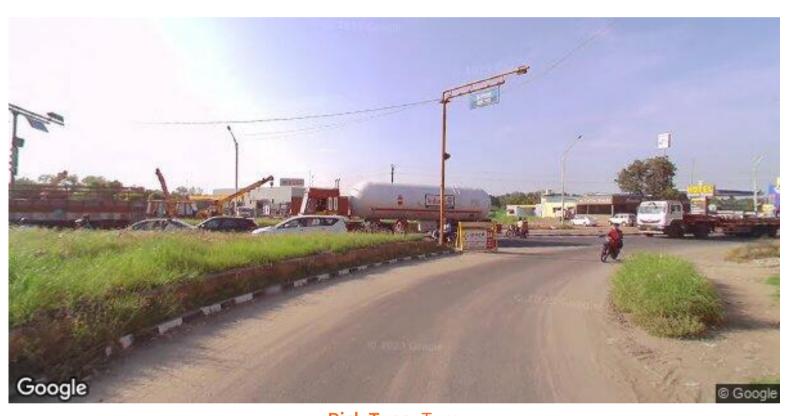
Risk Type: Turn
Risk Level: High
Speed Limit: 15 KM/Hr
Coordinates: 11.00778, 77.07085

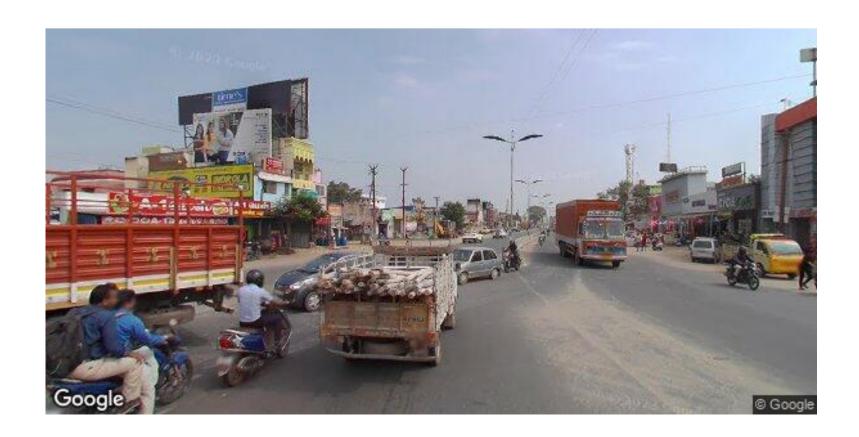
**Coordinates:** 11.02774, 77.12761

Risk Type: Turn
Risk Level: Medium
Speed Limit: 30 KM/Hr

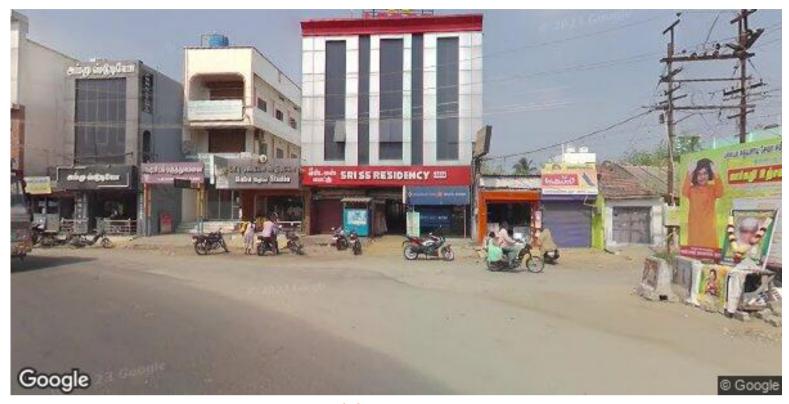
Risk Type: Turn
Risk Level: Medium
Speed Limit: 30 KM/Hr
Coordinates: 10.99557, 77.28171

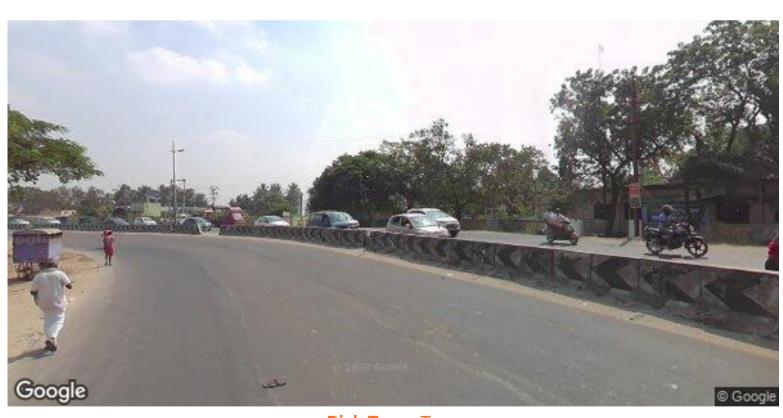
Risk Type: Turn
Risk Level: Medium
Speed Limit: 30 KM/Hr
Coordinates: 10.99436, 77.28183

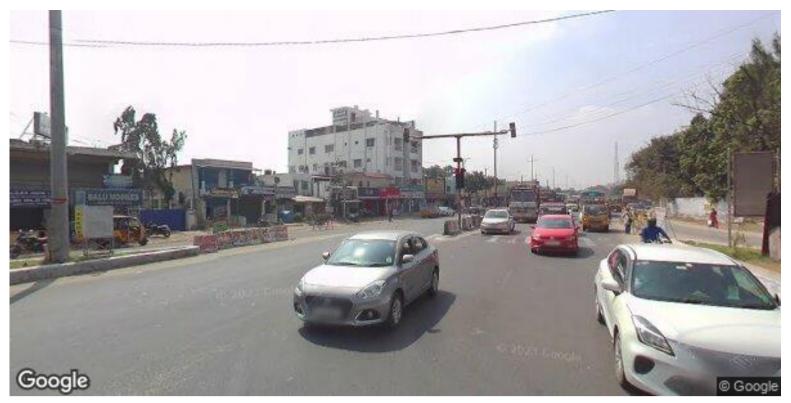
Risk Type: Turn
Risk Level: High
Speed Limit: 15 KM/Hr
Coordinates: 10.99400, 77.28557

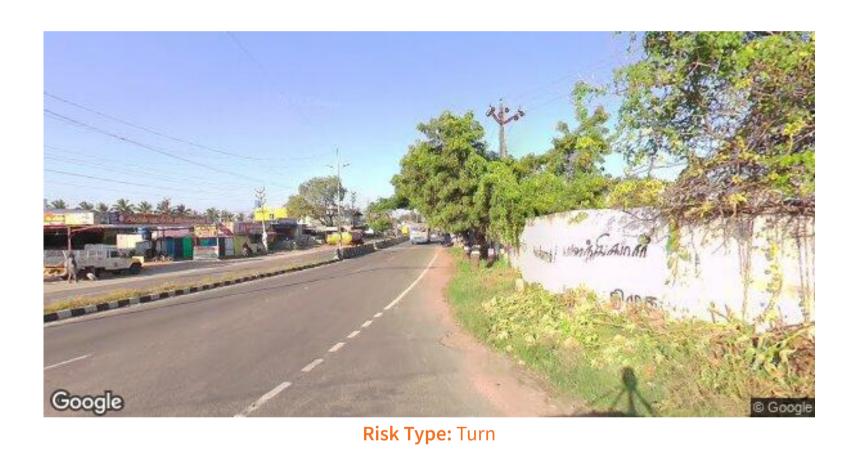
Speed Limit: 30 KM/Hr Coordinates: 10.98116, 77.27933

Risk Level: Medium

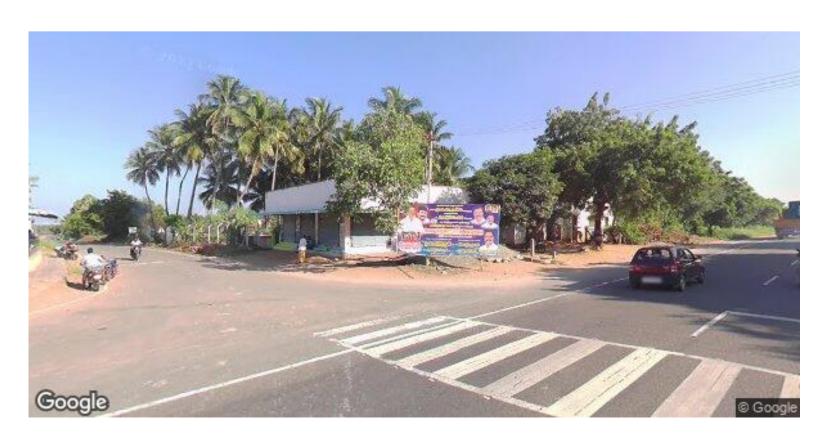
**Coordinates:** 10.72904, 77.28051

Risk Type: Blind Spot Risk Level: Blind Spot Speed Limit: 10 KM/Hr

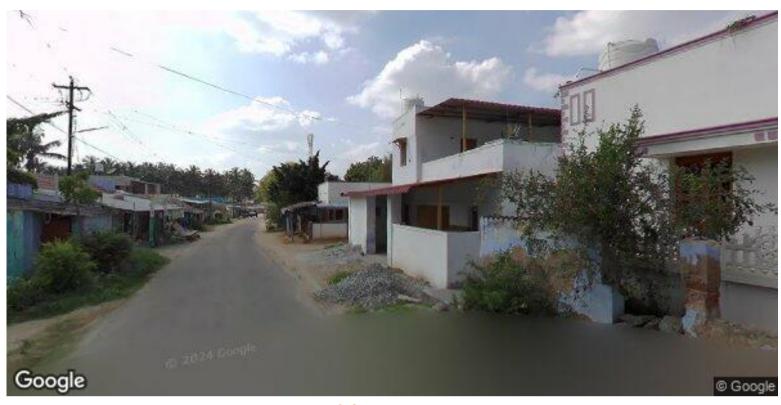
**Coordinates:** 10.73958, 77.31080

Risk Type: Turn
Risk Level: High
Speed Limit: 15 KM/Hr
