# JOURNEY RISK MANAGEMENT (JRM) STUDY

# **Salem Terminal to CHERAN PETROLEUMS**

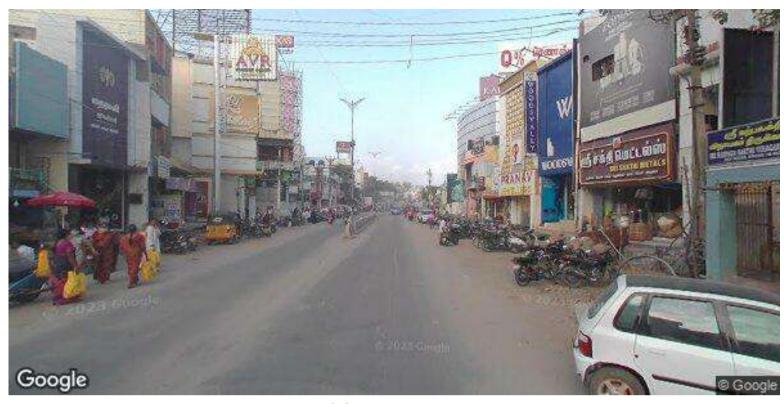
**Coordinates:** 11.3453211, 77.7304652

Risk Type: U-Turn
Risk Level: High
Speed Limit: 10 KM/Hr

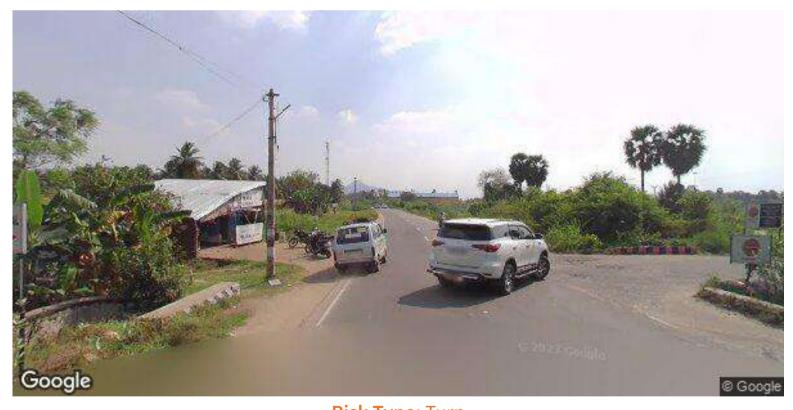
Risk Type: Turn
Risk Level: High
Speed Limit: 15 KM/Hr
Coordinates: 11.44029, 77.87544

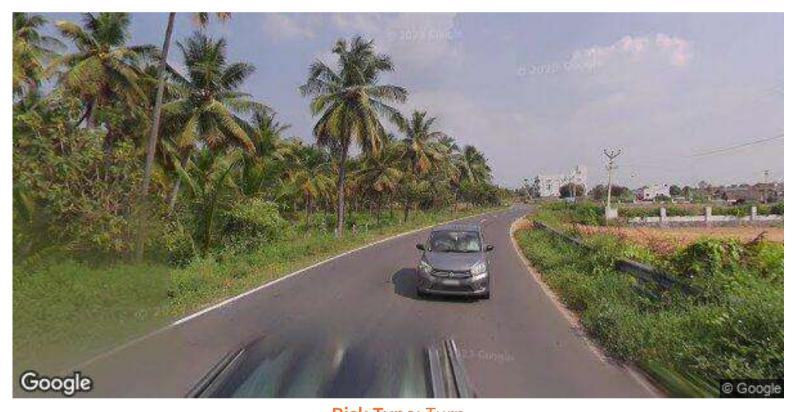
Risk Type: Turn
Risk Level: Medium
Speed Limit: 30 KM/Hr
Coordinates: 11.45357, 77.85789

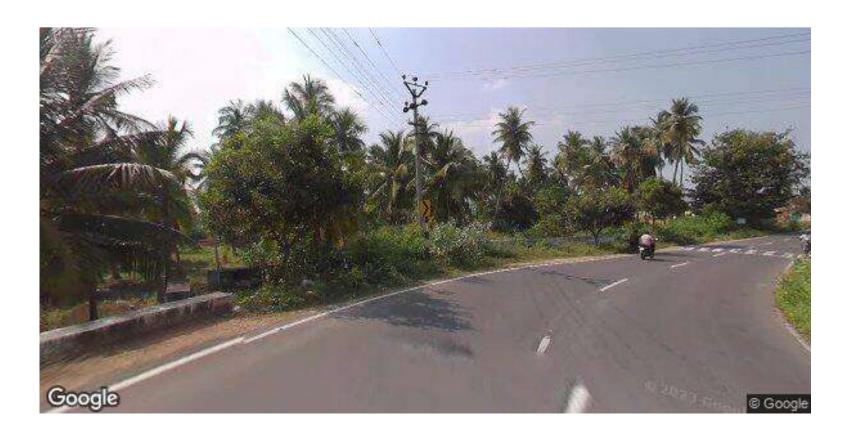
**Coordinates:** 11.45348, 77.85706

Risk Type: Turn
Risk Level: Medium
Speed Limit: 30 KM/Hr

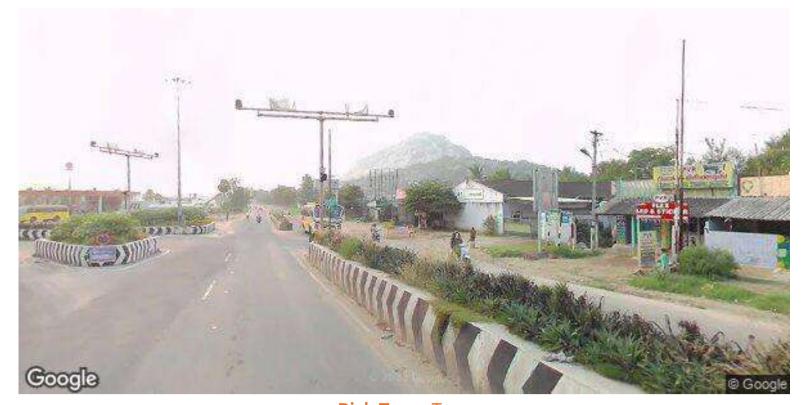
Risk Type: Turn
Risk Level: Medium
Speed Limit: 30 KM/Hr
Coordinates: 11.46312, 77.84886

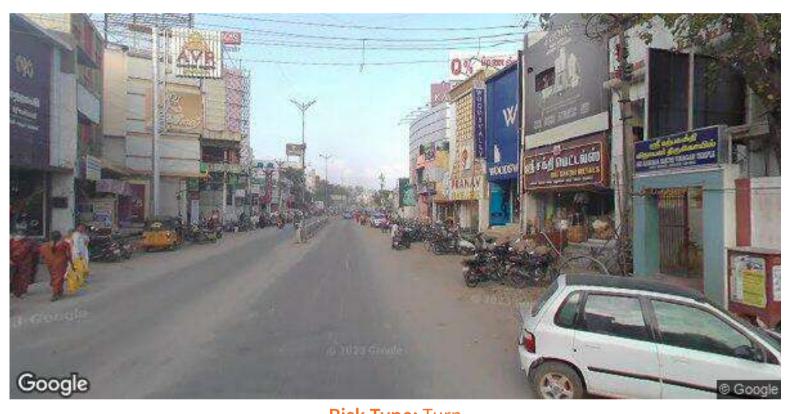
Risk Type: Turn
Risk Level: High
Speed Limit: 15 KM/Hr
Coordinates: 11.34532, 77.73047

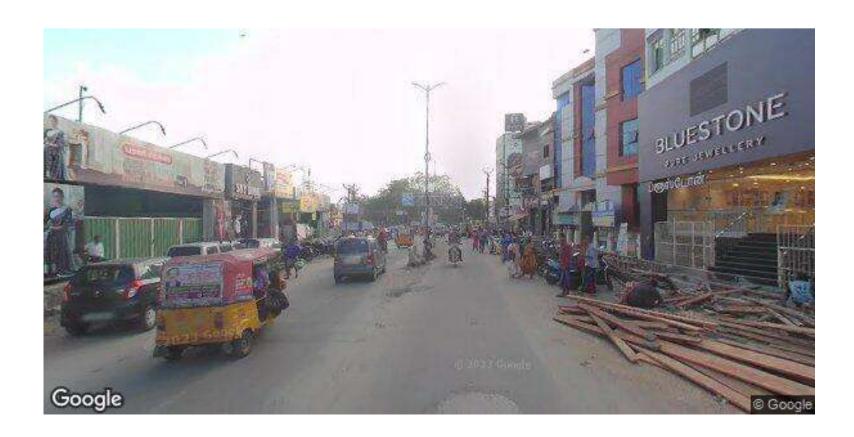
**Coordinates:** 11.34535, 77.73036

Risk Type: Blind Spot Risk Level: Blind Spot Speed Limit: 10 KM/Hr

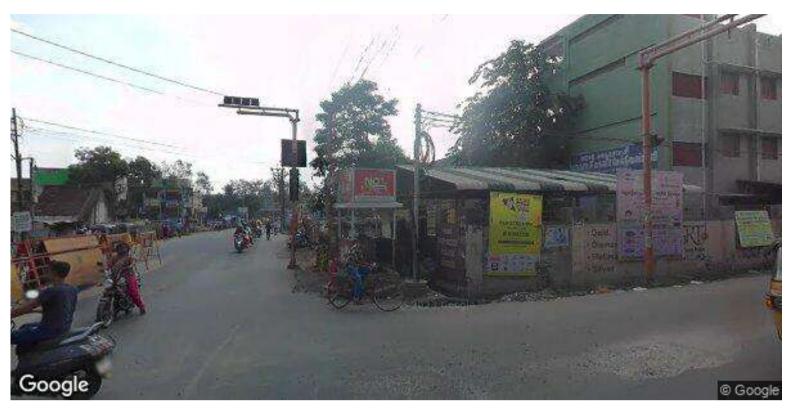
**Coordinates:** 11.34964, 77.73257

Risk Type: Blind Spot Risk Level: Blind Spot Speed Limit: 10 KM/Hr

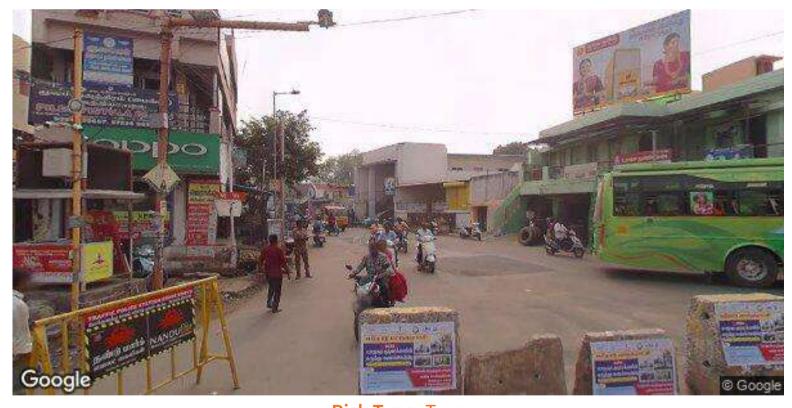
**Coordinates:** 11.35072, 77.72261

Risk Type: Turn
Risk Level: High
Speed Limit: 15 KM/Hr

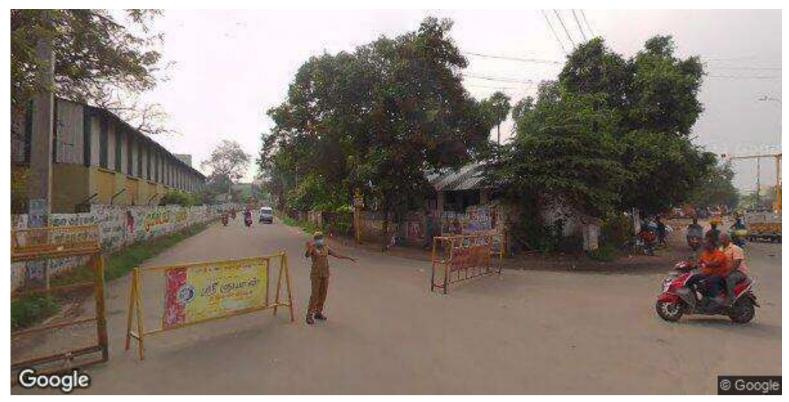
Risk Type: Turn
Risk Level: High
Speed Limit: 15 KM/Hr
Coordinates: 11.35306, 77.71961

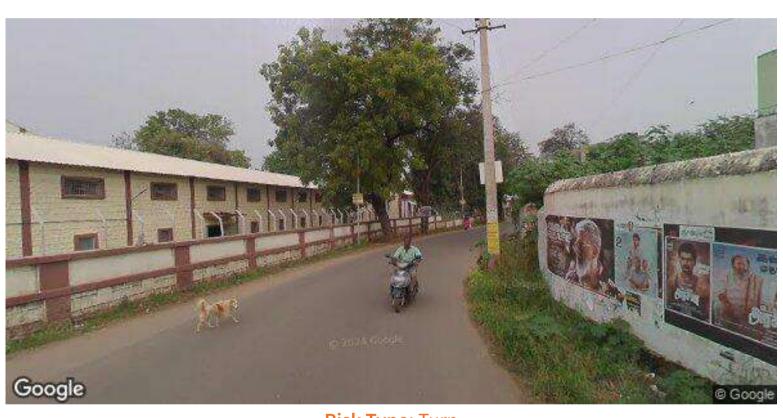
Risk Type: Turn
Risk Level: Medium
Speed Limit: 30 KM/Hr
Coordinates: 11.35269, 77.71811

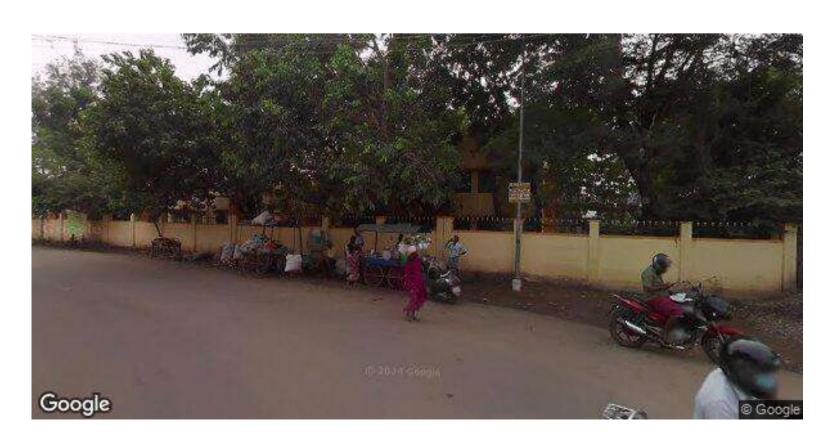
**Coordinates:** 11.35173, 77.71753

Risk Type: Turn
Risk Level: Medium
Speed Limit: 30 KM/Hr

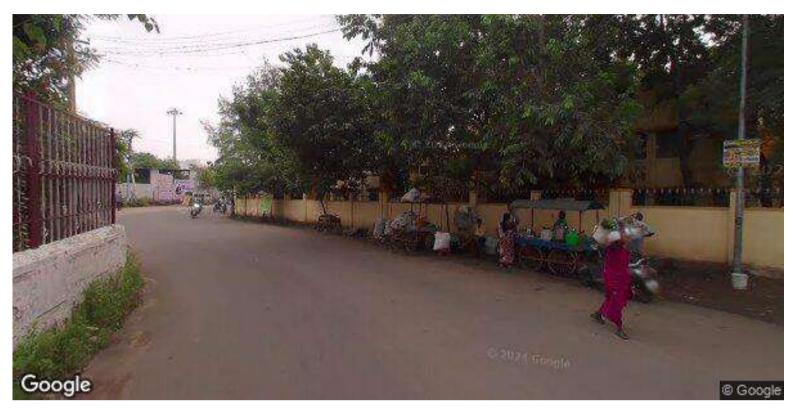
**Coordinates:** 11.35167, 77.71753

Risk Type: Turn
Risk Level: Medium
Speed Limit: 30 KM/Hr

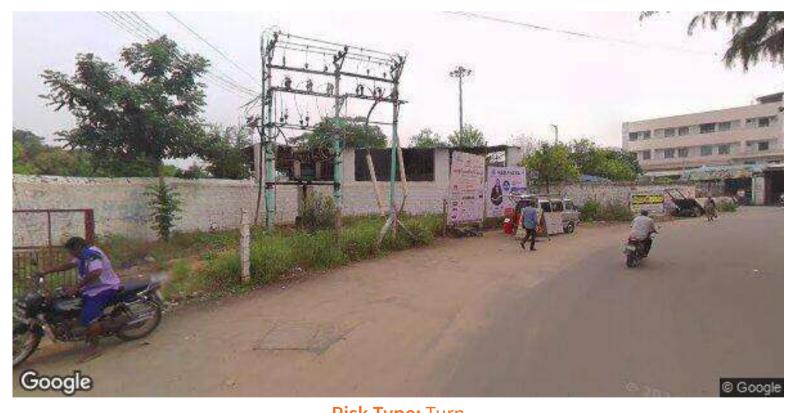
**Coordinates:** 11.35138, 77.71774

Risk Type: Turn
Risk Level: Medium
Speed Limit: 30 KM/Hr

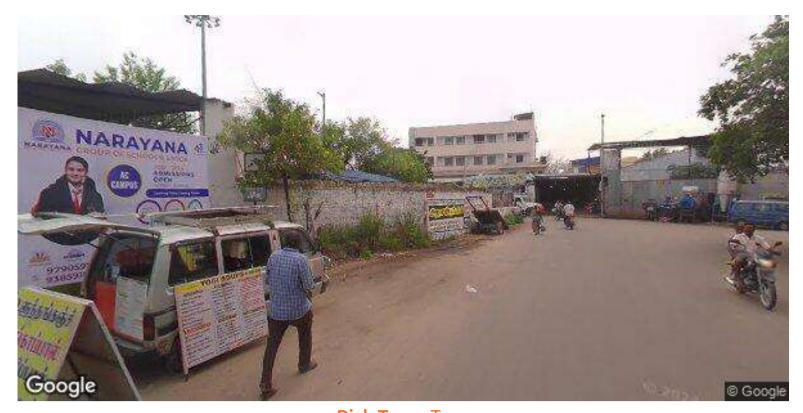
Risk Type: Turn
Risk Level: Medium
Speed Limit: 30 KM/Hr
Coordinates: 11.35129, 77.71775

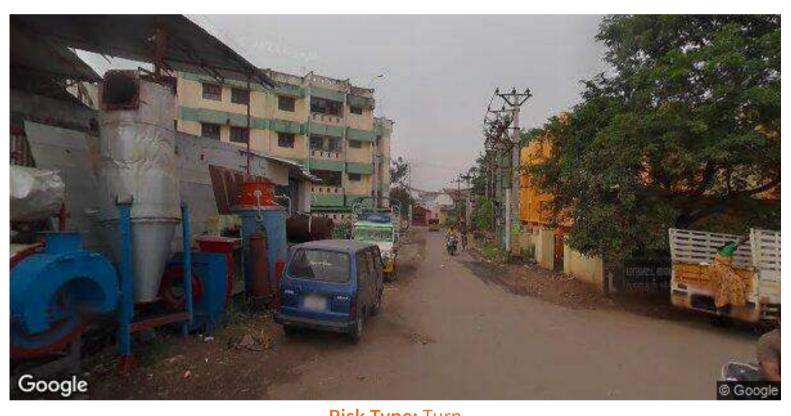
Risk Type: Turn
Risk Level: High
Speed Limit: 15 KM/Hr
Coordinates: 11.35101, 77.71764

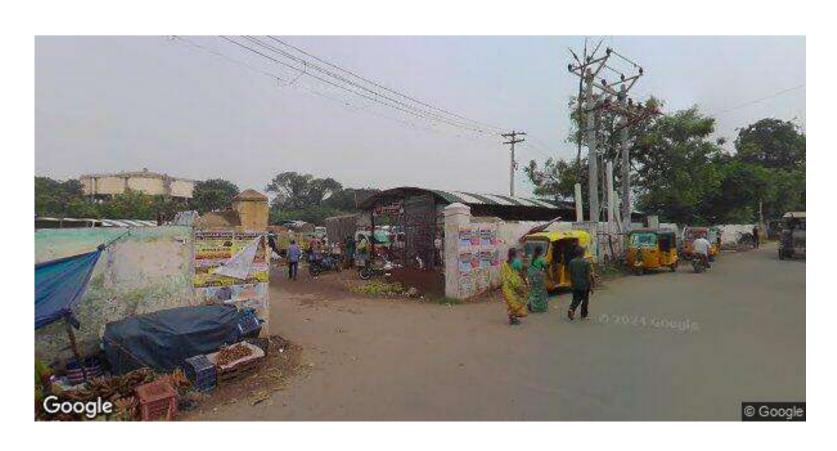
**Coordinates:** 11.35076, 77.71790

Risk Type: Turn
Risk Level: High
Speed Limit: 15 KM/Hr

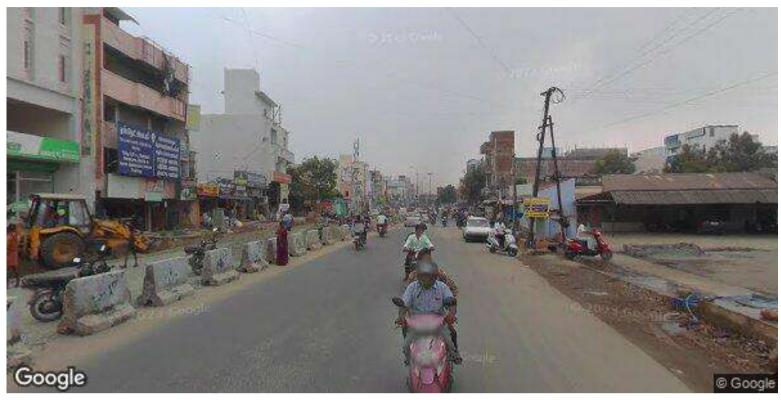
**Coordinates:** 11.34859, 77.71744

Risk Type: Turn
Risk Level: High
Speed Limit: 15 KM/Hr

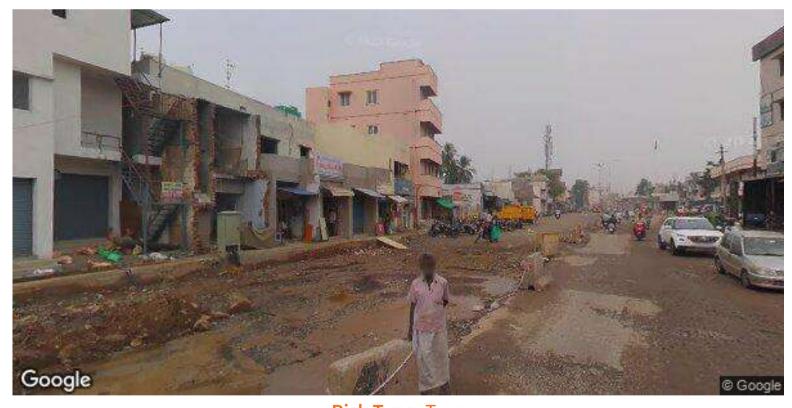
Risk Type: Turn
Risk Level: Medium
Speed Limit: 30 KM/Hr
Coordinates: 11.35250, 77.71083

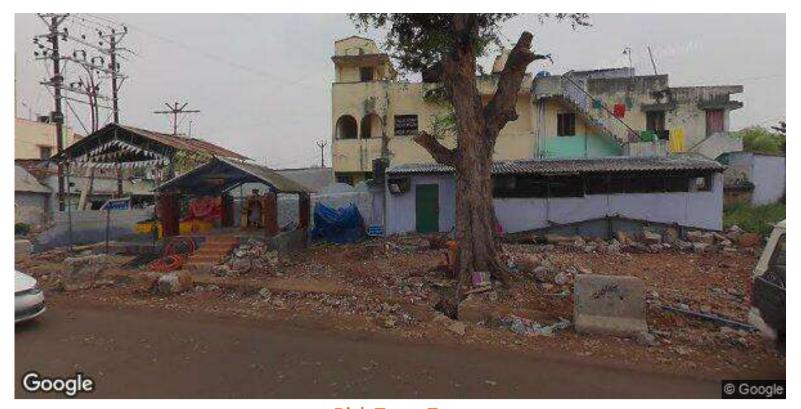
Risk Type: Turn
Risk Level: Medium
Speed Limit: 30 KM/Hr
Coordinates: 11.35249, 77.71072

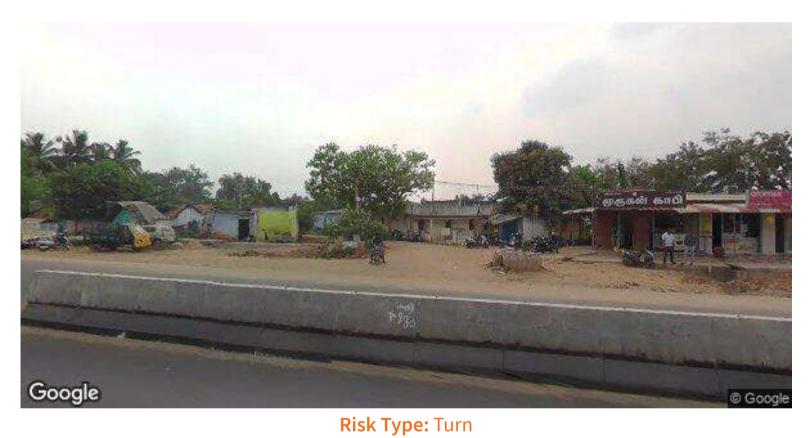
Risk Level: High
Speed Limit: 15 KM/Hr
Coordinates: 11.35664, 77.70582

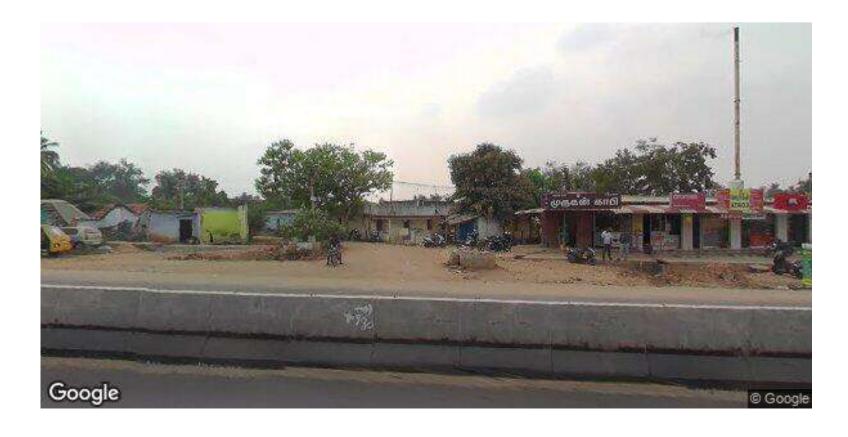
**Coordinates:** 11.35658, 77.70571

Risk Type: Turn
Risk Level: Medium
Speed Limit: 30 KM/Hr
