# JOURNEY RISK MANAGEMENT (JRM) STUDY

# Salem Terminal To SRI GANESH LATCHUMI TRADERS

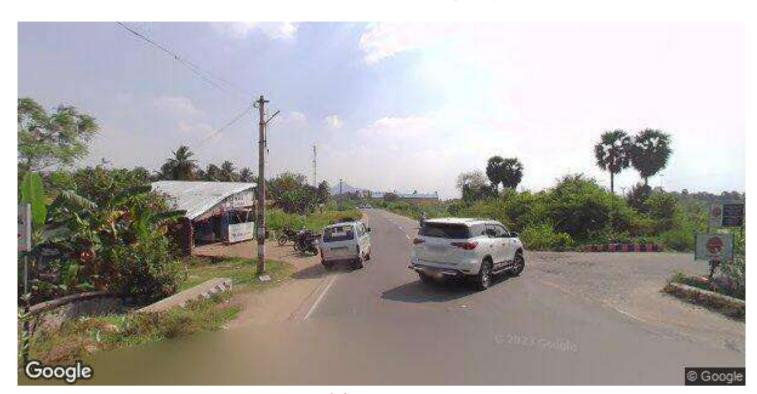
Risk Type: Turn
Risk Level: High
Speed Limit: 15 KM/Hr
Coordinates: 11.44029, 77.87544

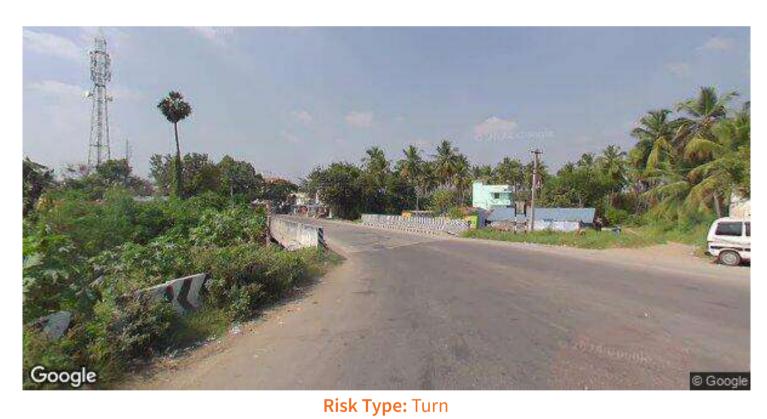
Risk Level: High
Speed Limit: 15 KM/Hr
Coordinates: 11.44893, 77.87413

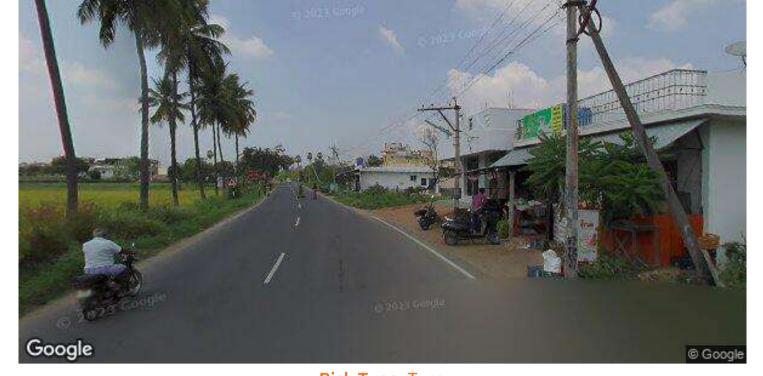
Risk Type: Turn
Risk Level: Medium
Speed Limit: 30 KM/Hr
Coordinates: 11.45127, 77.86734

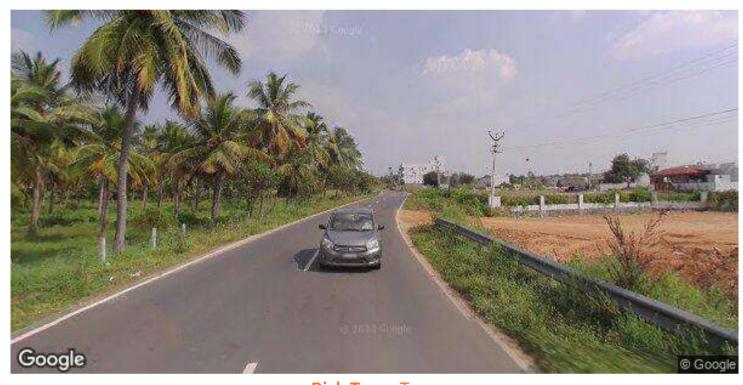
Risk Type: Turn
Risk Level: Medium
Speed Limit: 30 KM/Hr
Coordinates: 11.45354, 77.85798

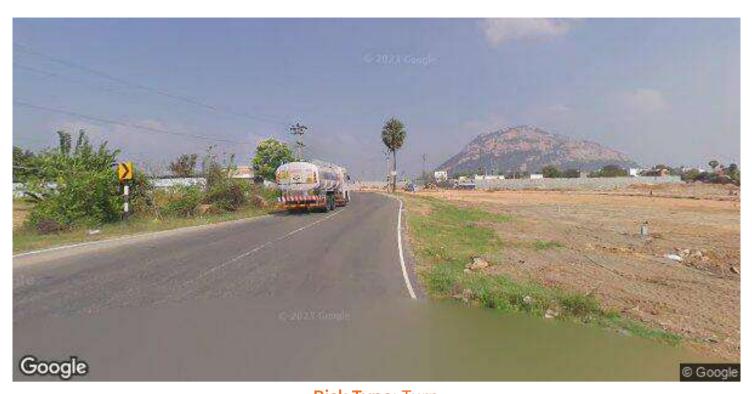
Risk Type: Turn
Risk Level: Medium
Speed Limit: 30 KM/Hr
Coordinates: 11.45845, 77.85141

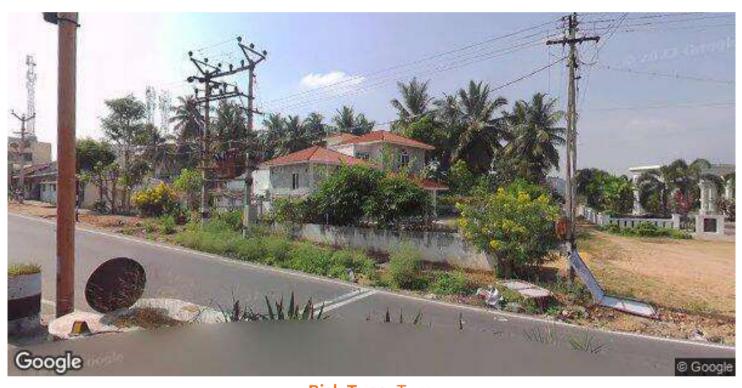
Risk Type: Turn
Risk Level: High
Speed Limit: 15 KM/Hr

**Coordinates:** 11.46303, 77.84945

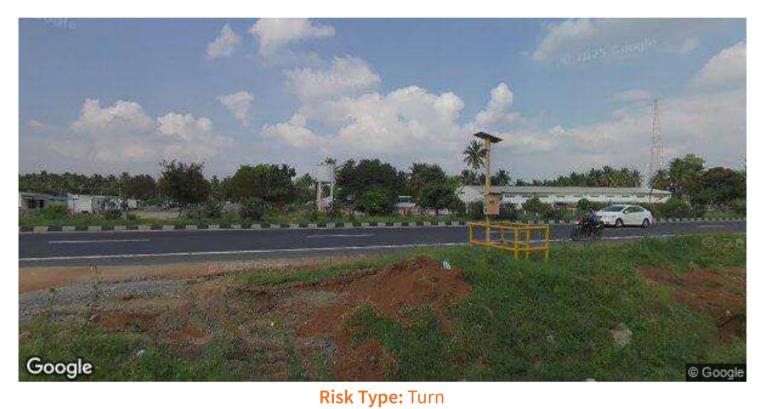
Risk Level: Medium
Speed Limit: 30 KM/Hr
Coordinates: 11.29141, 77.58266

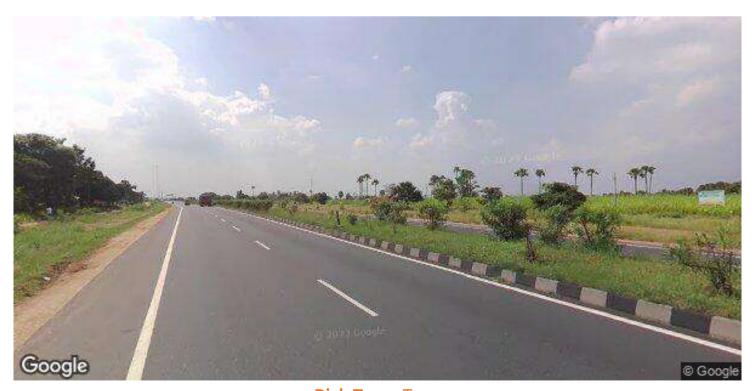
Risk Type: Turn
Risk Level: Medium

Speed Limit: 30 KM/Hr Coordinates: 11.29012, 77.56873

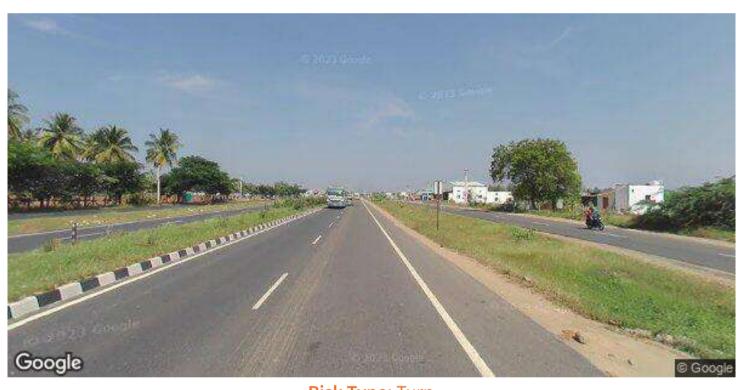
Risk Type: Turn
Risk Level: High
Speed Limit: 15 KM/Hr
Coordinates: 11.20358, 77.42732

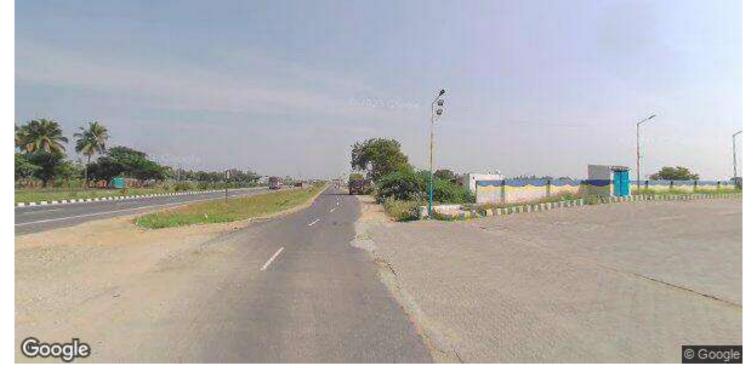
Risk Type: Turn
Risk Level: High
Speed Limit: 15 KM/Hr

**Coordinates:** 11.20335, 77.42730

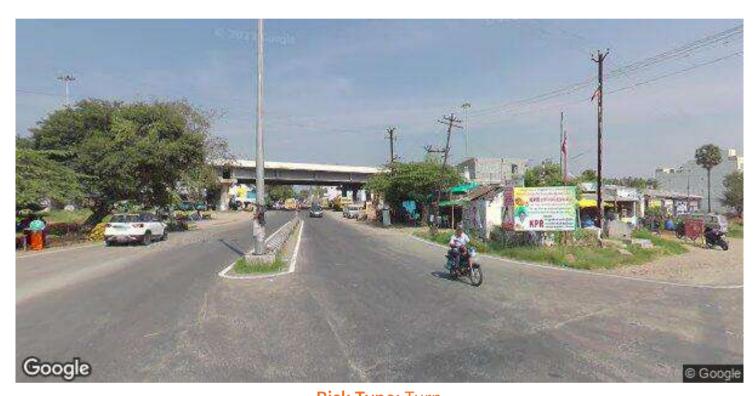
Risk Type: Turn
Risk Level: High
Speed Limit: 15 KM/Hr

**Coordinates:** 11.19962, 77.42240
