# JOURNEY RISK MANAGEMENT (JRM) STUDY

#### Salem Terminal ToSREE PARANI AGENCIES

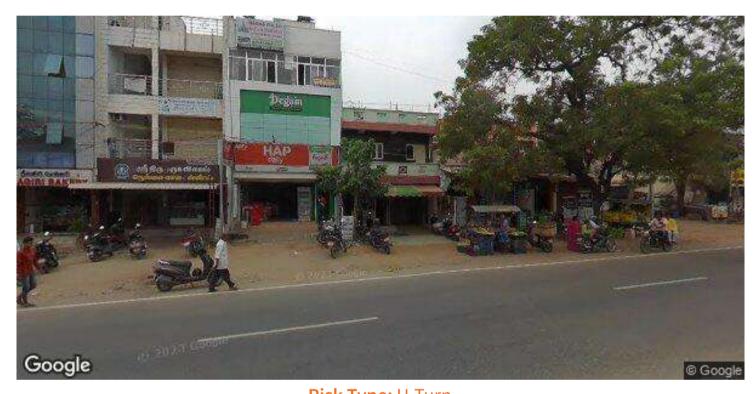
**Coordinates:** 11.1365755, 77.3224245

Risk Type: U-Turn
Risk Level: High
Speed Limit: 10 KM/Hr

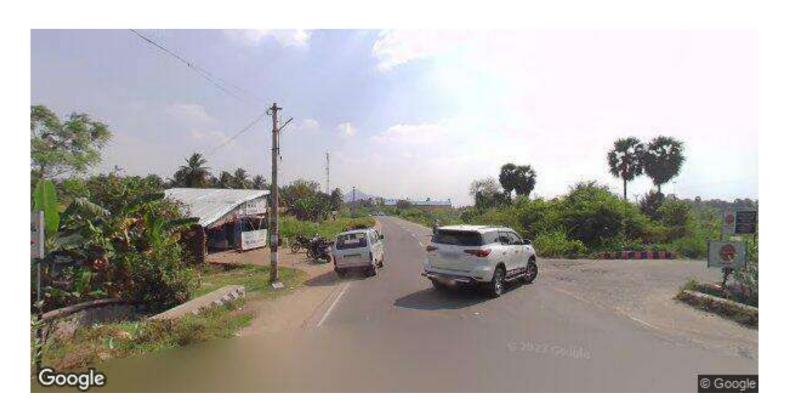
**Coordinates:** 11.44029, 77.87544

Risk Type: Turn
Risk Level: High
Speed Limit: 15 KM/Hr

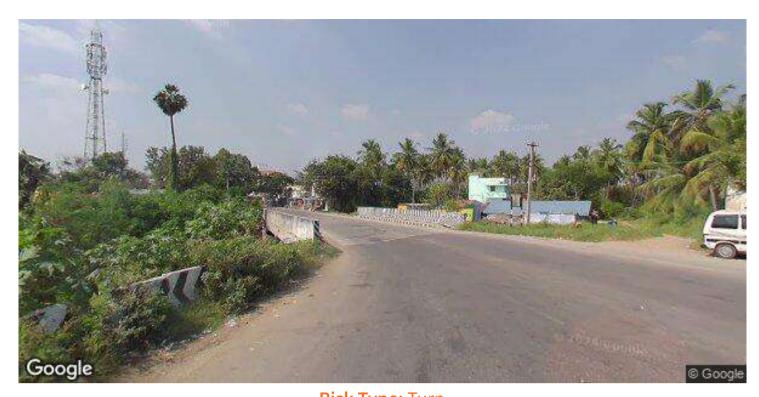
Risk Type: Turn
Risk Level: High
Speed Limit: 15 KM/Hr
Coordinates: 11.44893, 77.87413

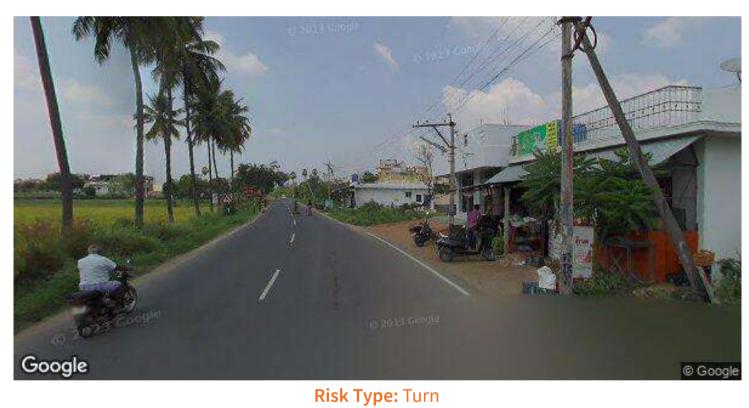
Risk Type: Turn
Risk Level: Medium
Speed Limit: 30 KM/Hr
Coordinates: 11.45127, 77.86734

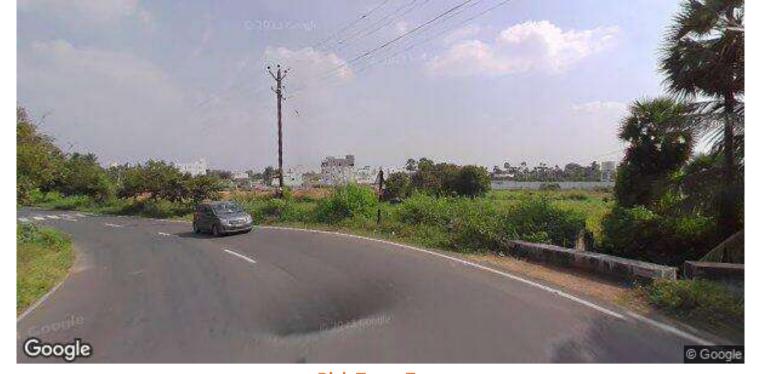
Risk Type: Turn
Risk Level: High
Speed Limit: 15 KM/Hr
Coordinates: 11.45350, 77.85700

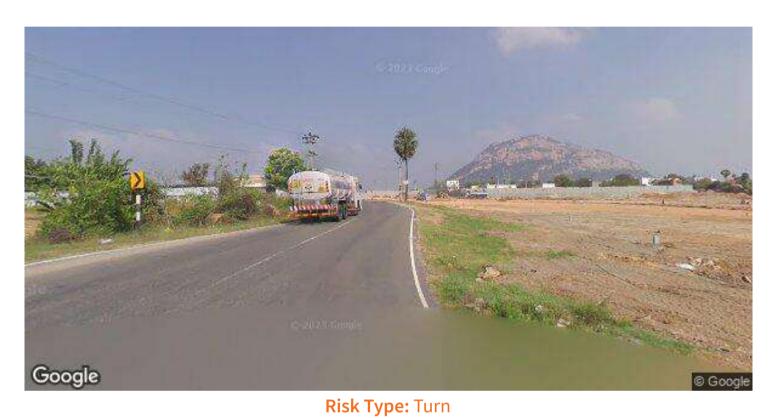
Risk Level: Medium
Speed Limit: 30 KM/Hr
Coordinates: 11.45845, 77.85141

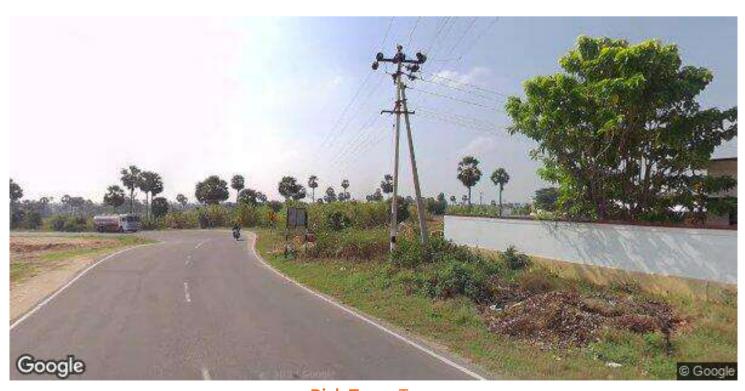
Risk Type: Turn
Risk Level: Medium

Speed Limit: 30 KM/Hr Coordinates: 11.45889, 77.85136

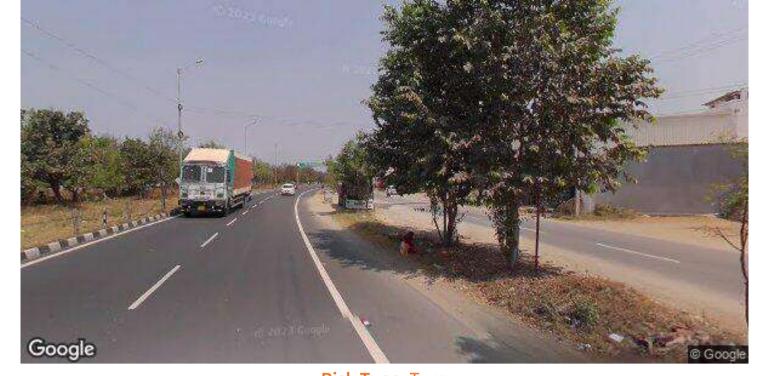
Risk Type: Turn
Risk Level: Medium
Speed Limit: 30 KM/Hr
Coordinates: 11.43175, 77.67757

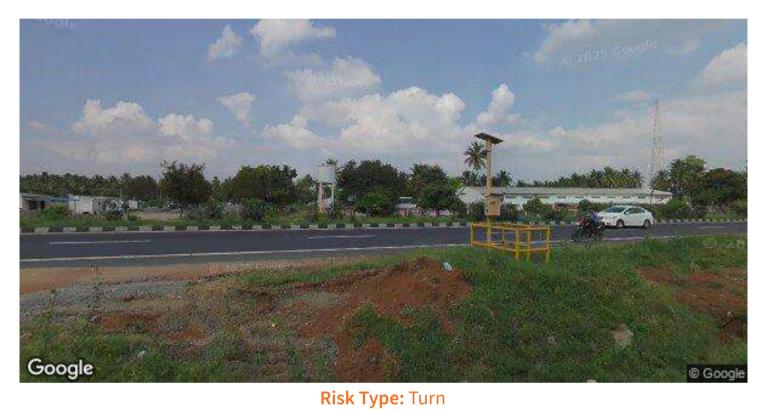
Risk Level: Medium
Speed Limit: 30 KM/Hr
Coordinates: 11.29141, 77.58266

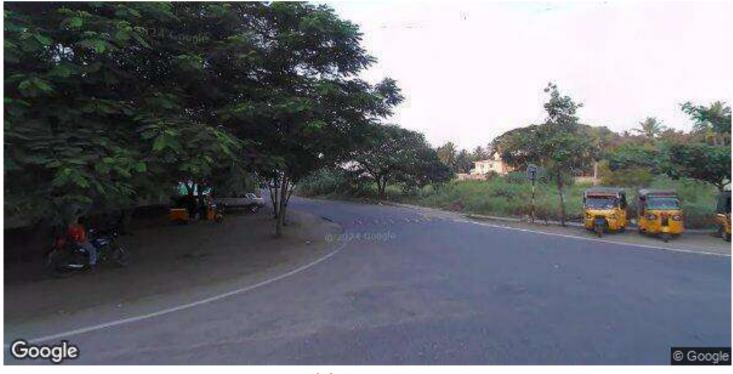
Risk Type: Turn Risk Level: High

Speed Limit: 15 KM/Hr Coordinates: 11.18267, 77.28532

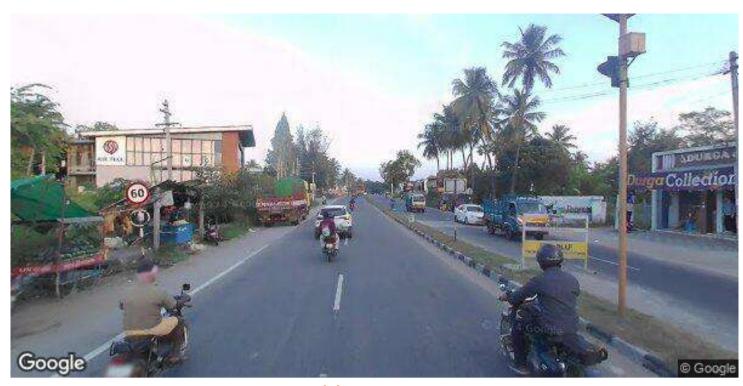
Risk Type: Turn
Risk Level: Medium
Speed Limit: 30 KM/Hr
Coordinates: 11.18242, 77.28553

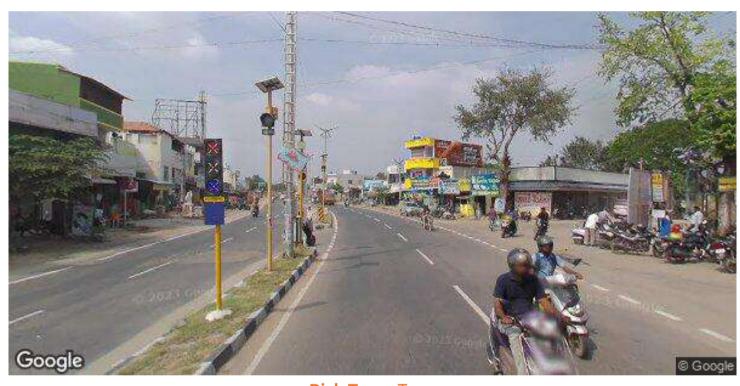
Risk Type: Turn
Risk Level: Medium
Speed Limit: 30 KM/Hr
Coordinates: 11.16527, 77.30700

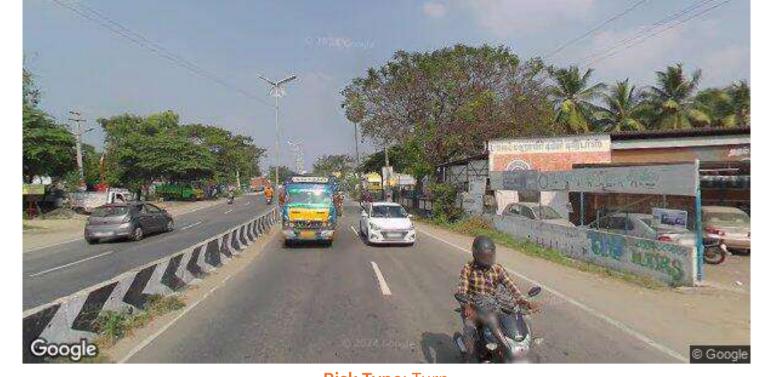
Risk Type: Turn
Risk Level: Medium
Speed Limit: 30 KM/Hr
Coordinates: 11.16093, 77.30955

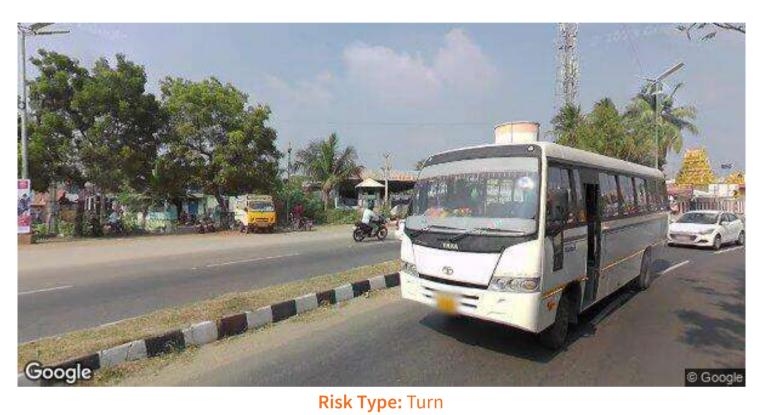
Risk Level: High
Speed Limit: 15 KM/Hr
Coordinates: 11.15180, 77.30889

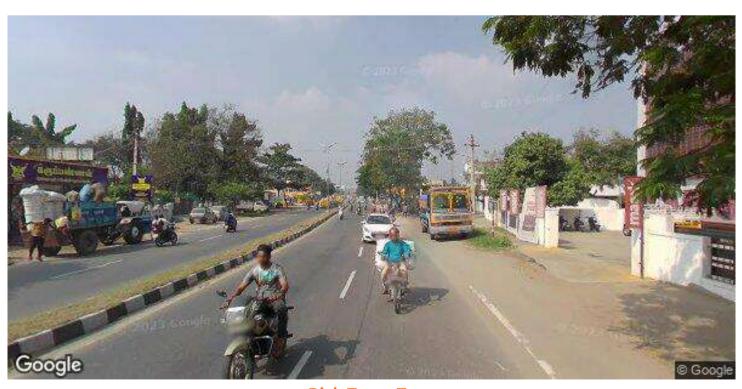
Risk Type: Turn
Risk Level: Medium

Speed Limit: 30 KM/Hr Coordinates: 11.15175, 77.31121

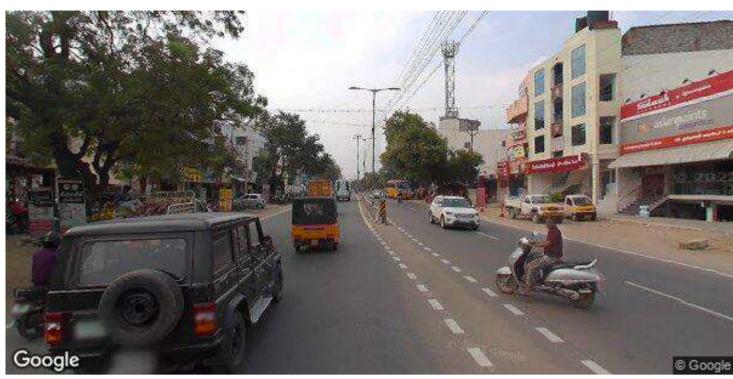
Risk Type: Blind Spot
Risk Level: Blind Spot
Speed Limit: 10 KM/Hr
Coordinates: 11.13653, 77.32237

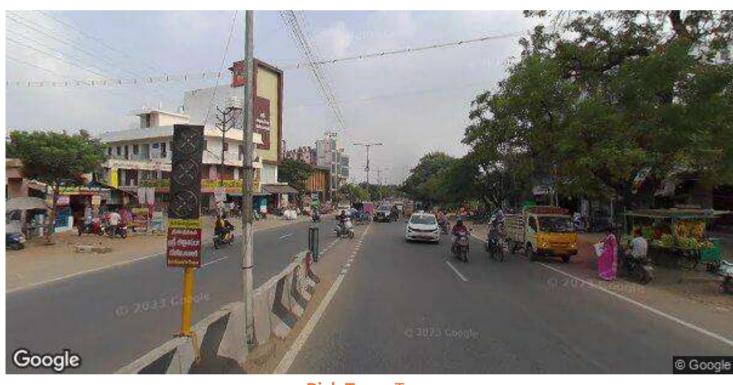
Risk Type: Turn
Risk Level: High
Speed Limit: 15 KM/Hr
Coordinates: 11.13664, 77.32220

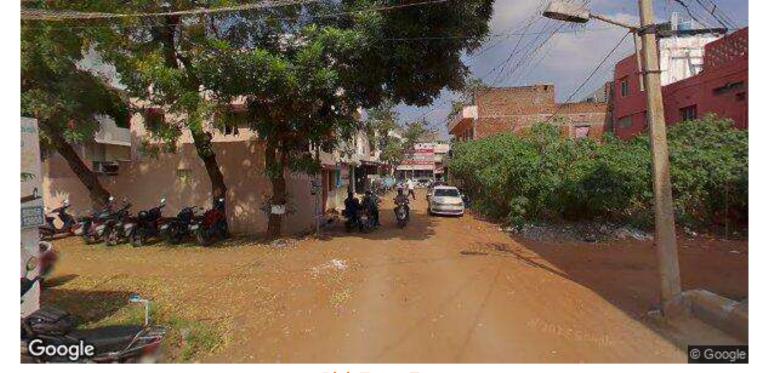
**Coordinates:** 11.13629, 77.32186

Risk Type: Turn
Risk Level: High
Speed Limit: 15 KM/Hr
