JOURNEY RISK MANAGEMENT (JRM) STUDY

IOCL Coimbatore Terminal to Royal Agency

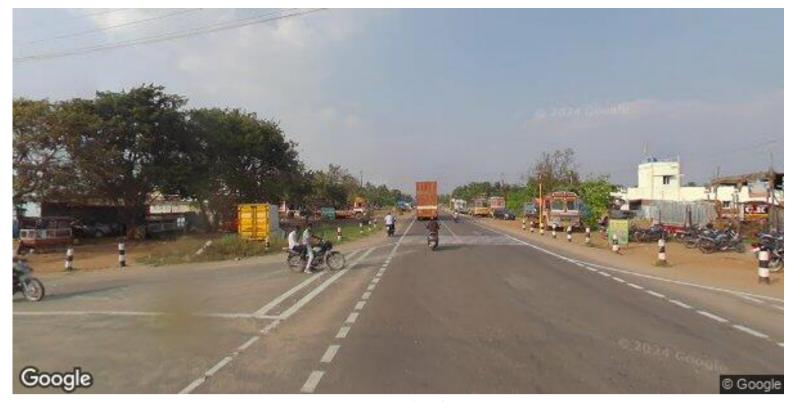
Coordinates: 11.03211, 77.07640

Risk Type: Blind Spot Risk Level: Blind Spot Speed Limit: 10 KM/Hr

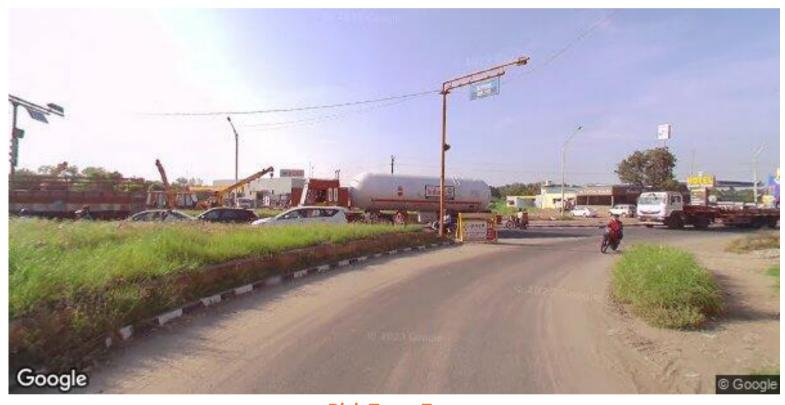
Coordinates: 11.00778, 77.07085

Risk Type: Turn
Risk Level: High
Speed Limit: 15 KM/Hr

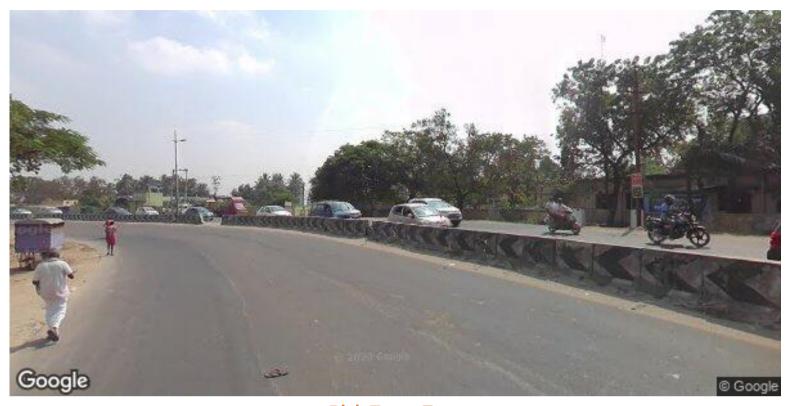
Coordinates: 10.99436, 77.28183

Risk Type: Turn
Risk Level: Medium
Speed Limit: 30 KM/Hr

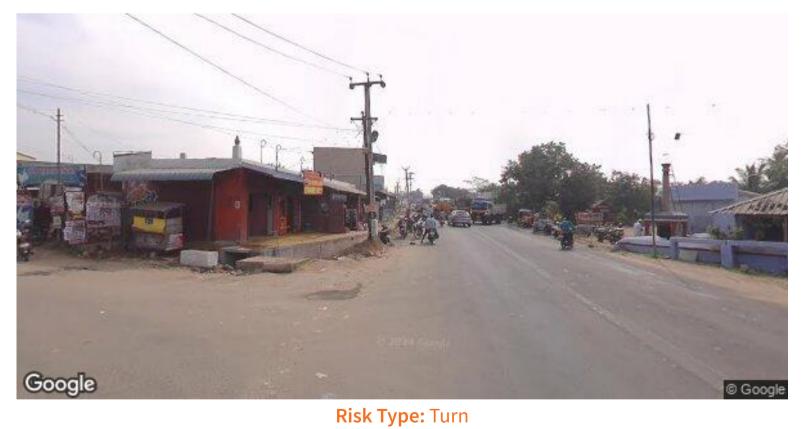
Coordinates: 10.99378, 77.29404

Risk Type: Turn
Risk Level: High
Speed Limit: 15 KM/Hr

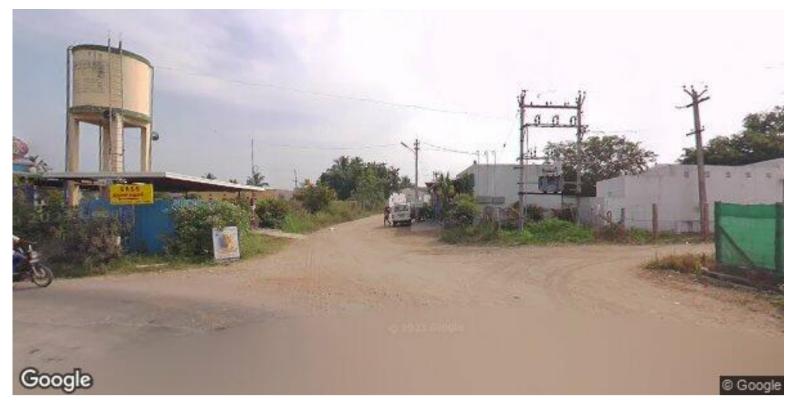
Coordinates: 10.99561, 77.30039

Risk Type: Turn
Risk Level: High
Speed Limit: 15 KM/Hr

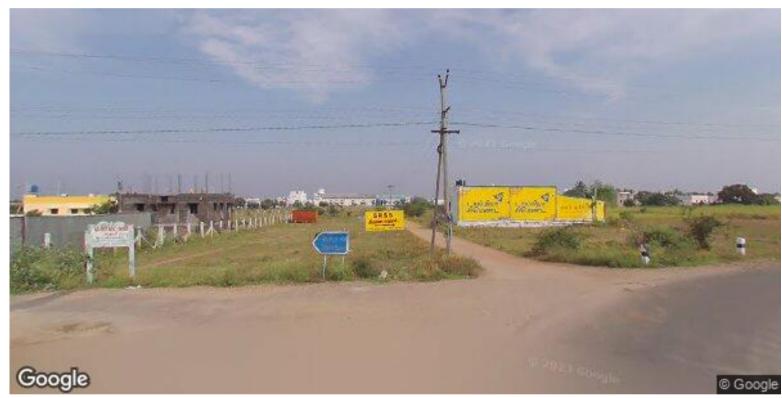
Coordinates: 10.99794, 77.30012

Risk Type: Turn
Risk Level: High
Speed Limit: 15 KM/Hr

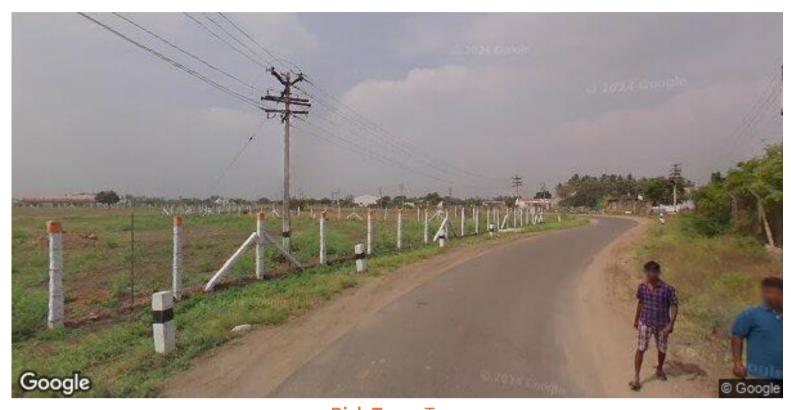
Coordinates: 11.00268, 77.31086

Risk Type: Turn
Risk Level: Medium
Speed Limit: 30 KM/Hr

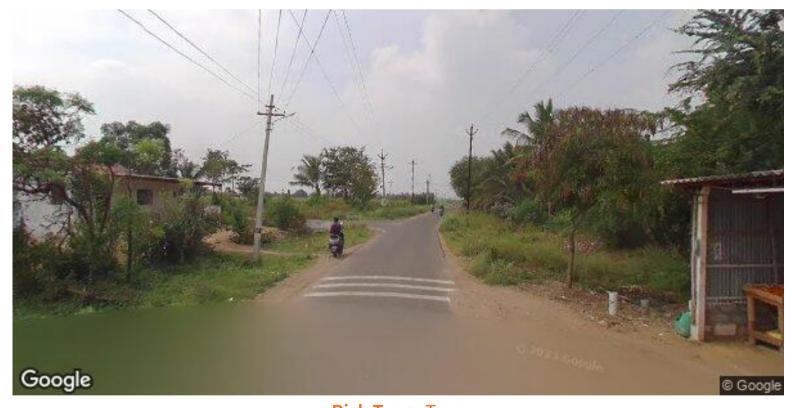
Coordinates: 11.00466, 77.32367

Risk Type: Turn
Risk Level: Medium
Speed Limit: 30 KM/Hr

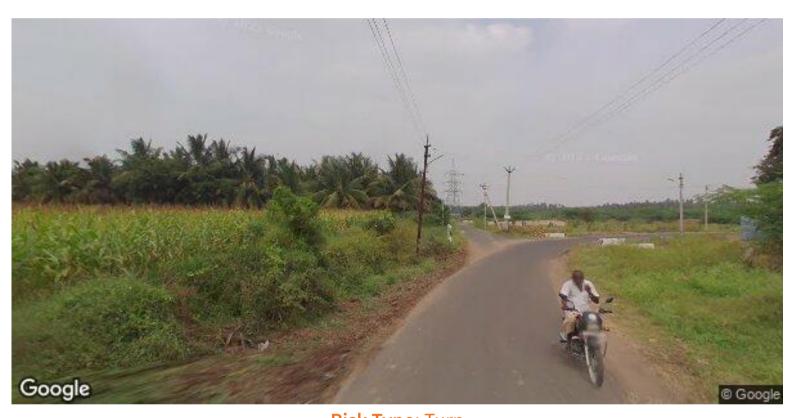
Risk Type: Turn
Risk Level: Medium
Speed Limit: 30 KM/Hr
Coordinates: 11.00746, 77.32453

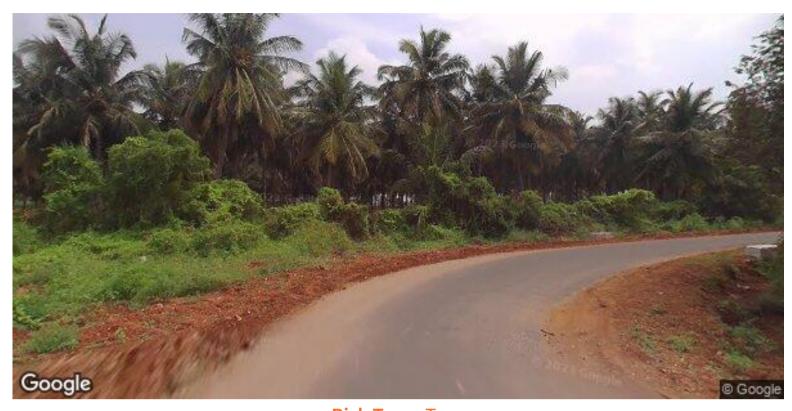
Risk Type: Turn
Risk Level: High
Speed Limit: 15 KM/Hr
Coordinates: 11.01019, 77.33100

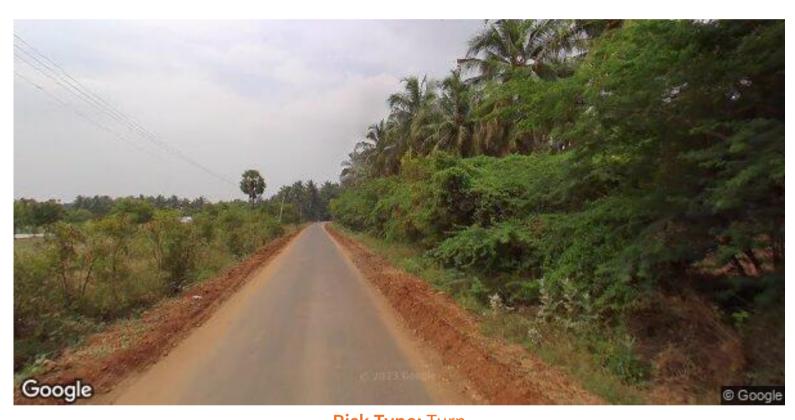
Risk Type: Turn
Risk Level: Medium
Speed Limit: 30 KM/Hr
Coordinates: 11.00865, 77.33304

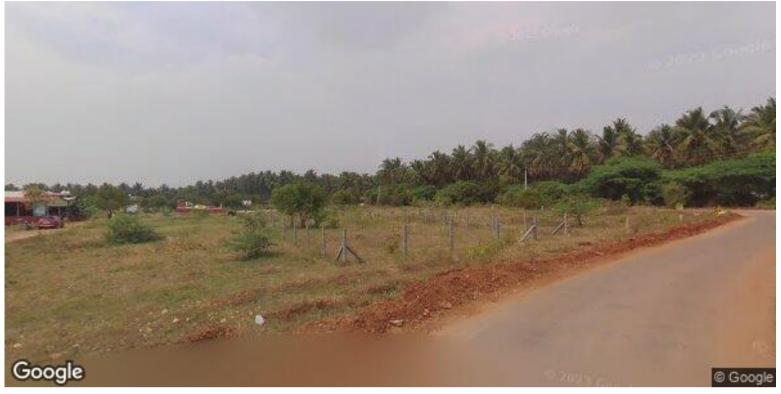
Coordinates: 11.00812, 77.33338

Risk Type: Turn
Risk Level: High
Speed Limit: 15 KM/Hr

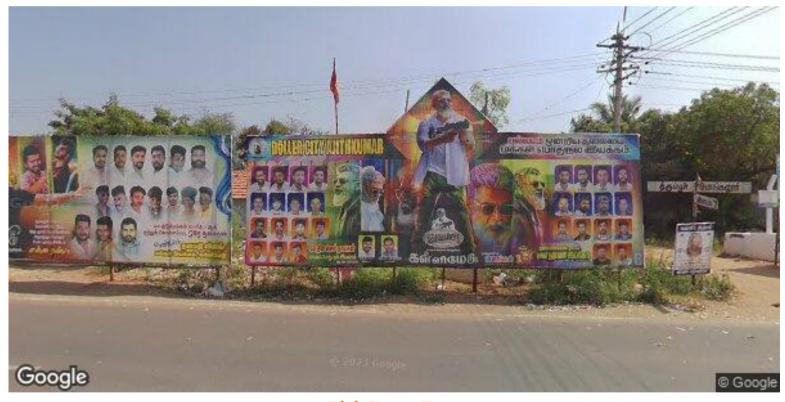
Coordinates: 11.00849, 77.33640

Risk Type: Turn
Risk Level: High
Speed Limit: 15 KM/Hr

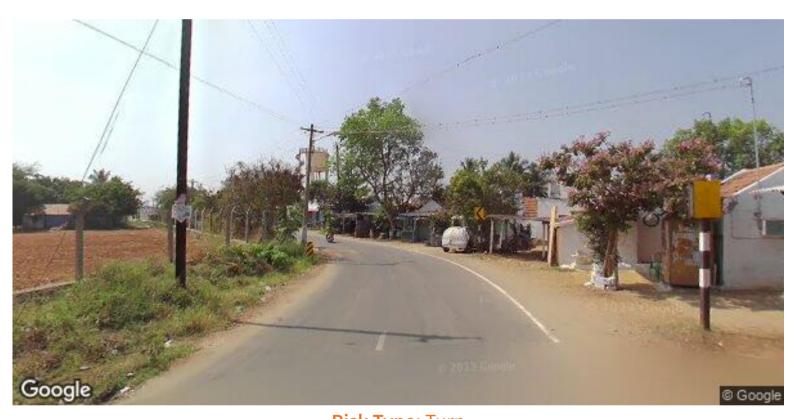
Risk Type: Turn
Risk Level: Medium
Speed Limit: 30 KM/Hr
Coordinates: 11.00928, 77.33651

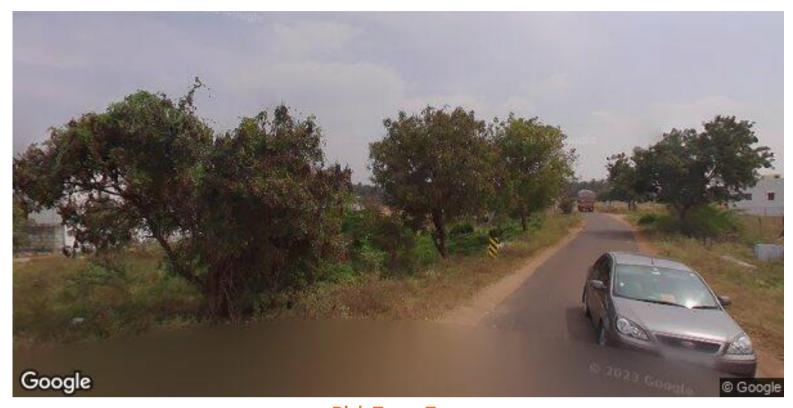
Risk Type: Turn
Risk Level: Medium
Speed Limit: 30 KM/Hr
Coordinates: 11.01250, 77.34852

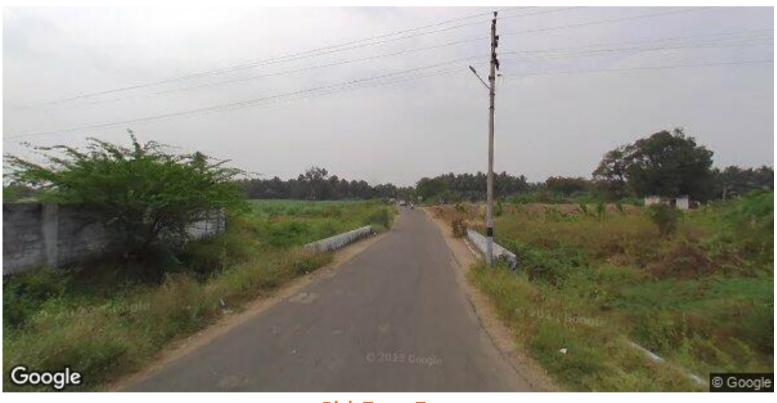
Risk Type: Turn
Risk Level: Medium
Speed Limit: 30 KM/Hr
Coordinates: 11.01424, 77.35740

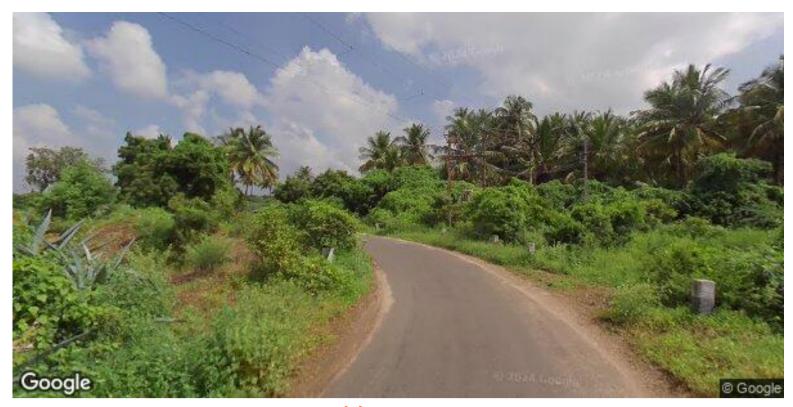
Risk Type: Turn
Risk Level: Medium
Speed Limit: 30 KM/Hr
Coordinates: 11.01156, 77.38296

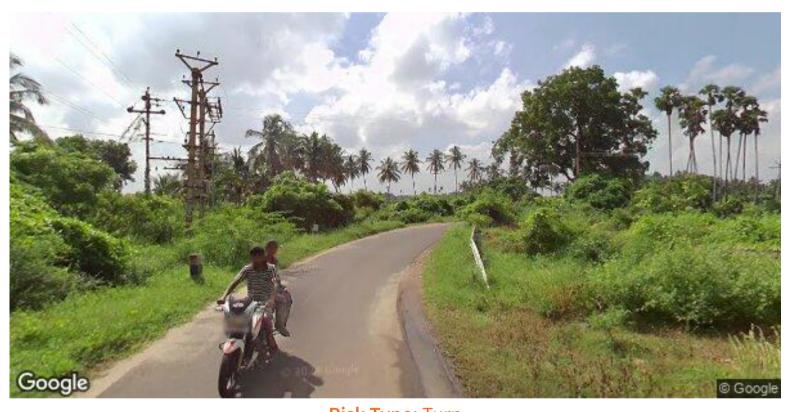
Risk Type: Turn
Risk Level: Medium
Speed Limit: 30 KM/Hr
Coordinates: 11.01182, 77.38311

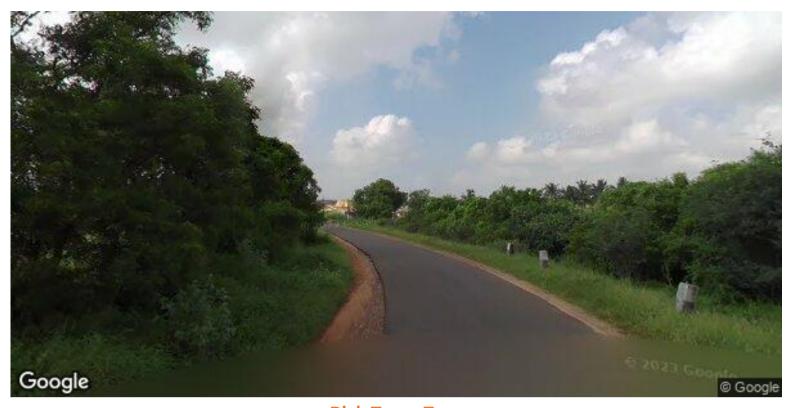
Risk Type: Turn
Risk Level: Medium
Speed Limit: 30 KM/Hr
Coordinates: 11.01519, 77.38618

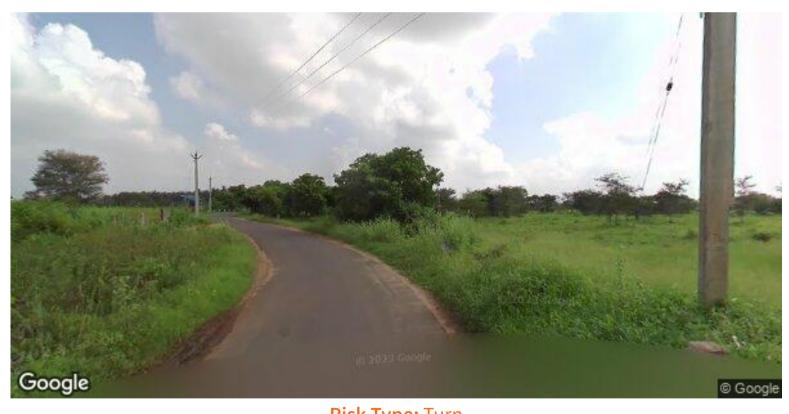
Risk Type: Turn
Risk Level: Medium
Speed Limit: 30 KM/Hr
Coordinates: 11.01501, 77.38870

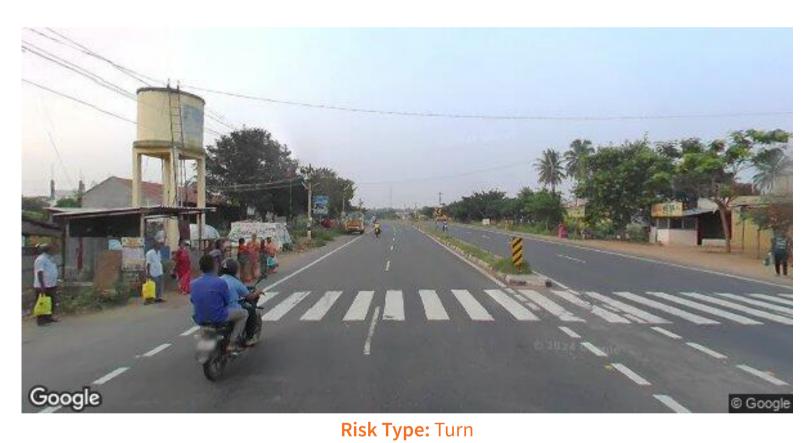
Risk Level: High
Speed Limit: 15 KM/Hr
Coordinates: 11.01719, 77.39768

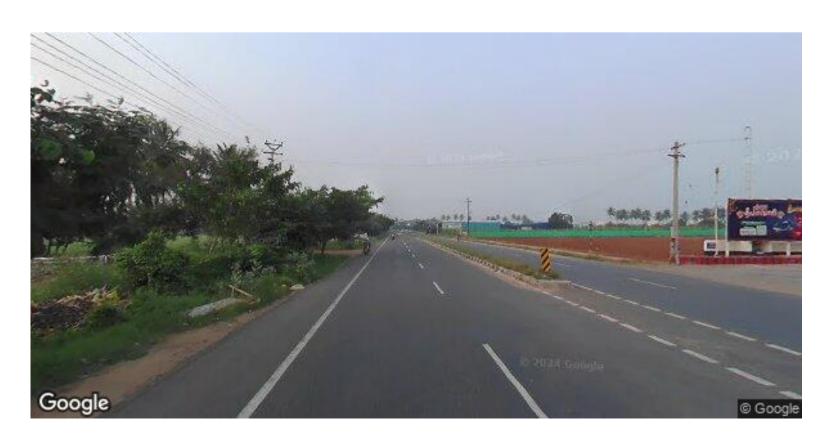
Coordinates: 11.02731, 77.39486

Risk Type: Blind Spot Risk Level: Blind Spot Speed Limit: 10 KM/Hr

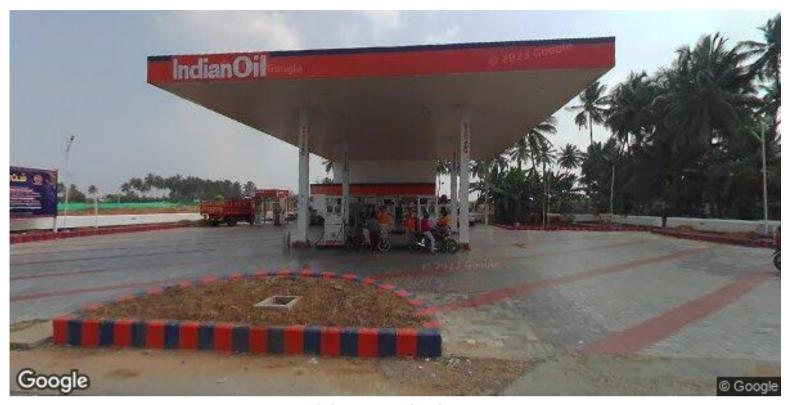
Coordinates: 11.02732, 77.39494

Risk Type: Blind Spot
Risk Level: Blind Spot
Speed Limit: 10 KM/Hr
