JOURNEY RISK MANAGEMENT (JRM) STUDY

Salem Terminal TO PON NATARAJAN AGENCIES

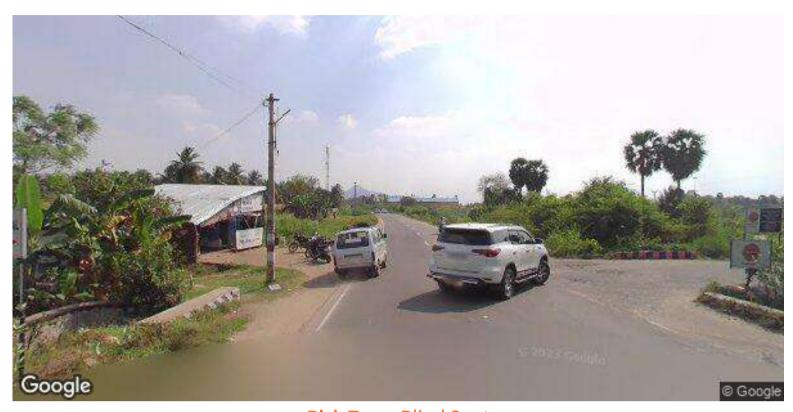
Risk Type: Blind Spot
Speed Limit: 10 KM/Hr
Distance from Start: 0.32 km
Coordinates: 11.44029, 77.87544

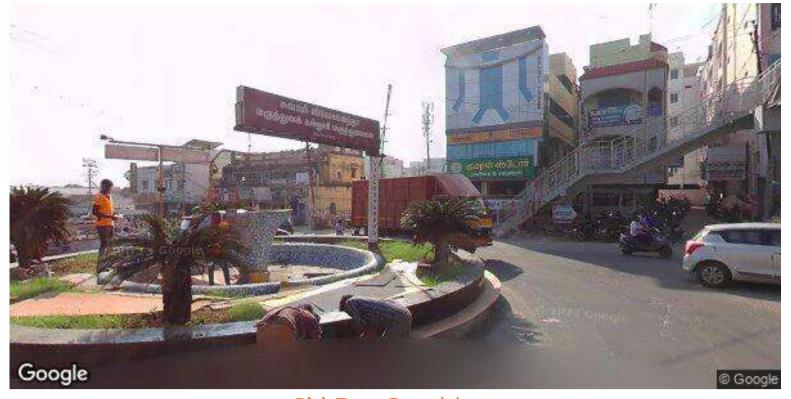
Risk Type: Roundabout
Speed Limit: 15 KM/Hr
Distance from Start: 7.46 km
Coordinates: 11.38395, 77.89480

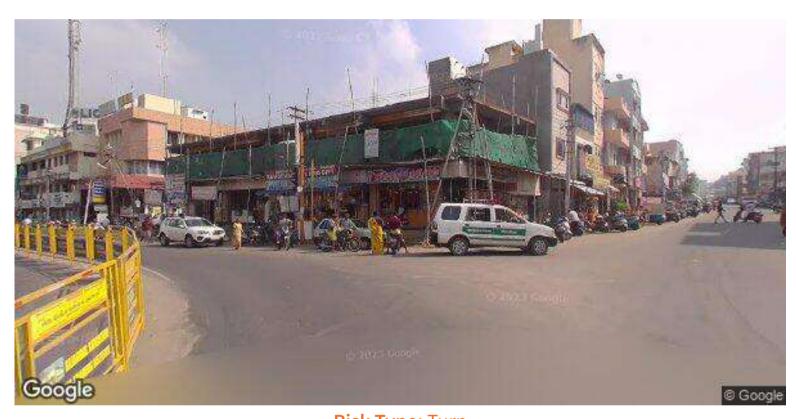
Risk Type: Turn
Speed Limit: 15 KM/Hr
Distance from Start: 7.98 km
Coordinates: 11.37868, 77.89498

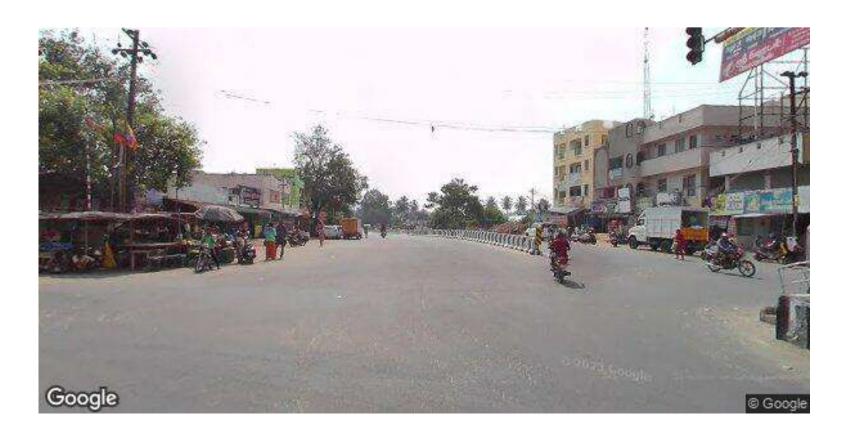
Risk Type: Turn
Speed Limit: 15 KM/Hr
Distance from Start: 9.66 km

Coordinates: 11.36604, 77.88887

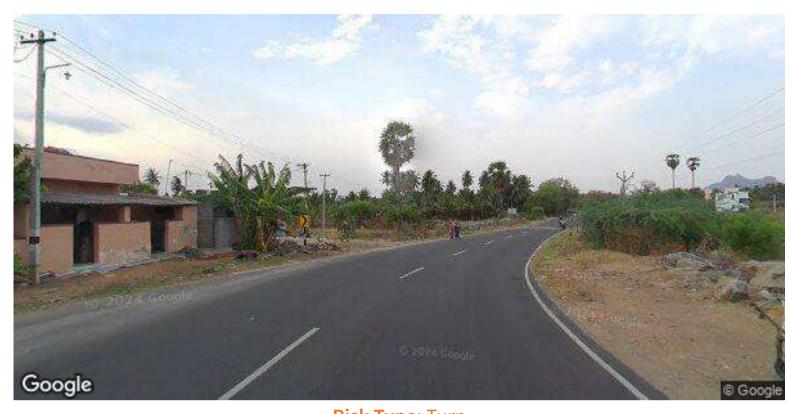
Risk Type: Turn
Speed Limit: 15 KM/Hr
Distance from Start: 13.80 km
Coordinates: 11.33882, 77.86218

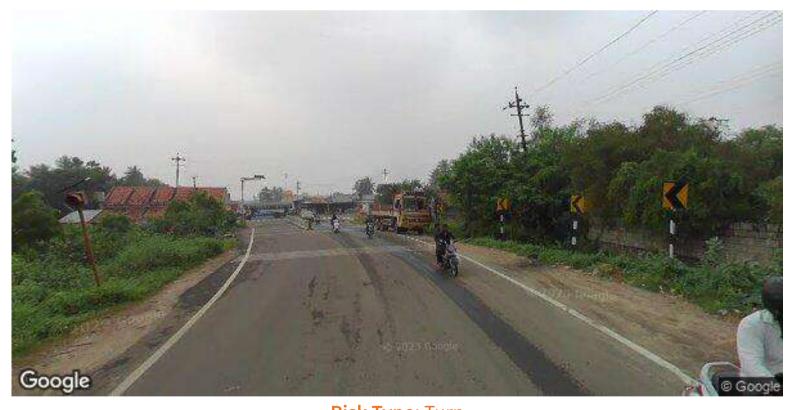
Risk Type: Turn
Speed Limit: 15 KM/Hr
Distance from Start: 25.68 km
Coordinates: 11.30970, 77.76705

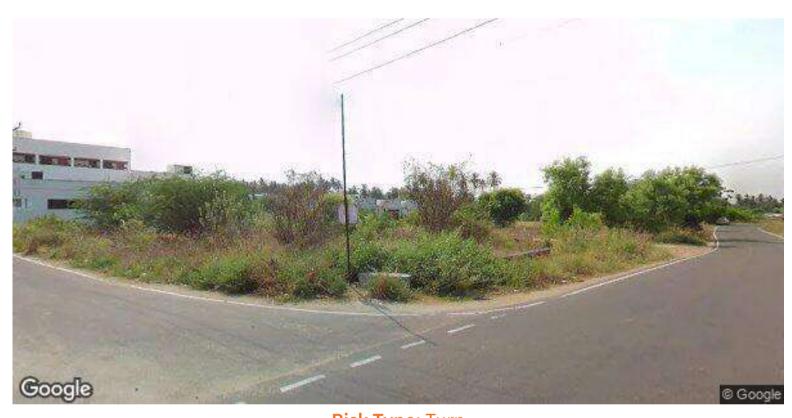
Risk Type: Turn
Speed Limit: 15 KM/Hr
Distance from Start: 28.94 km
Coordinates: 11.29133, 77.74660

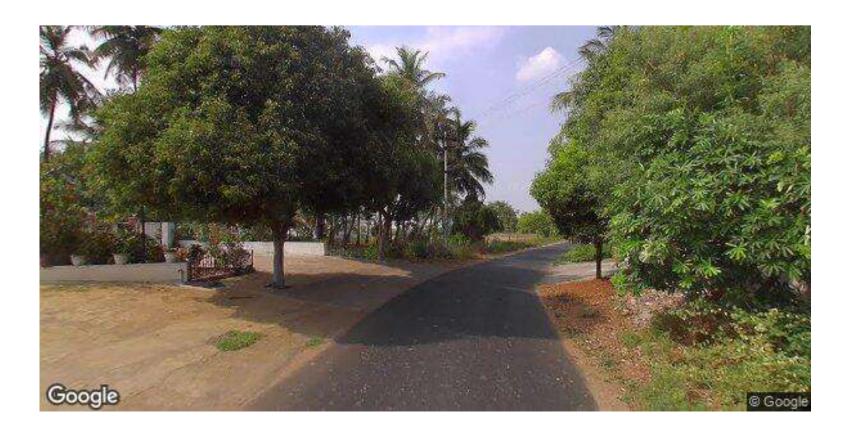
Risk Type: Turn
Speed Limit: 15 KM/Hr
Distance from Start: 29.44 km

Coordinates: 11.28859, 77.74323

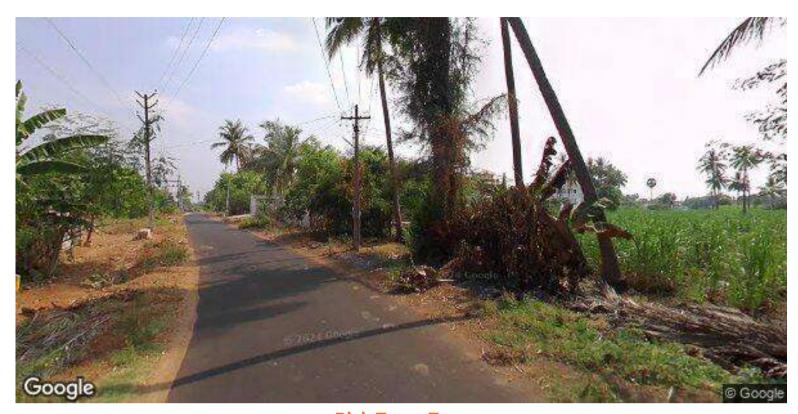
Risk Type: Turn
Speed Limit: 15 KM/Hr
Distance from Start: 31.46 km
Coordinates: 11.27558, 77.73107

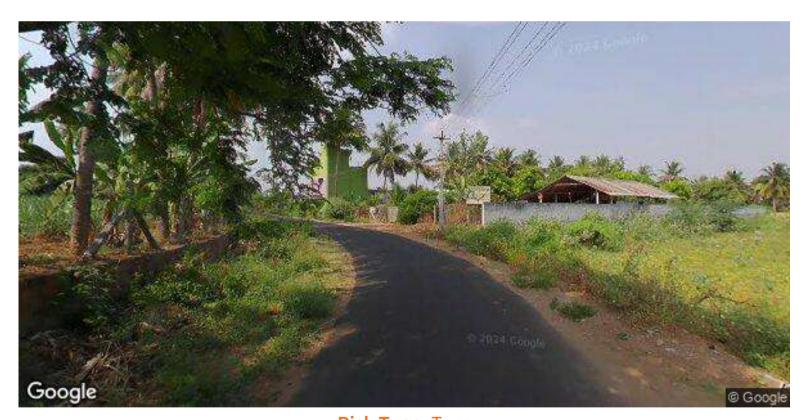
Risk Type: Turn
Speed Limit: 15 KM/Hr
Distance from Start: 31.78 km
Coordinates: 11.27326, 77.72991

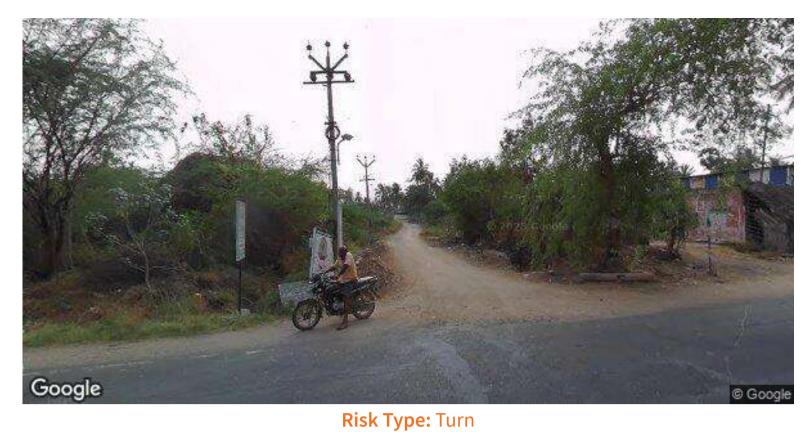
Speed Limit: 15 KM/Hr
Distance from Start: 32.04 km
Coordinates: 11.27330, 77.72711

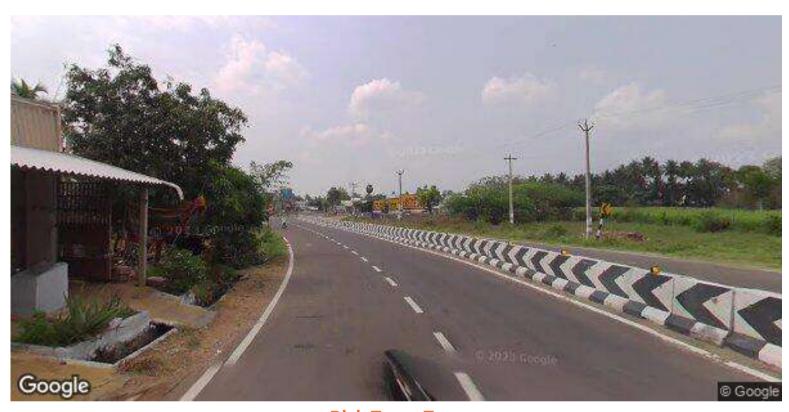
Risk Type: Turn
Speed Limit: 15 KM/Hr
Distance from Start: 37.90 km
Coordinates: 11.22378, 77.71384
