JOURNEY RISK MANAGEMENT (JRM) STUDY

Salem Terminal TO ESAAN AGENCIES

Route Safety Analysis Report

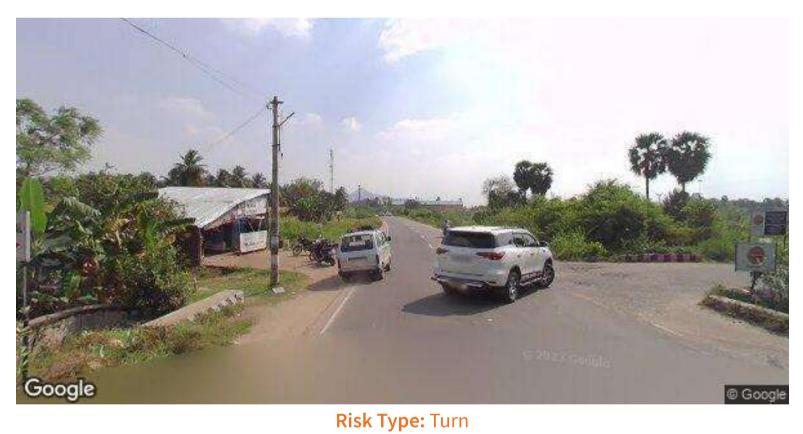
Coordinates: 11.44029, 77.87544

Risk Type: Turn
Risk Level: High
Speed Limit: 15 KM/Hr

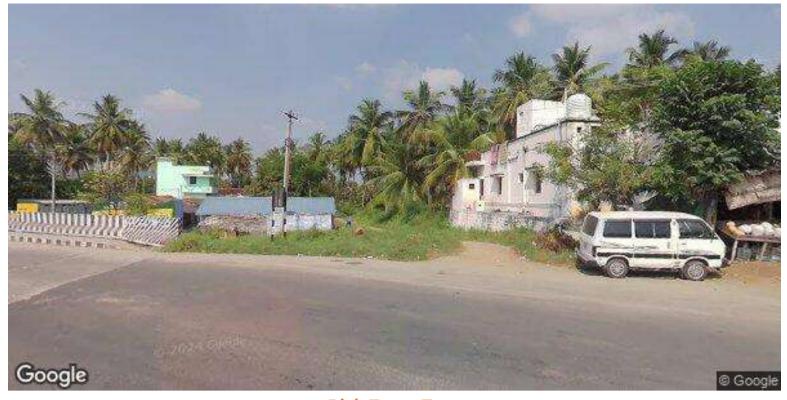
Risk Type: Turn
Risk Level: High
Speed Limit: 15 KM/Hr
Coordinates: 11.44898, 77.87410

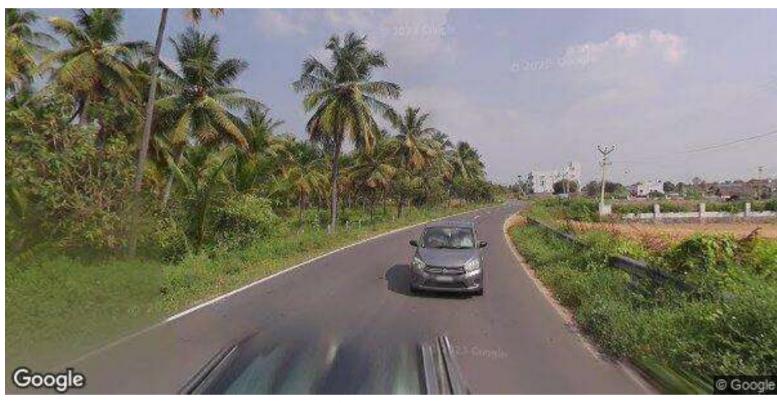
Risk Type: Turn
Risk Level: Medium
Speed Limit: 30 KM/Hr
Coordinates: 11.45357, 77.85789

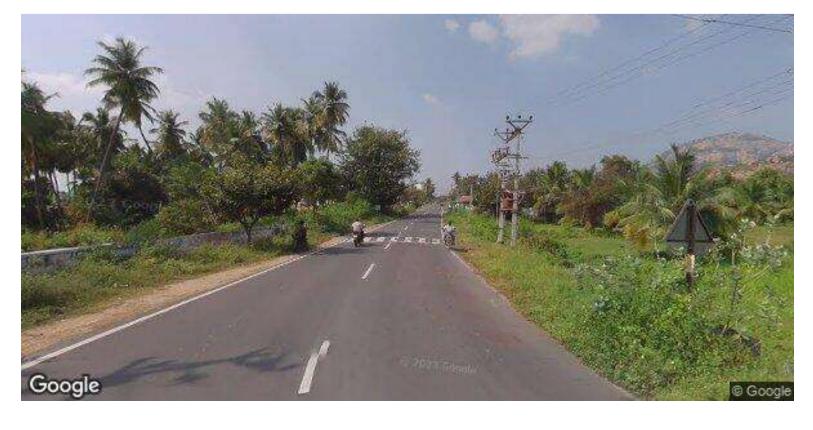
Coordinates: 11.45352, 77.85698

Risk Type: Turn
Risk Level: High
Speed Limit: 15 KM/Hr

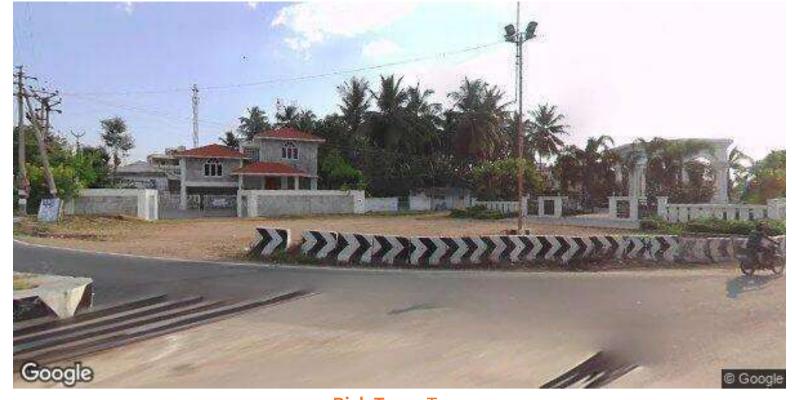
Risk Type: Turn
Risk Level: Medium
Speed Limit: 30 KM/Hr
Coordinates: 11.46314, 77.84928

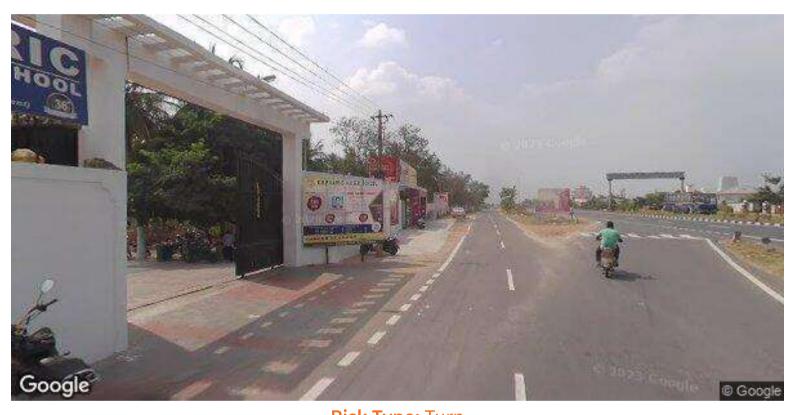
Risk Type: Turn
Risk Level: Medium
Speed Limit: 30 KM/Hr
Coordinates: 11.45509, 77.81383

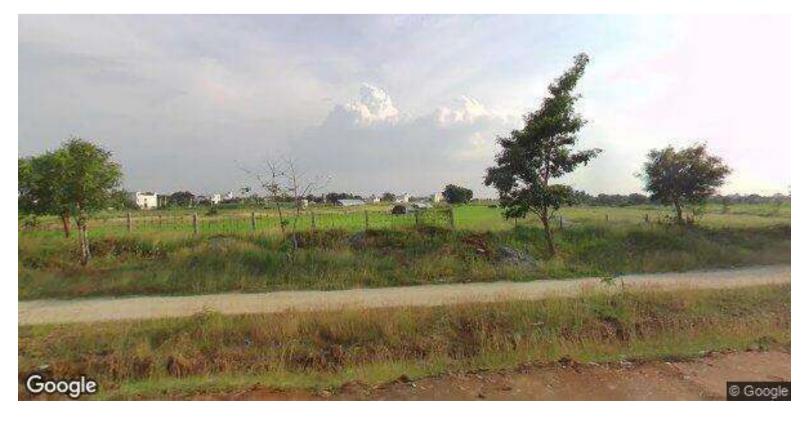
Coordinates: 11.29288, 77.59029

Risk Type: Turn
Risk Level: Medium
Speed Limit: 30 KM/Hr

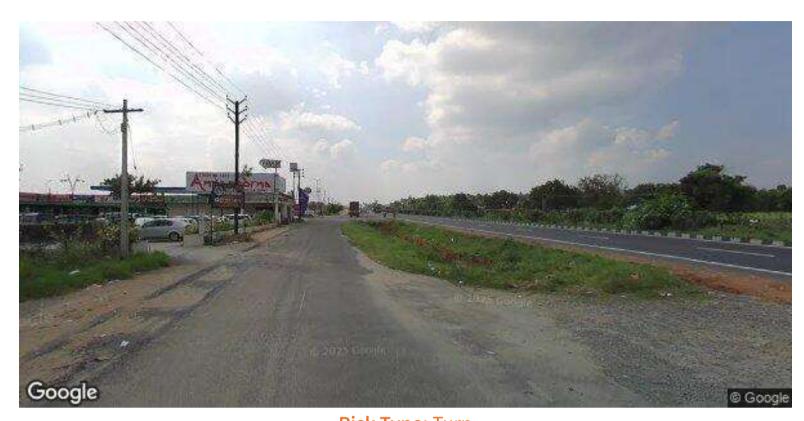
Risk Type: Turn
Risk Level: Medium
Speed Limit: 30 KM/Hr
Coordinates: 11.29140, 77.58253

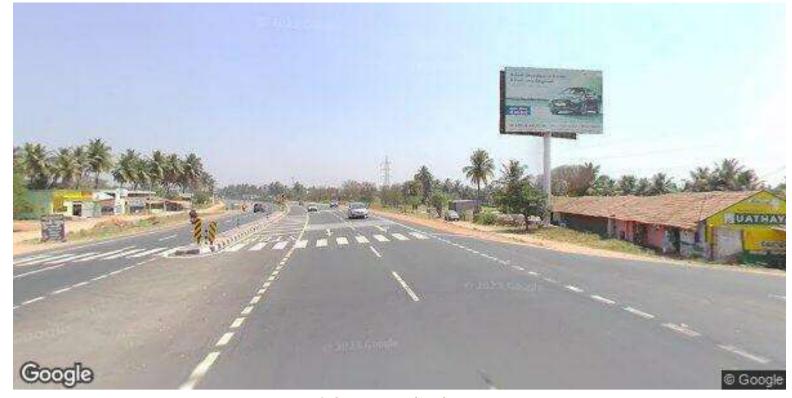
Risk Type: Blind Spot
Risk Level: Blind Spot
Speed Limit: 10 KM/Hr
Coordinates: 11.23716, 77.50666

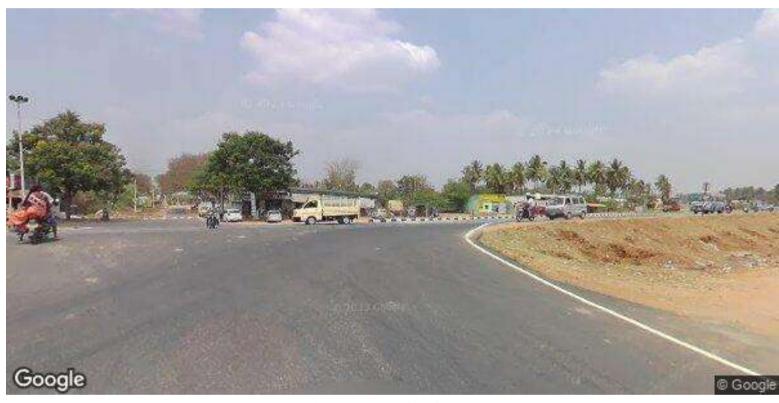
Coordinates: 11.23704, 77.50676

Risk Type: Blind Spot Risk Level: Blind Spot Speed Limit: 10 KM/Hr

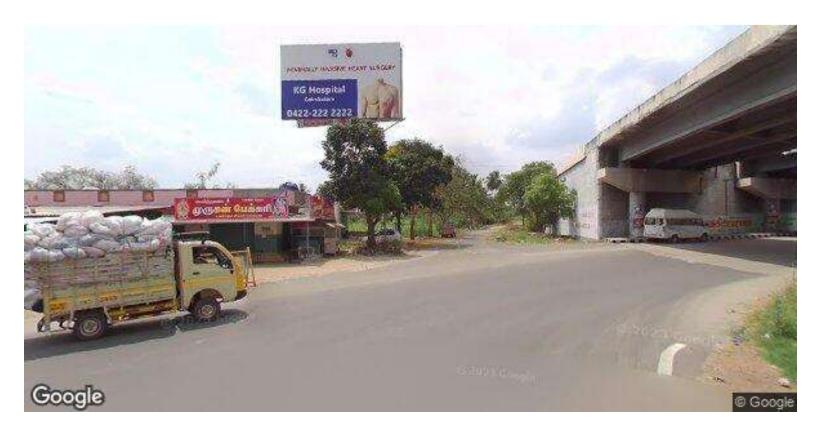
Coordinates: 11.23686, 77.50216

Risk Type: Blind Spot Risk Level: Blind Spot Speed Limit: 10 KM/Hr

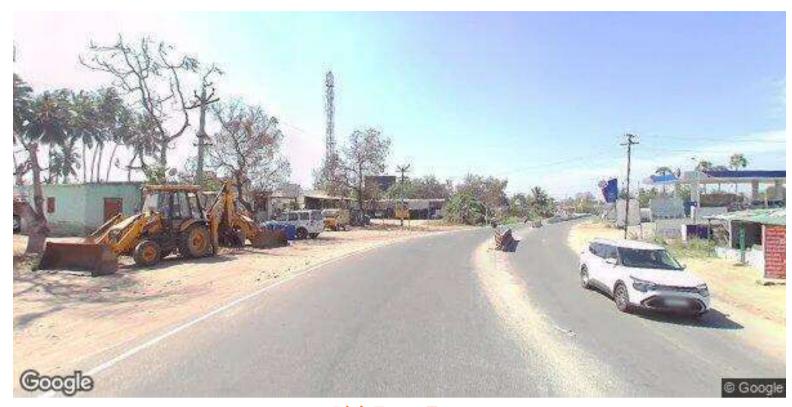
Risk Type: Turn
Risk Level: Medium
Speed Limit: 30 KM/Hr
Coordinates: 11.23649, 77.50219

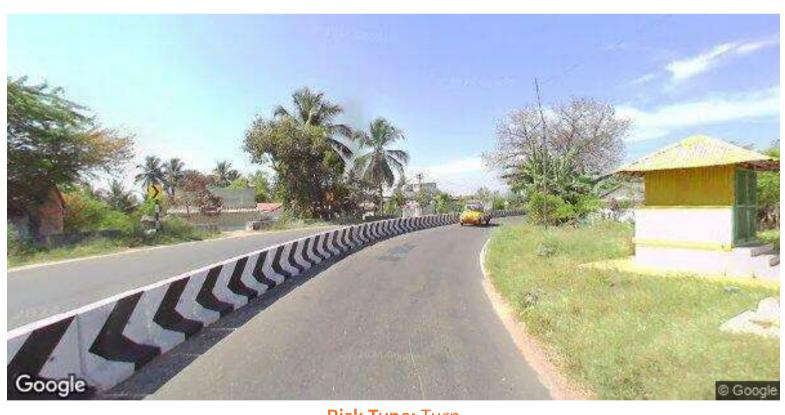
Coordinates: 11.23396, 77.50105

Risk Type: Turn
Risk Level: Medium
Speed Limit: 30 KM/Hr

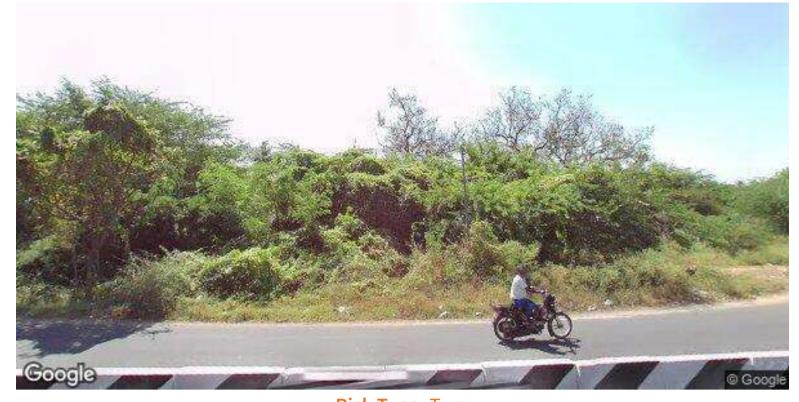
Risk Type: Turn
Risk Level: Medium
Speed Limit: 30 KM/Hr
Coordinates: 11.23329, 77.49966

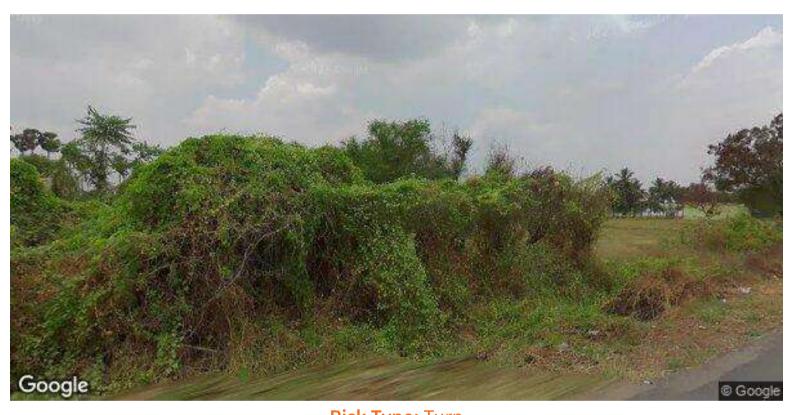
Risk Type: Turn
Risk Level: Medium
Speed Limit: 30 KM/Hr
Coordinates: 11.17851, 77.46169

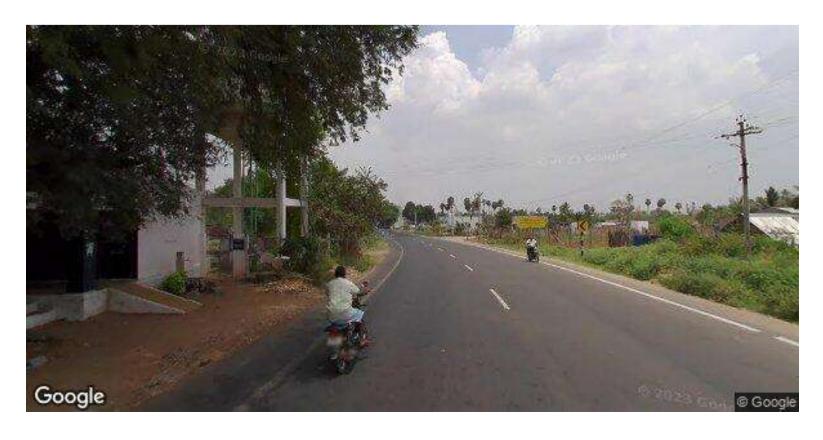
Coordinates: 11.17521, 77.45978

Risk Type: Turn
Risk Level: Medium
Speed Limit: 30 KM/Hr

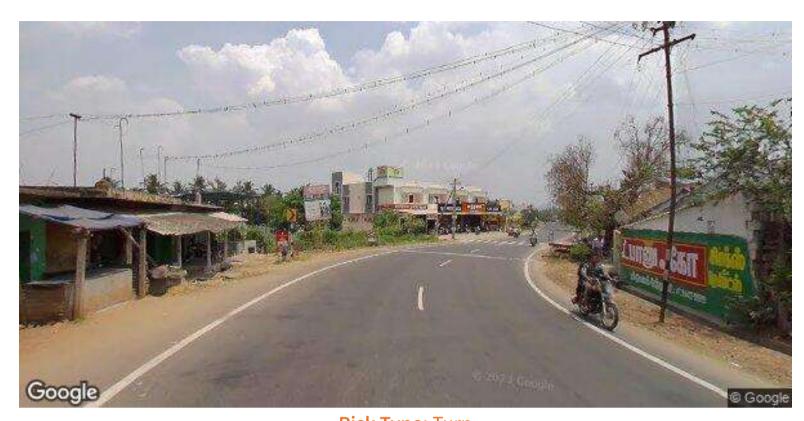
Risk Type: Turn
Risk Level: Medium
Speed Limit: 30 KM/Hr
Coordinates: 11.17368, 77.45730

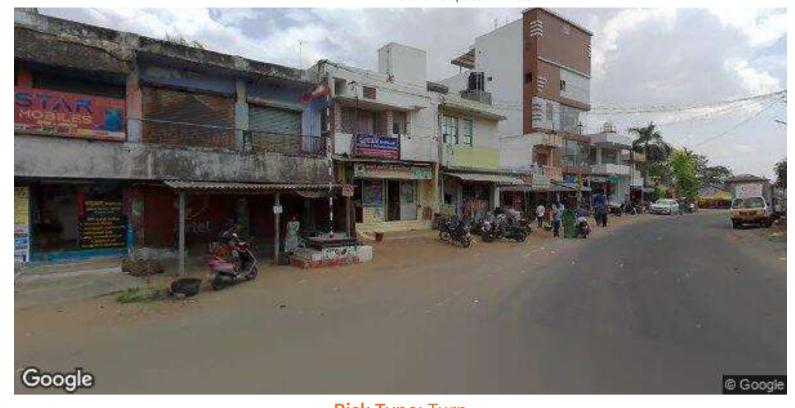
Risk Type: Turn
Risk Level: Medium
Speed Limit: 30 KM/Hr
Coordinates: 11.17048, 77.45544

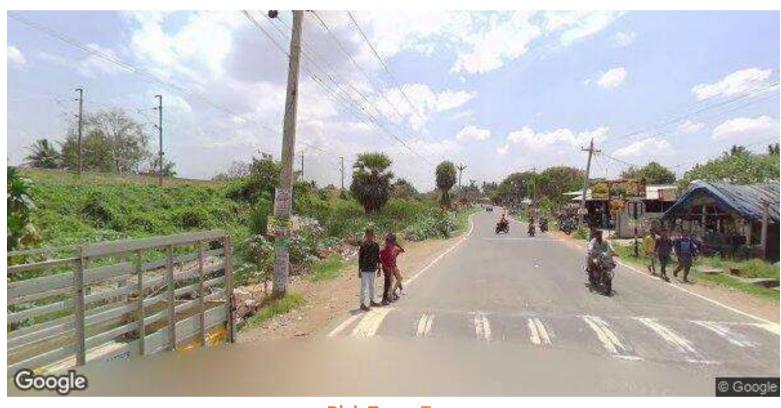
Coordinates: 11.16706, 77.45494

Risk Type: Turn
Risk Level: Medium
Speed Limit: 30 KM/Hr
