JOURNEY RISK MANAGEMENT (JRM) STUDY

IOCL Coimbatore Terminal to Sruthi Agencies

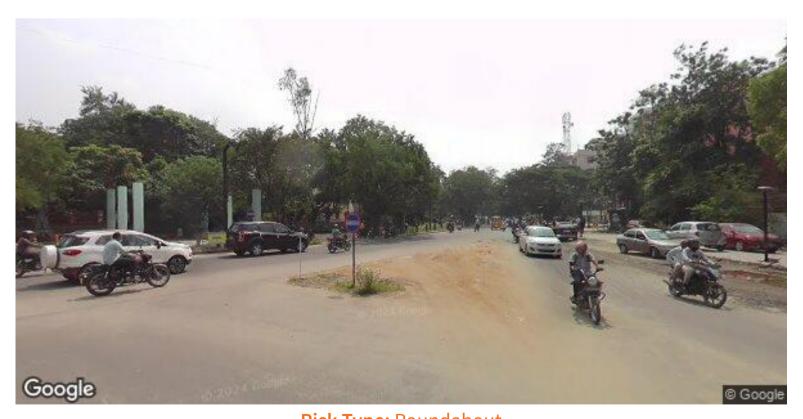
Coordinates: 11.00090, 76.97343

Risk Type: Roundabout
Risk Level: High
Speed Limit: 15 KM/Hr

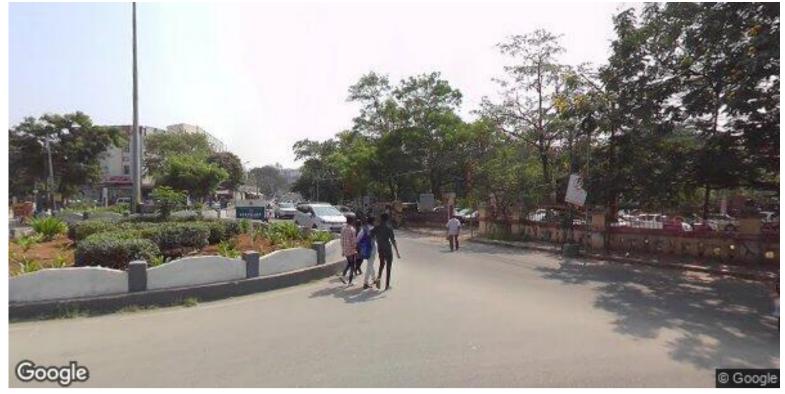
Risk Type: Roundabout
Risk Level: High
Speed Limit: 15 KM/Hr
Coordinates: 11.00086, 76.96971

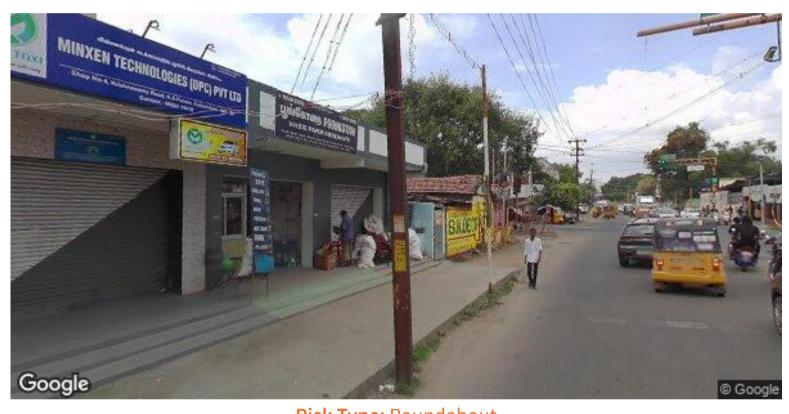
Risk Type: Roundabout
Risk Level: High
Speed Limit: 15 KM/Hr
Coordinates: 11.01082, 76.95733

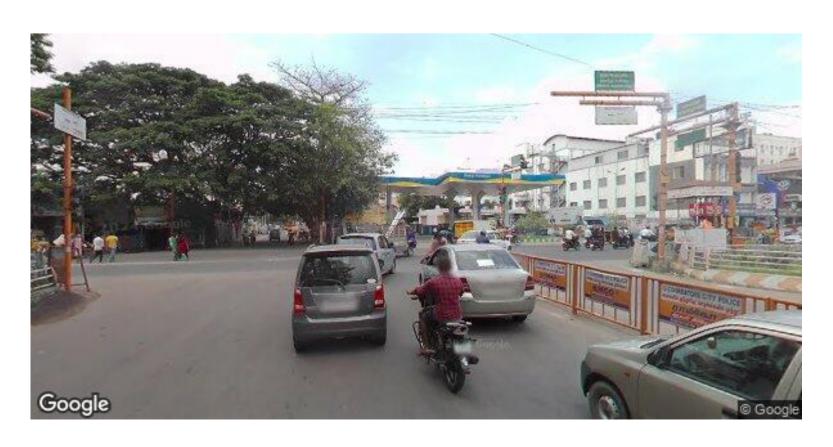
Coordinates: 11.01308, 76.95512

Risk Type: Roundabout
Risk Level: High
Speed Limit: 15 KM/Hr

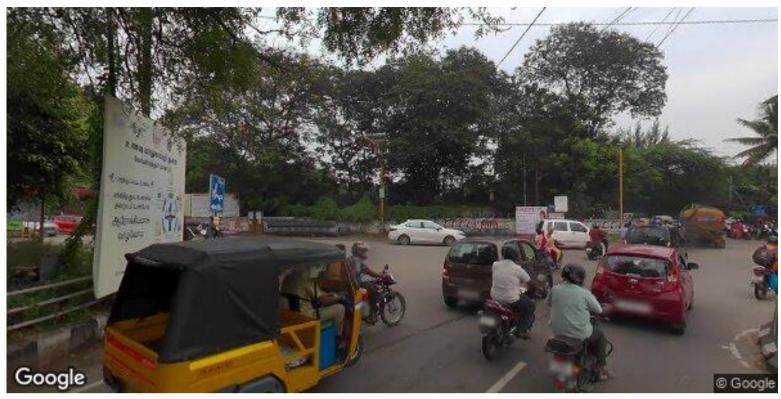
Coordinates: 11.01366, 76.94209

Risk Type: Roundabout
Risk Level: High
Speed Limit: 15 KM/Hr

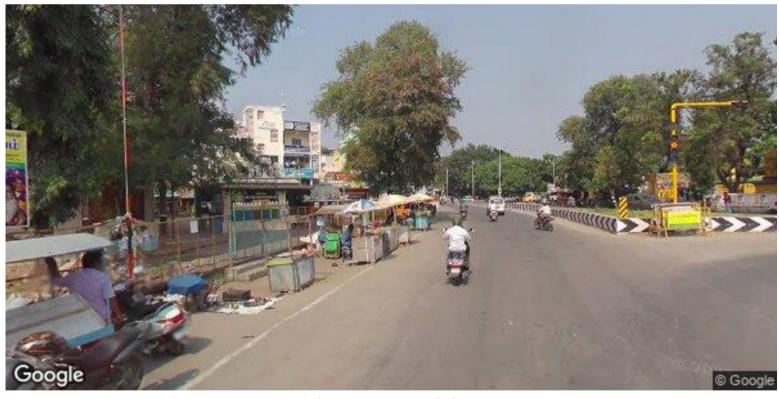
Coordinates: 11.02653, 76.90591

Risk Type: Roundabout
Risk Level: High
Speed Limit: 15 KM/Hr

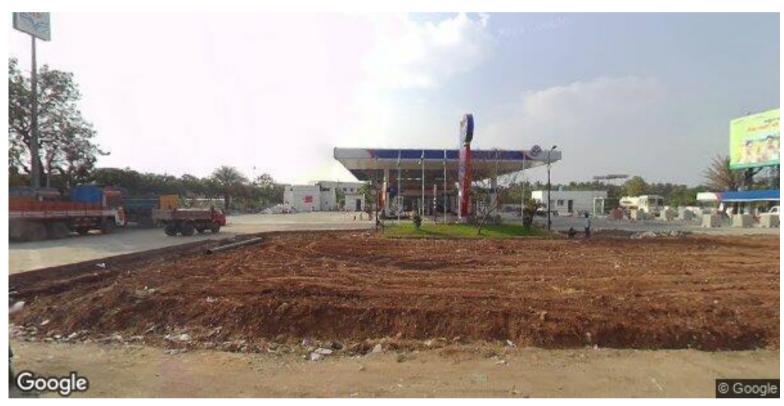
Risk Type: Turn
Risk Level: Medium
Speed Limit: 30 KM/Hr
Coordinates: 11.00873, 77.07114

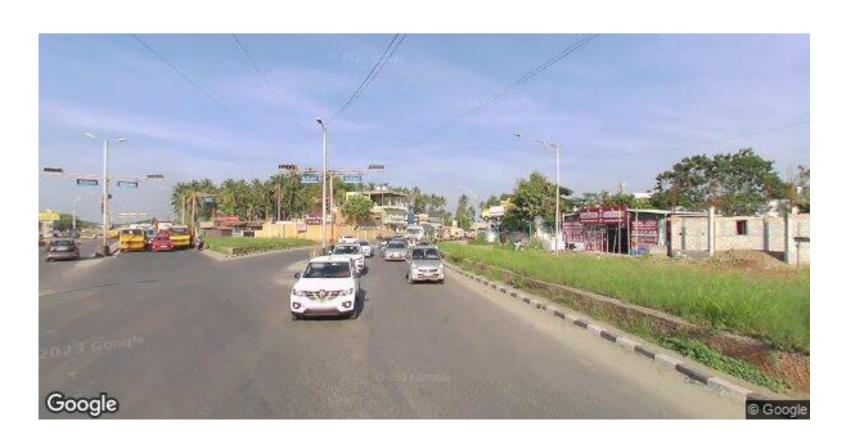
Coordinates: 11.00737, 77.07049

Risk Type: Turn
Risk Level: Medium
Speed Limit: 30 KM/Hr

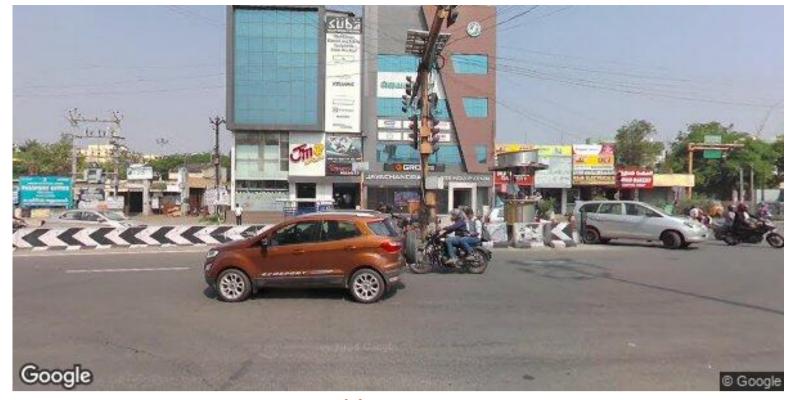
Risk Type: Turn
Risk Level: Medium
Speed Limit: 30 KM/Hr
Coordinates: 11.00252, 76.96815

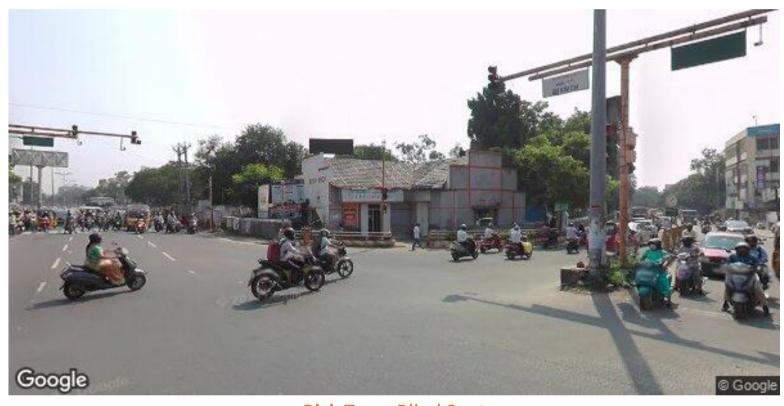
Risk Type: Blind Spot
Risk Level: Blind Spot
Speed Limit: 10 KM/Hr
Coordinates: 11.00256, 76.96817

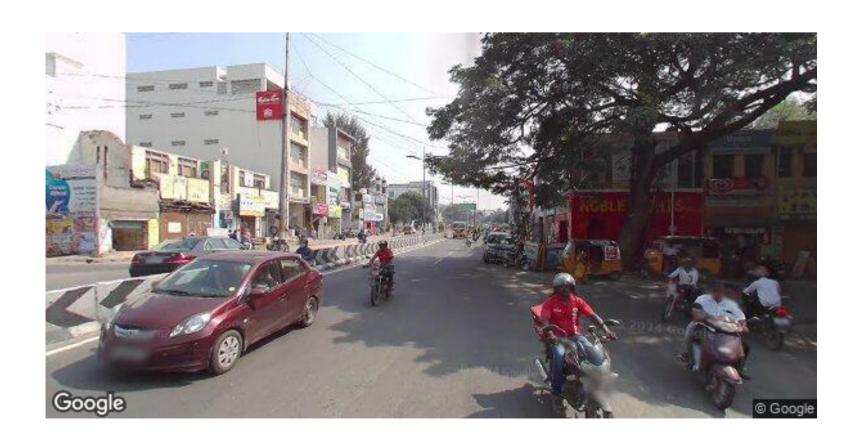
Coordinates: 11.00232, 76.96670

Risk Type: Turn
Risk Level: High
Speed Limit: 15 KM/Hr

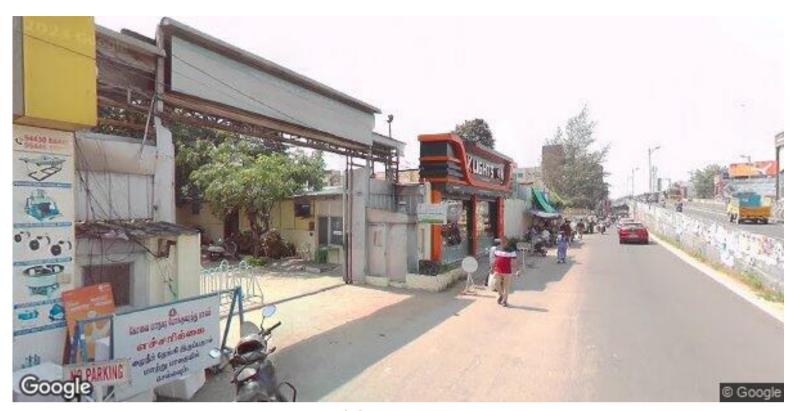
Risk Type: Turn
Risk Level: Medium
Speed Limit: 30 KM/Hr
Coordinates: 11.00226, 76.96666

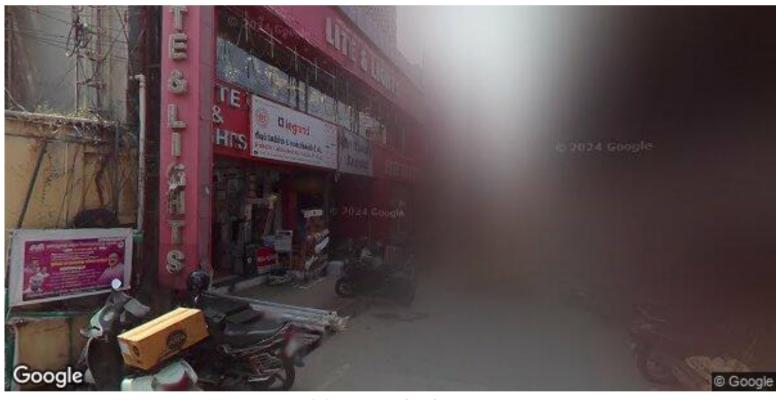
Coordinates: 11.00207, 76.96546

Risk Type: Blind Spot Risk Level: Blind Spot Speed Limit: 10 KM/Hr

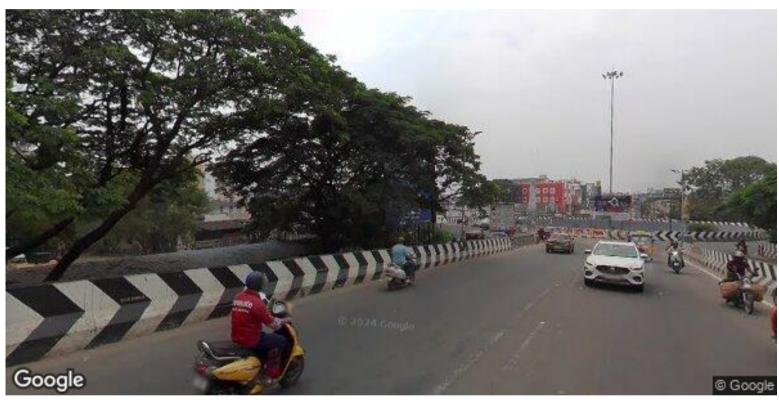
Risk Type: Blind Spot
Risk Level: Blind Spot
Speed Limit: 10 KM/Hr
Coordinates: 11.00167, 76.96341

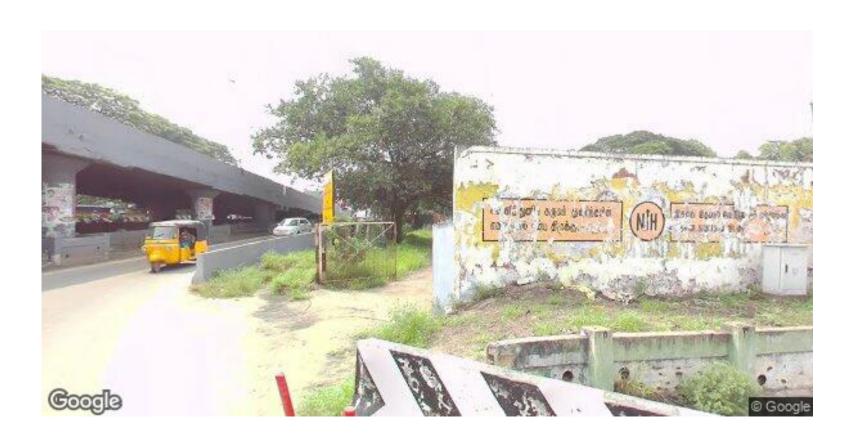
Coordinates: 11.00187, 76.96359

Risk Type: Turn
Risk Level: Medium
Speed Limit: 30 KM/Hr

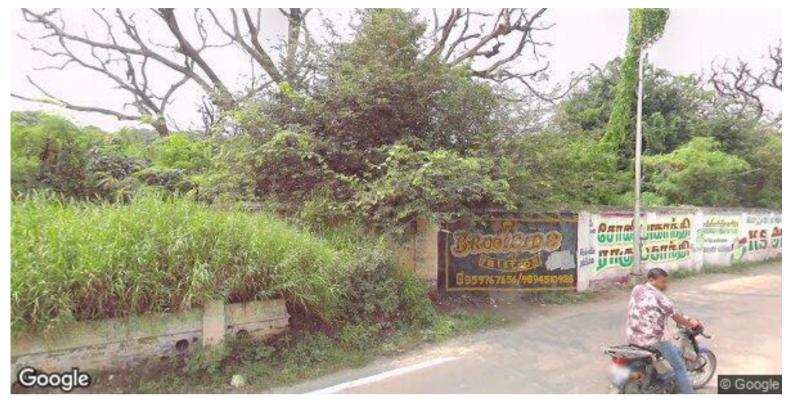
Risk Type: Turn
Risk Level: Medium
Speed Limit: 30 KM/Hr
Coordinates: 11.00297, 76.96303

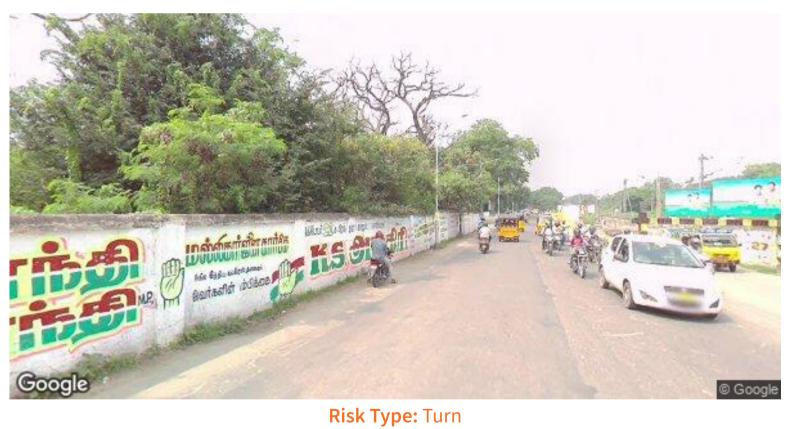
Risk Level: Medium
Speed Limit: 30 KM/Hr
Coordinates: 11.00306, 76.96304

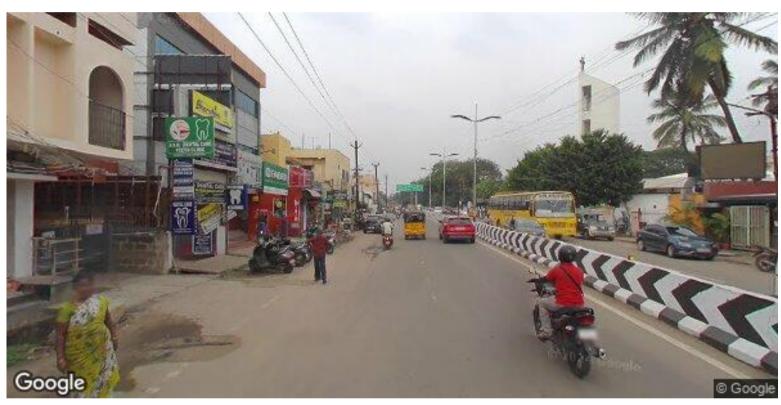
Risk Type: Turn
Risk Level: High
Speed Limit: 15 KM/Hr
Coordinates: 11.01214, 76.94302

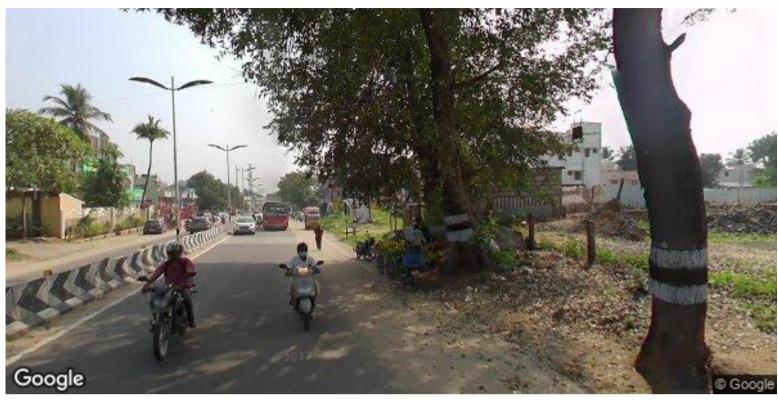
Coordinates: 11.02842, 76.90033

Risk Type: Turn
Risk Level: Medium
Speed Limit: 30 KM/Hr

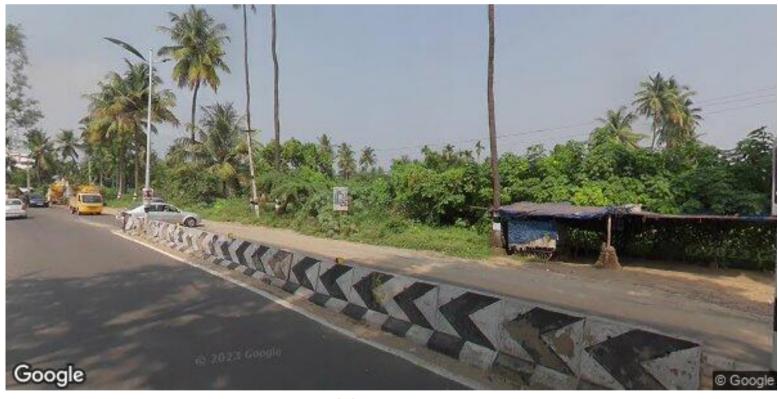
Coordinates: 11.02844, 76.90031

Risk Type: Turn
Risk Level: Medium
Speed Limit: 30 KM/Hr
