JOURNEY RISK MANAGEMENT (JRM) STUDY

IOCL Coimbatore Terminal to Sri Mookambikai Agencies

Route Safety Analysis: Athappagoundenpudur to Sultanpet via MDR881, Tamil Nadu

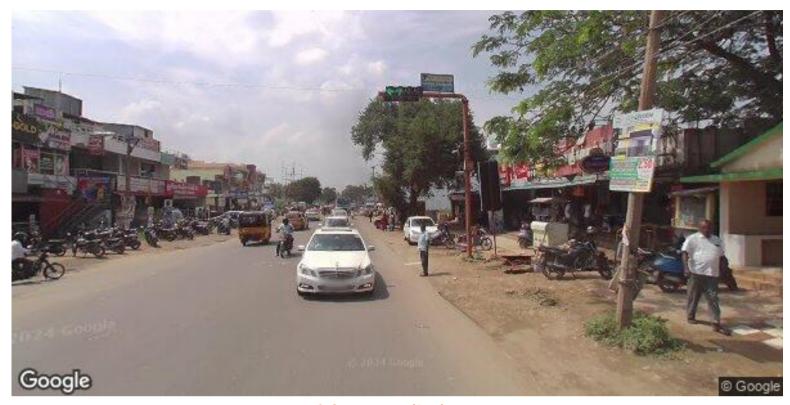
Risk Type: Blind Spot
Risk Level: Blind Spot
Speed Limit: 10 KM/Hr
Coordinates: 11.01005, 77.08007

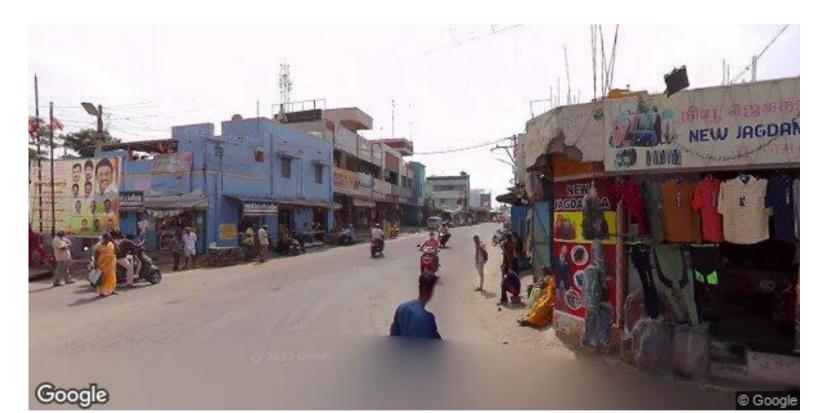
Risk Type: Turn
Risk Level: High
Speed Limit: 15 KM/Hr
Coordinates: 10.99360, 77.08607

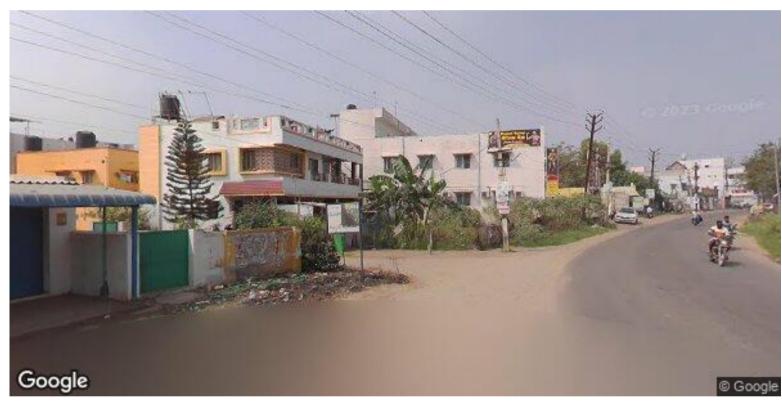
Risk Type: Turn
Risk Level: Medium
Speed Limit: 30 KM/Hr
Coordinates: 10.99147, 77.08623

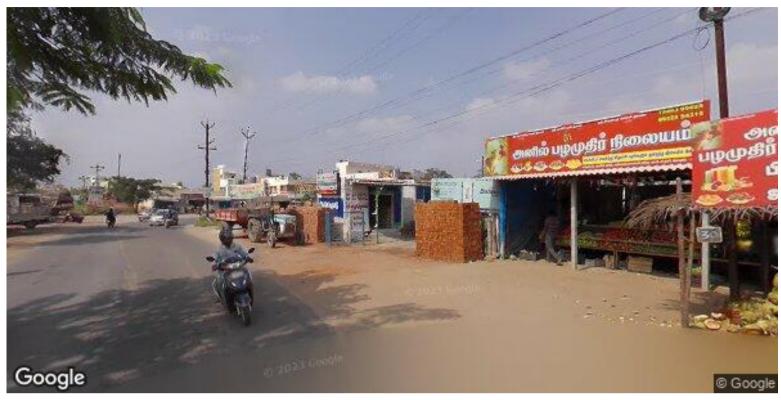
Coordinates: 10.99150, 77.08684

Risk Type: Turn
Risk Level: Medium
Speed Limit: 30 KM/Hr

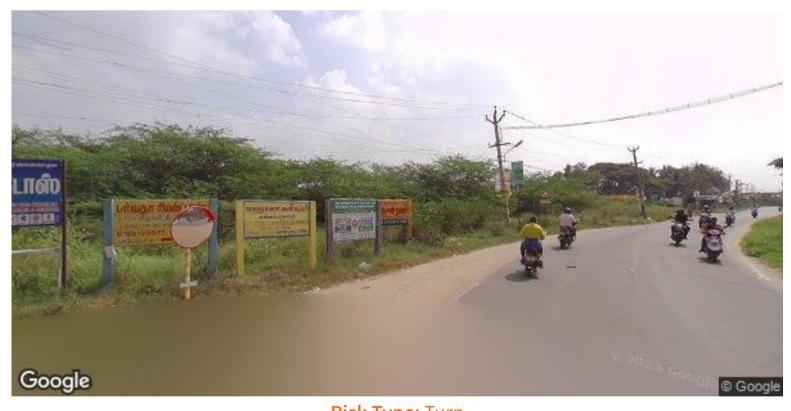
Coordinates: 10.99143, 77.08704

Risk Type: Turn
Risk Level: Medium
Speed Limit: 30 KM/Hr

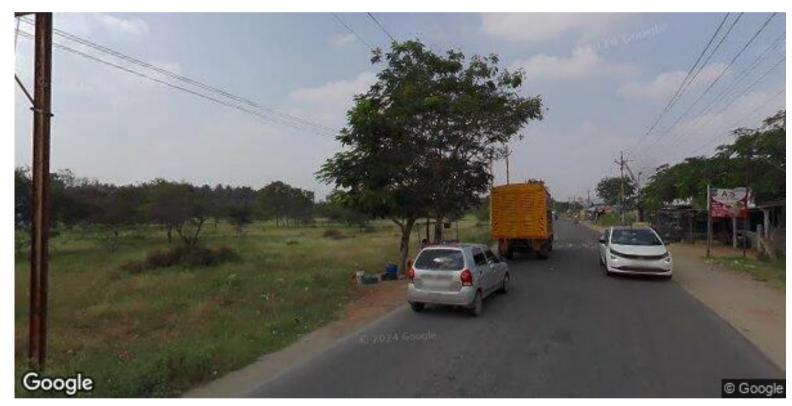
Risk Type: Turn
Risk Level: Medium
Speed Limit: 30 KM/Hr
Coordinates: 10.96690, 77.09891

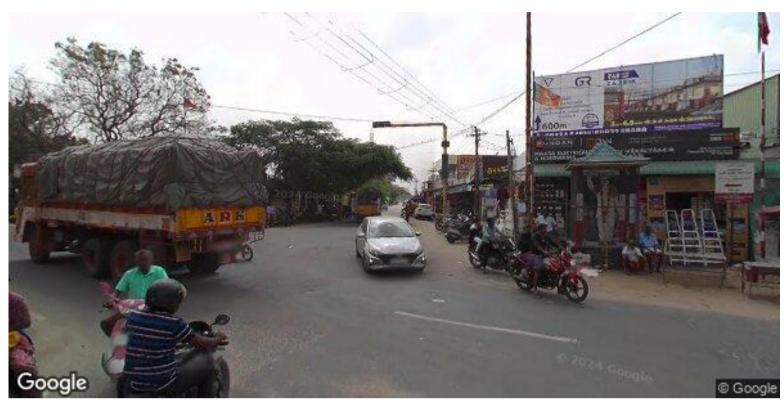
Coordinates: 10.95872, 77.10030

Risk Type: Turn
Risk Level: High
Speed Limit: 15 KM/Hr

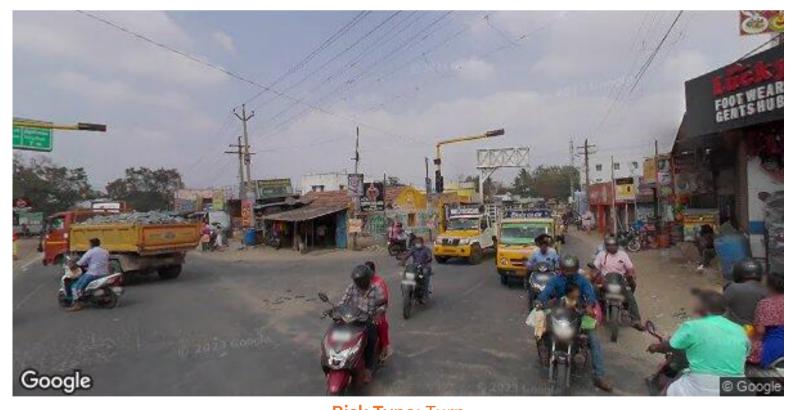
Risk Type: Turn
Risk Level: High
Speed Limit: 15 KM/Hr
Coordinates: 10.95871, 77.10037

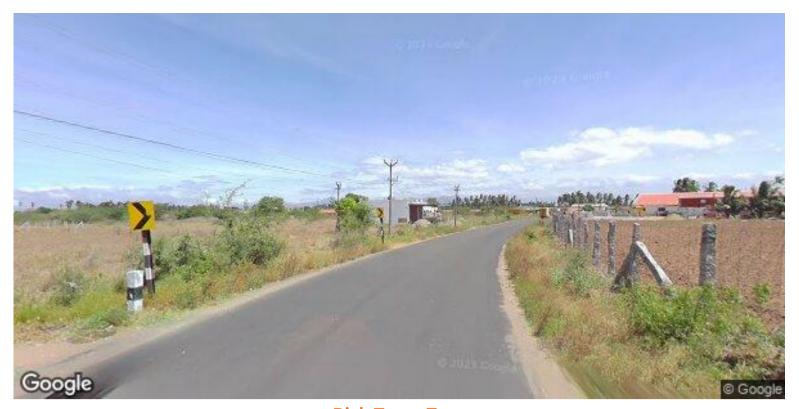
Risk Type: Turn
Risk Level: Medium
Speed Limit: 30 KM/Hr
Coordinates: 10.94760, 77.10404

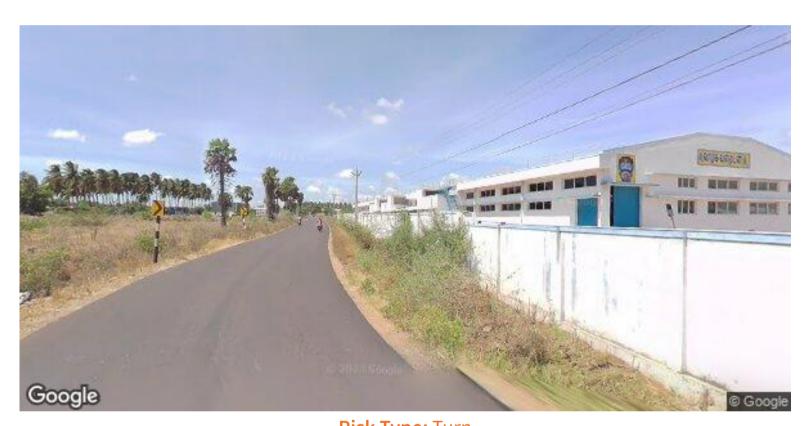
Risk Type: Turn
Risk Level: Medium
Speed Limit: 30 KM/Hr
Coordinates: 10.94726, 77.10468

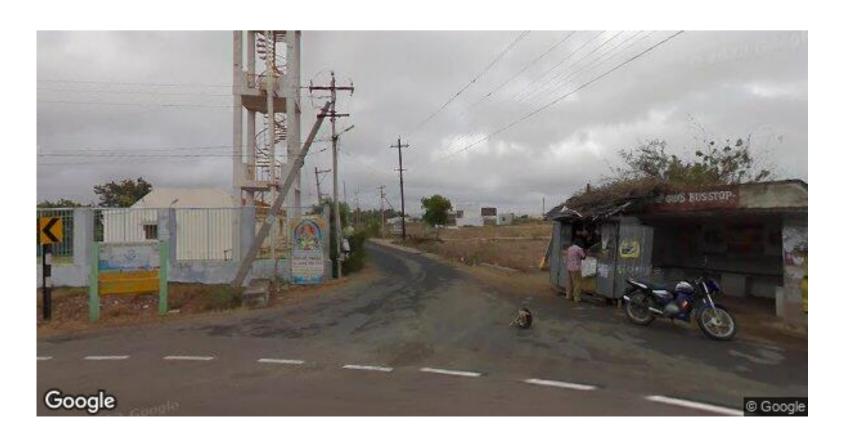
Coordinates: 10.94262, 77.10723

Risk Type: Blind Spot Risk Level: Blind Spot Speed Limit: 10 KM/Hr

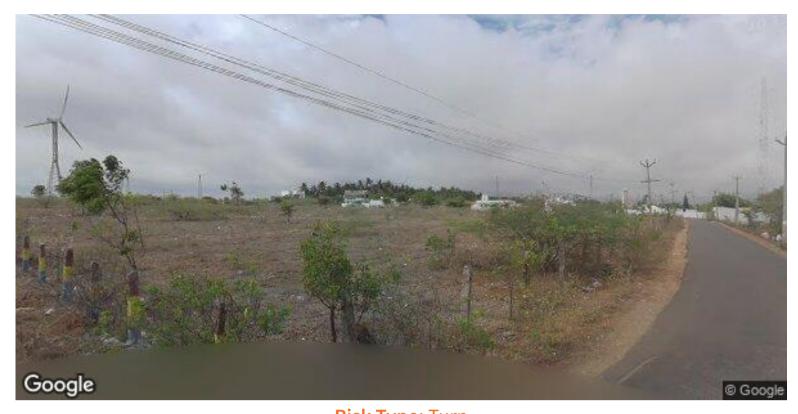
Risk Type: Turn
Risk Level: High
Speed Limit: 15 KM/Hr
Coordinates: 10.94340, 77.10925

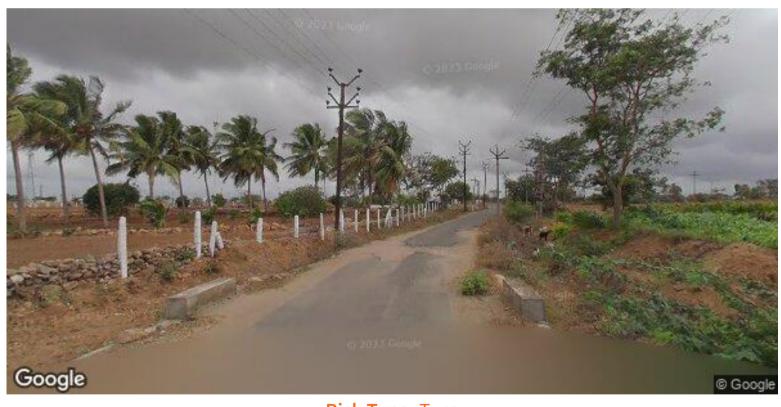
Risk Type: Turn
Risk Level: Medium
Speed Limit: 30 KM/Hr
Coordinates: 10.92492, 77.11587

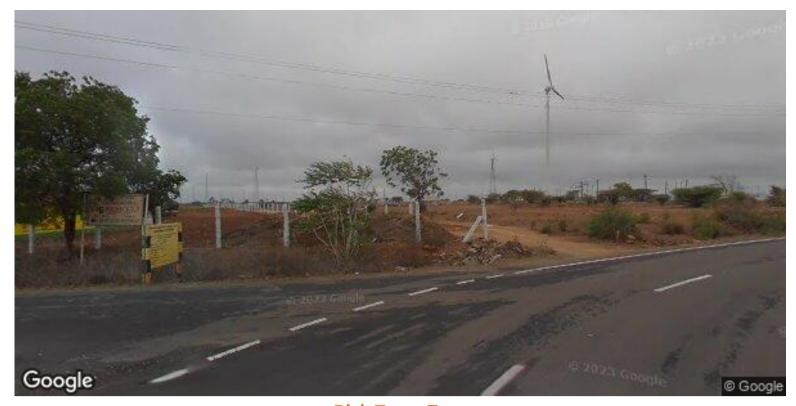
Risk Type: Turn
Risk Level: Medium
Speed Limit: 30 KM/Hr
Coordinates: 10.92372, 77.11547

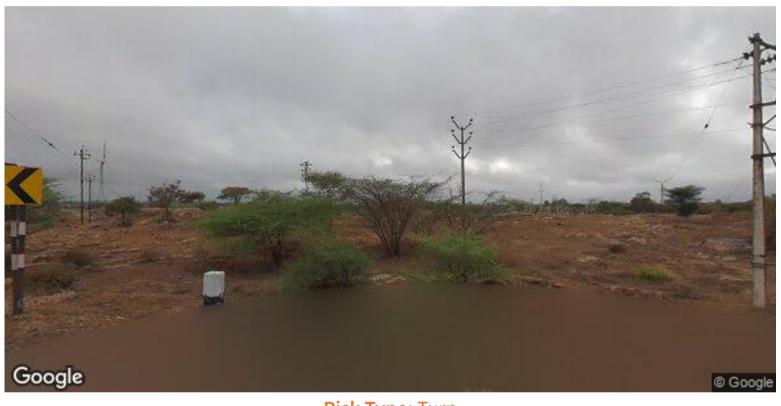
Risk Type: Turn
Risk Level: Medium
Speed Limit: 30 KM/Hr
Coordinates: 10.92270, 77.11562

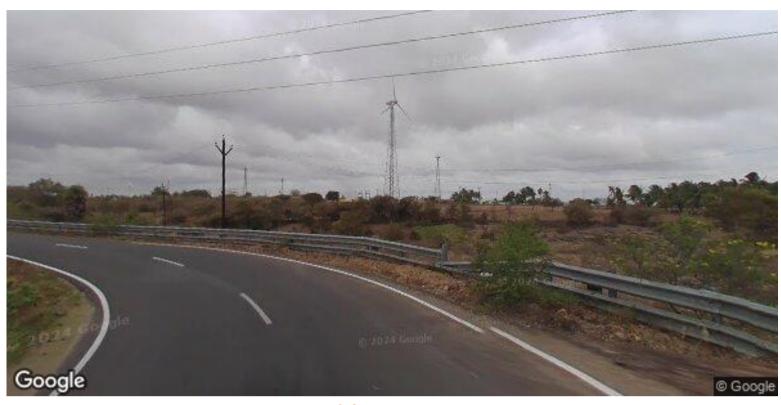
Risk Type: Turn
Risk Level: Medium
Speed Limit: 30 KM/Hr
Coordinates: 10.91081, 77.12302

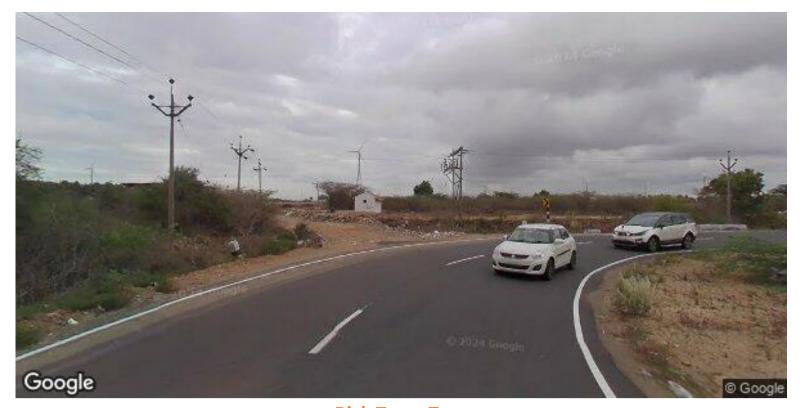
Risk Type: Turn
Risk Level: Medium
Speed Limit: 30 KM/Hr
Coordinates: 10.91151, 77.12434

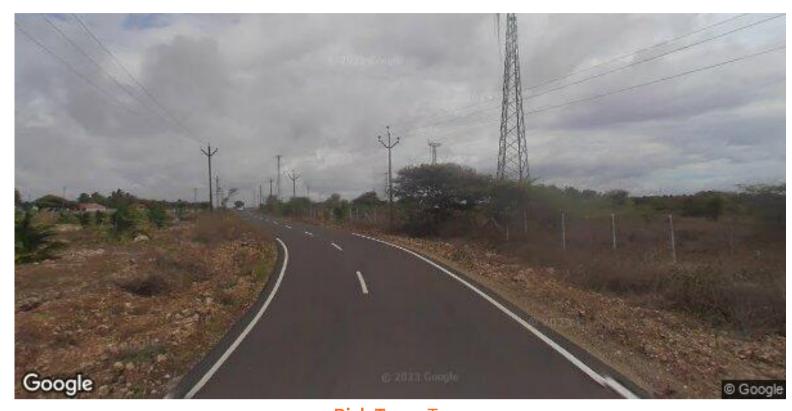
Coordinates: 10.90876, 77.12759

Risk Type: Turn
Risk Level: Medium
Speed Limit: 30 KM/Hr

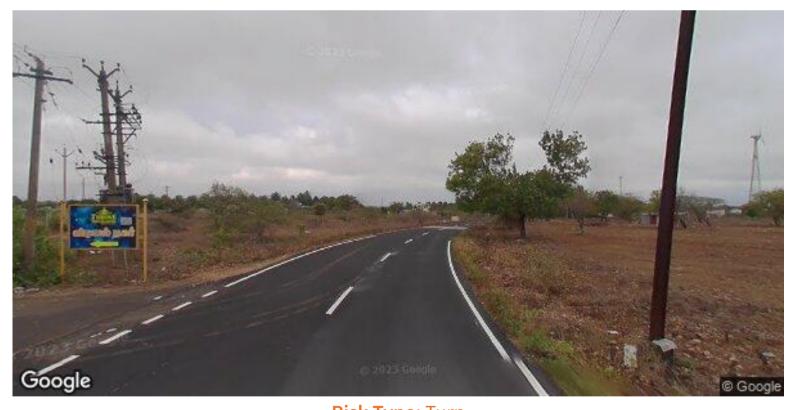
Risk Type: Turn
Risk Level: Medium
Speed Limit: 30 KM/Hr
Coordinates: 10.90545, 77.13168

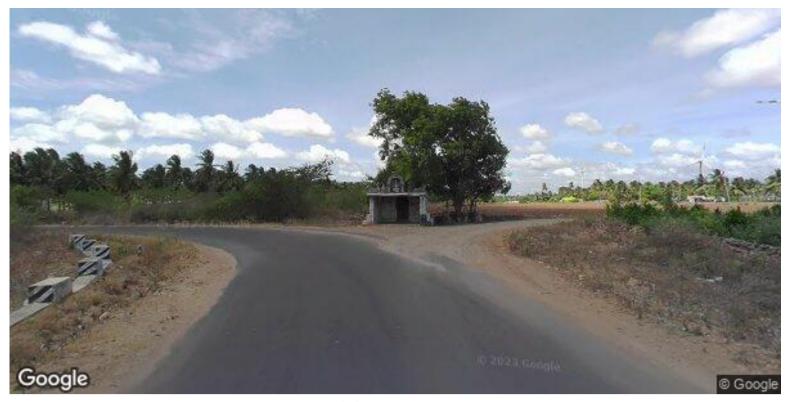
Risk Type: Turn
Risk Level: Medium
Speed Limit: 30 KM/Hr
Coordinates: 10.89766, 77.13692

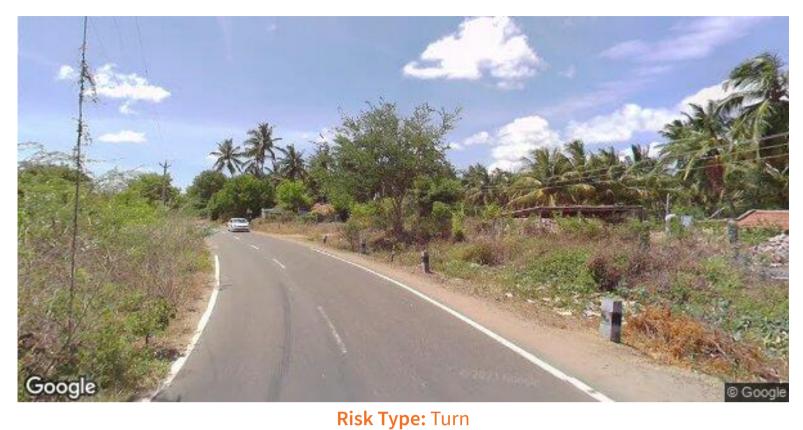
Coordinates: 10.89197, 77.14253

Risk Type: Turn

Risk Level: Medium

Speed Limit: 30 KM/Hr

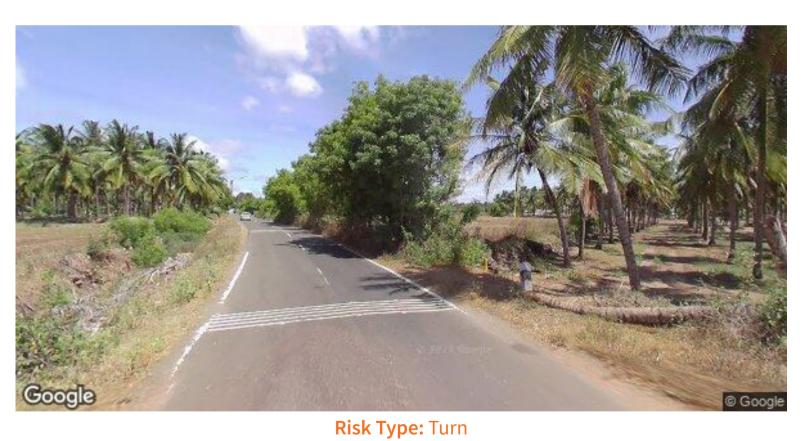
Risk Type. Turn
Risk Level: Medium
Speed Limit: 30 KM/Hr
Coordinates: 10.89241, 77.14486

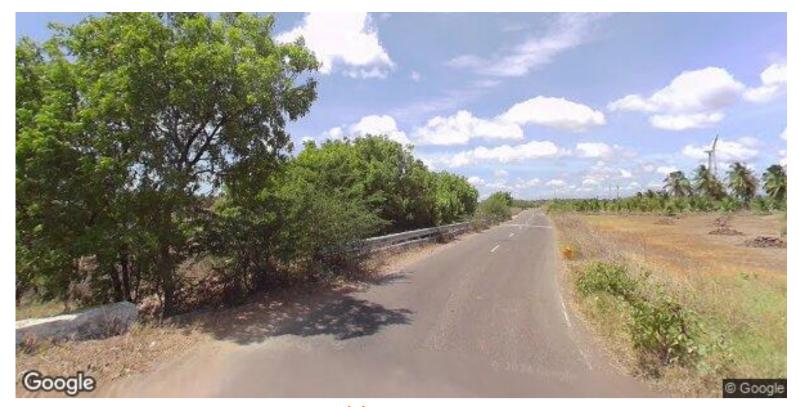
Risk Type: Turn
Risk Level: Medium
Speed Limit: 30 KM/Hr
Coordinates: 10.89236, 77.14497

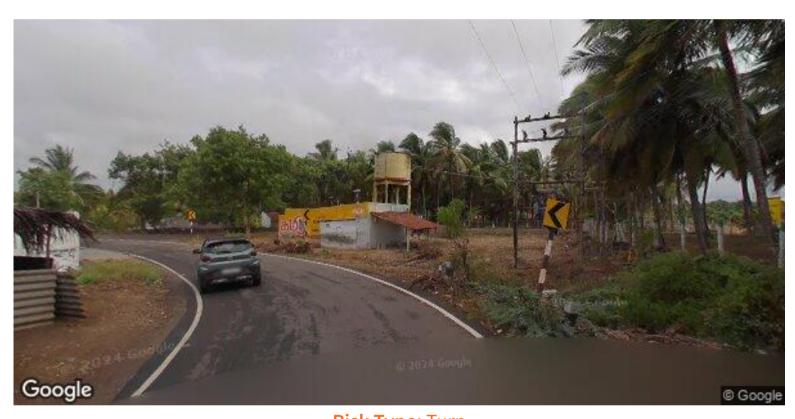
Risk Type: Turn
Risk Level: Medium
Speed Limit: 30 KM/Hr
Coordinates: 10.88399, 77.14962

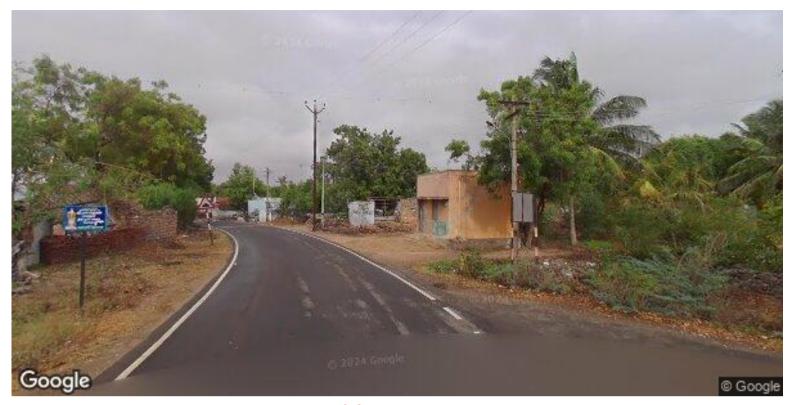
Coordinates: 10.88391, 77.15009

Risk Type: Turn
Risk Level: Medium
Speed Limit: 30 KM/Hr

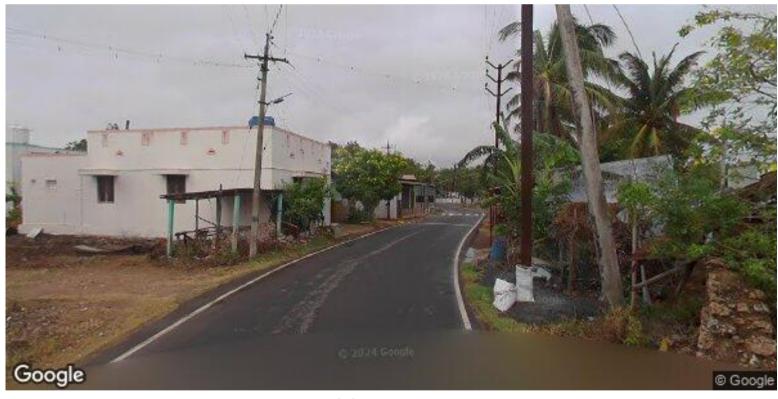
Coordinates: 10.88467, 77.15087

Risk Type: Turn
Risk Level: Medium
Speed Limit: 30 KM/Hr

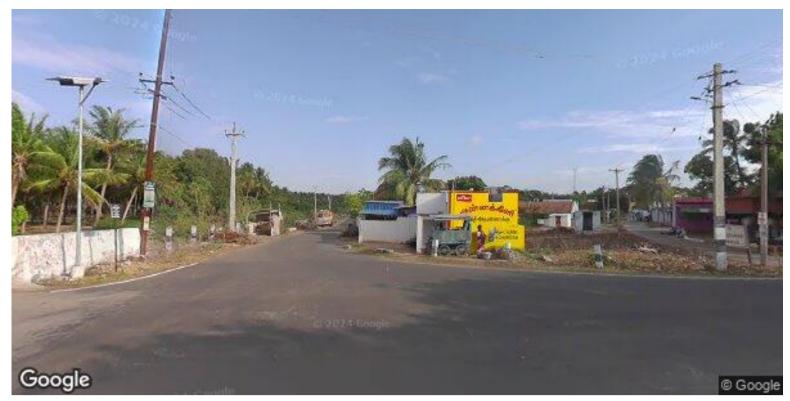
Risk Type: Turn
Risk Level: High
Speed Limit: 15 KM/Hr
Coordinates: 10.88510, 77.15153

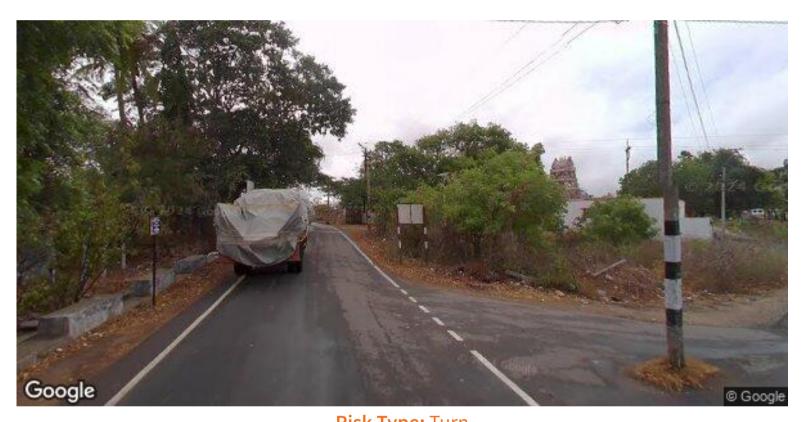
Risk Type: Turn
Risk Level: High
Speed Limit: 15 KM/Hr
Coordinates: 10.88070, 77.15428

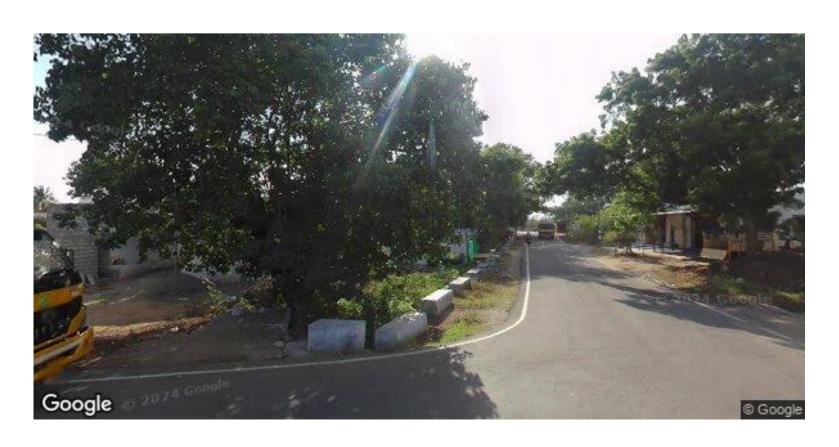
Coordinates: 10.88066, 77.15466

Risk Type: Turn
Risk Level: High
Speed Limit: 15 KM/Hr

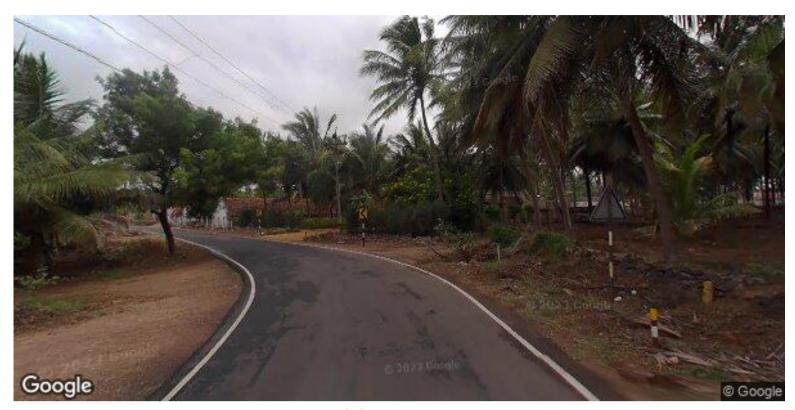
Risk Type: Turn
Risk Level: Medium
Speed Limit: 30 KM/Hr
Coordinates: 10.87580, 77.15538

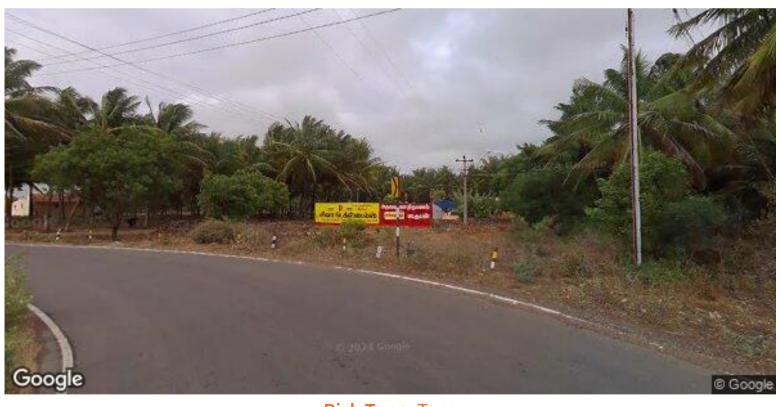
Risk Type: Turn
Risk Level: Medium
Speed Limit: 30 KM/Hr
Coordinates: 10.86481, 77.15684

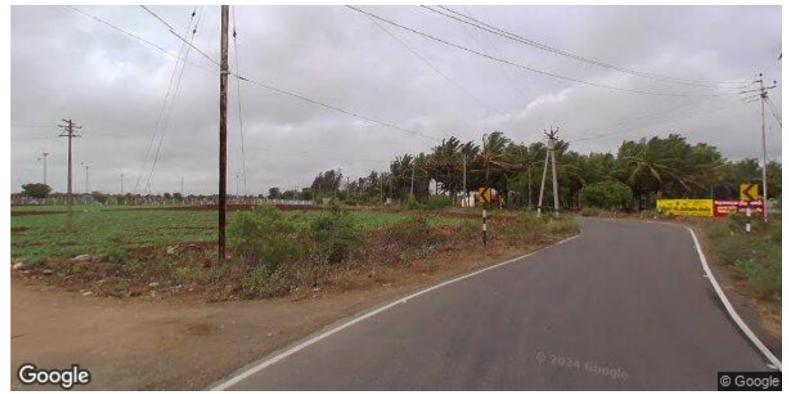
Risk Type: Turn
Risk Level: High
Speed Limit: 15 KM/Hr
Coordinates: 10.86464, 77.15662

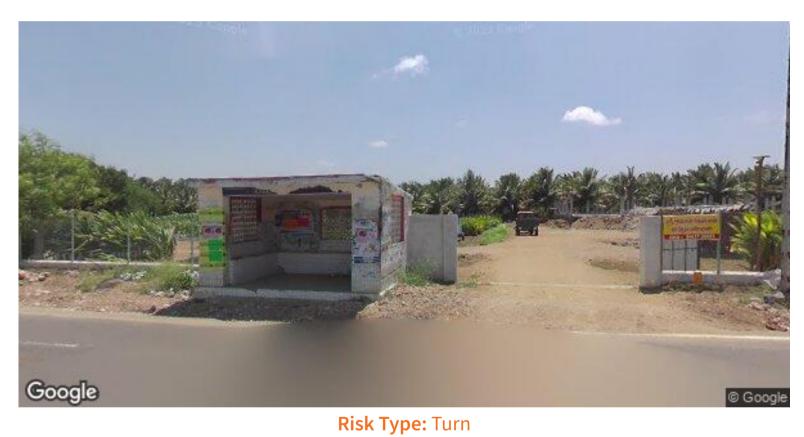
Risk Level: High
Speed Limit: 15 KM/Hr
Coordinates: 10.86243, 77.15711

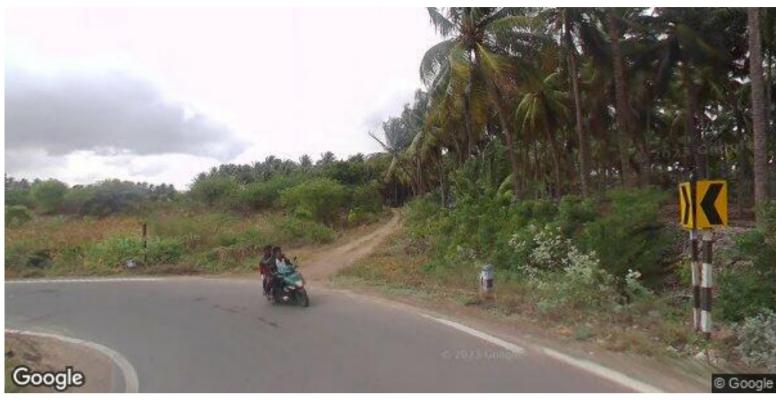
Risk Type: Turn
Risk Level: Medium
Speed Limit: 30 KM/Hr
Coordinates: 10.86418, 77.17498

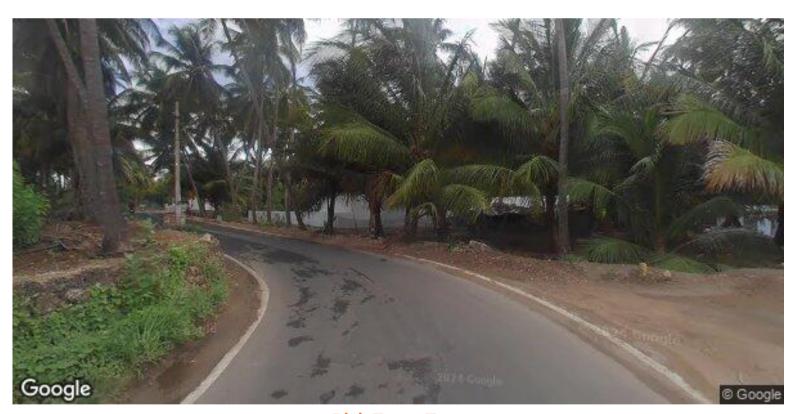
Risk Type: Turn
Risk Level: High
Speed Limit: 15 KM/Hr
Coordinates: 10.86301, 77.17570

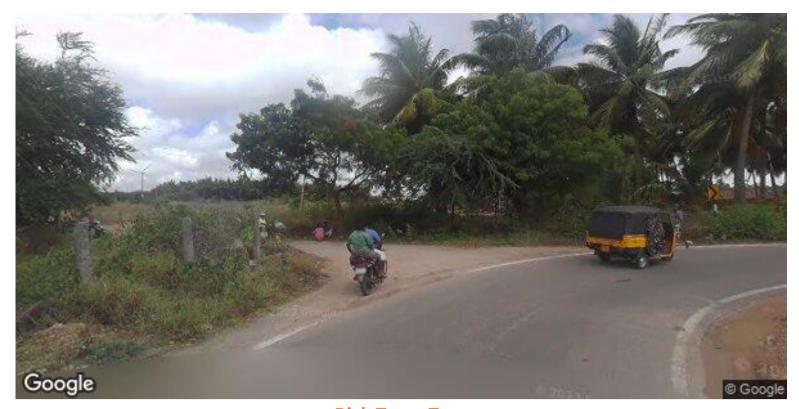
Risk Type: Turn
Risk Level: High
Speed Limit: 15 KM/Hr
Coordinates: 10.86213, 77.17967

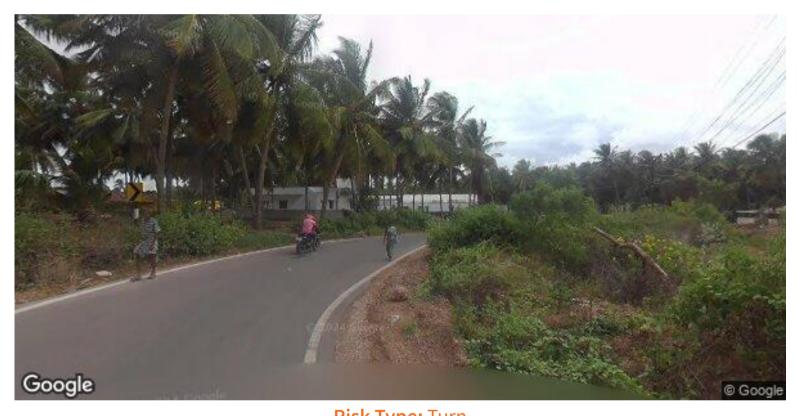
Risk Type: Turn
Risk Level: Medium
Speed Limit: 30 KM/Hr
Coordinates: 10.86204, 77.17973

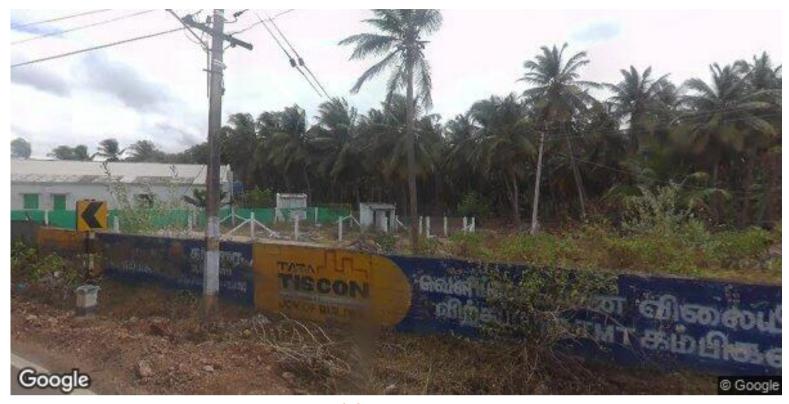
Coordinates: 10.86148, 77.17968

Risk Type: Turn
Risk Level: Medium
Speed Limit: 30 KM/Hr

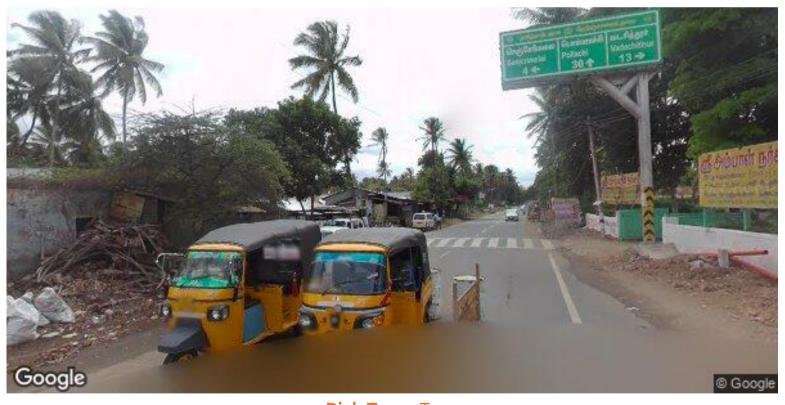
Coordinates: 10.85856, 77.18315

Risk Type: Turn
Risk Level: High
Speed Limit: 15 KM/Hr
