JOURNEY RISK MANAGEMENT (JRM) STUDY

IOCL Coimbatore Terminal to K Mohammed Abdul Khader

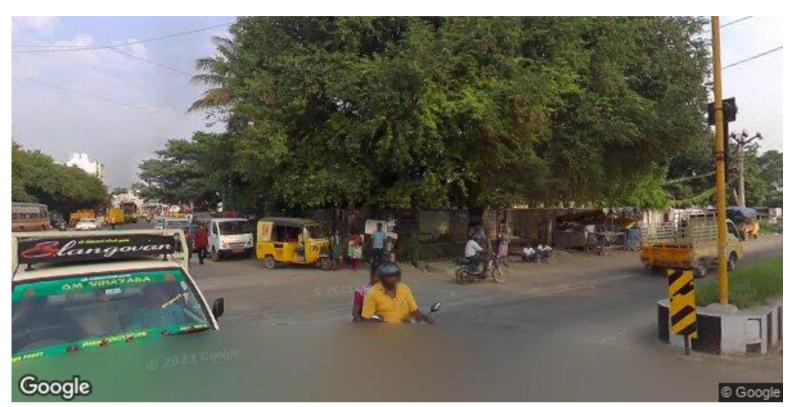
Coordinates: 11.07800, 77.03707

Risk Type: Roundabout Risk Level: High Speed Limit: 15 KM/Hr

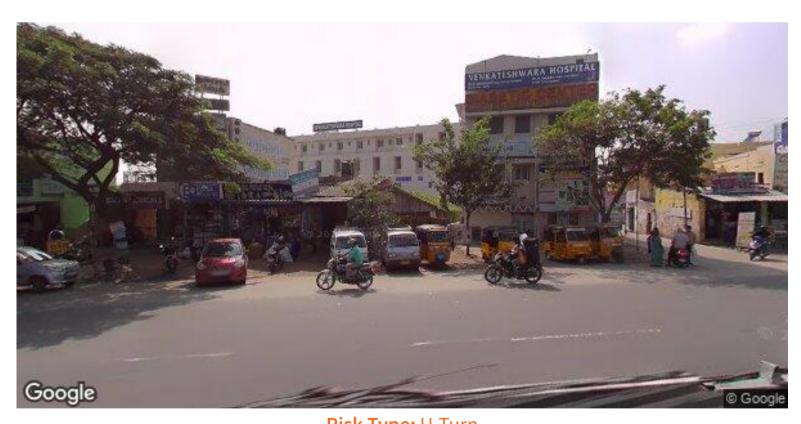
Coordinates: 11.0549503, 77.0650284

Risk Type: U-Turn
Risk Level: High
Speed Limit: 10 KM/Hr

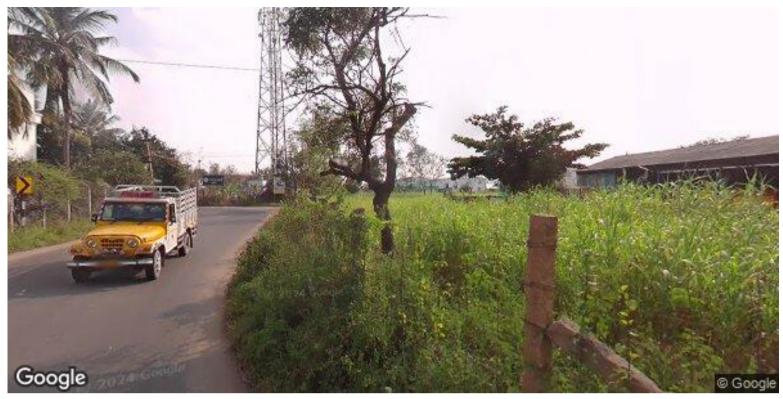
Coordinates: 11.05218, 77.07692

Risk Type: Turn
Risk Level: High
Speed Limit: 15 KM/Hr

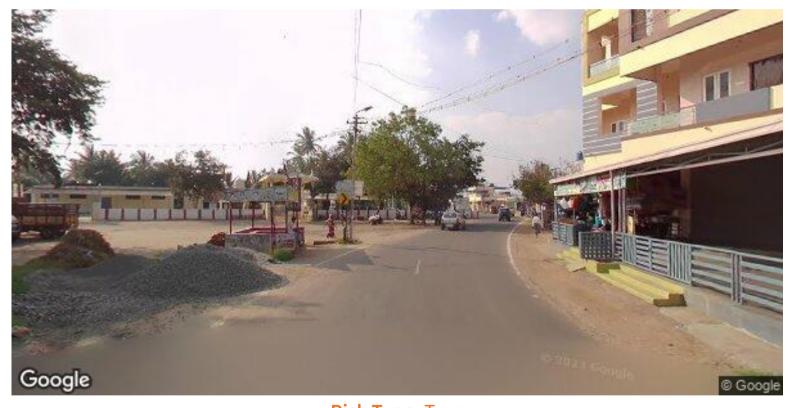
Coordinates: 11.05281, 77.07261

Risk Type: Turn
Risk Level: Medium
Speed Limit: 30 KM/Hr

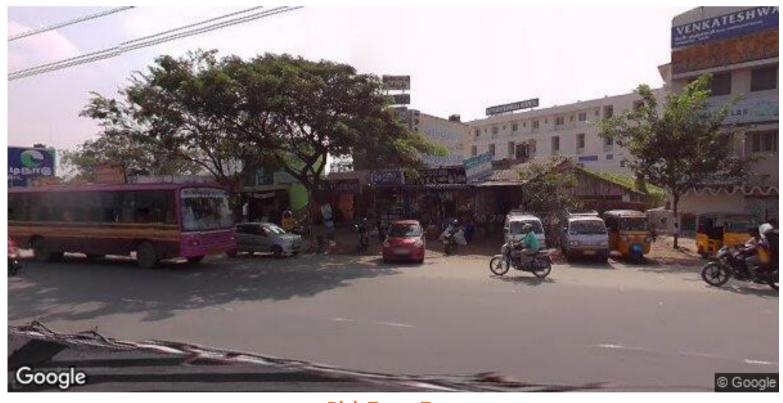
Coordinates: 11.05498, 77.06509

Risk Type: Turn
Risk Level: High
Speed Limit: 15 KM/Hr

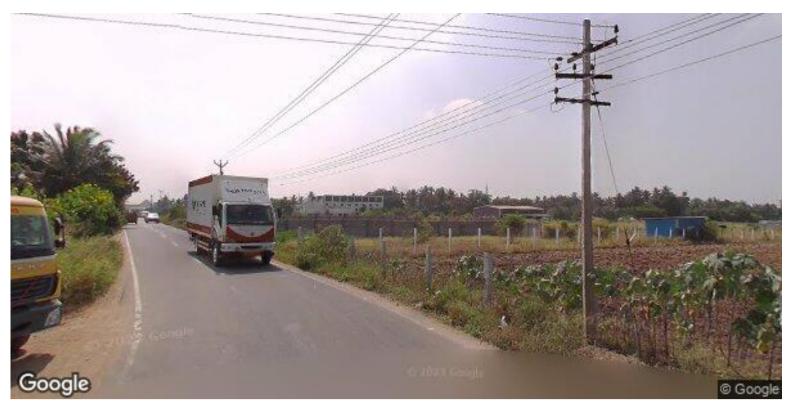
Risk Type: Turn
Risk Level: High
Speed Limit: 15 KM/Hr
Coordinates: 11.07201, 77.06366

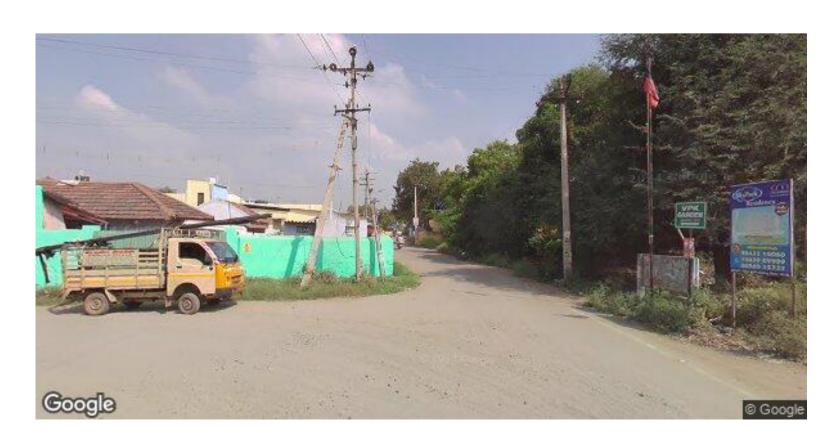
Coordinates: 11.07865, 77.06377

Risk Type: Blind Spot
Risk Level: Blind Spot
Speed Limit: 10 KM/Hr

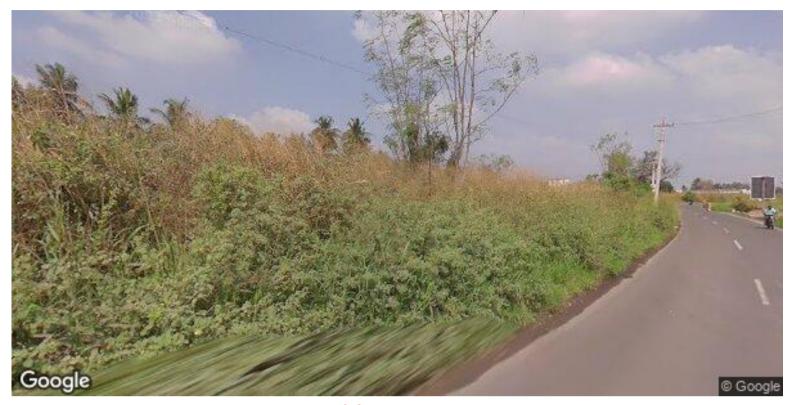
Coordinates: 11.07773, 77.05884

Risk Type: Turn
Risk Level: High
Speed Limit: 15 KM/Hr

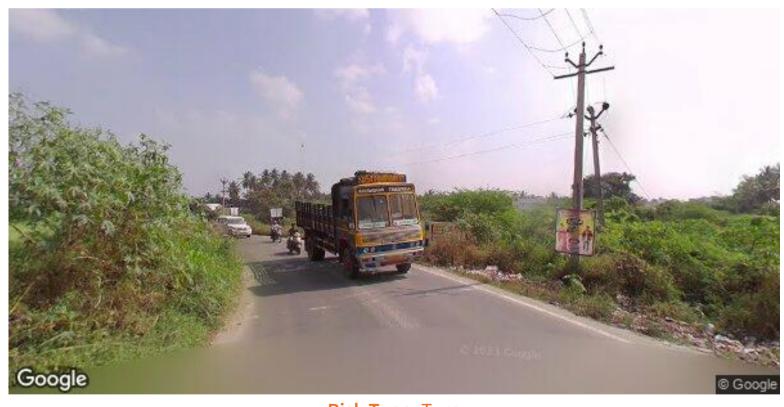
Risk Type: Turn
Risk Level: Medium
Speed Limit: 30 KM/Hr
Coordinates: 11.07655, 77.05823

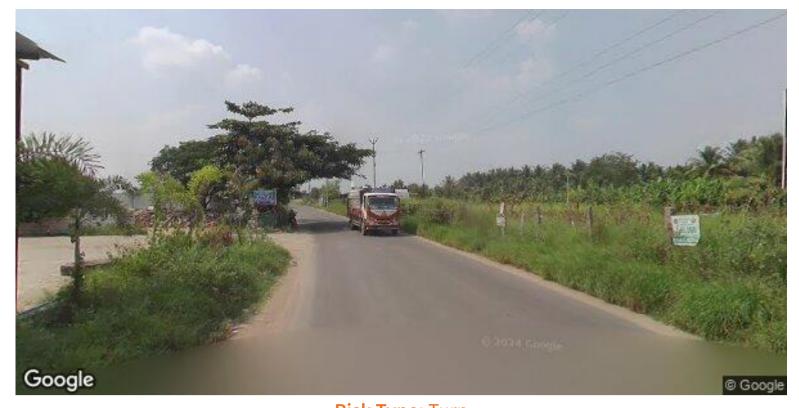
Risk Type: Turn
Risk Level: Medium
Speed Limit: 30 KM/Hr
Coordinates: 11.07807, 77.05306

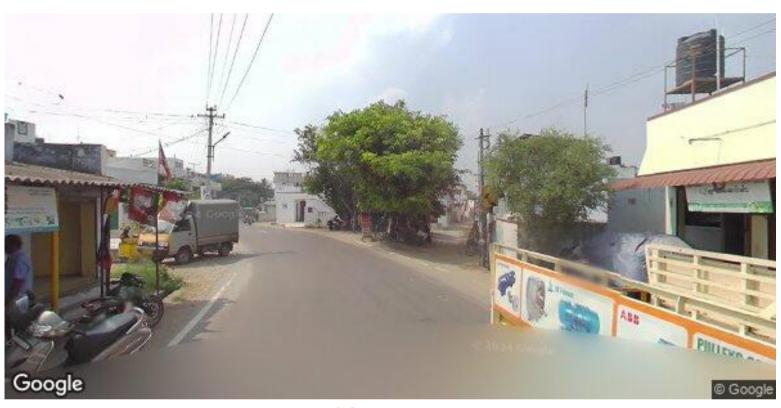
Risk Type: Turn
Risk Level: Medium
Speed Limit: 30 KM/Hr
Coordinates: 11.07854, 77.03872

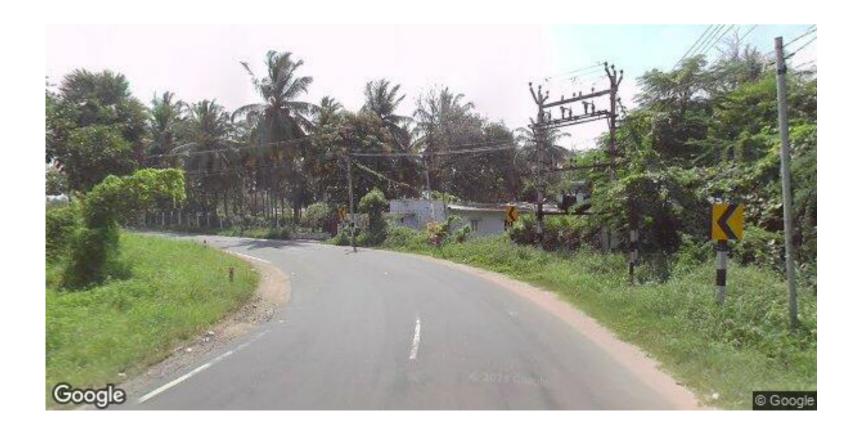
Coordinates: 11.09605, 77.03172

Risk Type: Turn
Risk Level: Medium
Speed Limit: 30 KM/Hr

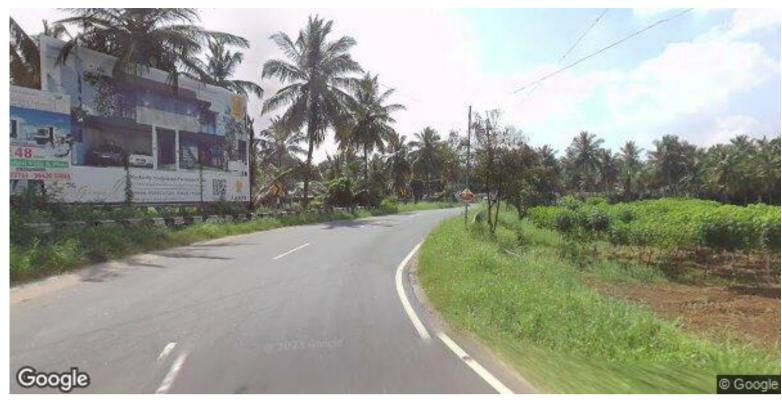
Risk Type: Turn
Risk Level: Medium
Speed Limit: 30 KM/Hr
Coordinates: 11.09655, 77.03237

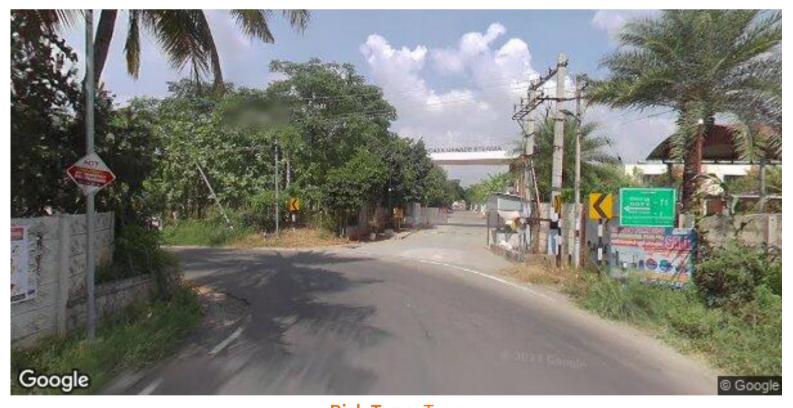
Risk Type: Turn
Risk Level: High
Speed Limit: 15 KM/Hr
Coordinates: 11.09837, 77.03248

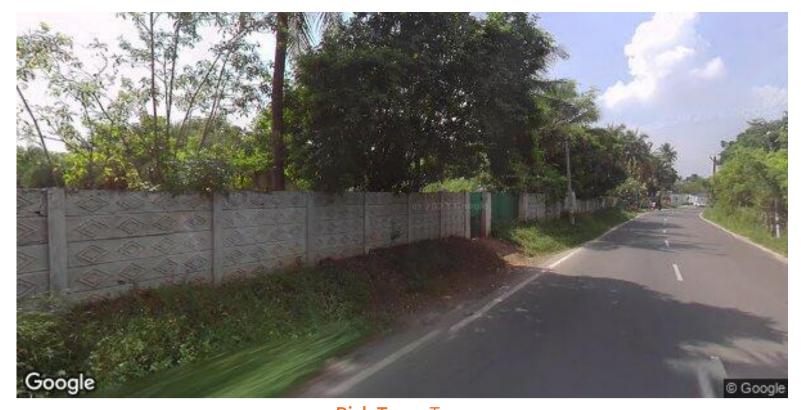
Risk Type: Turn
Risk Level: Medium
Speed Limit: 30 KM/Hr
Coordinates: 11.09852, 77.03233

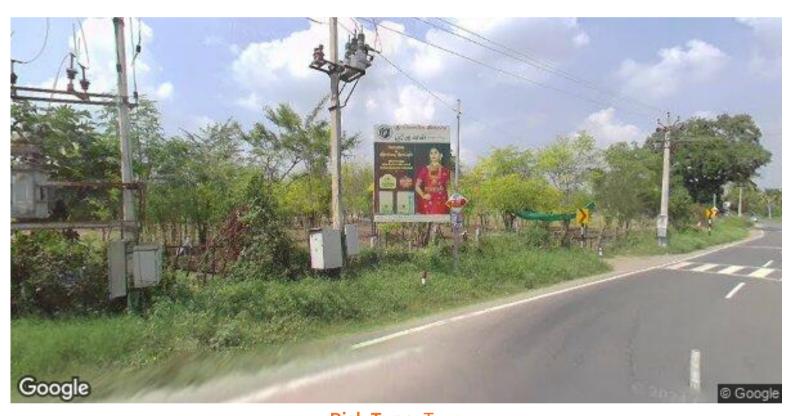
Risk Type: Turn
Risk Level: High
Speed Limit: 15 KM/Hr
Coordinates: 11.09883, 77.03091

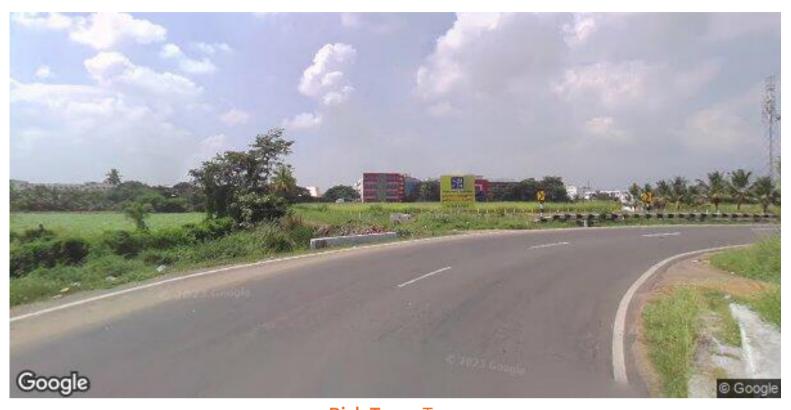
Risk Type: Turn
Risk Level: Medium
Speed Limit: 30 KM/Hr
Coordinates: 11.10312, 77.03001

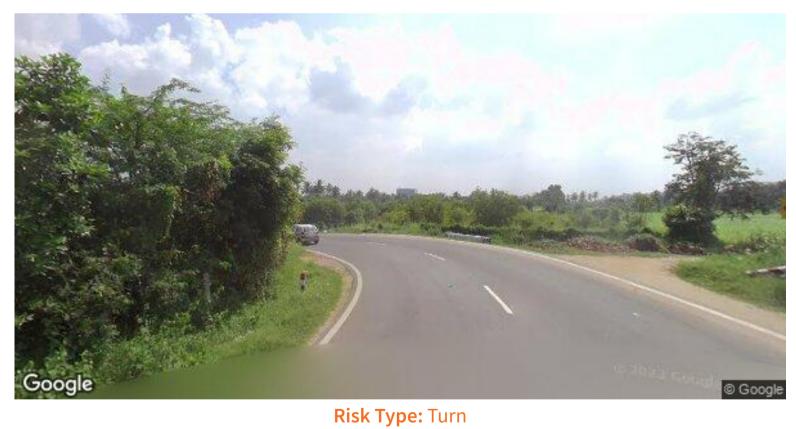
Risk Type. Turn
Risk Level: Medium
Speed Limit: 30 KM/Hr
Coordinates: 11.10331, 77.02984

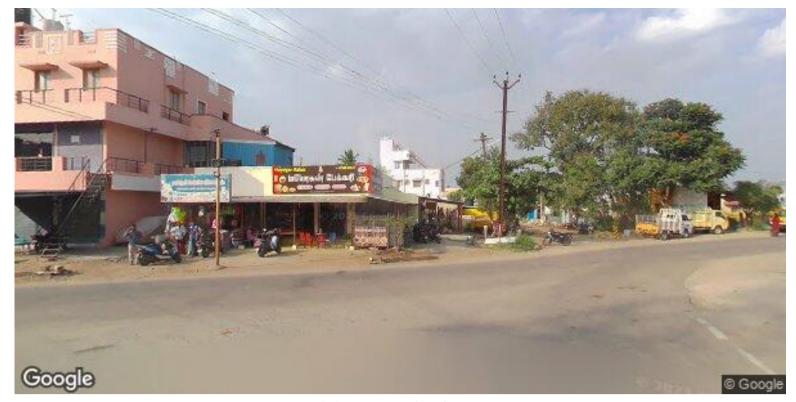
Coordinates: 11.11250, 77.03030

Risk Type: Blind Spot Risk Level: Blind Spot Speed Limit: 10 KM/Hr

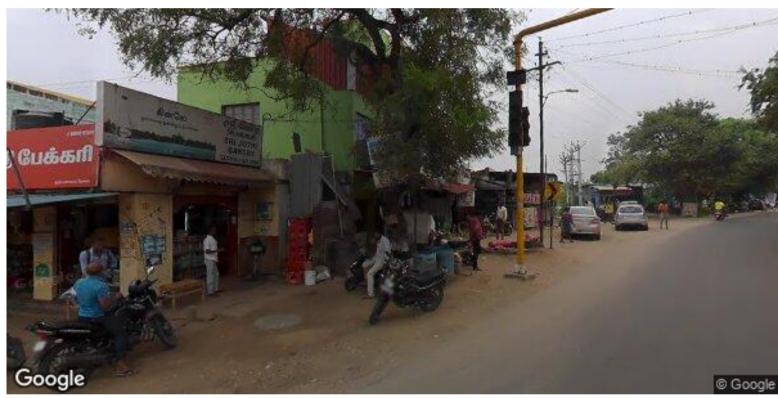
Risk Type: Blind Spot
Risk Level: Blind Spot
Speed Limit: 10 KM/Hr

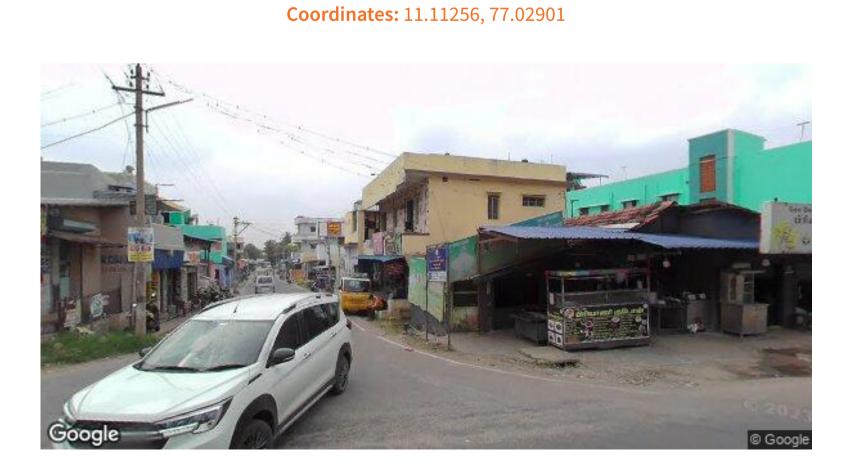
Coordinates: 11.13744, 77.03599

Risk Type: Blind Spot
Risk Level: Blind Spot
Speed Limit: 10 KM/Hr

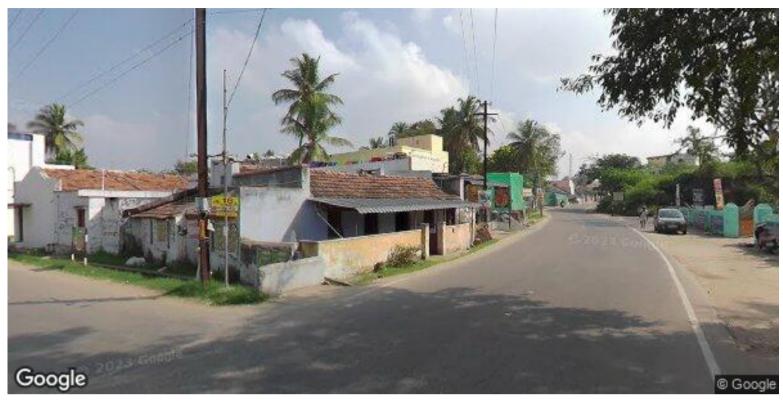
Coordinates: 11.13742, 77.03359

Risk Type: Blind Spot Risk Level: Blind Spot Speed Limit: 10 KM/Hr

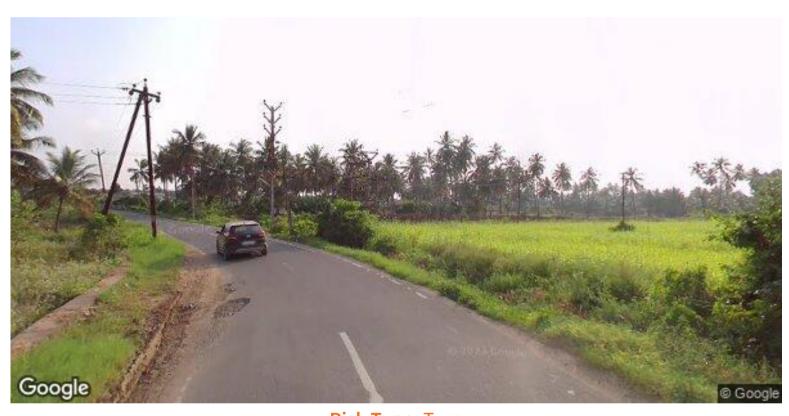
Risk Type: Turn
Risk Level: Medium
Speed Limit: 30 KM/Hr
Coordinates: 11.16732, 77.02884

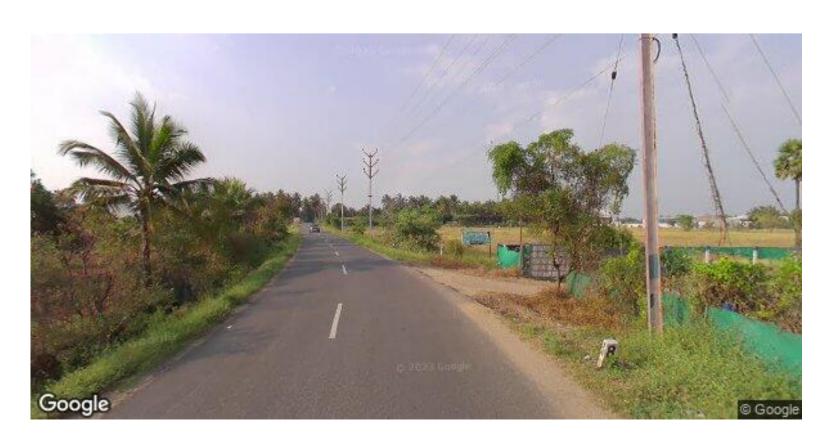
Coordinates: 11.16943, 77.02891

Risk Type: Turn
Risk Level: Medium
Speed Limit: 30 KM/Hr

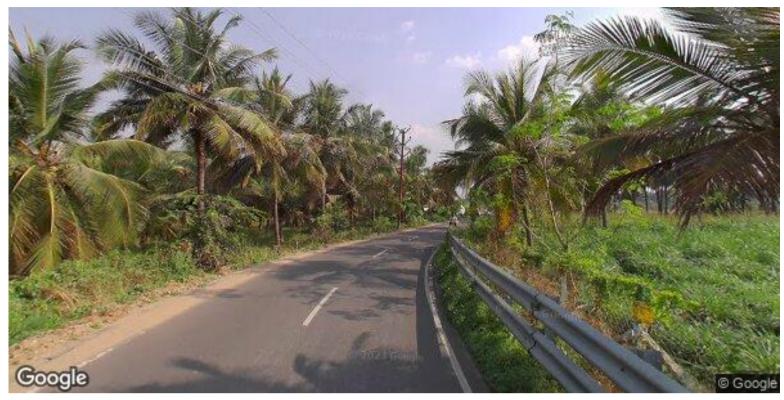
Risk Type: Turn
Risk Level: Medium
Speed Limit: 30 KM/Hr
Coordinates: 11.17187, 77.02752

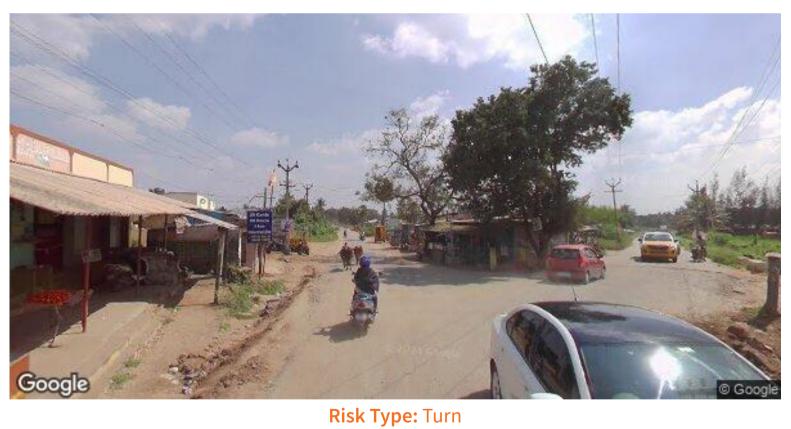
Risk Type. Turn
Risk Level: Medium
Speed Limit: 30 KM/Hr
Coordinates: 11.18436, 77.02299

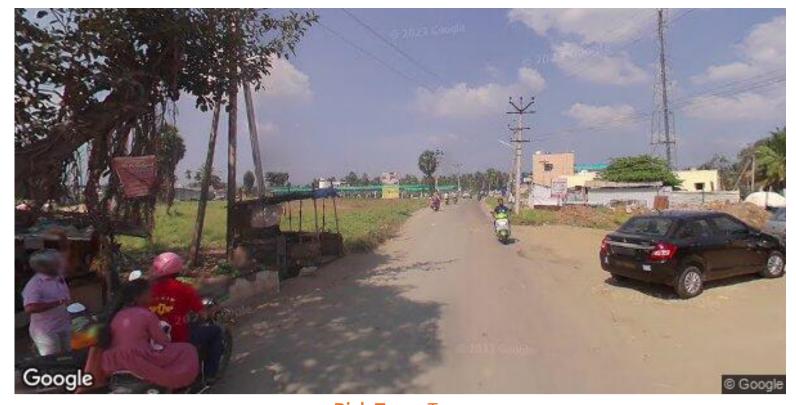
Risk Type: Turn
Risk Level: Medium
Speed Limit: 30 KM/Hr
Coordinates: 11.18446, 77.02279

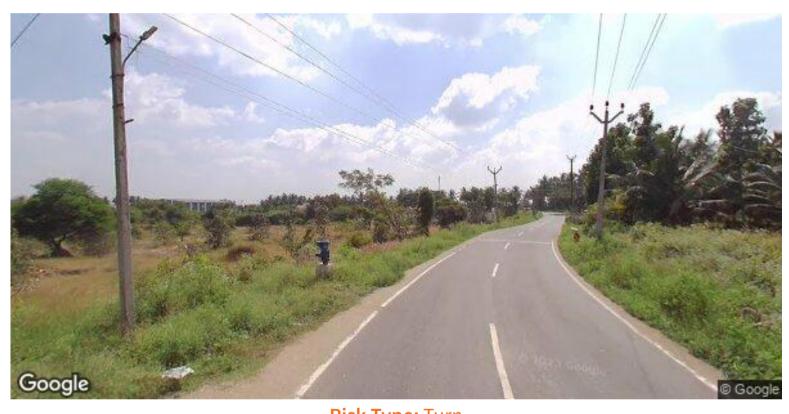
Risk Type: Turn
Risk Level: Medium
Speed Limit: 30 KM/Hr
Coordinates: 11.18881, 77.02127

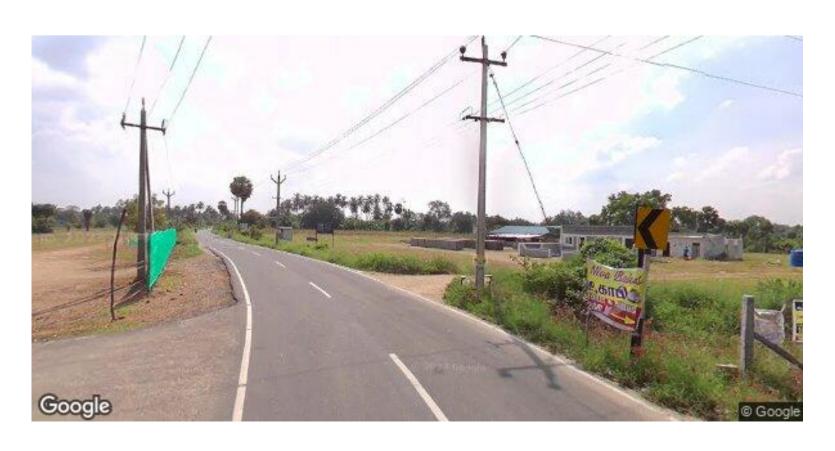
Coordinates: 11.20958, 77.00724

Risk Type: Turn
Risk Level: Medium
Speed Limit: 30 KM/Hr

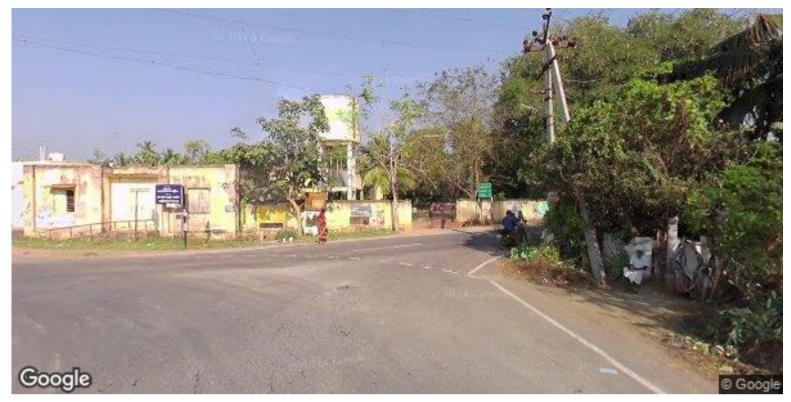
Risk Type: Turn
Risk Level: Medium
Speed Limit: 30 KM/Hr
Coordinates: 11.21403, 77.00250

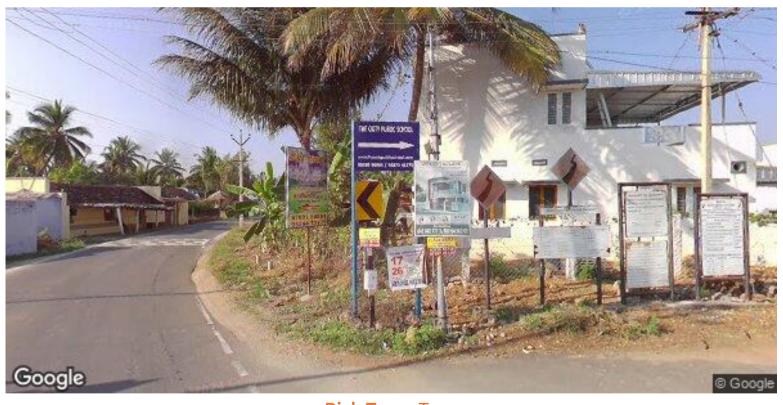
Risk Type: Turn
Risk Level: High
Speed Limit: 15 KM/Hr
Coordinates: 11.21427, 77.00246

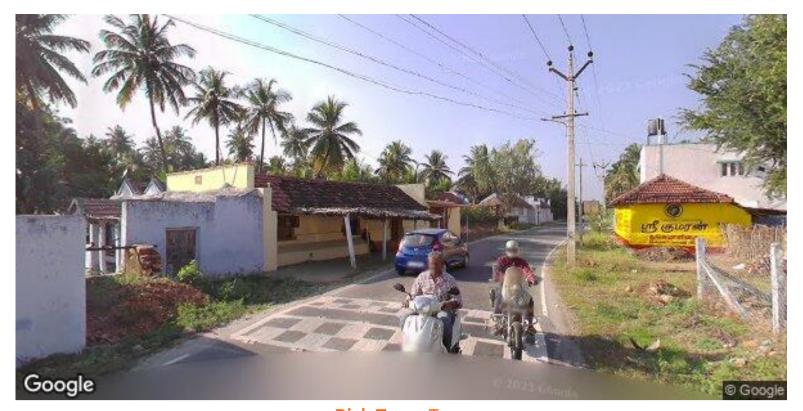
Risk Type: Turn
Risk Level: Medium
Speed Limit: 30 KM/Hr
Coordinates: 11.21435, 77.00232

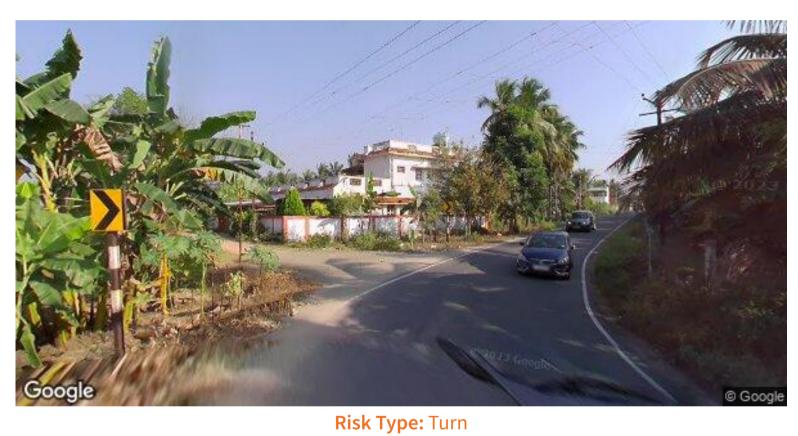
Risk Level: High
Speed Limit: 15 KM/Hr
Coordinates: 11.21575, 77.00174

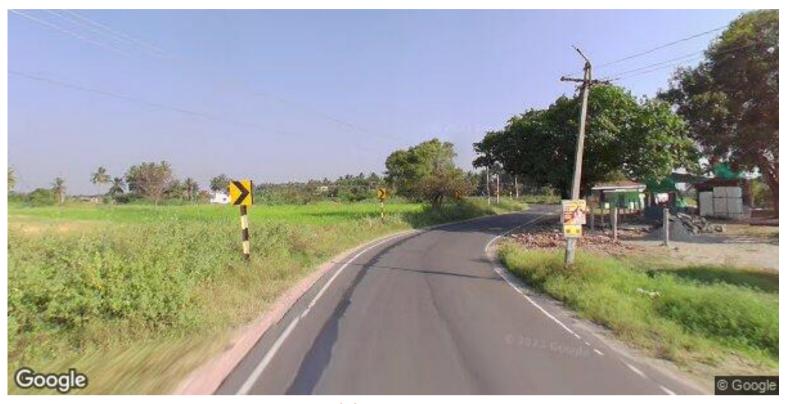
Risk Type: Turn
Risk Level: Medium
Speed Limit: 30 KM/Hr
Coordinates: 11.21638, 77.00010

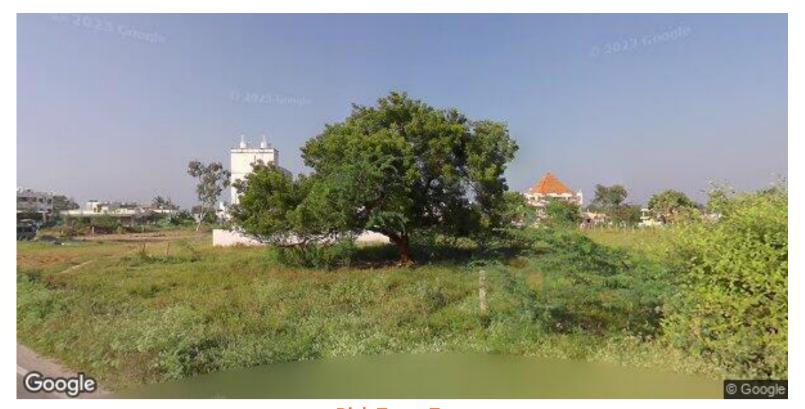
Risk Type: Turn
Risk Level: Medium
Speed Limit: 30 KM/Hr
Coordinates: 11.23428, 76.97860

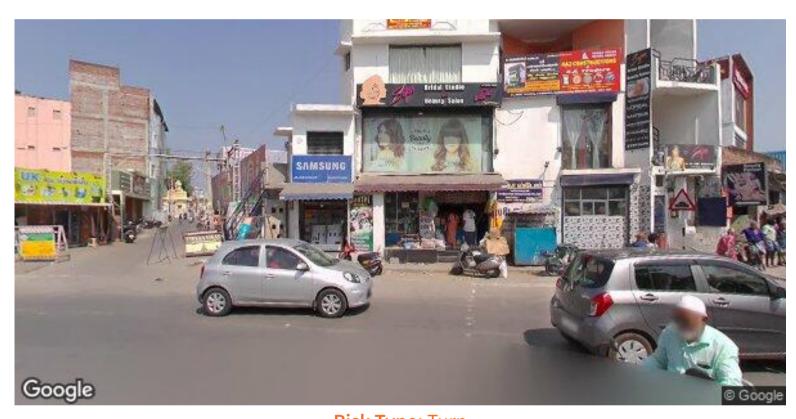
Risk Type: Turn
Risk Level: Medium
Speed Limit: 30 KM/Hr
Coordinates: 11.24082, 76.96002

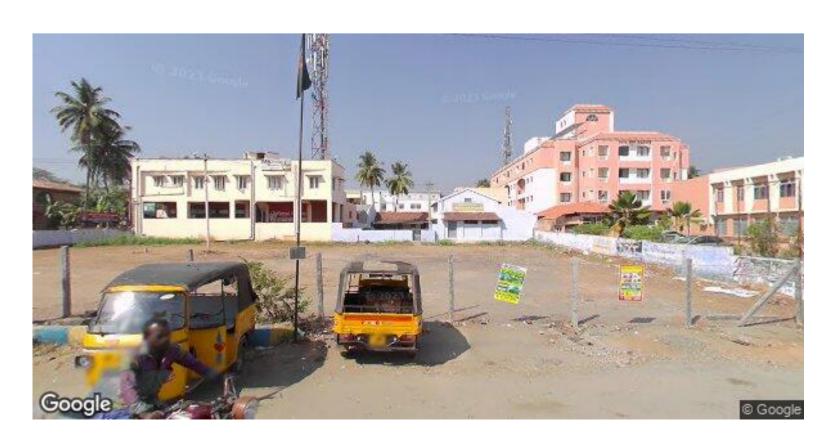
Coordinates: 11.30000, 76.93887

Risk Type: Blind Spot Risk Level: Blind Spot Speed Limit: 10 KM/Hr

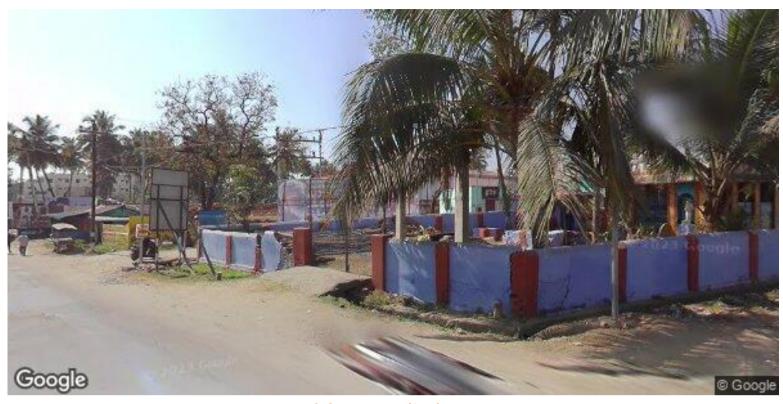
Coordinates: 11.30046, 76.94127

Risk Type: Blind Spot Risk Level: Blind Spot Speed Limit: 10 KM/Hr
