JOURNEY RISK MANAGEMENT (JRM) STUDY

Salem Terminal TO RAJA RATHNAM AGENCIES

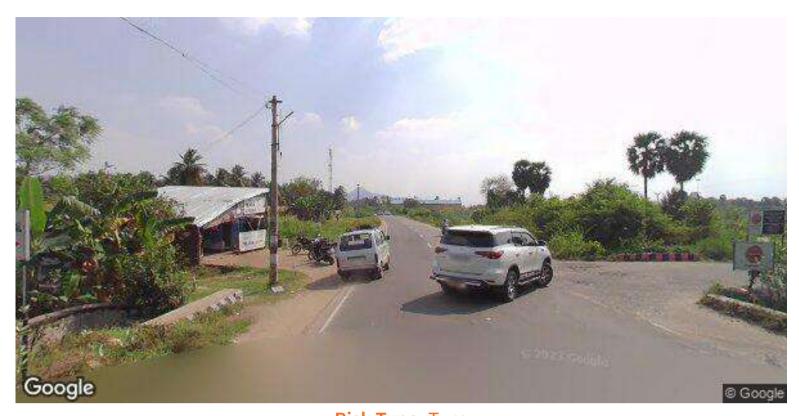
Risk Type: Turn
Speed Limit: 15 KM/Hr
Distance from Start: 0.28 km
Coordinates: 11.44029, 77.87544

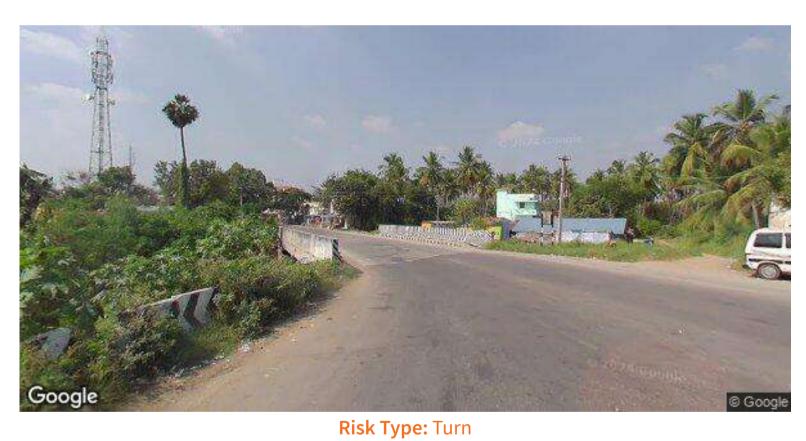
Speed Limit: 15 KM/Hr
Distance from Start: 1.29 km
Coordinates: 11.44893, 77.87413

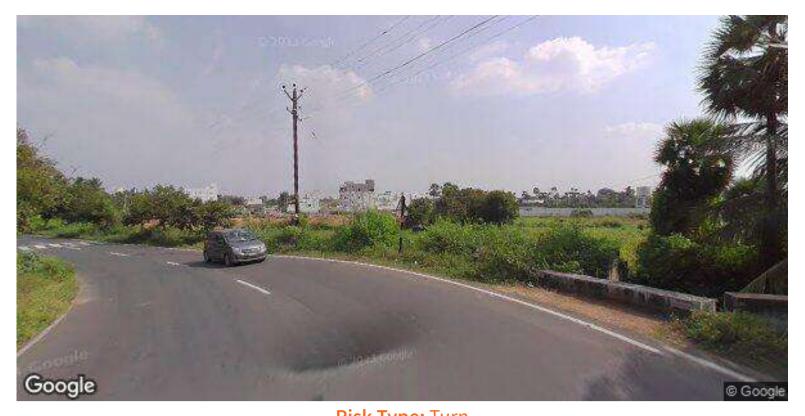
Risk Type: Turn
Speed Limit: 15 KM/Hr
Distance from Start: 3.28 km
Coordinates: 11.45350, 77.85700

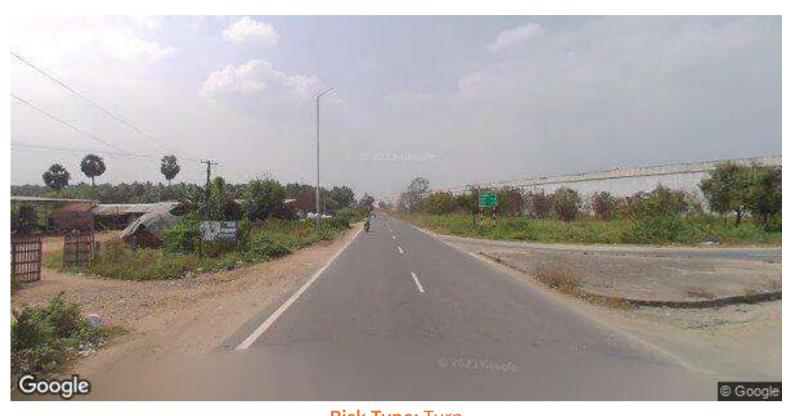
Risk Type: Turn
Speed Limit: 15 KM/Hr
Distance from Start: 8.35 km
Coordinates: 11.45542, 77.81725

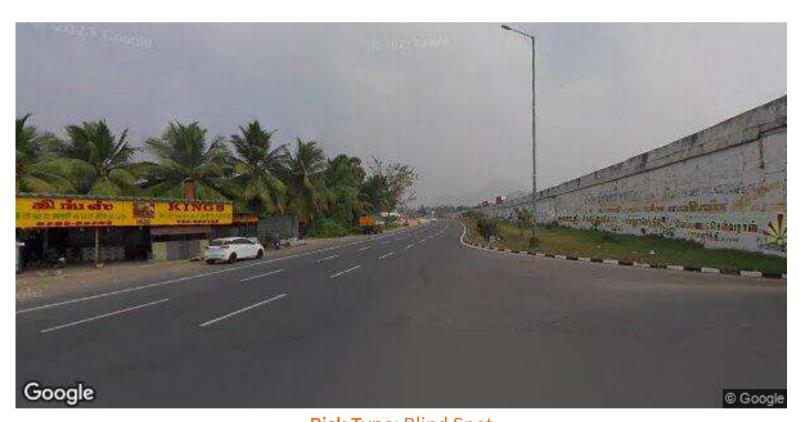
Risk Type: Blind Spot
Speed Limit: 10 KM/Hr
Distance from Start: 8.49 km
Coordinates: 11.45634, 77.81673

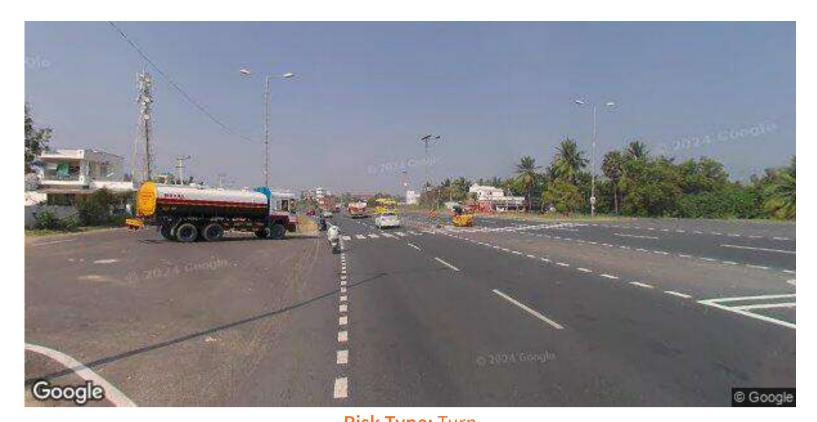
Risk Type: Turn
Speed Limit: 15 KM/Hr
Distance from Start: 13.81 km
Coordinates: 11.45081, 77.77034

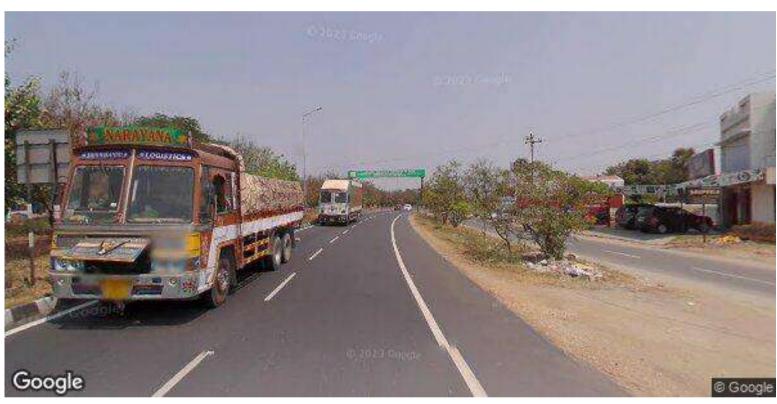
Risk Type: Turn
Speed Limit: 15 KM/Hr
Distance from Start: 24.40 km
Coordinates: 11.43192, 77.67803

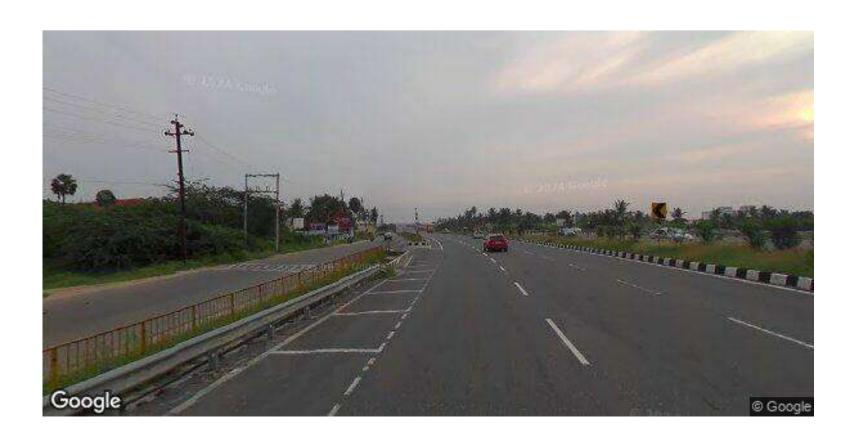
Risk Type: Turn
Speed Limit: 15 KM/Hr
Distance from Start: 83.57 km

Coordinates: 11.18785, 77.28659

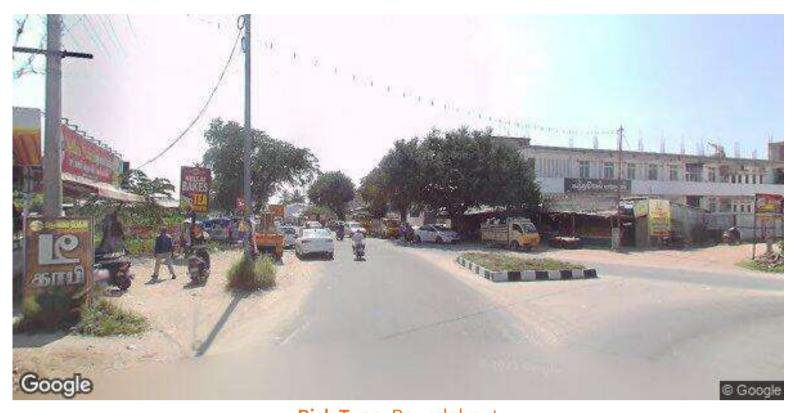
Risk Type: Roundabout
Speed Limit: 15 KM/Hr
Distance from Start: 86.60 km
Coordinates: 11.17250, 77.26863

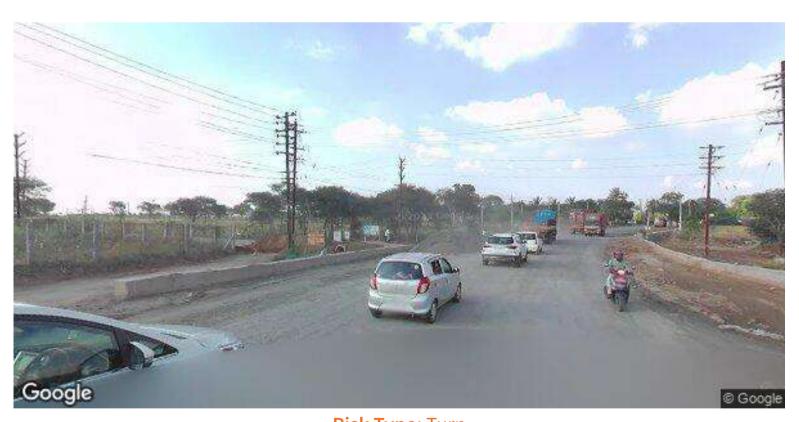
Risk Type: Turn
Speed Limit: 15 KM/Hr
Distance from Start: 89.65 km
Coordinates: 11.14580, 77.26363

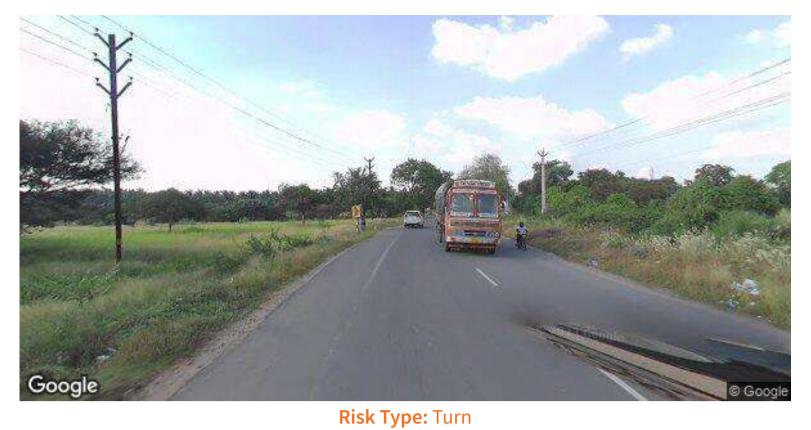
Speed Limit: 15 KM/Hr
Distance from Start: 90.23 km
Coordinates: 11.14029, 77.26520

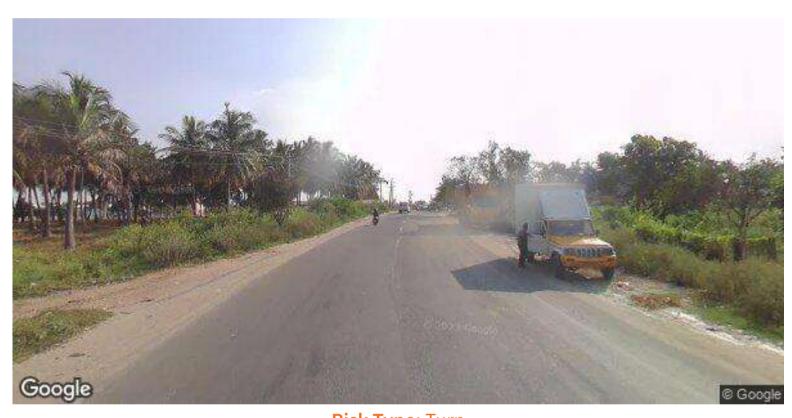
Risk Type: Turn
Speed Limit: 15 KM/Hr
Distance from Start: 93.78 km
Coordinates: 11.10890, 77.27134

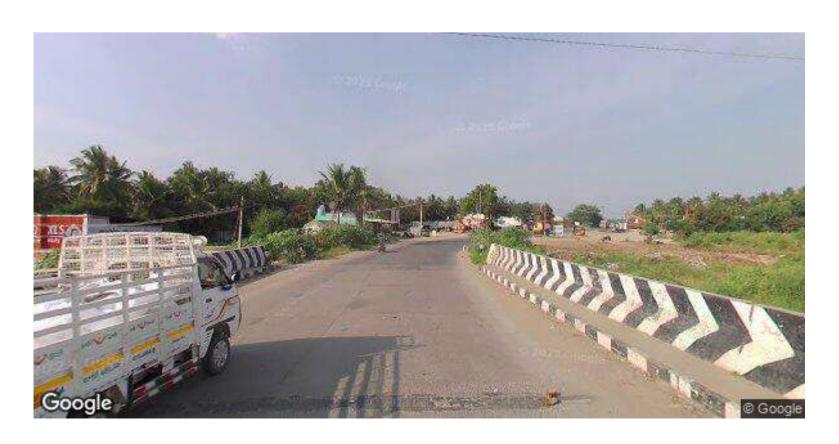
Risk Type: Turn
Speed Limit: 15 KM/Hr
Distance from Start: 94.21 km

Coordinates: 11.10628, 77.27042

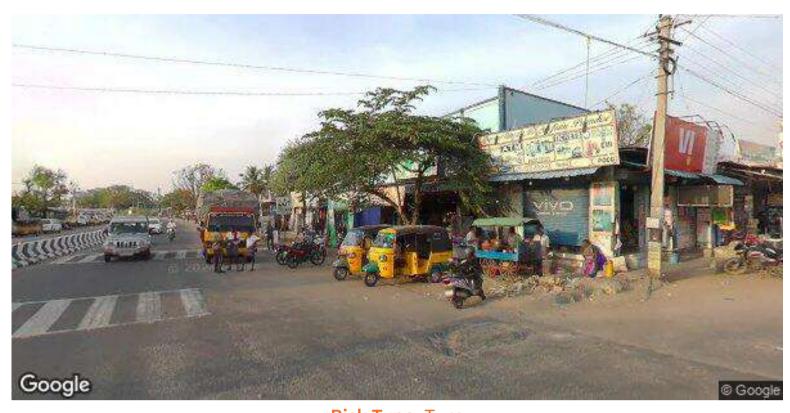
Risk Type: Turn
Speed Limit: 15 KM/Hr
Distance from Start: 94.66 km
Coordinates: 11.10249, 77.27147

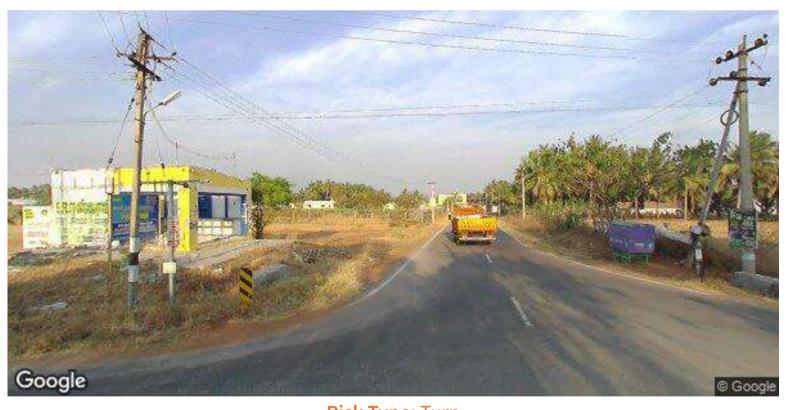
Risk Type: Turn
Speed Limit: 15 KM/Hr
Distance from Start: 97.21 km
Coordinates: 11.08036, 77.26776

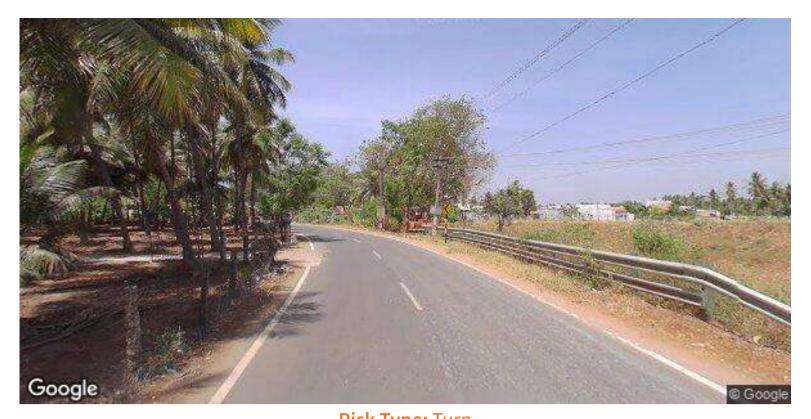
Risk Type: Turn
Speed Limit: 15 KM/Hr
Distance from Start: 97.73 km
Coordinates: 11.08063, 77.27250

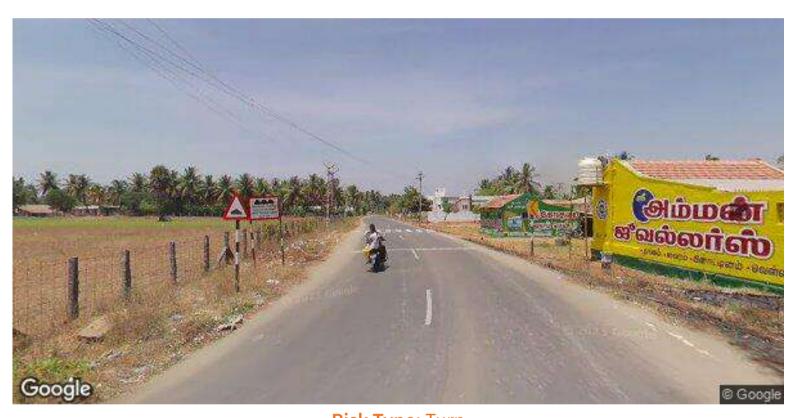
Risk Type: Turn
Speed Limit: 15 KM/Hr
Distance from Start: 98.08 km
Coordinates: 11.07990, 77.27587

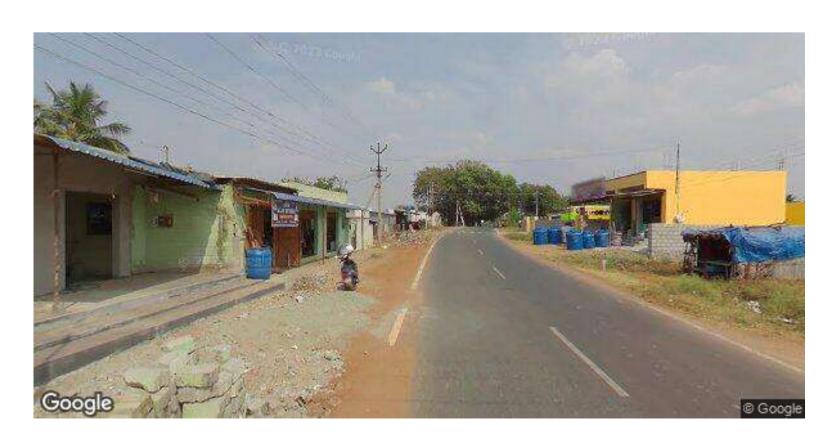
Risk Type: Turn
Speed Limit: 15 KM/Hr
Distance from Start: 98.85 km

Coordinates: 11.07952, 77.28248

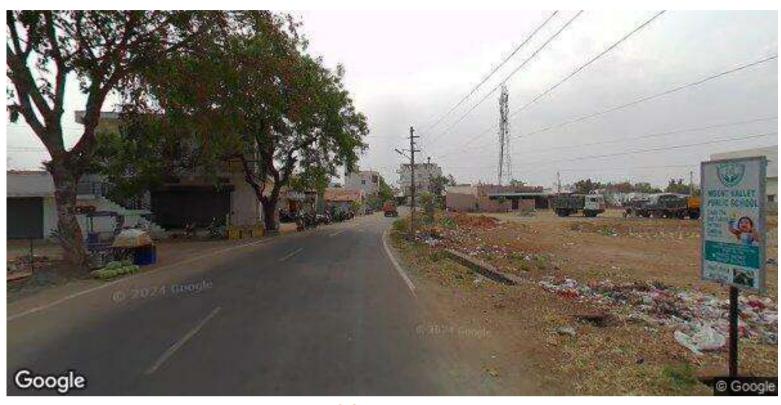
Risk Type: Turn
Speed Limit: 15 KM/Hr
Distance from Start: 99.46 km

Coordinates: 11.07878, 77.28748
