JOURNEY RISK MANAGEMENT (JRM) STUDY

Salem Terminal To SRI BALAGANAPATHI AGENCIES

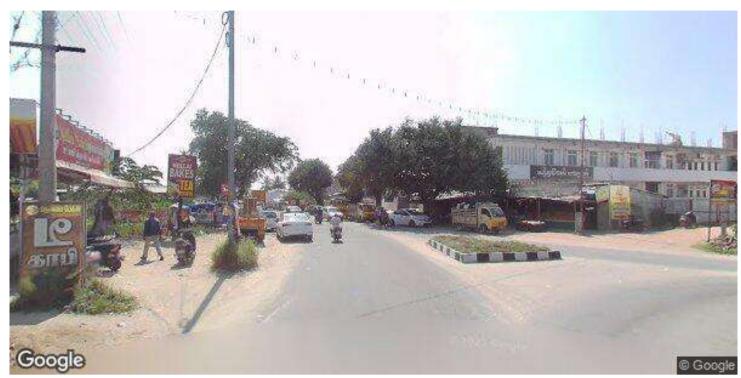
Coordinates: 11.17250, 77.26863

Risk Type: Roundabout
Risk Level: High
Speed Limit: 15 KM/Hr

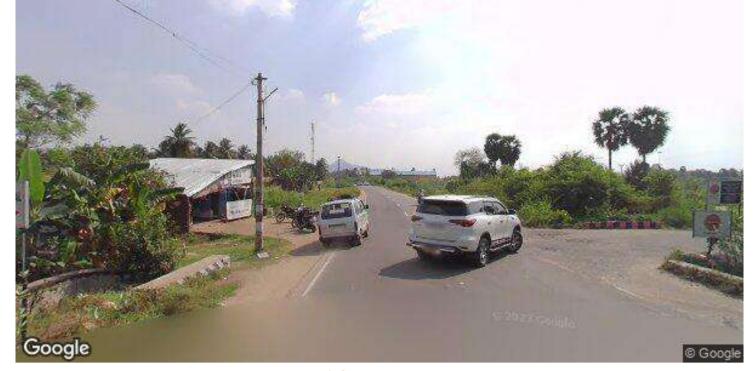
Risk Type: Turn
Risk Level: High
Speed Limit: 15 KM/Hr
Coordinates: 11.44029, 77.87544

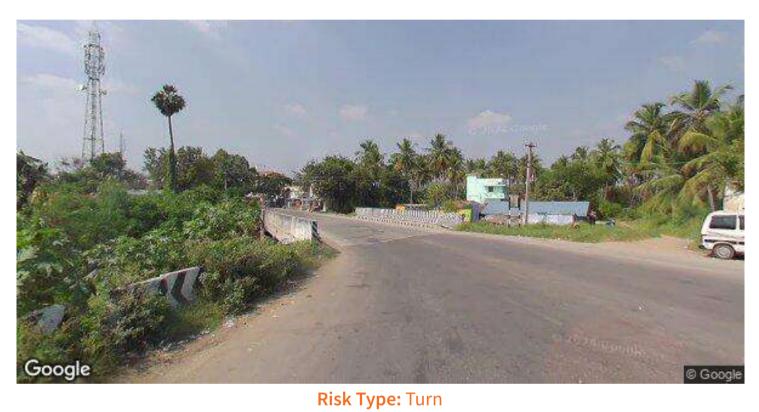
Risk Level: High
Speed Limit: 15 KM/Hr
Coordinates: 11.44893, 77.87413

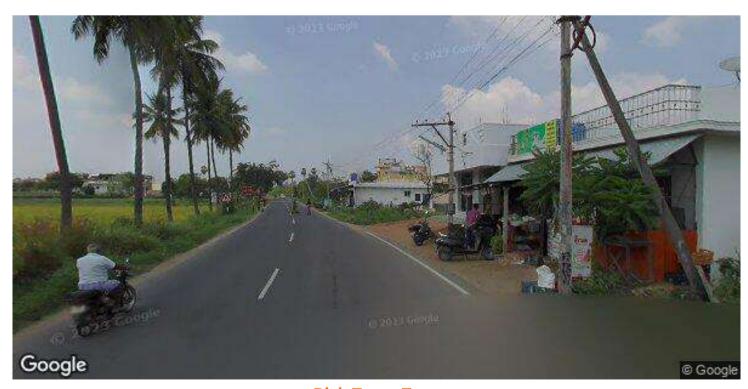
Risk Type: Turn
Risk Level: Medium

Speed Limit: 30 KM/Hr Coordinates: 11.45127, 77.86734

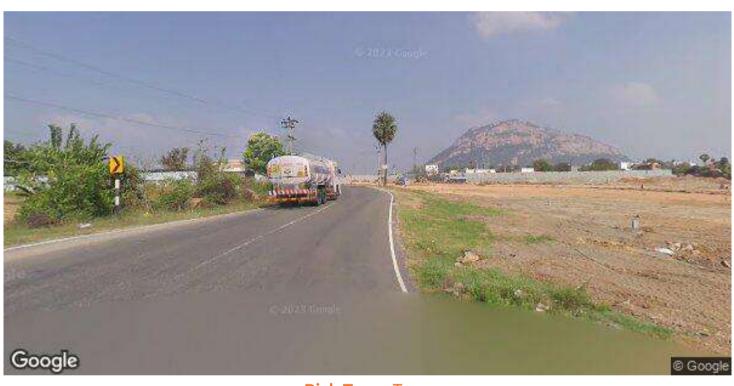
Risk Type: Turn
Risk Level: Medium
Speed Limit: 30 KM/Hr
Coordinates: 11.45845, 77.85141

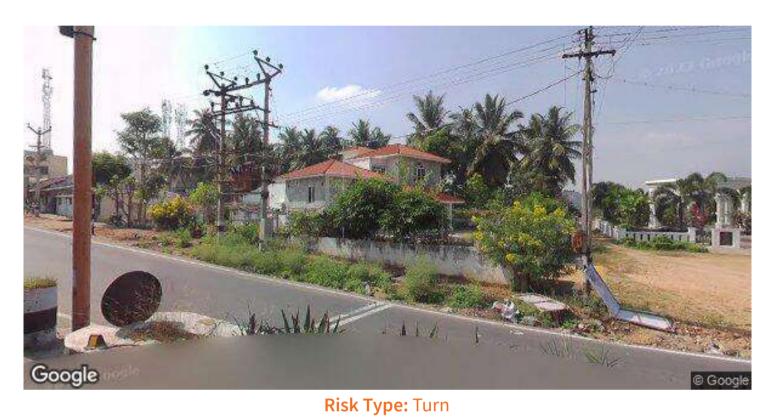
Risk Level: High
Speed Limit: 15 KM/Hr
Coordinates: 11.46303, 77.84945

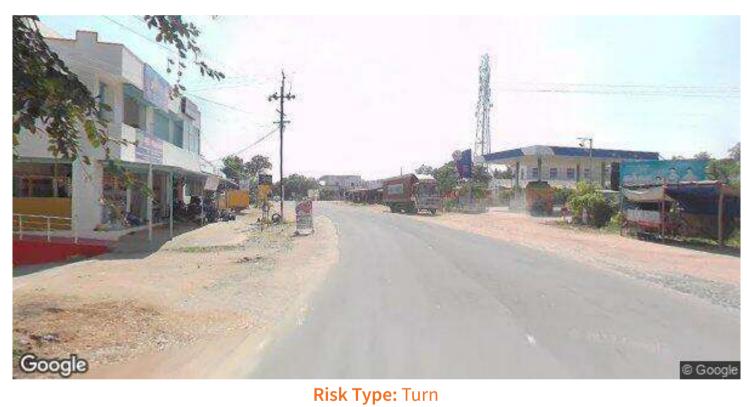
Risk Type: Turn
Risk Level: Medium
Speed Limit: 30 KM/Hr
Coordinates: 11.16875, 77.26763

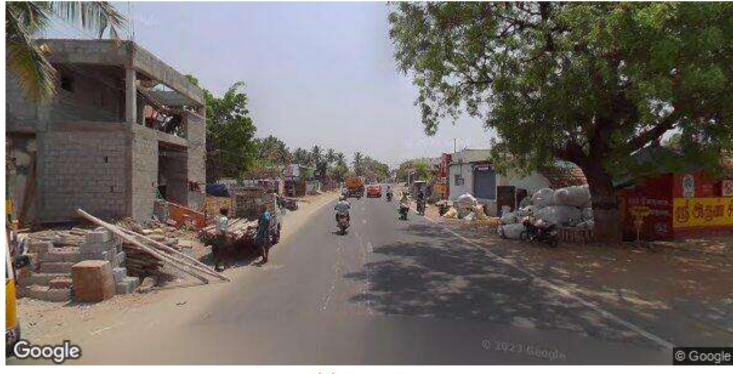
Coordinates: 11.10213, 77.28783

Risk Type: Turn Risk Level: High

Speed Limit: 15 KM/Hr
