JOURNEY RISK MANAGEMENT (JRM) STUDY

Salem Terminal to BHAVANI KOMARAPALAYAM LORRY

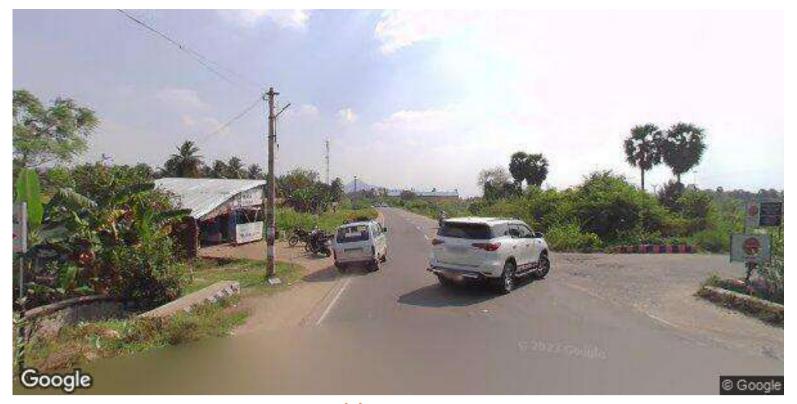
Risk Type: Turn
Risk Level: High
Speed Limit: 15 KM/Hr
Coordinates: 11.44029, 77.87544

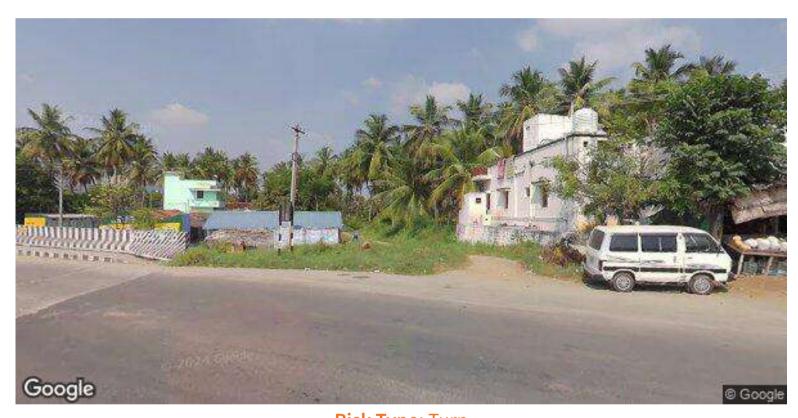
Risk Type: Turn
Risk Level: Medium
Speed Limit: 30 KM/Hr
Coordinates: 11.44898, 77.87410

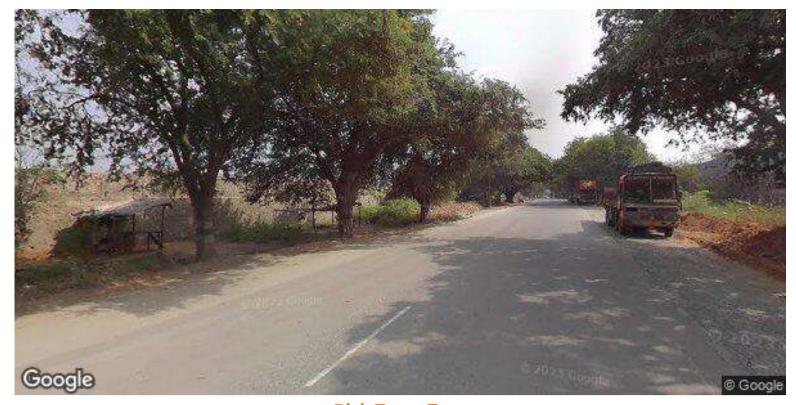
Risk Type: Turn
Risk Level: Medium
Speed Limit: 30 KM/Hr
Coordinates: 11.45697, 77.82719

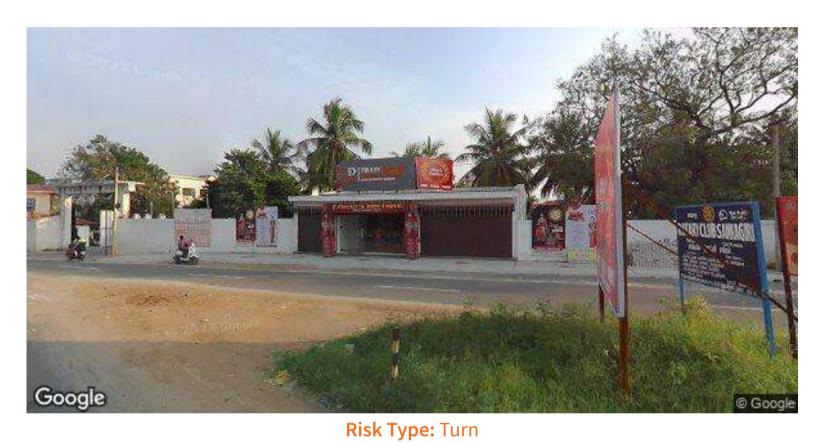
Risk Level: High
Speed Limit: 15 KM/Hr
Coordinates: 11.45516, 77.81346

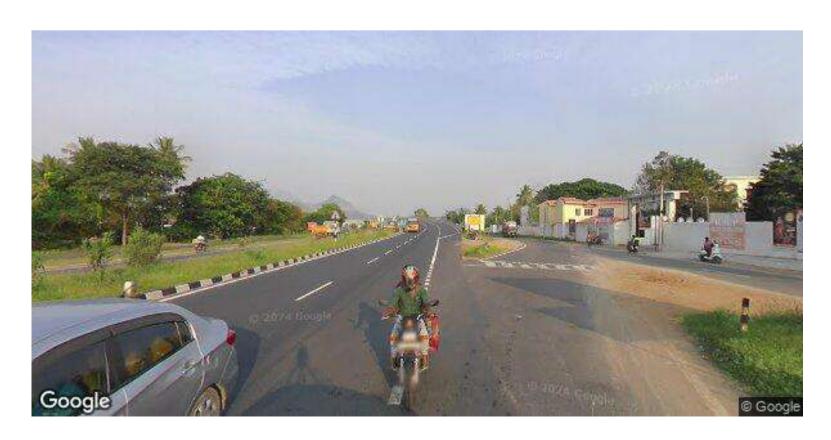
Coordinates: 11.45521, 77.81343

Risk Type: Turn
Risk Level: High
Speed Limit: 15 KM/Hr

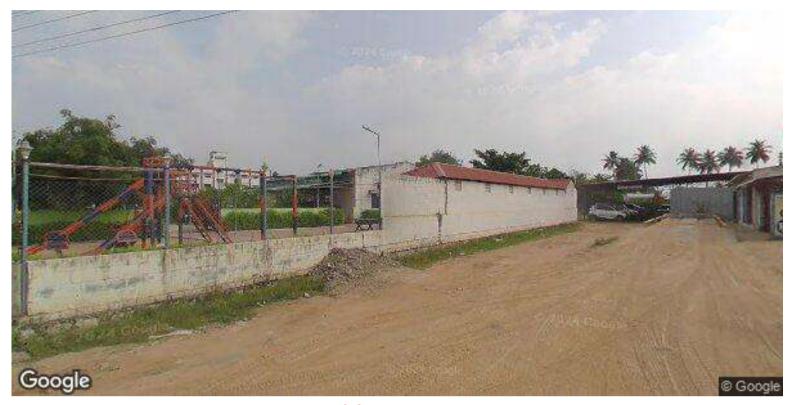
Risk Type: Turn
Risk Level: High
Speed Limit: 15 KM/Hr
Coordinates: 11.44377, 77.71562

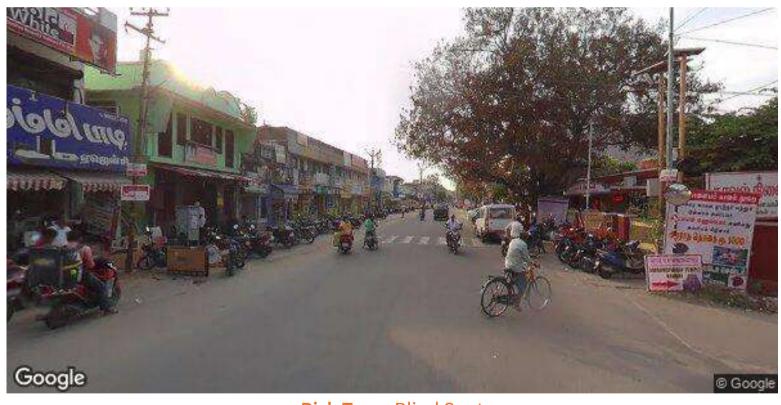
Coordinates: 11.44105, 77.69331

Risk Type: Blind Spot Risk Level: Blind Spot Speed Limit: 10 KM/Hr

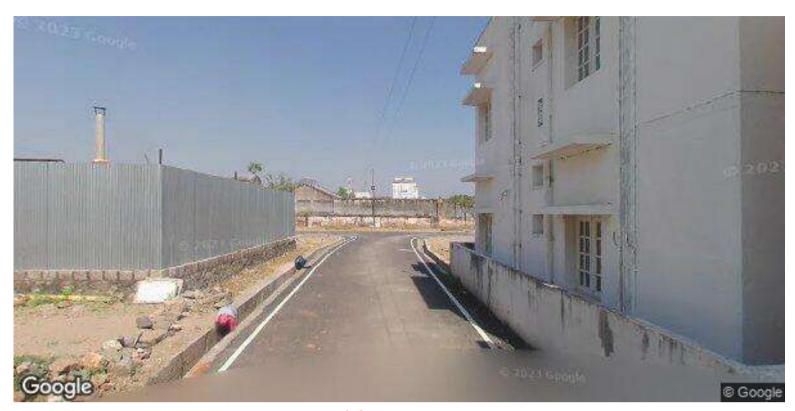
Coordinates: 11.44947, 77.68646

Risk Type: Turn
Risk Level: High
Speed Limit: 15 KM/Hr

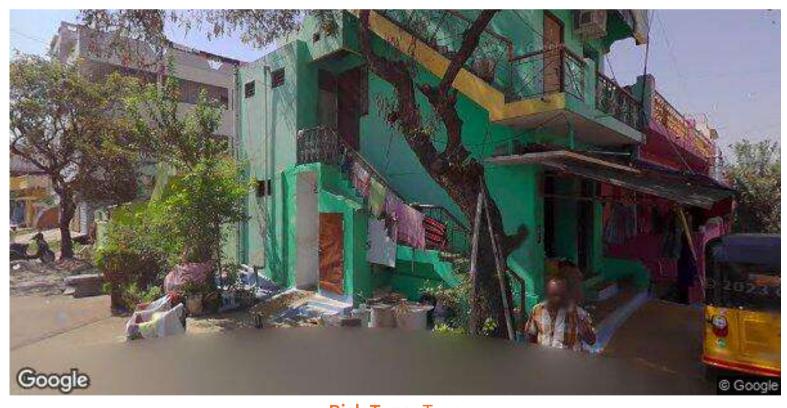
Risk Type: Turn
Risk Level: High
Speed Limit: 15 KM/Hr
Coordinates: 11.44801, 77.68596

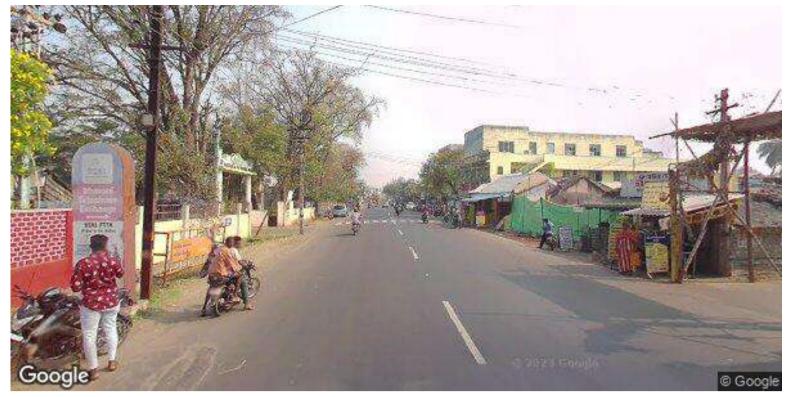
Coordinates: 11.44842, 77.68473

Risk Type: Blind Spot Risk Level: Blind Spot Speed Limit: 10 KM/Hr

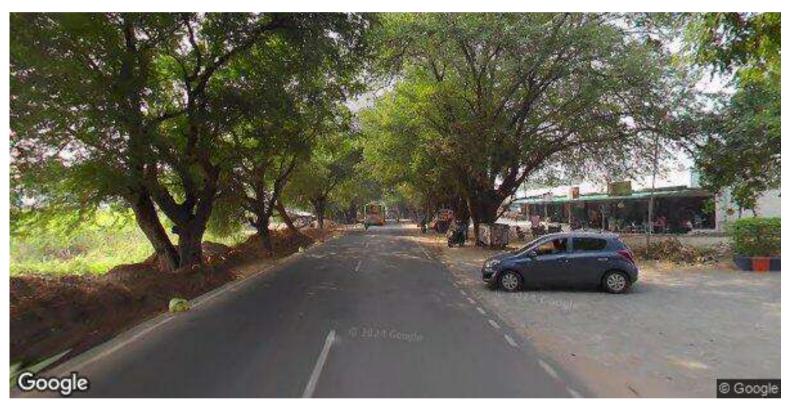
Coordinates: 11.49574, 77.69838

Risk Type: Turn
Risk Level: High
Speed Limit: 15 KM/Hr
