JOURNEY RISK MANAGEMENT (JRM) STUDY

Salem Terminal TO SRI VISHNU OILS

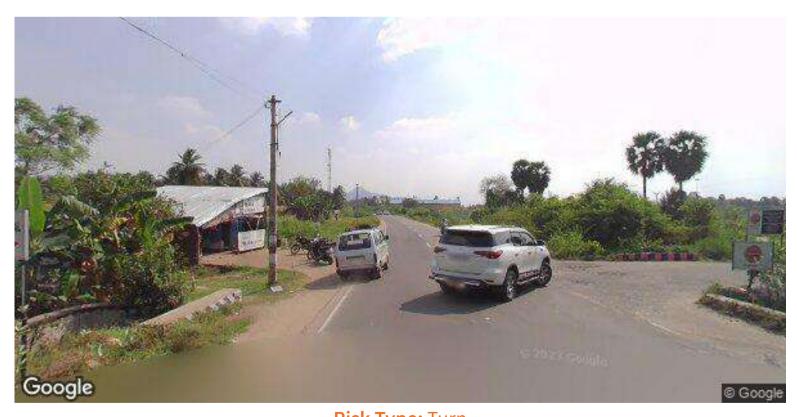
Risk Type: Turn
Speed Limit: 15 KM/Hr
Distance from Start: 0.32 km
Coordinates: 11.44029, 77.87544

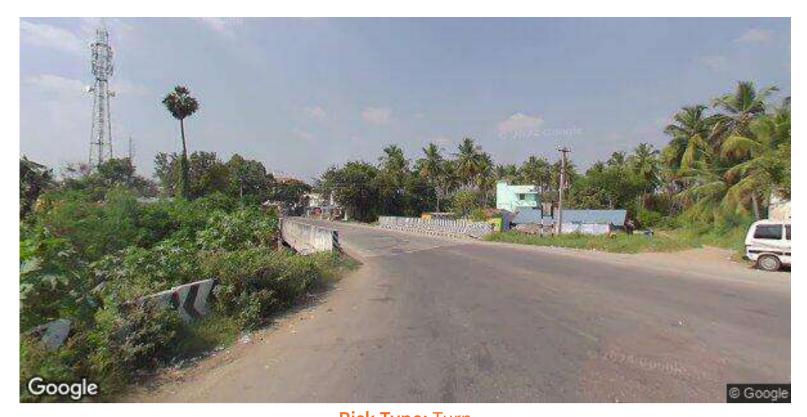
Risk Type: Turn
Speed Limit: 15 KM/Hr
Distance from Start: 1.37 km
Coordinates: 11.44893, 77.87413

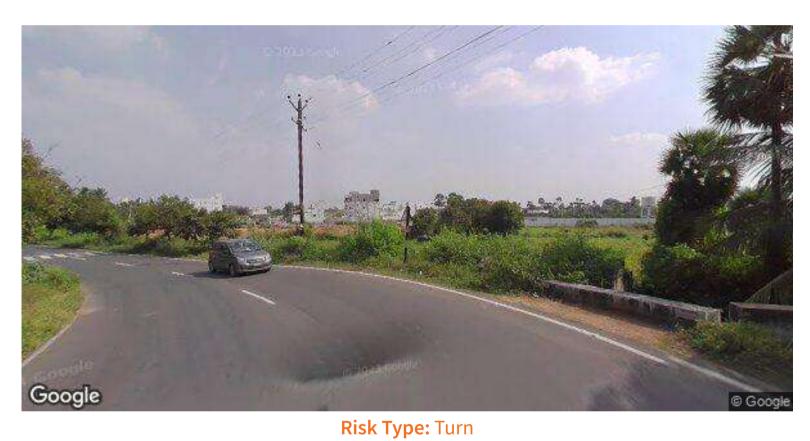
Speed Limit: 15 KM/Hr
Distance from Start: 3.34 km
Coordinates: 11.45350, 77.85700

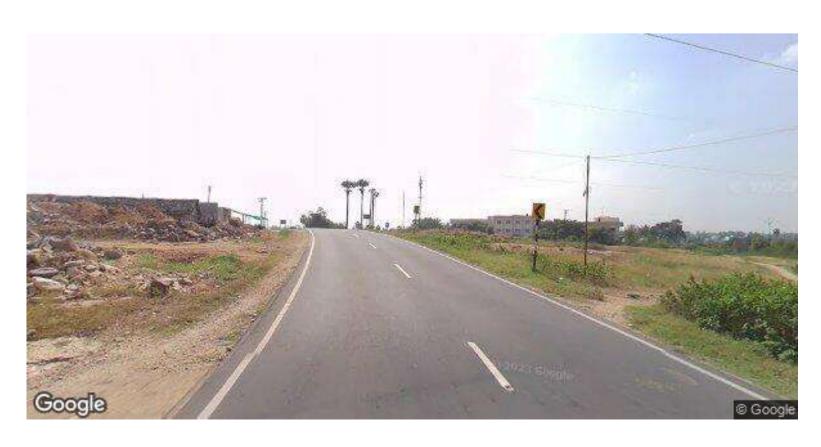
Risk Type: Turn
Speed Limit: 15 KM/Hr
Distance from Start: 4.37 km

Coordinates: 11.46046, 77.85037

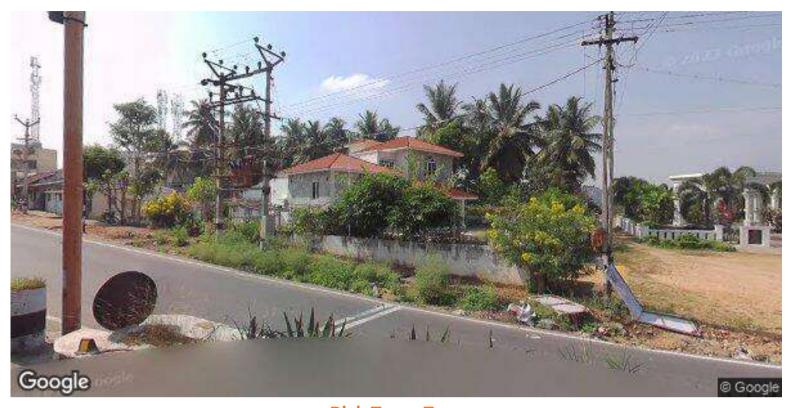
Risk Type: Turn
Speed Limit: 15 KM/Hr
Distance from Start: 4.73 km
Coordinates: 11.46303, 77.84945

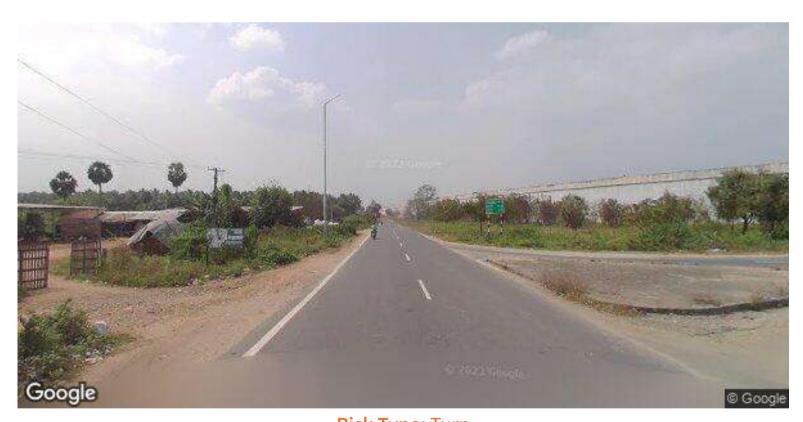
Risk Type: Turn
Speed Limit: 15 KM/Hr
Distance from Start: 8.39 km
Coordinates: 11.45542, 77.81725

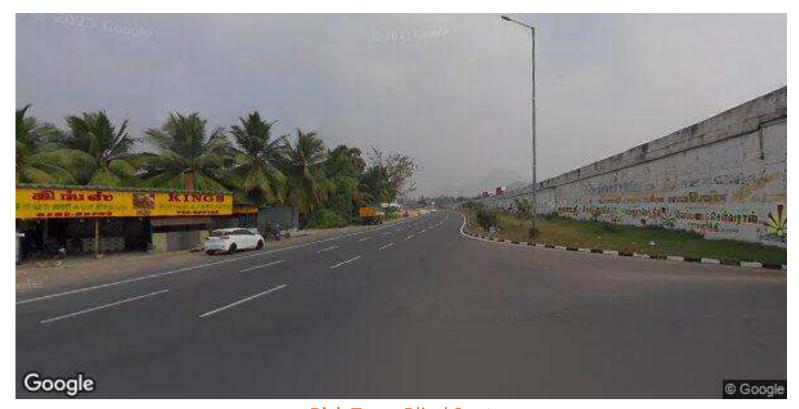
Risk Type: Blind Spot
Speed Limit: 10 KM/Hr
Distance from Start: 8.52 km
Coordinates: 11.45634, 77.81673

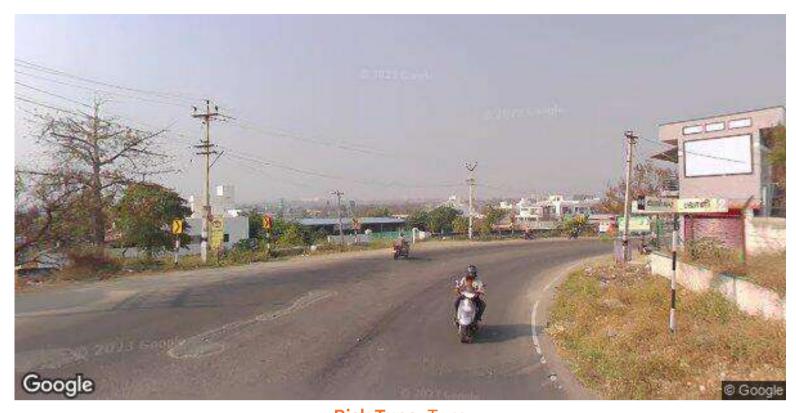
Risk Type: Turn
Speed Limit: 15 KM/Hr
Distance from Start: 25.61 km
Coordinates: 11.43278, 77.67024

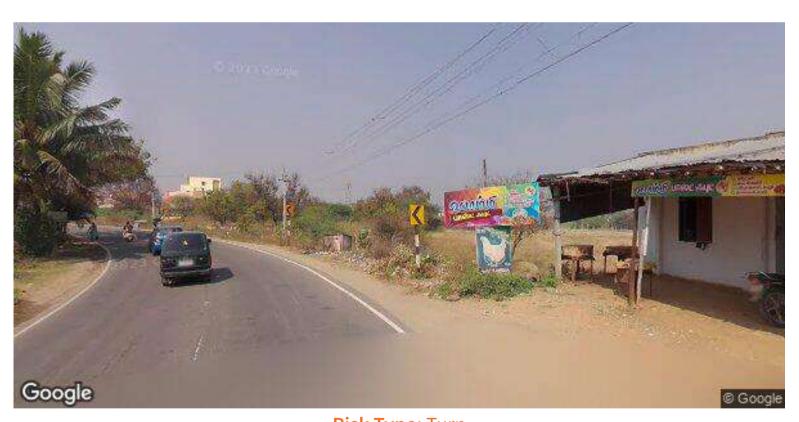
Risk Type: Turn
Speed Limit: 15 KM/Hr
Distance from Start: 25.99 km
Coordinates: 11.43346, 77.66700

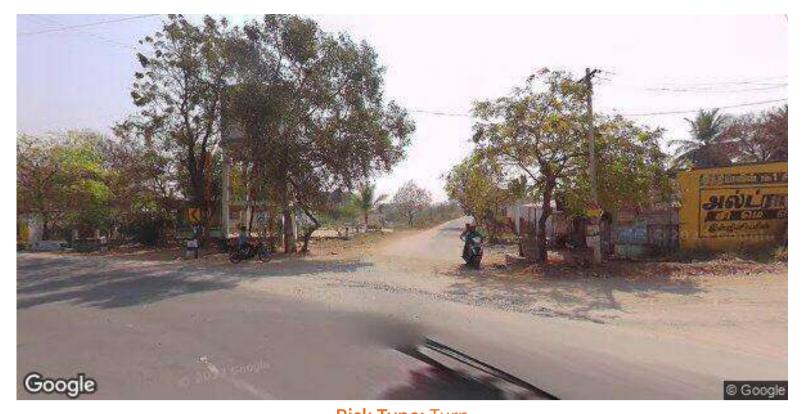
Risk Type: Turn
Speed Limit: 15 KM/Hr
Distance from Start: 26.18 km
Coordinates: 11.43225, 77.66561

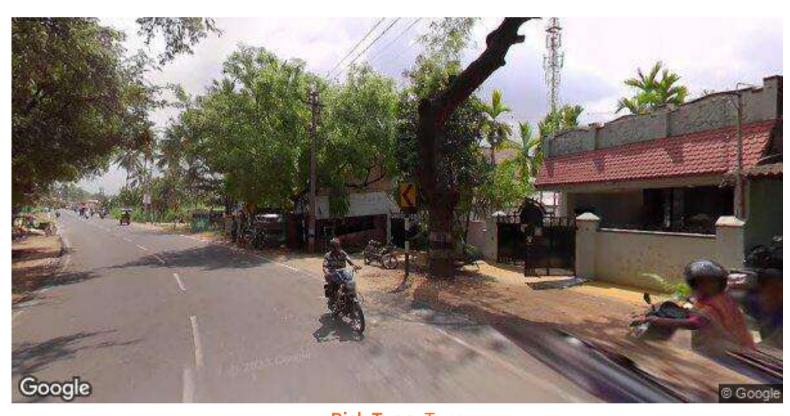
Risk Type: Turn
Speed Limit: 15 KM/Hr
Distance from Start: 36.98 km
Coordinates: 11.42837, 77.56935

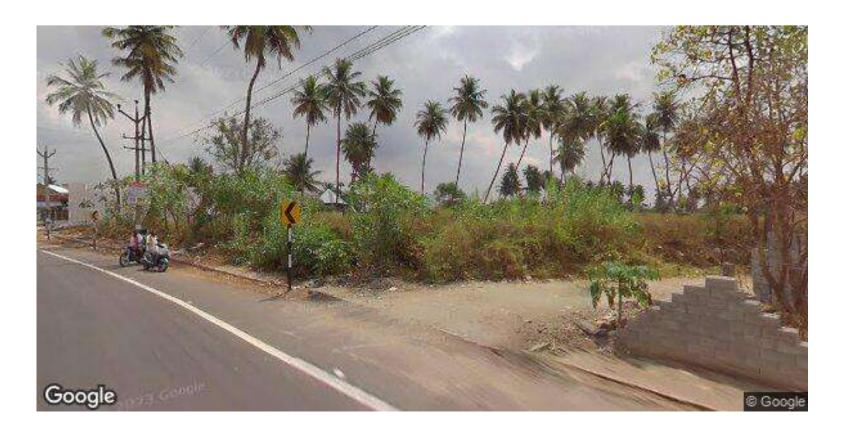
Risk Type: Turn
Speed Limit: 15 KM/Hr
Distance from Start: 37.63 km

Coordinates: 11.42707, 77.56407

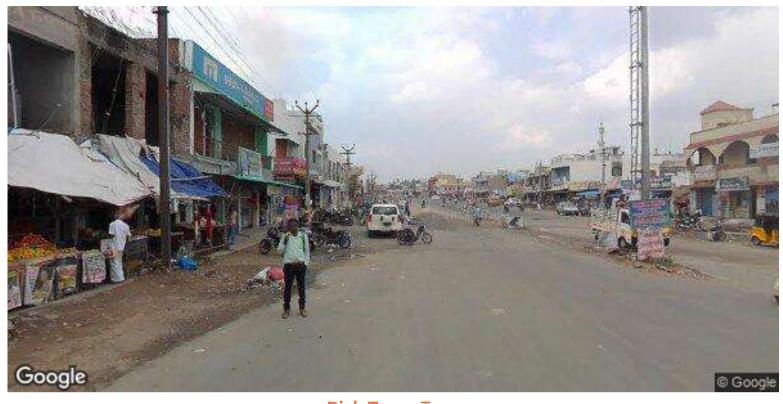
Risk Type: Turn
Speed Limit: 15 KM/Hr
Distance from Start: 38.46 km

Coordinates: 11.42329, 77.55798
