# JOURNEY RISK MANAGEMENT (JRM) STUDY

# IOCL Coimbatore Terminal to Sri Selvanayaki Agencies

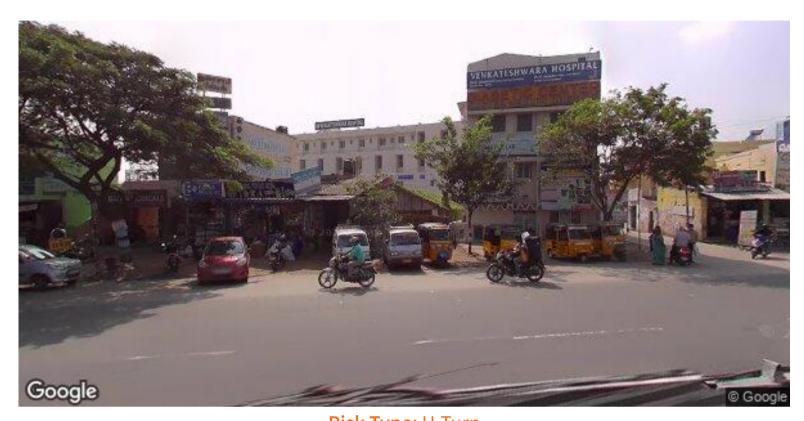
**Coordinates:** 11.0549503, 77.0650284

Risk Type: U-Turn
Risk Level: High
Speed Limit: 10 KM/Hr

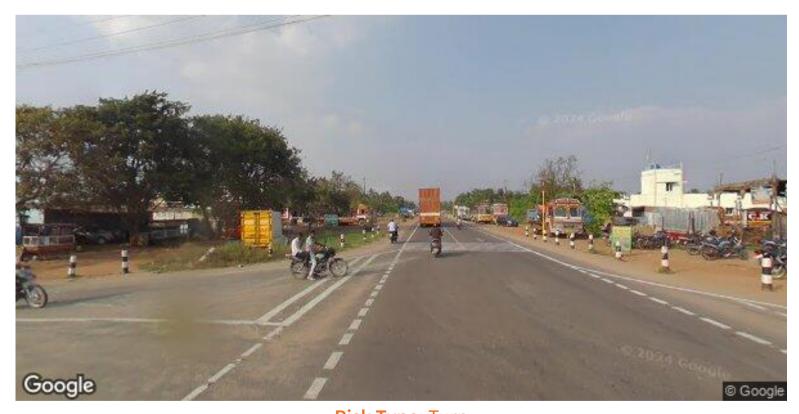
**Coordinates:** 11.03211, 77.07640

Risk Type: Turn
Risk Level: High
Speed Limit: 15 KM/Hr

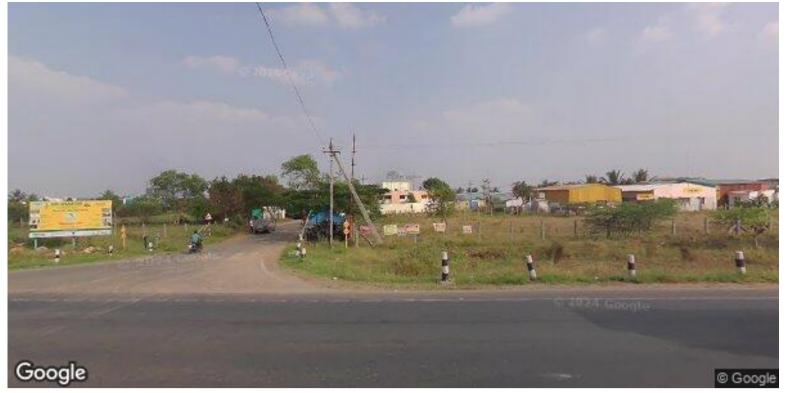
**Coordinates:** 11.05129, 77.07919

Risk Type: Turn
Risk Level: High
Speed Limit: 15 KM/Hr

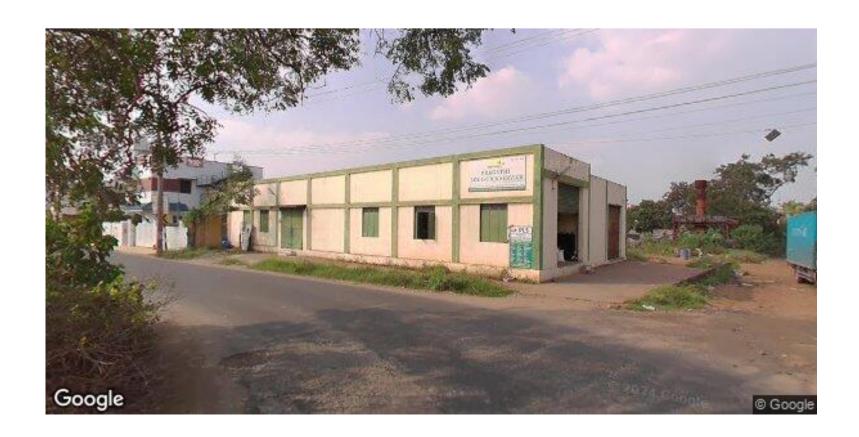
**Coordinates:** 11.05222, 77.07690

Risk Type: Turn
Risk Level: High
Speed Limit: 15 KM/Hr

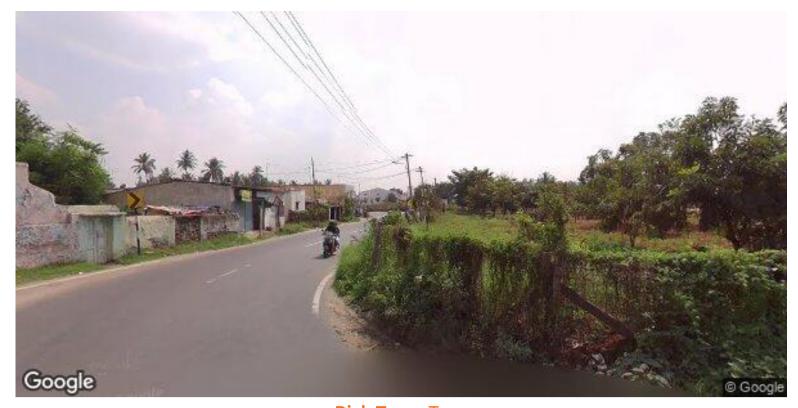
Risk Type: Turn
Risk Level: Medium
Speed Limit: 30 KM/Hr
Coordinates: 11.05411, 77.07097

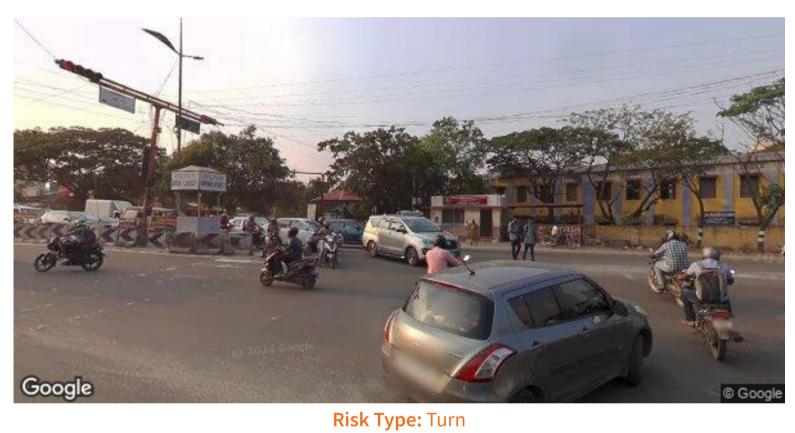
Risk Level: High
Speed Limit: 15 KM/Hr
Coordinates: 11.05529, 77.06566

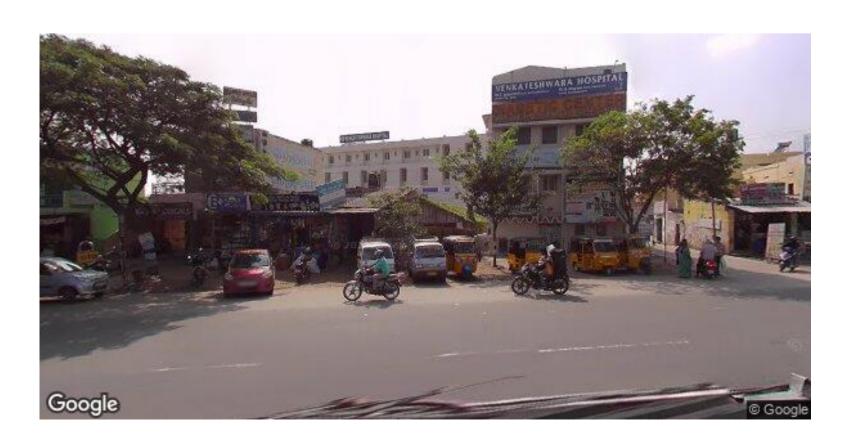
**Coordinates:** 11.05495, 77.06503

Risk Type: Turn
Risk Level: High
Speed Limit: 15 KM/Hr

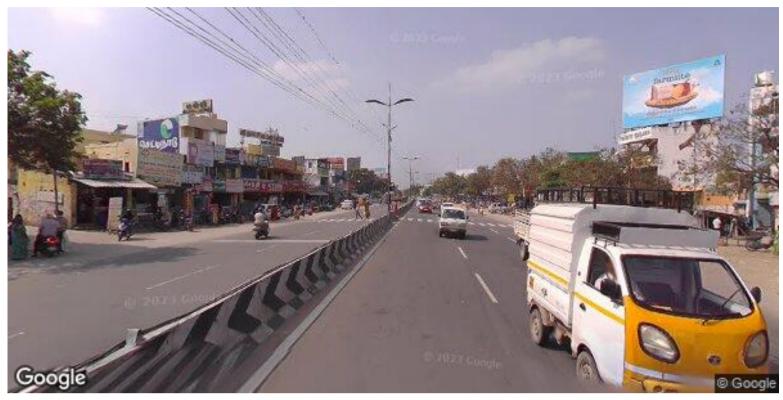
**Coordinates:** 11.05507, 77.06496

Risk Type: Blind Spot Risk Level: Blind Spot Speed Limit: 10 KM/Hr

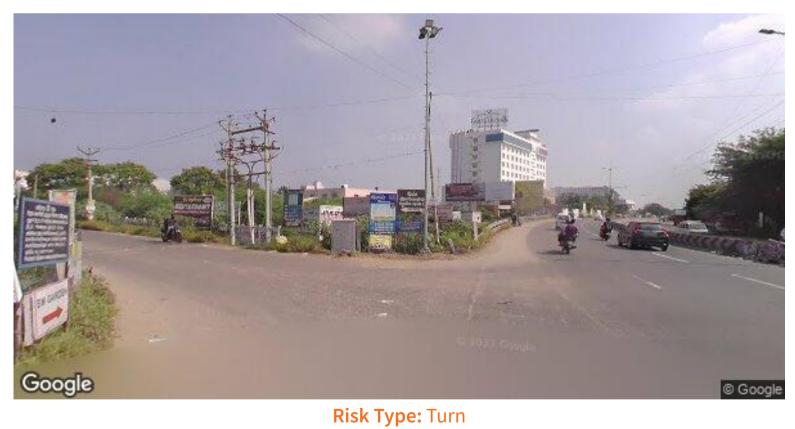
**Coordinates:** 11.05751, 77.06875

Risk Level: High

Speed Limit: 15 KM/Hr

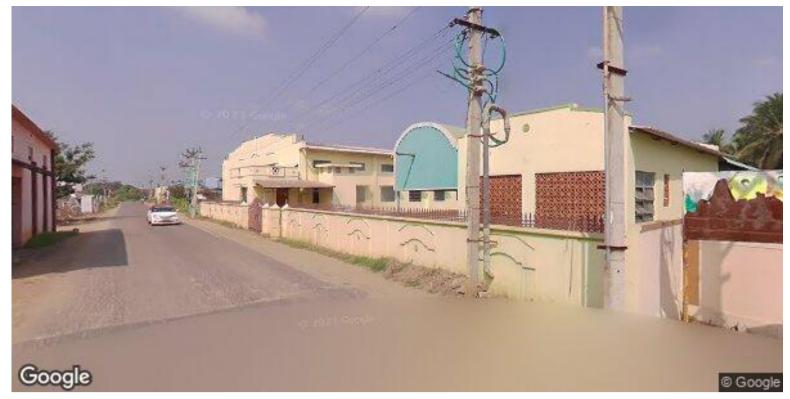
Risk Type: Turn
Risk Level: High
Speed Limit: 15 KM/Hr
Coordinates: 11.06437, 77.06865

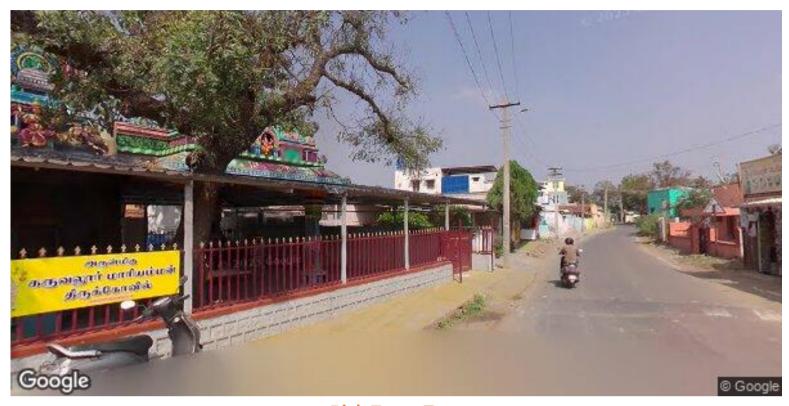
**Coordinates:** 11.06501, 77.06366

Risk Type: Turn
Risk Level: Medium
Speed Limit: 30 KM/Hr

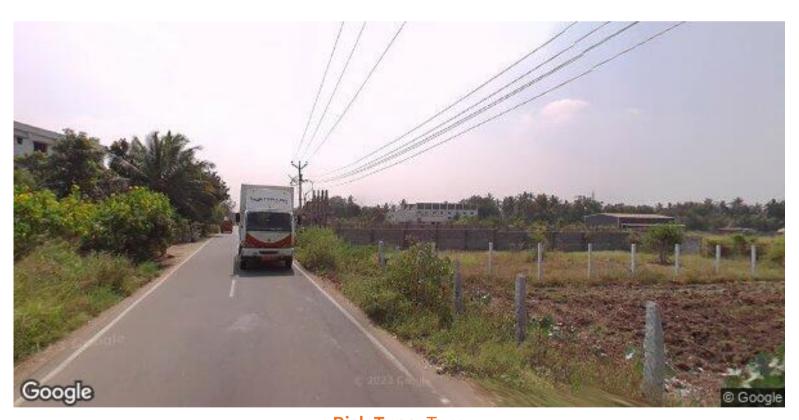
**Coordinates:** 11.07191, 77.06366

Risk Type: Turn
Risk Level: Medium
Speed Limit: 30 KM/Hr

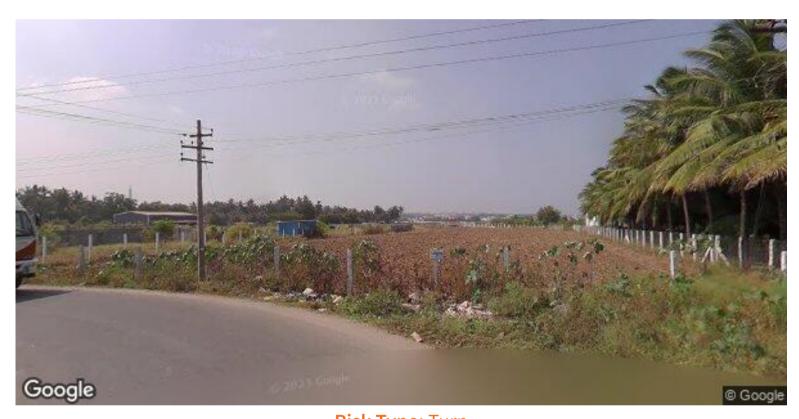
Risk Type: Turn
Risk Level: Medium
Speed Limit: 30 KM/Hr
Coordinates: 11.07209, 77.06370

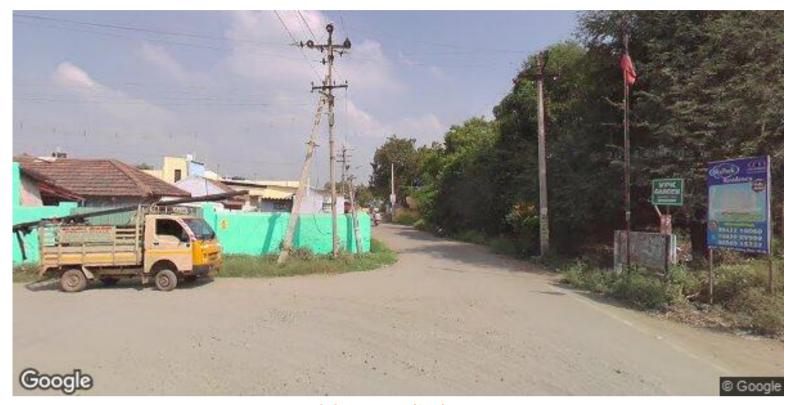
Risk Type: Blind Spot
Risk Level: Blind Spot
Speed Limit: 10 KM/Hr
Coordinates: 11.07865, 77.06377

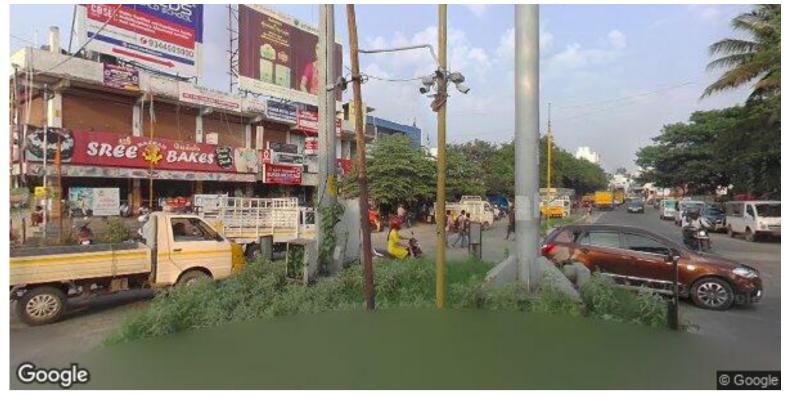
Risk Type: Turn
Risk Level: High
Speed Limit: 15 KM/Hr
Coordinates: 11.07798, 77.03706

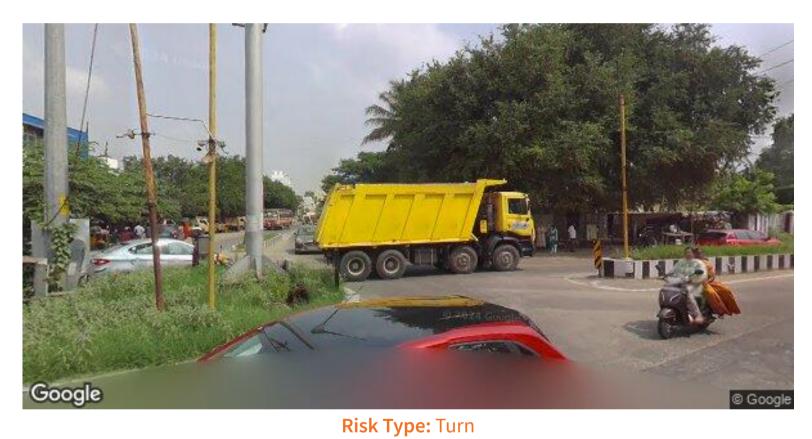
Risk Level: High
Speed Limit: 15 KM/Hr
Coordinates: 11.07795, 77.03702

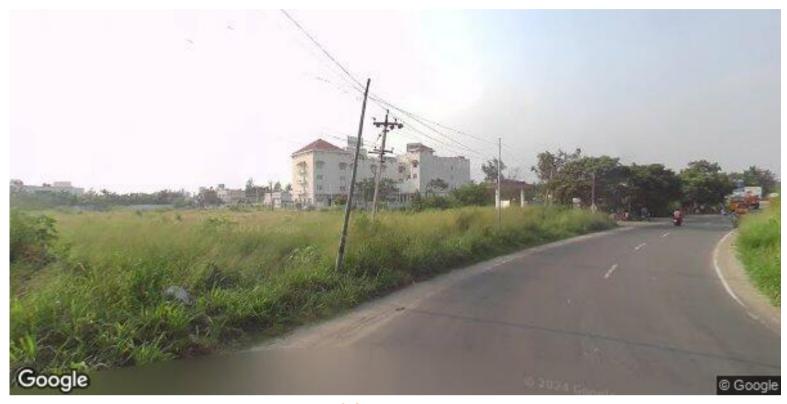
**Coordinates:** 11.07479, 77.02937

Risk Type: Turn
Risk Level: Medium
Speed Limit: 30 KM/Hr

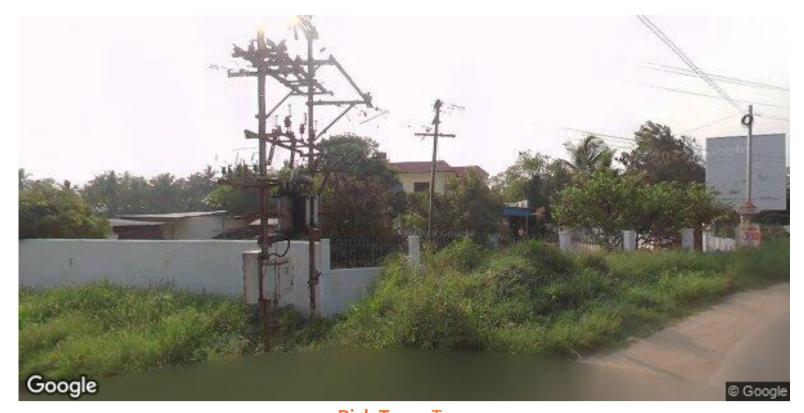
Risk Type: Turn
Risk Level: Medium
Speed Limit: 30 KM/Hr
Coordinates: 11.07626, 77.02677

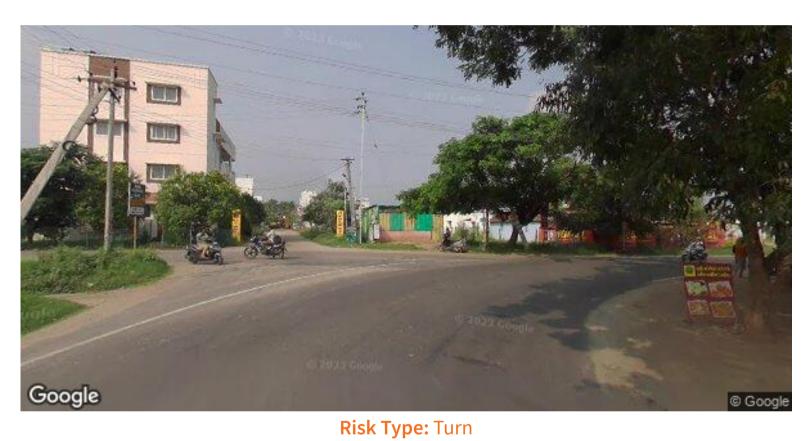
Risk Level: Medium
Speed Limit: 30 KM/Hr
Coordinates: 11.07573, 77.02044

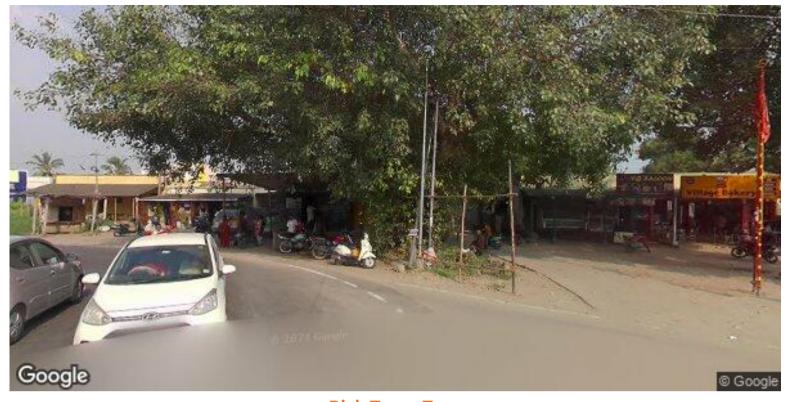
**Coordinates:** 11.07291, 77.01953

Risk Type: Turn
Risk Level: High
Speed Limit: 15 KM/Hr
