JOURNEY RISK MANAGEMENT (JRM) STUDY

Salem Terminal to TSP & CO

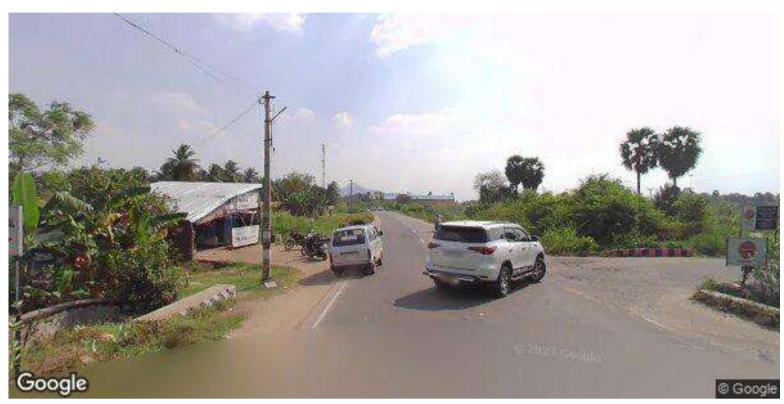
Coordinates: 11.44029, 77.87544

Risk Type: Turn
Risk Level: High
Speed Limit: 15 KM/Hr

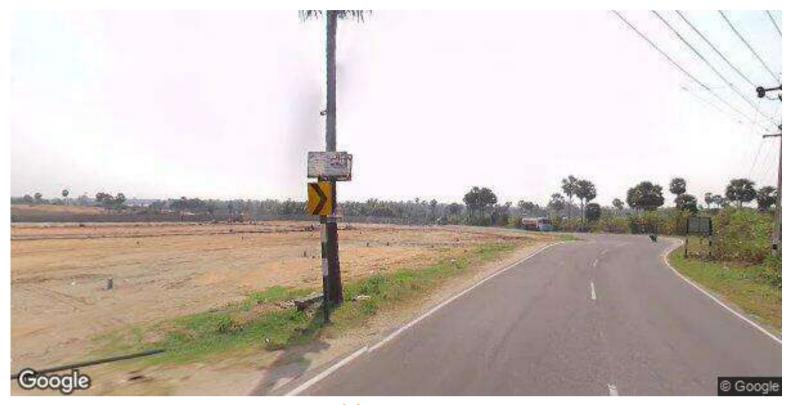
Coordinates: 11.45898, 77.85135

Risk Type: Turn
Risk Level: Medium
Speed Limit: 30 KM/Hr

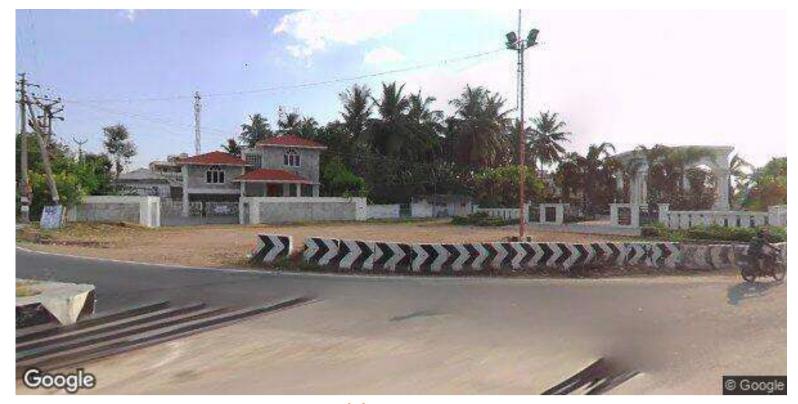
Risk Type: Turn
Risk Level: Medium
Speed Limit: 30 KM/Hr
Coordinates: 11.46314, 77.84928

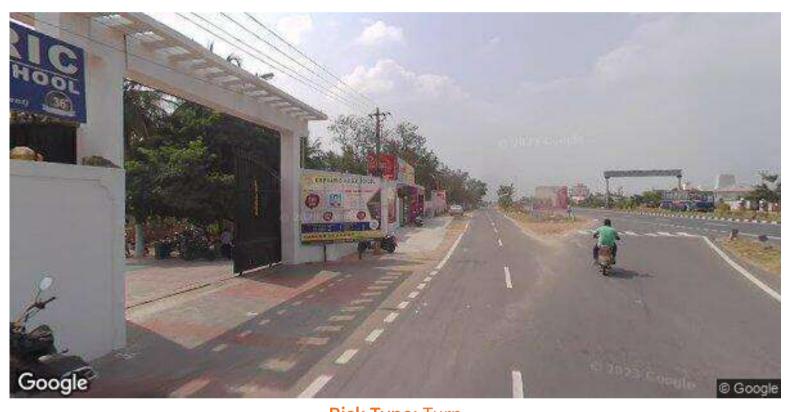
Risk Type: Turn
Risk Level: Medium
Speed Limit: 30 KM/Hr
Coordinates: 11.45509, 77.81383

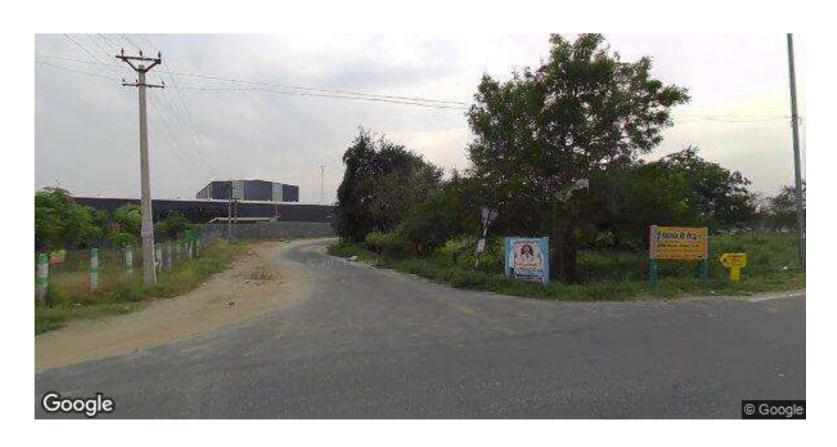
Coordinates: 11.20025, 77.40116

Risk Type: Turn
Risk Level: High
Speed Limit: 15 KM/Hr

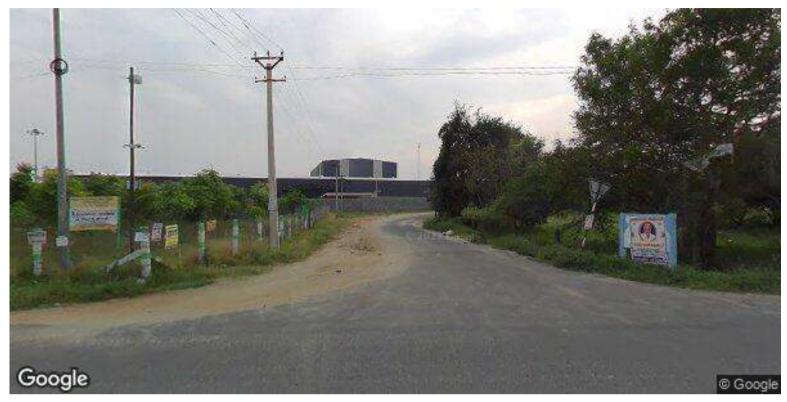
Risk Type: Turn
Risk Level: Medium
Speed Limit: 30 KM/Hr
Coordinates: 11.19997, 77.40107

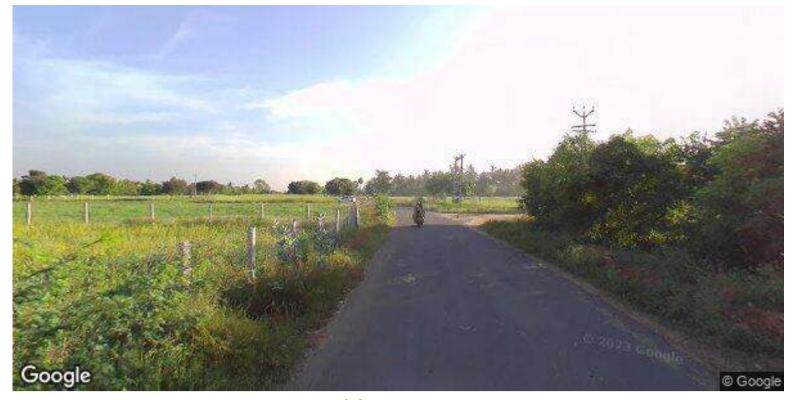
Risk Type: Turn
Risk Level: Medium
Speed Limit: 30 KM/Hr
Coordinates: 11.19598, 77.39467

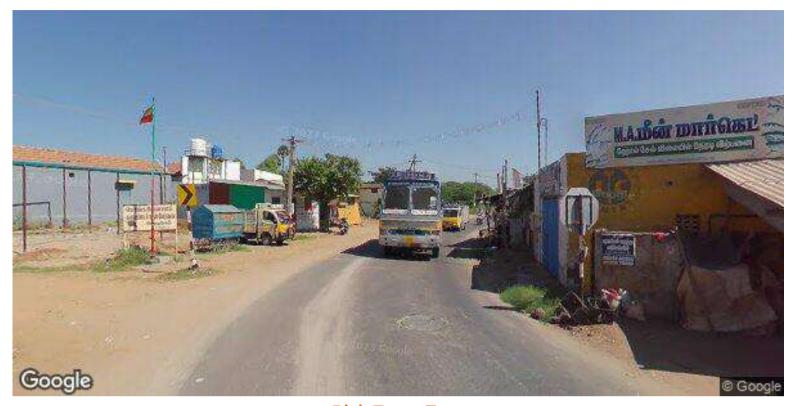
Coordinates: 11.16092, 77.38279

Risk Type: Turn
Risk Level: Medium
Speed Limit: 30 KM/Hr

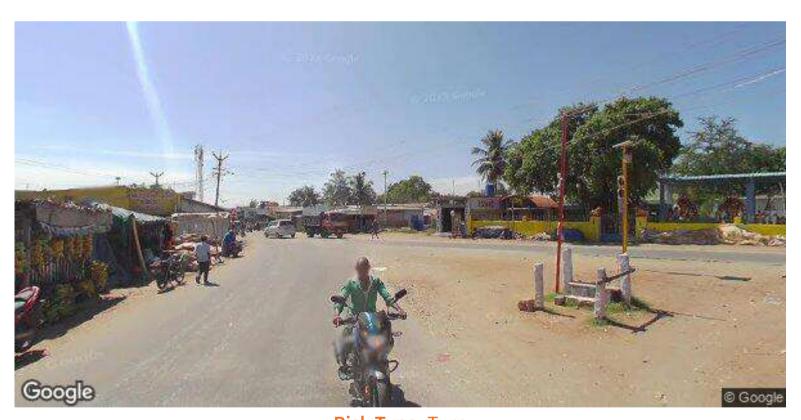
Coordinates: 11.16081, 77.38267

Risk Type: Turn
Risk Level: Medium
Speed Limit: 30 KM/Hr

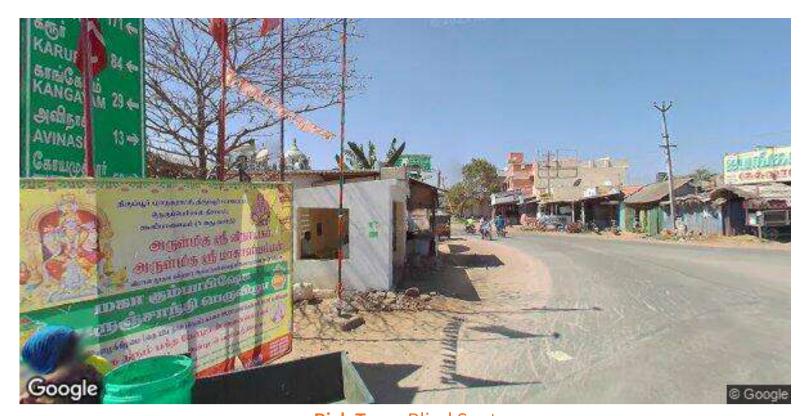
Coordinates: 11.15926, 77.38262

Risk Type: Blind Spot
Risk Level: Blind Spot
Speed Limit: 10 KM/Hr
