JOURNEY RISK MANAGEMENT (JRM) STUDY

Salem Terminal to AMR FUELS

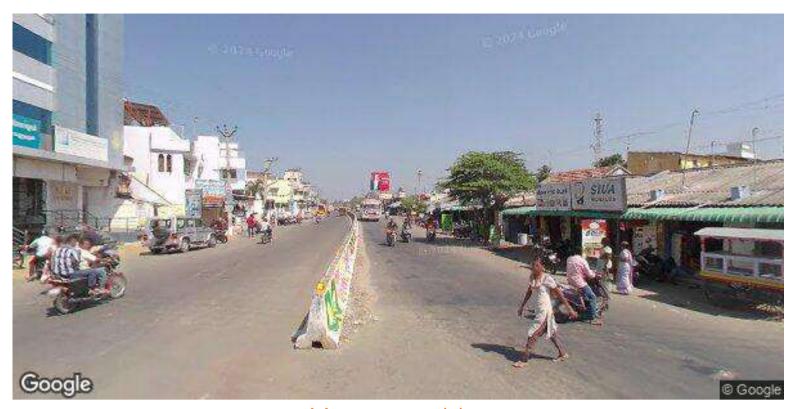
Coordinates: 11.37086, 77.74828

Risk Type: Roundabout
Risk Level: High
Speed Limit: 15 KM/Hr

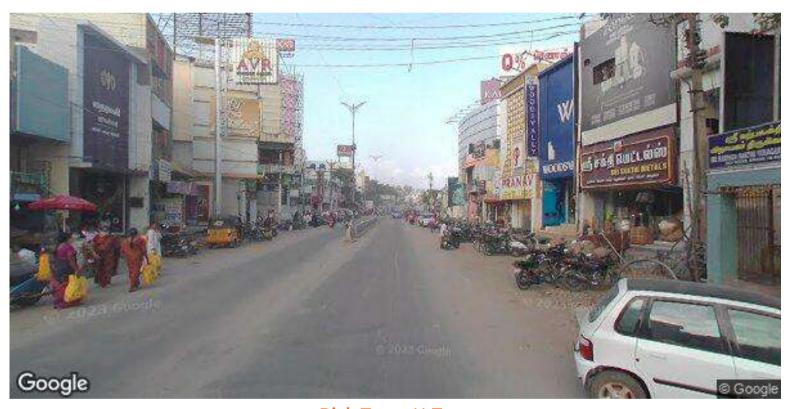
Coordinates: 11.3453211, 77.7304652

Risk Type: U-Turn
Risk Level: High
Speed Limit: 10 KM/Hr

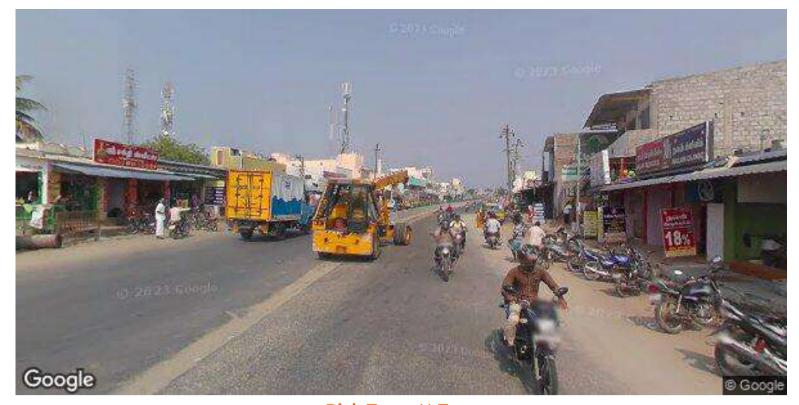
Coordinates: 11.3663553, 77.6968024

Risk Type: U-Turn
Risk Level: High
Speed Limit: 10 KM/Hr

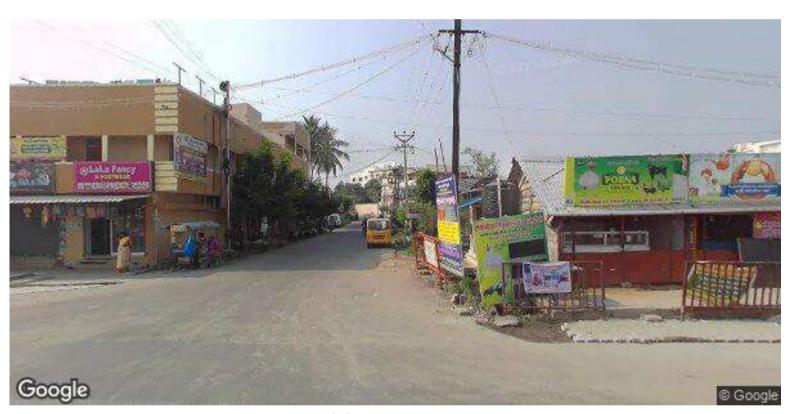
Coordinates: 11.3770605, 77.68412

Risk Type: U-Turn
Risk Level: High
Speed Limit: 10 KM/Hr

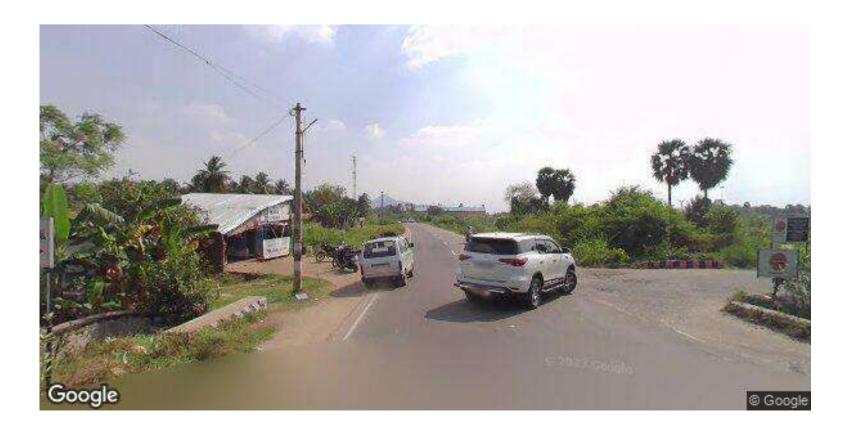
Coordinates: 11.44029, 77.87544

Risk Type: Turn
Risk Level: High
Speed Limit: 15 KM/Hr

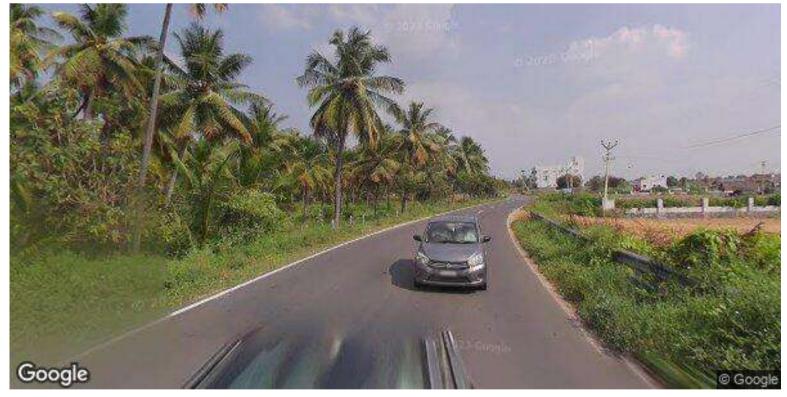
Risk Type: Turn
Risk Level: Medium
Speed Limit: 30 KM/Hr
Coordinates: 11.45357, 77.85789

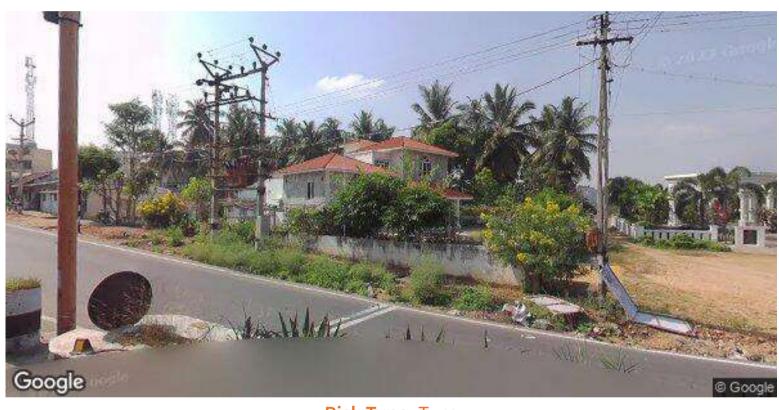
Risk Type: Turn
Risk Level: Medium
Speed Limit: 30 KM/Hr
Coordinates: 11.46303, 77.84945

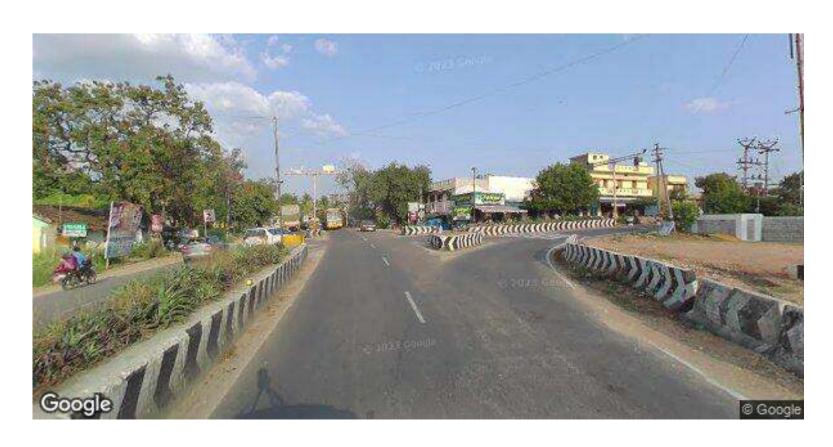
Coordinates: 11.46318, 77.84913

Risk Type: Turn
Risk Level: Medium
Speed Limit: 30 KM/Hr

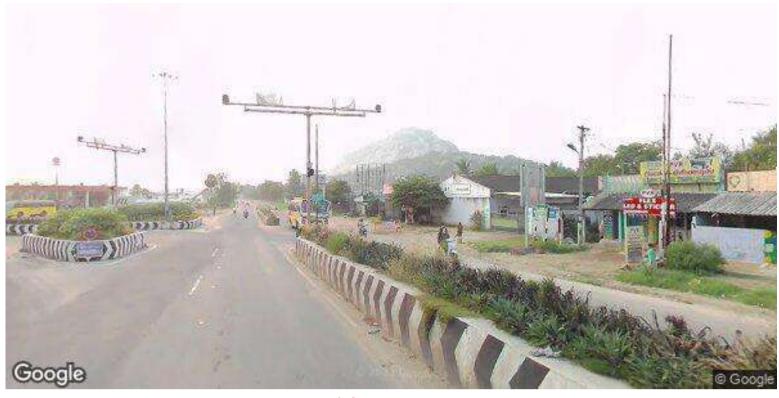
Risk Type: Turn
Risk Level: Medium
Speed Limit: 30 KM/Hr
Coordinates: 11.46312, 77.84886

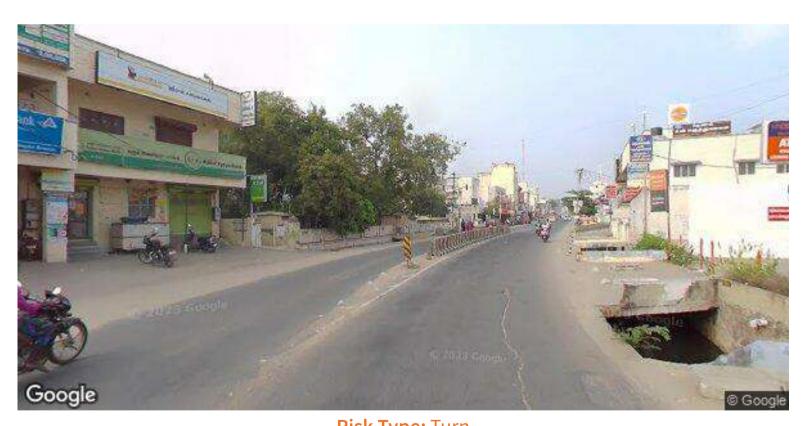
Risk Type: Turn
Risk Level: Medium
Speed Limit: 30 KM/Hr
Coordinates: 11.36622, 77.74789

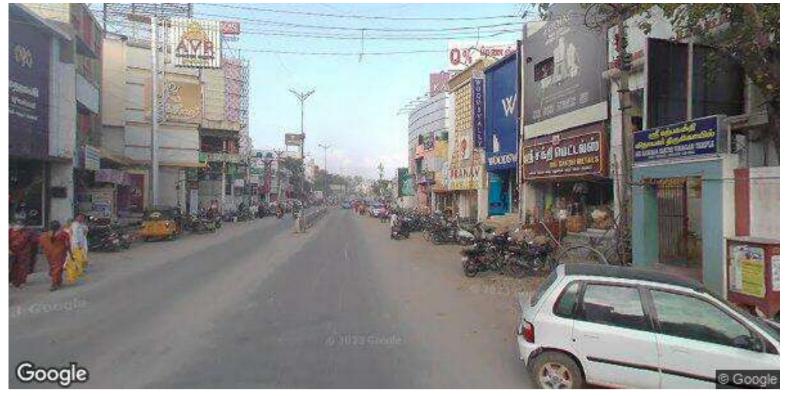
Risk Type: Turn
Risk Level: High
Speed Limit: 15 KM/Hr
Coordinates: 11.34532, 77.73047

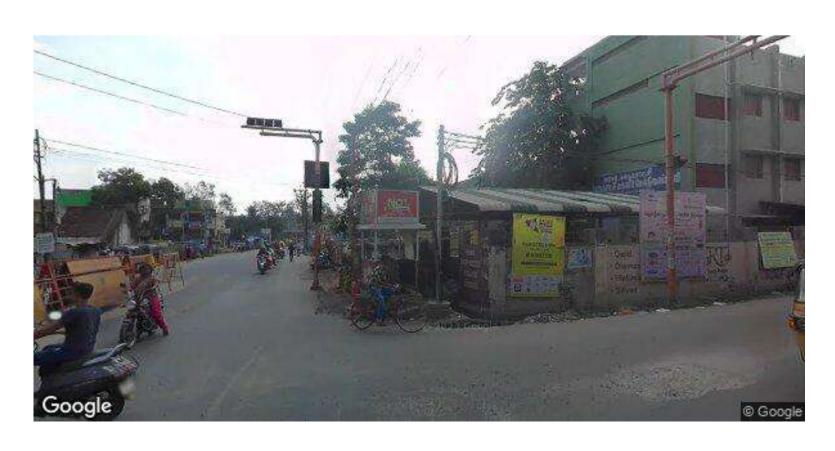
Coordinates: 11.34964, 77.73257

Risk Type: Blind Spot
Risk Level: Blind Spot
Speed Limit: 10 KM/Hr

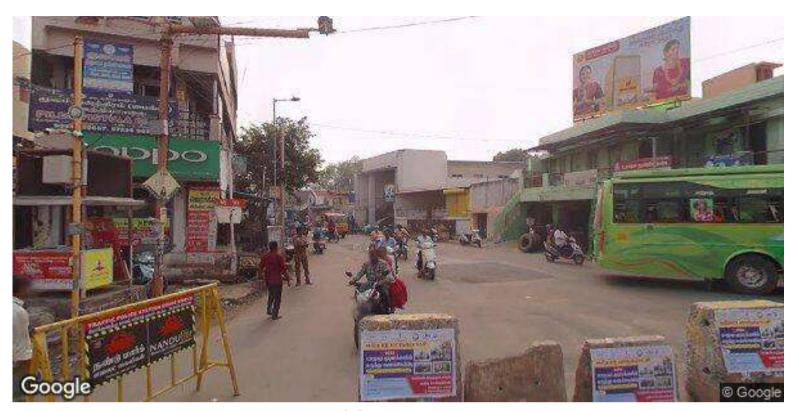
Coordinates: 11.35072, 77.72261

Risk Type: Turn
Risk Level: High
Speed Limit: 15 KM/Hr

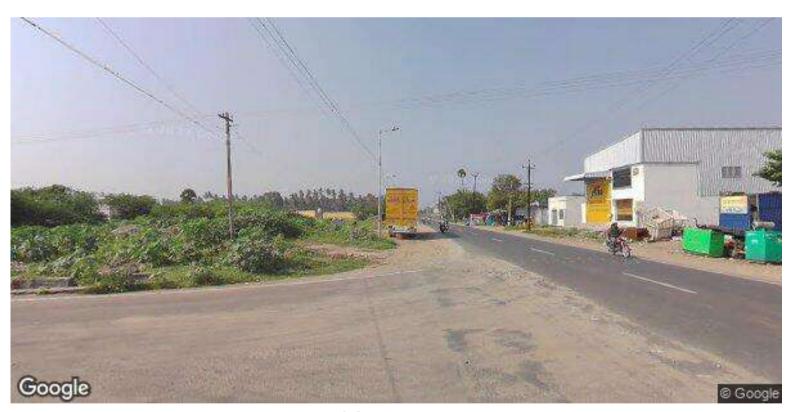
Coordinates: 11.37396, 77.70396

Risk Type: Turn
Risk Level: High
Speed Limit: 15 KM/Hr

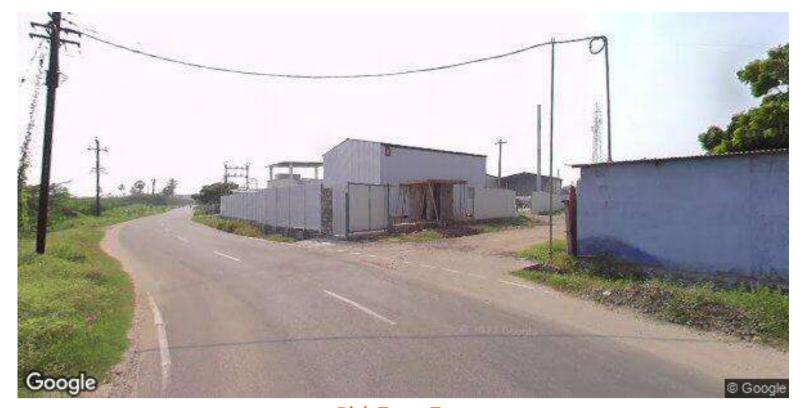
Risk Type: Turn
Risk Level: Medium
Speed Limit: 30 KM/Hr
Coordinates: 11.37309, 77.70214

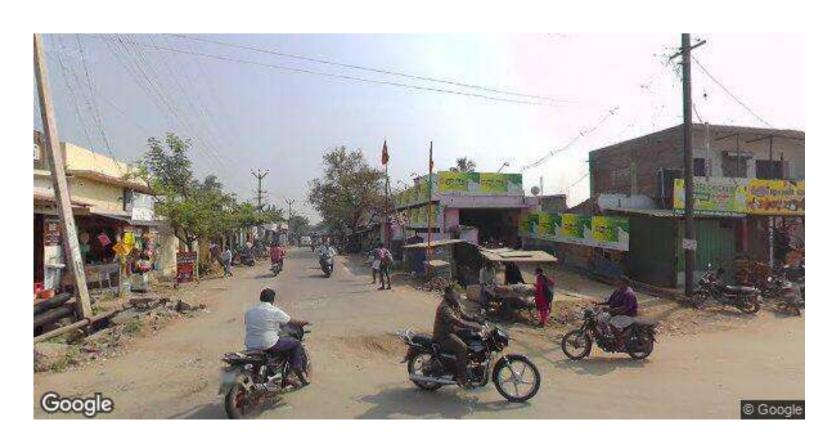
Coordinates: 11.36677, 77.69653

Risk Type: Blind Spot Risk Level: Blind Spot Speed Limit: 10 KM/Hr

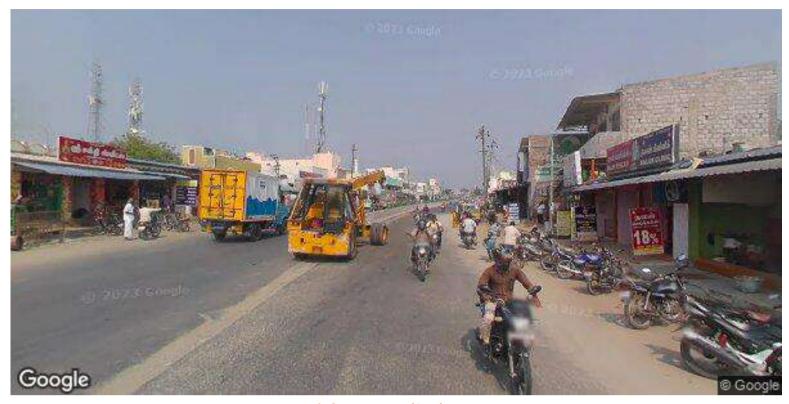
Coordinates: 11.36636, 77.69680

Risk Type: Blind Spot Risk Level: Blind Spot Speed Limit: 10 KM/Hr

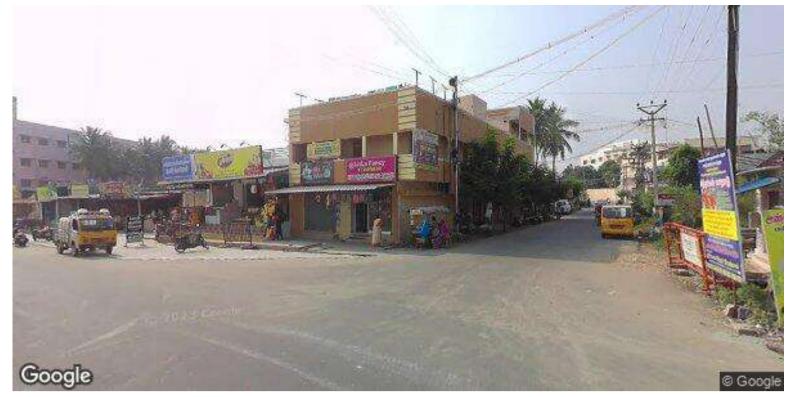
Risk Type: Turn
Risk Level: High
Speed Limit: 15 KM/Hr
Coordinates: 11.37706, 77.68412

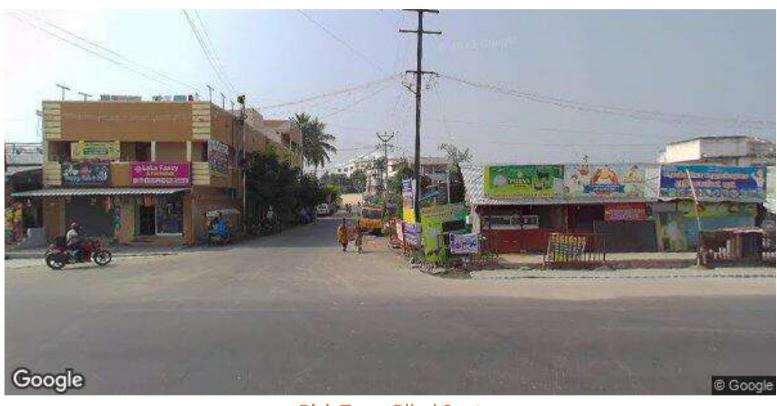
Coordinates: 11.37712, 77.68416

Risk Type: Blind Spot
Risk Level: Blind Spot
Speed Limit: 10 KM/Hr
