JOURNEY RISK MANAGEMENT (JRM) STUDY

Salem Terminal to BAGIYALAKSHMI AGENCY

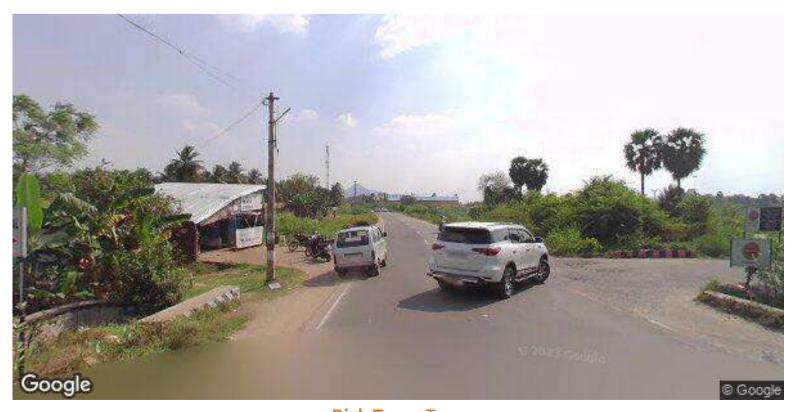
Risk Type: Turn Risk Level: High Speed Limit: 15 KM/Hr Coordinates: 11.44029, 77.87544

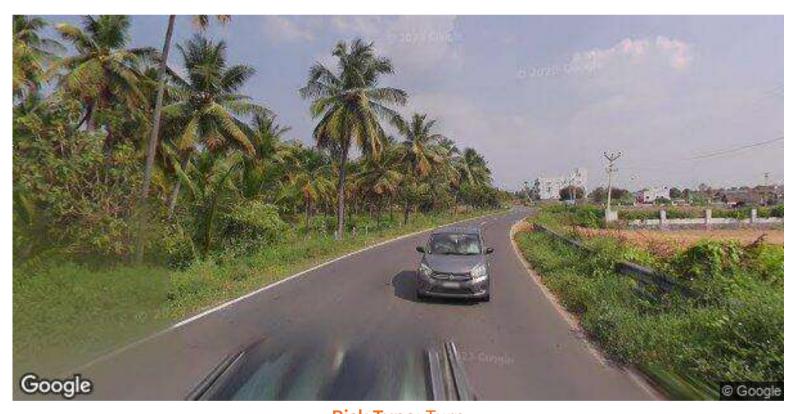
Risk Type: Turn
Risk Level: Medium
Speed Limit: 30 KM/Hr
Coordinates: 11.45357, 77.85789

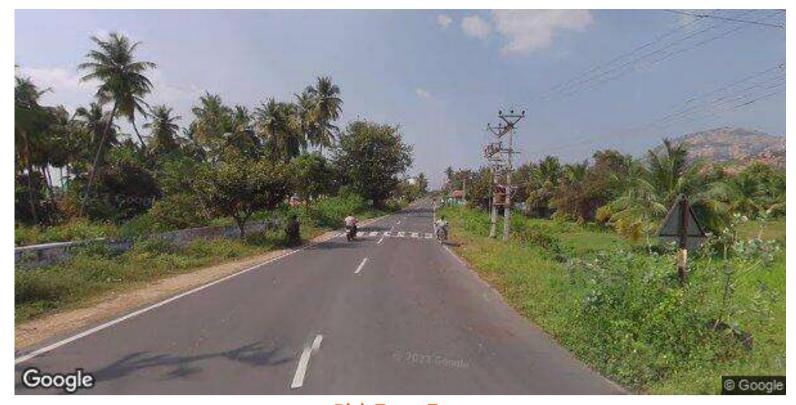
Risk Type: Turn
Risk Level: Medium
Speed Limit: 30 KM/Hr
Coordinates: 11.45352, 77.85698

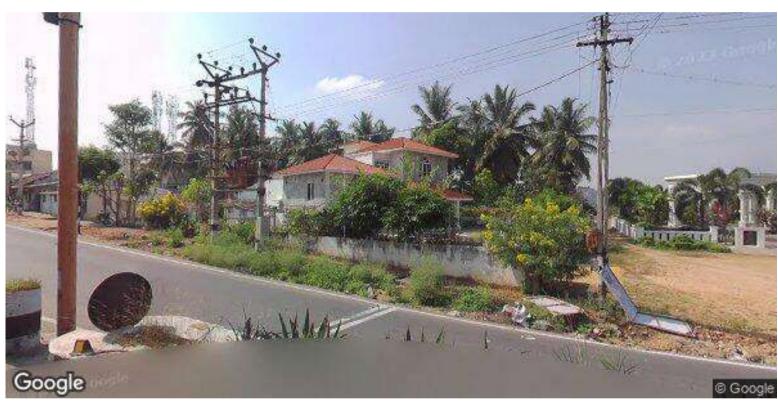
Risk Type: Turn
Risk Level: Medium
Speed Limit: 30 KM/Hr
Coordinates: 11.46303, 77.84945

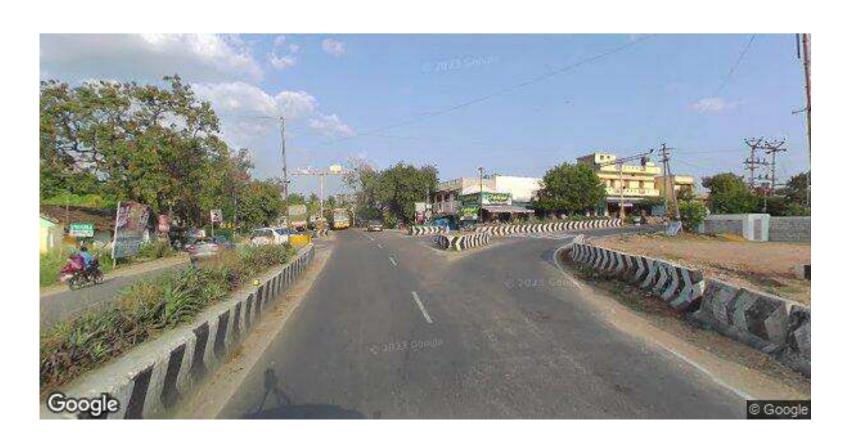
Coordinates: 11.46318, 77.84913

Risk Type: Turn
Risk Level: Medium
Speed Limit: 30 KM/Hr

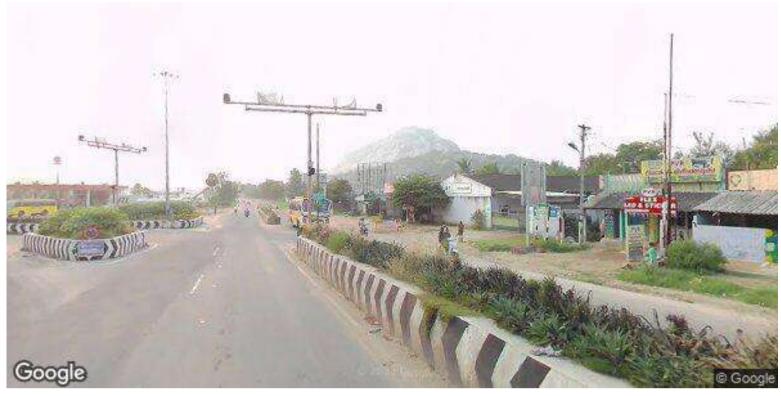
Coordinates: 11.46312, 77.84886

Risk Type: Turn
Risk Level: Medium
Speed Limit: 30 KM/Hr

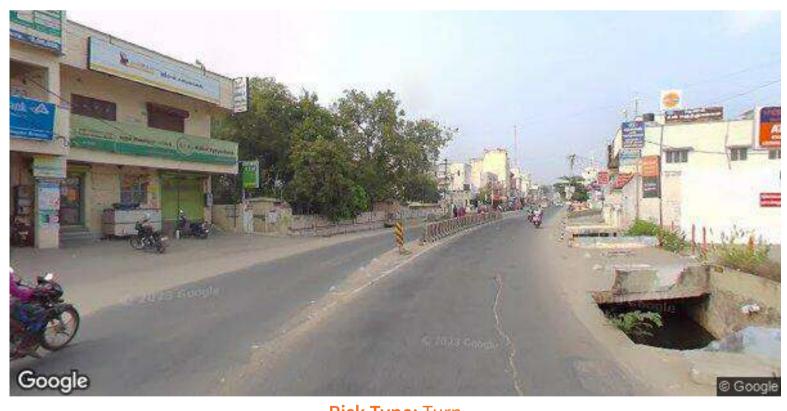
Coordinates: 11.36622, 77.74789

Risk Type: Turn
Risk Level: Medium
Speed Limit: 30 KM/Hr

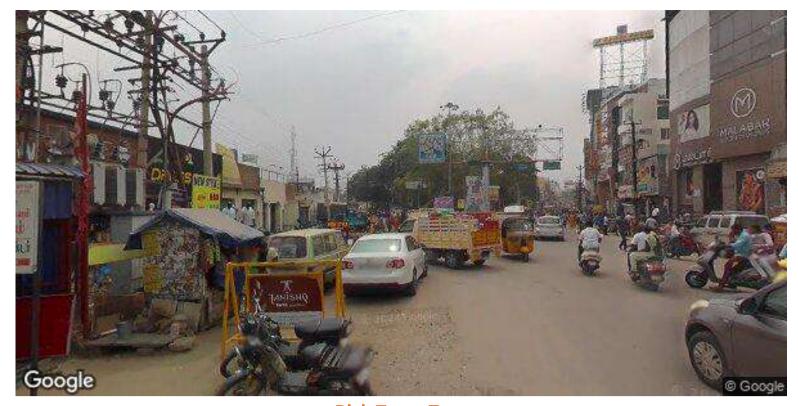
Risk Type: Turn
Risk Level: Medium
Speed Limit: 30 KM/Hr
Coordinates: 11.34493, 77.73032

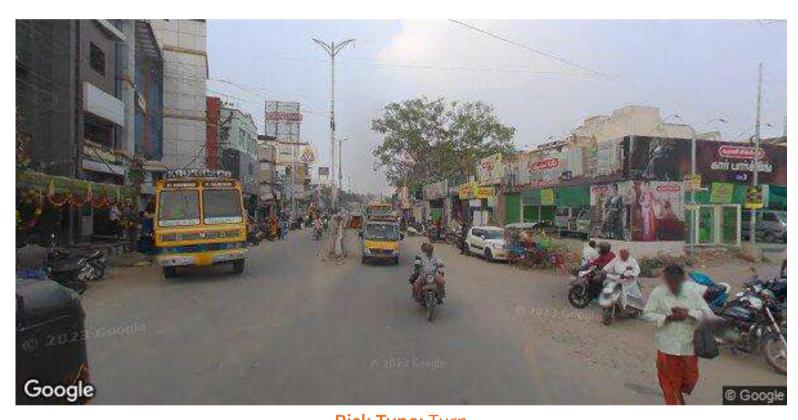
Risk Type: Turn
Risk Level: Medium
Speed Limit: 30 KM/Hr
Coordinates: 11.34487, 77.73024

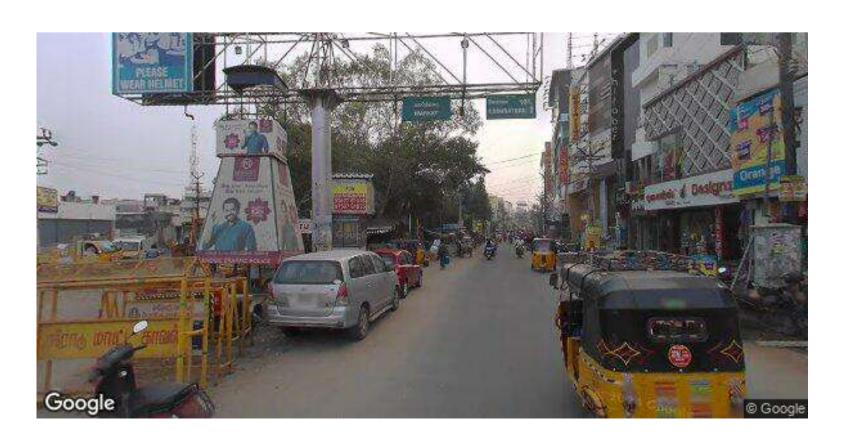
Coordinates: 11.34470, 77.73018

Risk Type: Turn
Risk Level: Medium
Speed Limit: 30 KM/Hr

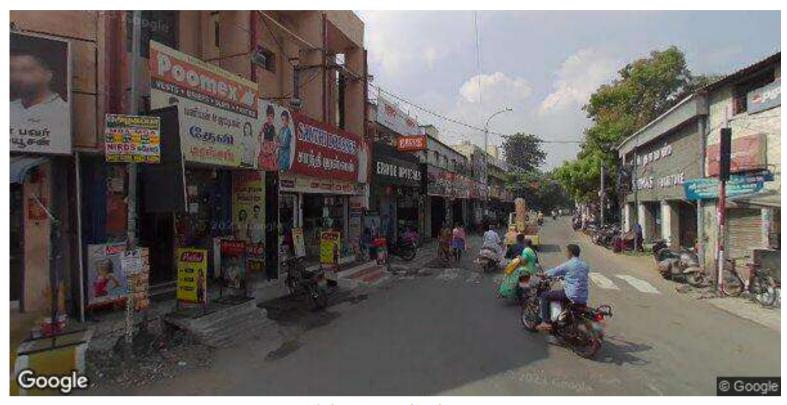
Coordinates: 11.33920, 77.72902

Risk Type: Blind Spot Risk Level: Blind Spot Speed Limit: 10 KM/Hr

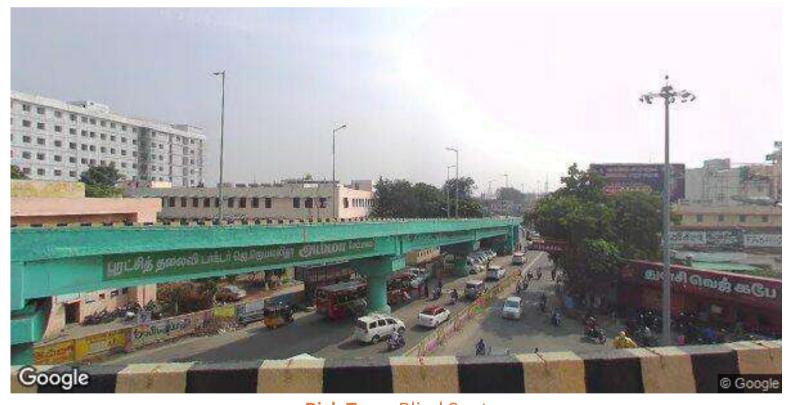
Coordinates: 11.34068, 77.71709

Risk Type: Blind Spot
Risk Level: Blind Spot
Speed Limit: 10 KM/Hr

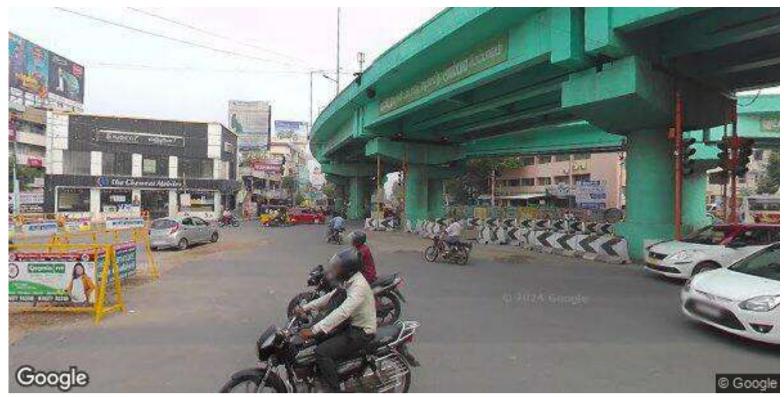
Coordinates: 11.34097, 77.71715

Risk Type: Blind Spot Risk Level: Blind Spot Speed Limit: 10 KM/Hr

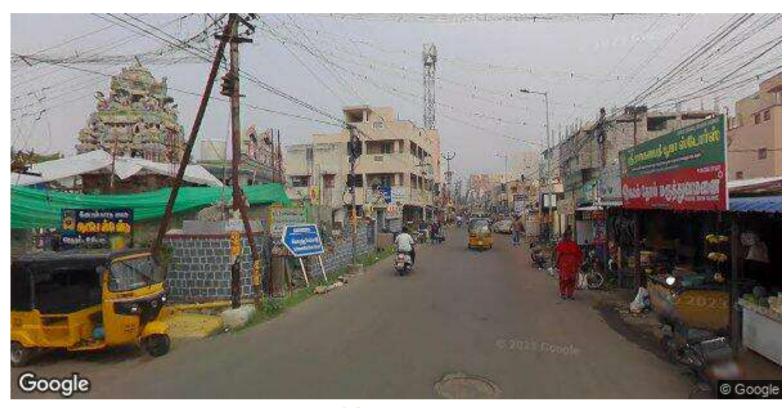
Coordinates: 11.34166, 77.71442

Risk Type: Turn
Risk Level: Medium
Speed Limit: 30 KM/Hr
