# JOURNEY RISK MANAGEMENT (JRM) STUDY

# Salem Terminal to CHAKRAVARTHY & CO

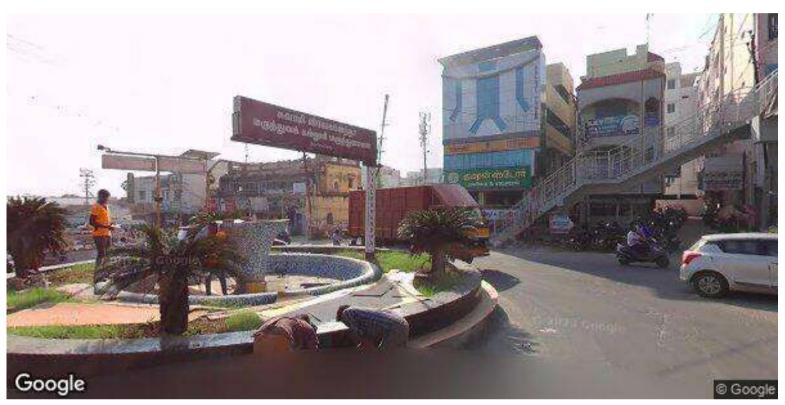
**Coordinates:** 11.38395, 77.89480

Risk Type: Roundabout
Risk Level: High
Speed Limit: 15 KM/Hr

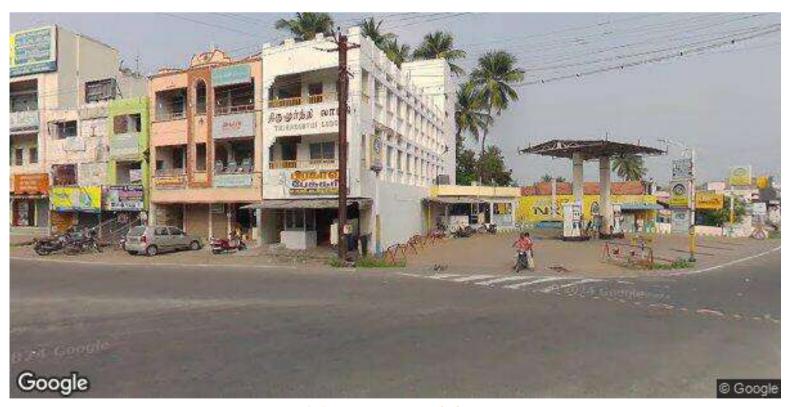
**Coordinates:** 11.00172, 77.56268

Risk Type: Roundabout
Risk Level: High
Speed Limit: 15 KM/Hr

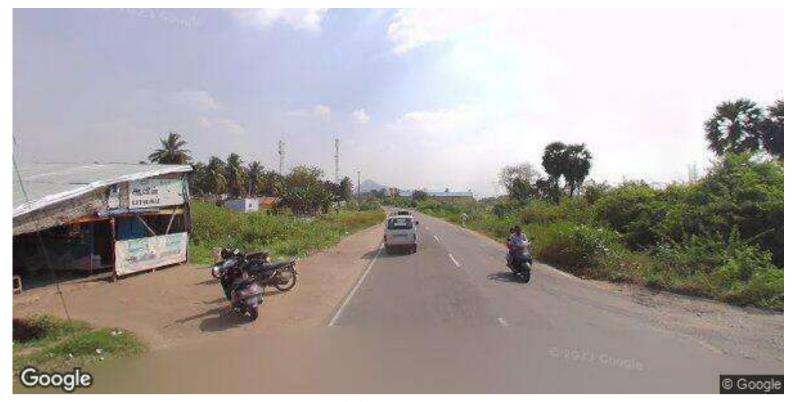
Risk Type: Turn
Risk Level: High
Speed Limit: 15 KM/Hr
Coordinates: 11.44022, 77.87546

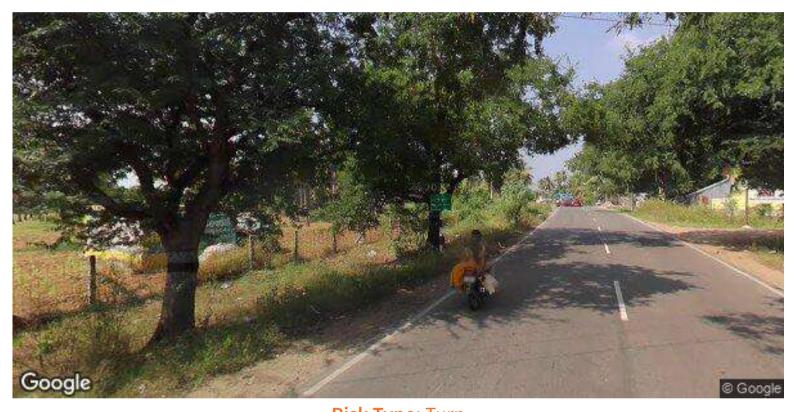
Risk Type: Turn
Risk Level: Medium
Speed Limit: 30 KM/Hr
Coordinates: 11.43107, 77.88171

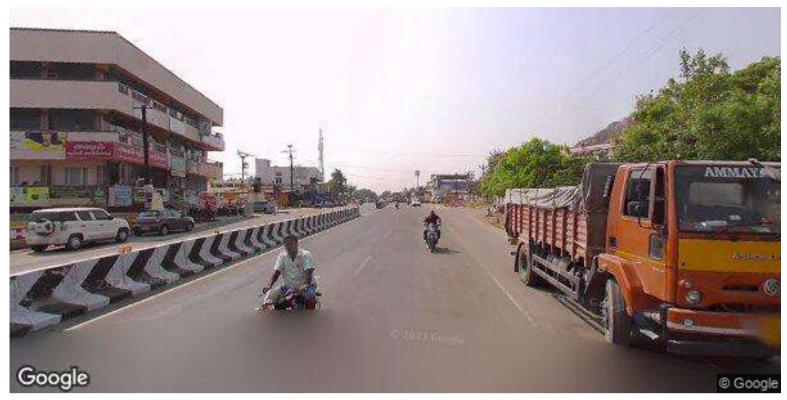
**Coordinates:** 11.39690, 77.88852

Risk Type: Turn
Risk Level: Medium
Speed Limit: 30 KM/Hr

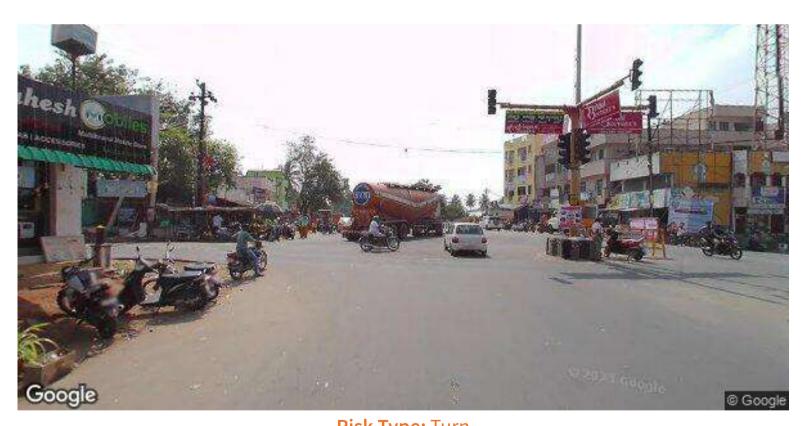
**Coordinates:** 11.36616, 77.88885

Risk Type: Turn
Risk Level: High
Speed Limit: 15 KM/Hr

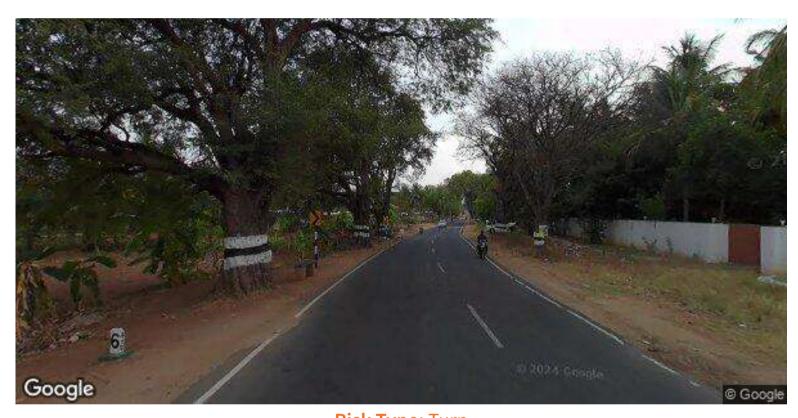
Risk Type: Turn
Risk Level: Medium
Speed Limit: 30 KM/Hr
Coordinates: 11.33561, 77.86176

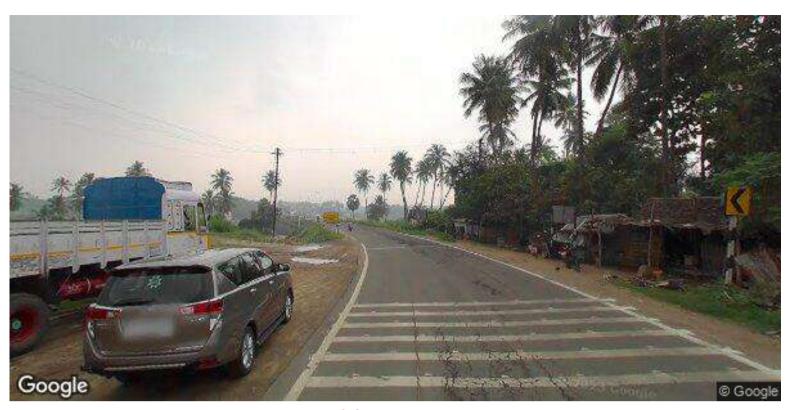
Risk Type: Turn
Risk Level: Medium
Speed Limit: 30 KM/Hr
Coordinates: 11.30952, 77.77587

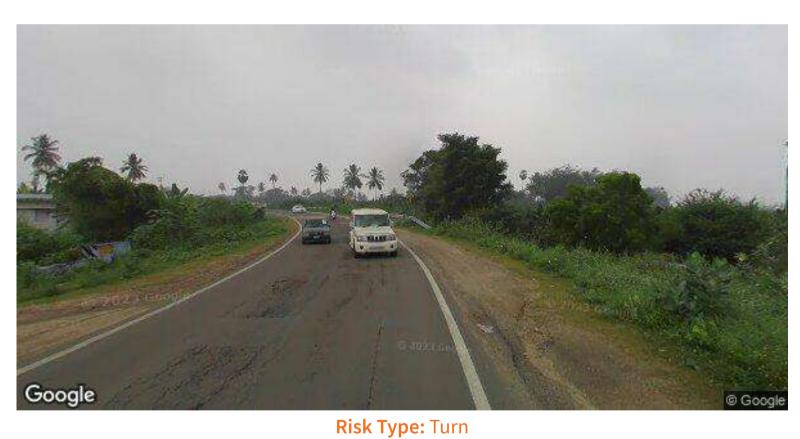
Risk Type: Turn
Risk Level: Medium
Speed Limit: 30 KM/Hr
Coordinates: 11.31111, 77.77178

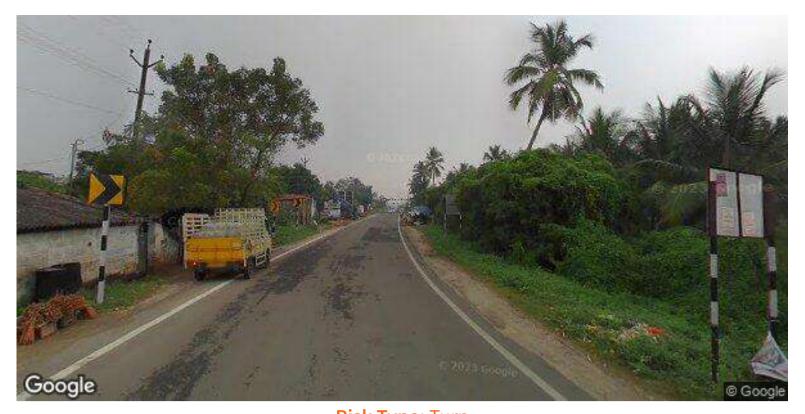
Risk Type: Turn
Risk Level: Medium
Speed Limit: 30 KM/Hr
Coordinates: 11.30973, 77.76712

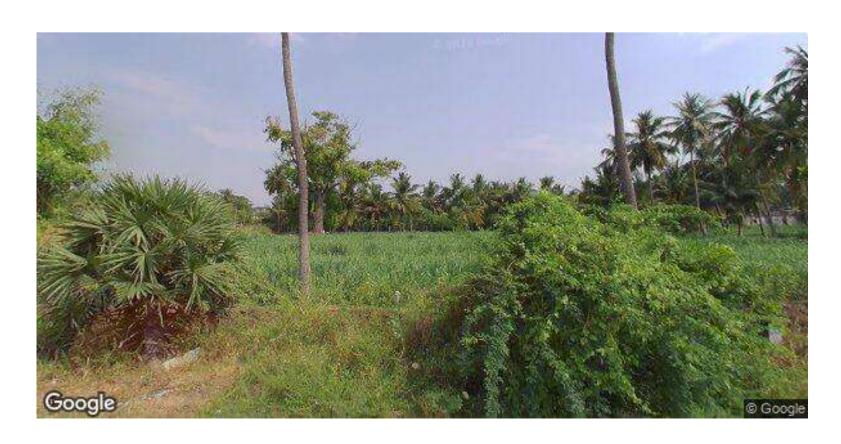
**Coordinates:** 11.29125, 77.74646

Risk Type: Turn
Risk Level: High
Speed Limit: 15 KM/Hr

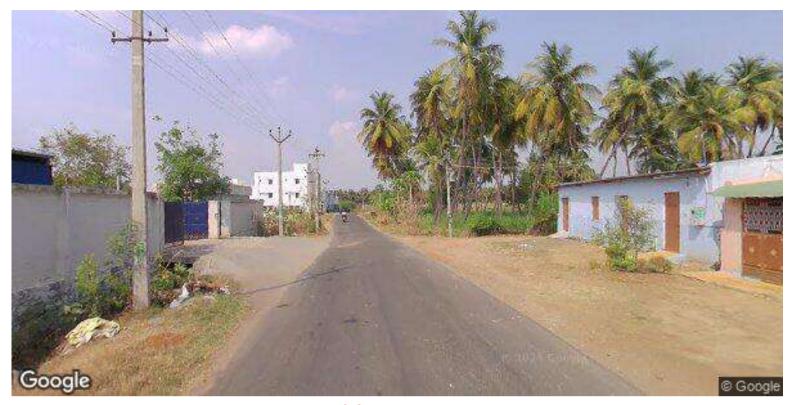
Risk Type: Turn
Risk Level: Medium
Speed Limit: 30 KM/Hr
Coordinates: 11.29076, 77.74528

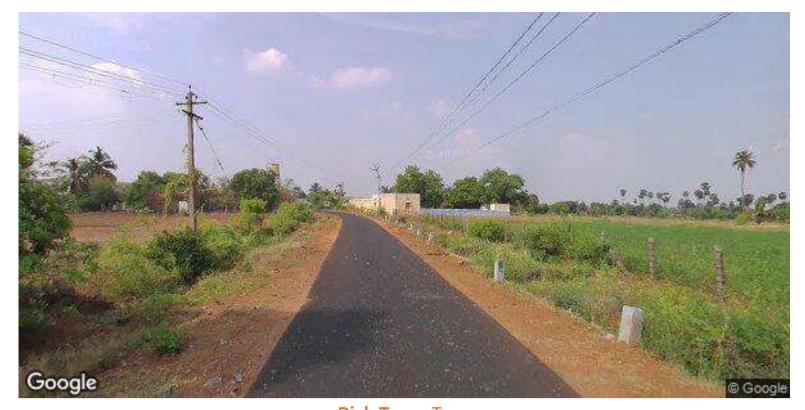
Risk Type: Turn
Risk Level: Medium
Speed Limit: 30 KM/Hr
Coordinates: 11.28518, 77.74231

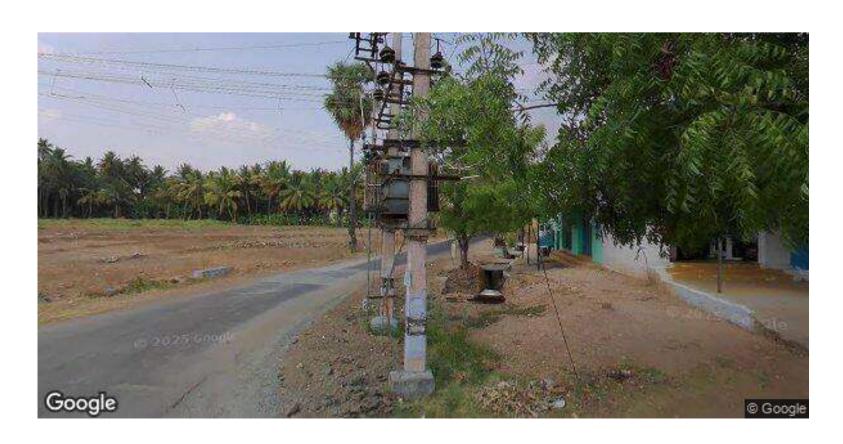
**Coordinates:** 11.27330, 77.72715

Risk Type: Blind Spot Risk Level: Blind Spot Speed Limit: 10 KM/Hr

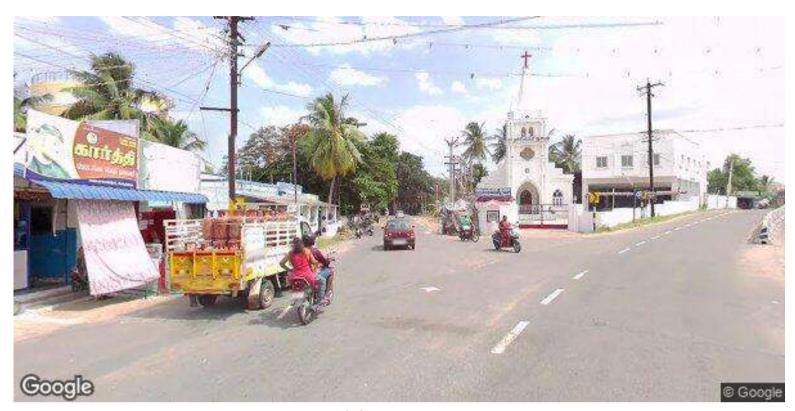
**Coordinates:** 11.23054, 77.71796

Risk Type: Turn
Risk Level: Medium
Speed Limit: 30 KM/Hr

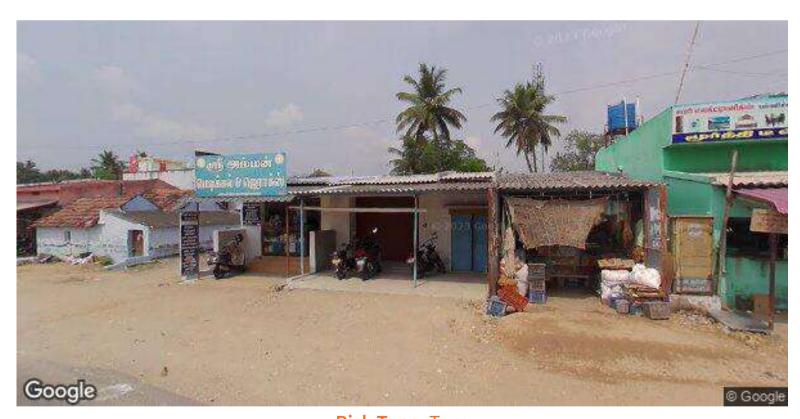
Risk Type: Turn
Risk Level: Medium
Speed Limit: 30 KM/Hr
Coordinates: 11.20776, 77.70916

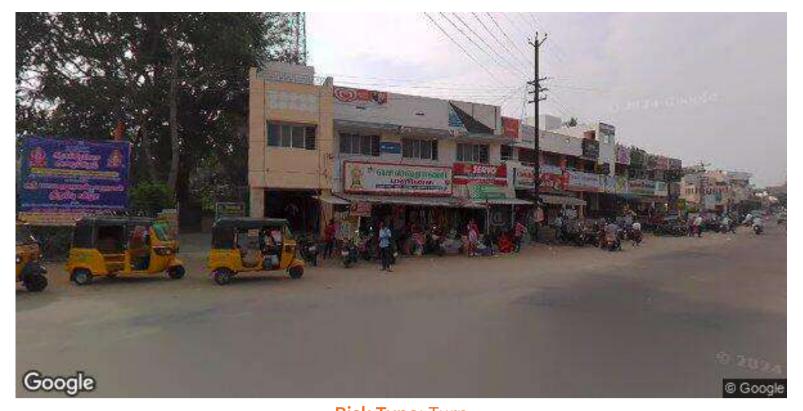
Risk Type: Turn
Risk Level: Medium
Speed Limit: 30 KM/Hr
Coordinates: 11.15942, 77.70068

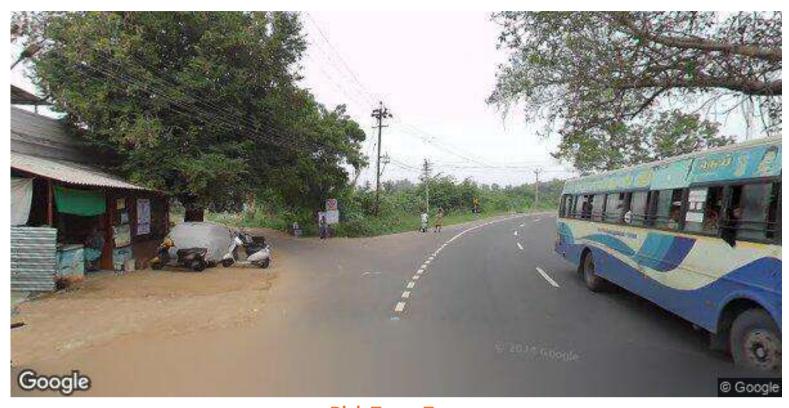
Risk Type: Turn
Risk Level: Medium
Speed Limit: 30 KM/Hr
Coordinates: 11.11710, 77.67175

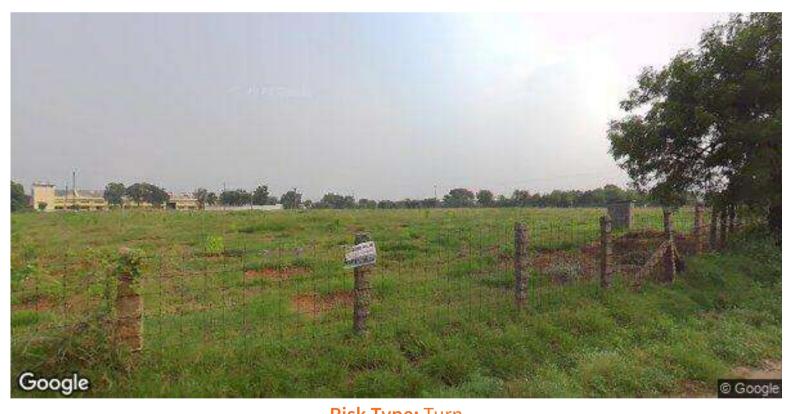
Risk Type: Turn
Risk Level: Medium
Speed Limit: 30 KM/Hr
Coordinates: 11.09491, 77.66603

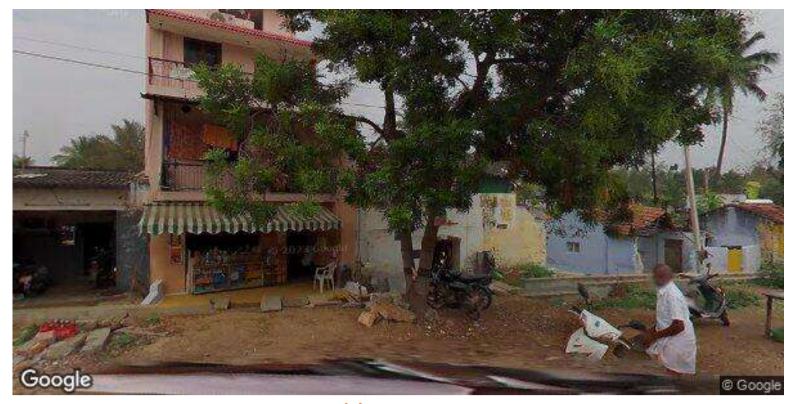
Risk Type: Turn
Risk Level: Medium
Speed Limit: 30 KM/Hr
Coordinates: 11.08696, 77.66407

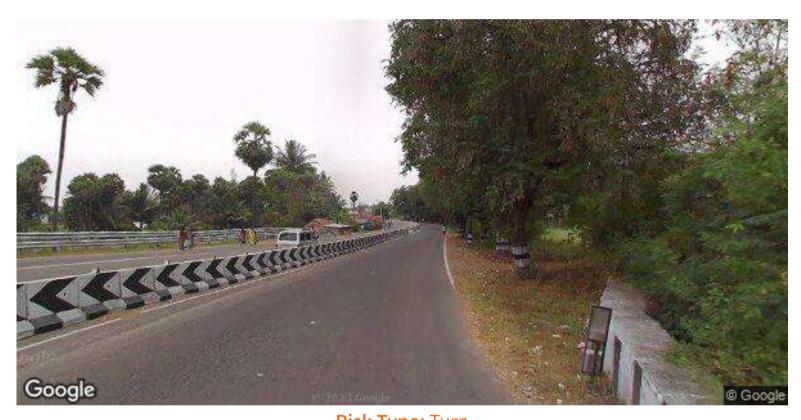
Risk Type: Turn
Risk Level: Medium
Speed Limit: 30 KM/Hr
Coordinates: 11.08296, 77.65857

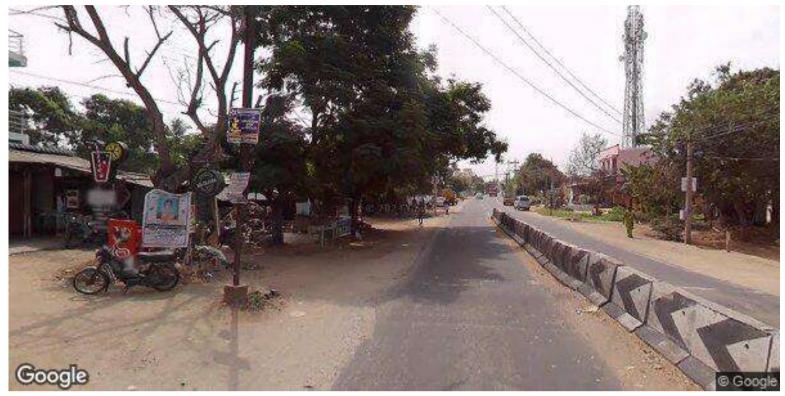
**Coordinates:** 11.00826, 77.56962

Risk Type: Turn
Risk Level: High
Speed Limit: 15 KM/Hr

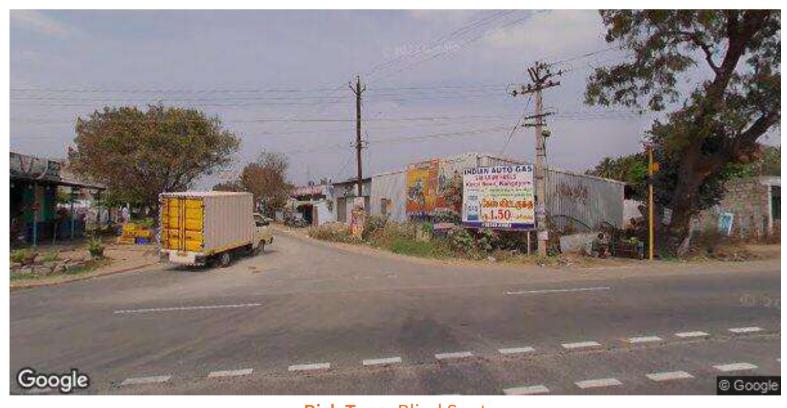
**Coordinates:** 11.00058, 77.56882

Risk Type: Blind Spot
Risk Level: Blind Spot
Speed Limit: 10 KM/Hr

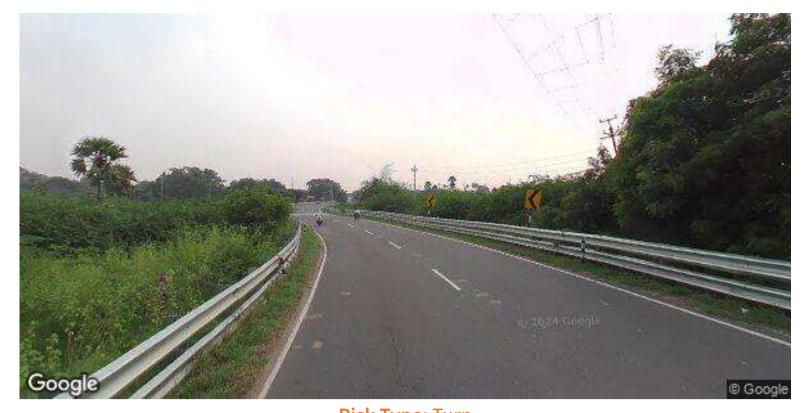
Risk Type: Turn
Risk Level: Medium
Speed Limit: 30 KM/Hr
Coordinates: 10.94862, 77.54680

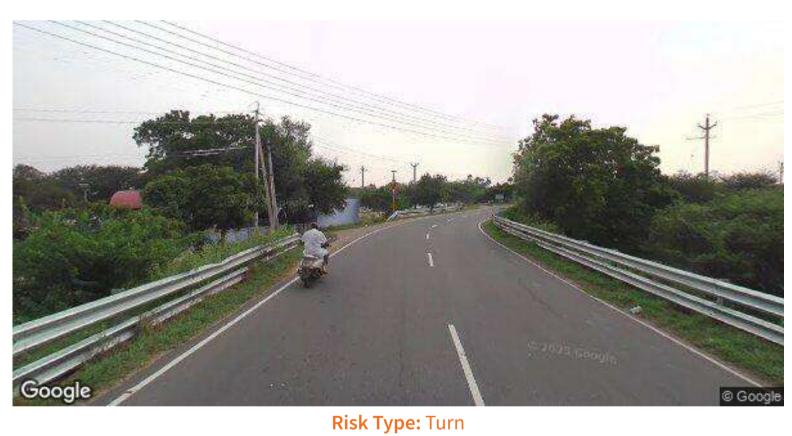
Coordinates: 10.94722, 77.54709

Risk Type: Turn

Risk Level: High

Speed Limit: 15 KM/Hr

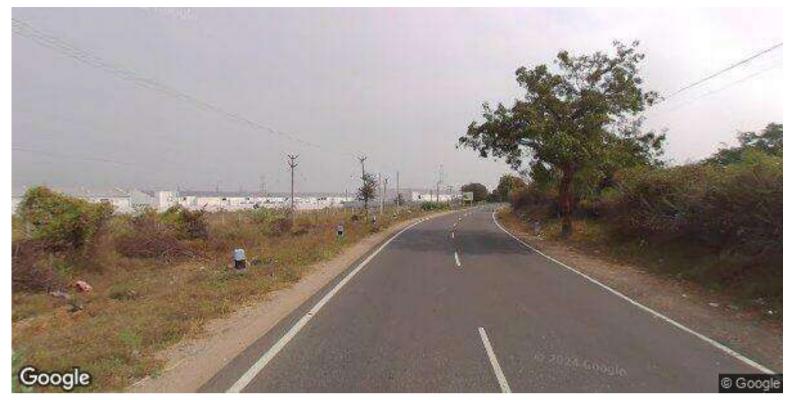
Risk Type: Turn
Risk Level: Medium
Speed Limit: 30 KM/Hr
Coordinates: 10.93765, 77.53710

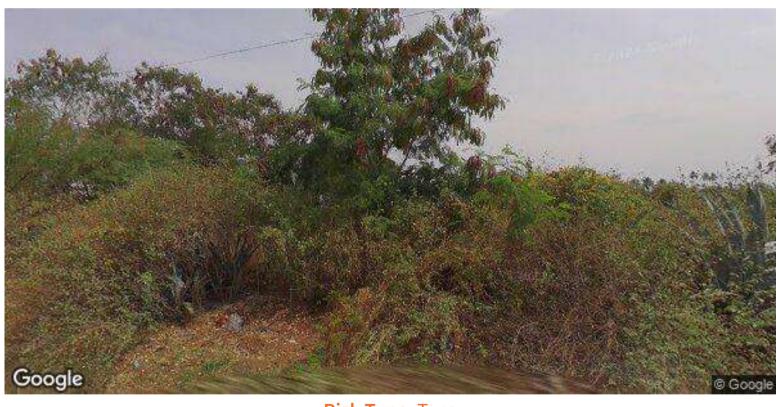
Risk Type: Turn
Risk Level: Medium
Speed Limit: 30 KM/Hr
Coordinates: 10.93054, 77.53265

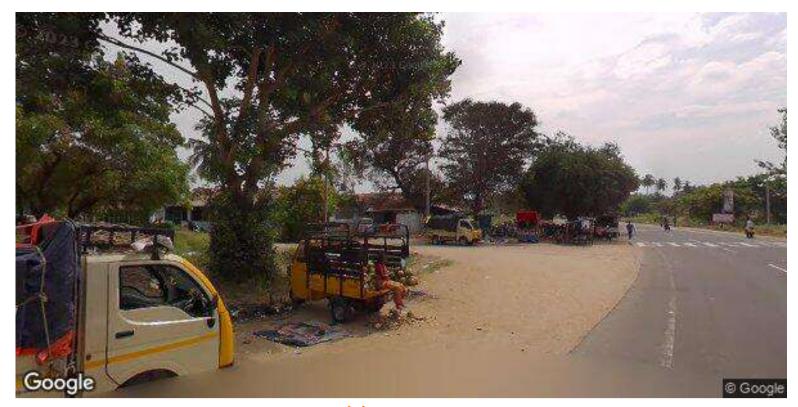
Risk Type: Turn
Risk Level: Medium
Speed Limit: 30 KM/Hr
Coordinates: 10.89213, 77.52646

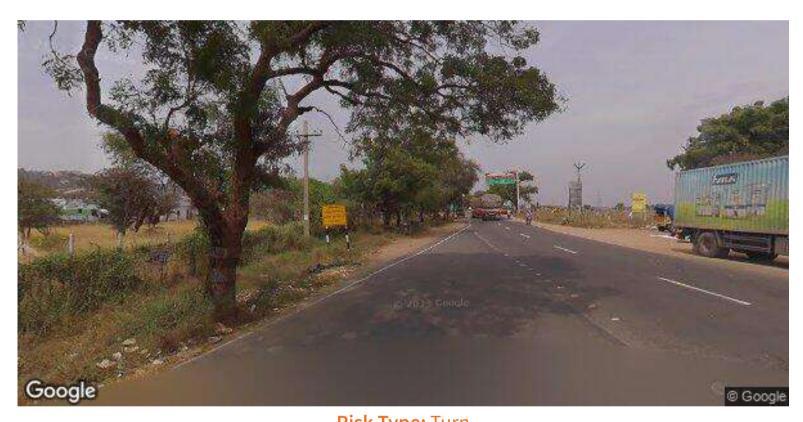
Risk Type: Turn
Risk Level: High
Speed Limit: 15 KM/Hr
Coordinates: 10.87916, 77.52773

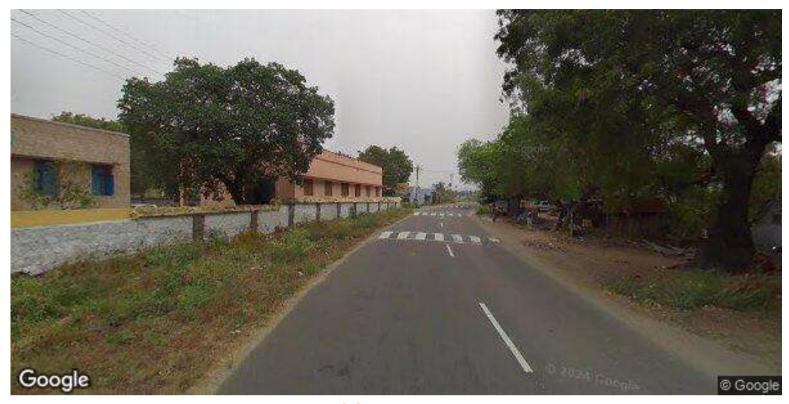
Risk Type: Turn
Risk Level: Medium
Speed Limit: 30 KM/Hr
Coordinates: 10.88260, 77.48881

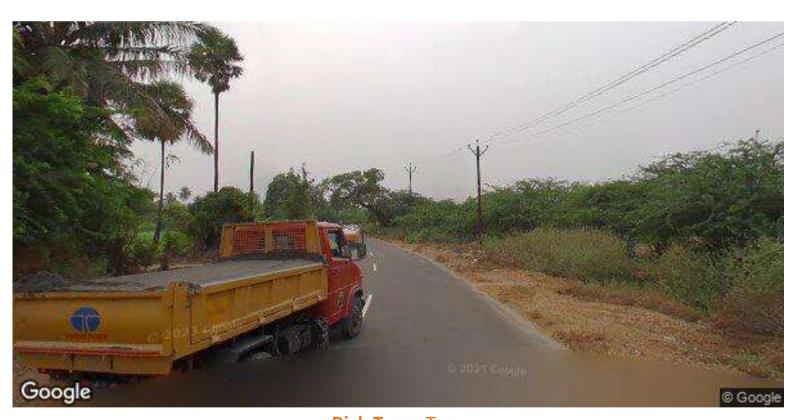
**Coordinates:** 10.88221, 77.48831

Risk Type: Turn
Risk Level: High
Speed Limit: 15 KM/Hr

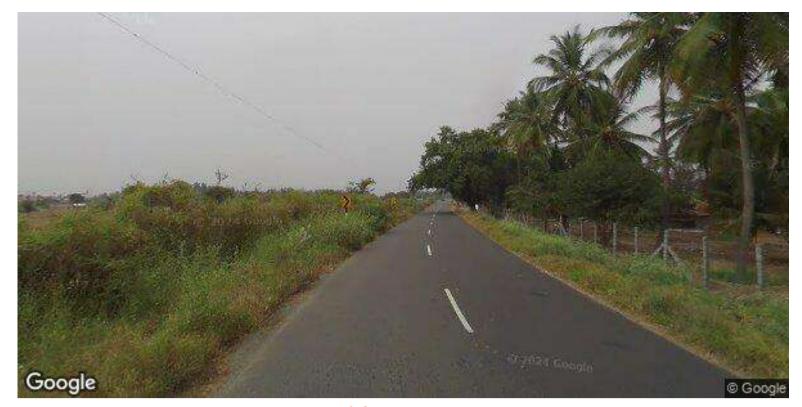
Risk Type: Turn
Risk Level: High
Speed Limit: 15 KM/Hr
Coordinates: 10.87783, 77.48740

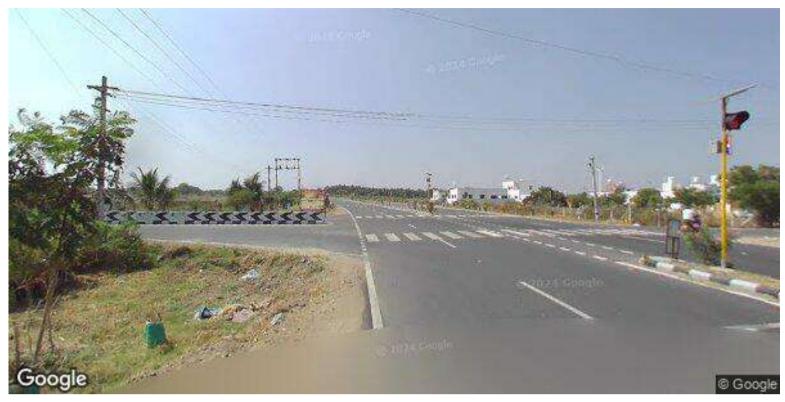
Risk Type: Turn
Risk Level: High
Speed Limit: 15 KM/Hr
Coordinates: 10.85361, 77.43716

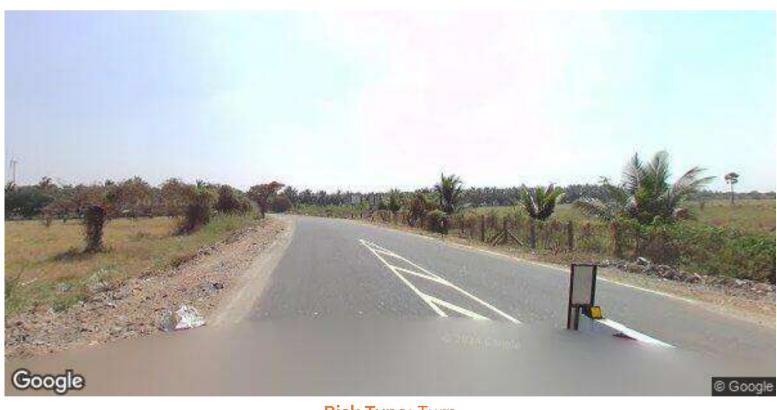
Risk Type: Turn
Risk Level: Medium
Speed Limit: 30 KM/Hr
Coordinates: 10.85334, 77.43681

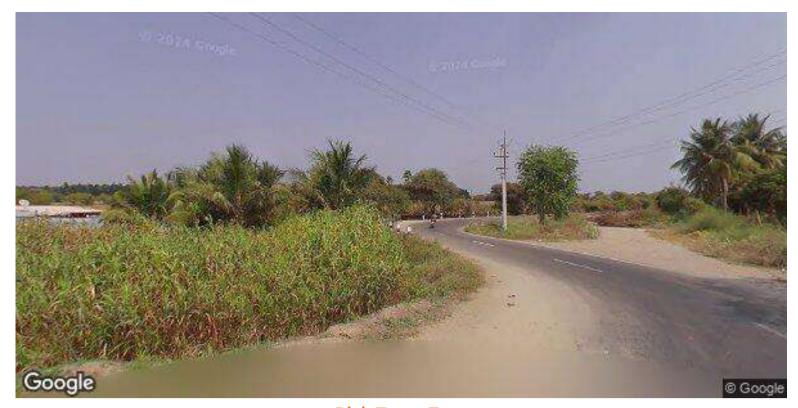
Risk Type: Turn
Risk Level: Medium
Speed Limit: 30 KM/Hr
Coordinates: 10.84267, 77.43414

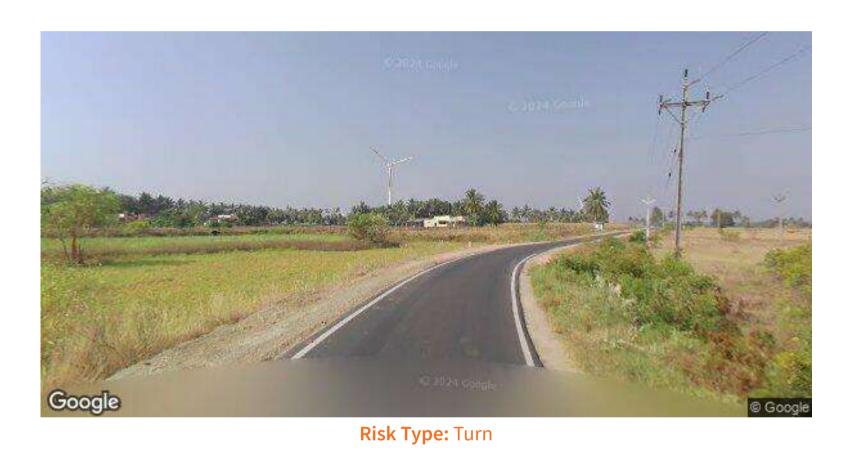
Speed Limit: 15 KM/Hr Coordinates: 10.83777, 77.40922

Risk Level: High

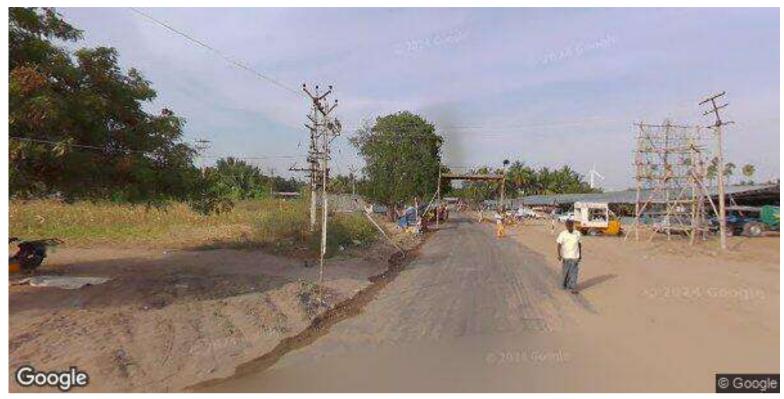
Risk Type: Turn
Risk Level: Medium
Speed Limit: 30 KM/Hr
Coordinates: 10.82716, 77.38831

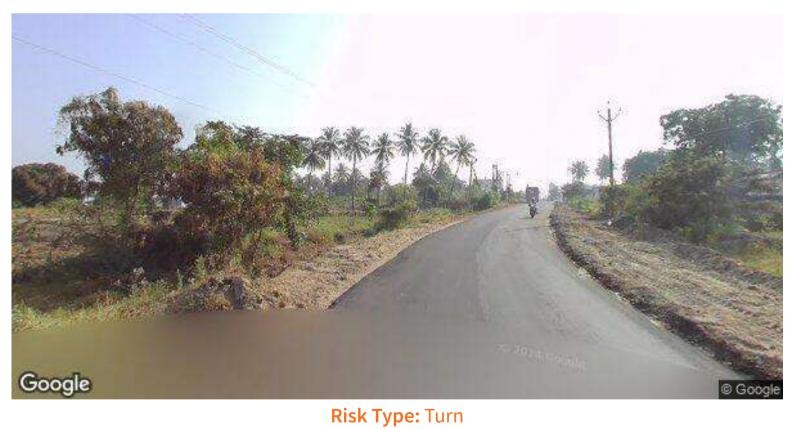
Risk Level: Medium
Speed Limit: 30 KM/Hr
Coordinates: 10.82438, 77.37275

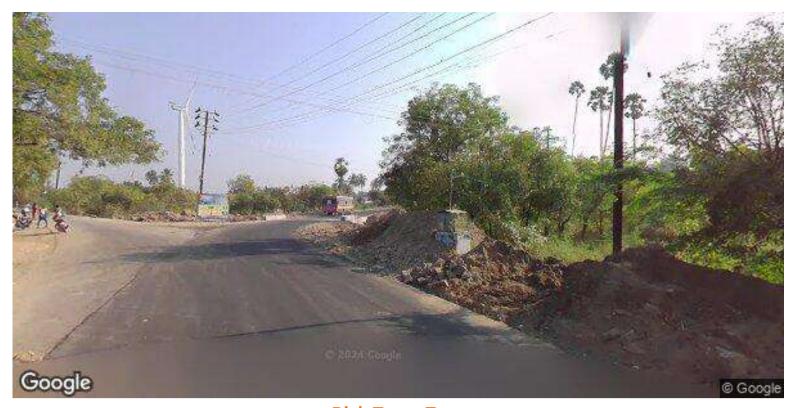
Risk Type: Turn
Risk Level: Medium
Speed Limit: 30 KM/Hr
Coordinates: 10.82376, 77.37202

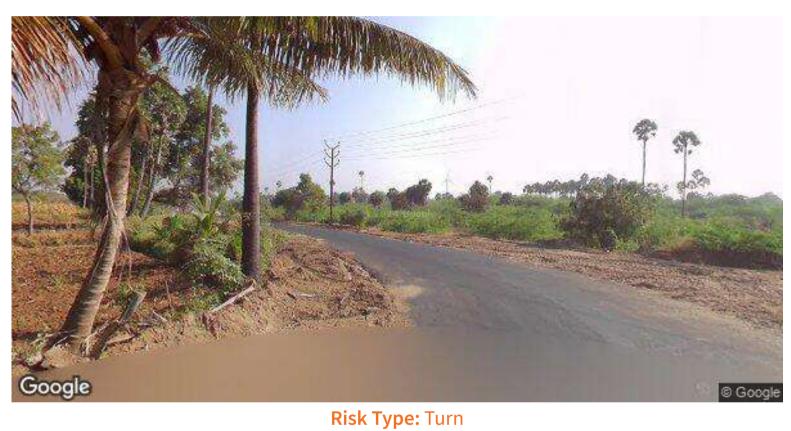
Risk Level: High
Speed Limit: 15 KM/Hr
Coordinates: 10.82150, 77.37132
