JOURNEY RISK MANAGEMENT (JRM) STUDY

Salem Terminal to ANNAMAR AGENCIES

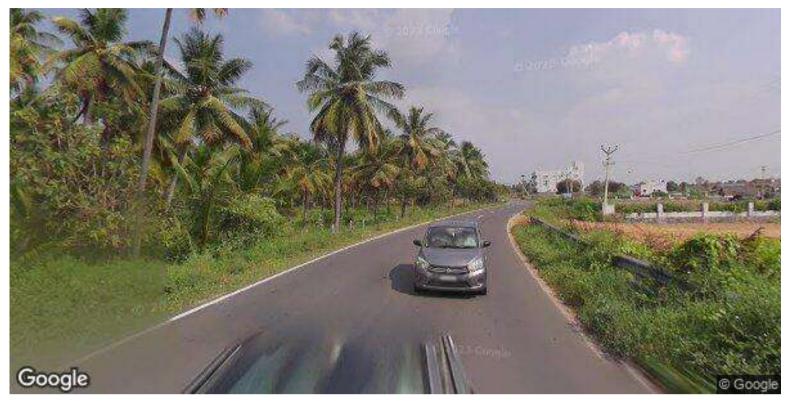
Coordinates: 11.45357, 77.85789

Risk Type: Turn
Risk Level: Medium
Speed Limit: 30 KM/Hr

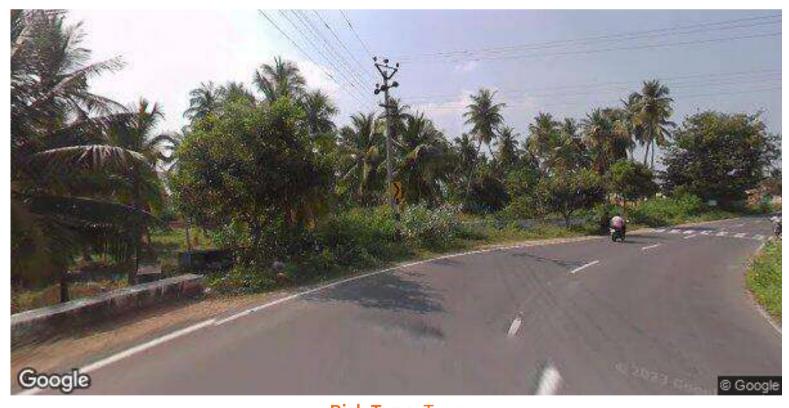
Coordinates: 11.45348, 77.85706

Risk Type: Turn
Risk Level: Medium
Speed Limit: 30 KM/Hr

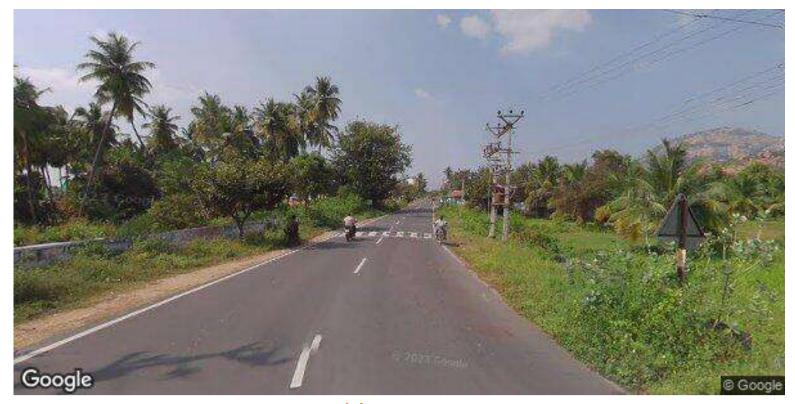
Risk Type: Turn
Risk Level: Medium
Speed Limit: 30 KM/Hr
Coordinates: 11.45352, 77.85698

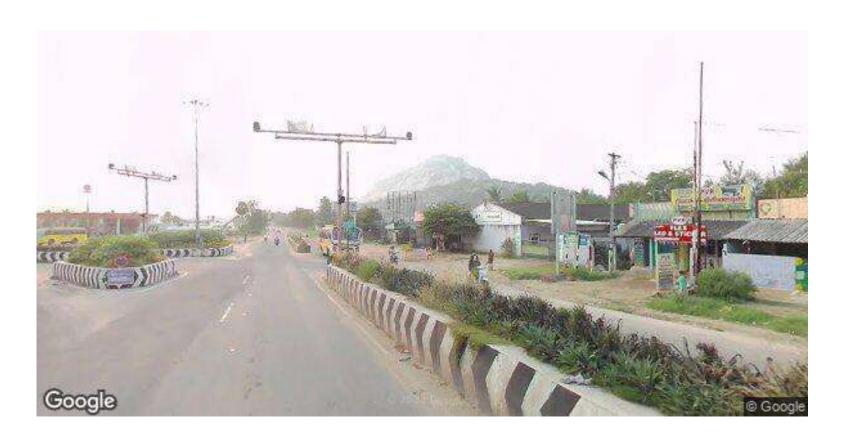
Coordinates: 11.46312, 77.84886

Risk Type: Turn
Risk Level: Medium
Speed Limit: 30 KM/Hr

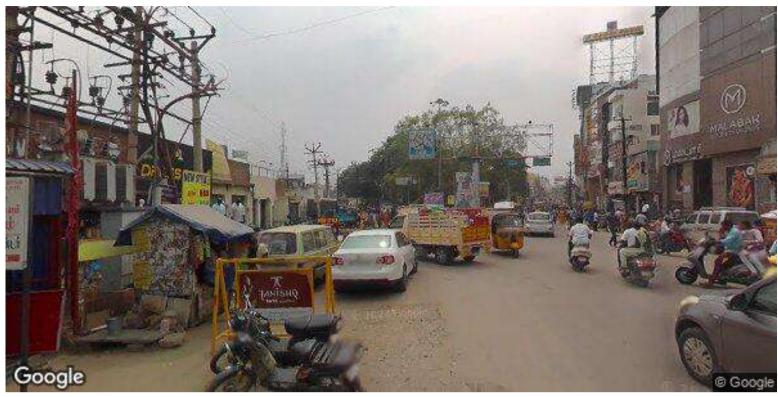
Coordinates: 11.34493, 77.73032

Risk Type: Turn
Risk Level: Medium
Speed Limit: 30 KM/Hr

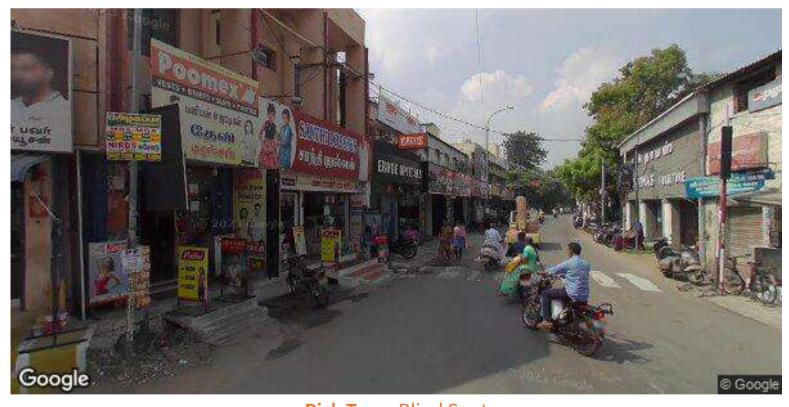
Coordinates: 11.33920, 77.72902

Risk Type: Blind Spot
Risk Level: Blind Spot
Speed Limit: 10 KM/Hr

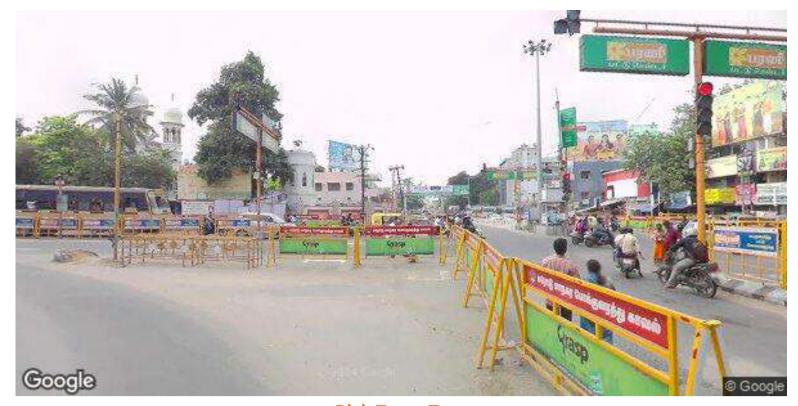
Risk Type: Turn
Risk Level: Medium
Speed Limit: 30 KM/Hr
Coordinates: 11.33914, 77.72659

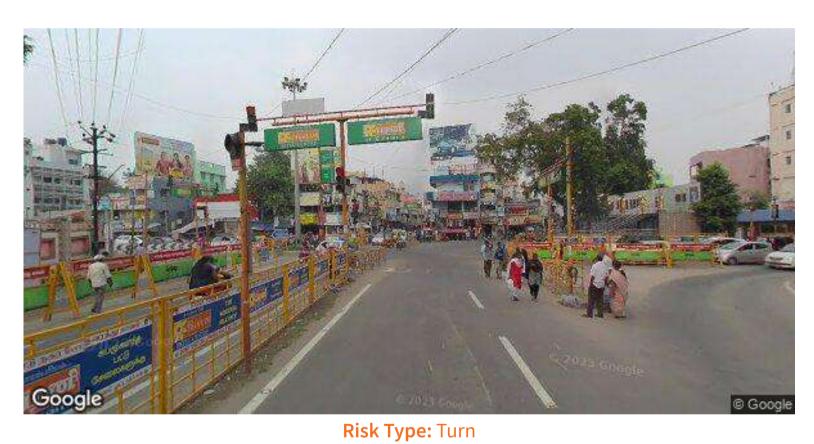
Risk Level: High
Speed Limit: 15 KM/Hr
Coordinates: 11.33890, 77.72637

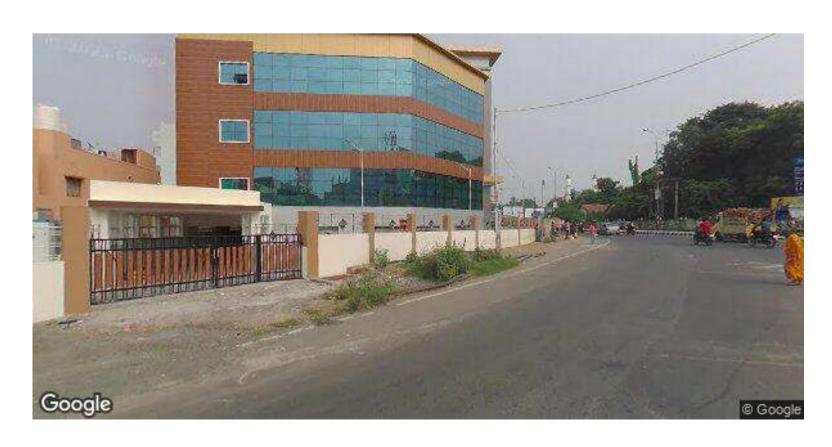
Coordinates: 11.33115, 77.72752

Risk Type: Turn
Risk Level: Medium
Speed Limit: 30 KM/Hr

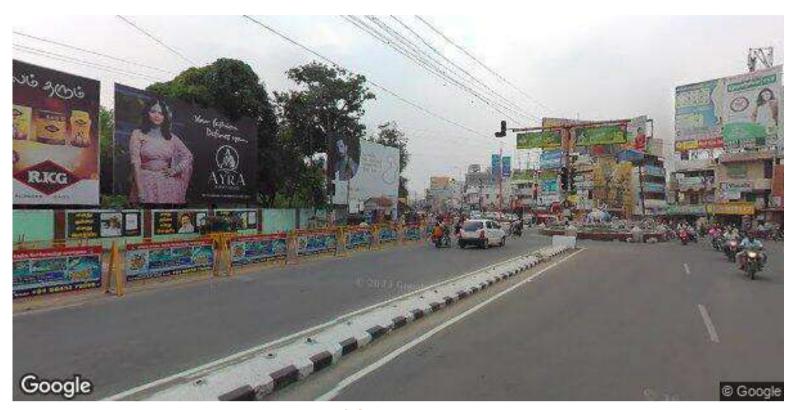
Coordinates: 11.33093, 77.72776

Risk Type: Turn
Risk Level: Medium
Speed Limit: 30 KM/Hr

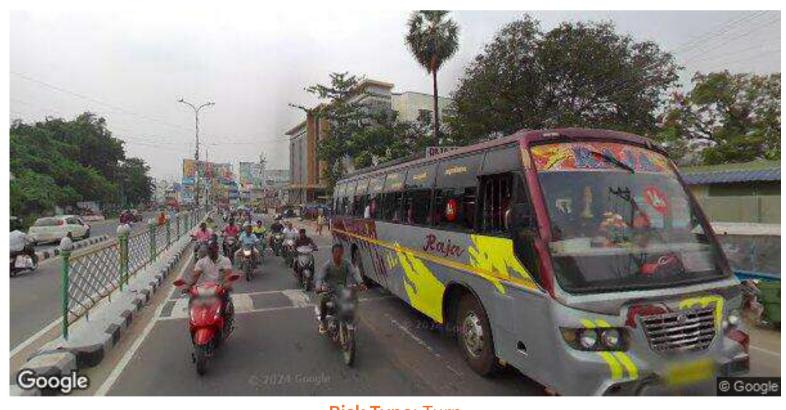
Coordinates: 11.33083, 77.72873

Risk Type: Turn
Risk Level: Medium
Speed Limit: 30 KM/Hr

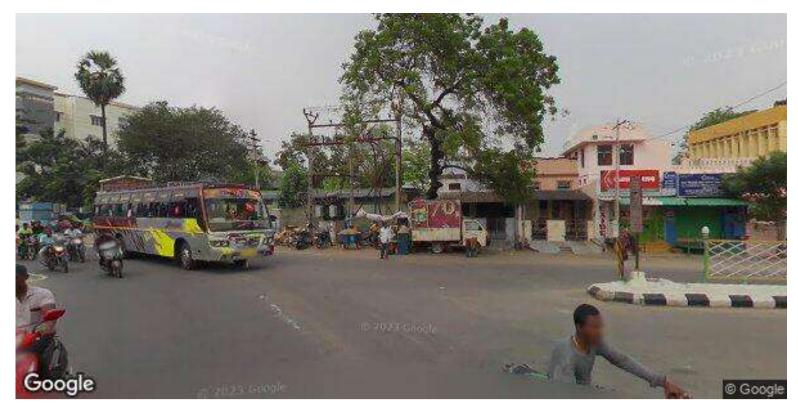
Risk Type: Turn
Risk Level: Medium
Speed Limit: 30 KM/Hr
Coordinates: 11.33072, 77.72888

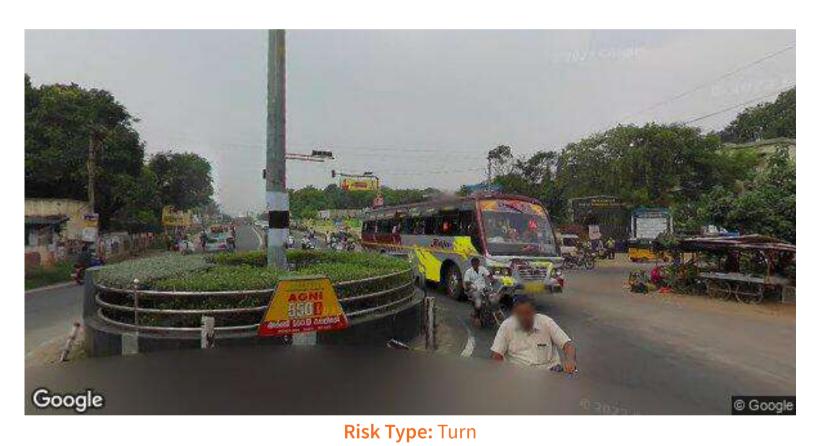
Risk Level: High
Speed Limit: 15 KM/Hr
Coordinates: 11.32699, 77.73073
