JOURNEY RISK MANAGEMENT (JRM) STUDY

Salem Terminal to AMMAN AGENCIES MULANUR

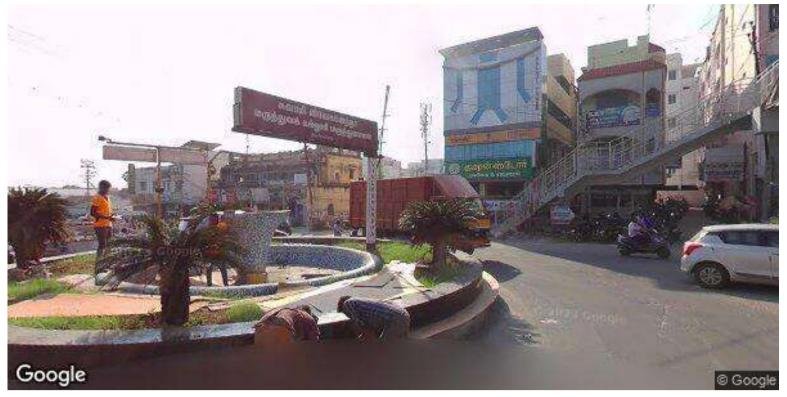
Risk Type: Roundabout
Risk Level: High
Speed Limit: 15 KM/Hr
Coordinates: 11.38395, 77.89480

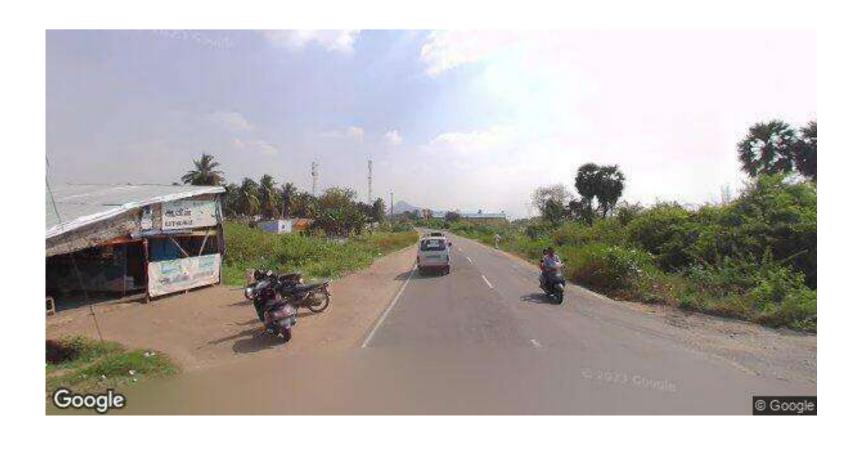
Coordinates: 11.44022, 77.87546

Risk Type: Turn
Risk Level: High
Speed Limit: 15 KM/Hr

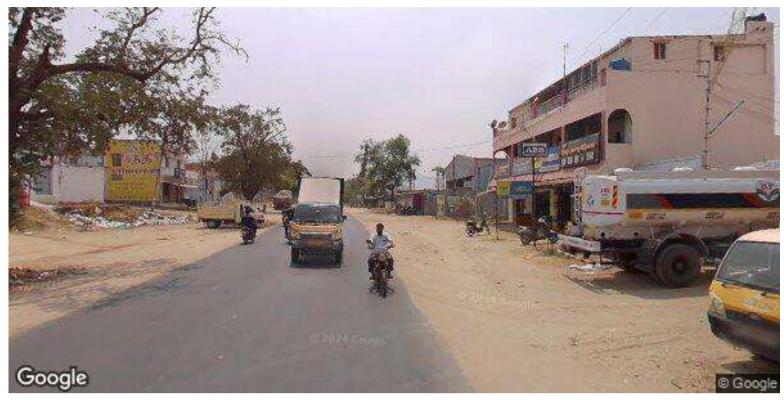
Coordinates: 11.39976, 77.88382

Risk Type: Turn
Risk Level: Medium
Speed Limit: 30 KM/Hr

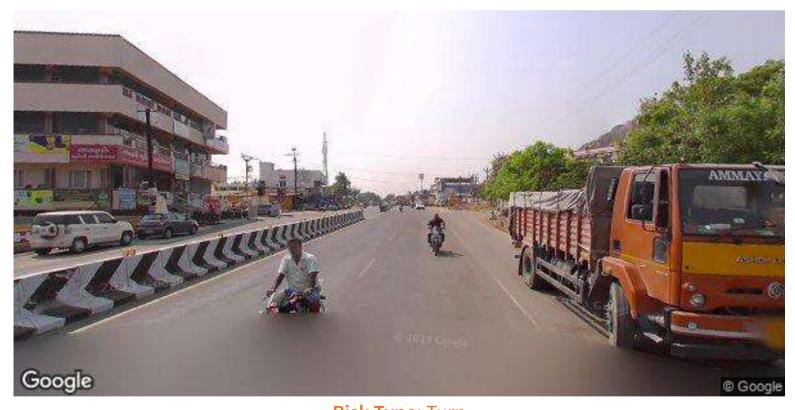
Risk Type: Turn
Risk Level: Medium
Speed Limit: 30 KM/Hr
Coordinates: 11.39690, 77.88852

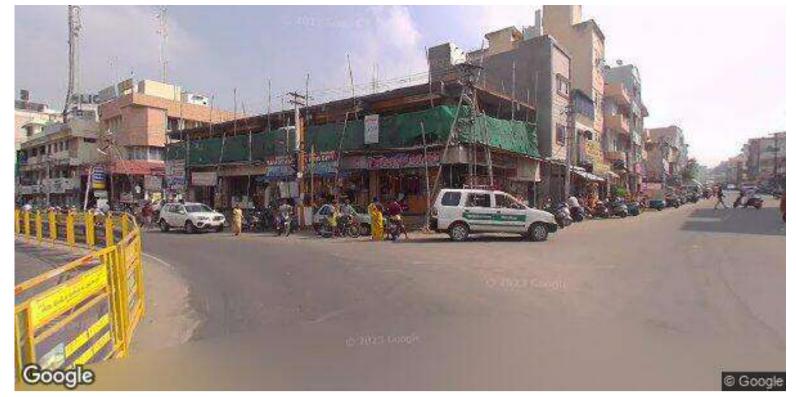
Risk Type: Turn
Risk Level: High
Speed Limit: 15 KM/Hr
Coordinates: 11.37868, 77.89498

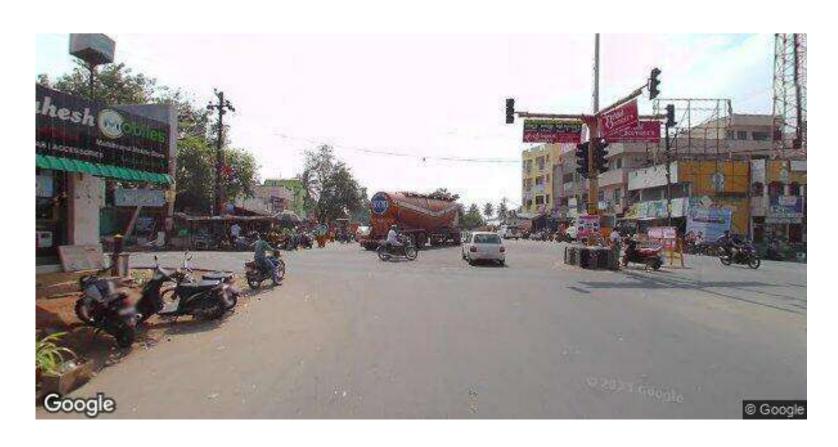
Coordinates: 11.36616, 77.88885

Risk Type: Turn
Risk Level: High
Speed Limit: 15 KM/Hr

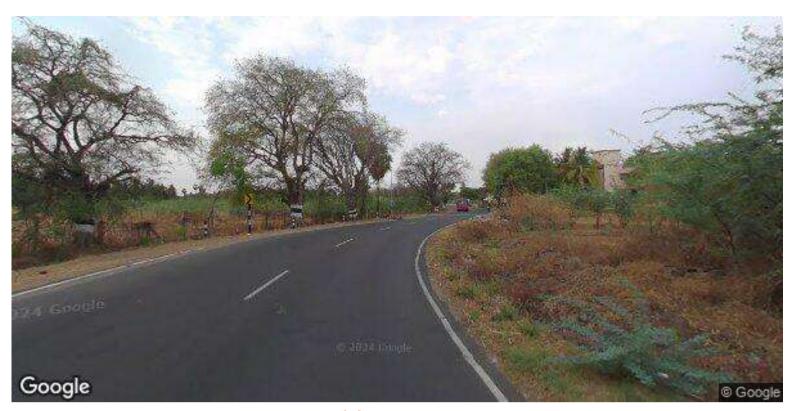
Coordinates: 11.34067, 77.86347

Risk Type: Turn
Risk Level: Medium
Speed Limit: 30 KM/Hr

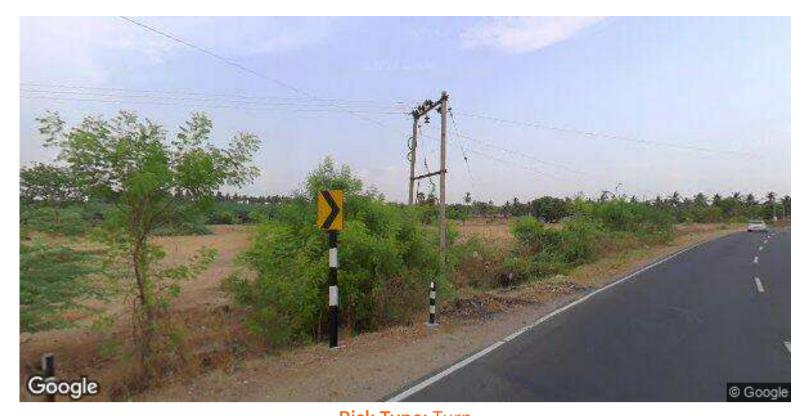
Risk Type: Turn
Risk Level: Medium
Speed Limit: 30 KM/Hr
Coordinates: 11.33778, 77.86236

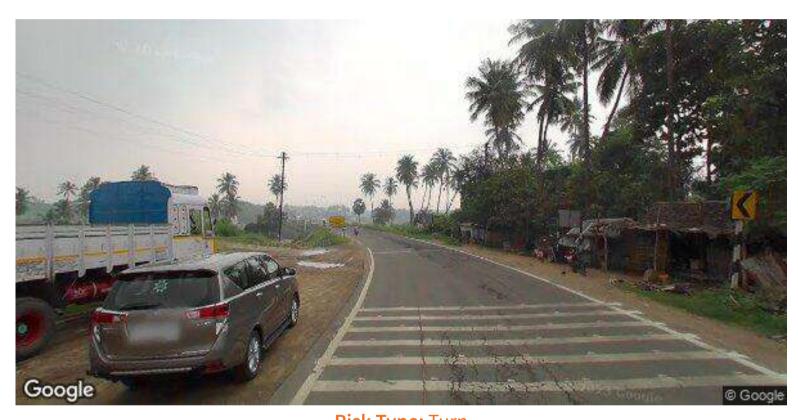
Risk Type: Turn
Risk Level: Medium
Speed Limit: 30 KM/Hr
Coordinates: 11.30952, 77.77587

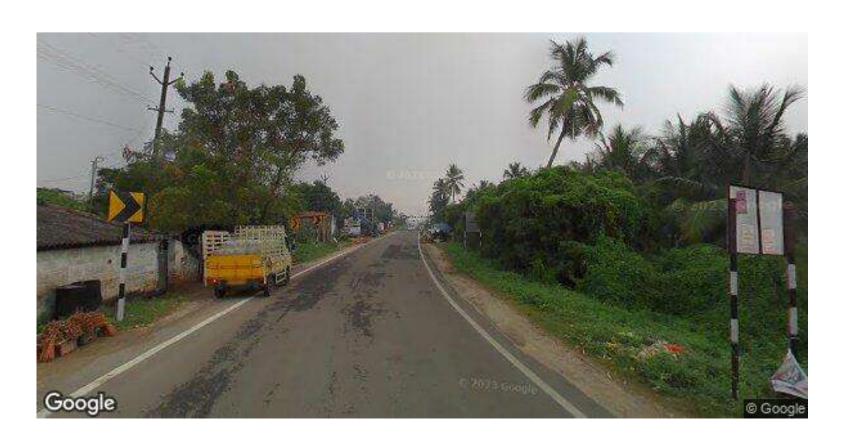
Coordinates: 11.30973, 77.76712

Risk Type: Turn
Risk Level: Medium
Speed Limit: 30 KM/Hr

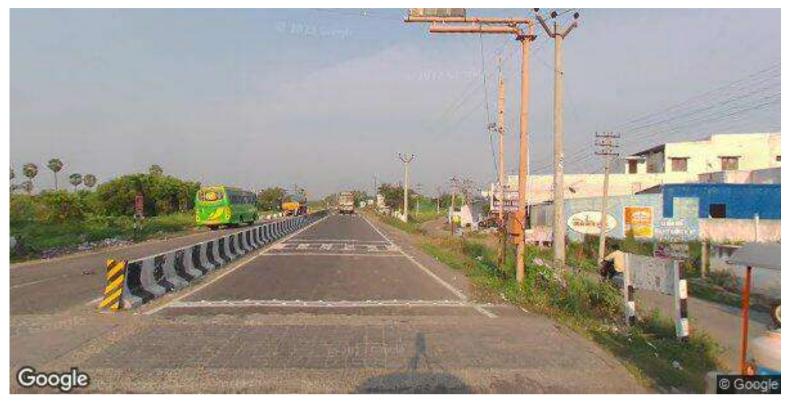
Coordinates: 11.29908, 77.75818

Risk Type: Turn
Risk Level: High
Speed Limit: 15 KM/Hr

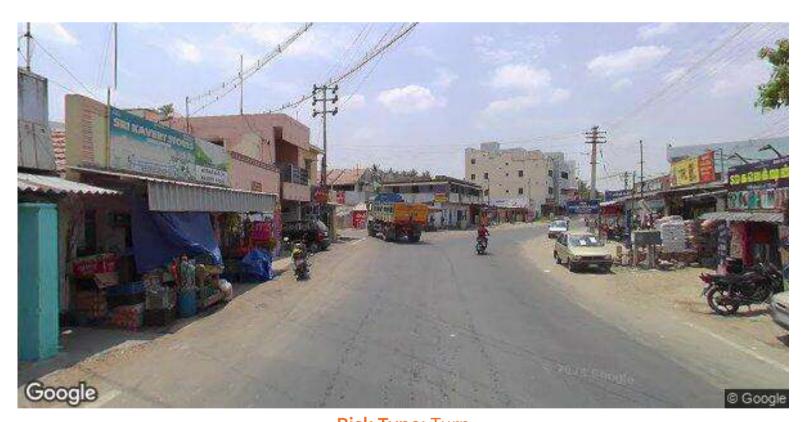
Risk Type: Turn
Risk Level: Medium
Speed Limit: 30 KM/Hr
Coordinates: 11.18935, 77.77078

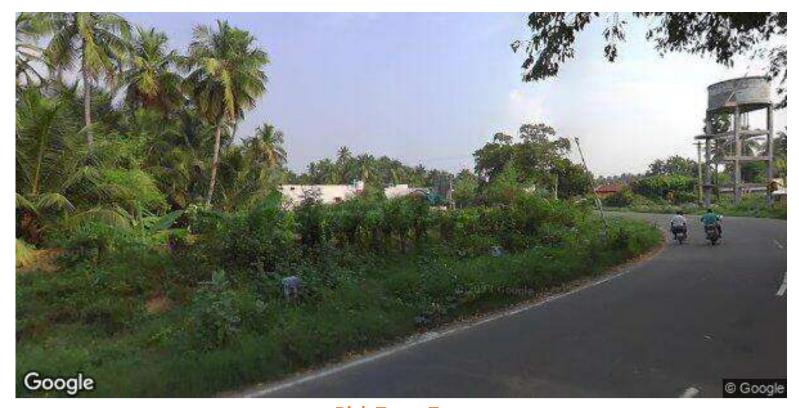
Risk Type: Turn
Risk Level: High
Speed Limit: 15 KM/Hr
Coordinates: 11.16434, 77.77360

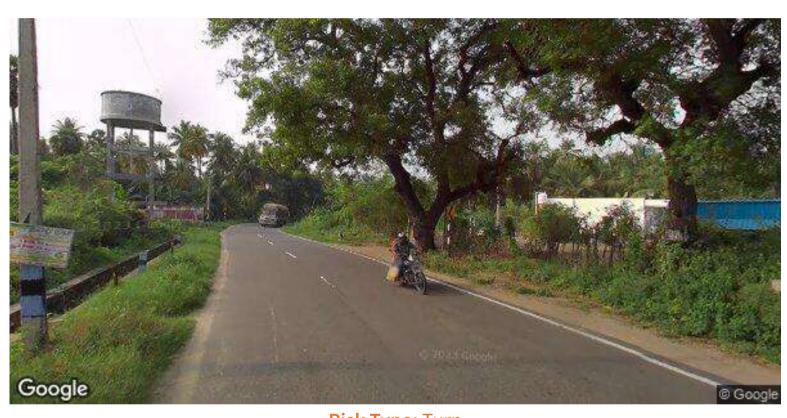
Risk Type: Turn
Risk Level: Medium
Speed Limit: 30 KM/Hr
Coordinates: 11.16375, 77.77424

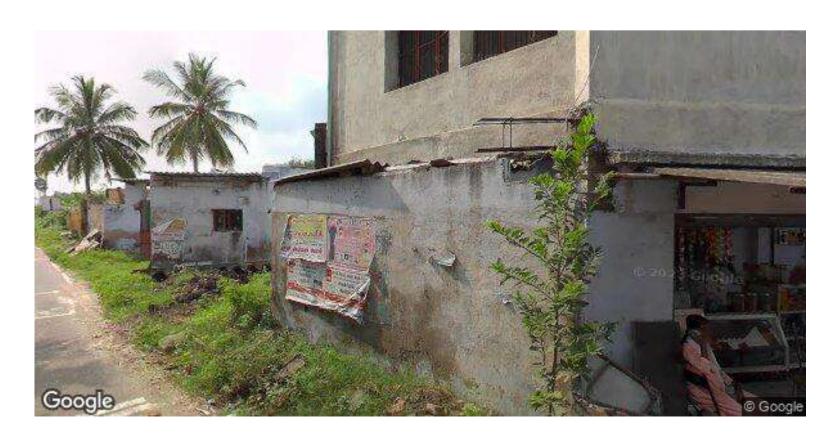
Coordinates: 11.13659, 77.76519

Risk Type: Turn
Risk Level: Medium
Speed Limit: 30 KM/Hr

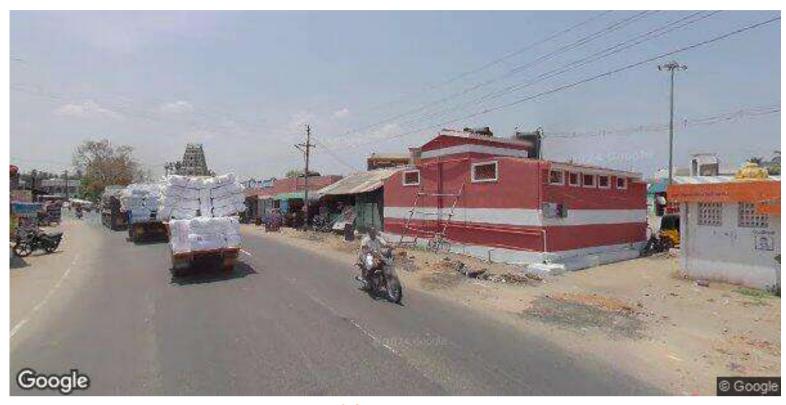
Coordinates: 11.04614, 77.73704

Risk Type: Turn
Risk Level: Medium
Speed Limit: 30 KM/Hr

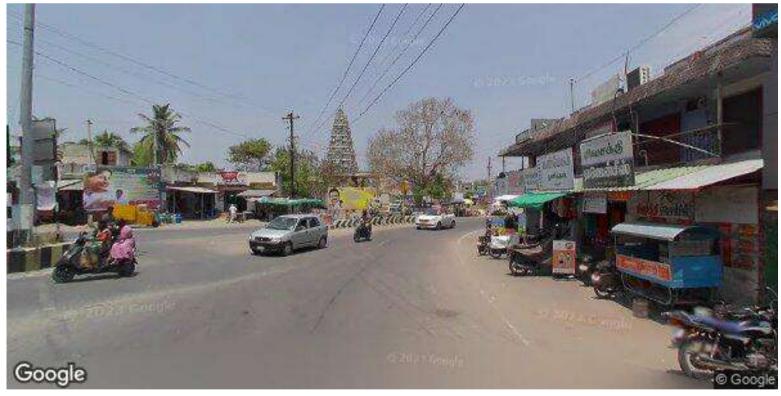
Risk Type: Turn
Risk Level: Medium
Speed Limit: 30 KM/Hr
Coordinates: 11.04505, 77.73623

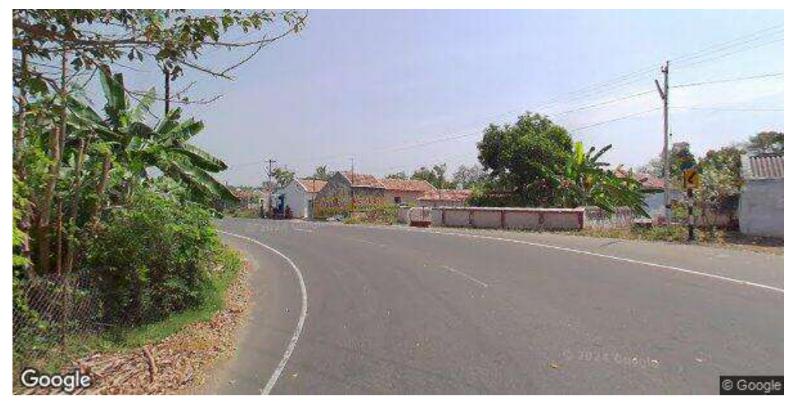
Risk Type: Turn
Risk Level: High
Speed Limit: 15 KM/Hr
Coordinates: 10.99023, 77.72506

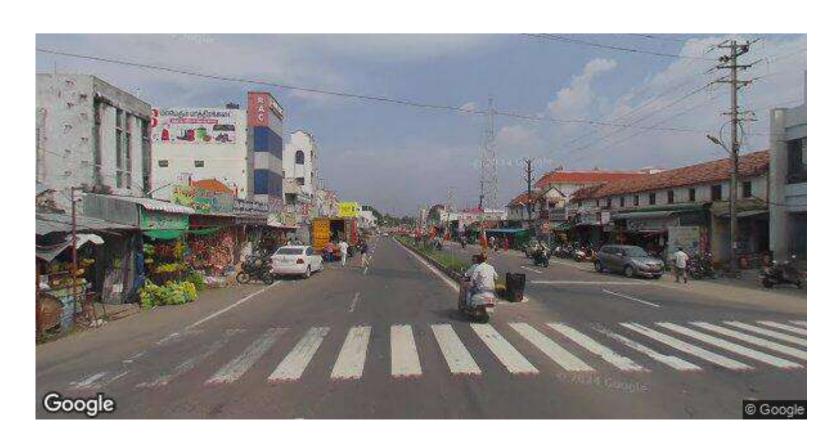
Coordinates: 10.94597, 77.71319

Risk Type: Blind Spot
Risk Level: Blind Spot
Speed Limit: 10 KM/Hr

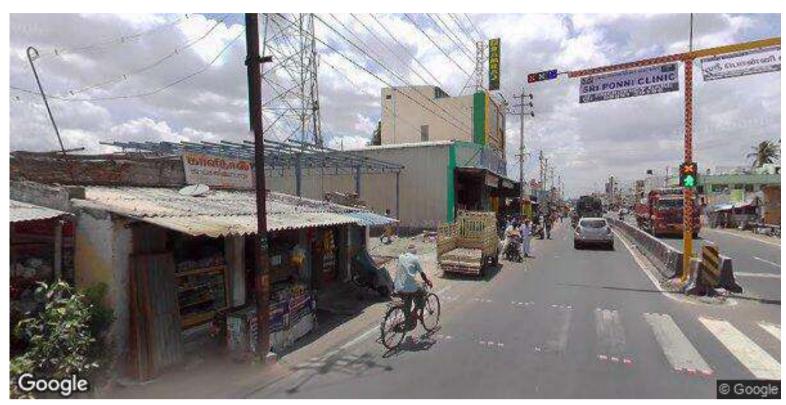
Coordinates: 10.94563, 77.71574

Risk Type: Turn
Risk Level: High
Speed Limit: 15 KM/Hr

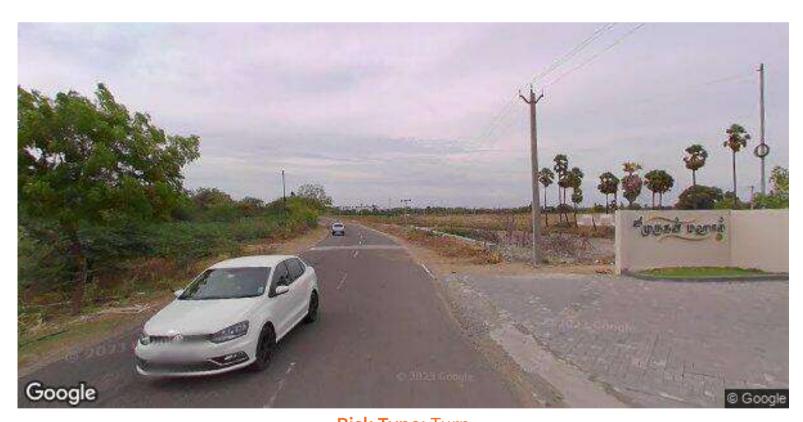
Risk Type: Turn
Risk Level: Medium
Speed Limit: 30 KM/Hr
Coordinates: 10.92228, 77.72392

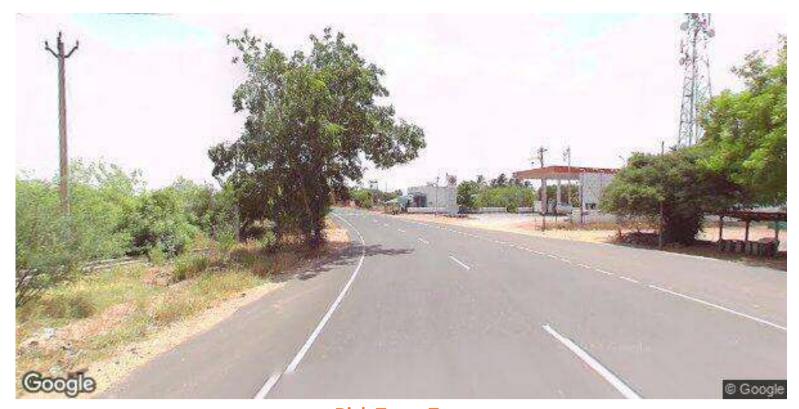
Risk Type: Turn
Risk Level: Medium
Speed Limit: 30 KM/Hr
Coordinates: 10.86278, 77.72143

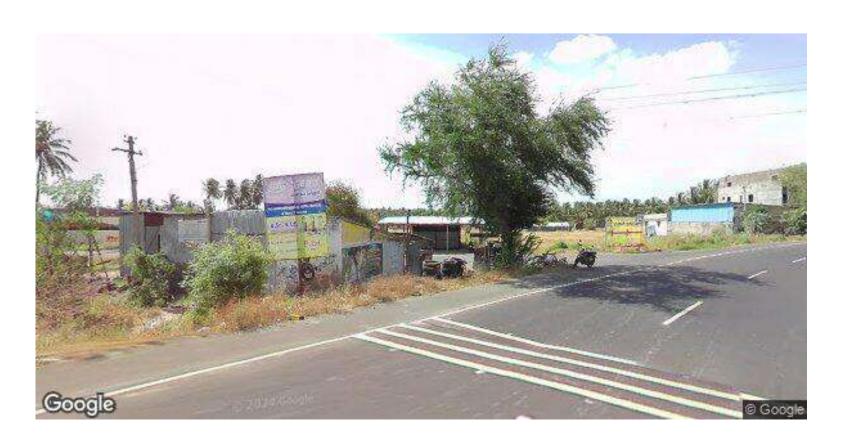
Coordinates: 10.86118, 77.71726

Risk Type: Turn
Risk Level: Medium
Speed Limit: 30 KM/Hr

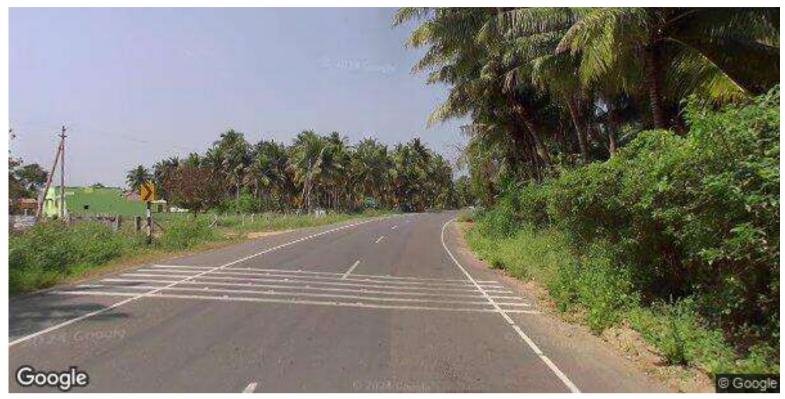
Risk Type: Turn
Risk Level: Medium
Speed Limit: 30 KM/Hr
Coordinates: 10.85613, 77.71791

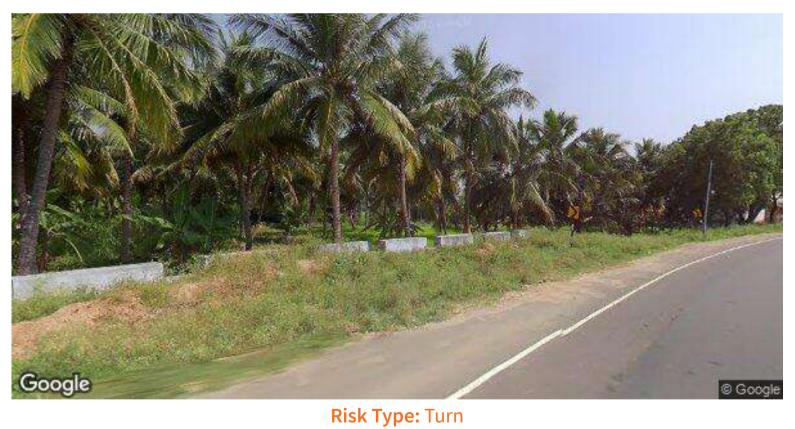
Risk Level: Medium
Speed Limit: 30 KM/Hr
Coordinates: 10.85462, 77.72064

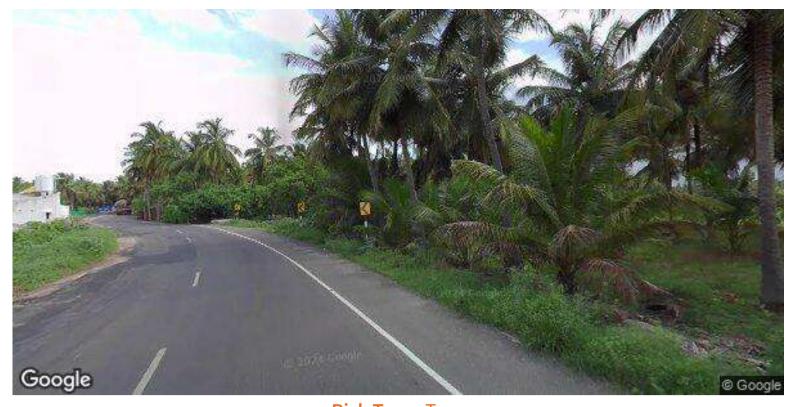
Risk Type: Turn
Risk Level: Medium
Speed Limit: 30 KM/Hr
Coordinates: 10.84875, 77.72076

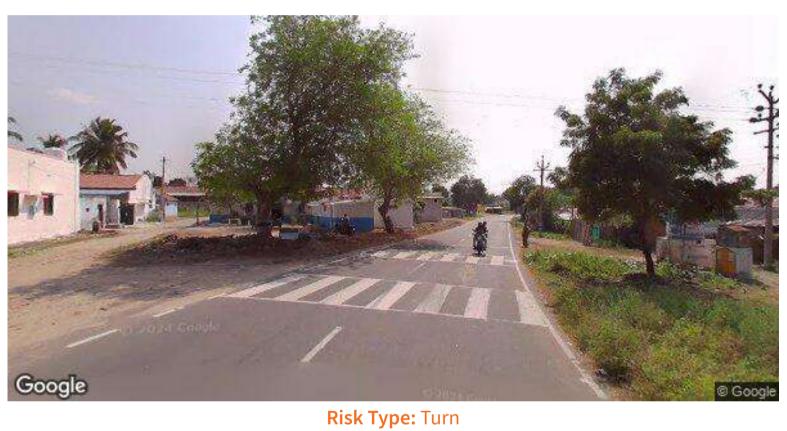
Coordinates: 10.82285, 77.72027

Risk Type: Turn

Risk Level: Medium

Speed Limit: 30 KM/Hr

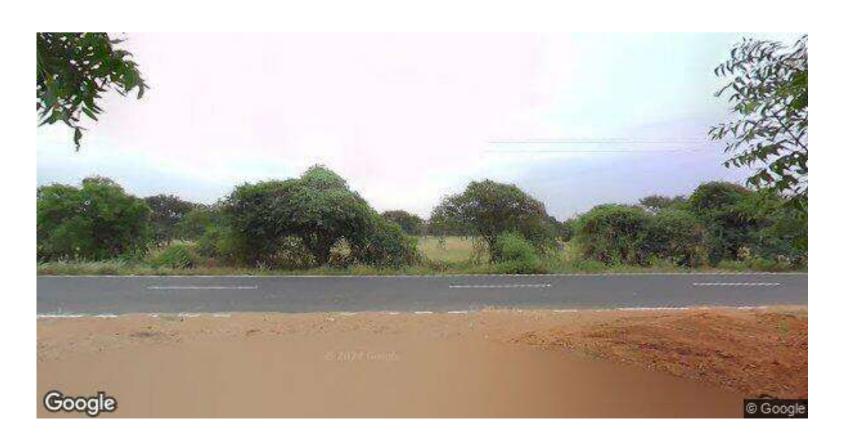
Coordinates: 10.81280, 77.71753

Risk Type: Turn
Risk Level: High
Speed Limit: 15 KM/Hr

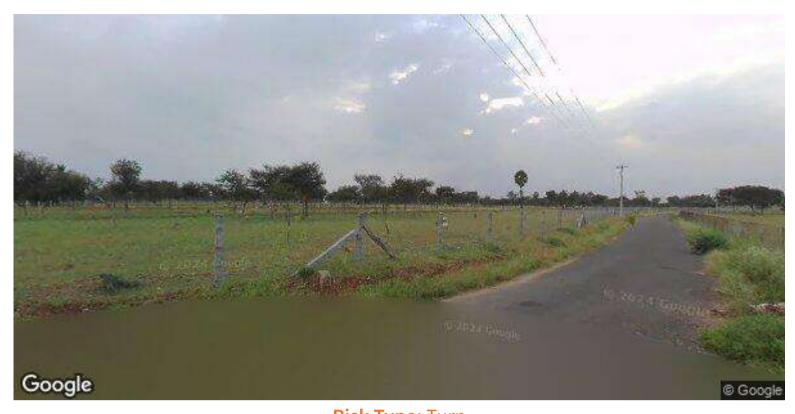
Risk Type: Turn
Risk Level: Medium
Speed Limit: 30 KM/Hr
Coordinates: 10.81256, 77.72035

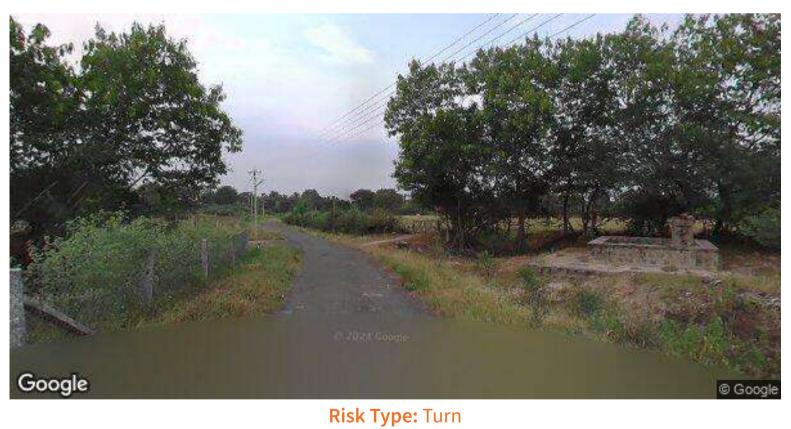
Risk Level: Medium
Speed Limit: 30 KM/Hr
Coordinates: 10.80911, 77.72390

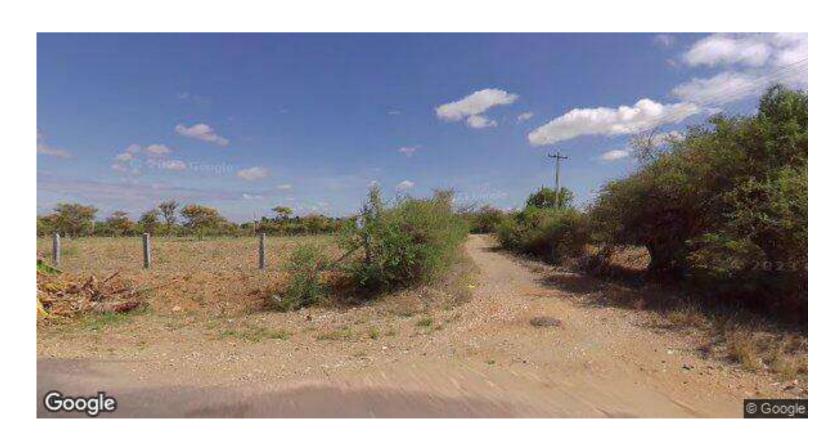
Coordinates: 10.80774, 77.72667

Risk Type: Turn
Risk Level: High
Speed Limit: 15 KM/Hr

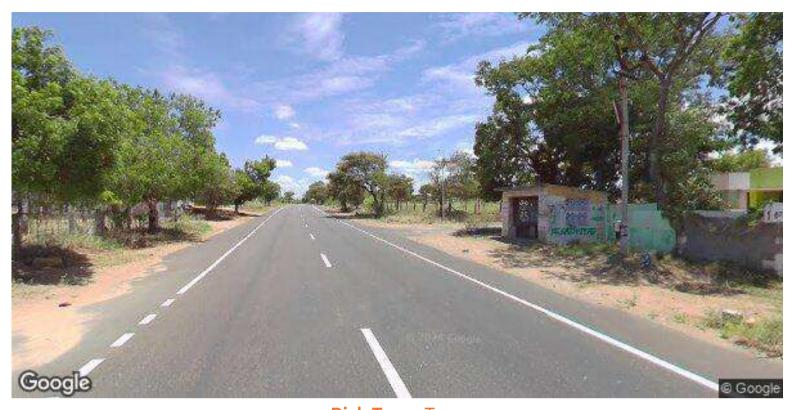
Coordinates: 10.80125, 77.72786

Risk Type: Turn
Risk Level: High
Speed Limit: 15 KM/Hr
