# IndianOil

## JOURNEY RISK MANAGEMENT (JRM) STUDY

### Salem Terminal to RAMESH AGENCIES

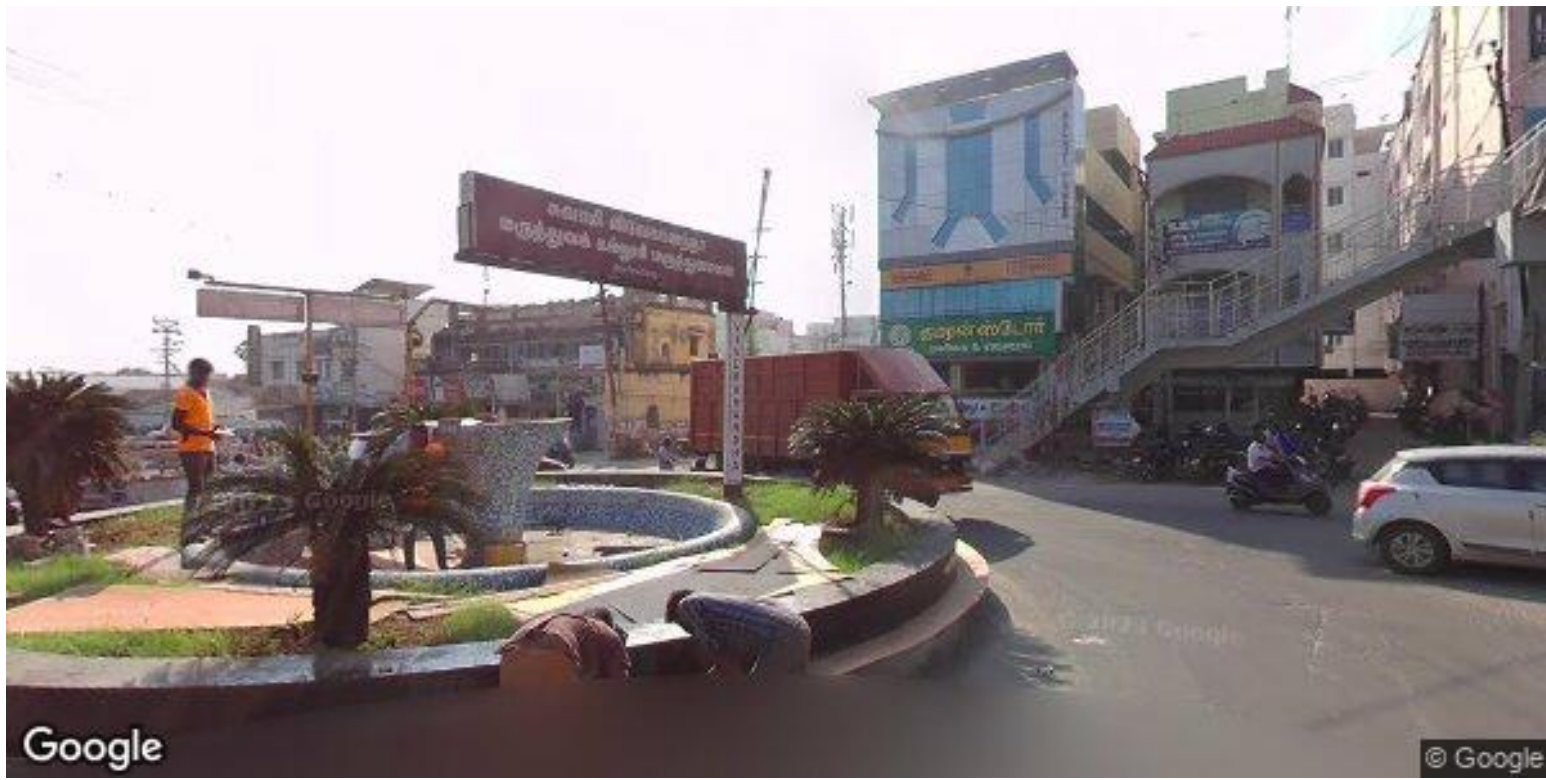
**Coordinates:** 11.38395, 77.89480

**Risk Type:** Roundabout

**Risk Level:** High

**Speed Limit:** 15 KM/Hr

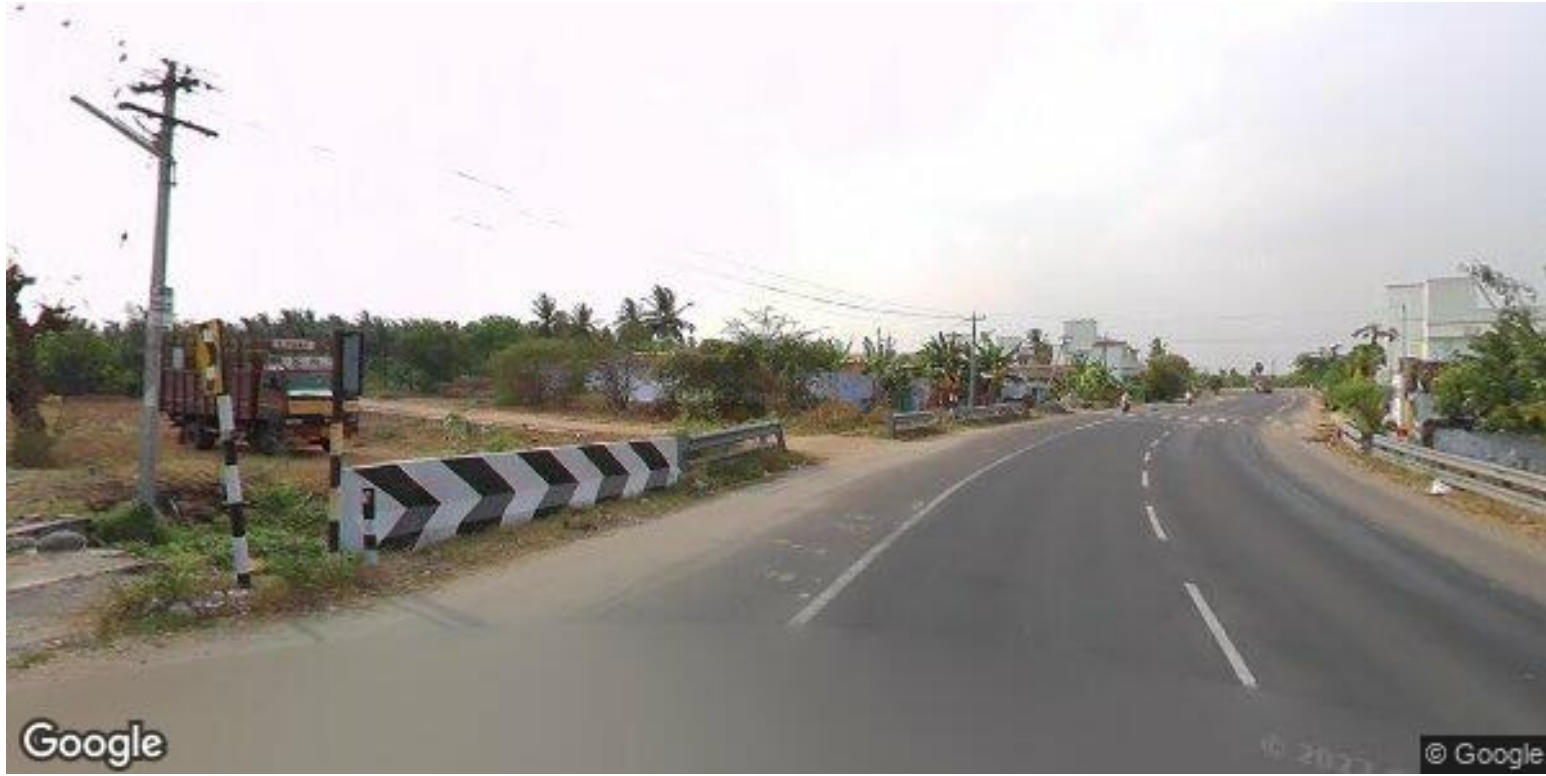
**Coordinates:** 11.16755, 78.01568

**Risk Type:** Turn

**Risk Level:** Medium

**Speed Limit:** 30 KM/Hr

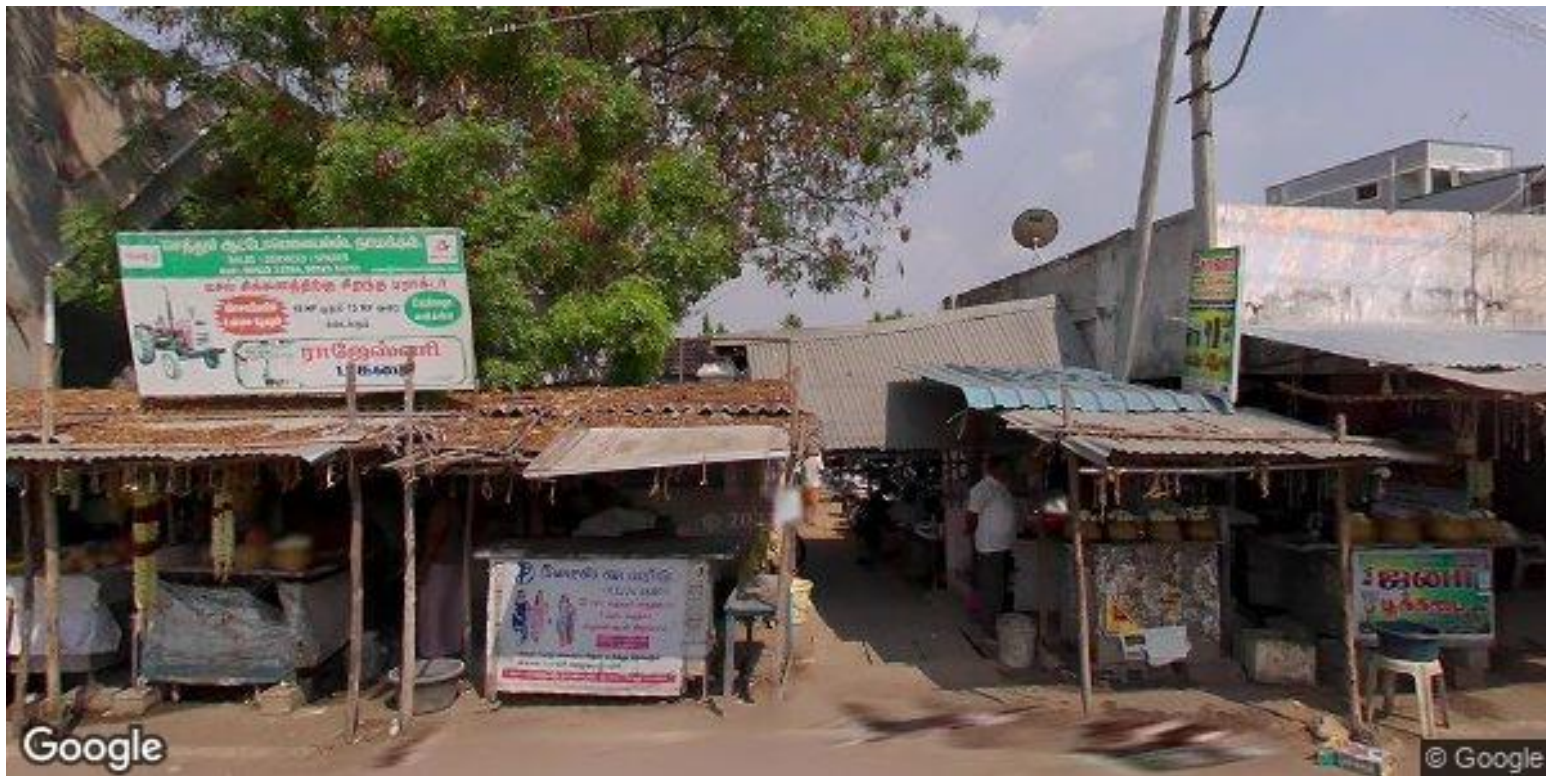
**Coordinates:** 11.15573, 78.02176

**Risk Type:** Turn

**Risk Level:** High

**Speed Limit:** 15 KM/Hr

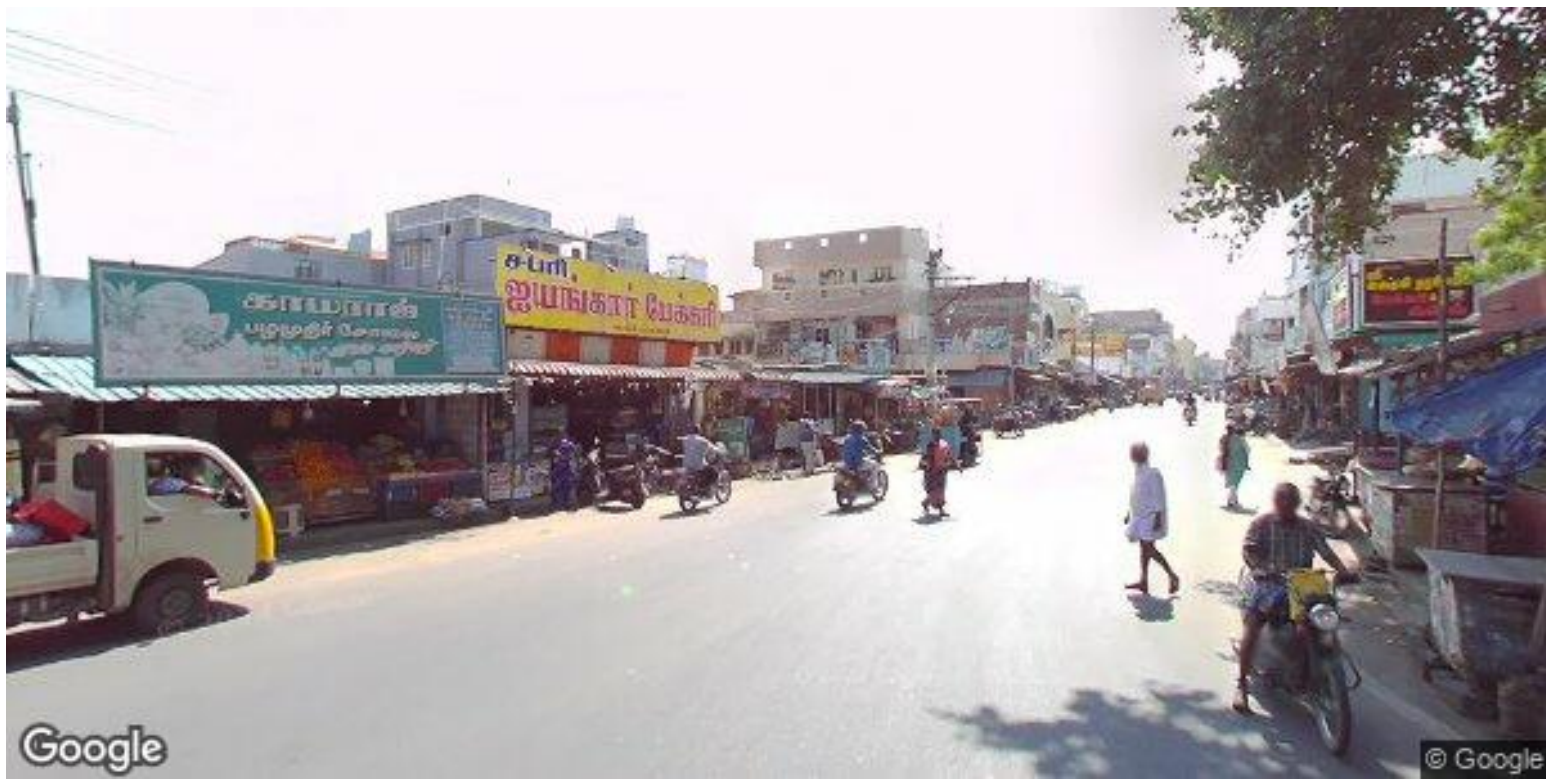
**Coordinates:** 11.15565, 78.02171

**Risk Type:** Turn

**Risk Level:** Medium

**Speed Limit:** 30 KM/Hr

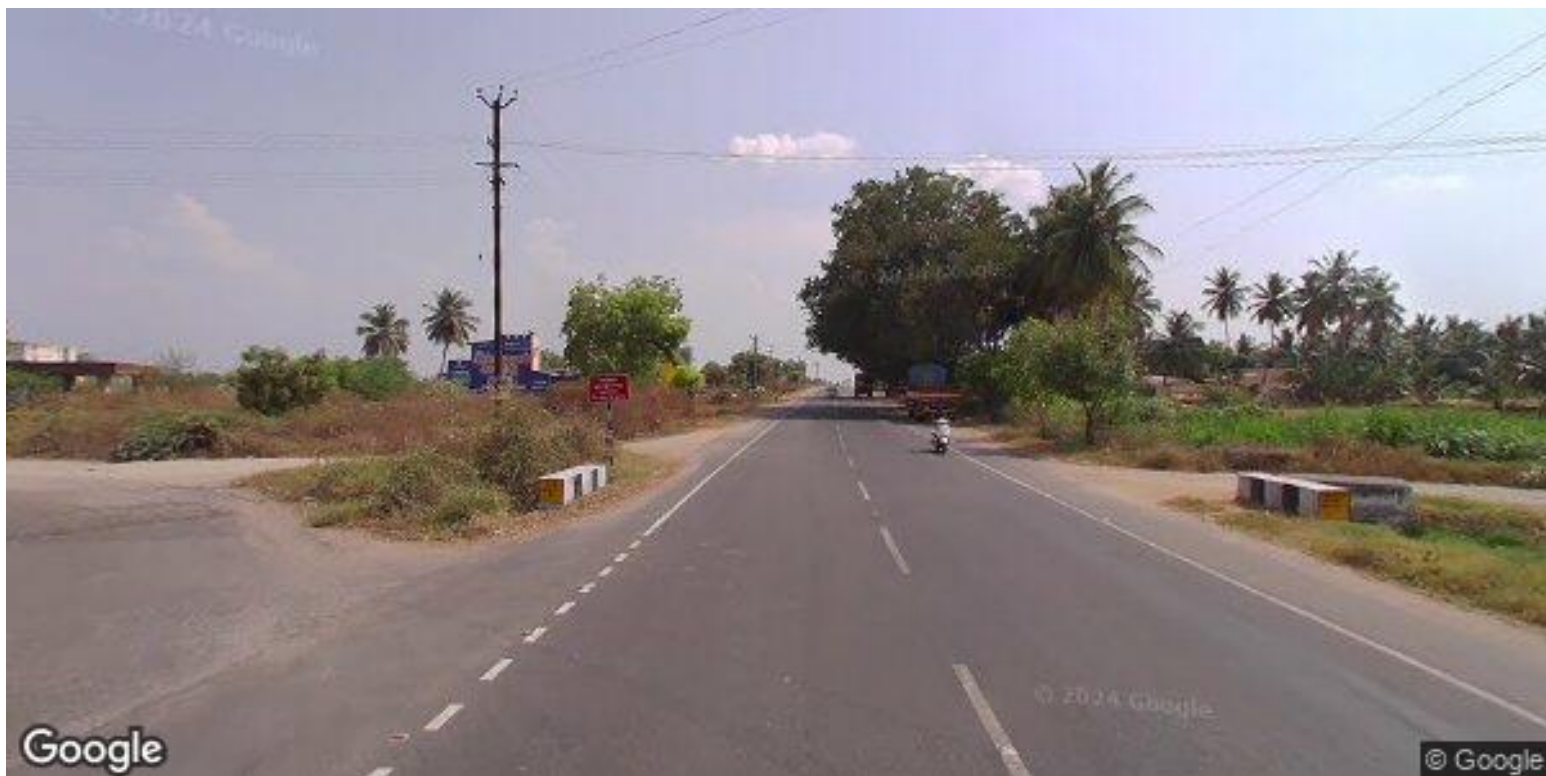
**Coordinates:** 11.14545, 78.02208

**Risk Type:** Turn

**Risk Level:** High

**Speed Limit:** 15 KM/Hr

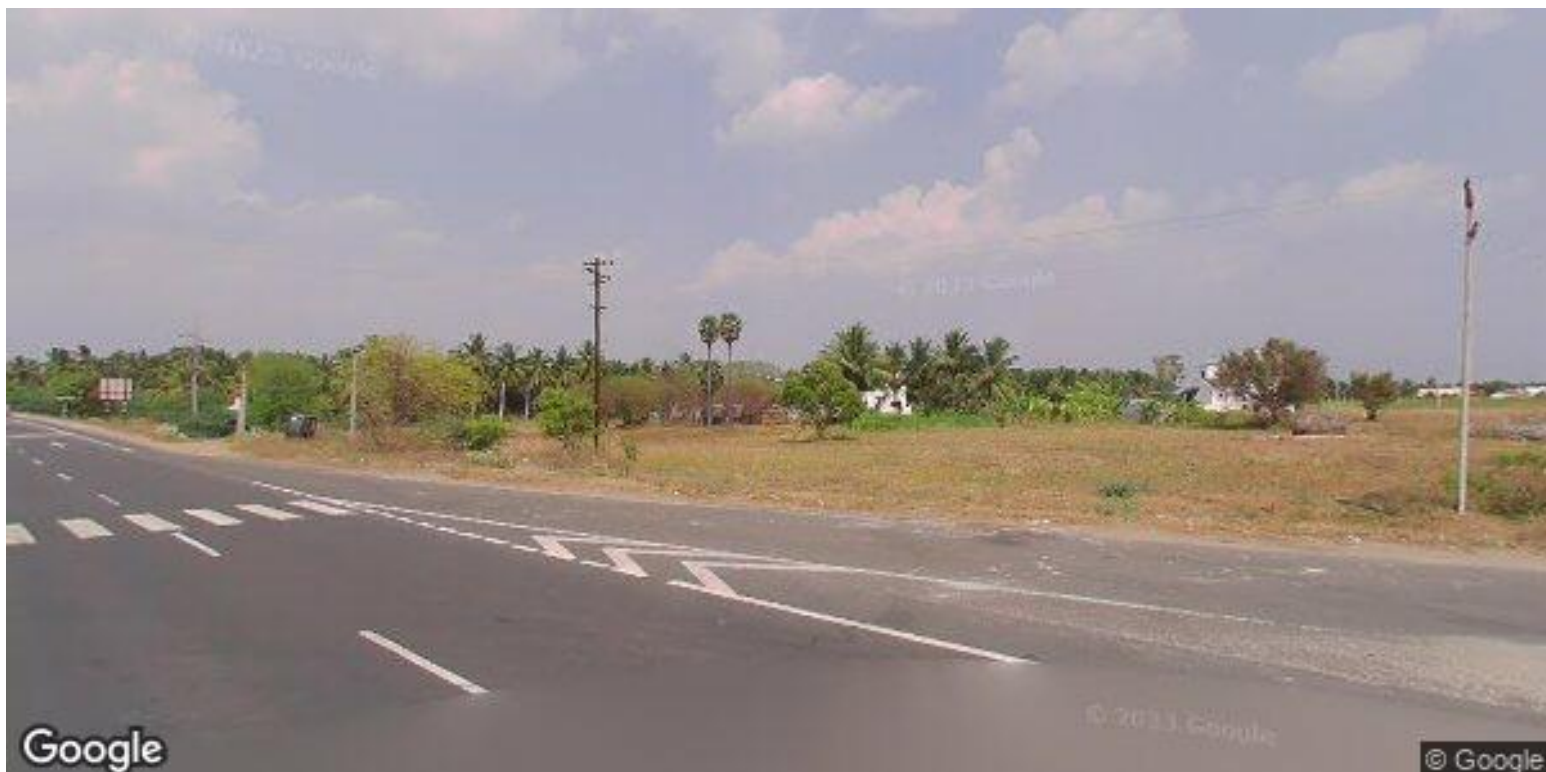
**Risk Type:** Blind Spot  
**Risk Level:** Blind Spot  
**Speed Limit:** 10 KM/Hr  
**Coordinates:** 11.14480, 78.02291

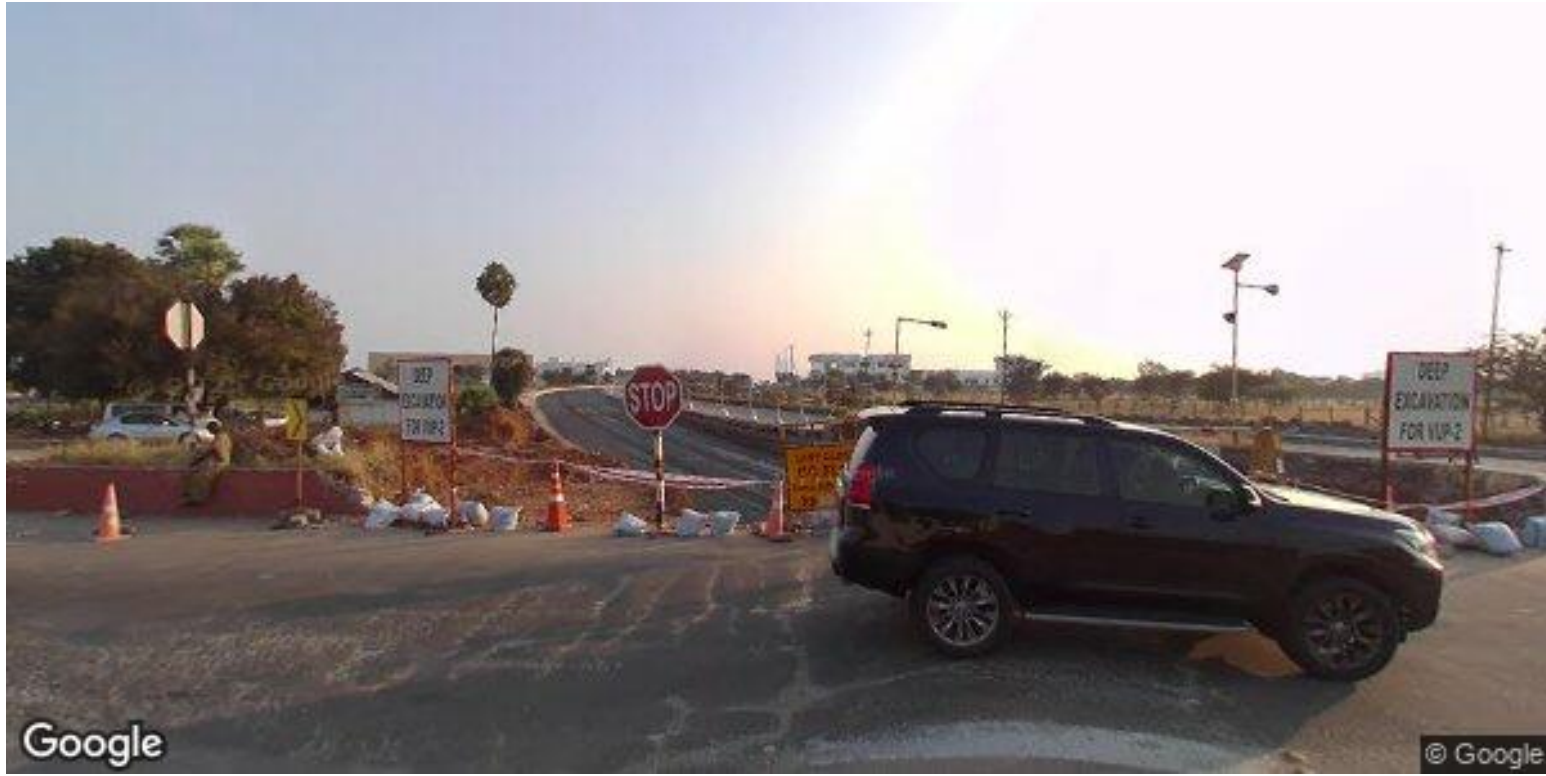
**Risk Type:** Blind Spot  
**Risk Level:** Blind Spot  
**Speed Limit:** 10 KM/Hr  
**Coordinates:** 11.01166, 78.06877

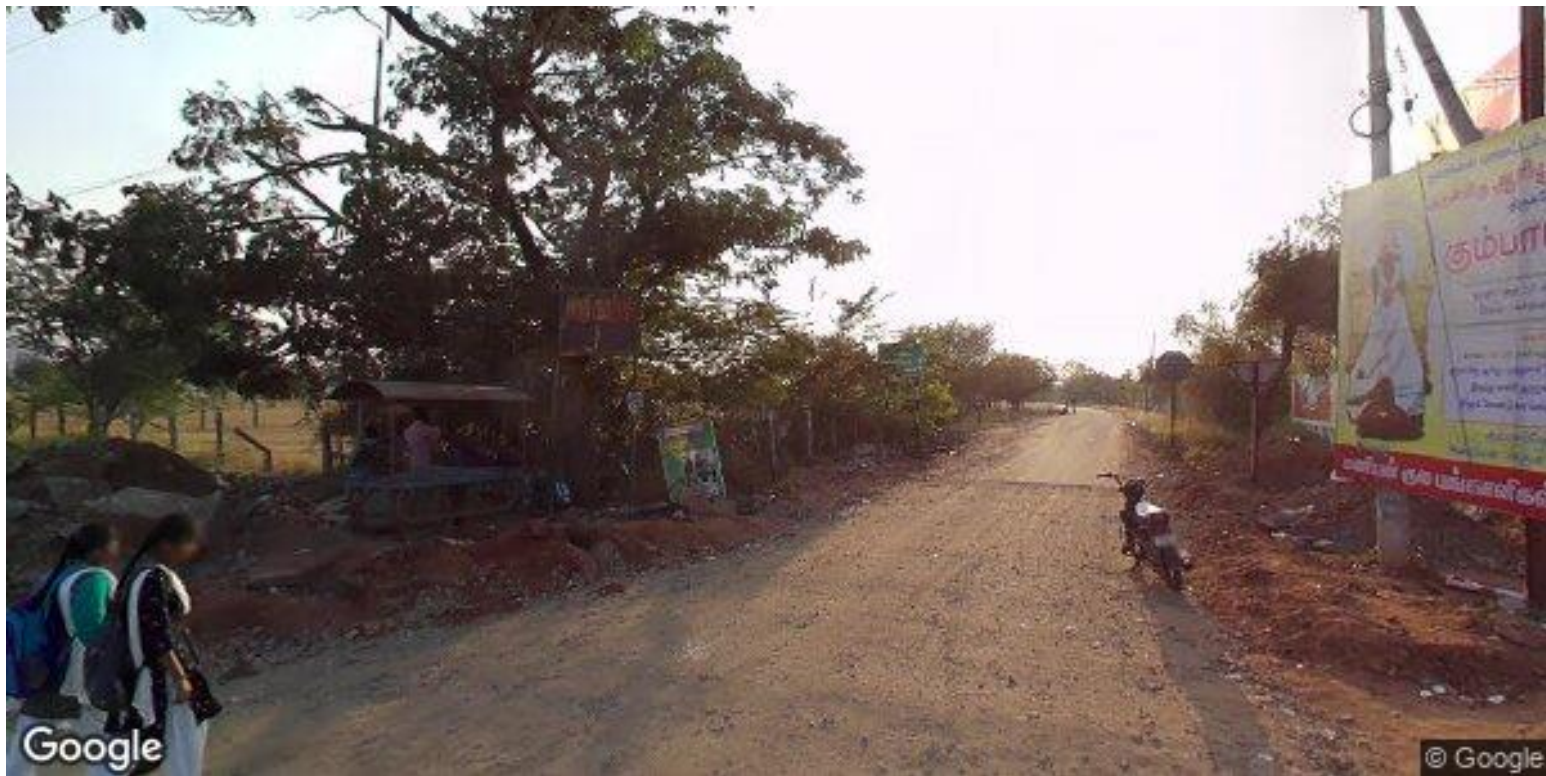
**Risk Type:** Turn  
**Risk Level:** High  
**Speed Limit:** 15 KM/Hr  
**Coordinates:** 11.01161, 78.06848

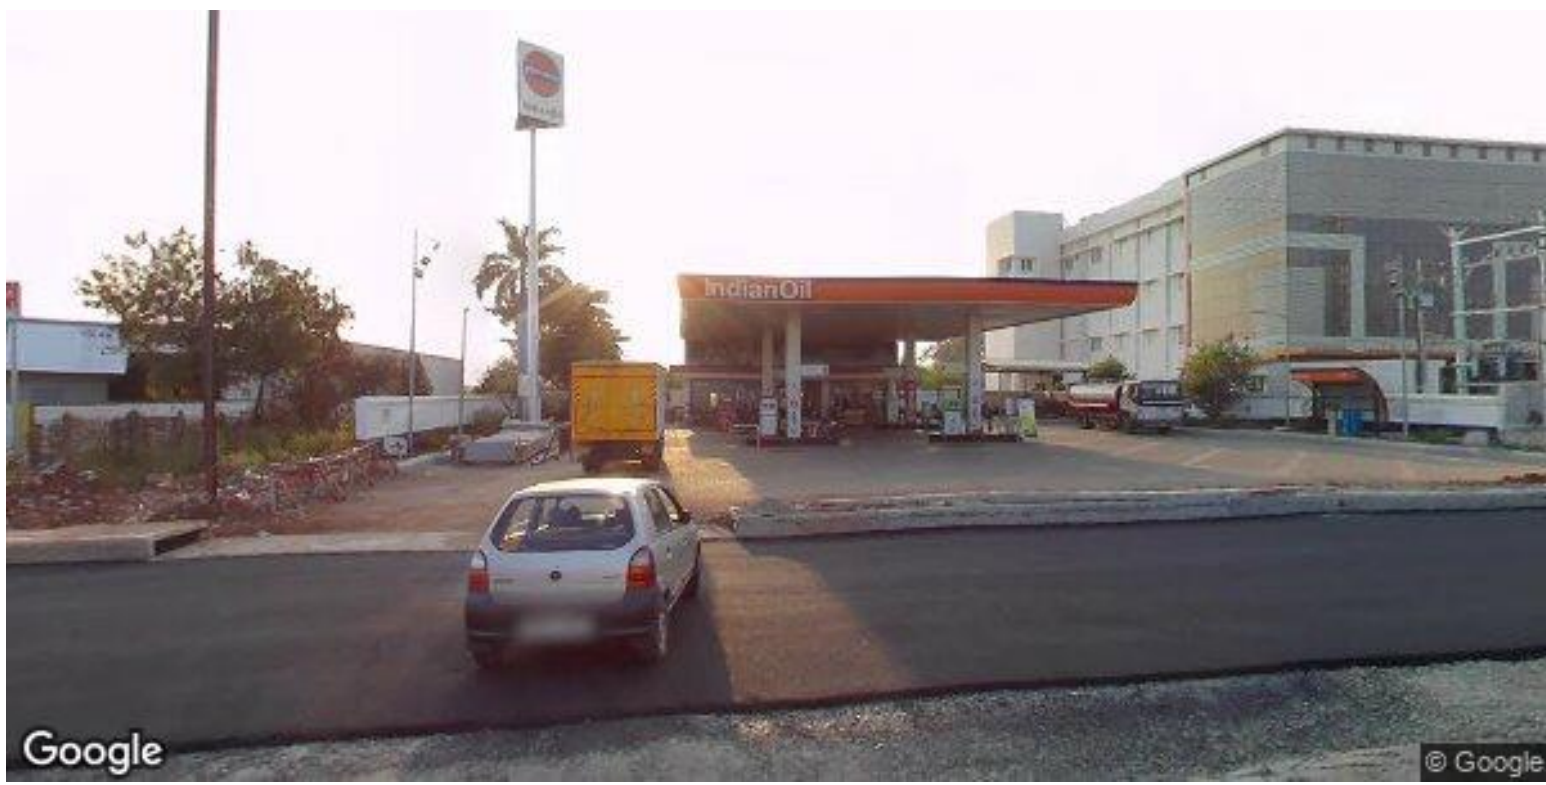
**Coordinates:** 11.01423, 78.06745

**Risk Type:** Turn

**Risk Level:** High

**Speed Limit:** 15 KM/Hr

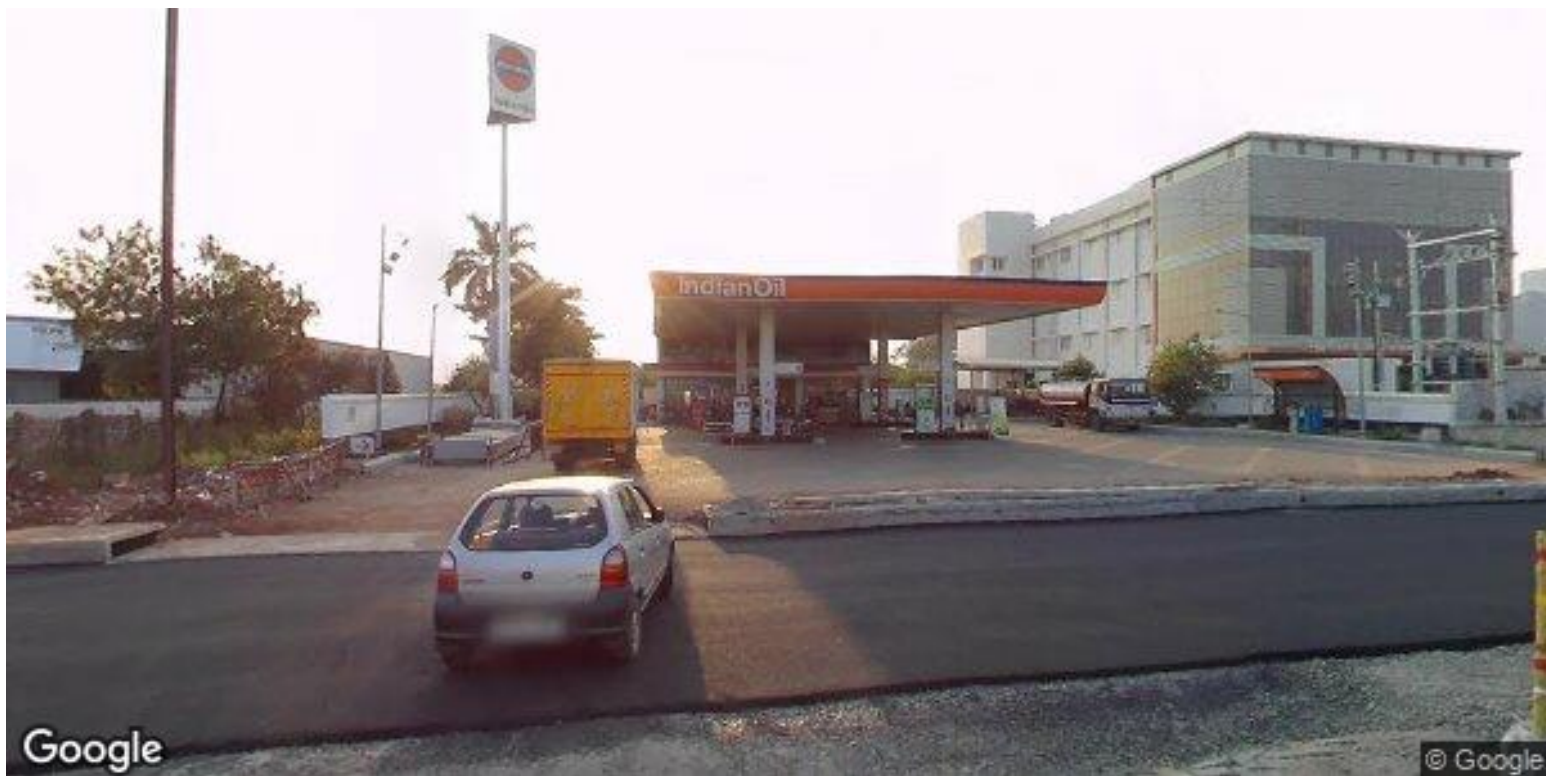
**Coordinates:** 11.01421, 78.06733

**Risk Type:** Turn

**Risk Level:** High

**Speed Limit:** 15 KM/Hr
