## **JOURNEY RISK MANAGEMENT (JRM) STUDY**

### **Salem Terminal To SRI KRISHNA & CO**

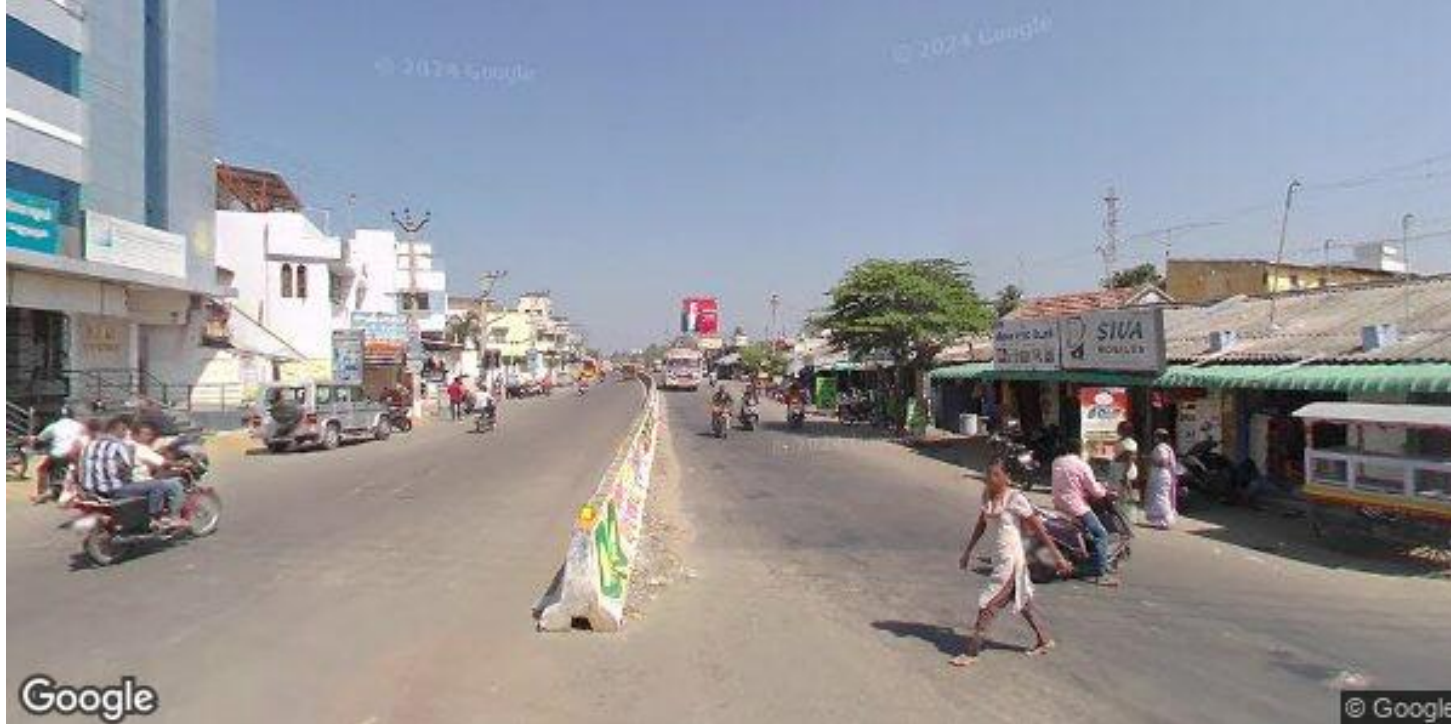
**Coordinates:** 11.37086, 77.74828

**Risk Type:** Roundabout

**Risk Level:** High

**Speed Limit:** 15 KM/Hr

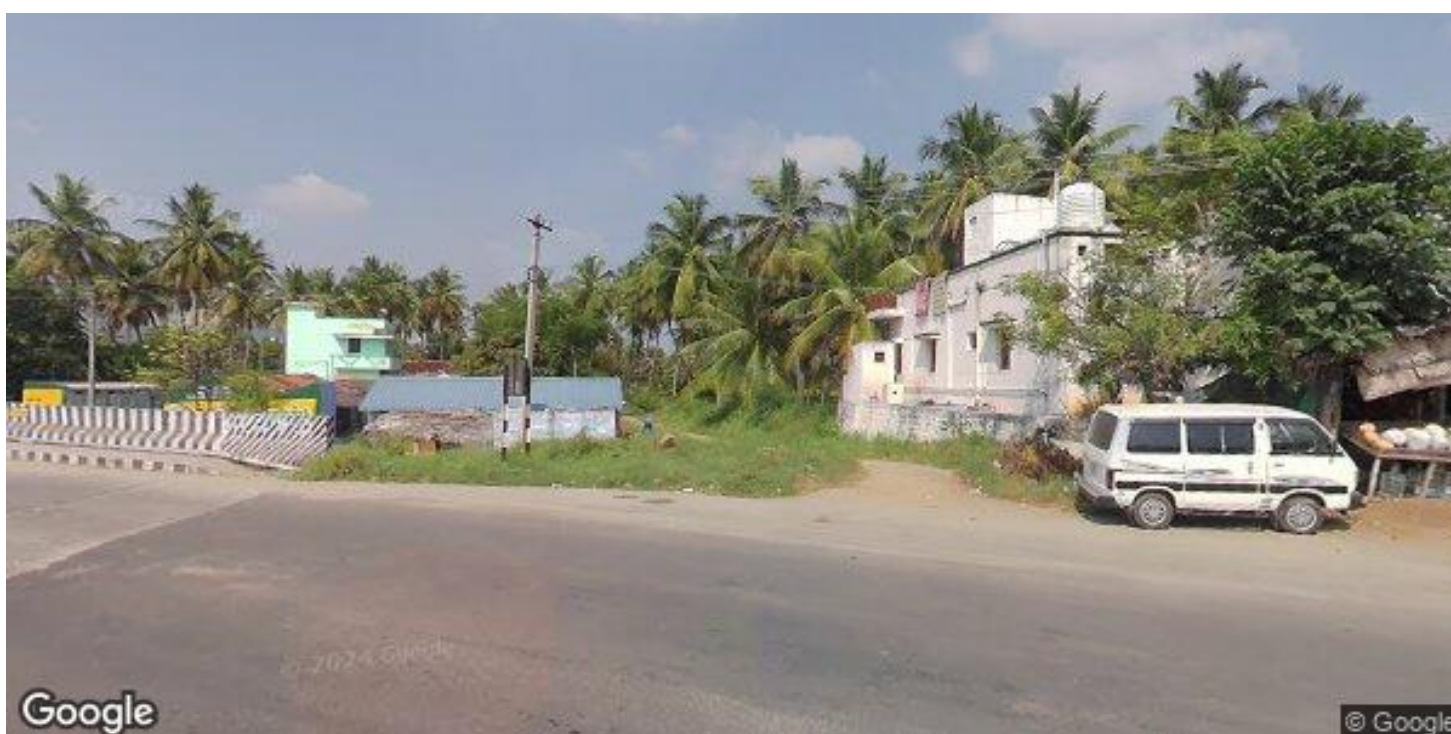
**Coordinates: 11.44898, 77.87410**

**Risk Type:** Turn

**Risk Level:** Medium

**Speed Limit: 30 KM/Hr**

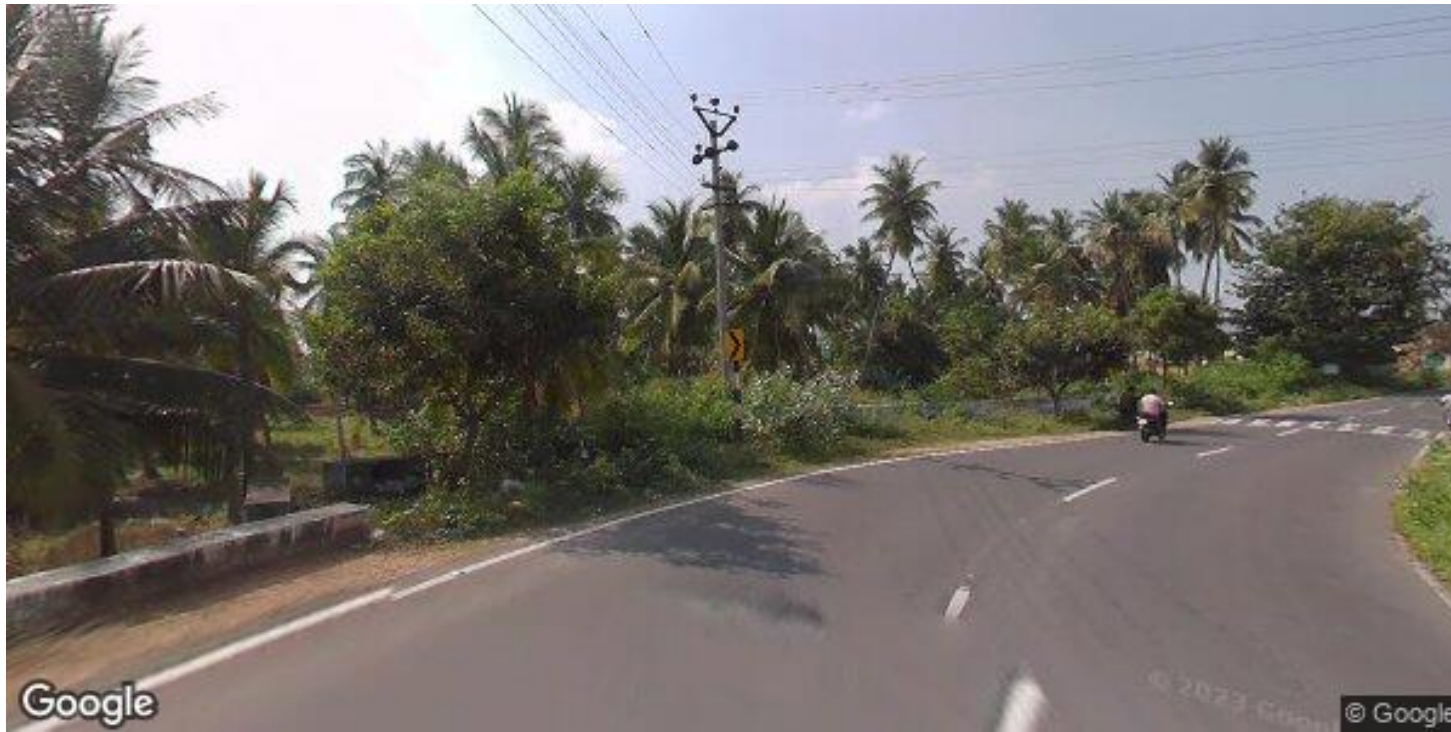
**Coordinates: 11.45348, 77.85706**

**Risk Type: Turn**

**Risk Level: Medium**

**Speed Limit: 30 KM/Hr**

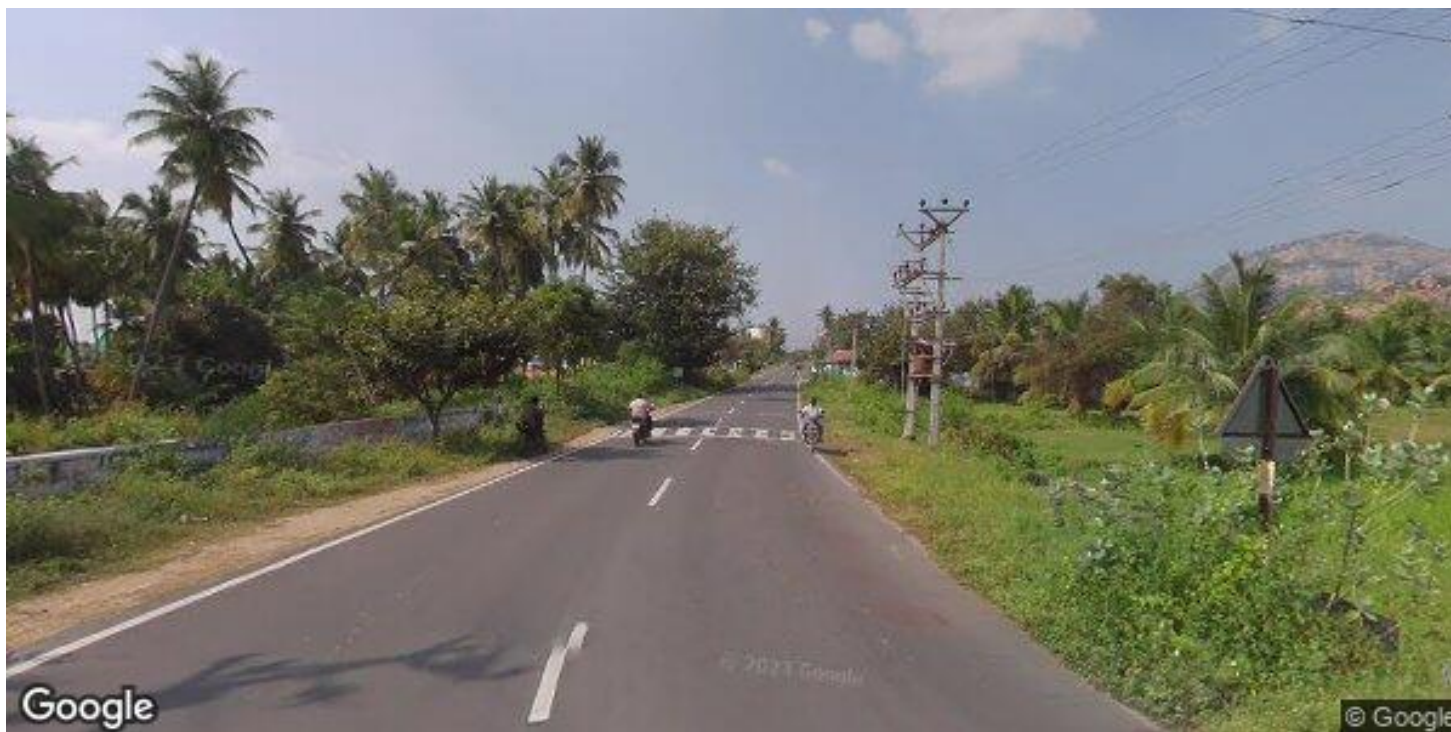
**Coordinates: 11.45352, 77.85698**

**Risk Type: Turn**

**Risk Level: Medium**

**Speed Limit: 30 KM/Hr**

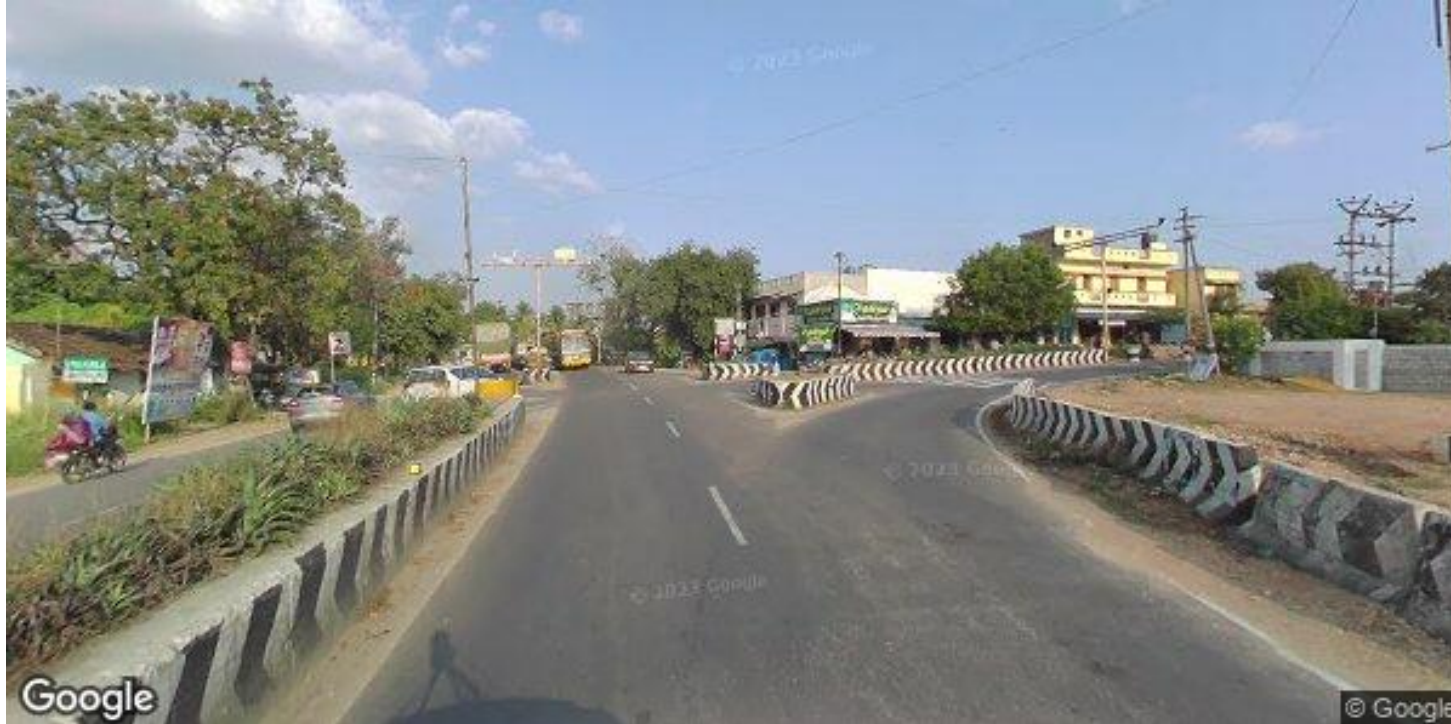
**Coordinates:** 11.46318, 77.84913

**Risk Type:** Turn

**Risk Level:** Medium

**Speed Limit:** 30 KM/Hr

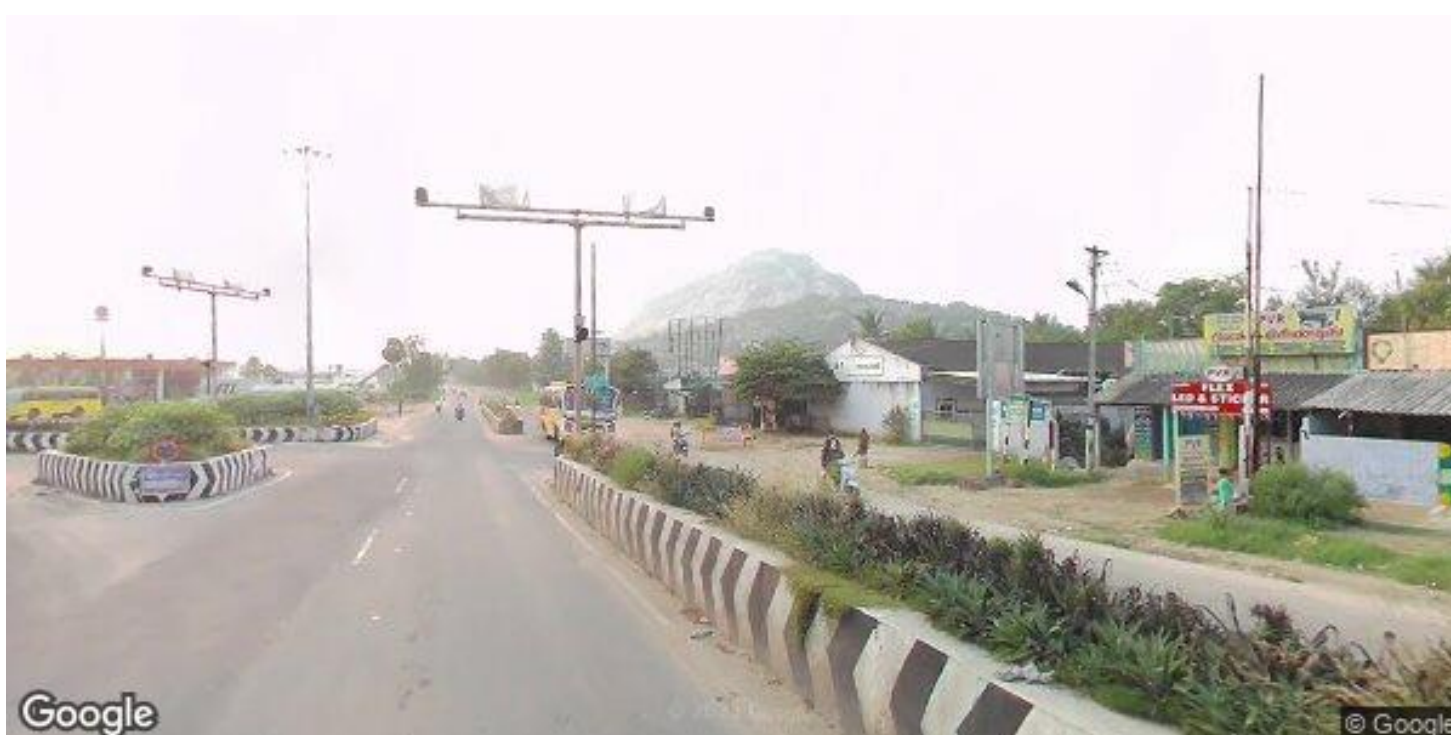
**Coordinates:** 11.46312, 77.84886

**Risk Type:** Turn

**Risk Level:** Medium

**Speed Limit:** 30 KM/Hr

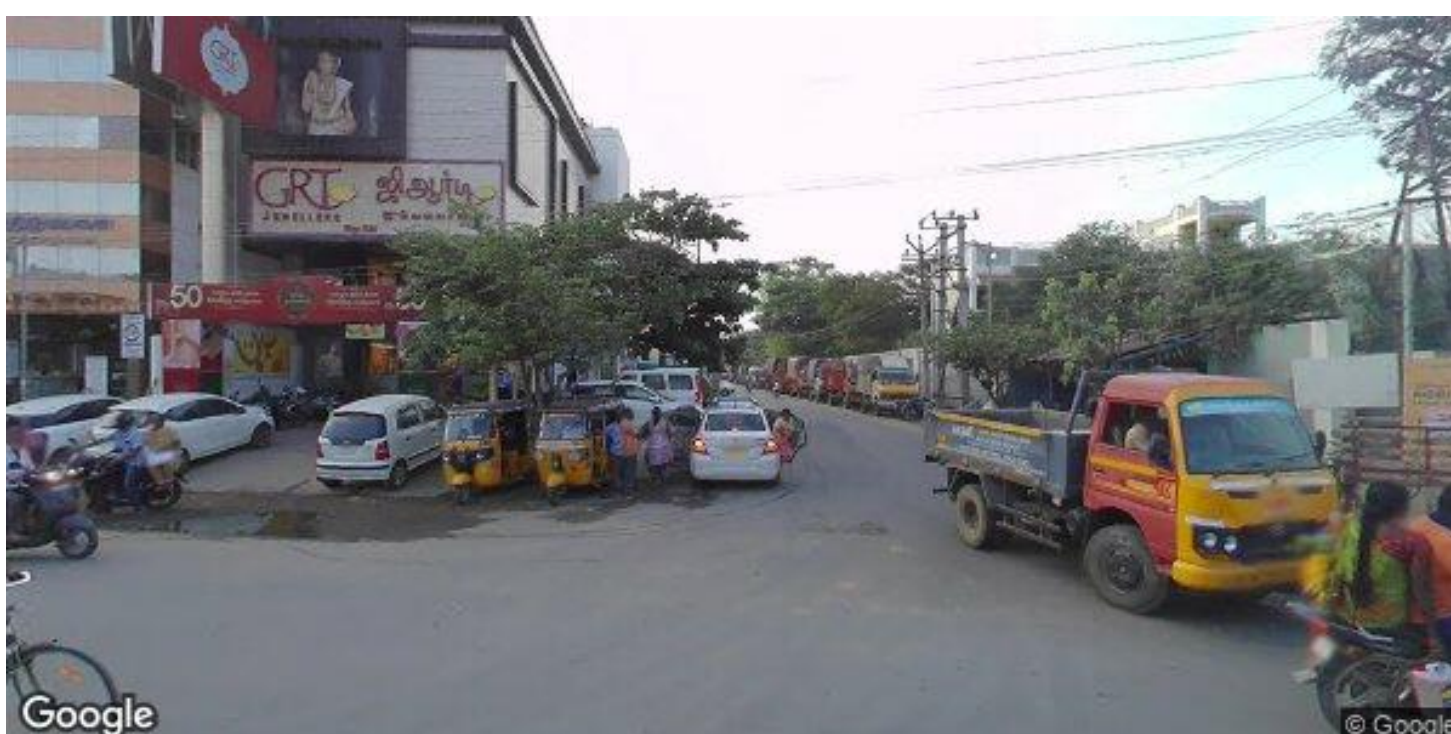
**Coordinates: 11.34678, 77.73104**

**Risk Type:** Turn

**Risk Level:** High

**Speed Limit: 15 KM/Hr**
