# IndianOil

## JOURNEY RISK MANAGEMENT (JRM) STUDY

### Salem Terminal to VASANTHA ENTERPRISES

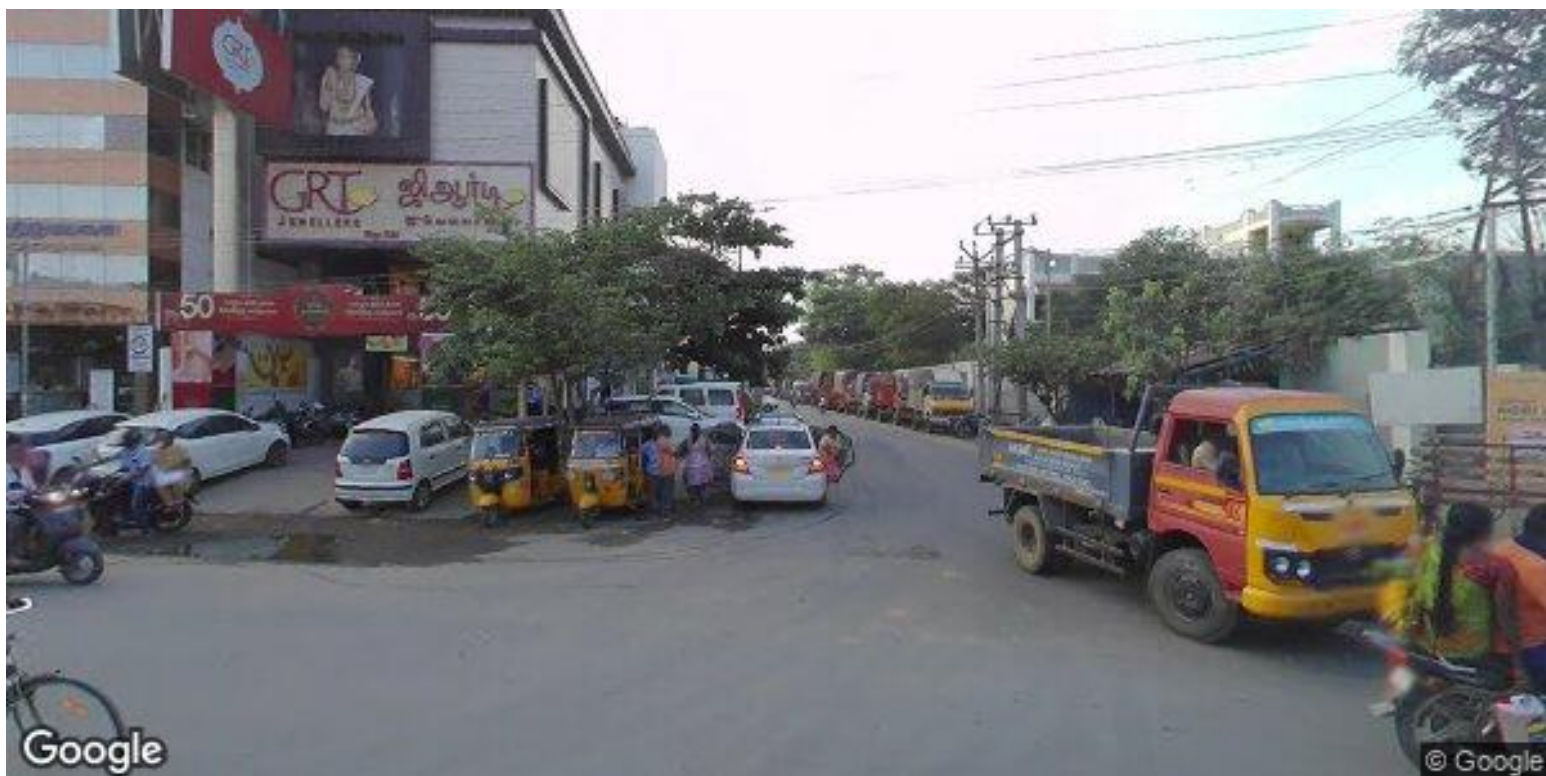
| | Risk Type | Risk Level | Coordinates | Speed Limit |
|---|---|---|---|---|
| 10 | Turn | High | 11.34678, 77.73104 | 15 KM/Hr |

**Risk Type:** Turn

**Risk Level:** High

**Speed Limit:** 15 KM/Hr

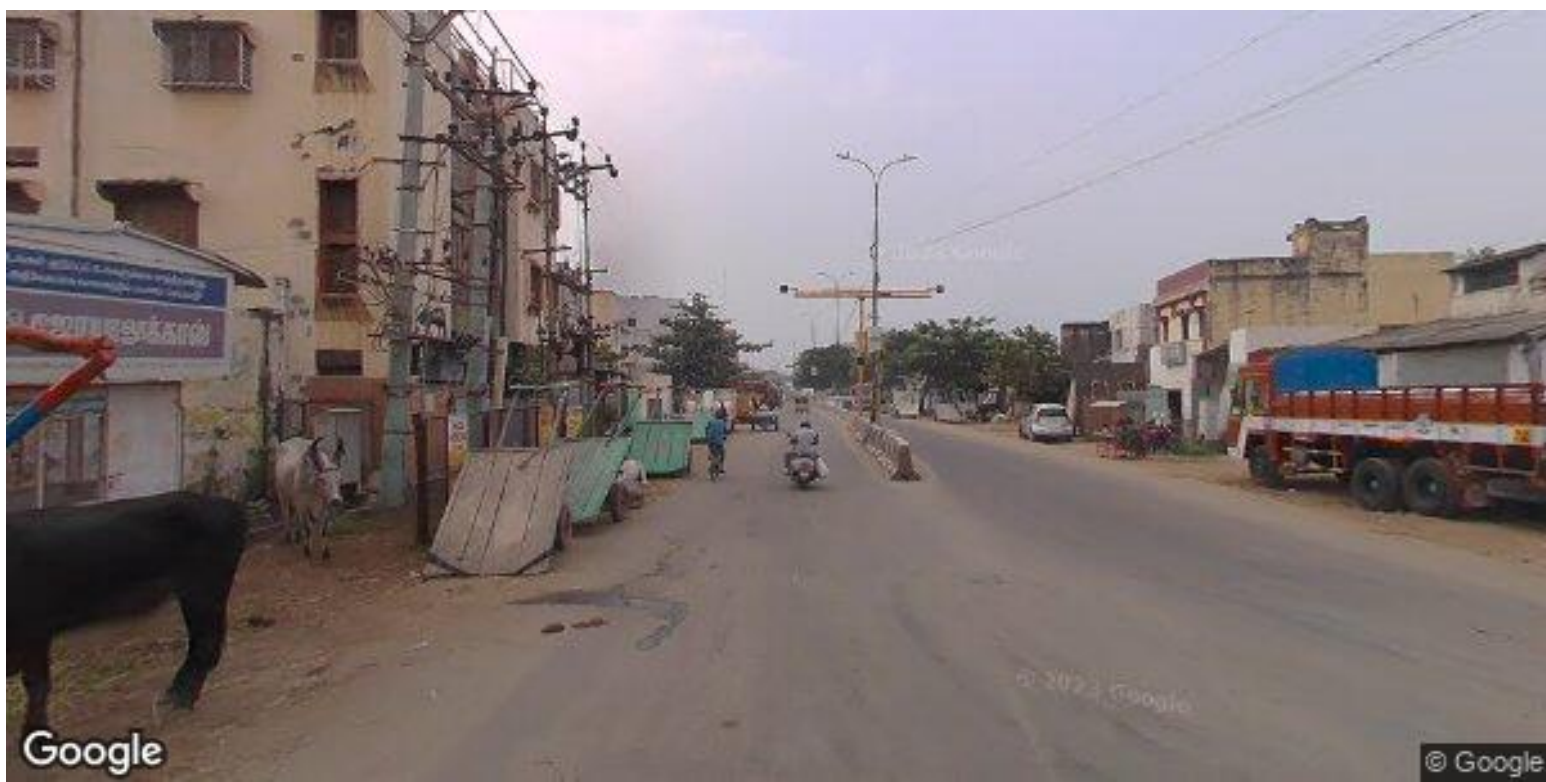
| | Risk Type | Risk Level | Coordinates | Speed Limit |
|---|---|---|---|---|
| 11 | Blind Spot | Blind Spot | 11.34680, 77.72584 | 10 KM/Hr |

**Risk Type:** Blind Spot

**Risk Level:** Blind Spot

**Speed Limit:** 10 KM/Hr

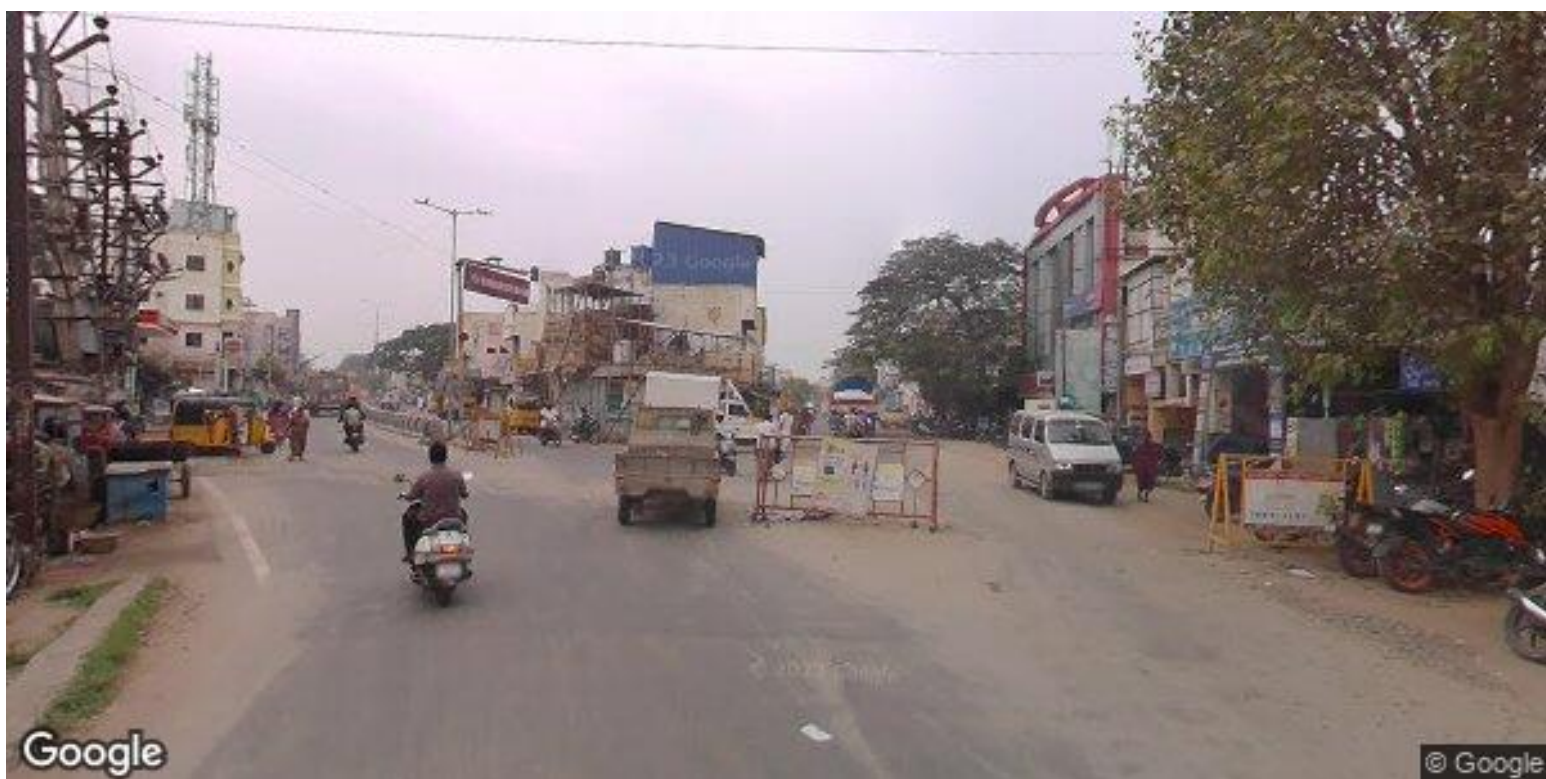
| | Risk Type | Risk Level | Coordinates | Speed Limit |
|---|---|---|---|---|
| 12 | Blind Spot | Blind Spot | 11.34492, 77.72706 | 10 KM/Hr |

**Risk Type:** Blind Spot

**Risk Level:** Blind Spot

**Speed Limit:** 10 KM/Hr

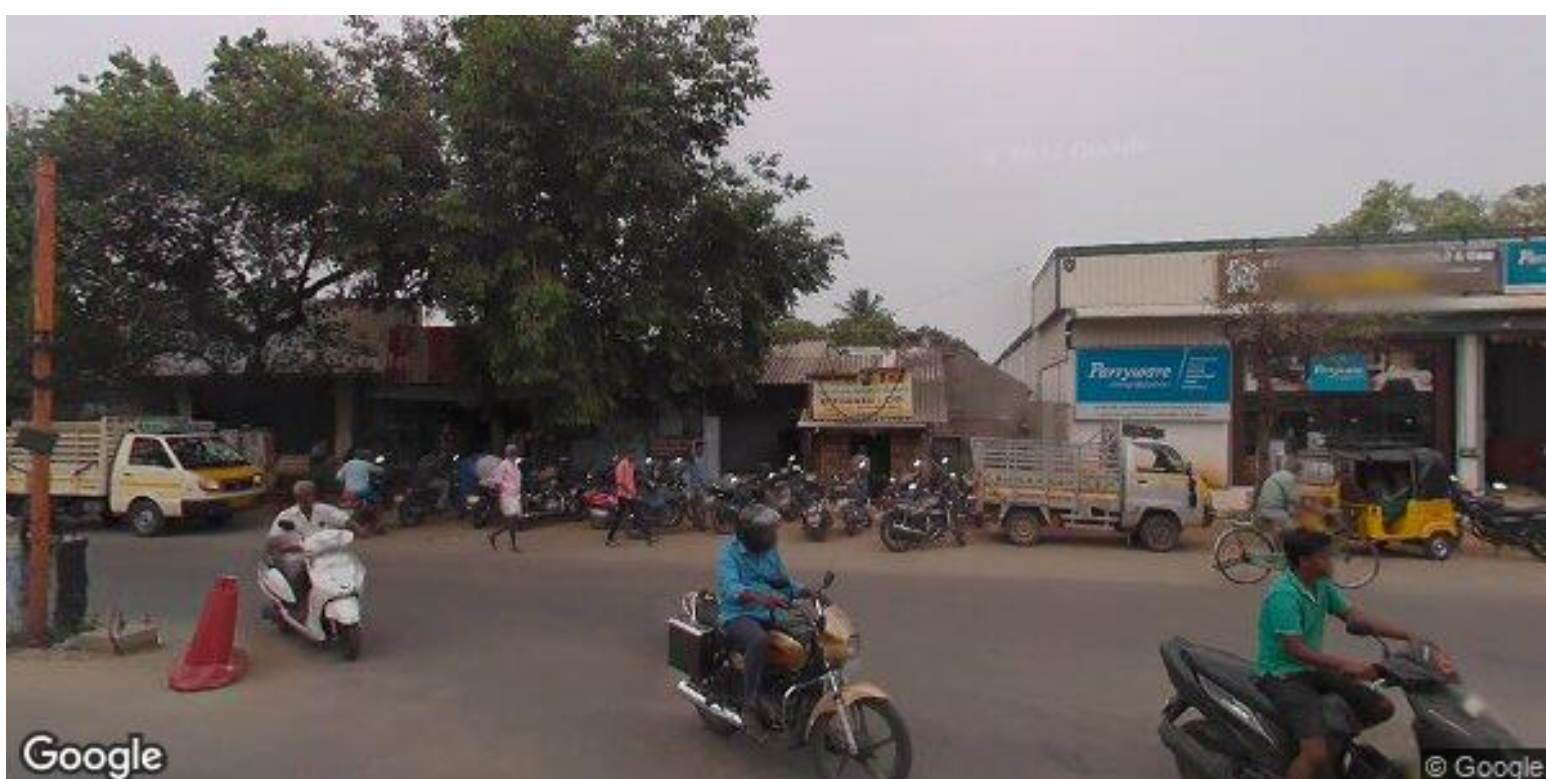
| | Risk Type | Risk Level | Coordinates | Speed Limit |
|---|---|---|---|---|
| 13 | Blind Spot | Blind Spot | 11.34716, 77.72174 | 10 KM/Hr |

**Risk Type:** Blind Spot  
**Risk Level:** Blind Spot  
**Speed Limit:** 10 KM/Hr  
**Coordinates:** 11.34716, 77.72174

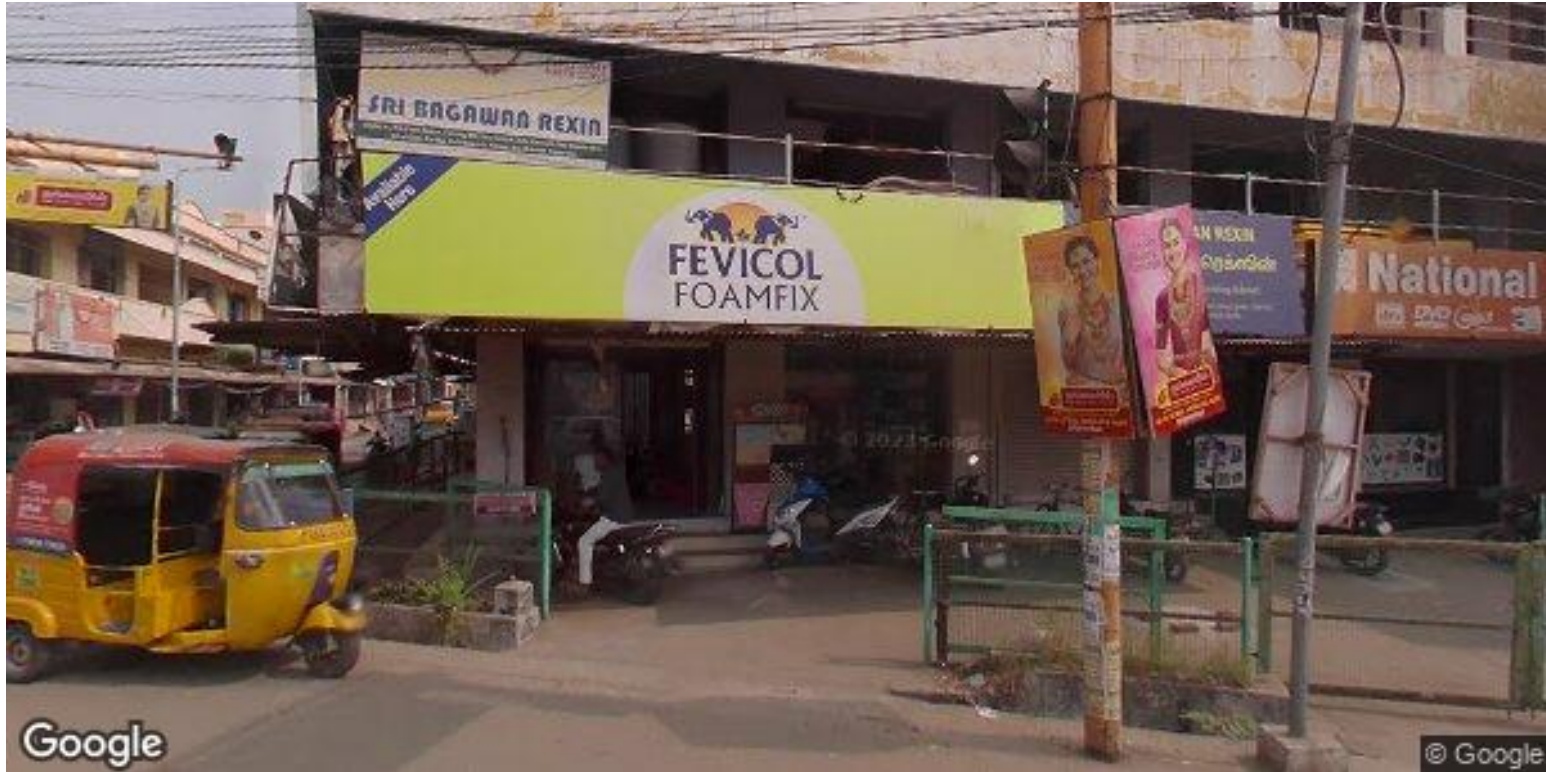
| | Risk Type | Risk Level | Coordinates | Speed Limit |
|---|---|---|---|---|
| 14 | Turn | Medium | 11.34477, 77.72149 | 30 KM/Hr |

**Risk Type:** Turn  
**Risk Level:** Medium  
**Speed Limit:** 30 KM/Hr  
**Coordinates:** 11.34477, 77.72149

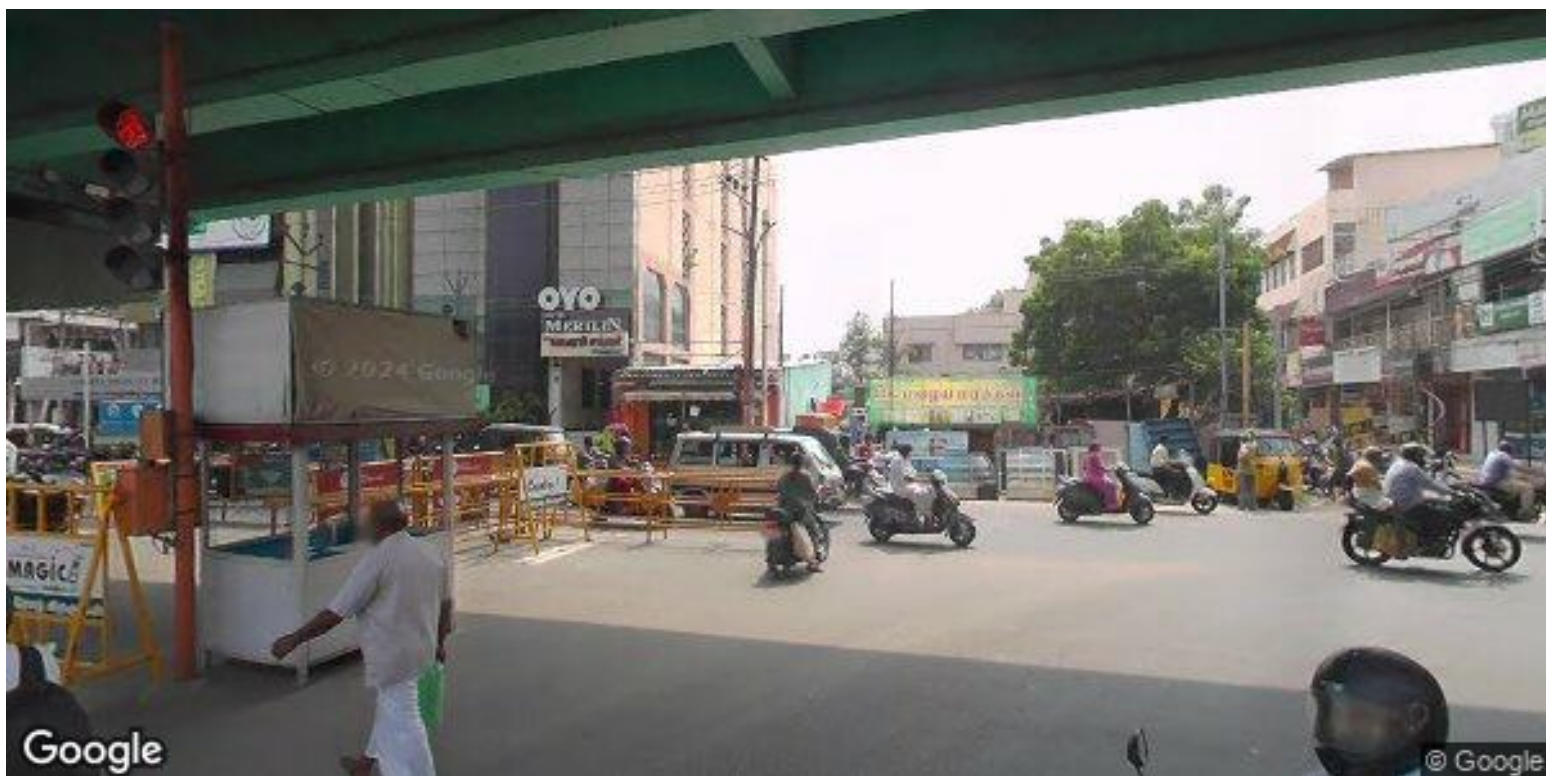
| | Risk Type | Risk Level | Coordinates | Speed Limit |
|---|---|---|---|---|
| 15 | Turn | High | 11.34049, 77.71907 | 15 KM/Hr |

**Risk Type:** Turn  
**Risk Level:** High  
**Speed Limit:** 15 KM/Hr  
**Coordinates:** 11.34049, 77.71907
