## JOURNEY RISK MANAGEMENT (JRM) STUDY

### Salem Terminal TO THANGGAMANI AGENCIES

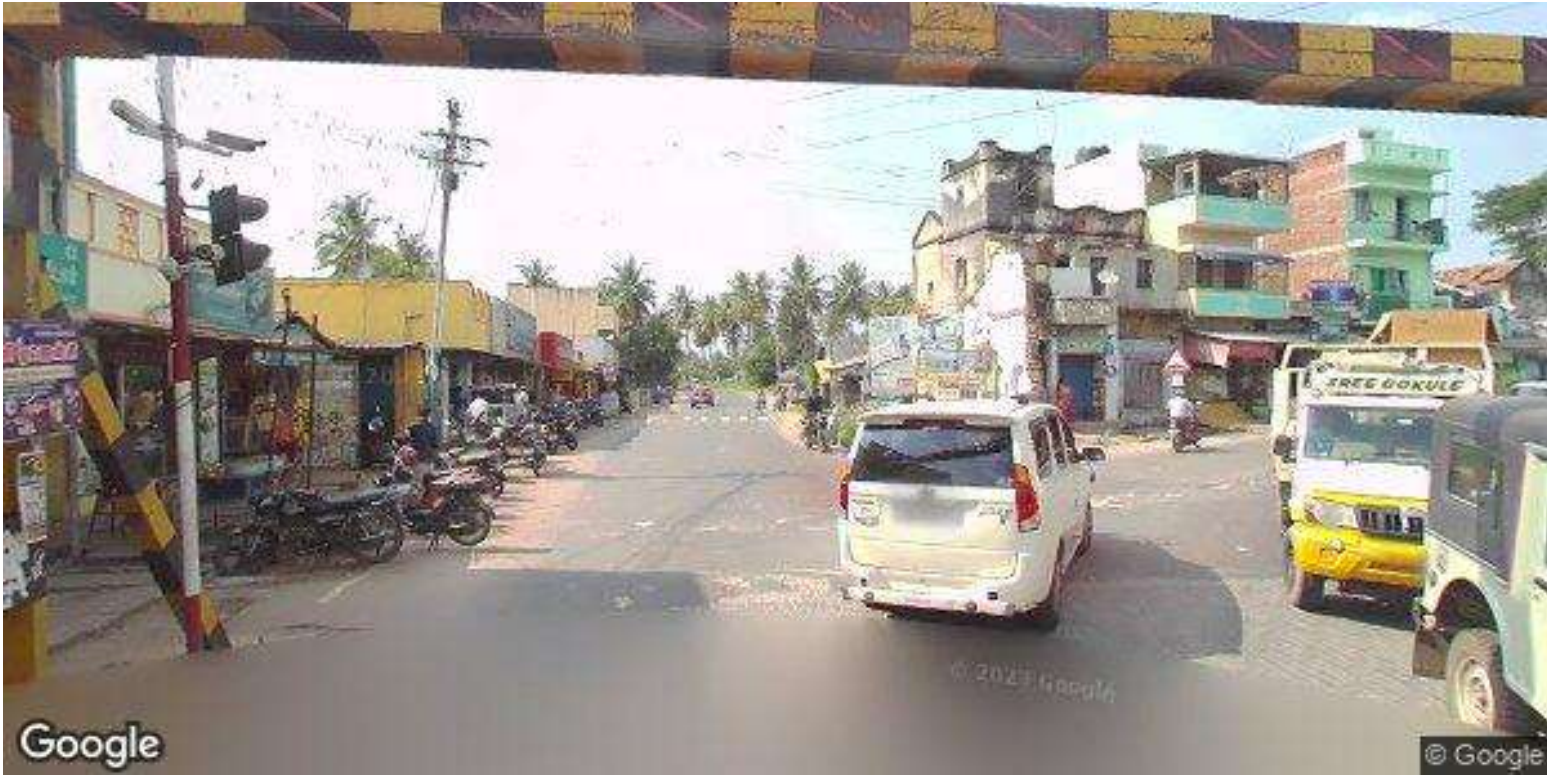
Risk Type: Turn  
Risk Level: High  
Speed Limit: 15 KM/Hr  
Coordinates: 11.45004, 77.87206

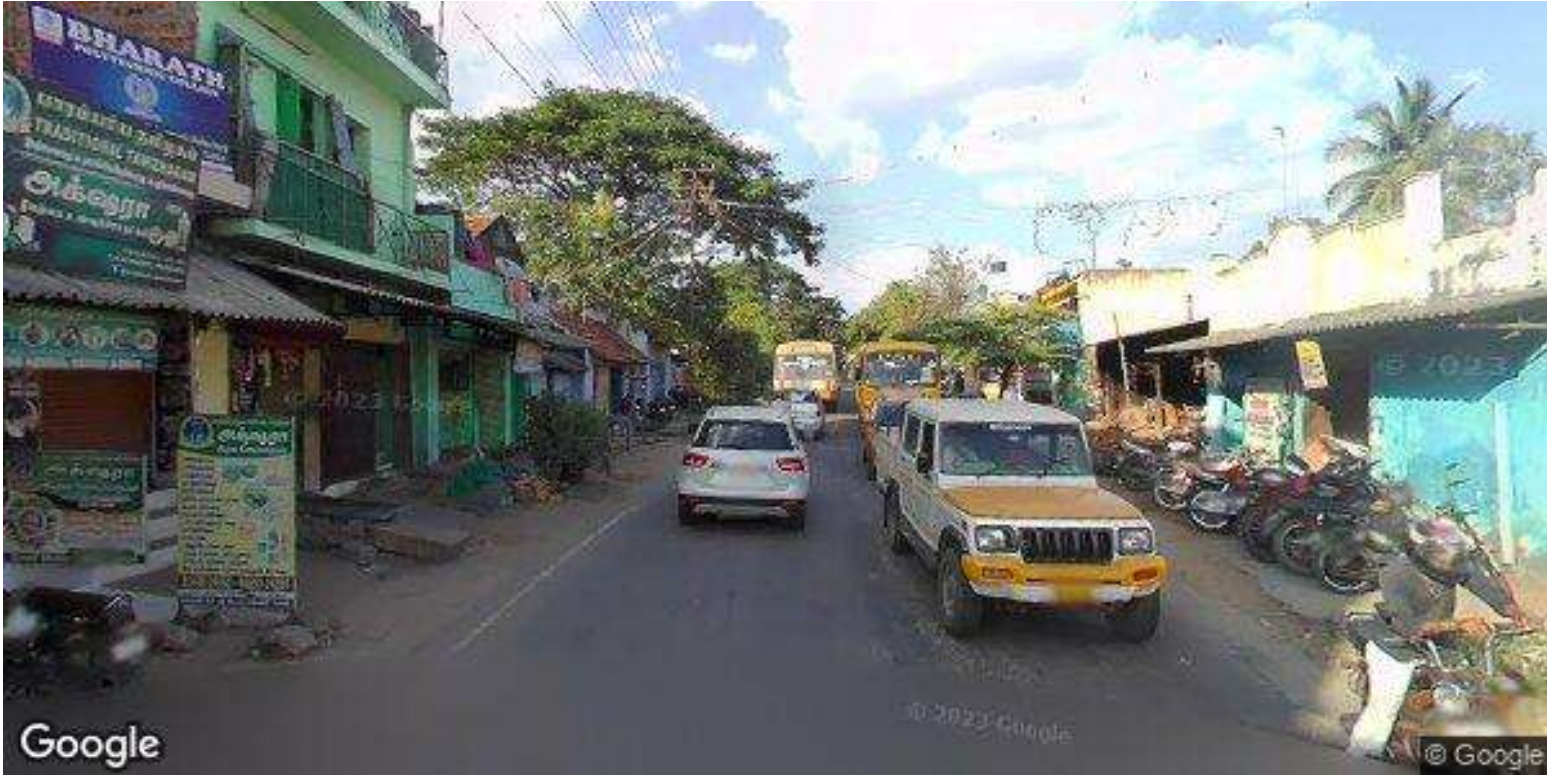
**Risk Type:** Turn  
**Risk Level:** Medium  
**Speed Limit:** 30 KM/Hr  
**Coordinates:** 11.45028, 77.87202

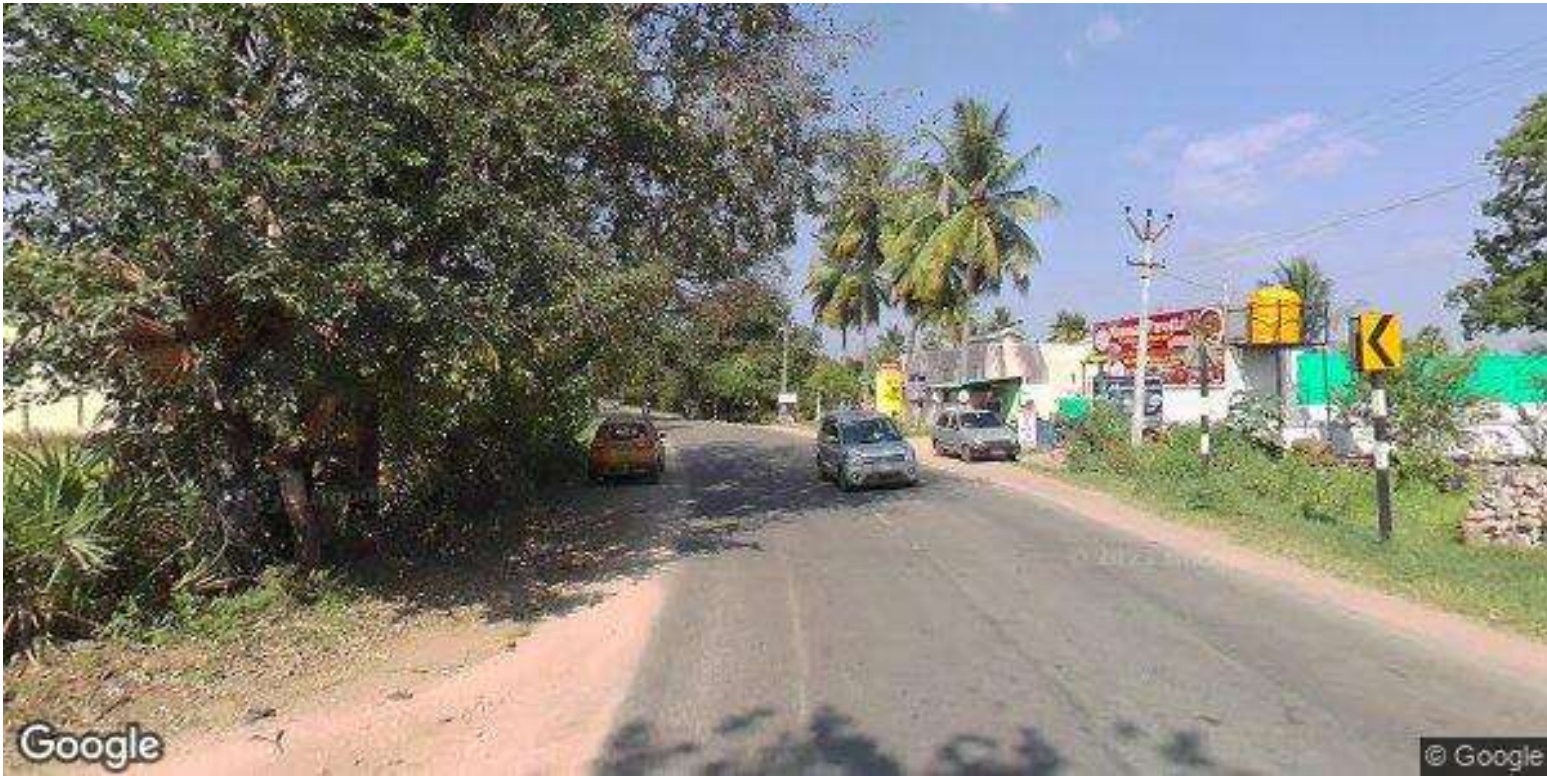
**Risk Type:** Turn  
**Risk Level:** Medium  
**Speed Limit:** 30 KM/Hr  
**Coordinates:** 11.45309, 77.87325

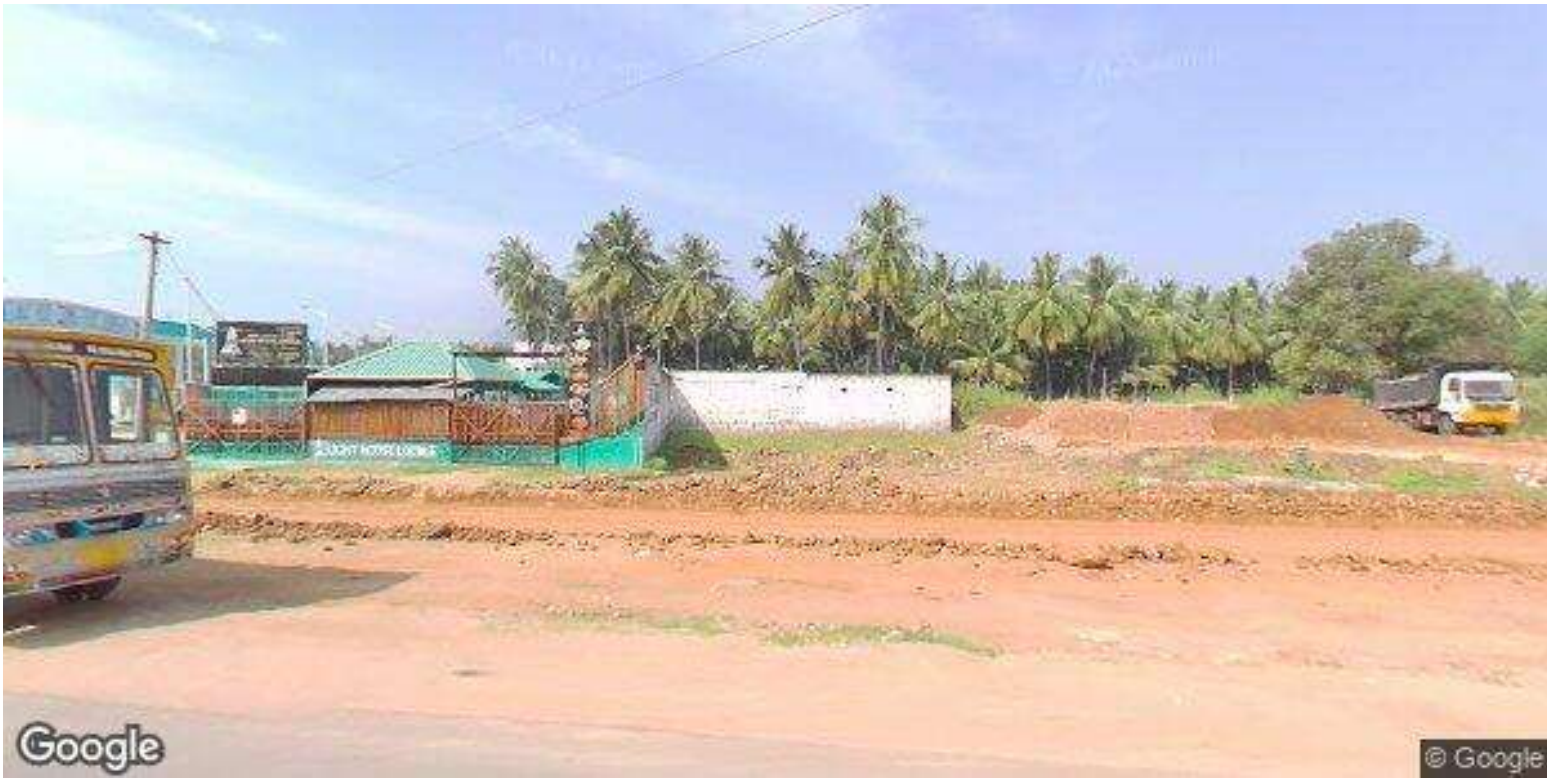
**Risk Type:** Turn  
**Risk Level:** Medium  
**Speed Limit:** 30 KM/Hr  
**Coordinates:** 11.61736, 78.10588

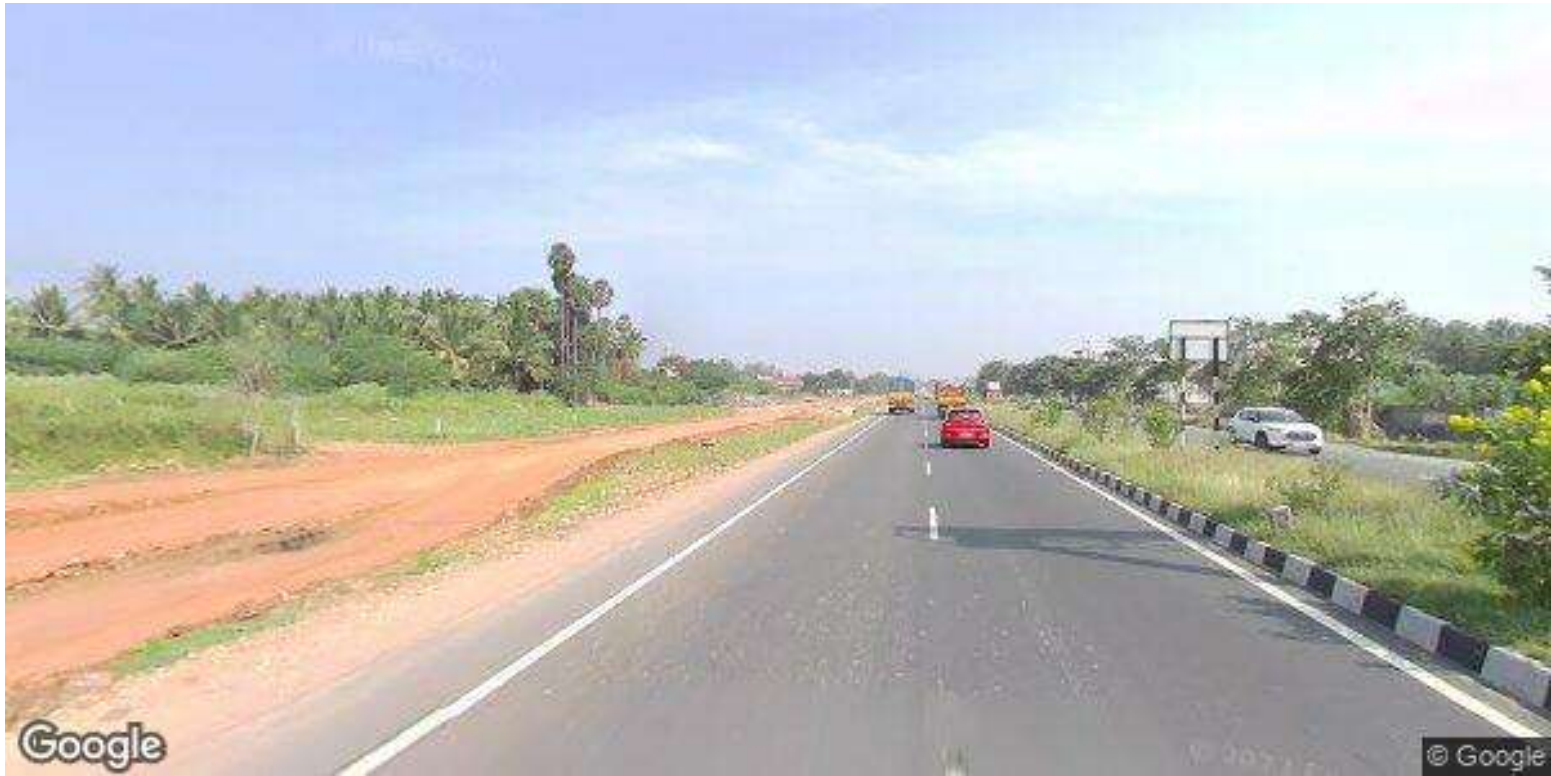
**Risk Type:** Turn  
**Risk Level:** Medium  
**Speed Limit:** 30 KM/Hr  
**Coordinates:** 11.61753, 78.10608

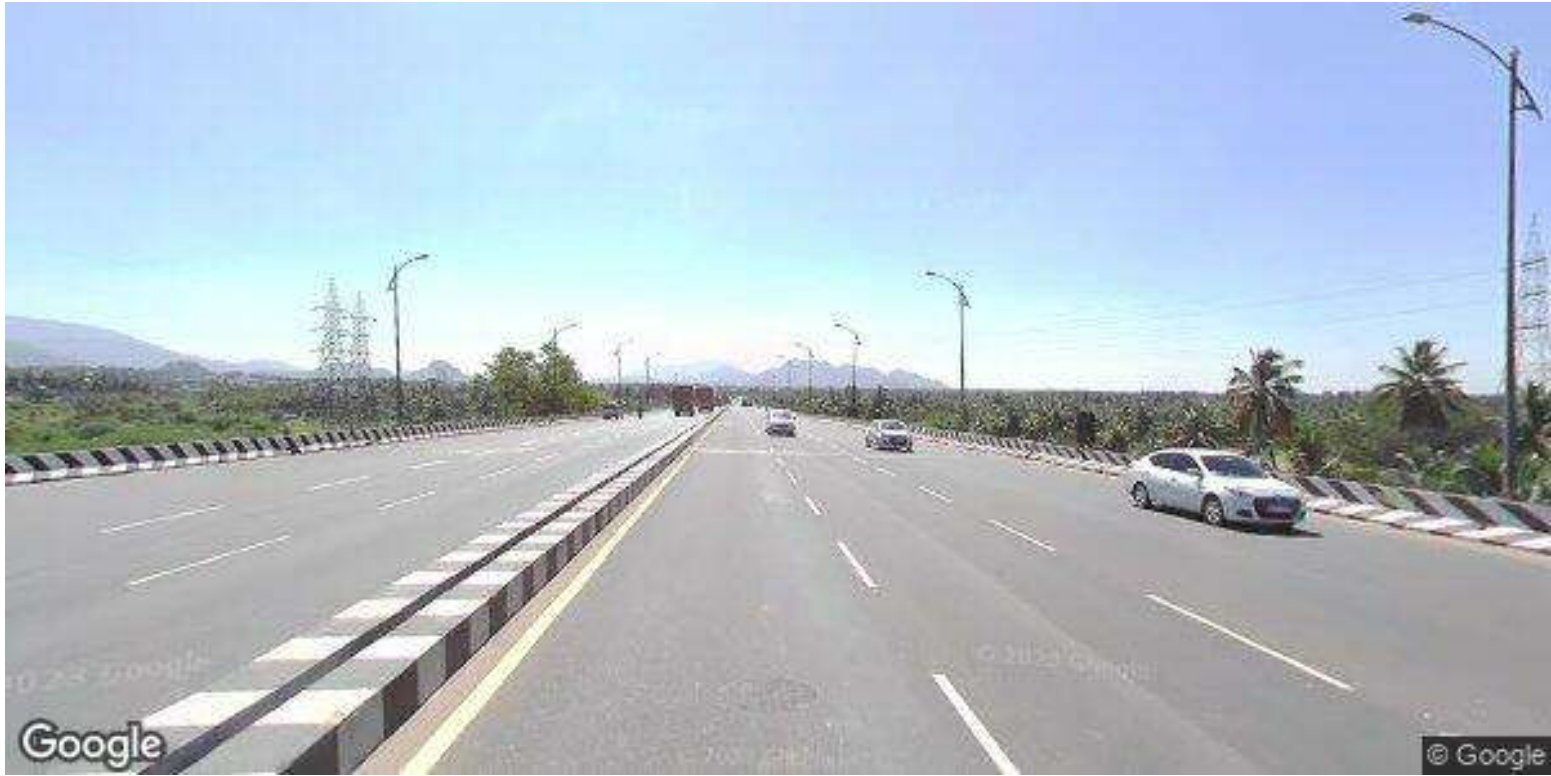
**Risk Type:** Turn  
**Risk Level:** Medium  
**Speed Limit:** 30 KM/Hr  
**Coordinates:** 11.64007, 78.11794

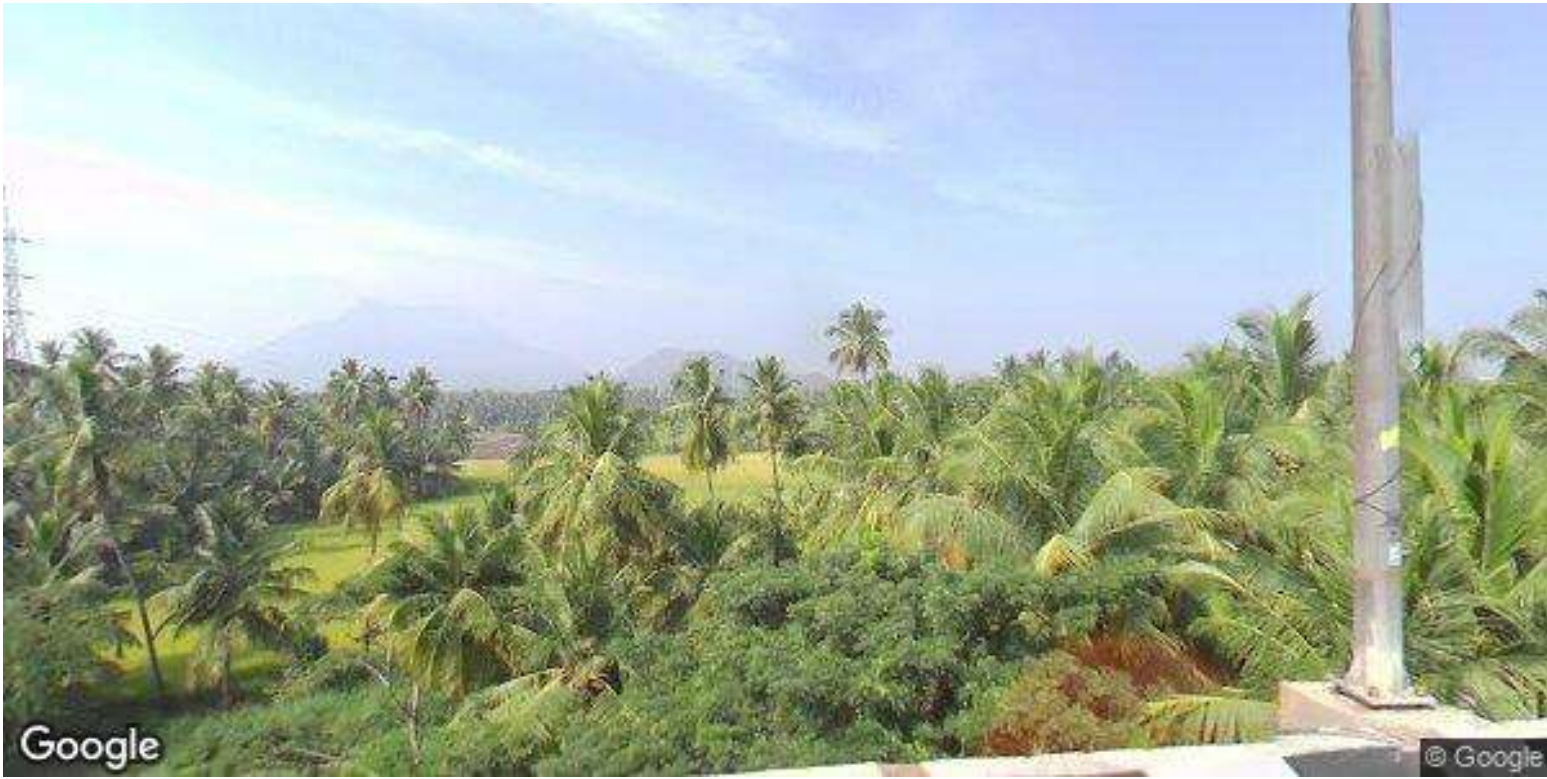
**Risk Type:** Turn  
**Risk Level:** Medium  
**Speed Limit:** 30 KM/Hr  
**Coordinates:** 11.64020, 78.11786

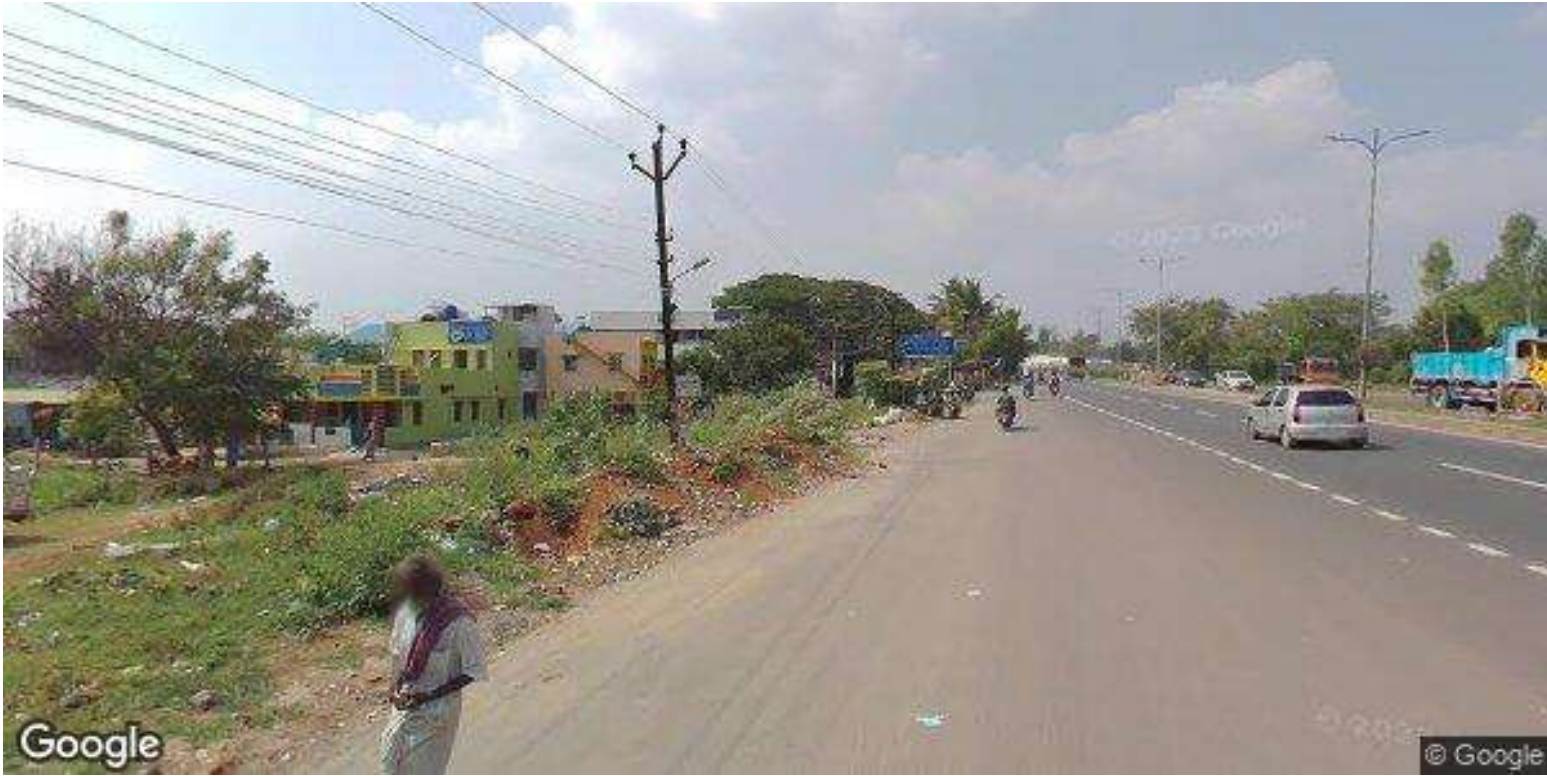
**Risk Type:** Turn  
**Risk Level:** High  
**Speed Limit:** 15 KM/Hr  
**Coordinates:** 11.69390, 78.10964

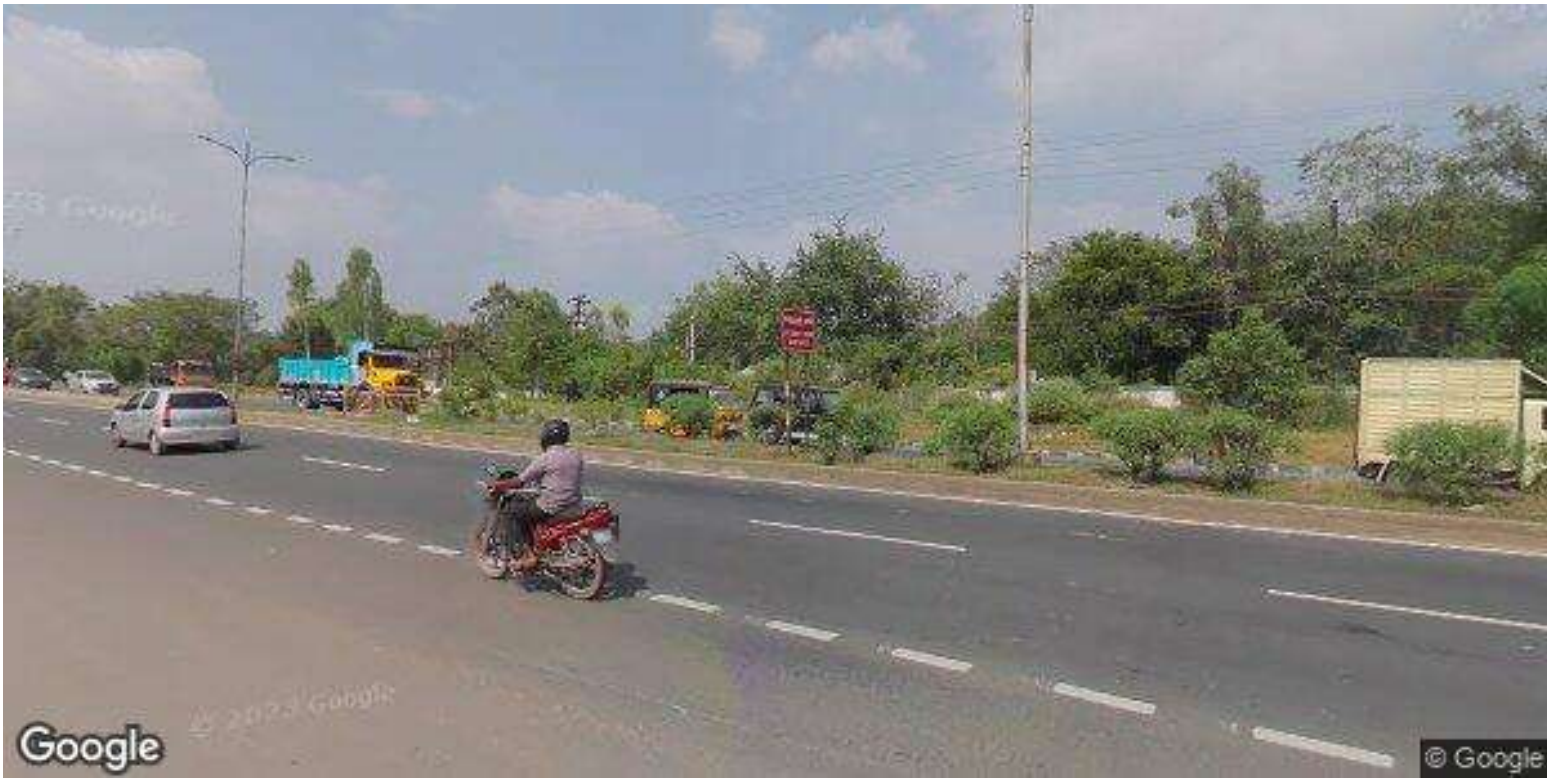
**Risk Type:** Turn  
**Risk Level:** High  
**Speed Limit:** 15 KM/Hr  
**Coordinates:** 11.69394, 78.10964

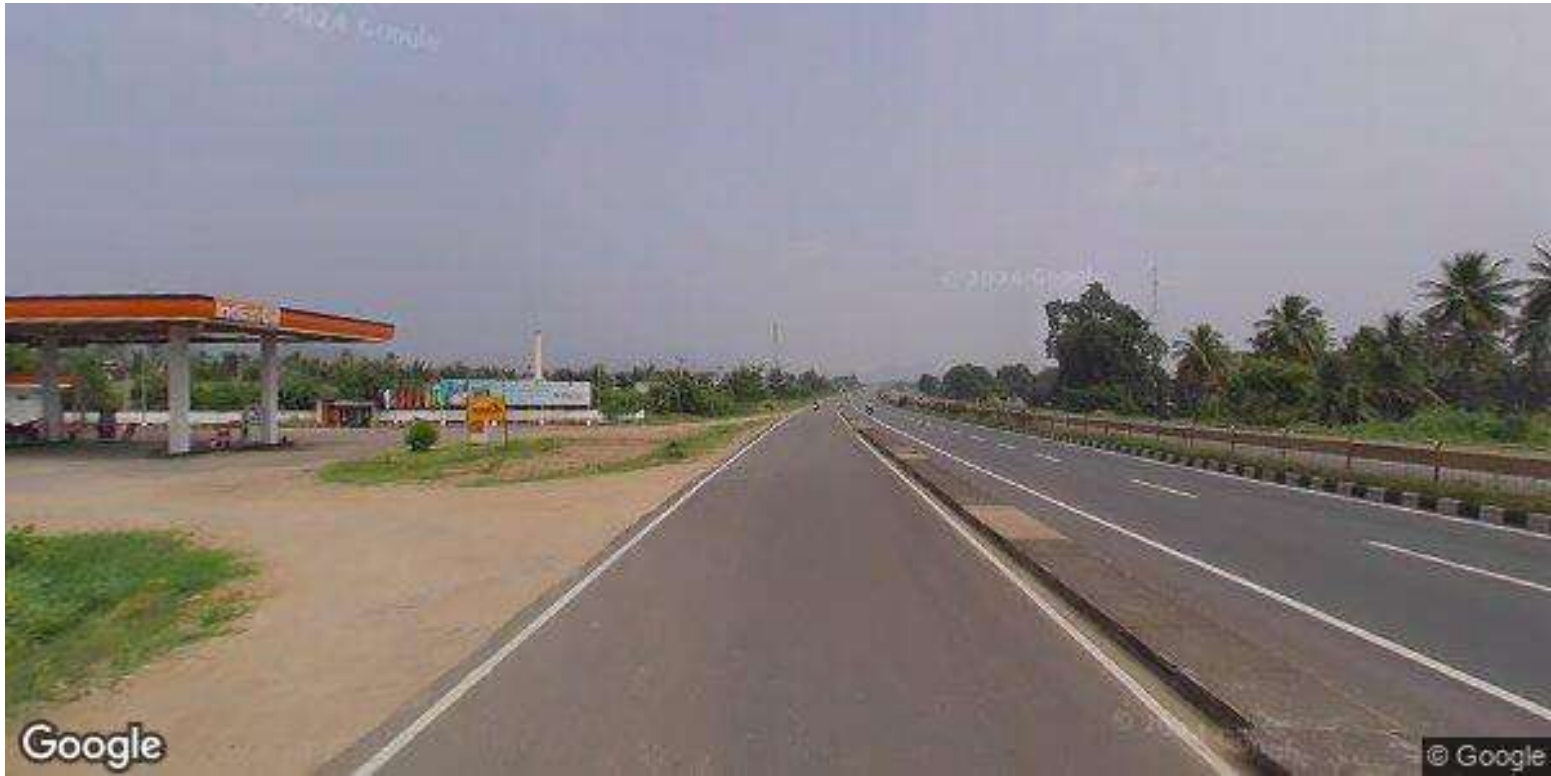
**Risk Type:** Turn  
**Risk Level:** Medium  
**Speed Limit:** 30 KM/Hr  
**Coordinates:** 11.85709, 78.07424

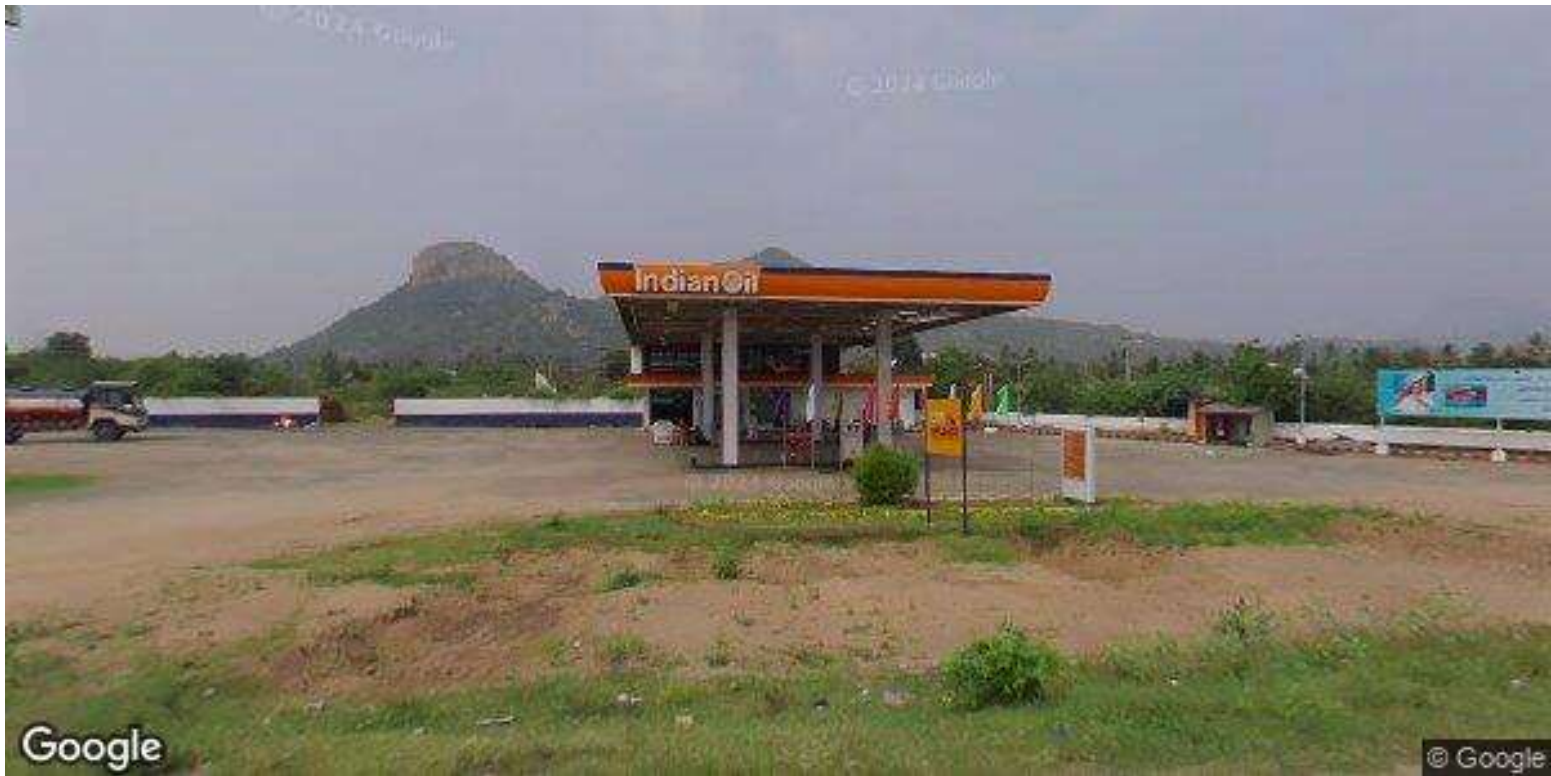
**Risk Type:** Turn  
**Risk Level:** High  
**Speed Limit:** 15 KM/Hr  
**Coordinates:** 11.85747, 78.07423

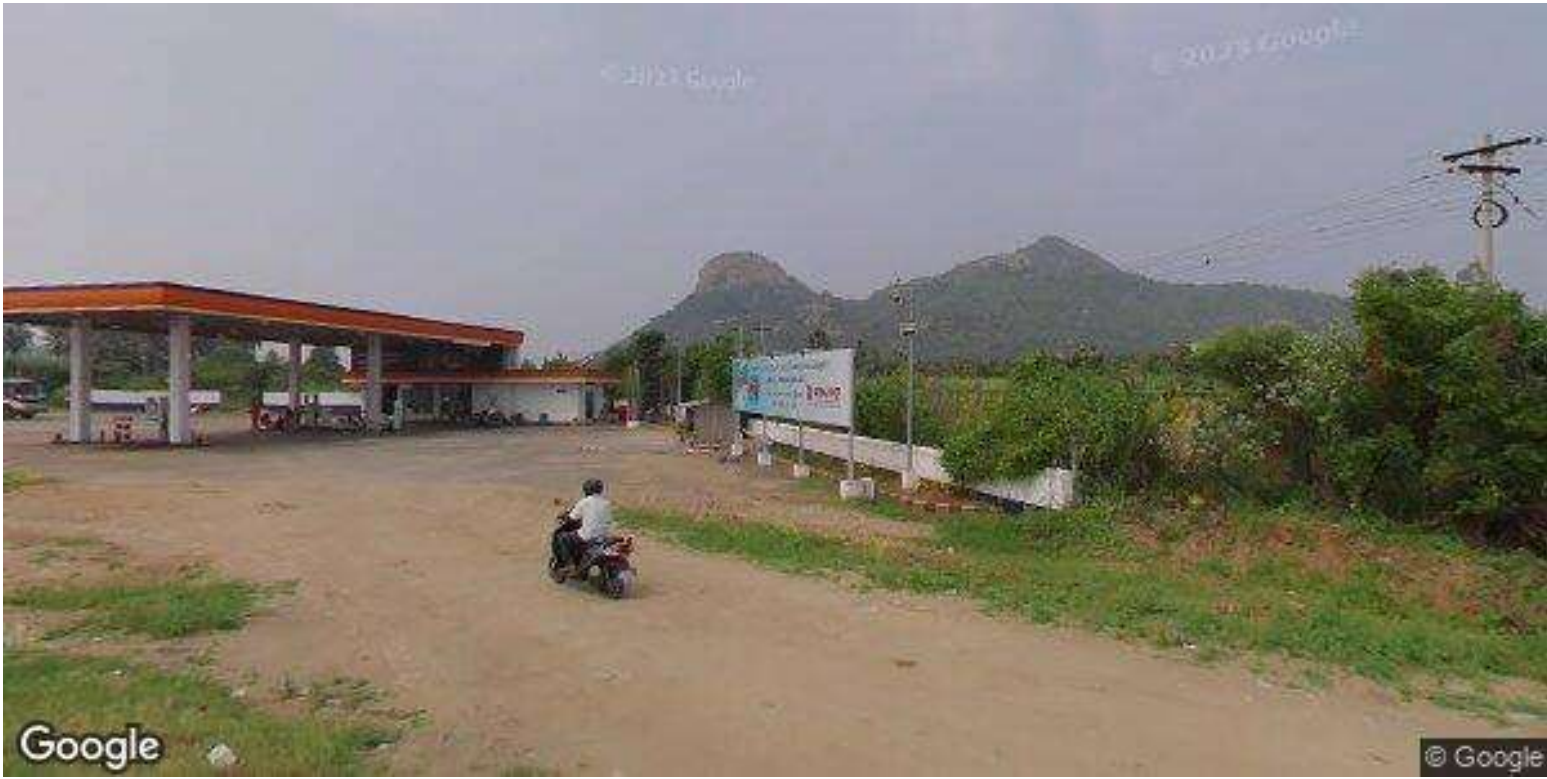
**Risk Type:** Turn  
**Risk Level:** High  
**Speed Limit:** 15 KM/Hr  
**Coordinates:** 11.85766, 78.07454

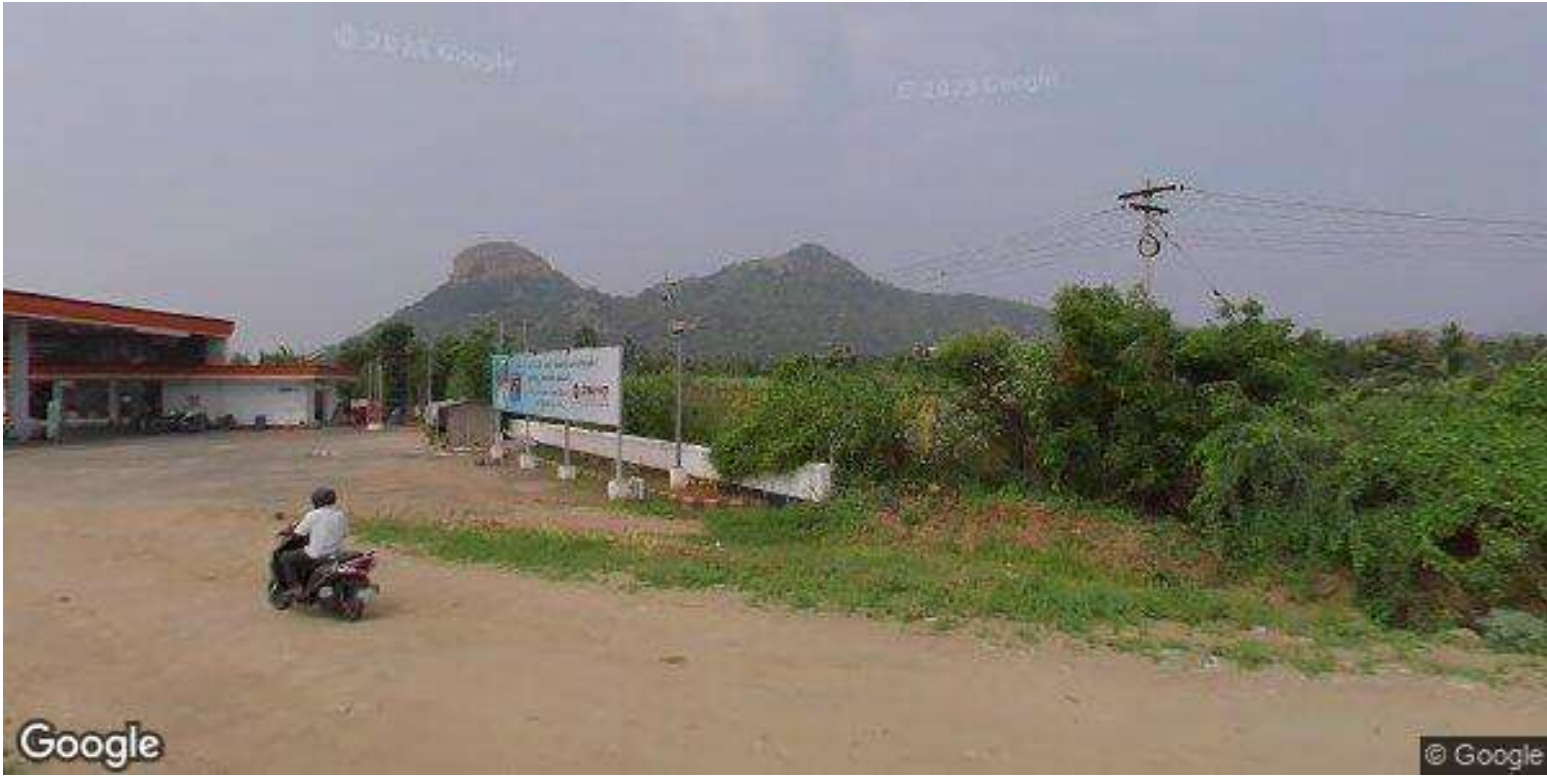
**Risk Type:** Turn  
**Risk Level:** High  
**Speed Limit:** 15 KM/Hr  
**Coordinates:** 11.85774, 78.07450
