# IndianOil

## **JOURNEY RISK MANAGEMENT (JRM) STUDY**

### **Salem Terminal TO STATE LORRY OWNERS FEDERATION**

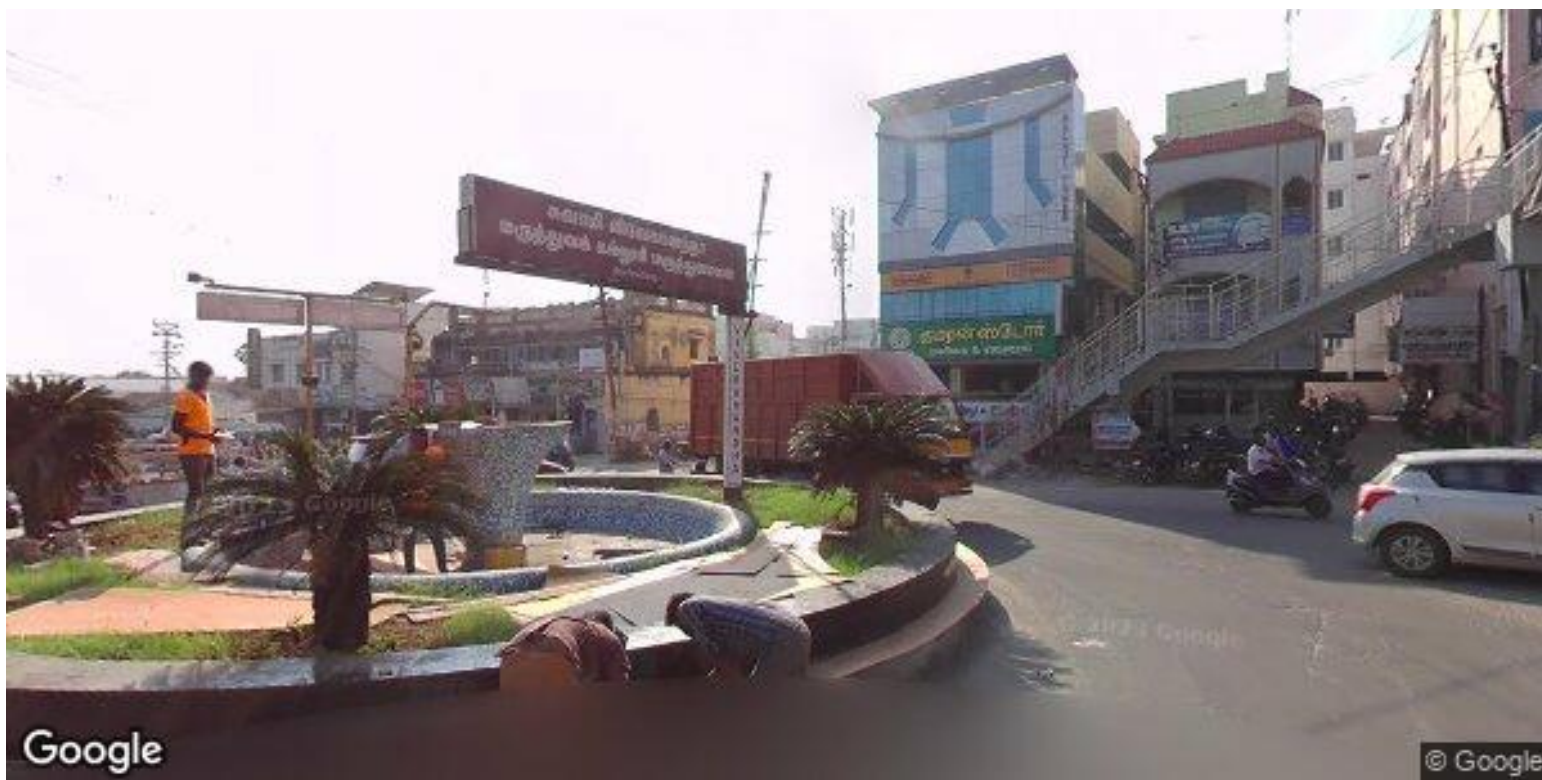
**Coordinates:** 11.38395, 77.89480

**Risk Type:** Roundabout

**Risk Level:** High

**Speed Limit:** 15 KM/Hr

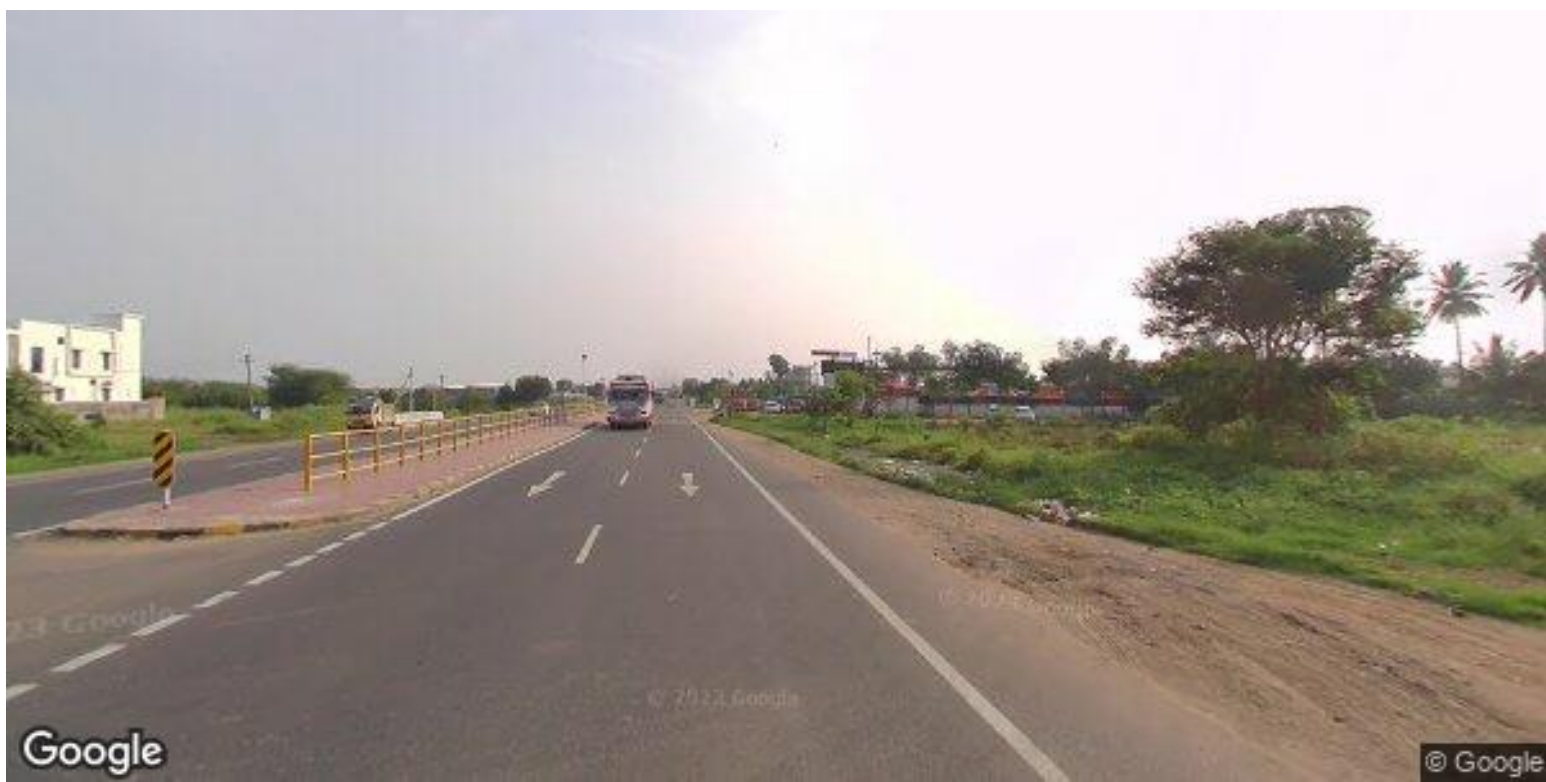
**Coordinates:** 11.2721854, 78.1639296

**Risk Type:** U-Turn

**Risk Level:** High

**Speed Limit:** 10 KM/Hr

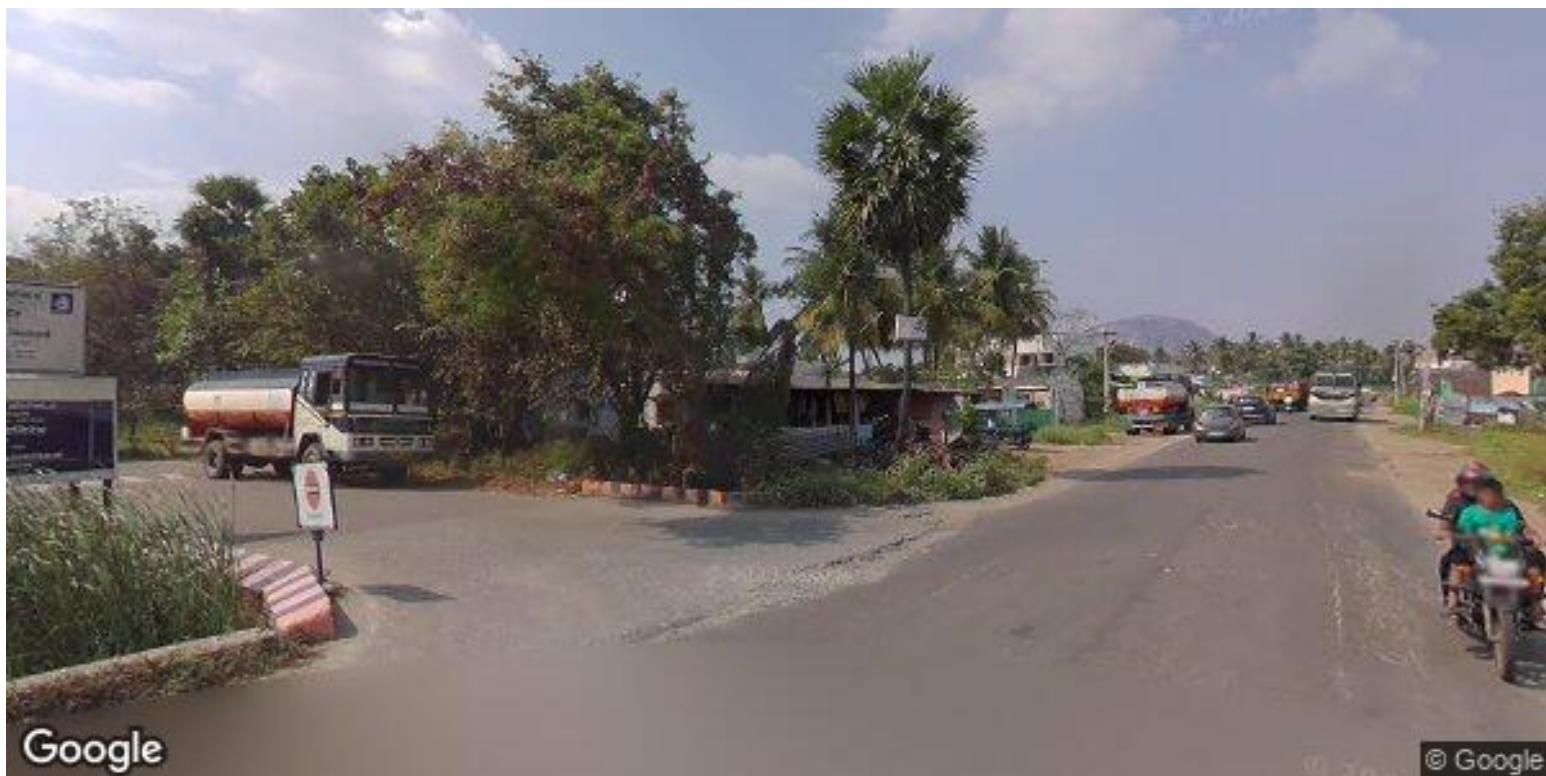
**Coordinates:** 11.44028, 77.87541

**Risk Type:** Turn

**Risk Level:** High

**Speed Limit:** 15 KM/Hr

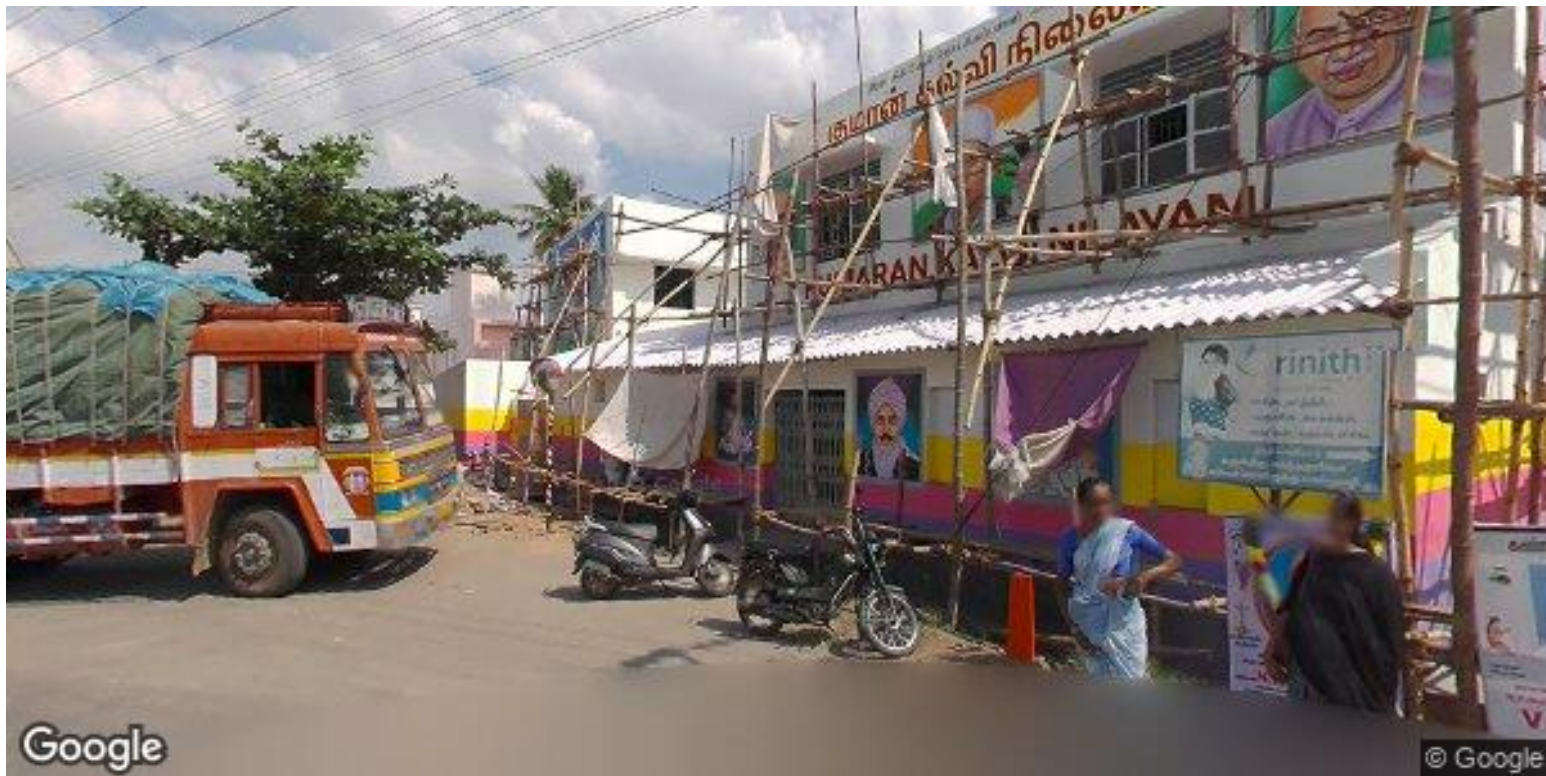
**Coordinates:** 11.38182, 77.90259

**Risk Type:** Turn

**Risk Level:** Medium

**Speed Limit:** 30 KM/Hr

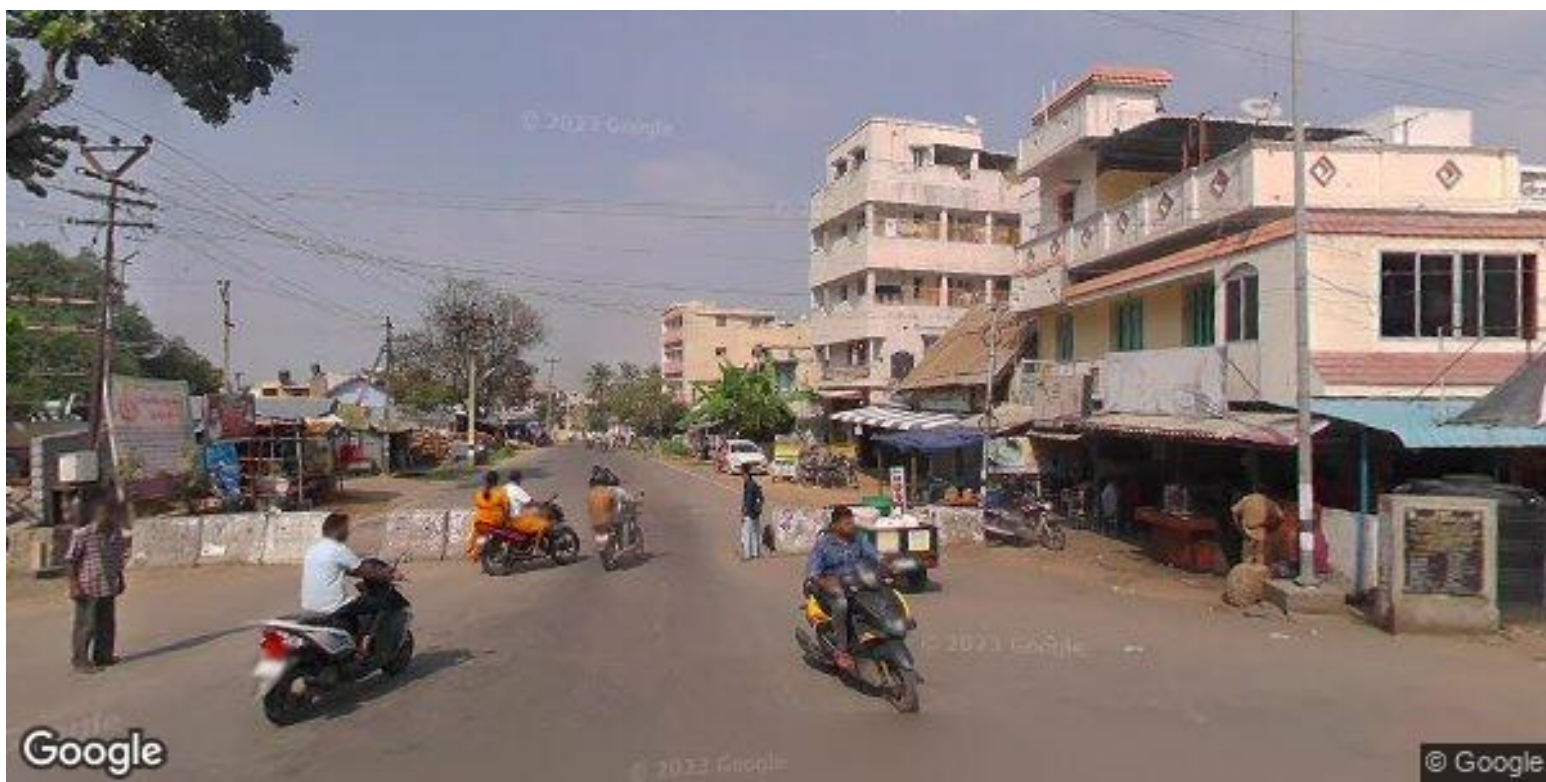
**Risk Type:** Blind Spot  
**Risk Level:** Blind Spot  
**Speed Limit:** 10 KM/Hr  
**Coordinates:** 11.37841, 77.90140

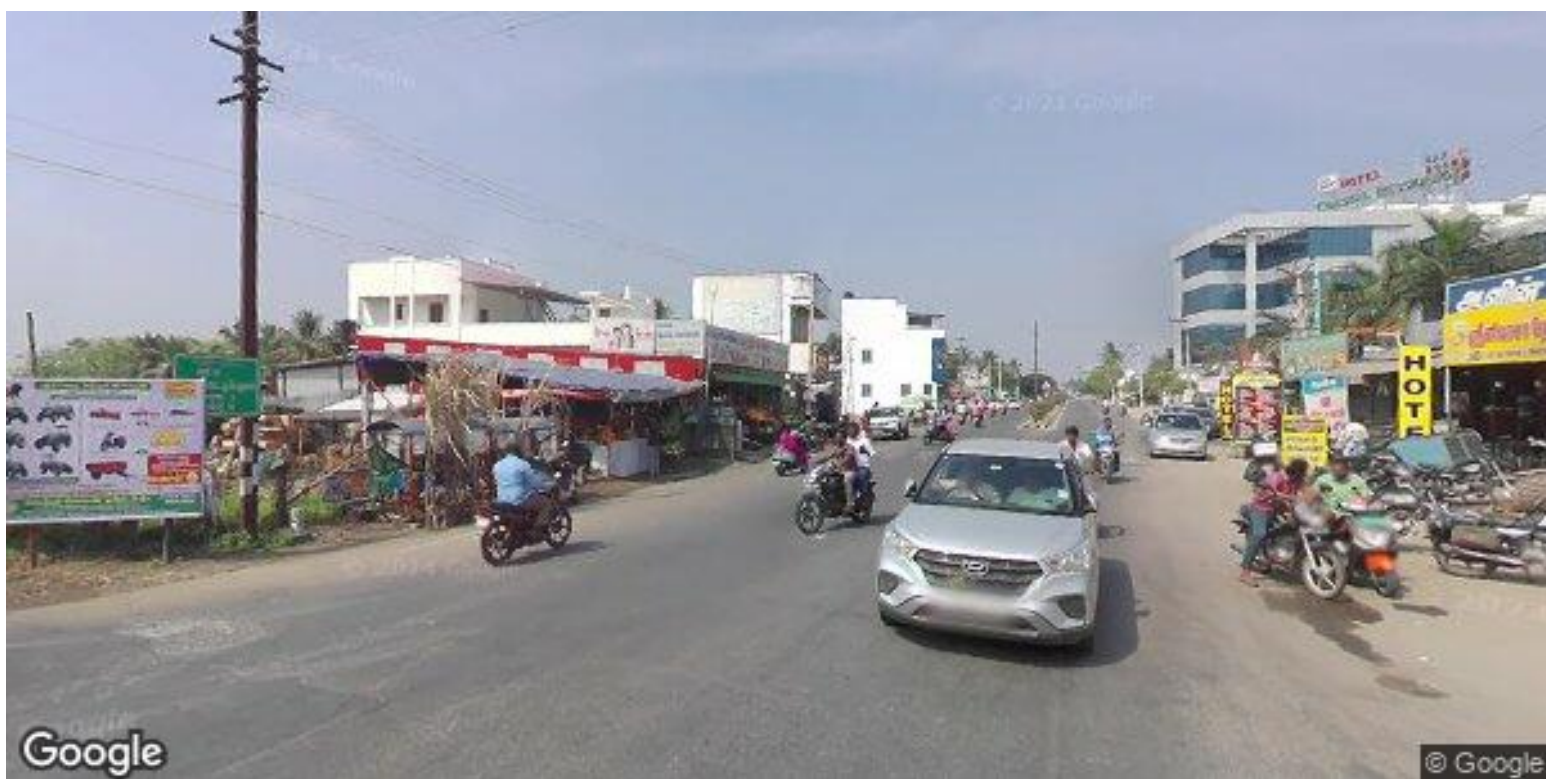
**Risk Type:** Turn  
**Risk Level:** High  
**Speed Limit:** 15 KM/Hr  
**Coordinates:** 11.23961, 78.14223

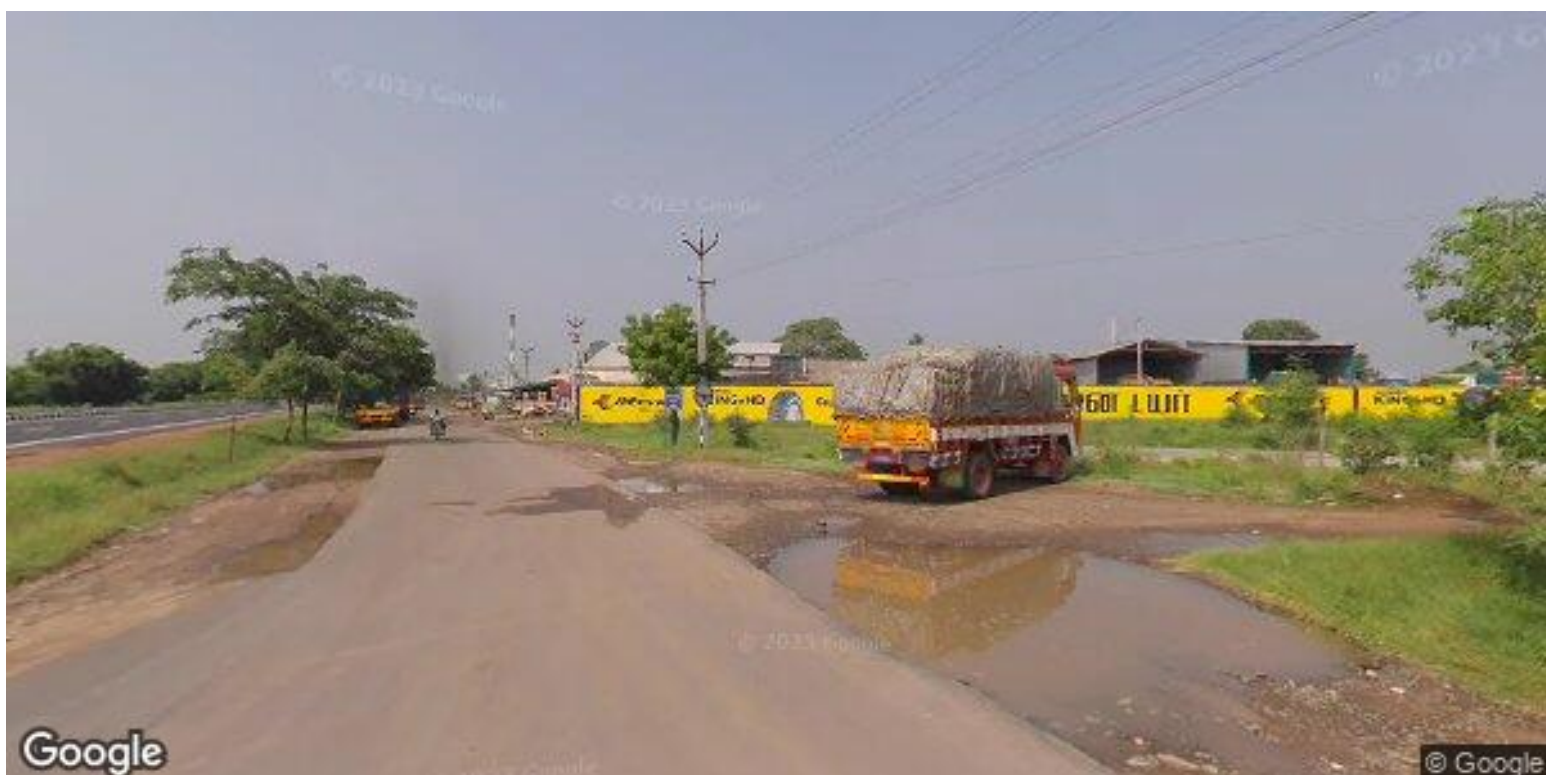
**Coordinates:** 11.24549, 78.14753

**Risk Type:** Turn

**Risk Level:** High

**Speed Limit:** 15 KM/Hr

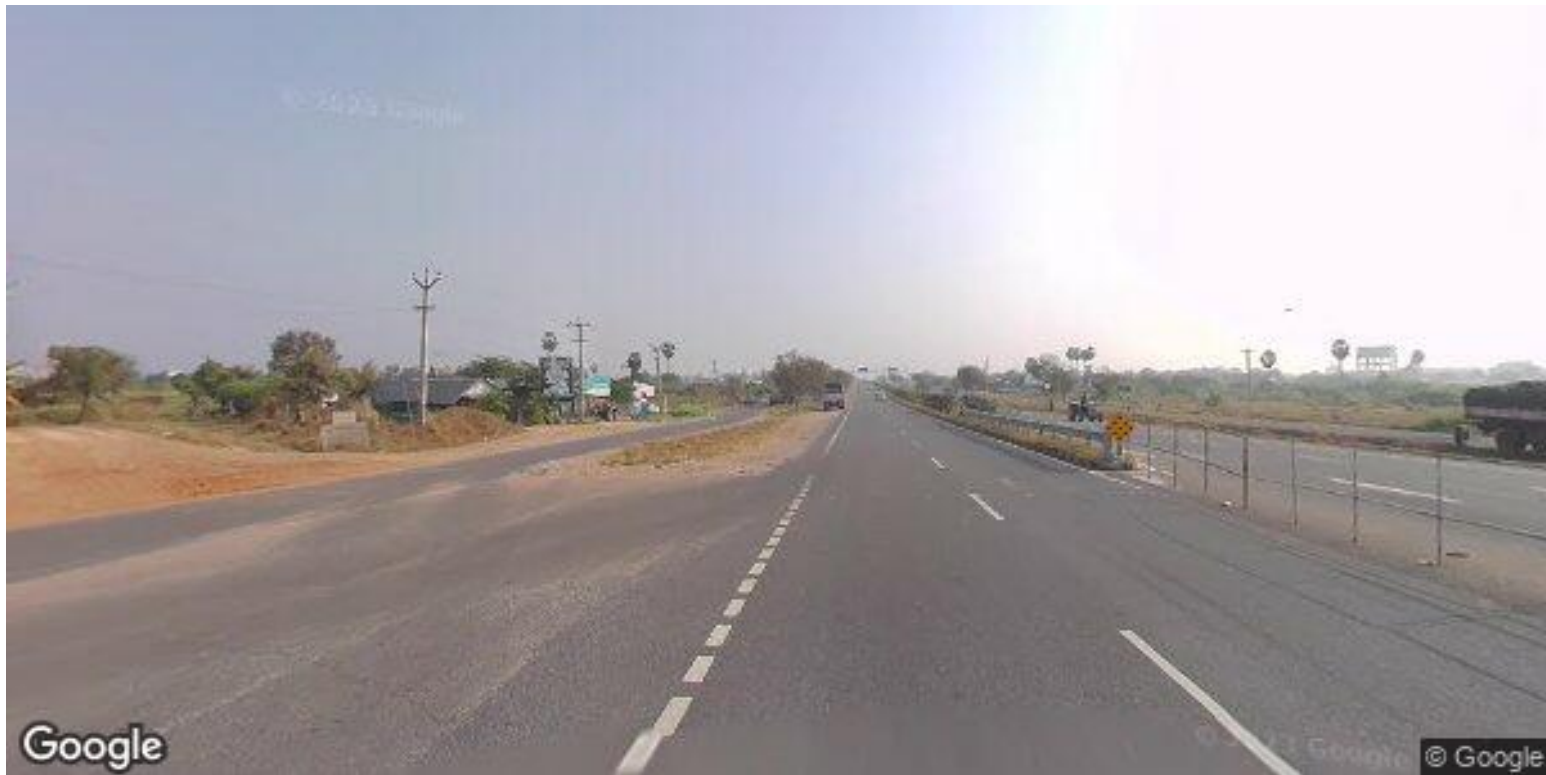
**Coordinates:** 11.24537, 78.14763

**Risk Type:** Turn

**Risk Level:** High

**Speed Limit:** 15 KM/Hr

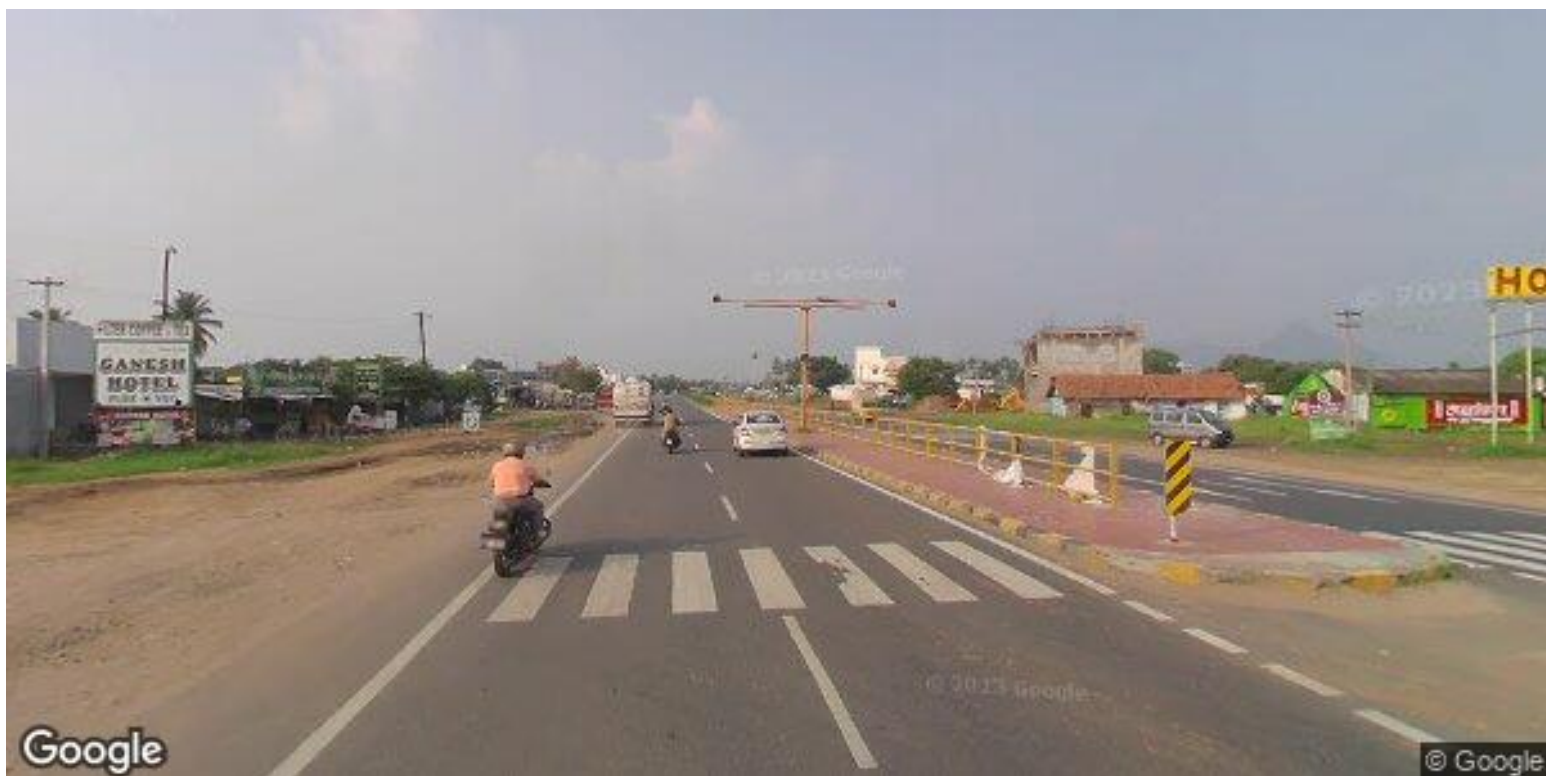
**Coordinates:** 11.27219, 78.16393

**Risk Type:** Blind Spot

**Risk Level:** Blind Spot

**Speed Limit:** 10 KM/Hr

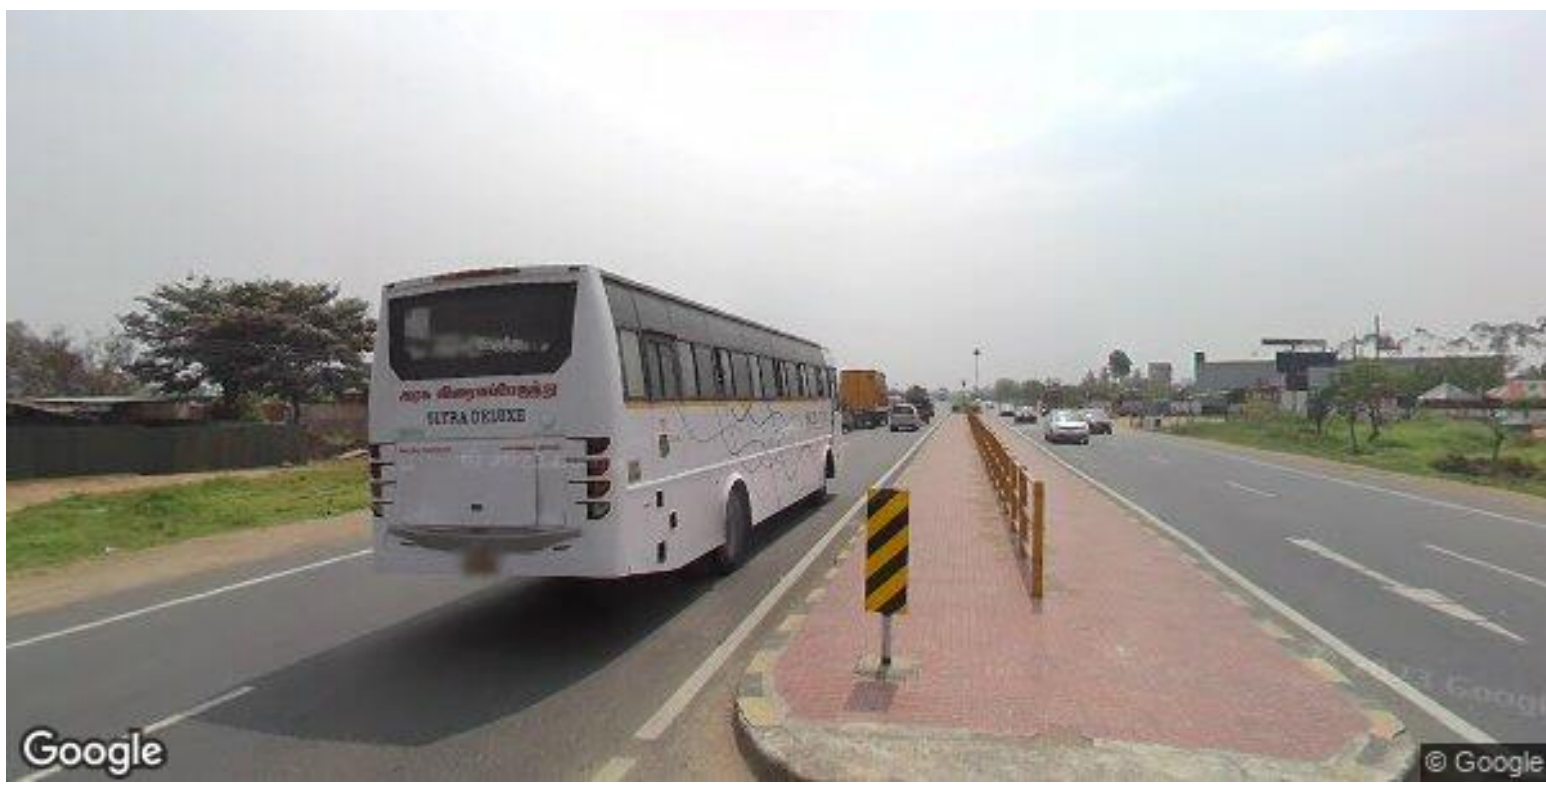
**Coordinates:** 11.27216, 78.16405

**Risk Type:** Turn

**Risk Level:** High

**Speed Limit:** 15 KM/Hr
