# IndianOil

## JOURNEY RISK MANAGEMENT (JRM) STUDY

### Salem Terminal to Sri Hari Agencies

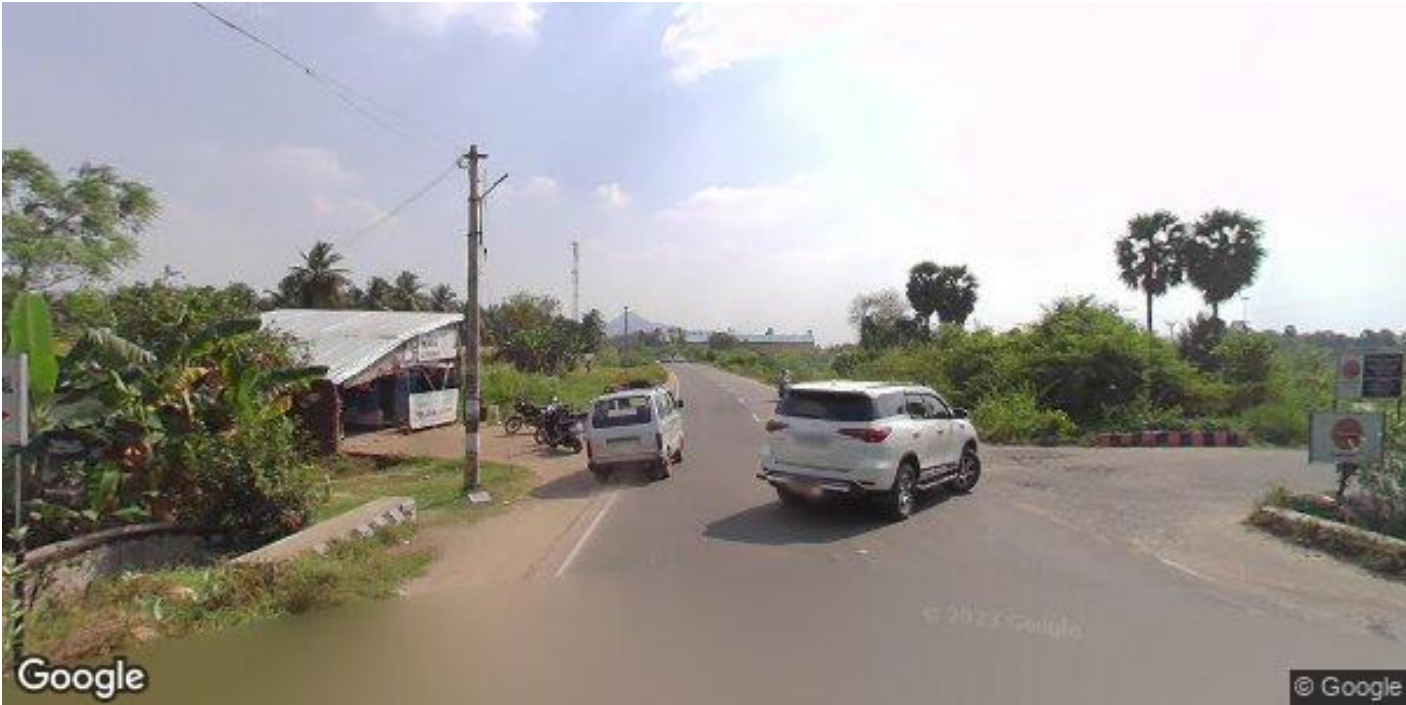
| | Risk Type | Risk Level | Coordinates | Speed Limit |
|---|---|---|---|---|
| 3 | Turn | High | 11.44029, 77.87544 | 15 KM/Hr |

Risk Type: Turn  
Risk Level: High  
Speed Limit: 15 KM/Hr  
Coordinates: 11.44029, 77.87544

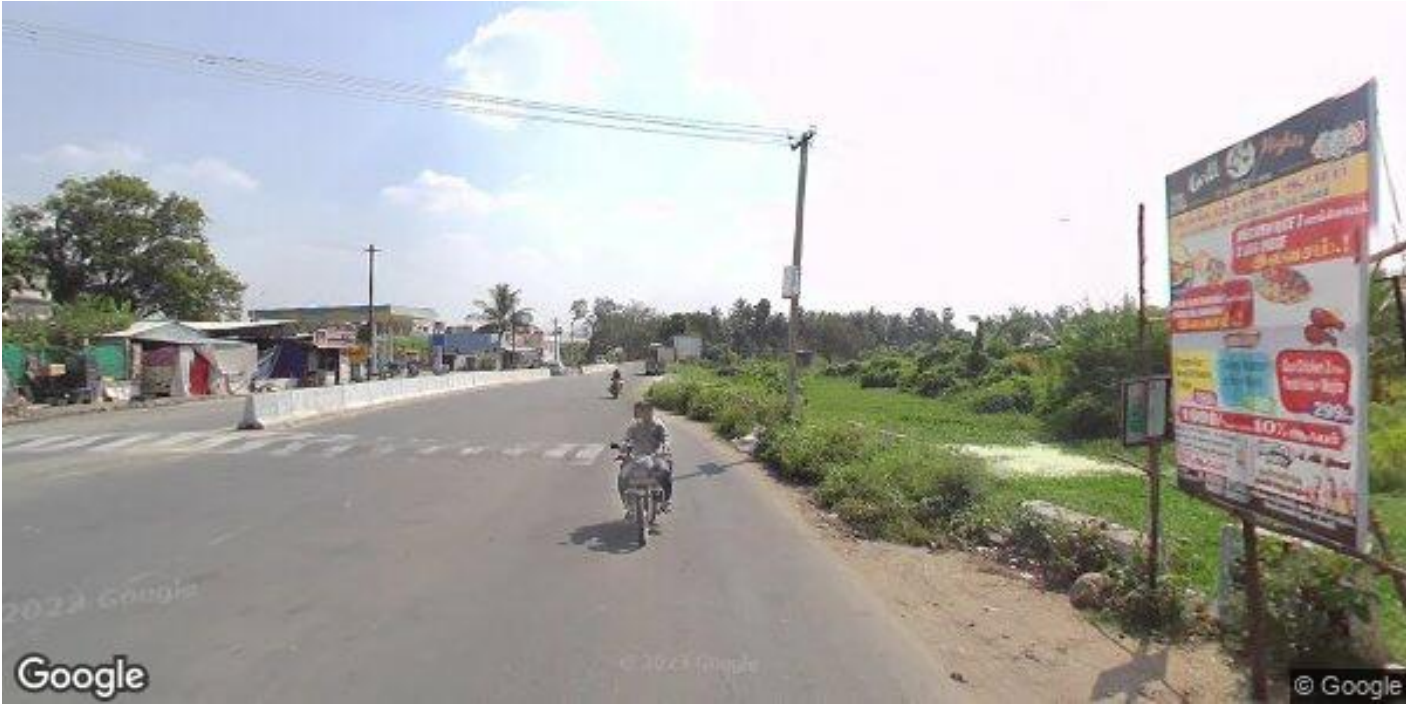
| | Risk Type | Risk Level | Coordinates | Speed Limit |
|---|---|---|---|---|
| 4 | Blind Spot | Blind Spot | 11.44861, 77.87429 | 10 KM/Hr |

Risk Type: Blind Spot  
Risk Level: Blind Spot  
Speed Limit: 10 KM/Hr  
Coordinates: 11.44861, 77.87429

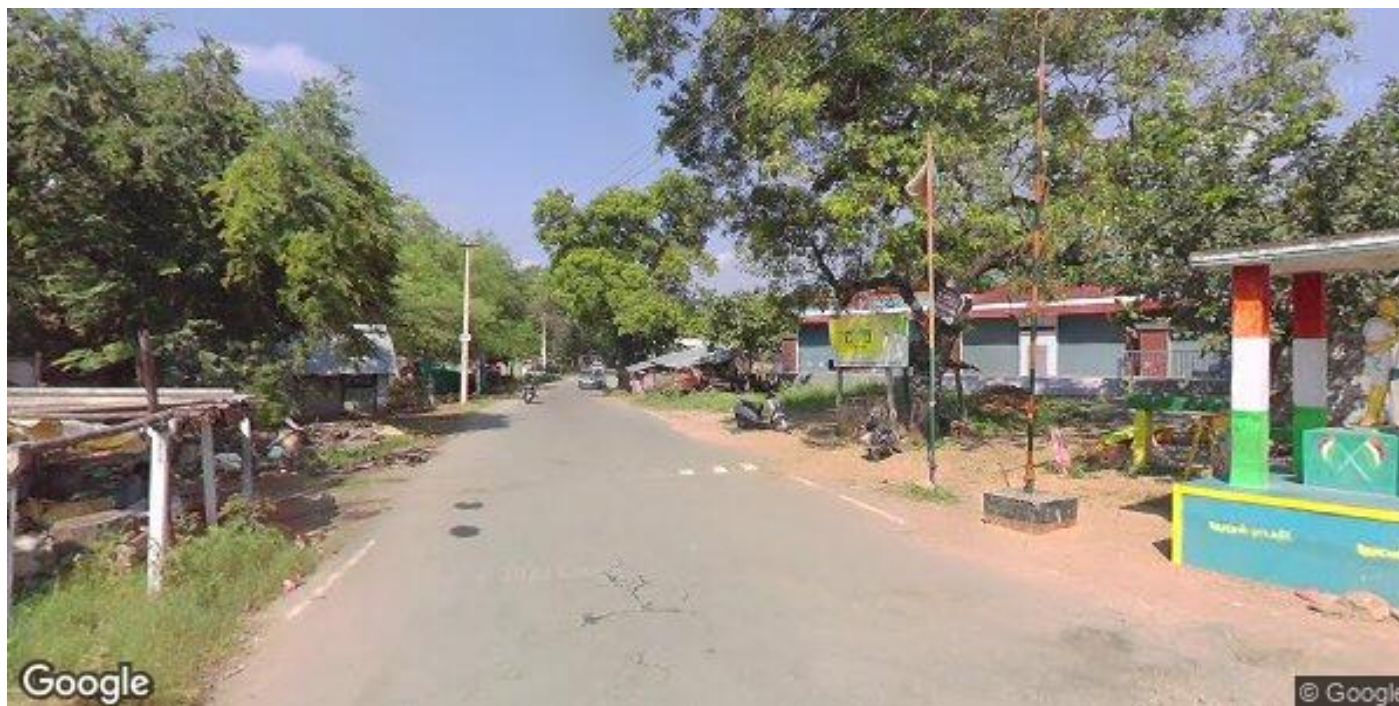
| | Risk Type | Risk Level | Coordinates | Speed Limit |
|---|---|---|---|---|
| 5 | Turn | High | 11.43673, 77.91703 | 15 KM/Hr |

**Risk Type:** Turn  
**Risk Level:** High  
**Speed Limit:** 15 KM/Hr  
**Coordinates:** 11.43673, 77.91703

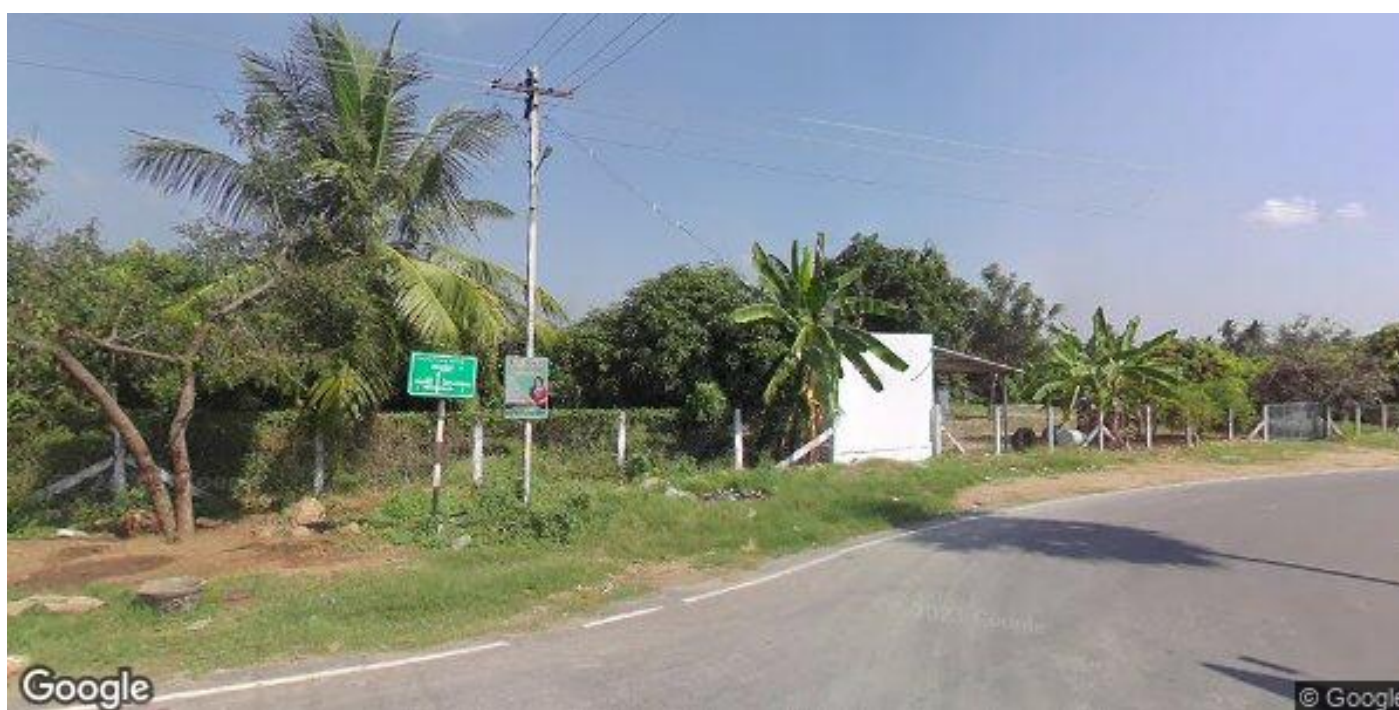
| | Risk Type | Risk Level | Coordinates | Speed Limit |
|---|---|---|---|---|
| 6 | Turn | High | 11.43926, 77.91705 | 15 KM/Hr |

**Risk Type:** Turn  
**Risk Level:** High  
**Speed Limit:** 15 KM/Hr  
**Coordinates:** 11.43926, 77.91705

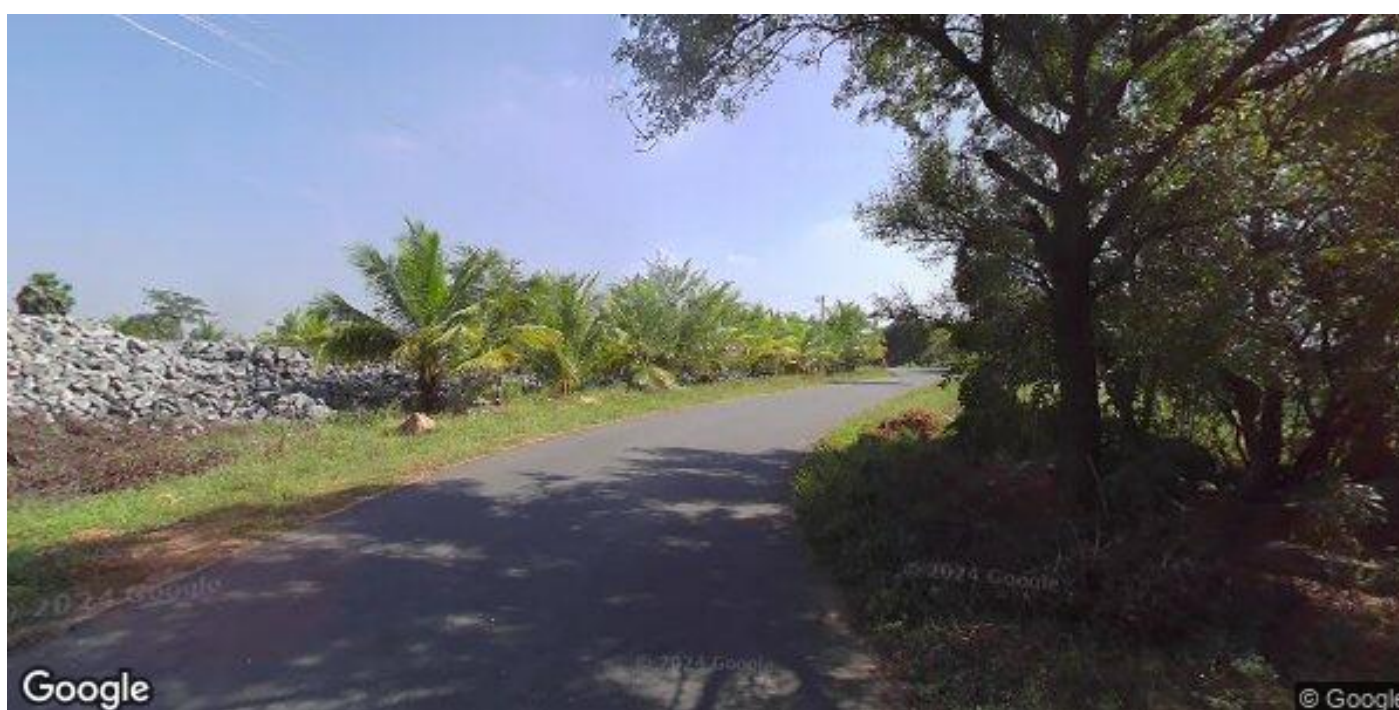
| | Risk Type | Risk Level | Coordinates | Speed Limit |
|---|---|---|---|---|
| 7 | Turn | Medium | 11.44030, 77.93066 | 30 KM/Hr |

**Risk Type:** Turn  
**Risk Level:** Medium  
**Speed Limit:** 30 KM/Hr  
**Coordinates:** 11.44030, 77.93066

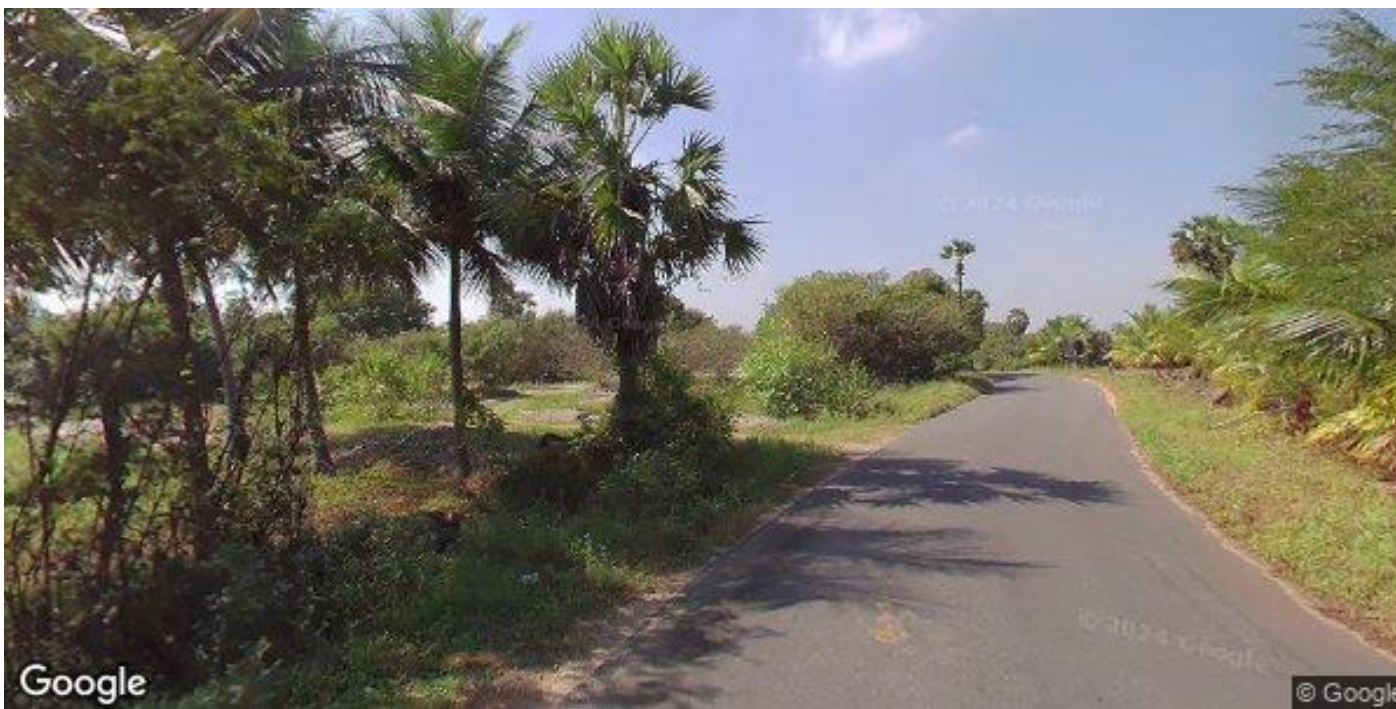
| | Risk Type | Risk Level | Coordinates | Speed Limit |
|---|---|---|---|---|
| 8 | Turn | Medium | 11.44075, 77.93216 | 30 KM/Hr |

**Risk Type:** Turn  
**Risk Level:** Medium  
**Speed Limit:** 30 KM/Hr  
**Coordinates:** 11.44075, 77.93216

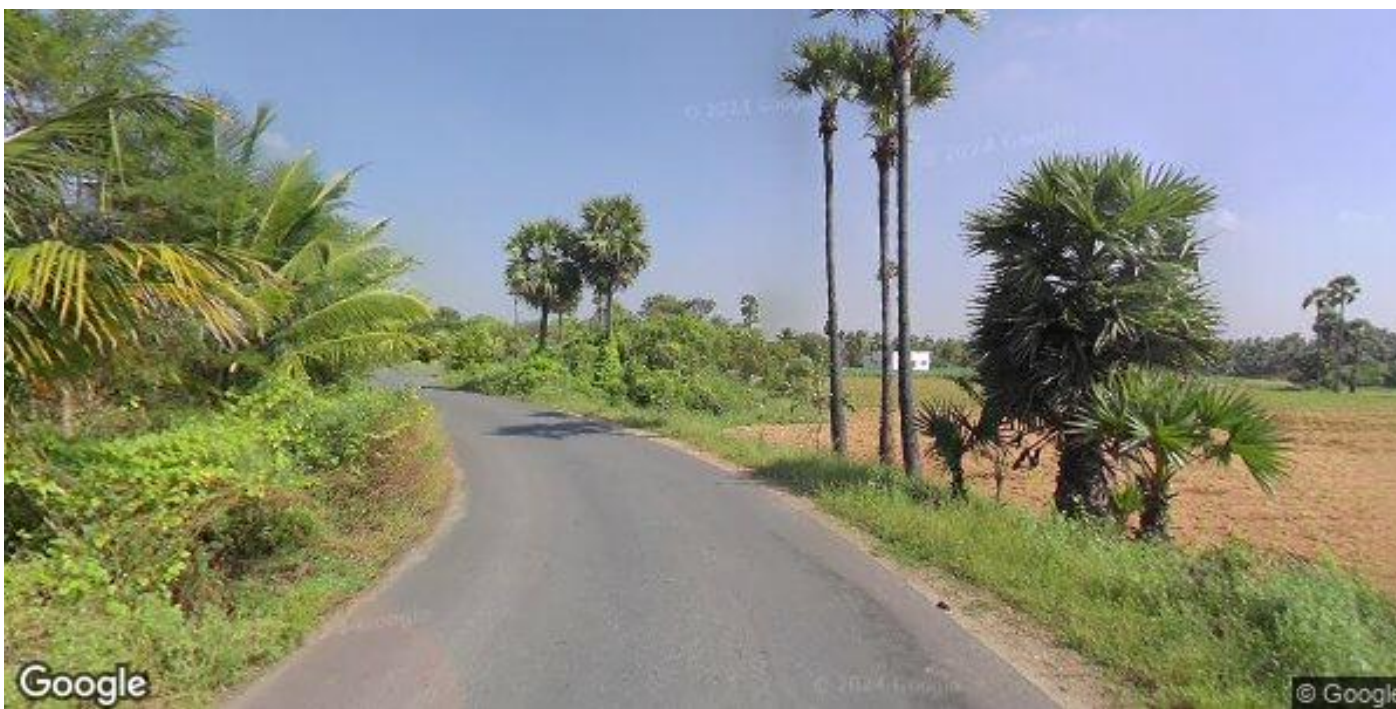
| | Risk Type | Risk Level | Coordinates | Speed Limit |
|---|---|---|---|---|
| 9 | Turn | Medium | 11.44088, 77.93223 | 30 KM/Hr |

**Risk Type:** Turn  
**Risk Level:** Medium  
**Speed Limit:** 30 KM/Hr  
**Coordinates:** 11.44088, 77.93223

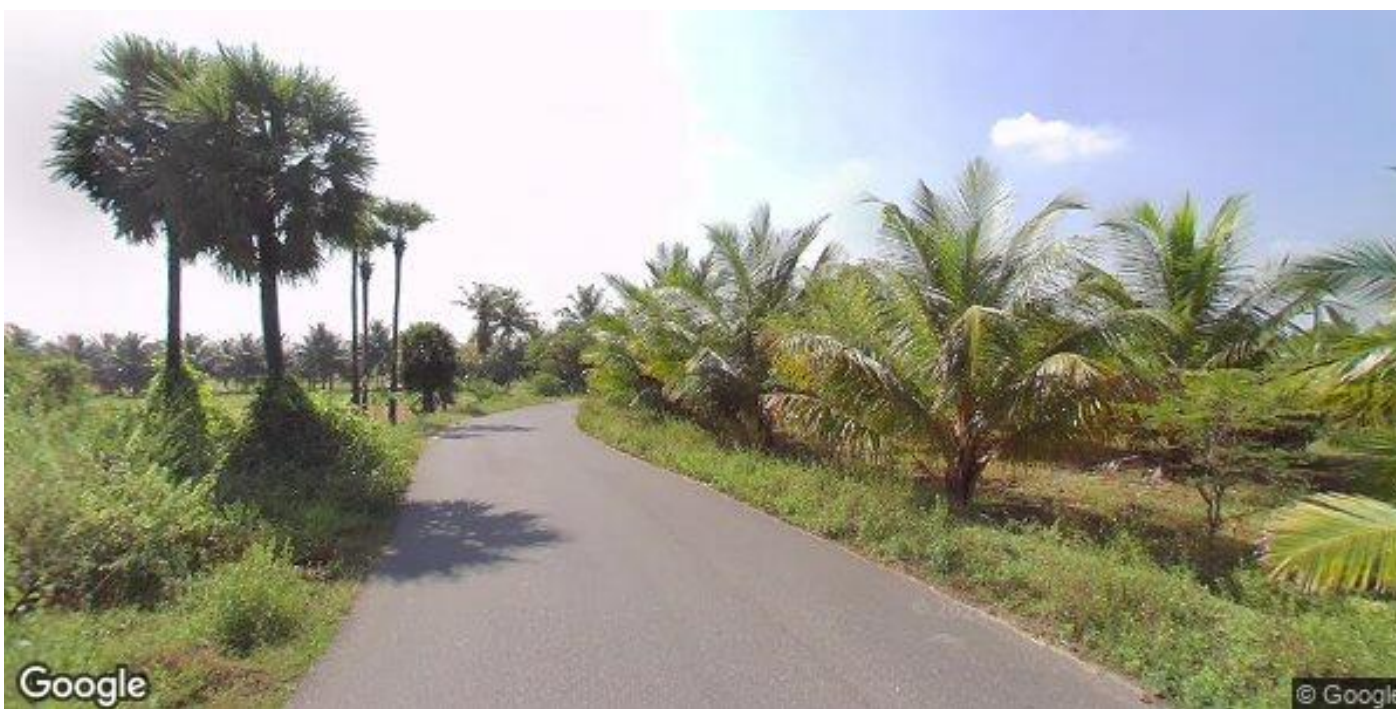
| | Risk Type | Risk Level | Coordinates | Speed Limit |
|---|---|---|---|---|
| 10 | Turn | Medium | 11.44127, 77.93218 | 30 KM/Hr |

**Risk Type:** Turn  
**Risk Level:** Medium  
**Speed Limit:** 30 KM/Hr  
**Coordinates:** 11.44127, 77.93218

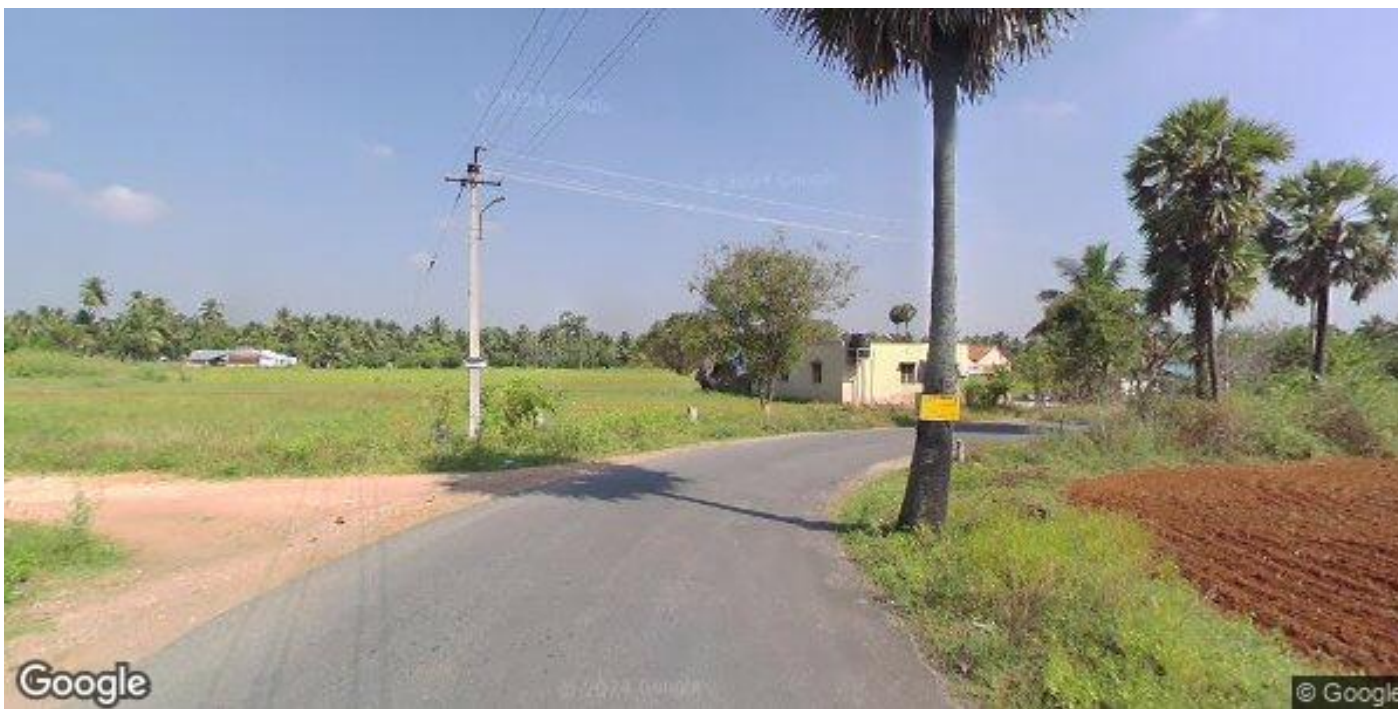
| | Risk Type | Risk Level | Coordinates | Speed Limit |
|---|---|---|---|---|
| 11 | Turn | Medium | 11.44243, 77.93244 | 30 KM/Hr |

**Risk Type:** Turn  
**Risk Level:** Medium  
**Speed Limit:** 30 KM/Hr  
**Coordinates:** 11.44243, 77.93244

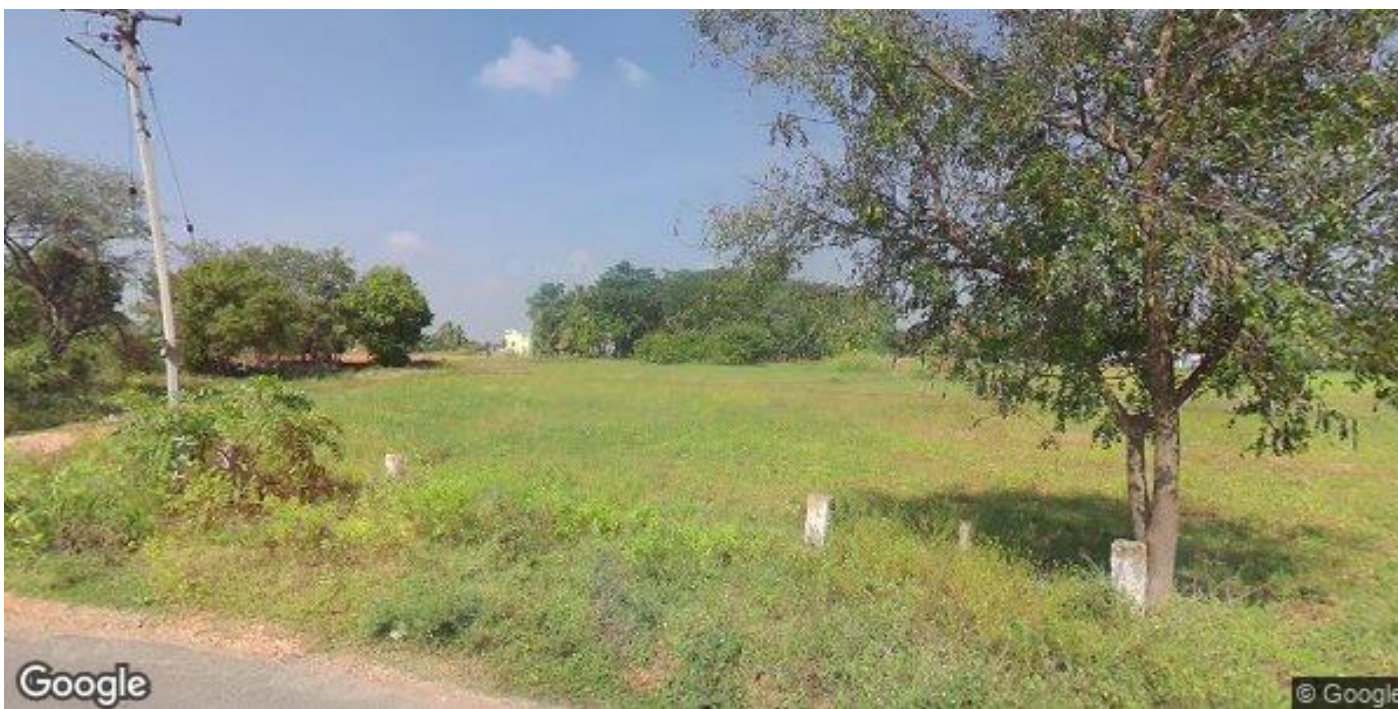
| | Risk Type | Risk Level | Coordinates | Speed Limit |
|---|---|---|---|---|
| 12 | Turn | Medium | 11.44254, 77.93256 | 30 KM/Hr |

**Risk Type:** Turn  
**Risk Level:** Medium  
**Speed Limit:** 30 KM/Hr  
**Coordinates:** 11.44254, 77.93256

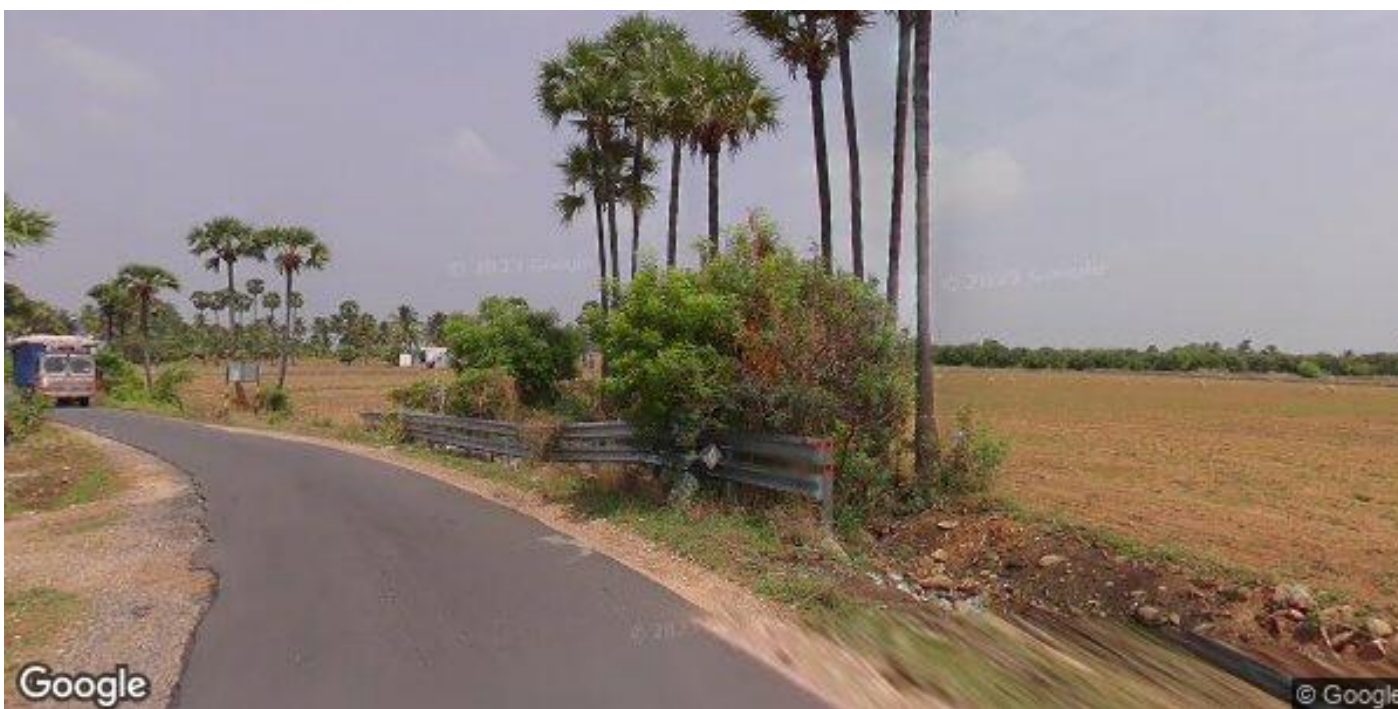
| | Risk Type | Risk Level | Coordinates | Speed Limit |
|---|---|---|---|---|
| 13 | Turn | Medium | 11.44550, 77.95329 | 30 KM/Hr |

**Risk Type:** Turn  
**Risk Level:** Medium  
**Speed Limit:** 30 KM/Hr  
**Coordinates:** 11.44550, 77.95329

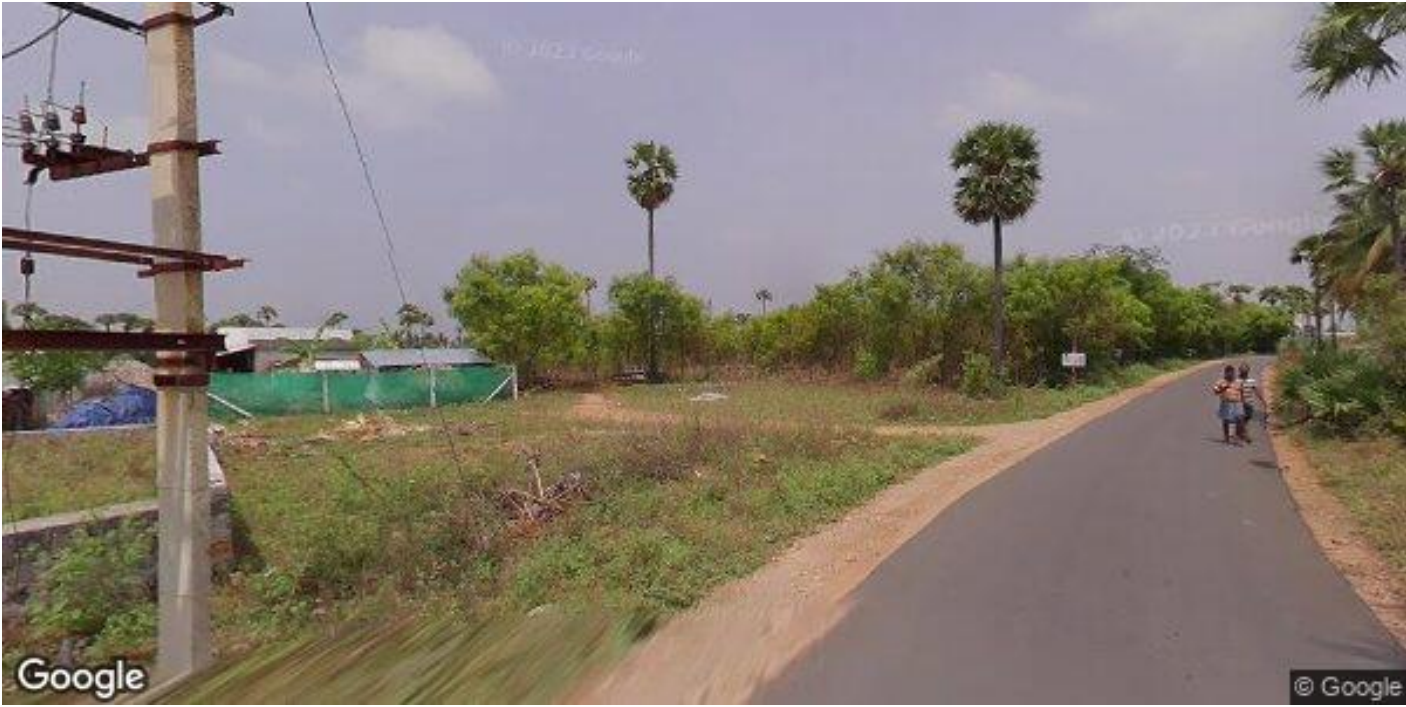
| | Risk Type | Risk Level | Coordinates | Speed Limit |
|---|---|---|---|---|
| 14 | Turn | Medium | 11.44369, 77.96036 | 30 KM/Hr |

**Risk Type:** Turn  
**Risk Level:** Medium  
**Speed Limit:** 30 KM/Hr  
**Coordinates:** 11.44369, 77.96036

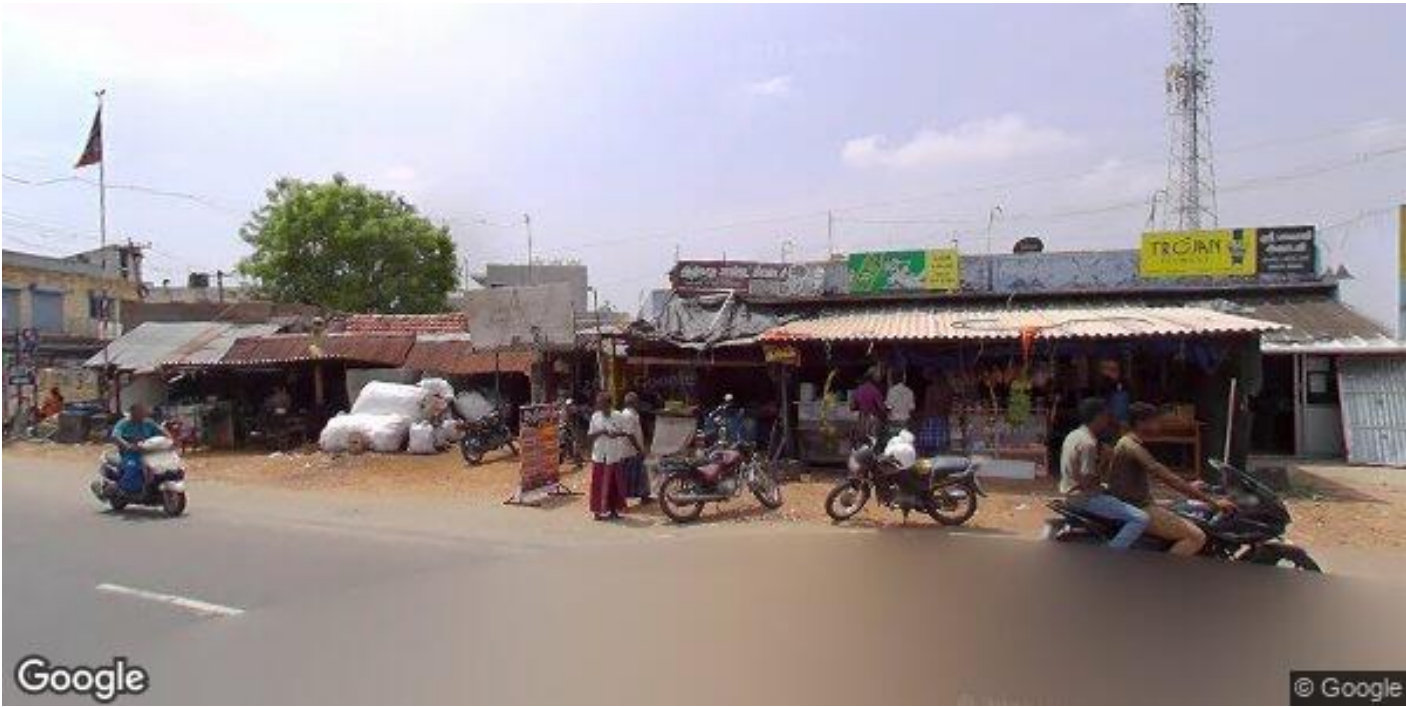
| | Risk Type | Risk Level | Coordinates | Speed Limit |
|---|---|---|---|---|
| 15 | Turn | High | 11.44387, 77.96283 | 15 KM/Hr |

**Risk Type:** Turn  
**Risk Level:** High  
**Speed Limit:** 15 KM/Hr  
**Coordinates:** 11.44387, 77.96283

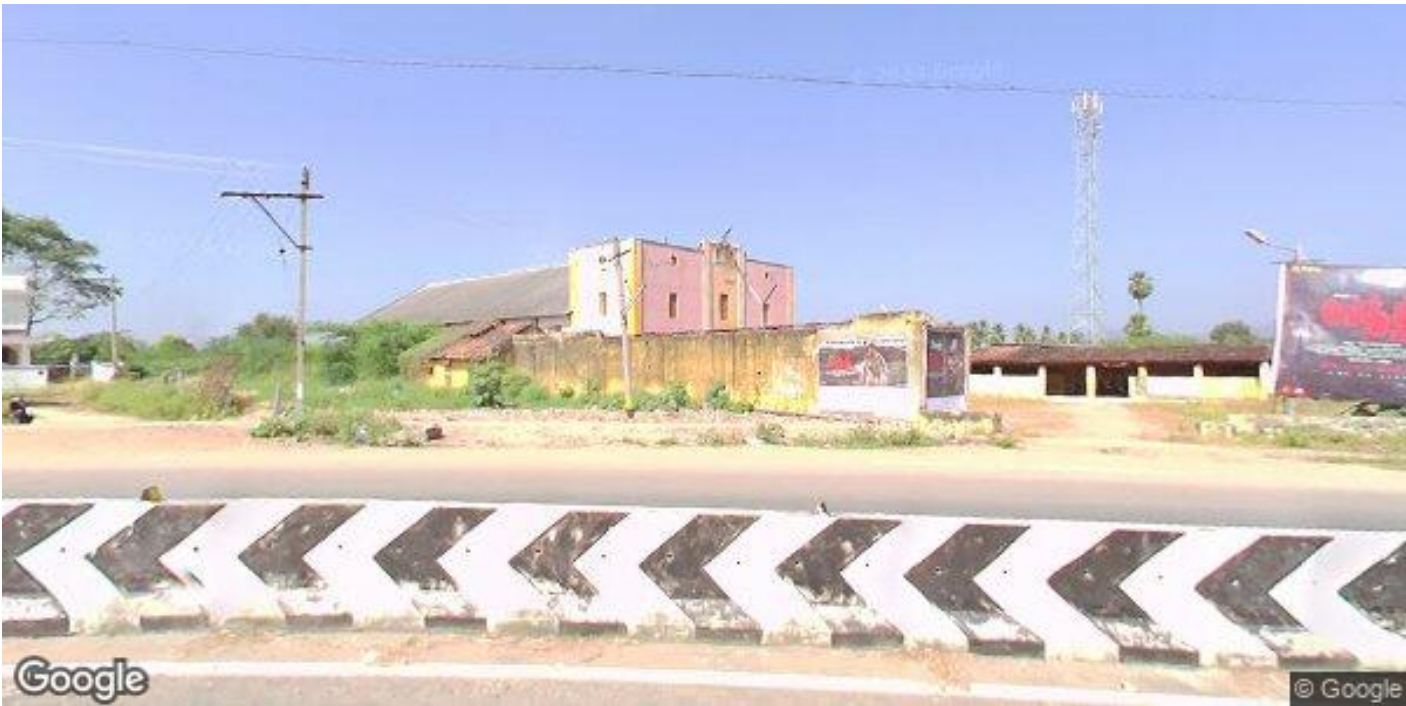
| | Risk Type | Risk Level | Coordinates | Speed Limit |
|---|---|---|---|---|
| 16 | Turn | Medium | 11.53064, 78.04684 | 30 KM/Hr |

**Risk Type:** Turn  
**Risk Level:** Medium  
**Speed Limit:** 30 KM/Hr  
**Coordinates:** 11.53064, 78.04684

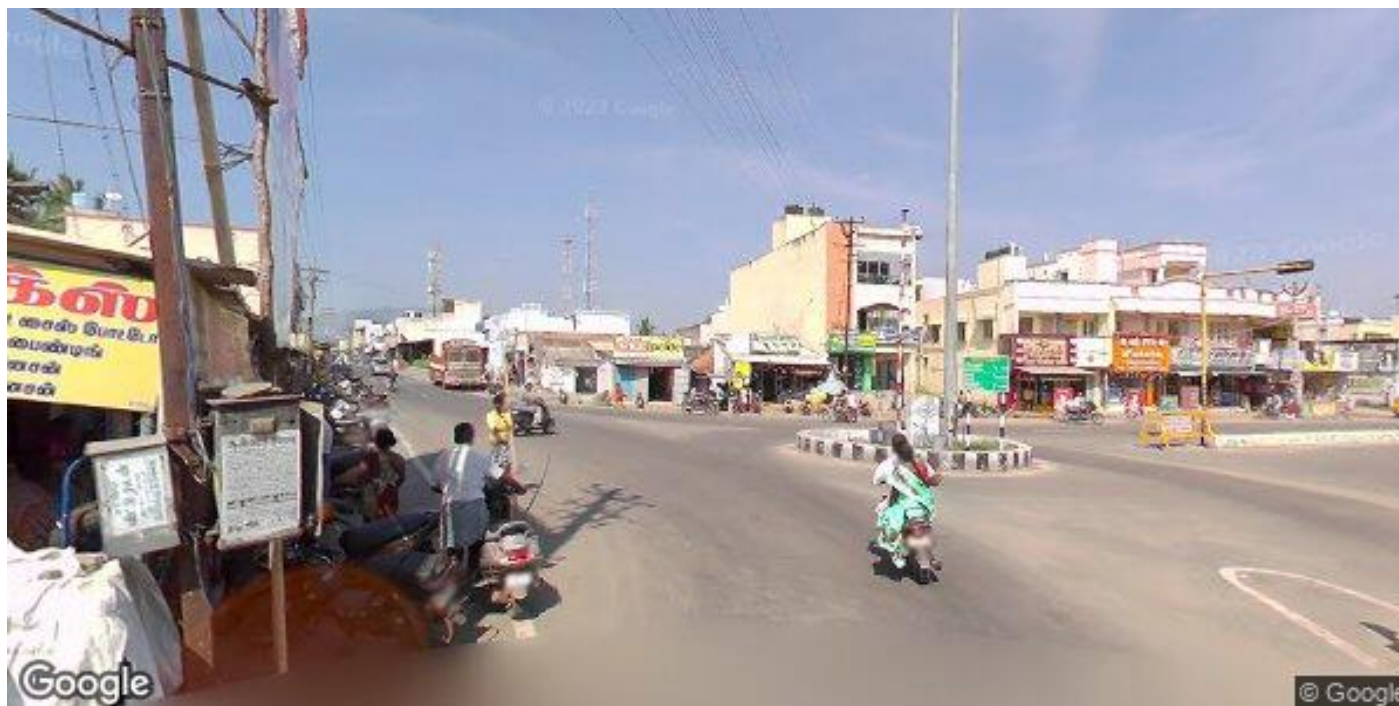
| | Risk Type | Risk Level | Coordinates | Speed Limit |
|---|---|---|---|---|
| 17 | Turn | Medium | 11.53170, 78.05073 | 30 KM/Hr |

### Risk Type: Turn

**Risk Level: Medium**

**Speed Limit: 30 KM/Hr**

Coordinates: 11.53170, 78.05073
