# IndianOil

## JOURNEY RISK MANAGEMENT (JRM) STUDY

**Salem Terminal TO NAMAKKAL TAL. RIG  
URIMAIYALARGAL SA**

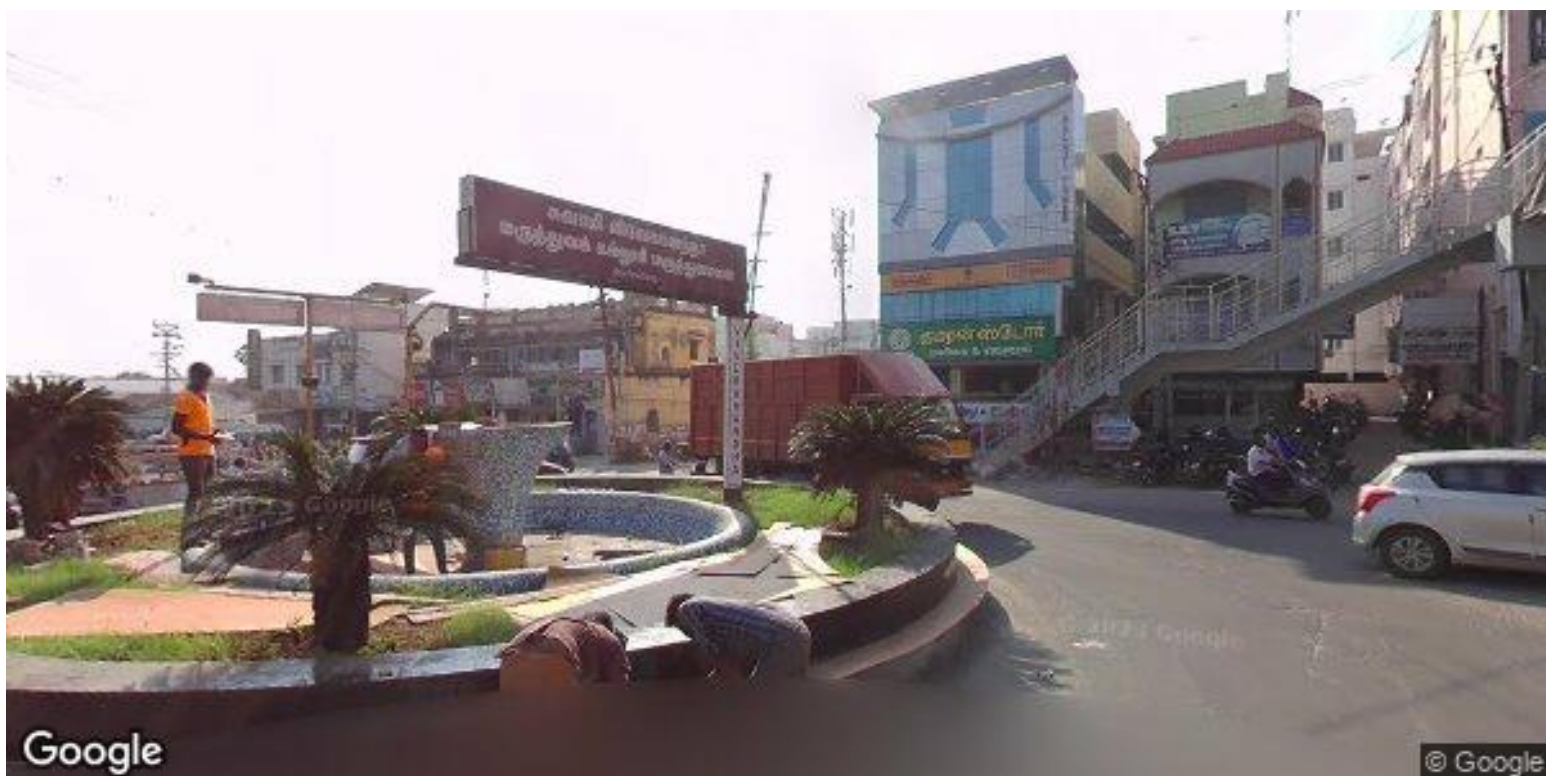
**Coordinates:** 11.38395, 77.89480

**Risk Type:** Roundabout

**Risk Level:** High

**Speed Limit:** 15 KM/Hr

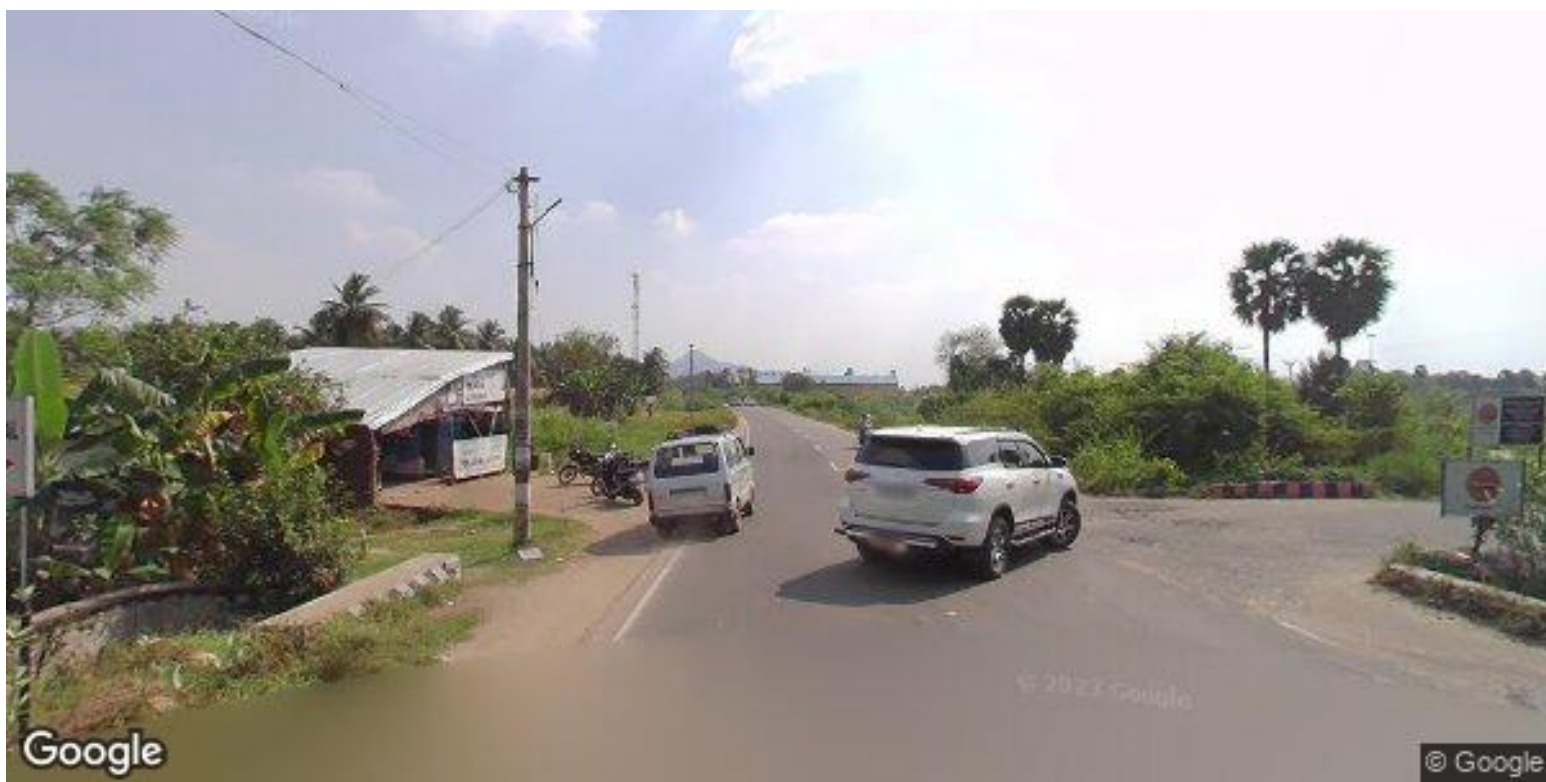
**Coordinates:** 11.44029, 77.87544

**Risk Type:** Blind Spot

**Risk Level:** Blind Spot

**Speed Limit:** 10 KM/Hr

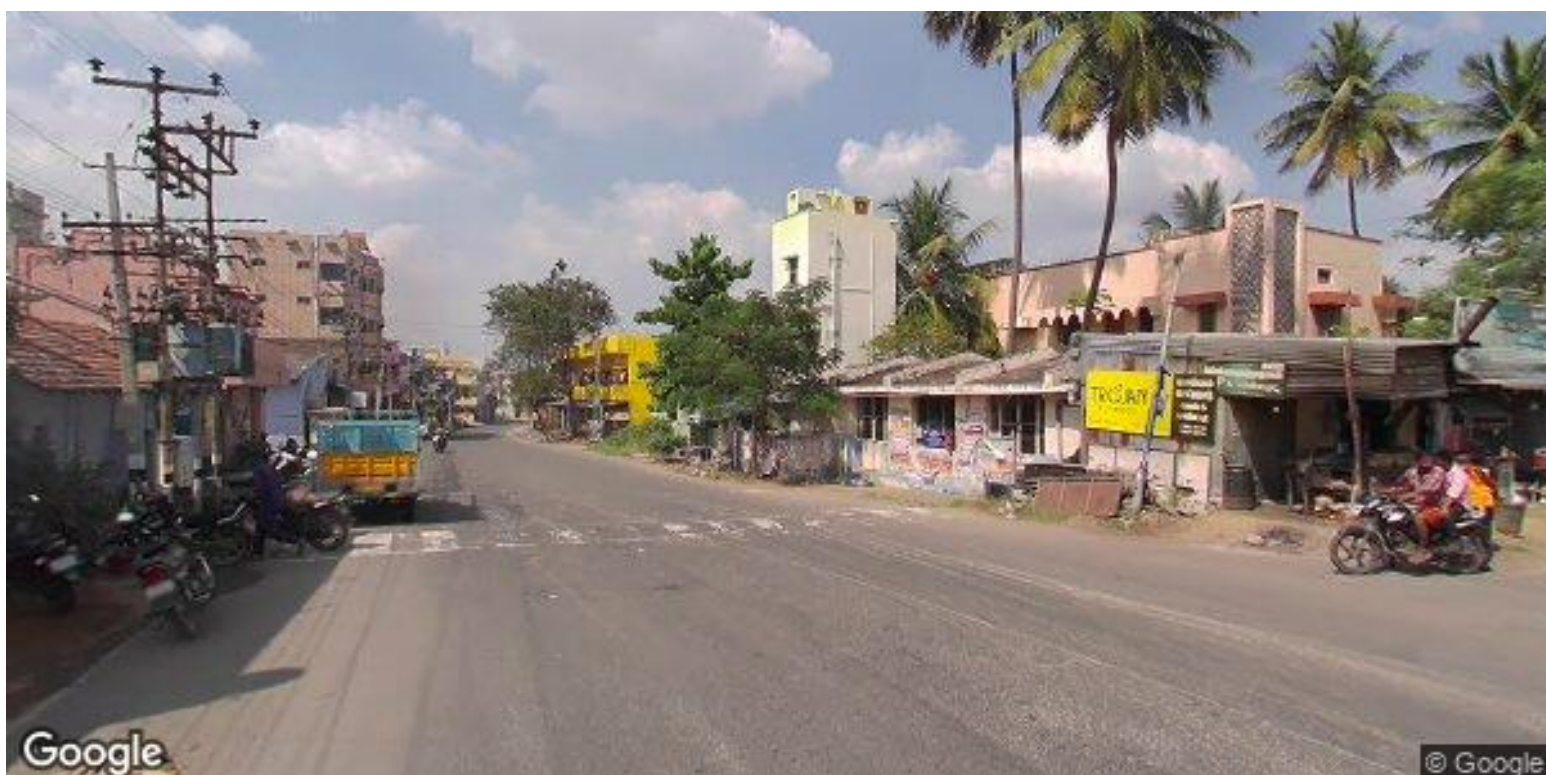
**Coordinates:** 11.38190, 77.90254

**Risk Type:** Turn

**Risk Level:** High

**Speed Limit:** 15 KM/Hr

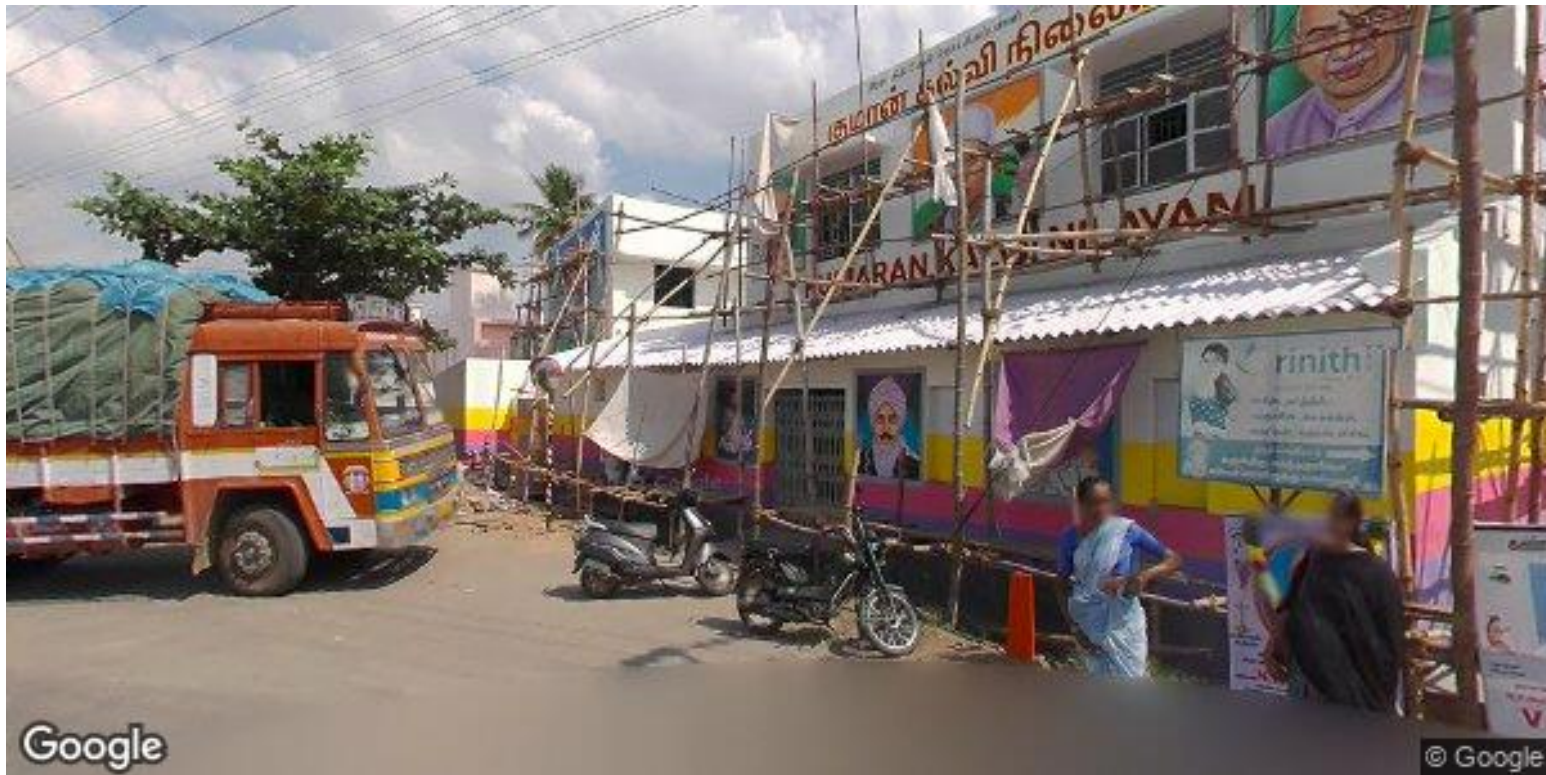
**Coordinates:** 11.38182, 77.90259

**Risk Type:** Turn

**Risk Level:** Medium

**Speed Limit:** 30 KM/Hr

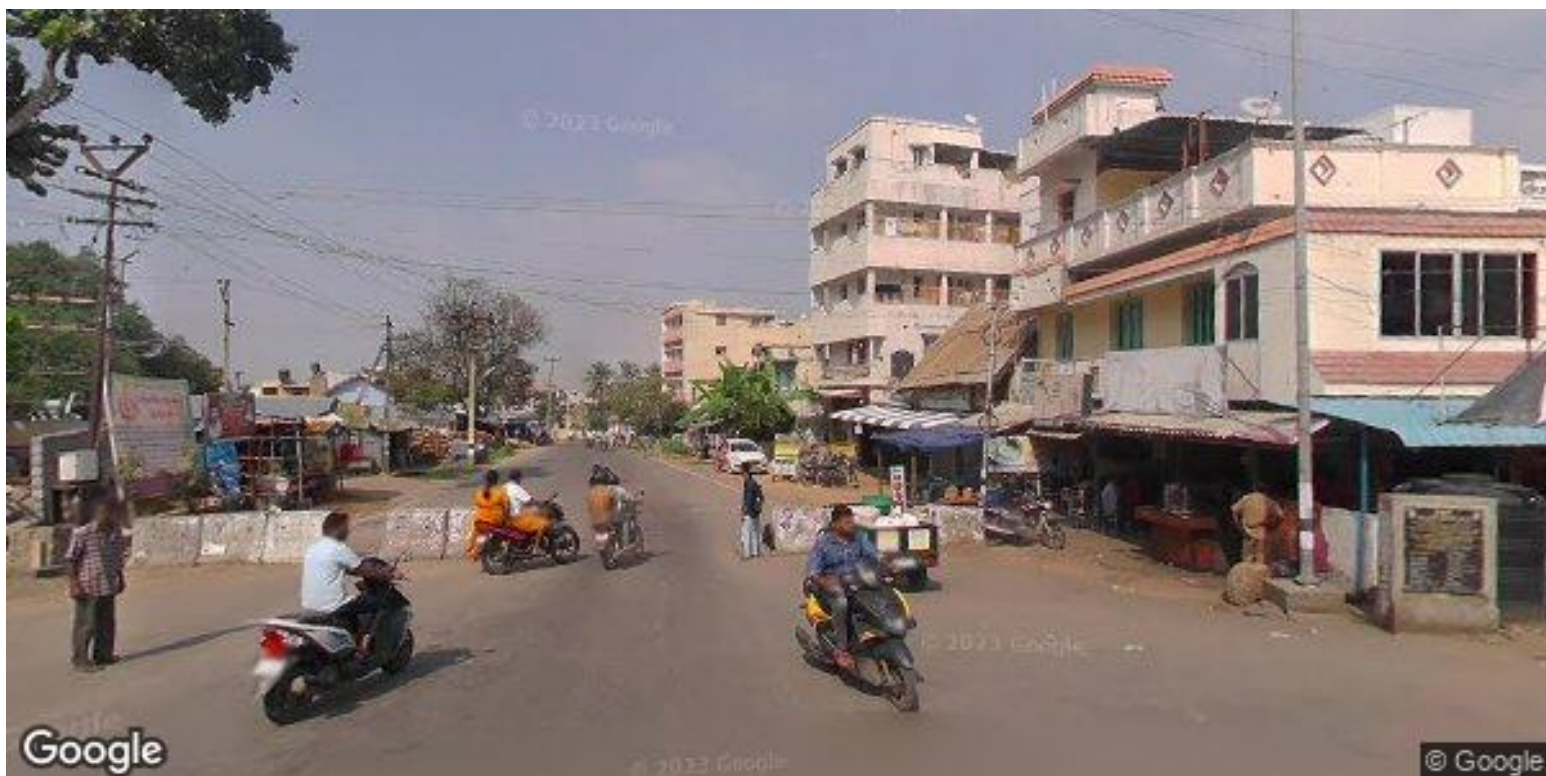
**Coordinates:** 11.37841, 77.90140

**Risk Type:** Blind Spot

**Risk Level:** Blind Spot

**Speed Limit:** 10 KM/Hr

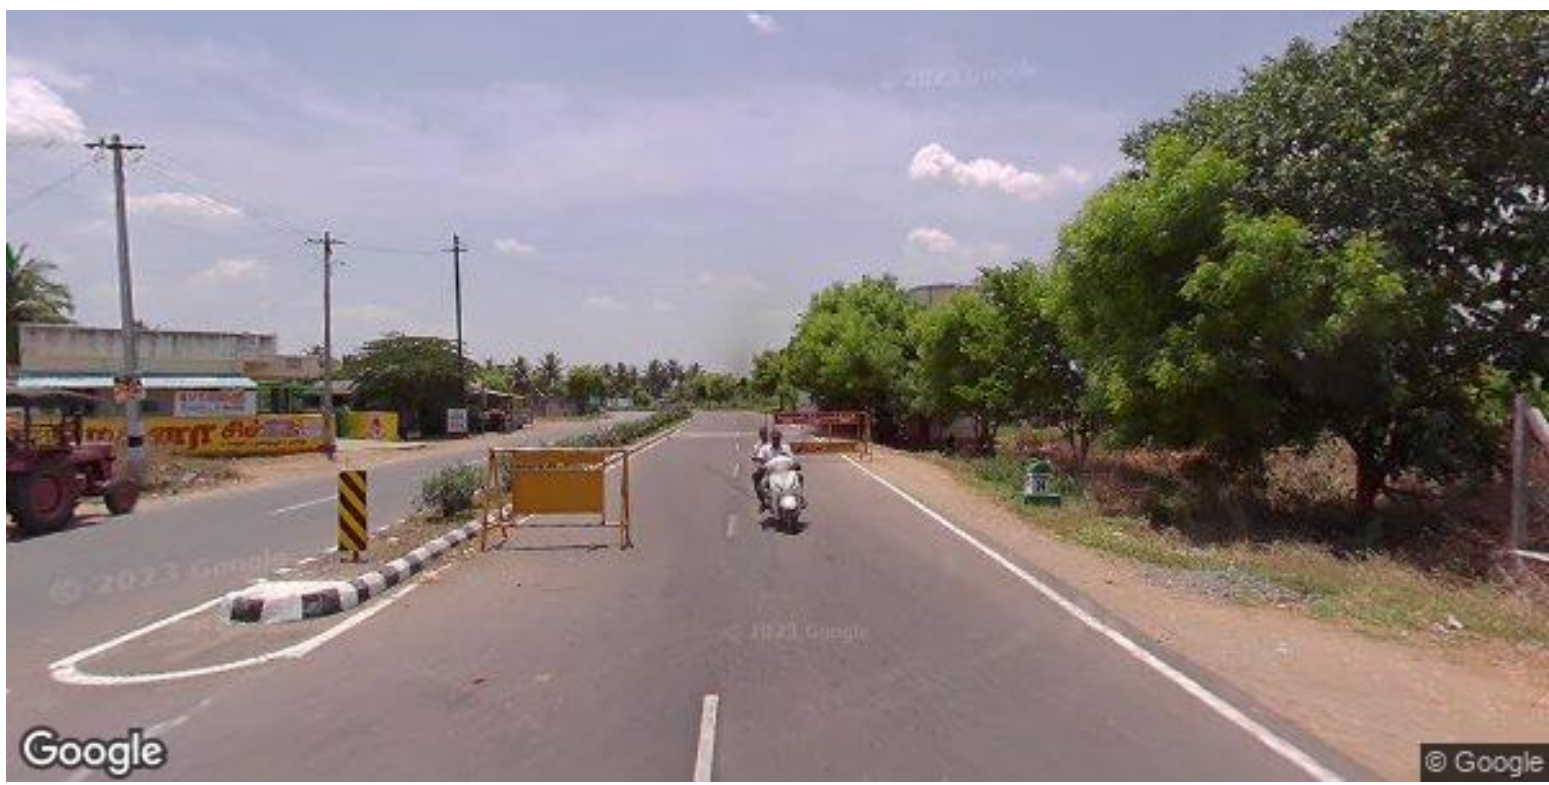
**Coordinates:** 11.27732, 78.08017

**Risk Type:** Turn

**Risk Level:** High

**Speed Limit:** 15 KM/Hr
