# IndianOil

## JOURNEY RISK MANAGEMENT (JRM) STUDY

### Salem Terminal TO SHRI SHANMUGA ENTERPRISES

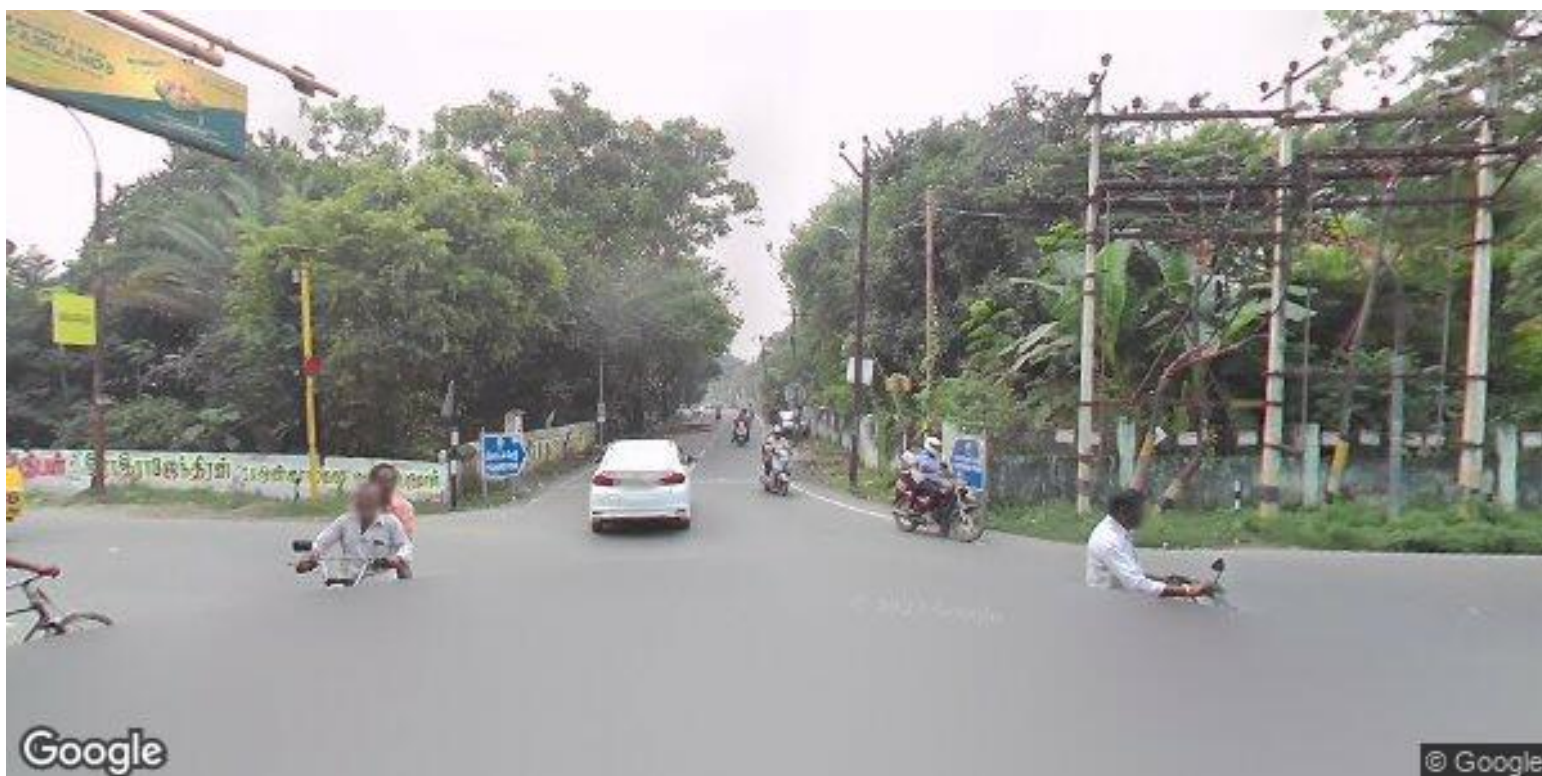
**Coordinates:** 11.6762303, 78.1575524

**Risk Type:** U-Turn

**Risk Level:** High

**Speed Limit:** 10 KM/Hr

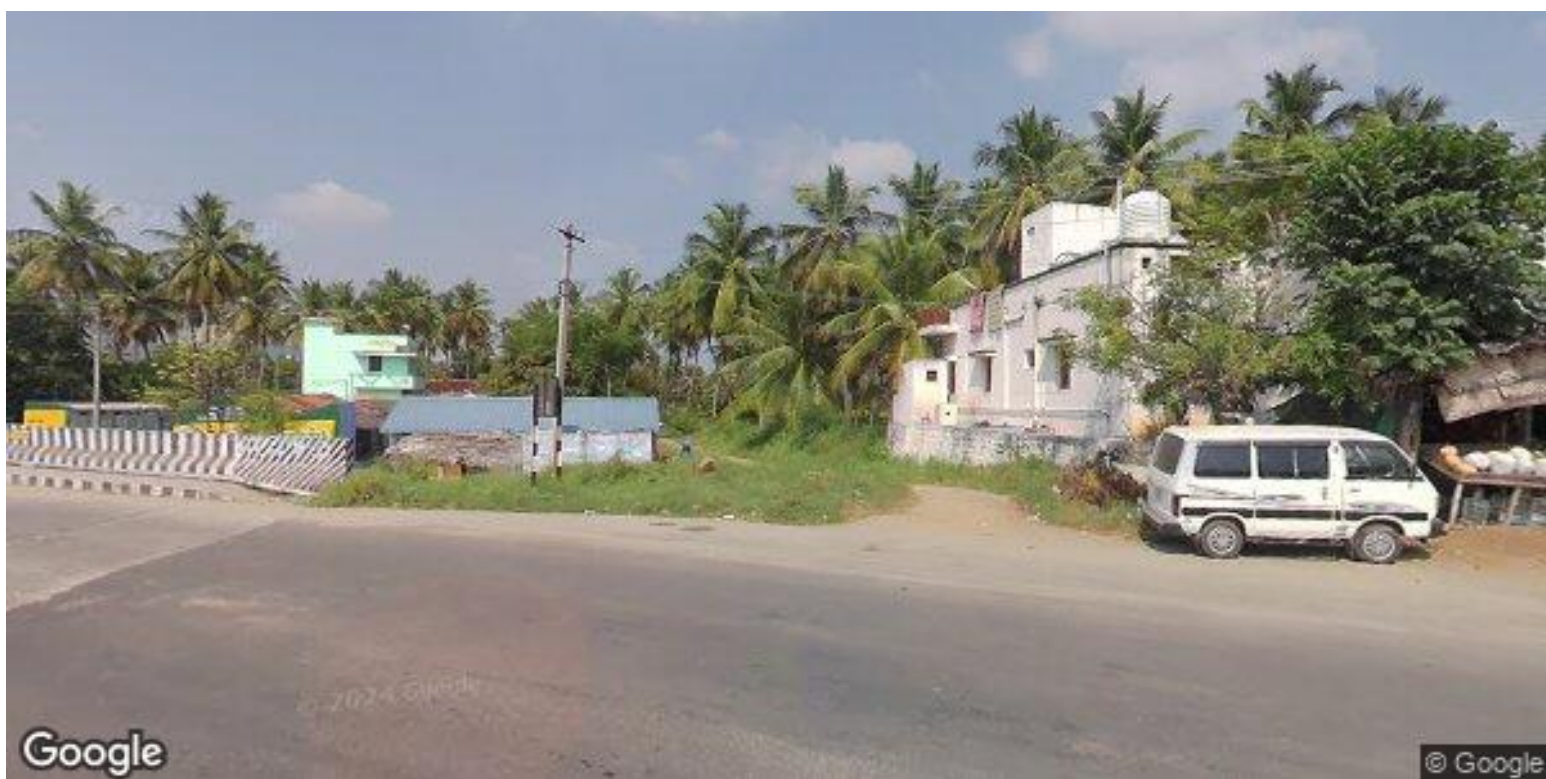
**Coordinates:** 11.44898, 77.87410

**Risk Type:** Turn

**Risk Level:** Medium

**Speed Limit:** 30 KM/Hr

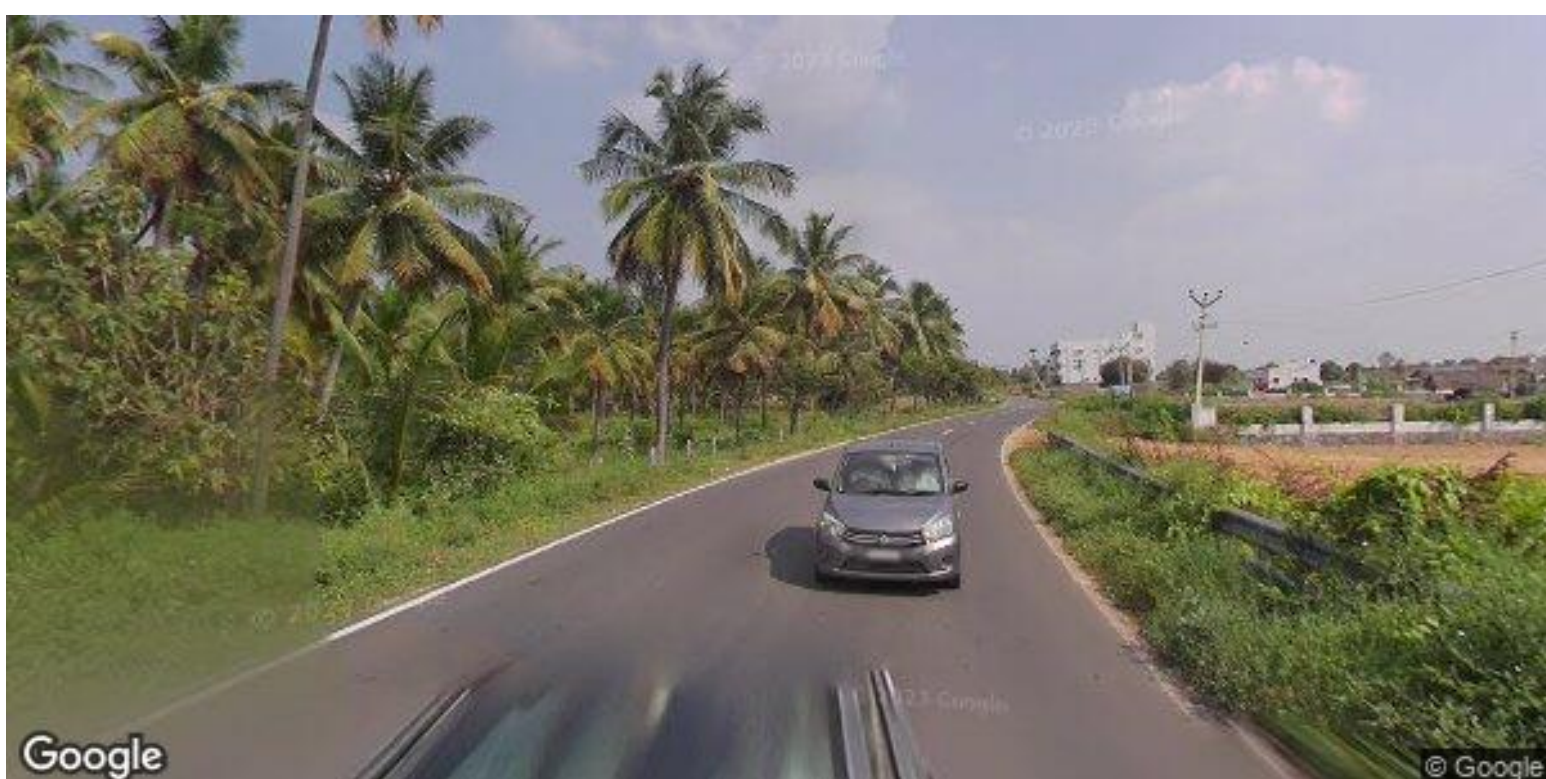
**Risk Type:** Turn  
**Risk Level:** Medium  
**Speed Limit:** 30 KM/Hr  
**Coordinates:** 11.45357, 77.85789

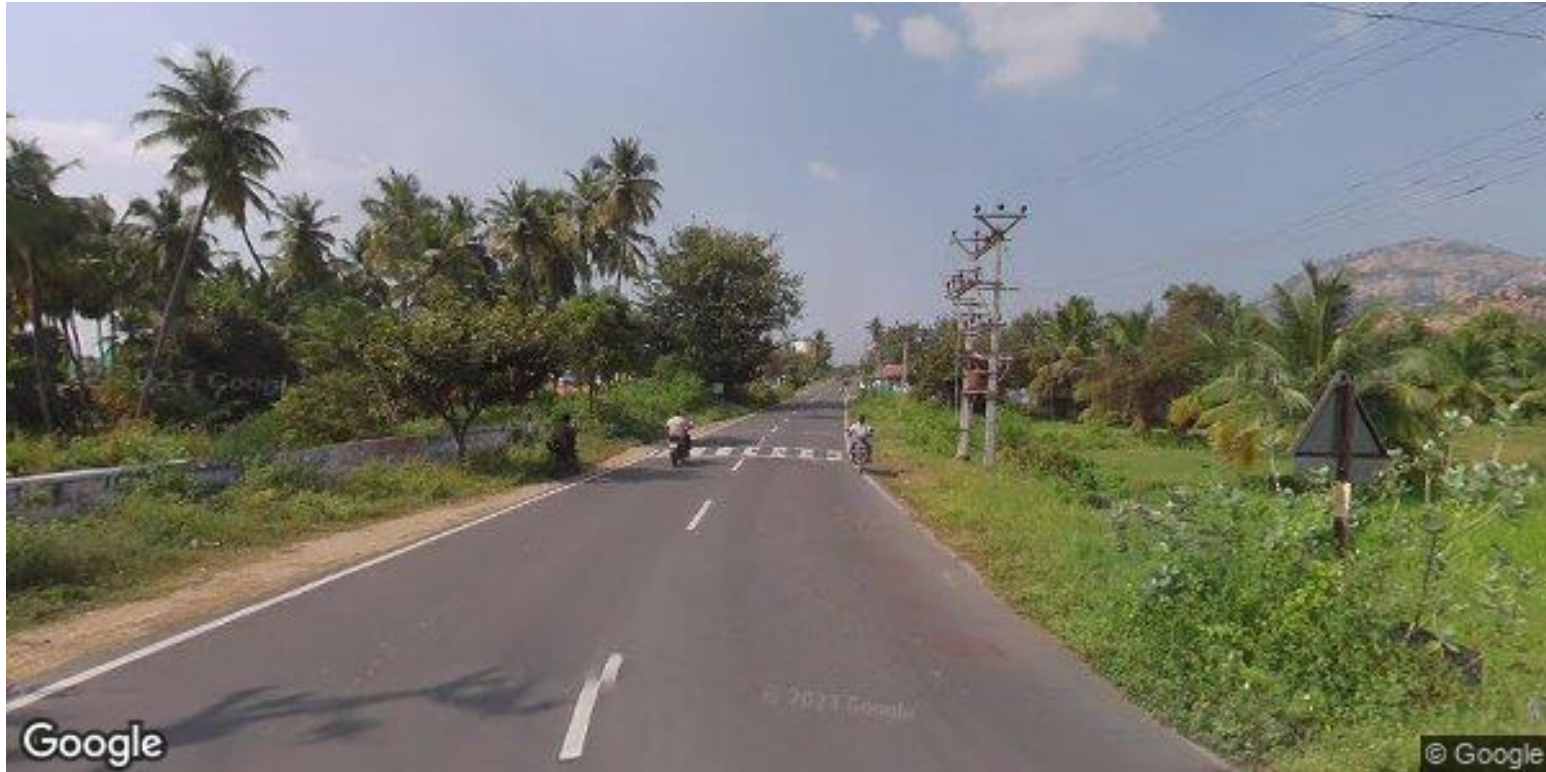
**Risk Type:** Turn  
**Risk Level:** Medium  
**Speed Limit:** 30 KM/Hr  
**Coordinates:** 11.45352, 77.85698

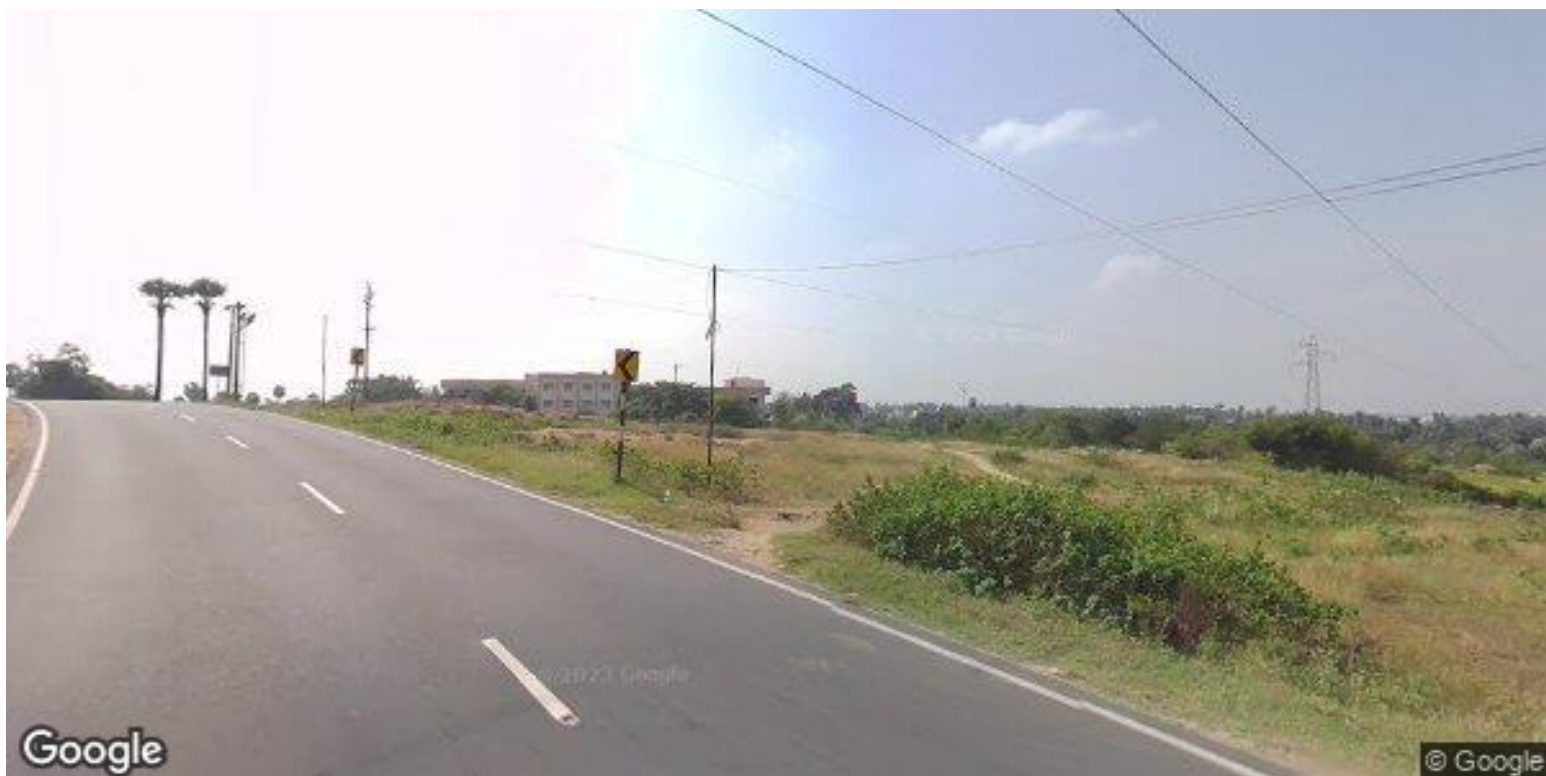
**Risk Type:** Turn  
**Risk Level:** Medium  
**Speed Limit:** 30 KM/Hr  
**Coordinates:** 11.46048, 77.85036

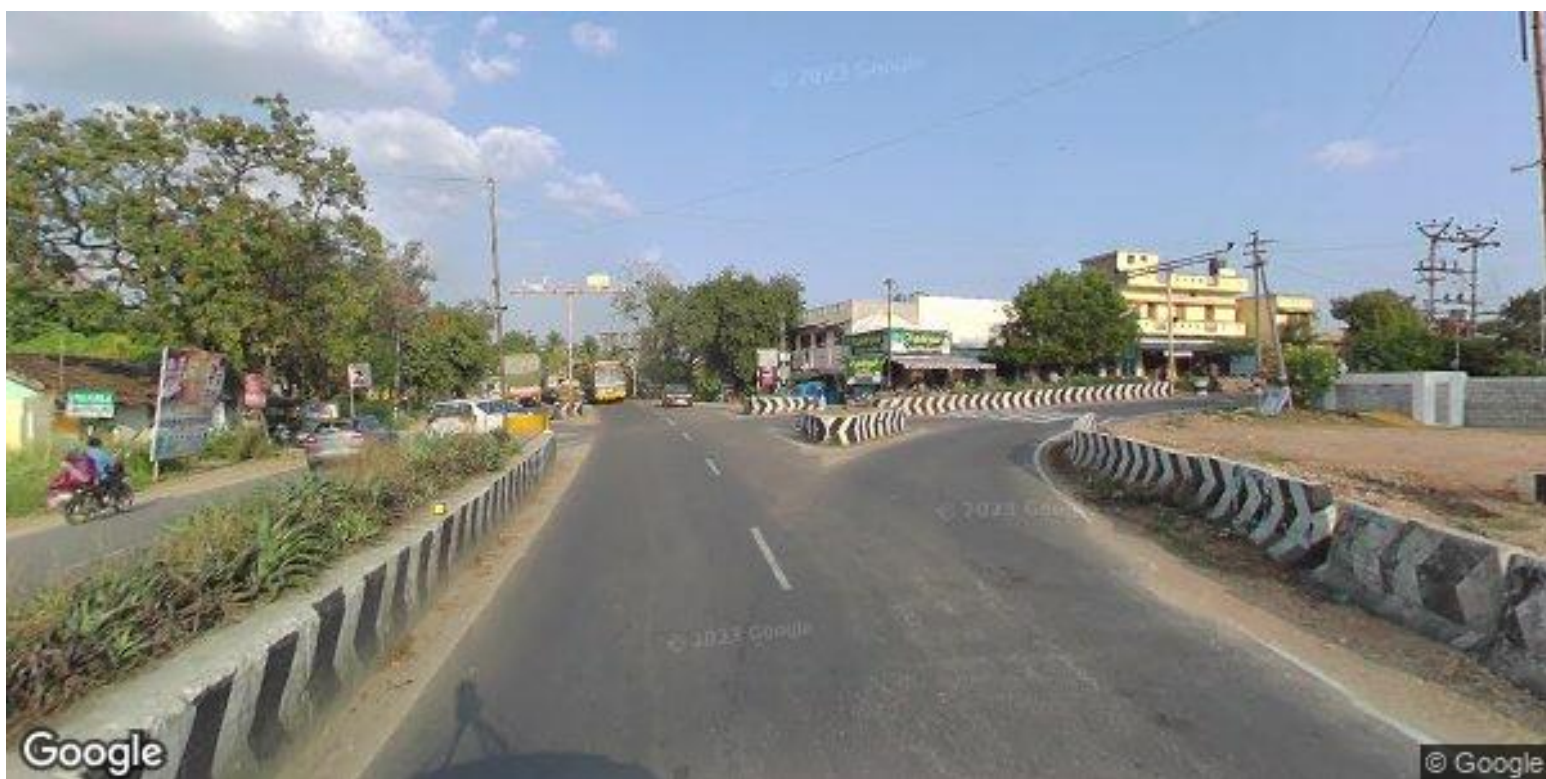
**Coordinates:** 11.46318, 77.84913

**Risk Type:** Turn

**Risk Level:** Medium

**Speed Limit:** 30 KM/Hr

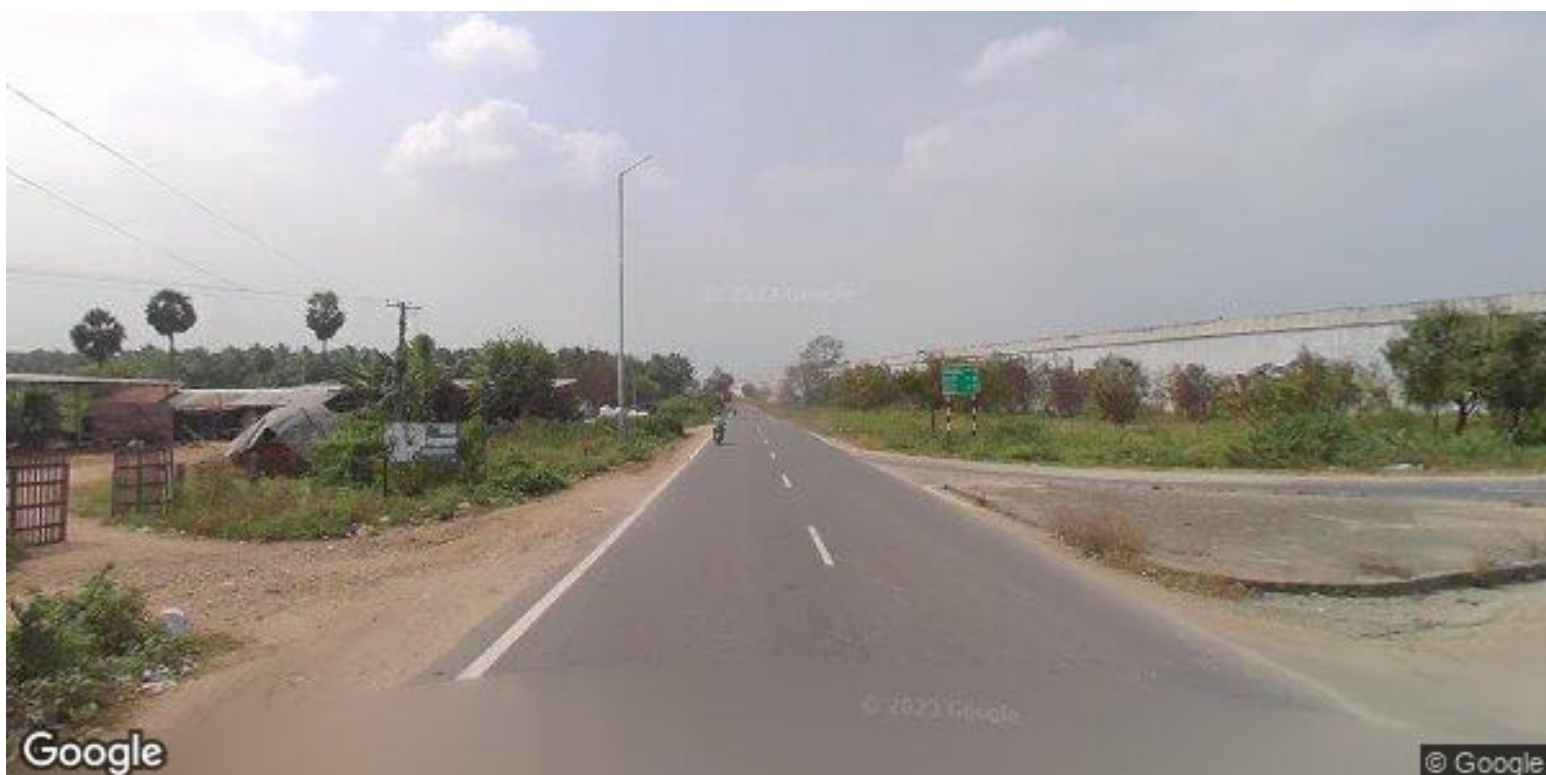
**Risk Type:** Turn  
**Risk Level:** High  
**Speed Limit:** 15 KM/Hr  
**Coordinates:** 11.45542, 77.81725

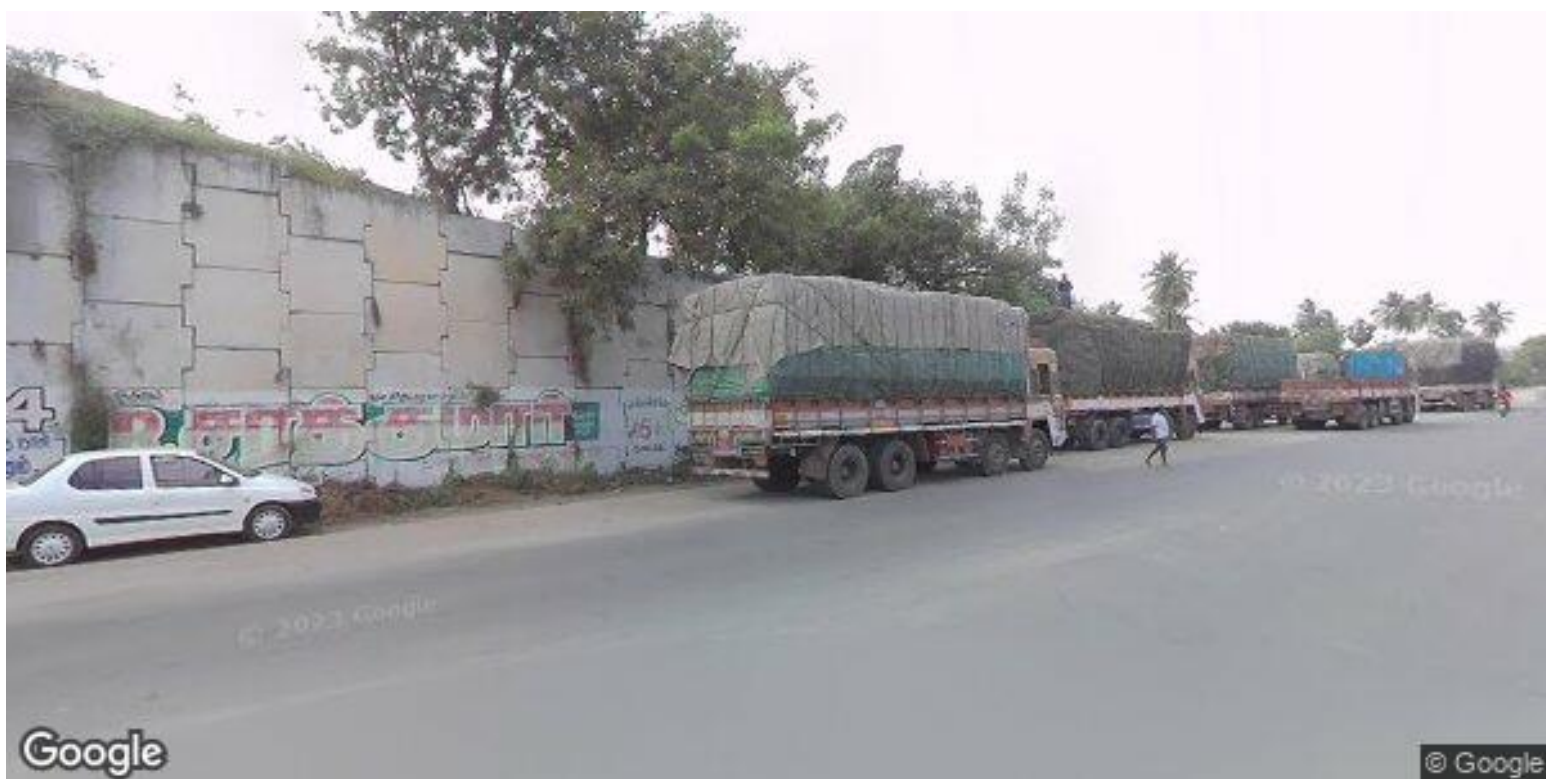
**Coordinates:** 11.49365, 77.88596

**Risk Type:** Turn

**Risk Level:** Medium

**Speed Limit:** 30 KM/Hr

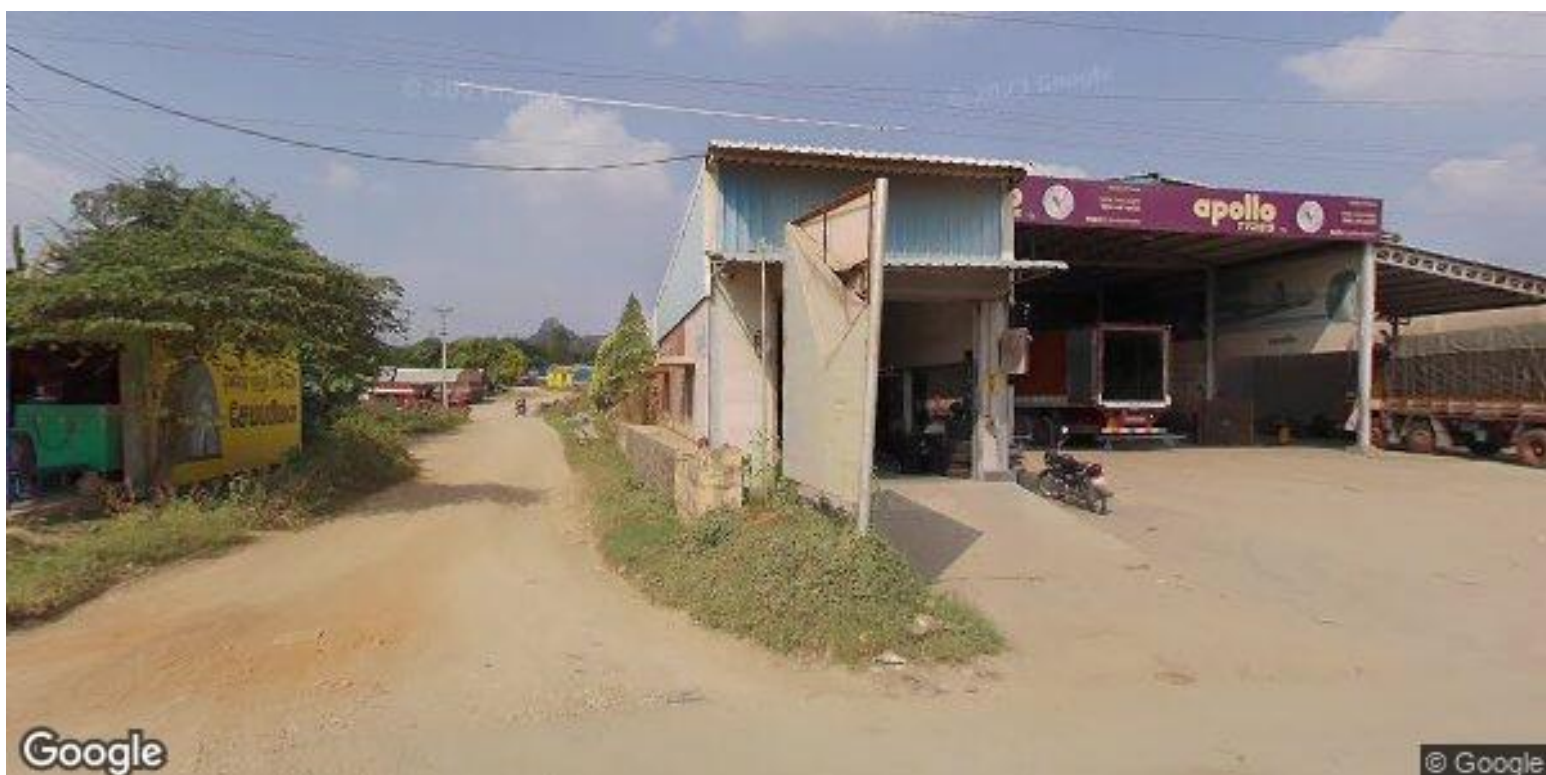
**Coordinates: 11.49235, 77.89561**

**Risk Type: Turn**

**Risk Level: High**

**Speed Limit: 15 KM/Hr**

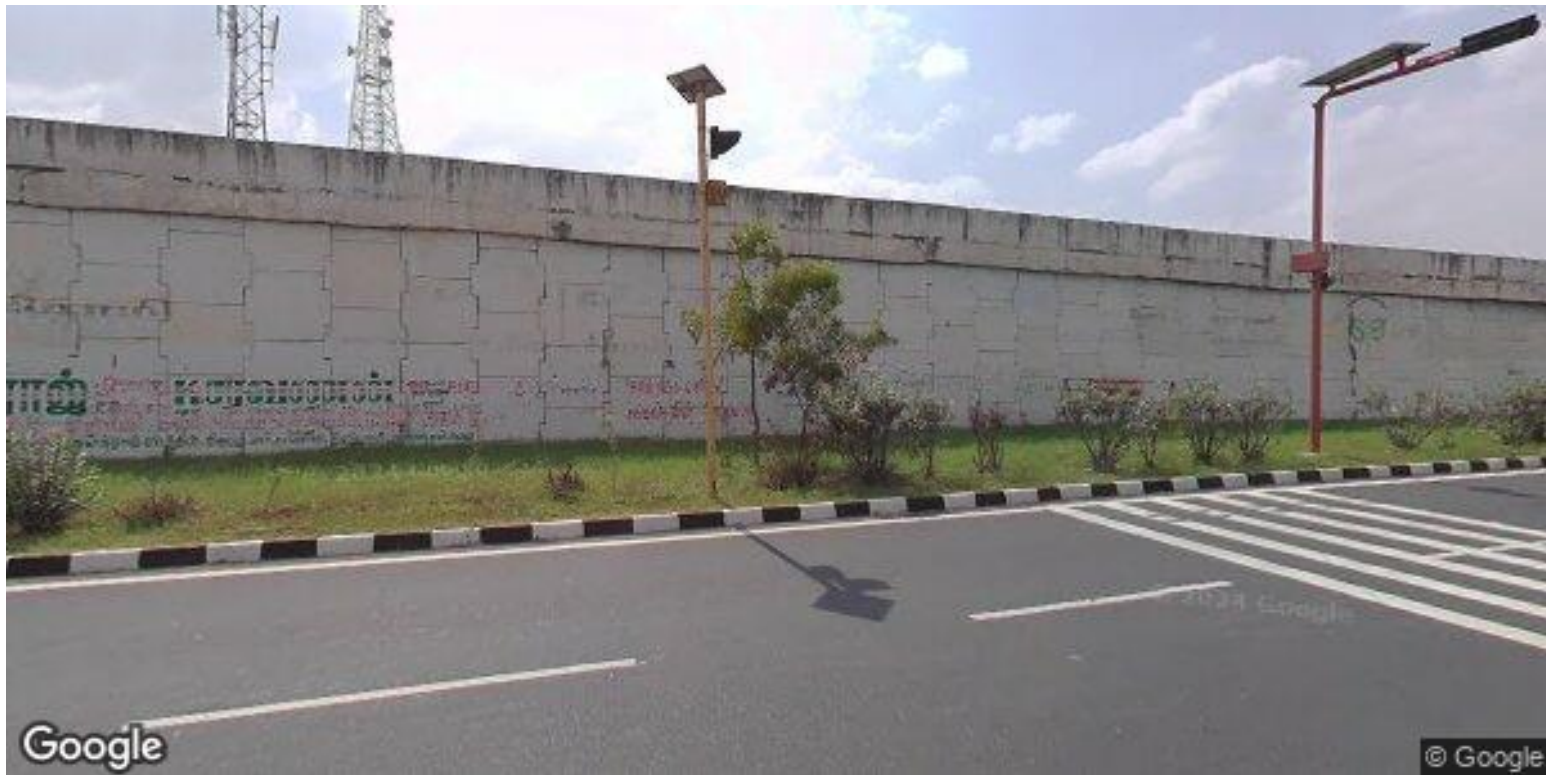
**Coordinates: 11.49225, 77.89560**

**Risk Type: Blind Spot**

**Risk Level: Blind Spot**

**Speed Limit: 10 KM/Hr**

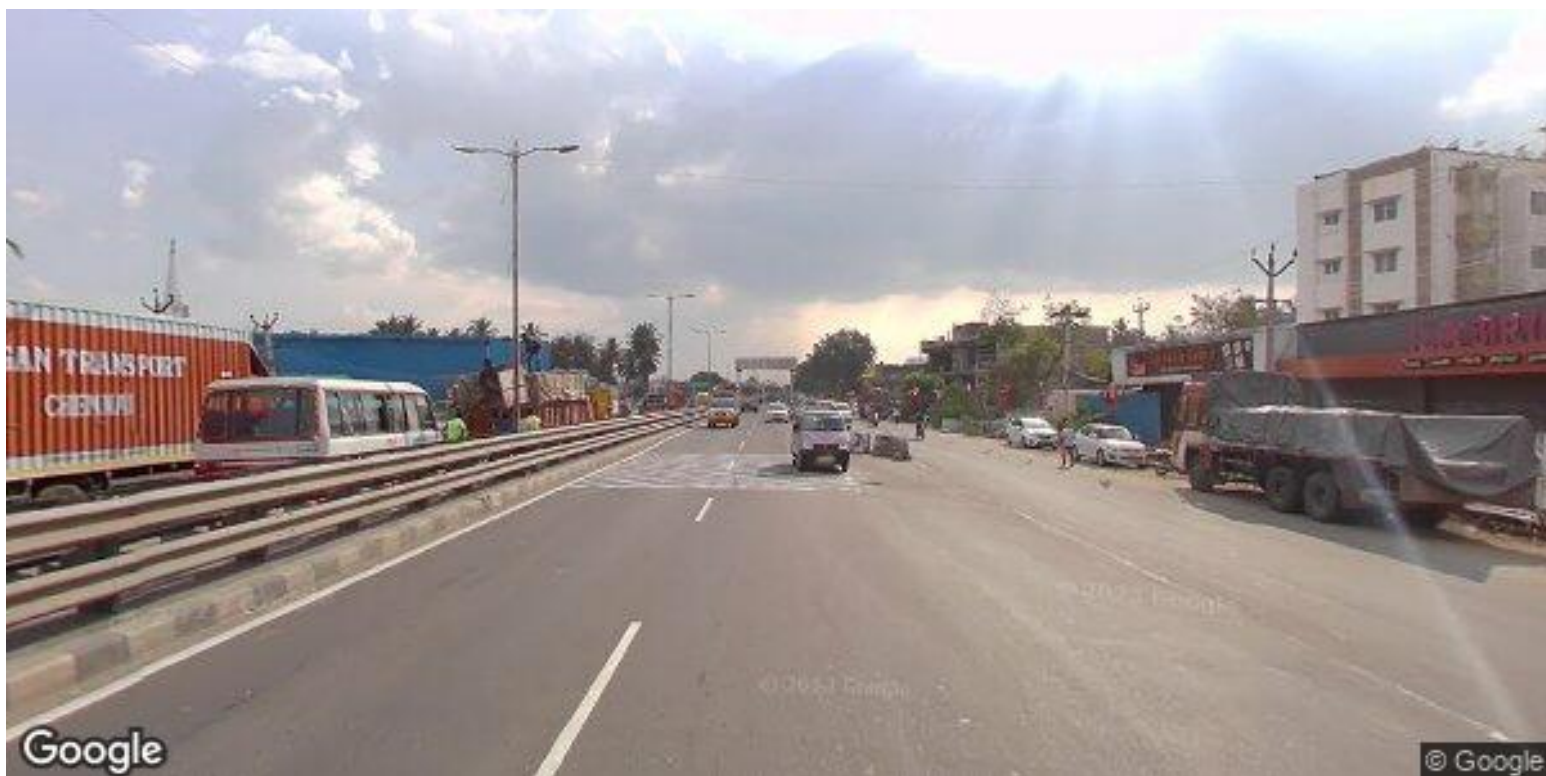
**Coordinates: 11.67074, 78.12668**

**Risk Type: Turn**

**Risk Level: High**

**Speed Limit: 15 KM/Hr**

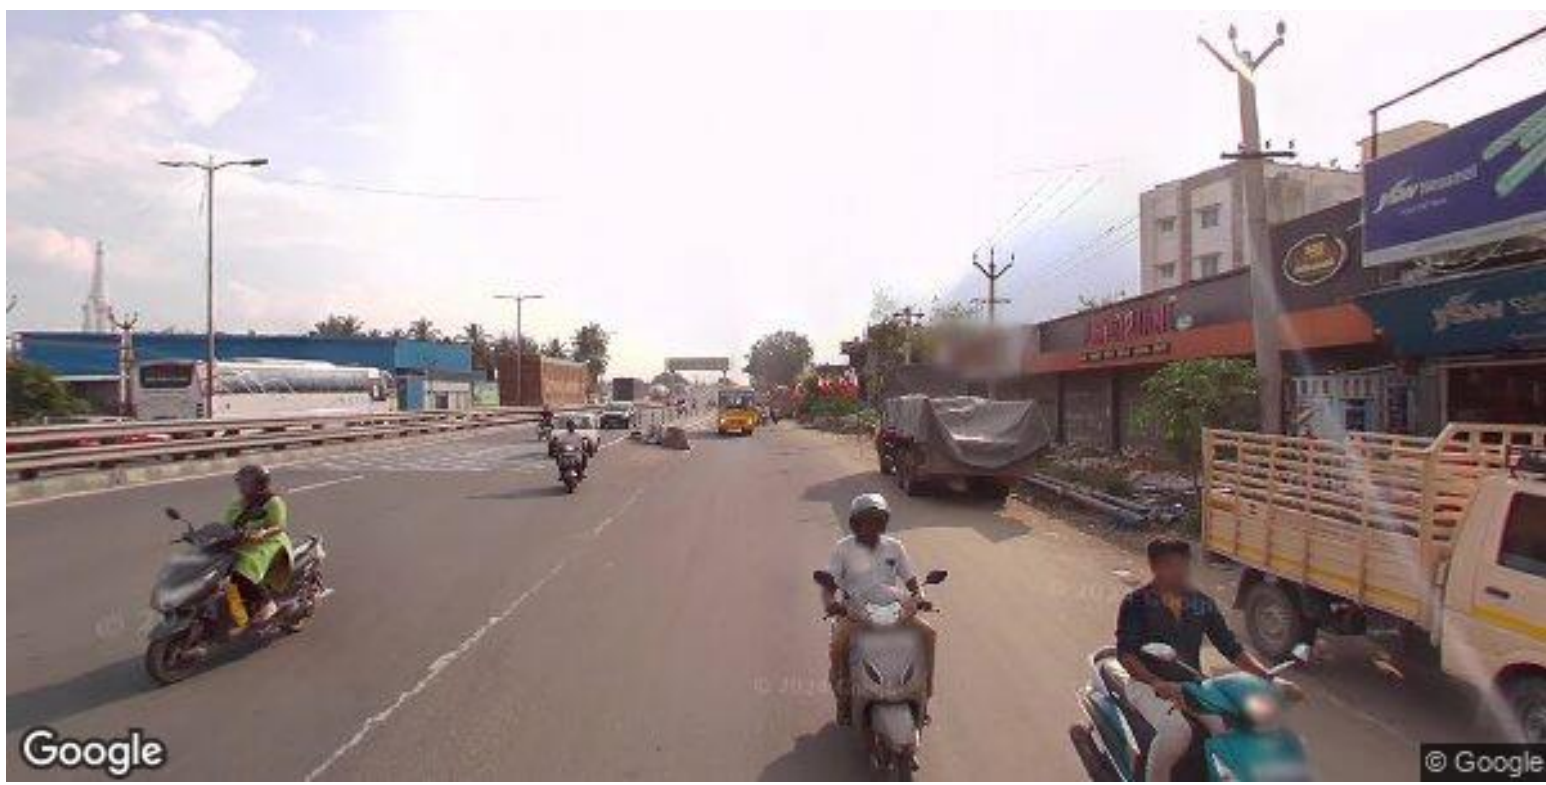
**Coordinates:** 11.67081, 78.12661

**Risk Type:** Turn

**Risk Level:** High

**Speed Limit:** 15 KM/Hr

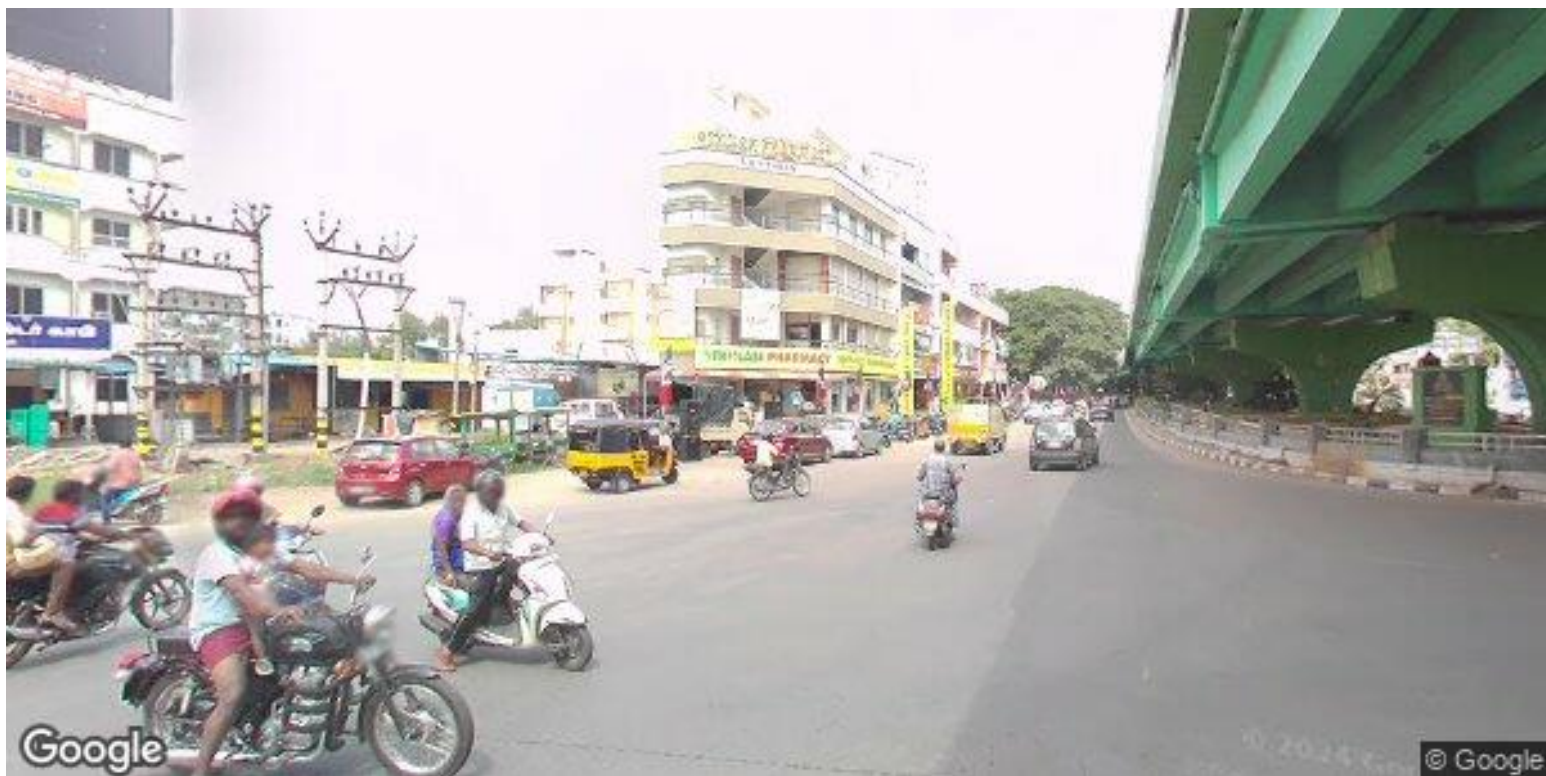
**Coordinates:** 11.67582, 78.12786

**Risk Type:** Turn

**Risk Level:** High

**Speed Limit:** 15 KM/Hr

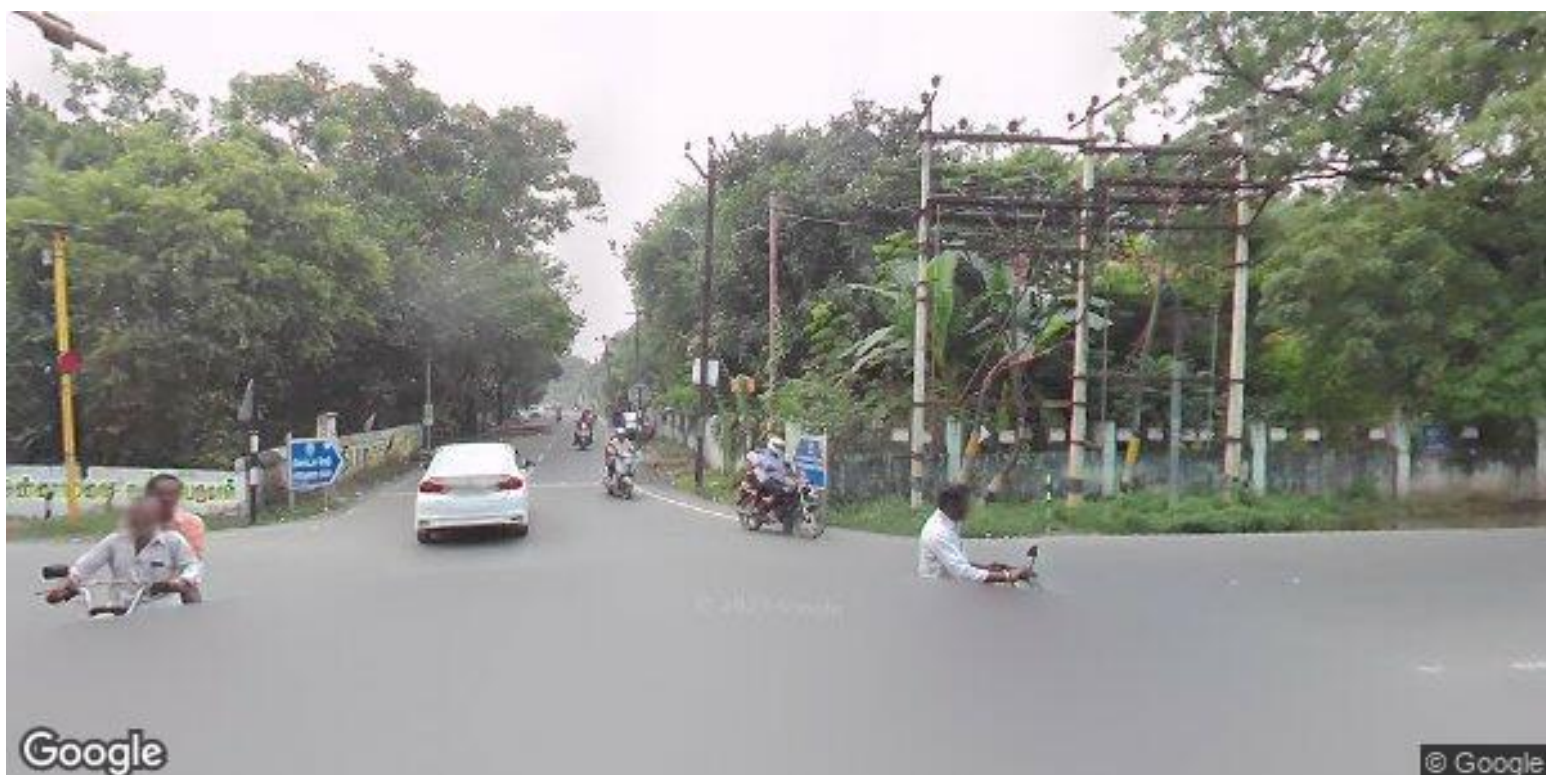
**Coordinates: 11.67623, 78.15755**

**Risk Type: Turn**

**Risk Level: High**

**Speed Limit: 15 KM/Hr**

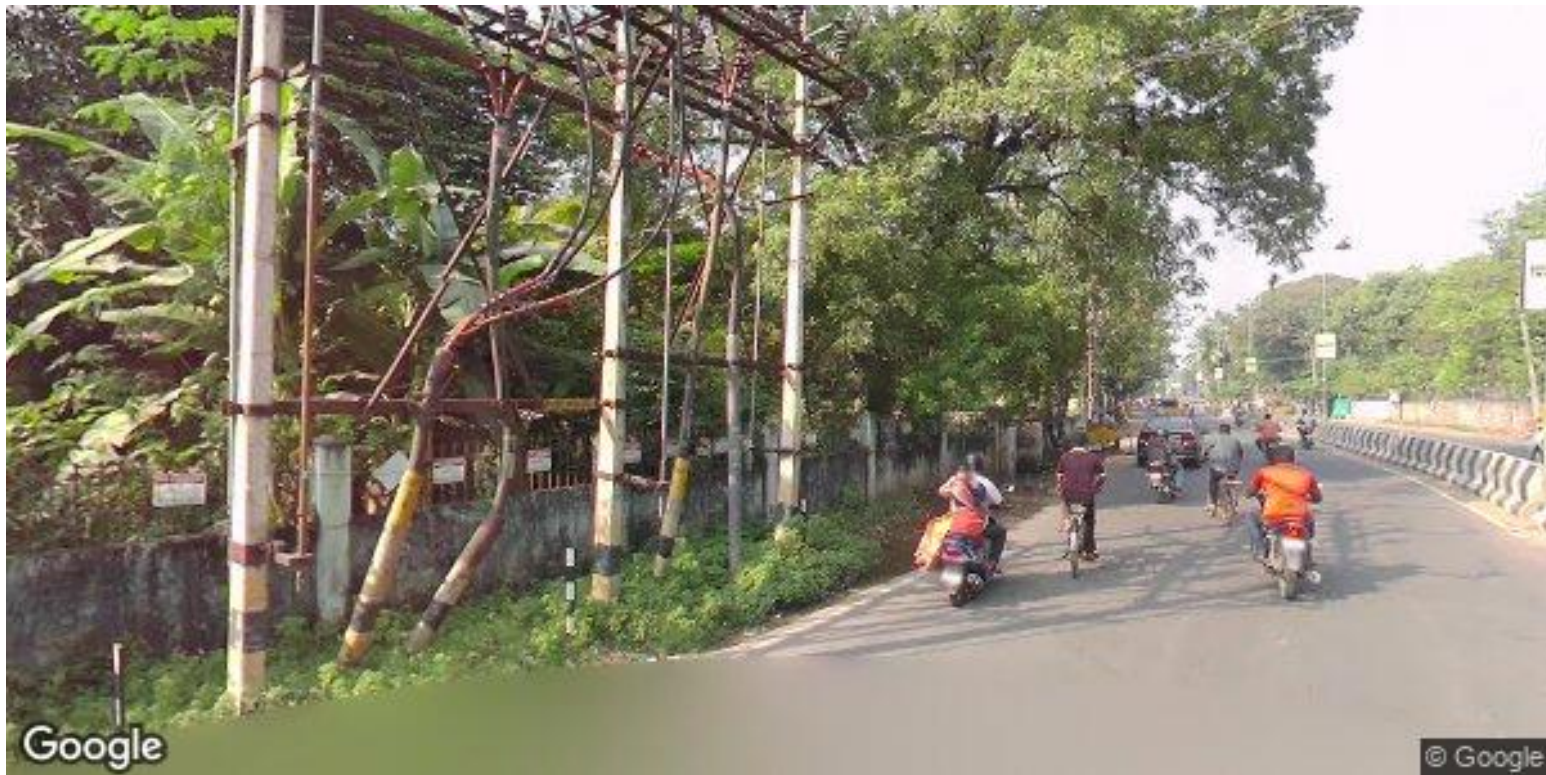
**Coordinates: 11.67615, 78.15756**

**Risk Type: Blind Spot**

**Risk Level: Blind Spot**

**Speed Limit: 10 KM/Hr**

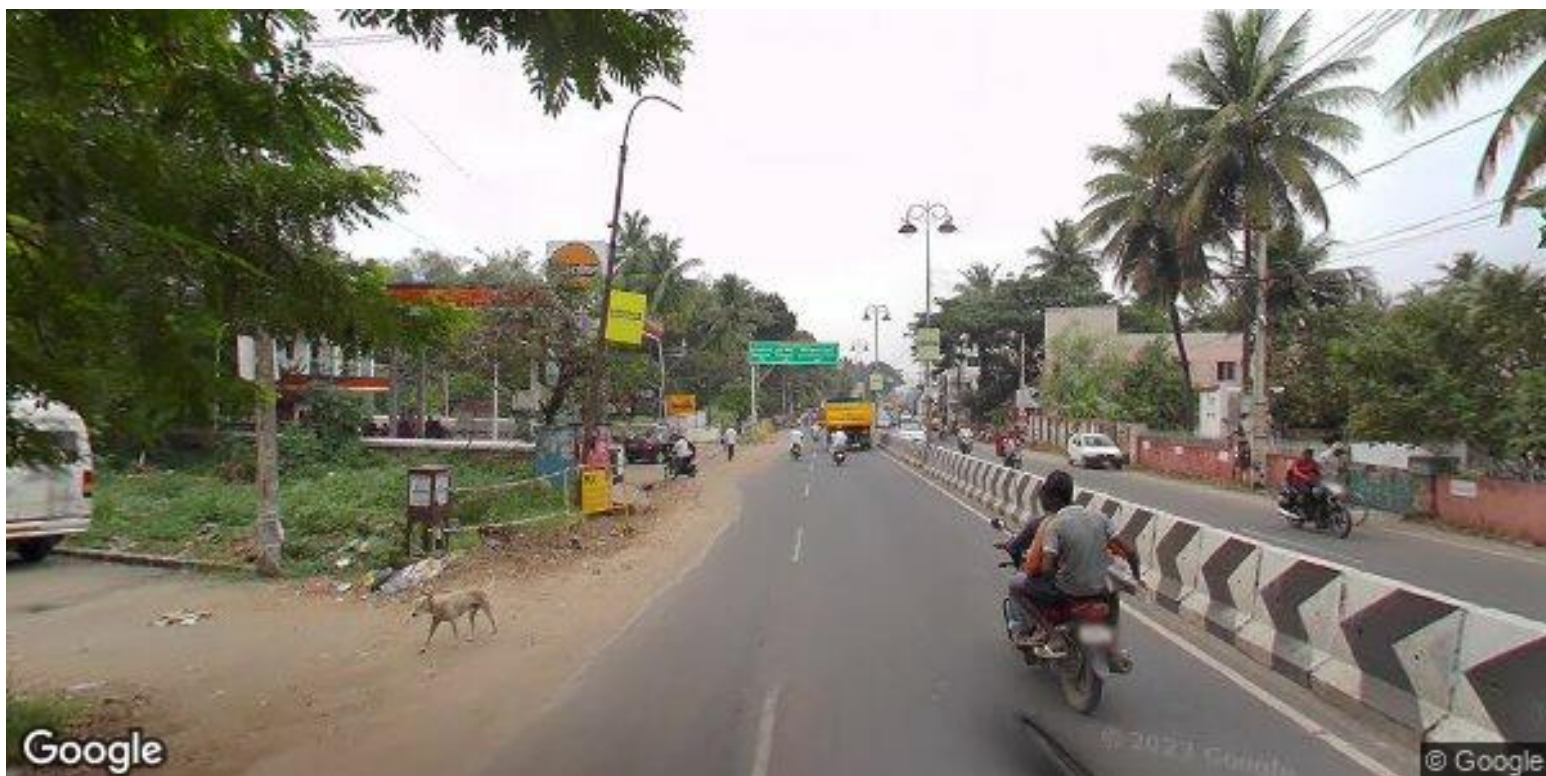
**Coordinates: 11.67603, 78.15558**

**Risk Type: Turn**

**Risk Level: High**

**Speed Limit: 15 KM/Hr**
