# IndianOil

## JOURNEY RISK MANAGEMENT (JRM) STUDY

### Salem Terminal TO JAI MARUTHI TRADERS

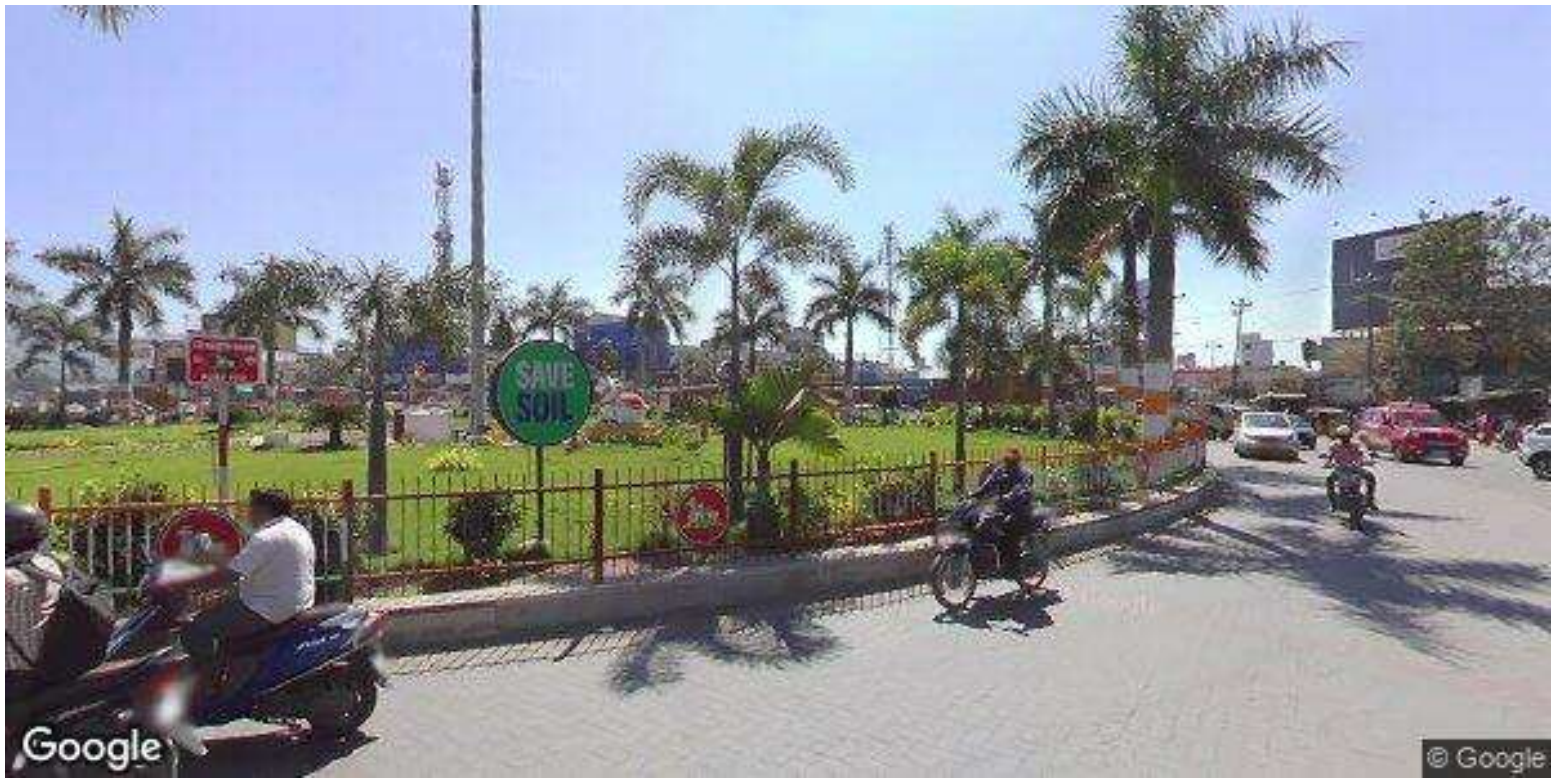
Coordinates: 11.63303, 78.12713

Risk Type: Roundabout

Risk Level: High

Speed Limit: 15 KM/Hr

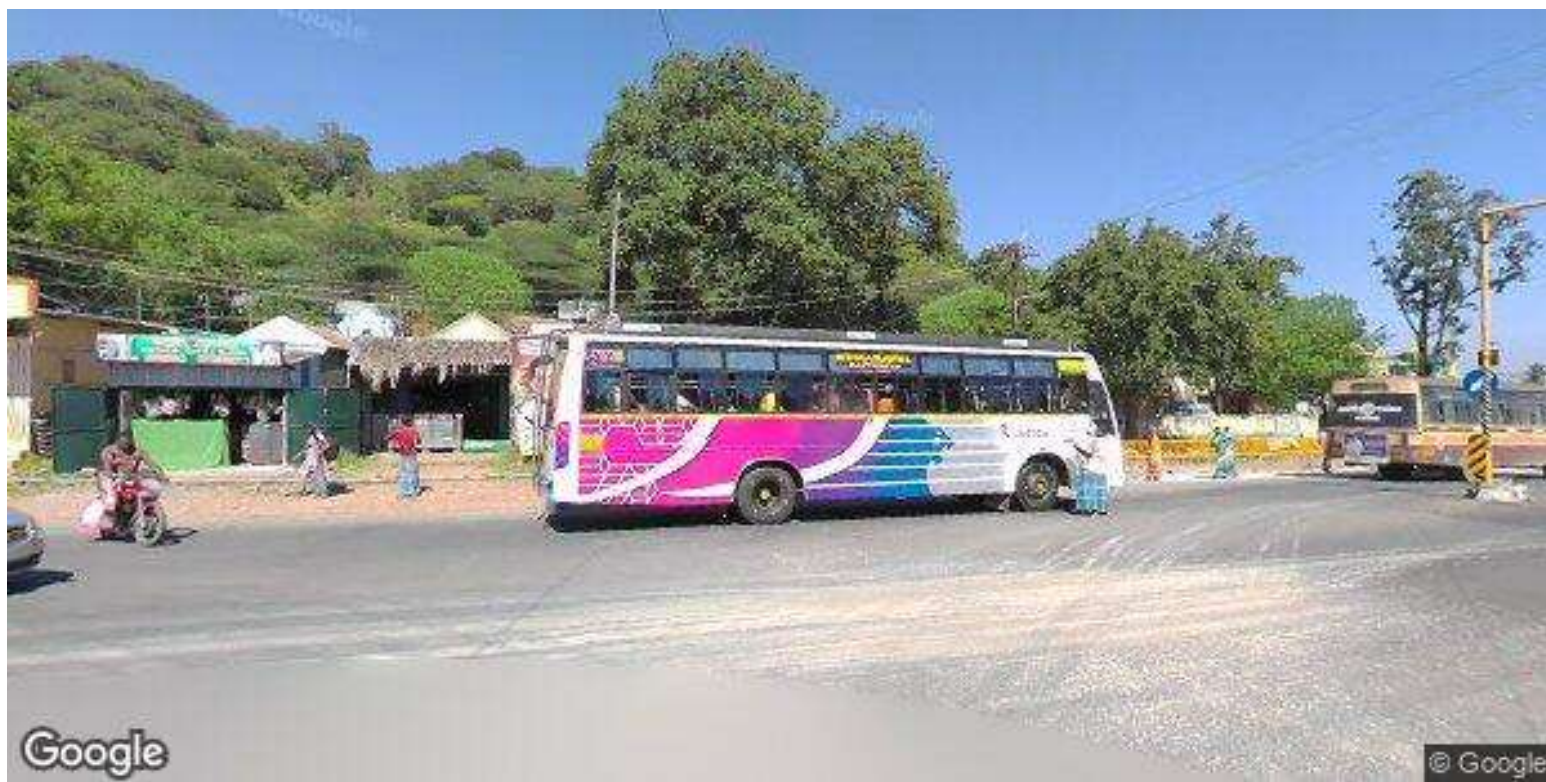
**Coordinates: 11.5709952, 78.4994313**

**Risk Type: U-Turn**

**Risk Level: High**

**Speed Limit: 10 KM/Hr**

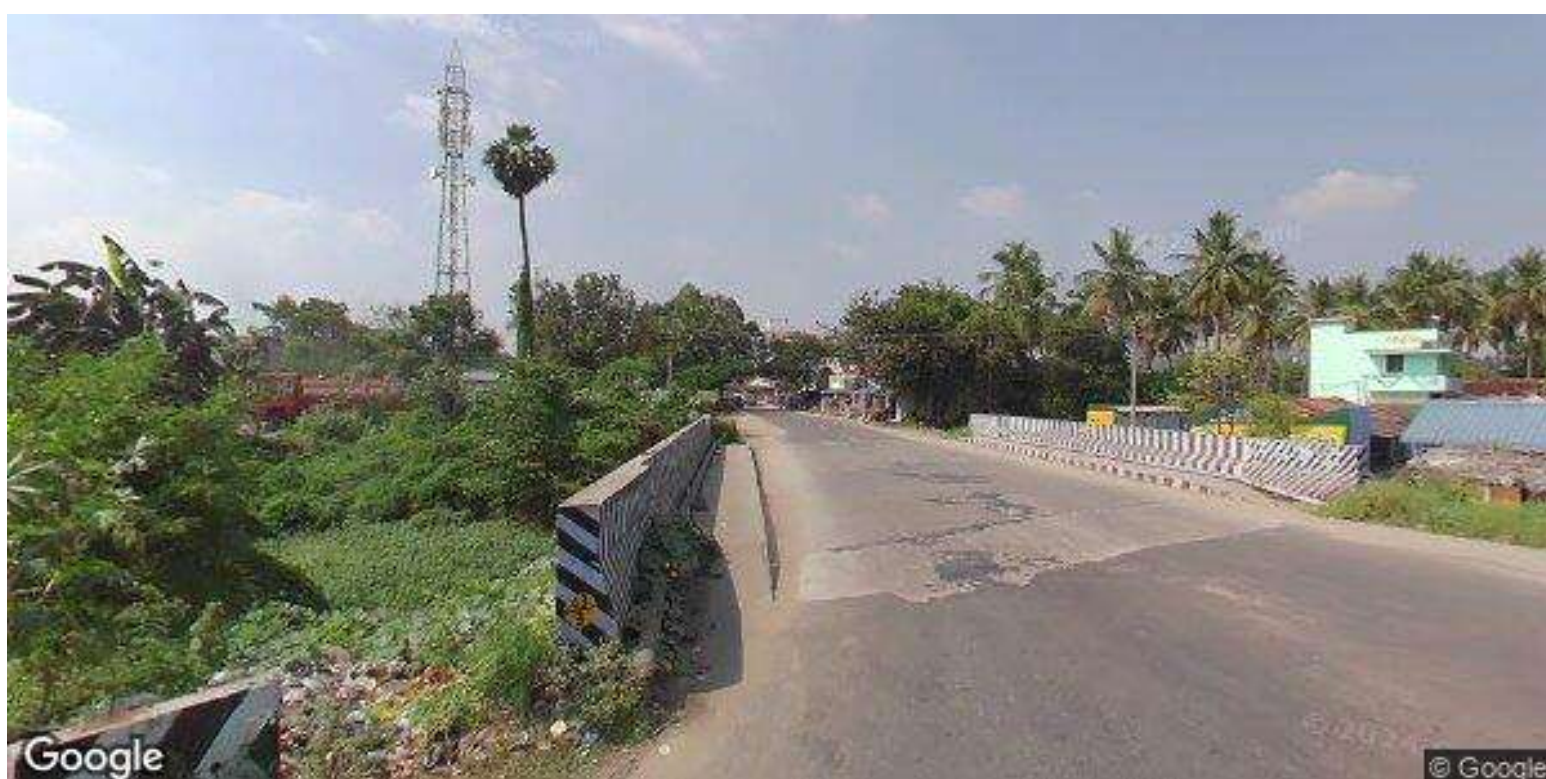
Coordinates: 11.44900, 77.87406

Risk Type: Turn

Risk Level: Medium

Speed Limit: 30 KM/Hr

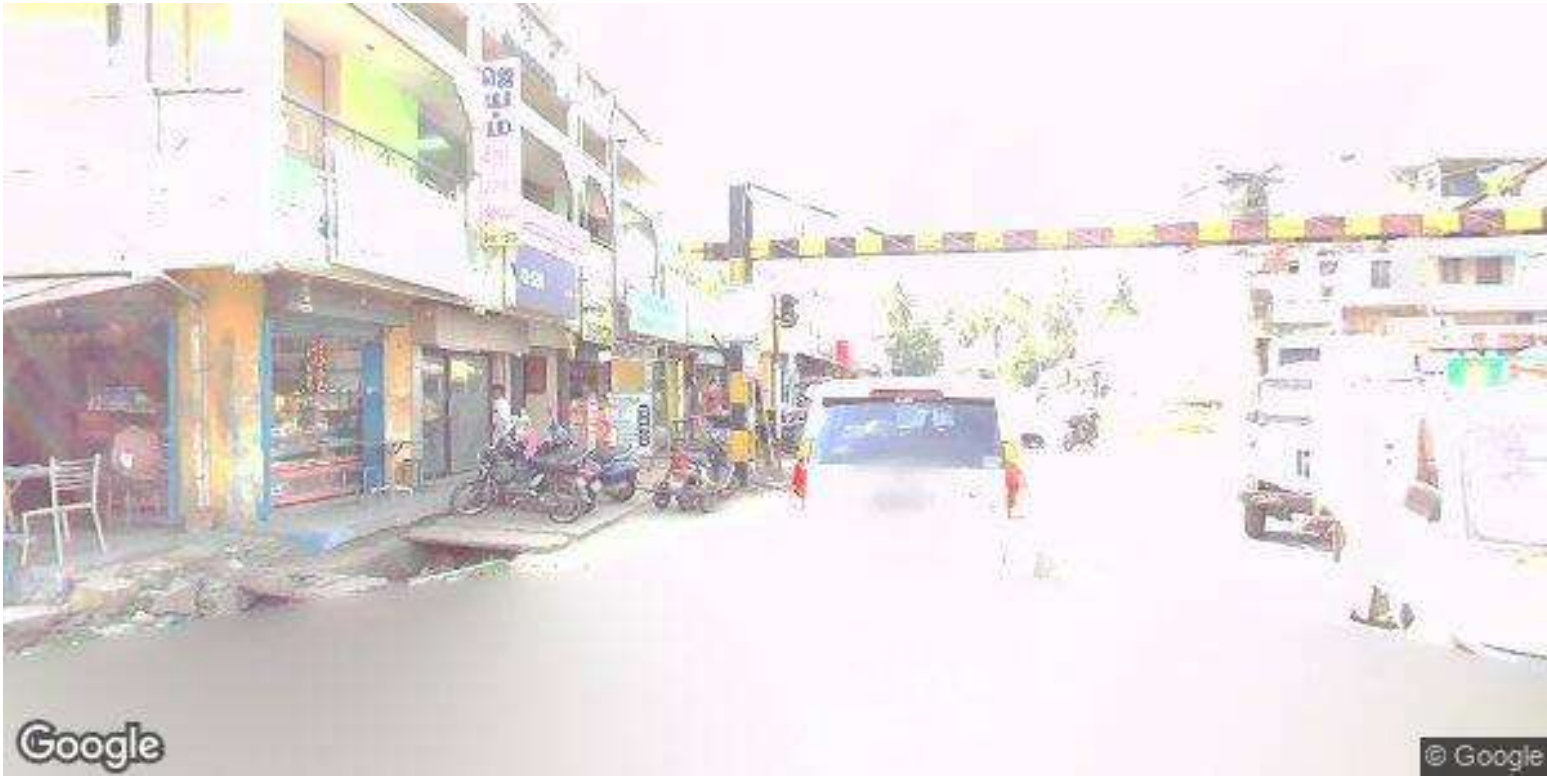
Coordinates: 11.45000, 77.87213

Risk Type: Turn

Risk Level: Medium

Speed Limit: 30 KM/Hr

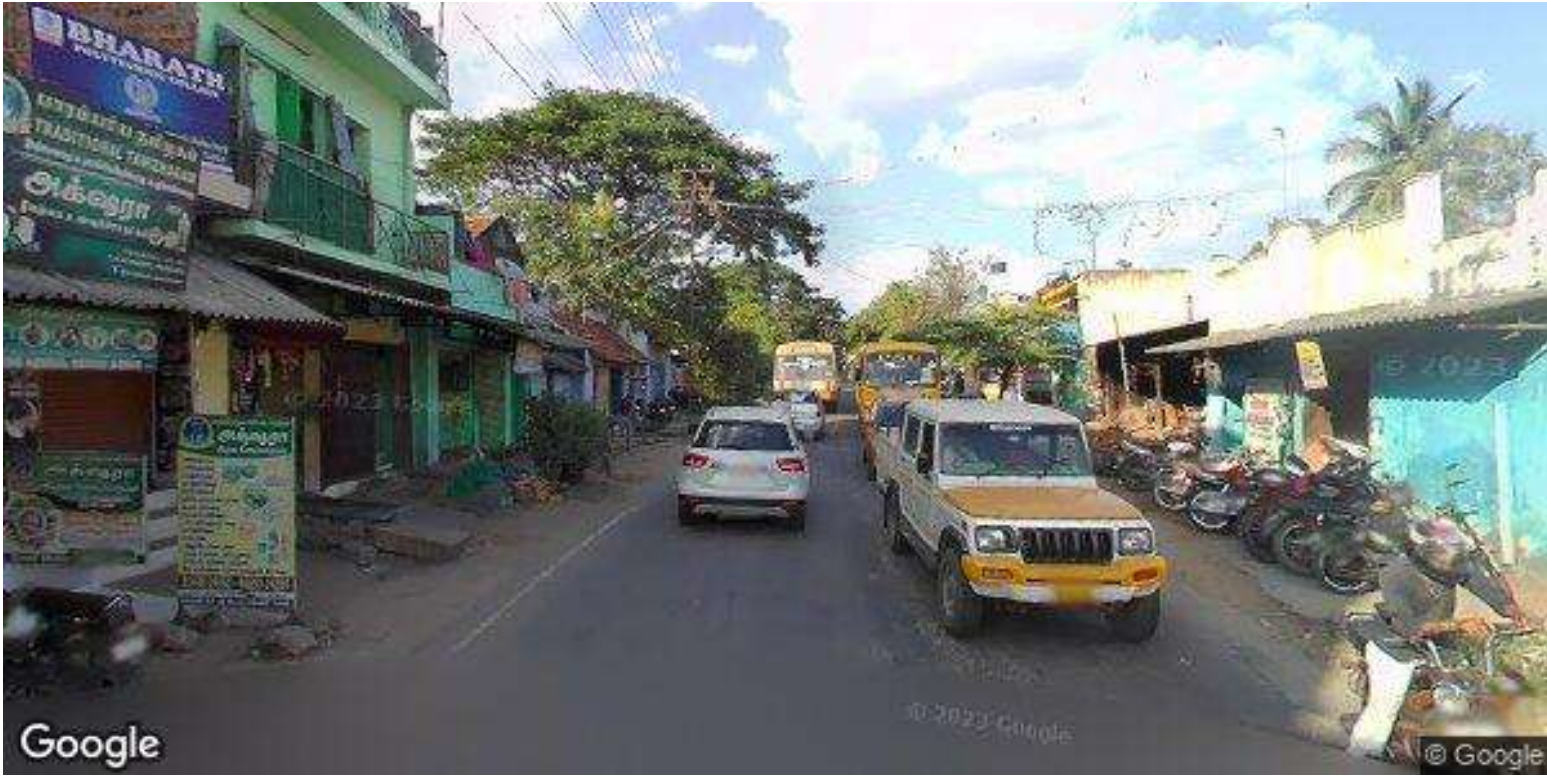
Coordinates: 11.45028, 77.87202

Risk Type: Turn

Risk Level: High

Speed Limit: 15 KM/Hr

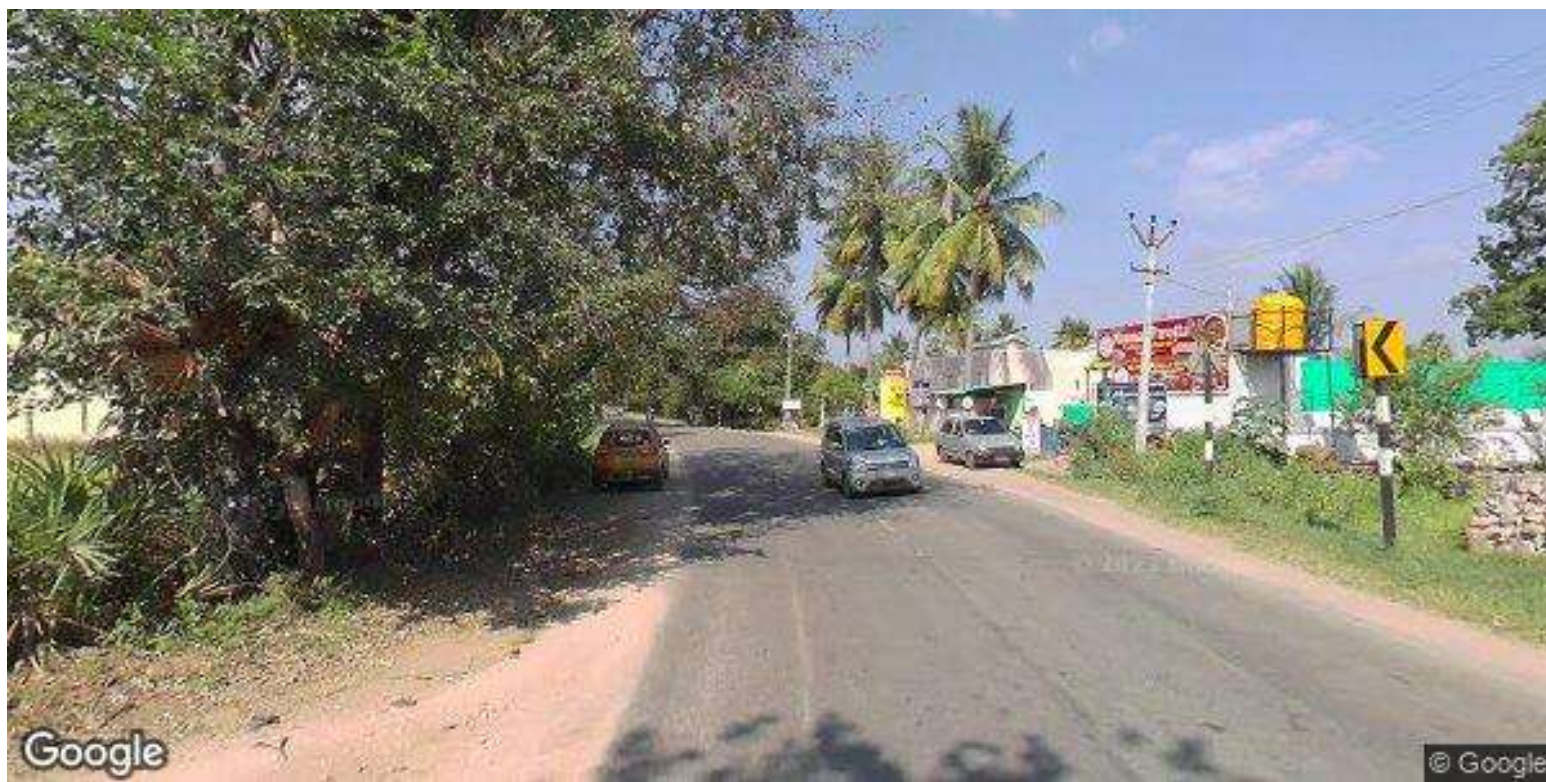
**Coordinates: 11.45309, 77.87325**

**Risk Type: Turn**

**Risk Level: Medium**

**Speed Limit: 30 KM/Hr**

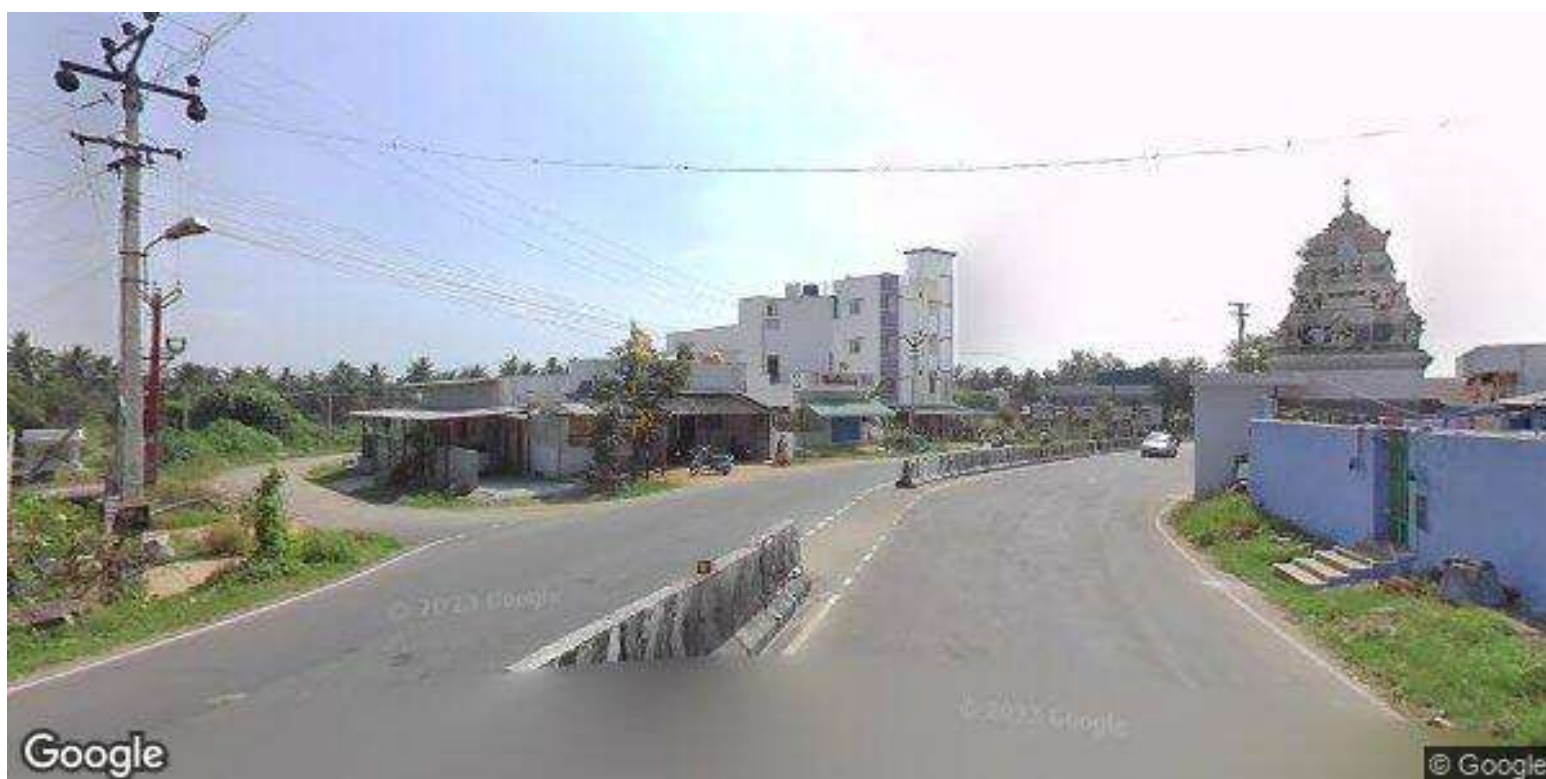
**Coordinates: 11.46400, 77.87323**

**Risk Type: Turn**

**Risk Level: Medium**

**Speed Limit: 30 KM/Hr**

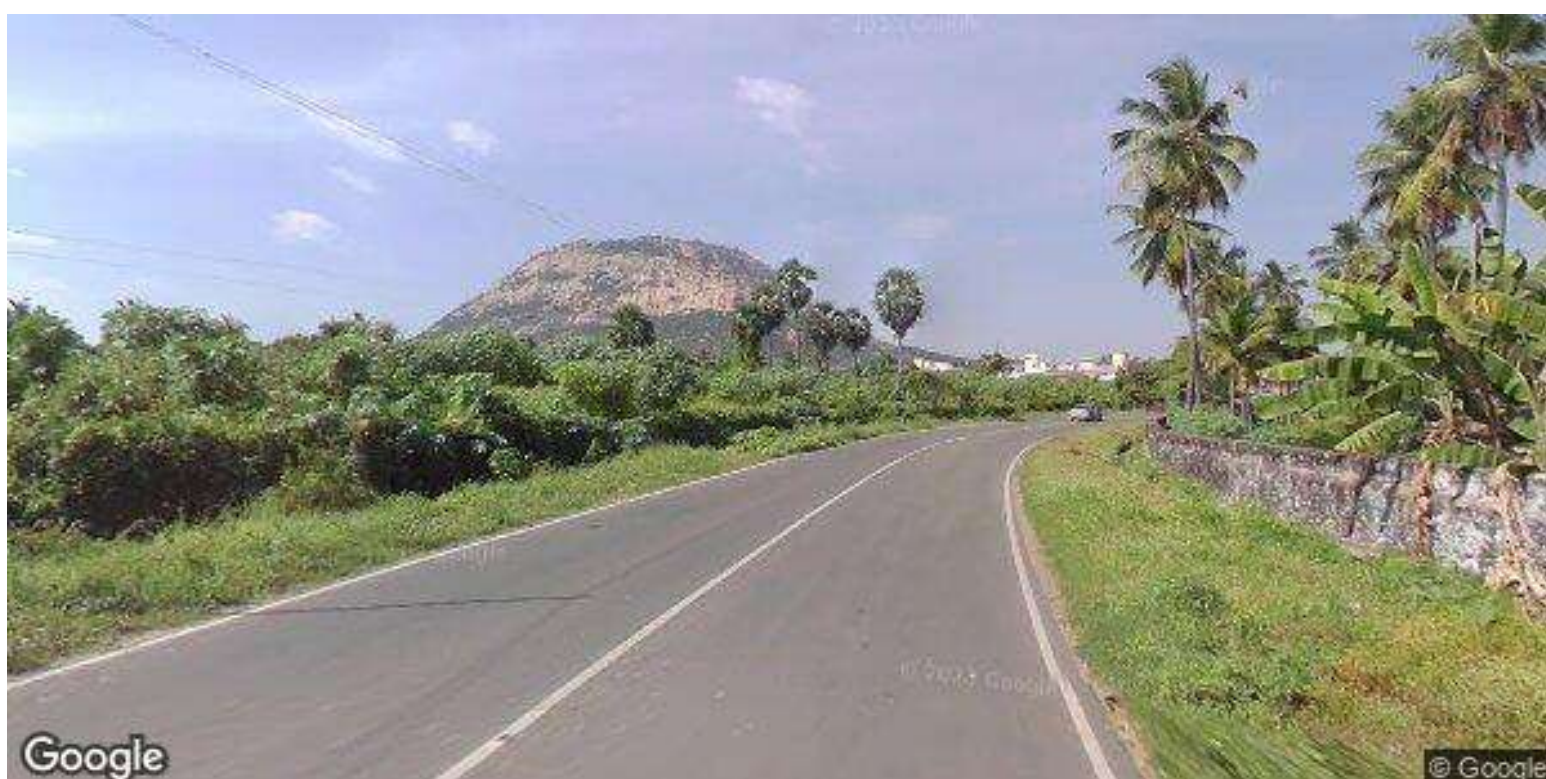
Coordinates: 11.46765, 77.87037

Risk Type: Turn

Risk Level: Medium

Speed Limit: 30 KM/Hr

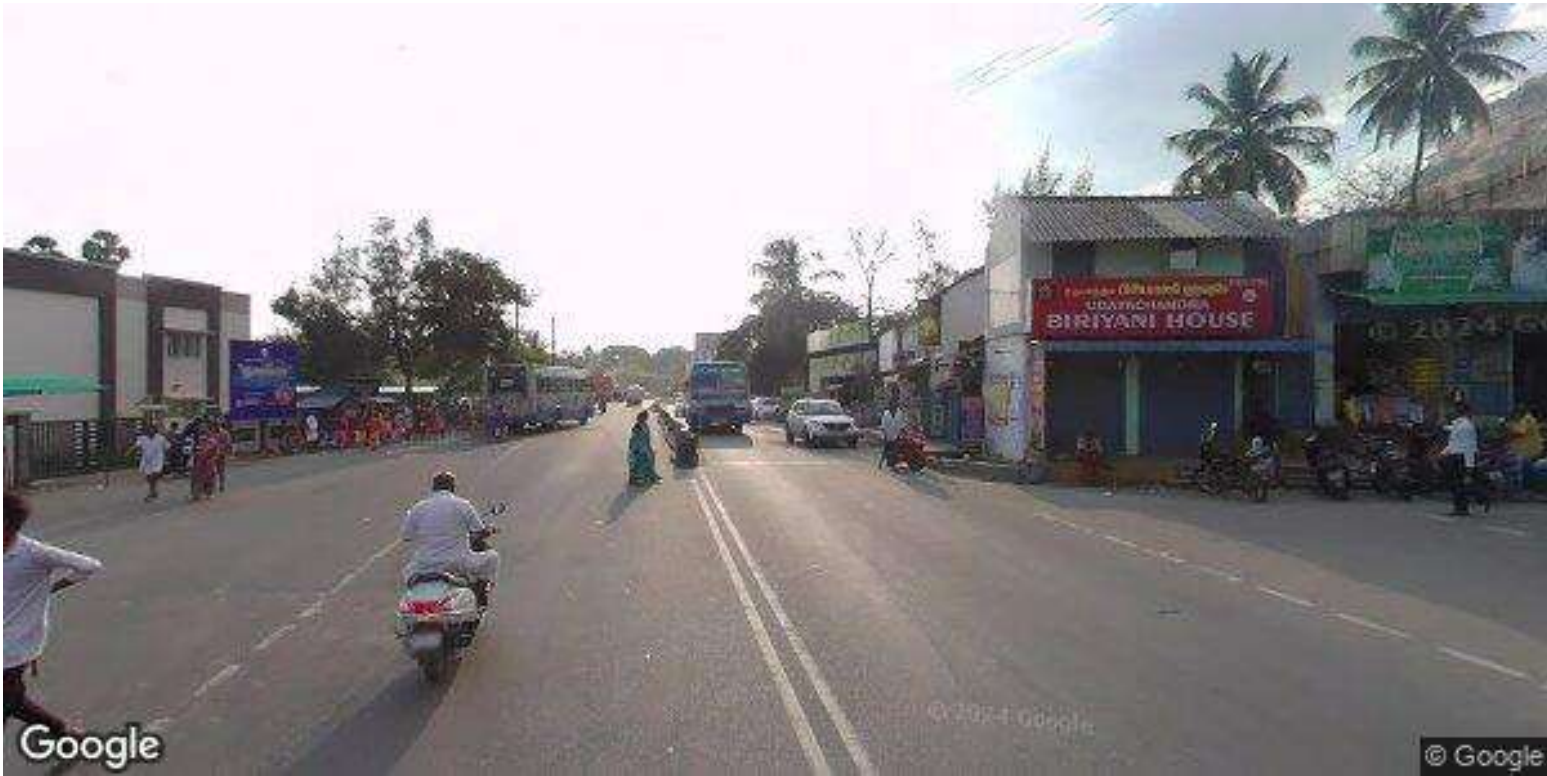
Coordinates: 11.47403, 77.86841

Risk Type: Turn

Risk Level: High

Speed Limit: 15 KM/Hr

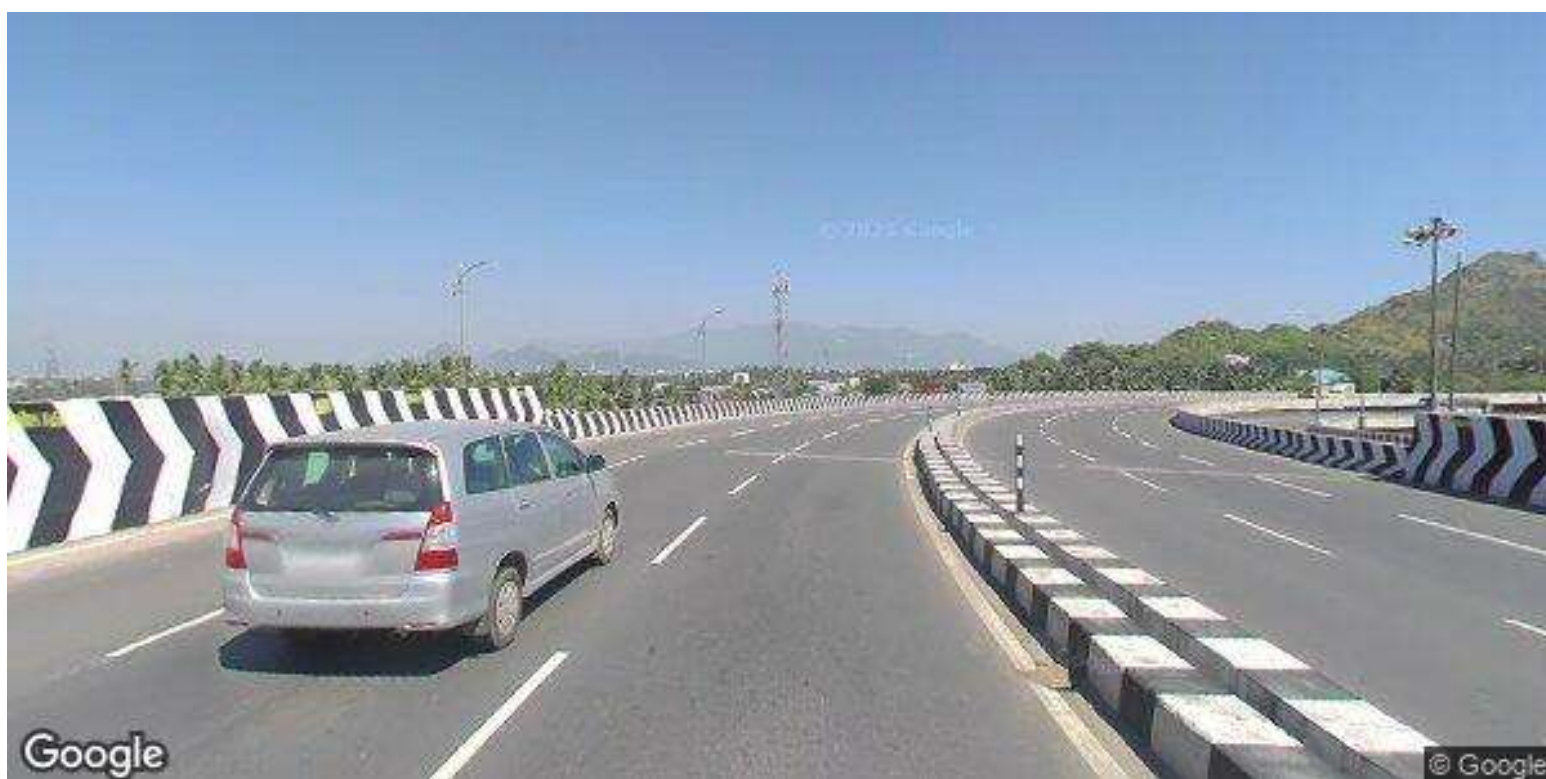
**Coordinates:** 11.64172, 78.11817

**Risk Type:** Turn

**Risk Level:** Medium

**Speed Limit:** 30 KM/Hr

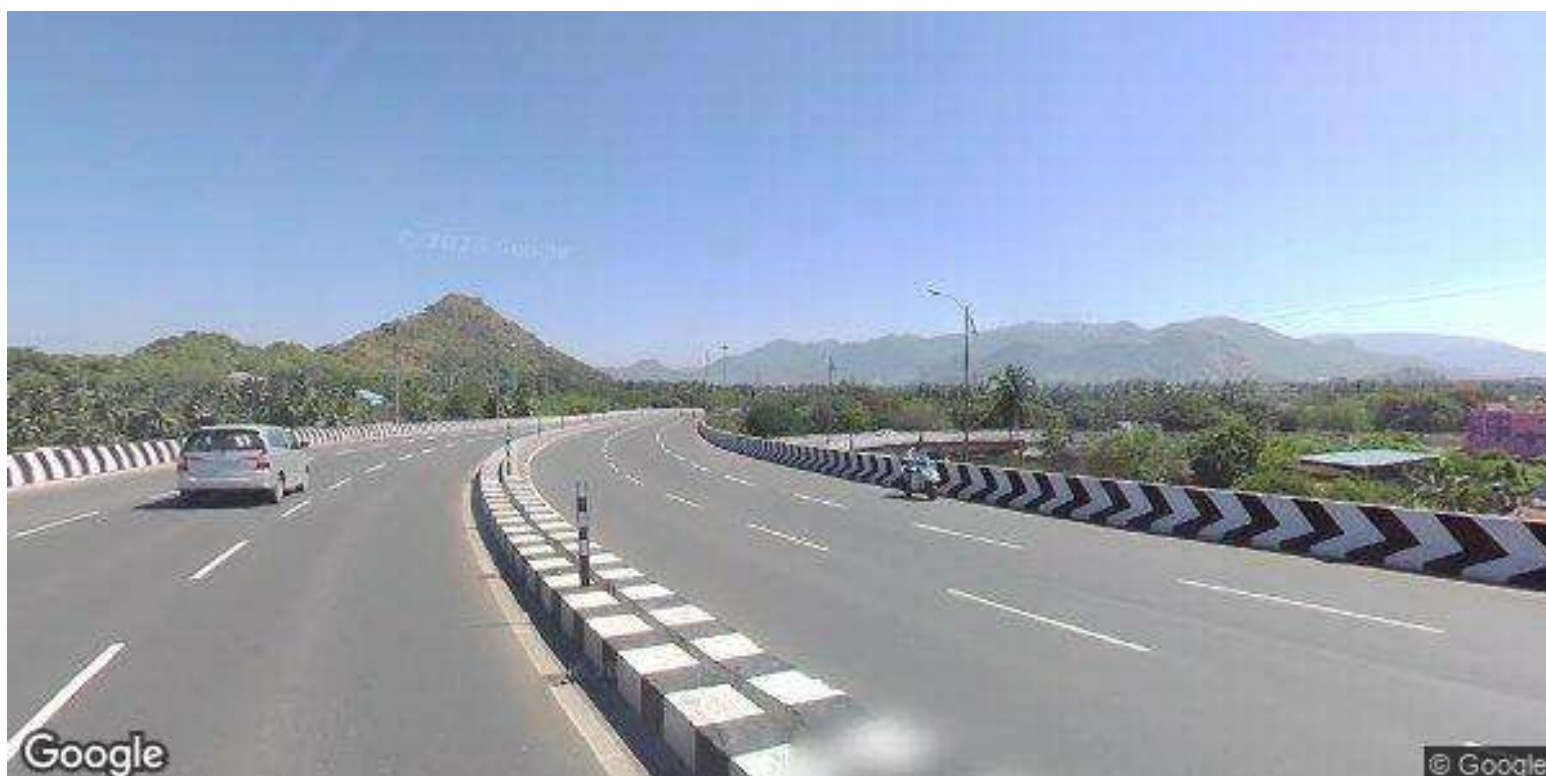
**Risk Type:** Turn  
**Risk Level:** Medium  
**Speed Limit:** 30 KM/Hr  
**Coordinates:** 11.64216, 78.11875

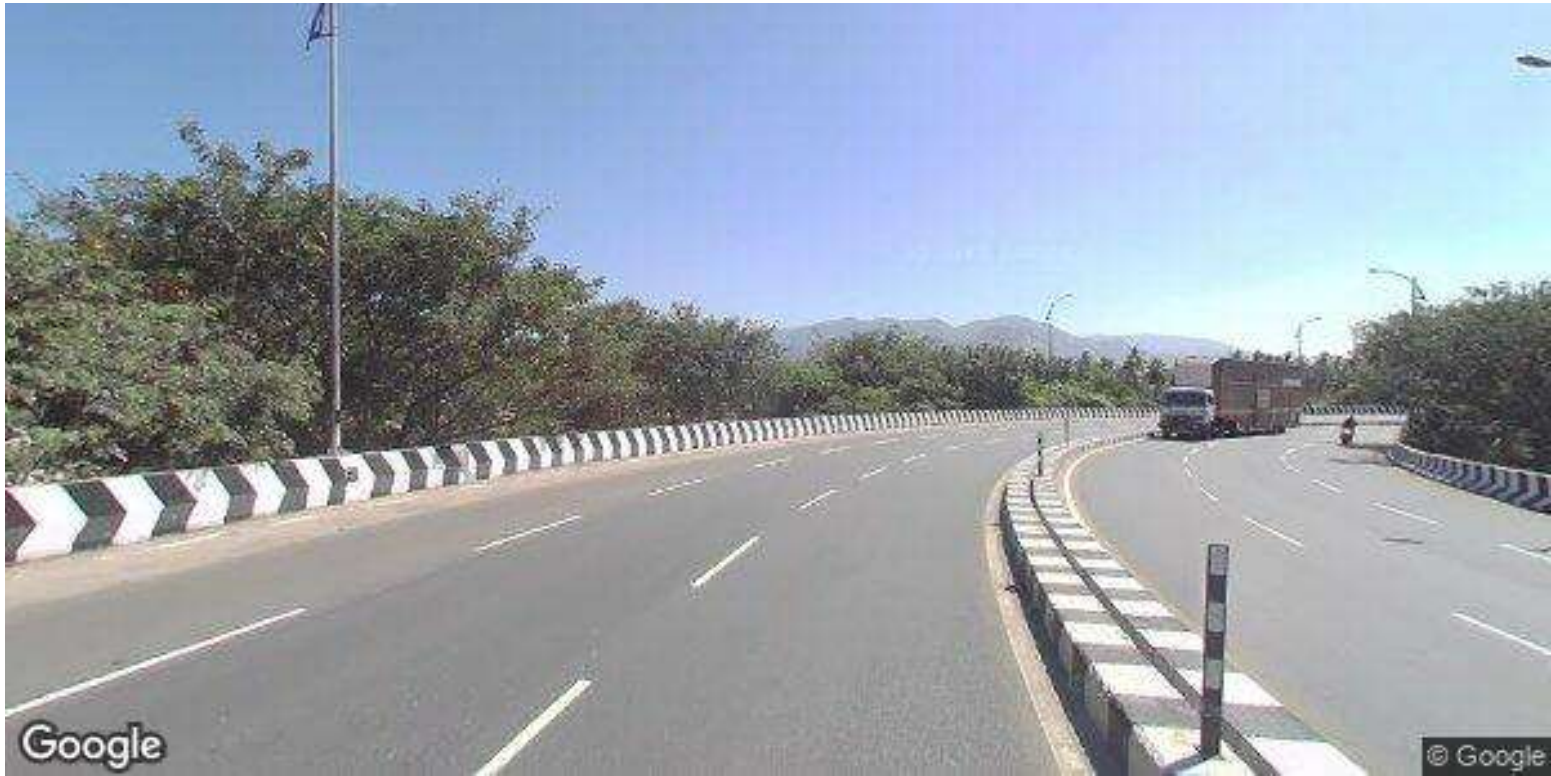
**Risk Type:** Turn  
**Risk Level:** Medium  
**Speed Limit:** 30 KM/Hr  
**Coordinates:** 11.64195, 78.12129

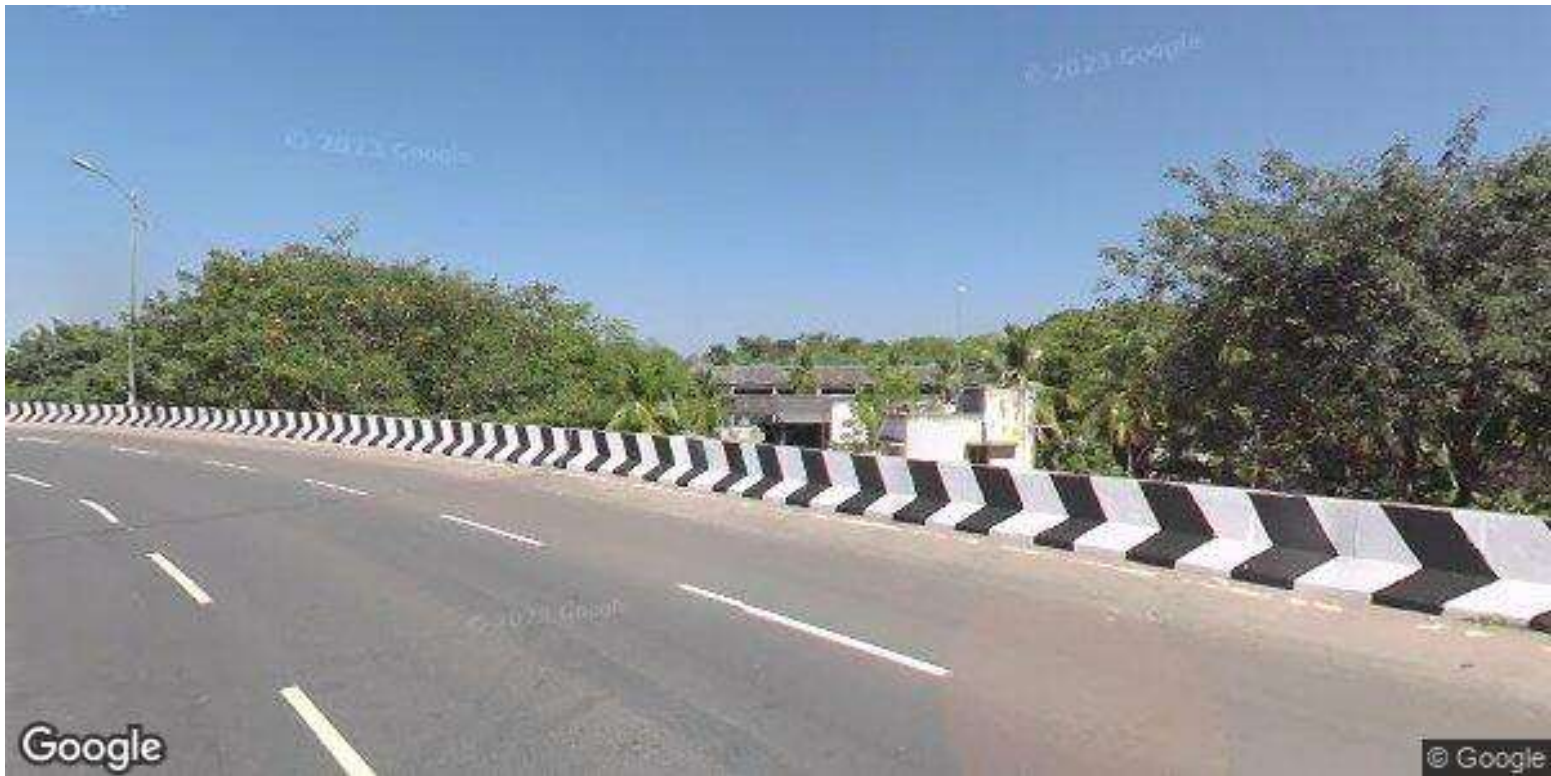
**Risk Type:** Turn  
**Risk Level:** Medium  
**Speed Limit:** 30 KM/Hr  
**Coordinates:** 11.64162, 78.12160

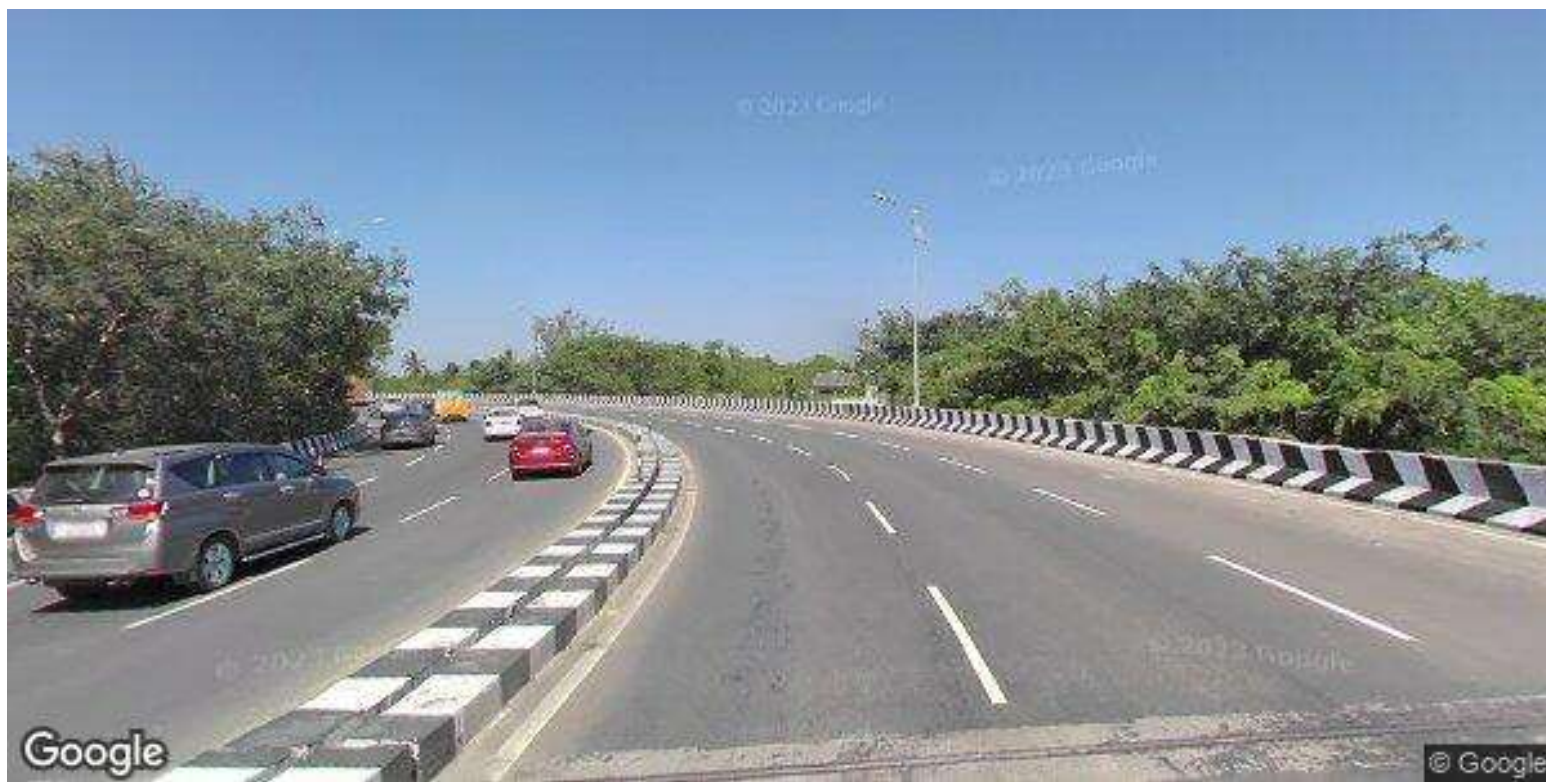
**Coordinates:** 11.64120, 78.12168

**Risk Type:** Turn

**Risk Level:** Medium

**Speed Limit:** 30 KM/Hr

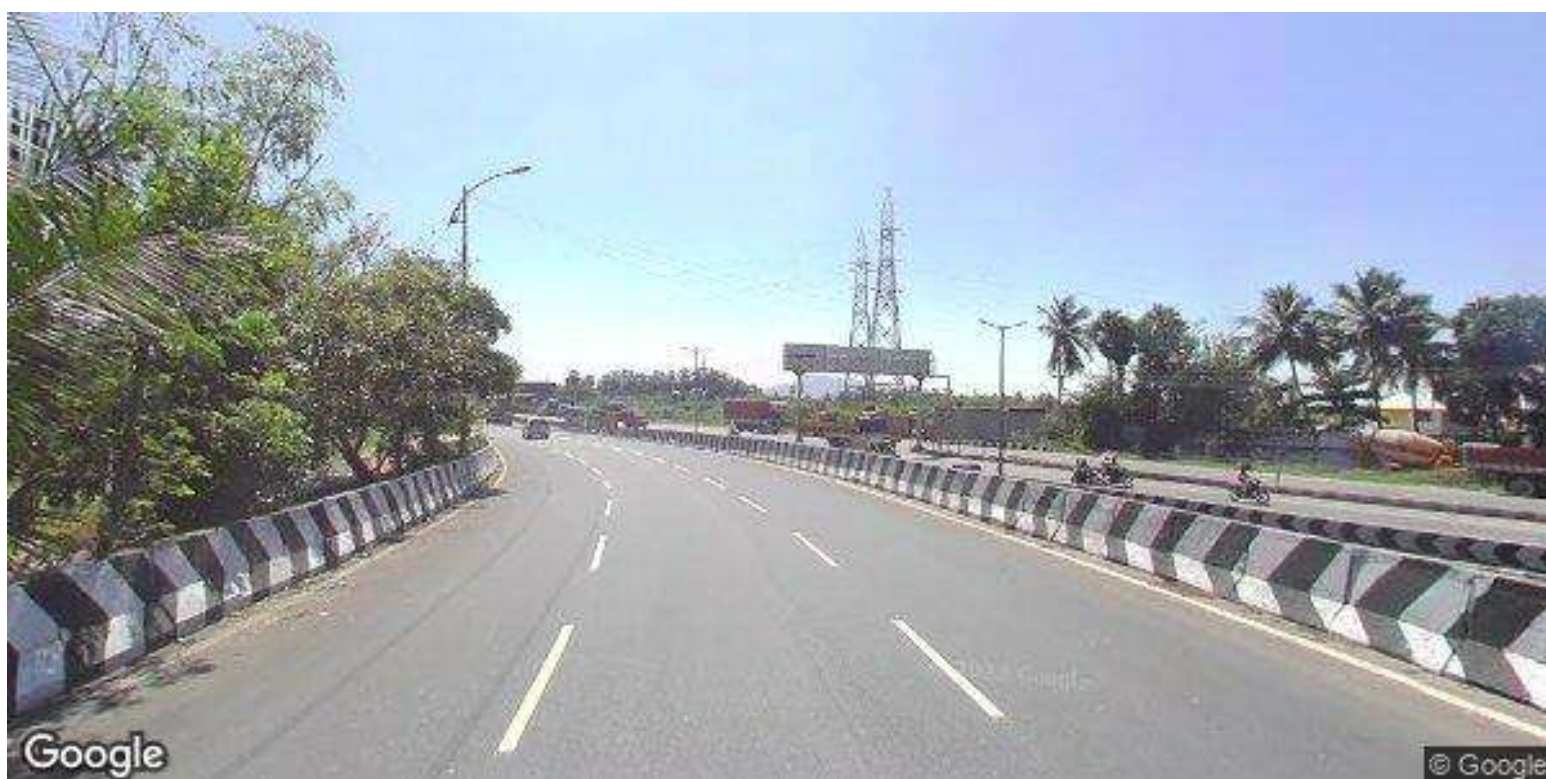
**Coordinates:** 11.63948, 78.12081

**Risk Type:** Turn

**Risk Level:** Medium

**Speed Limit:** 30 KM/Hr

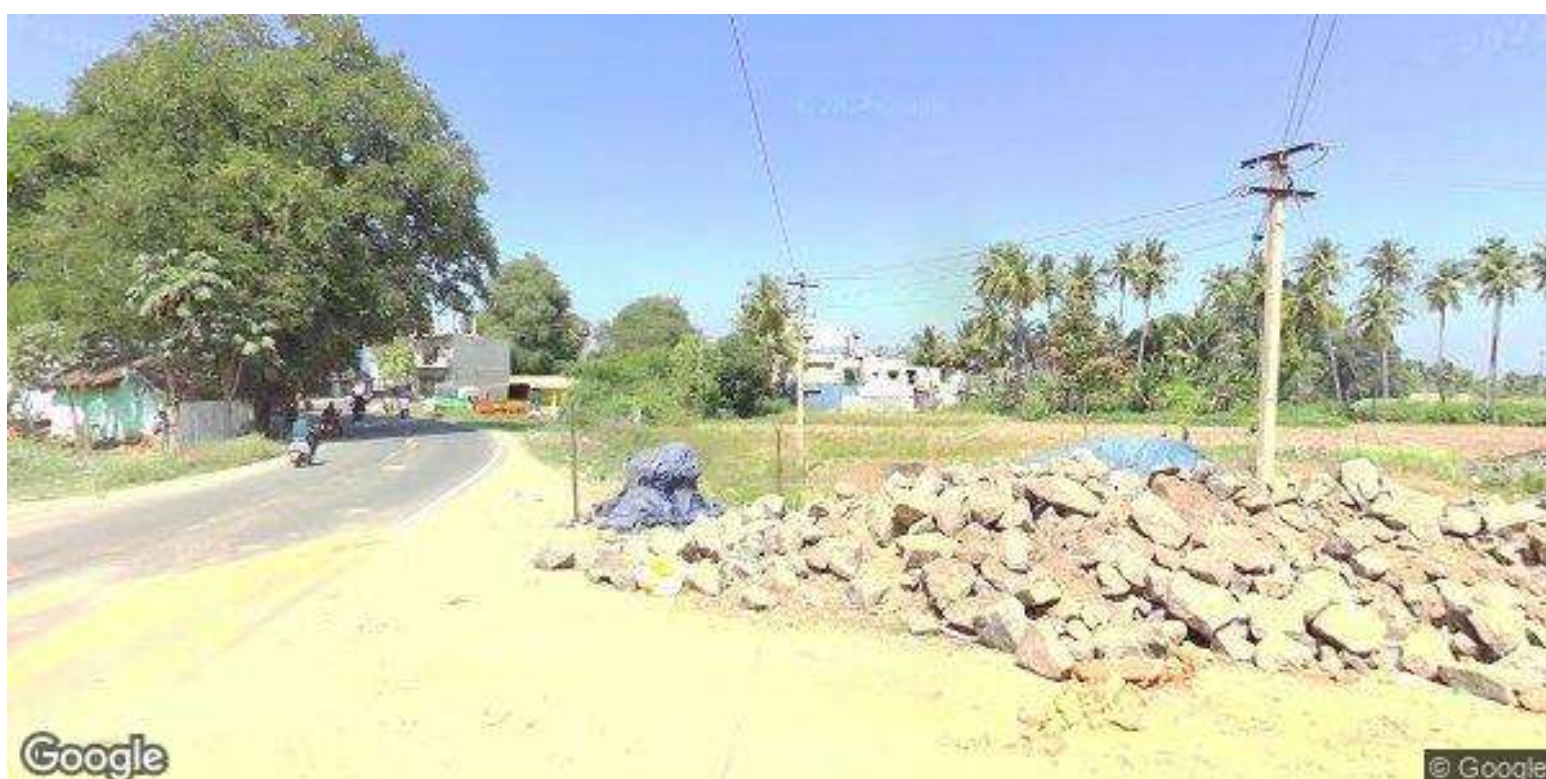
**Risk Type:** Turn  
**Risk Level:** High  
**Speed Limit:** 15 KM/Hr  
**Coordinates:** 11.64953, 78.40233

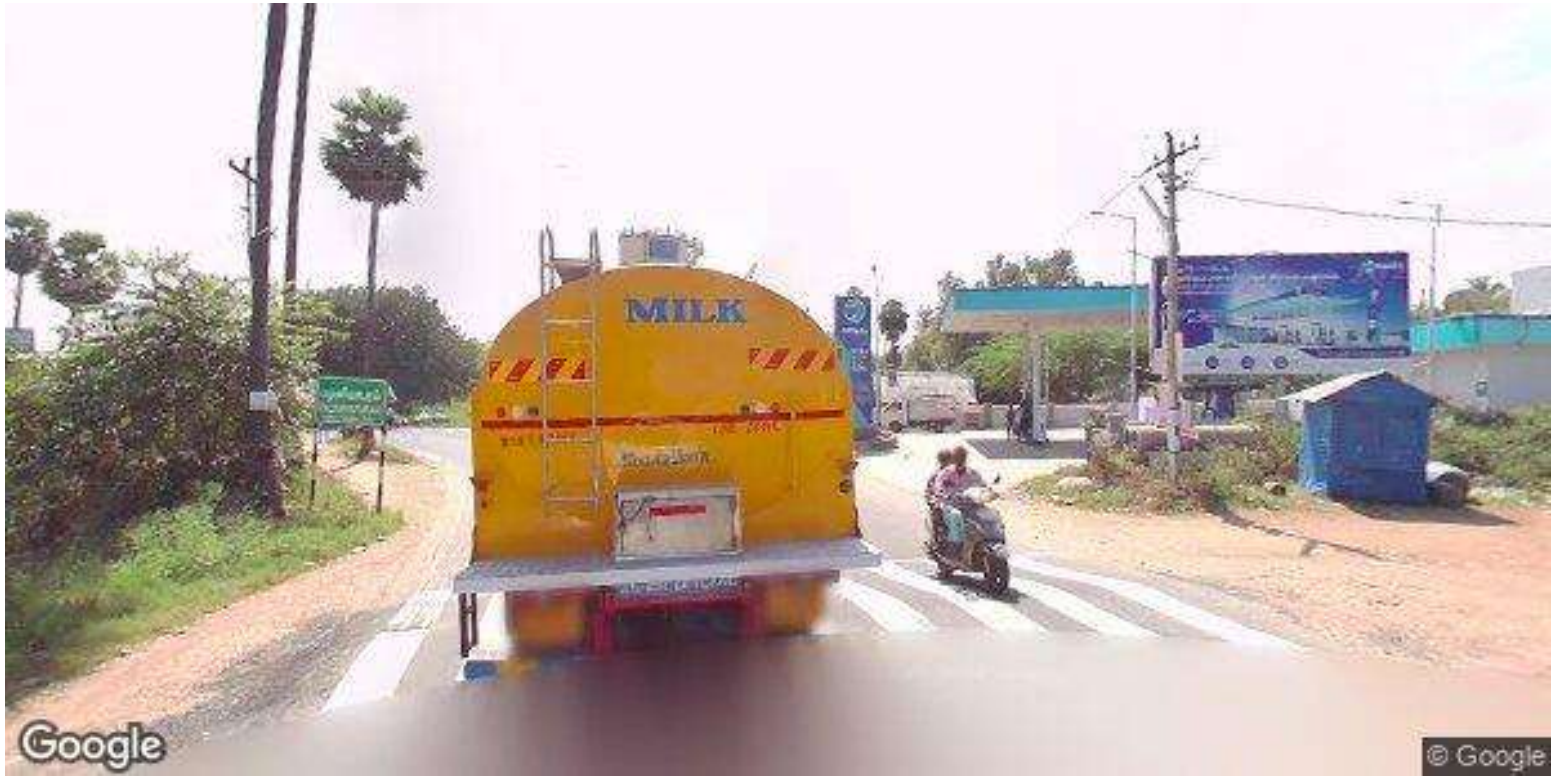
**Risk Type:** Turn  
**Risk Level:** Medium  
**Speed Limit:** 30 KM/Hr  
**Coordinates:** 11.64476, 78.40198

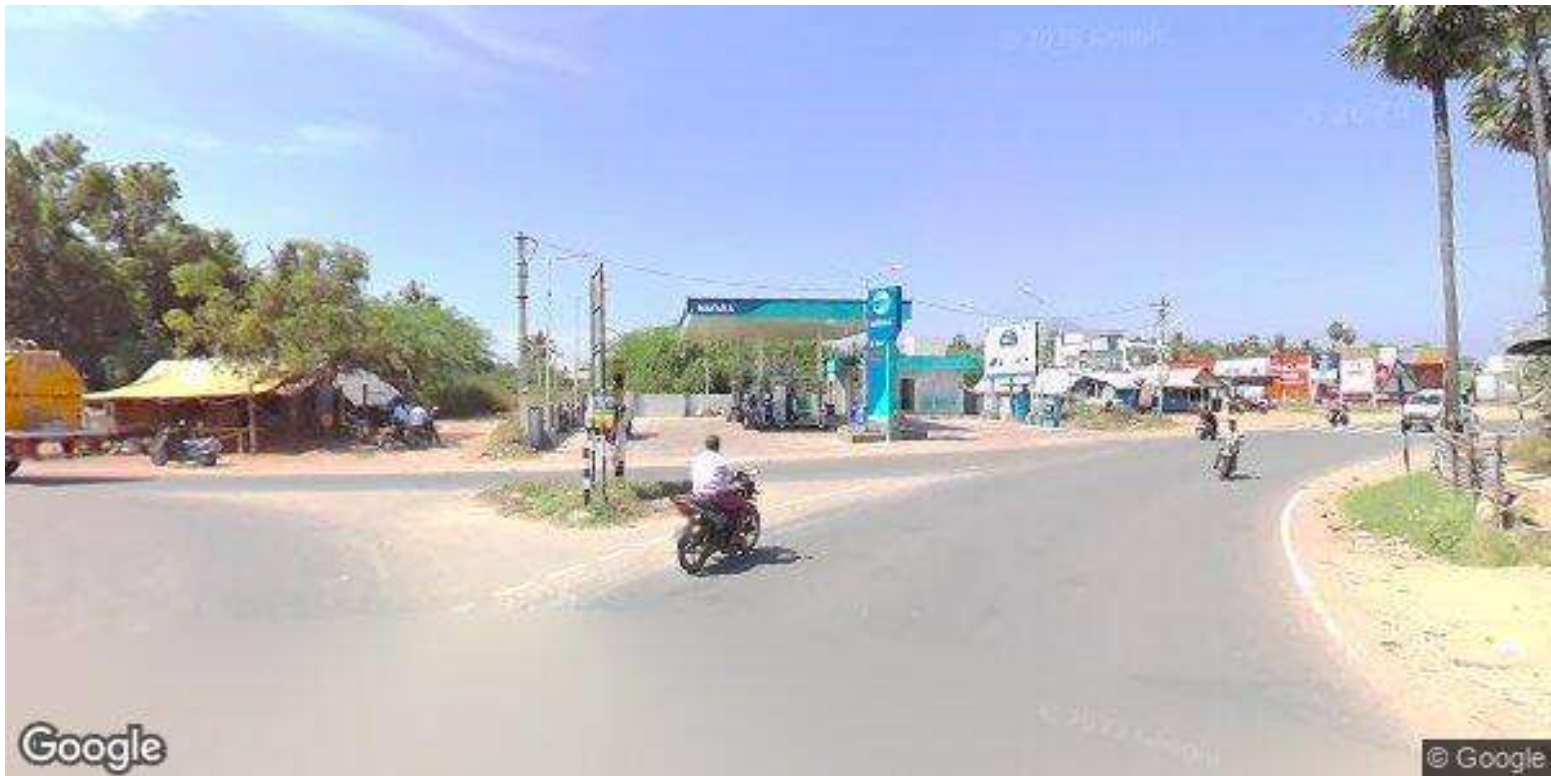
**Risk Type:** Turn  
**Risk Level:** High  
**Speed Limit:** 15 KM/Hr  
**Coordinates:** 11.64429, 78.40220
