# IndianOil

## JOURNEY RISK MANAGEMENT (JRM) STUDY

### Salem Terminal TO JAI MARUTHI TRADERS

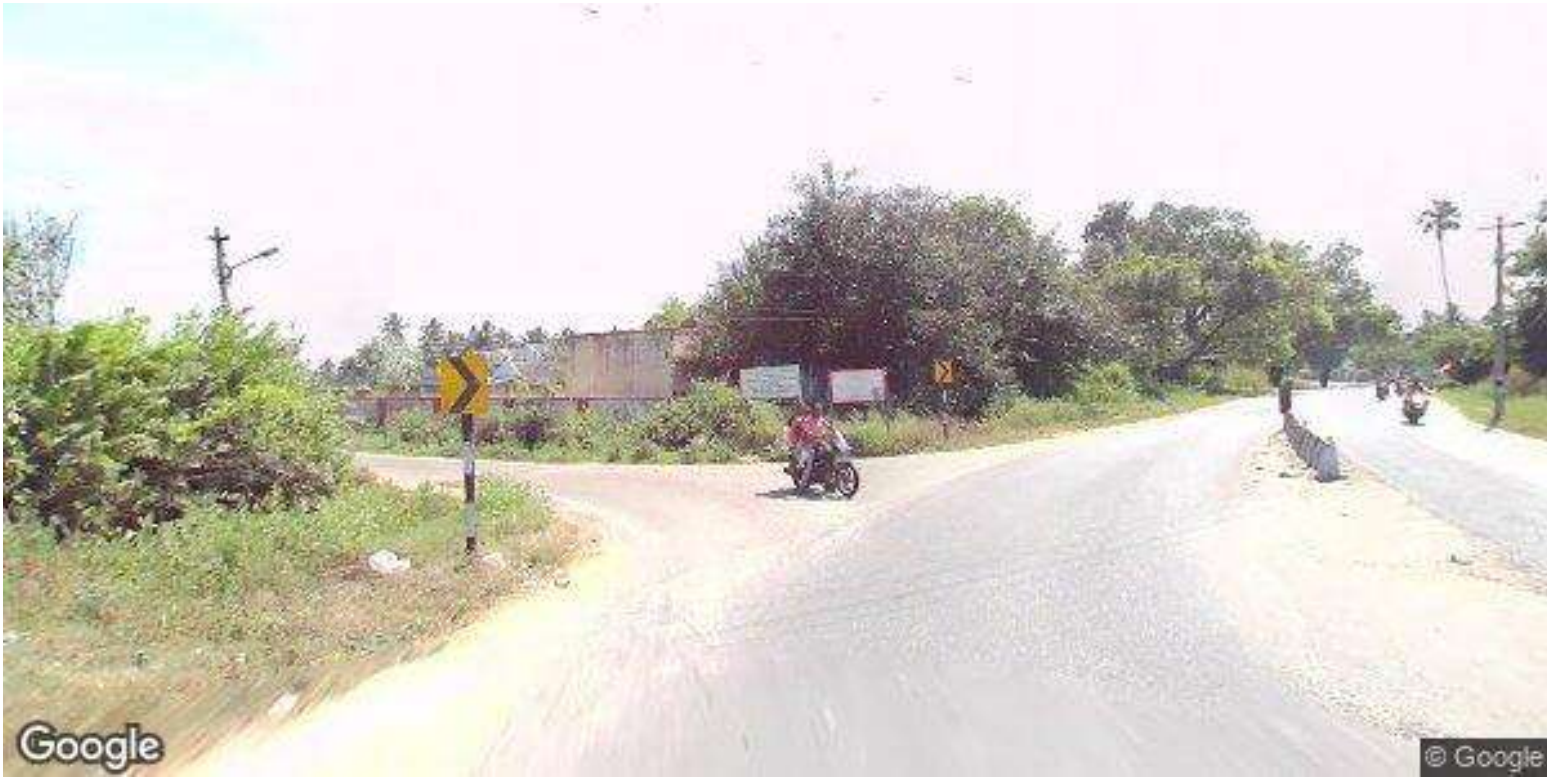
**Risk Type:** Turn  
**Risk Level:** High  
**Speed Limit:** 15 KM/Hr  
**Coordinates:** 11.64407, 78.40406

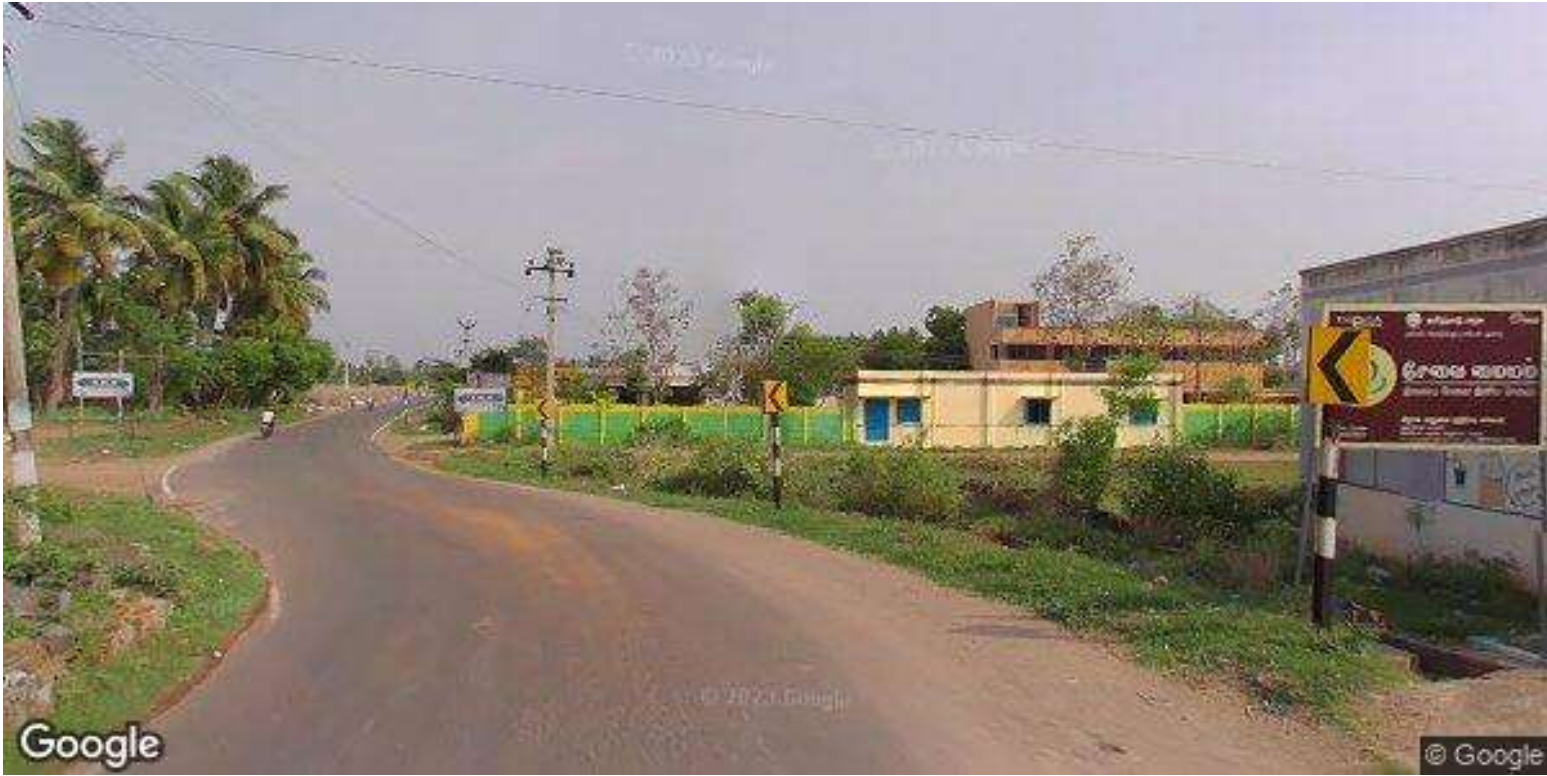
**Risk Type:** Turn  
**Risk Level:** Medium  
**Speed Limit:** 30 KM/Hr  
**Coordinates:** 11.62347, 78.40744

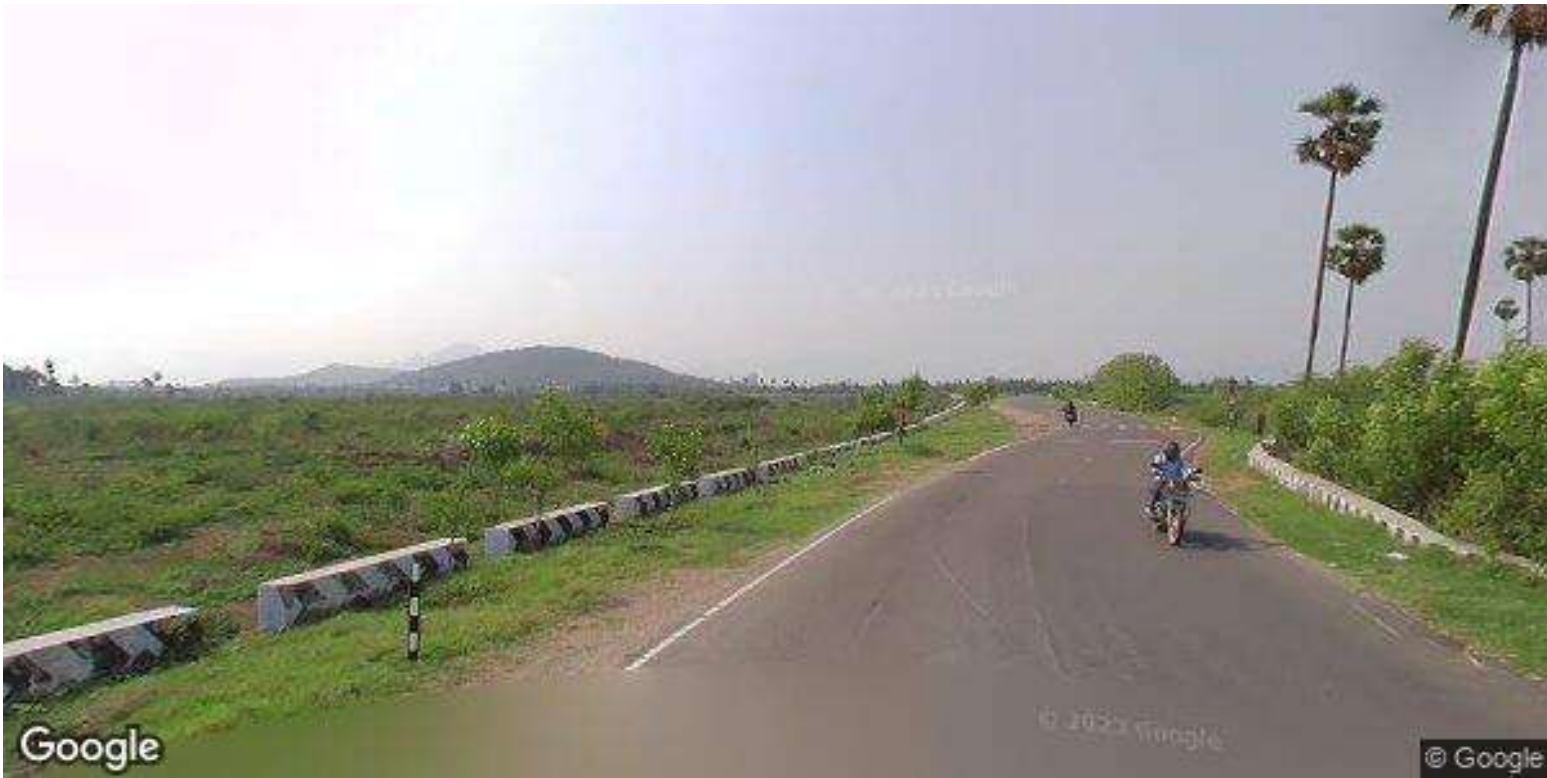
**Risk Type:** Turn  
**Risk Level:** High  
**Speed Limit:** 15 KM/Hr  
**Coordinates:** 11.61234, 78.41126

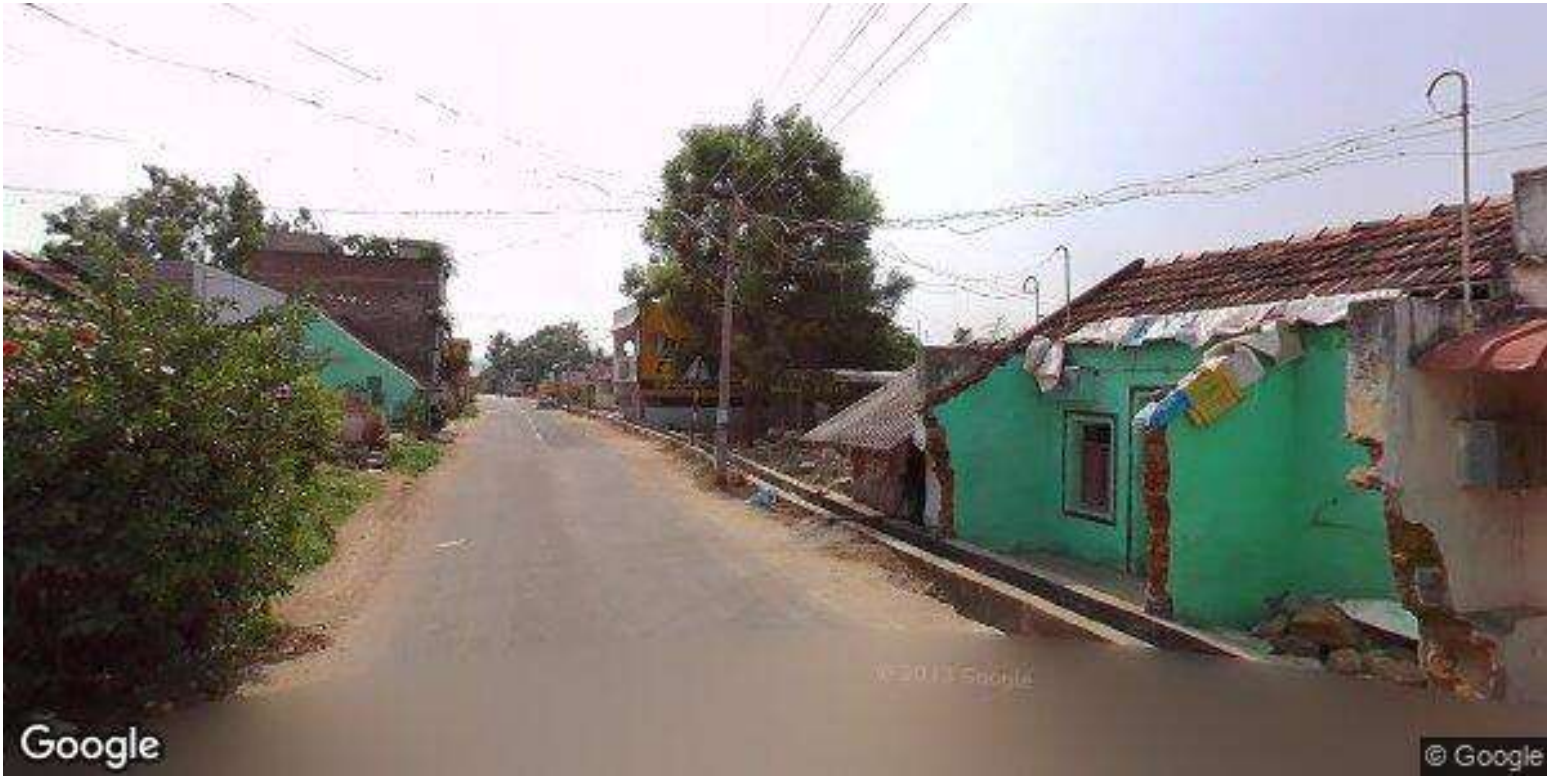
**Risk Type:** Turn  
**Risk Level:** Medium  
**Speed Limit:** 30 KM/Hr  
**Coordinates:** 11.60904, 78.41789

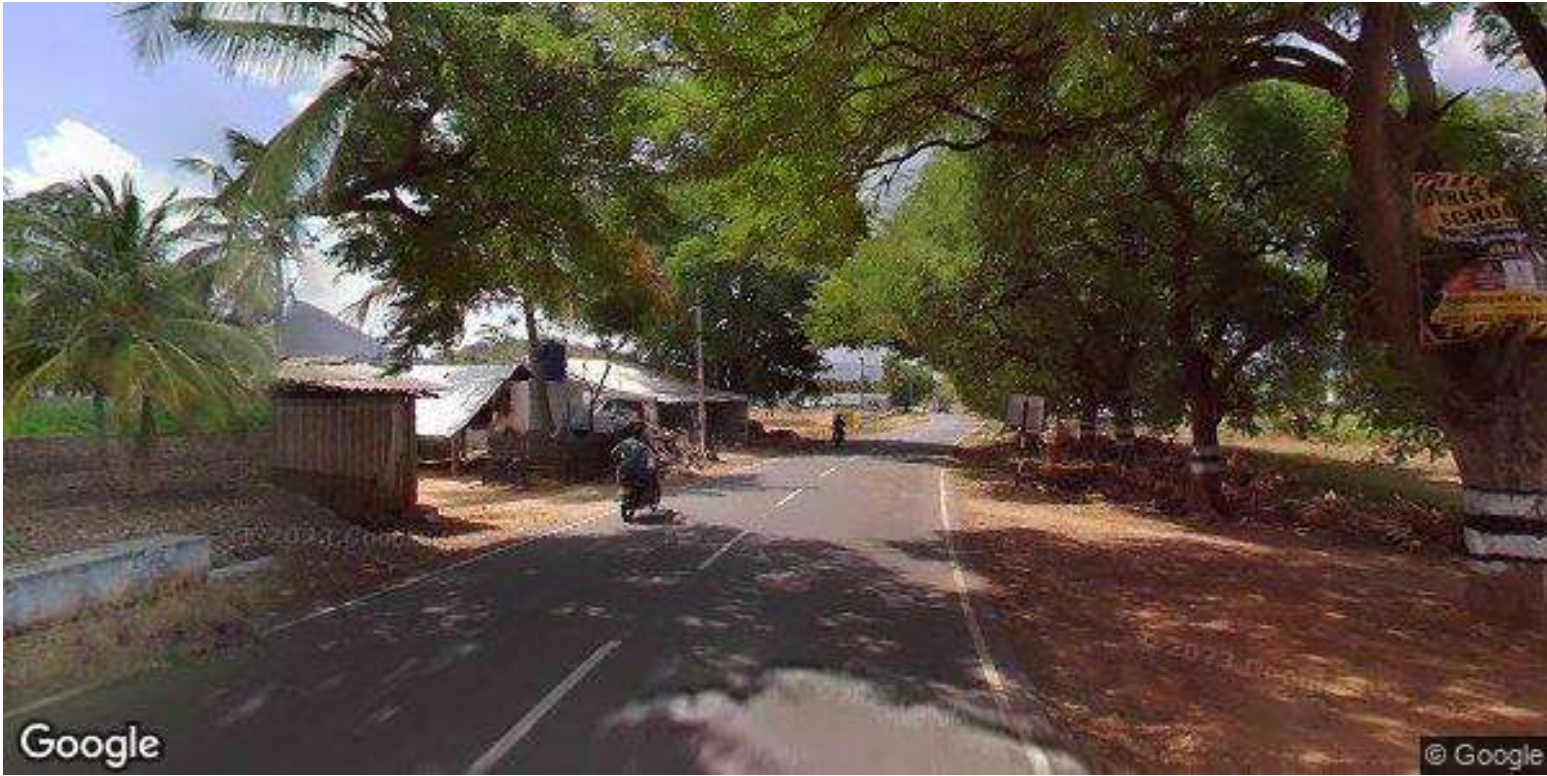
**Risk Type:** Turn  
**Risk Level:** Medium  
**Speed Limit:** 30 KM/Hr  
**Coordinates:** 11.59837, 78.43873

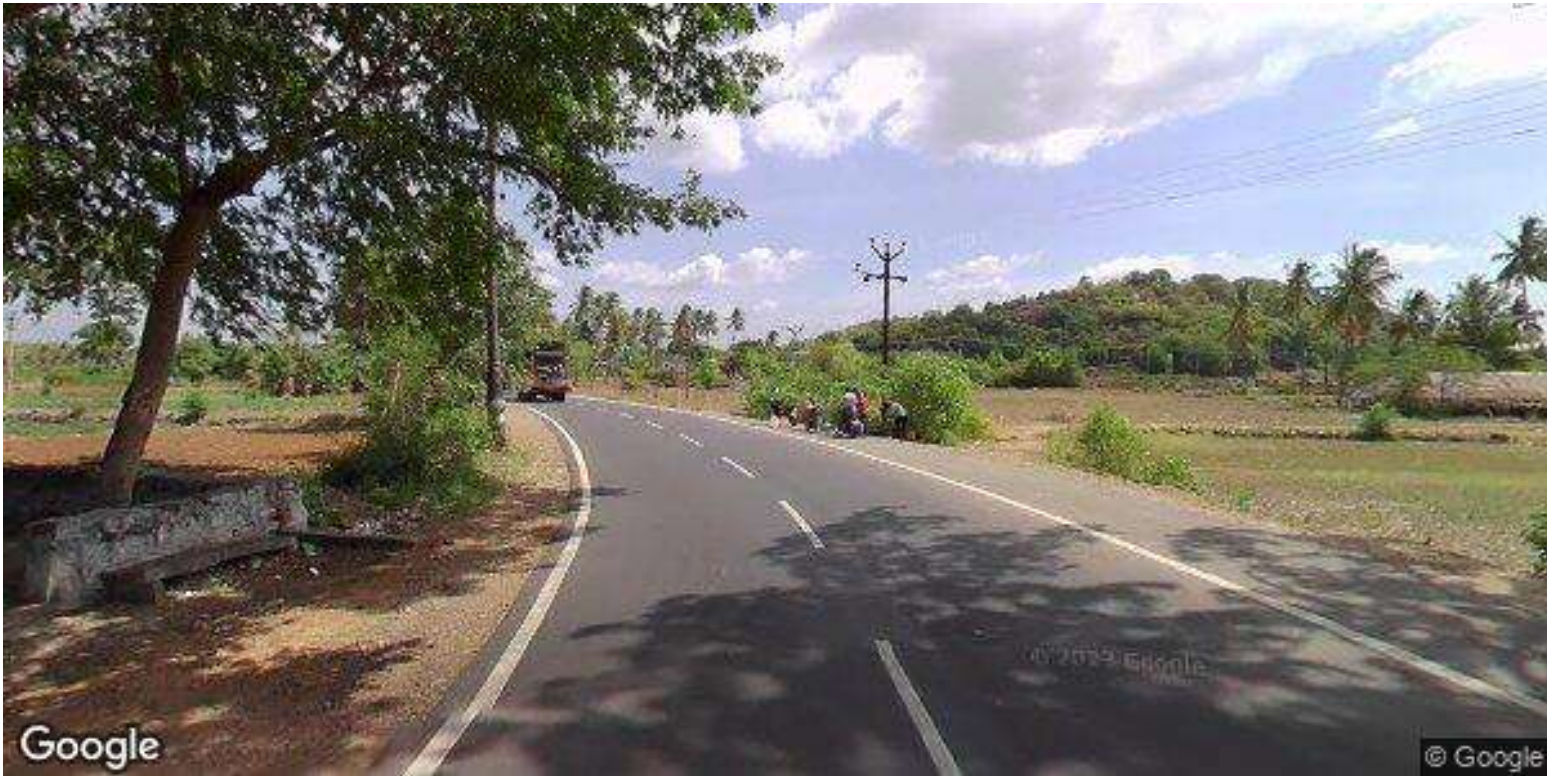
**Risk Type:** Turn  
**Risk Level:** Medium  
**Speed Limit:** 30 KM/Hr  
**Coordinates:** 11.59152, 78.44336

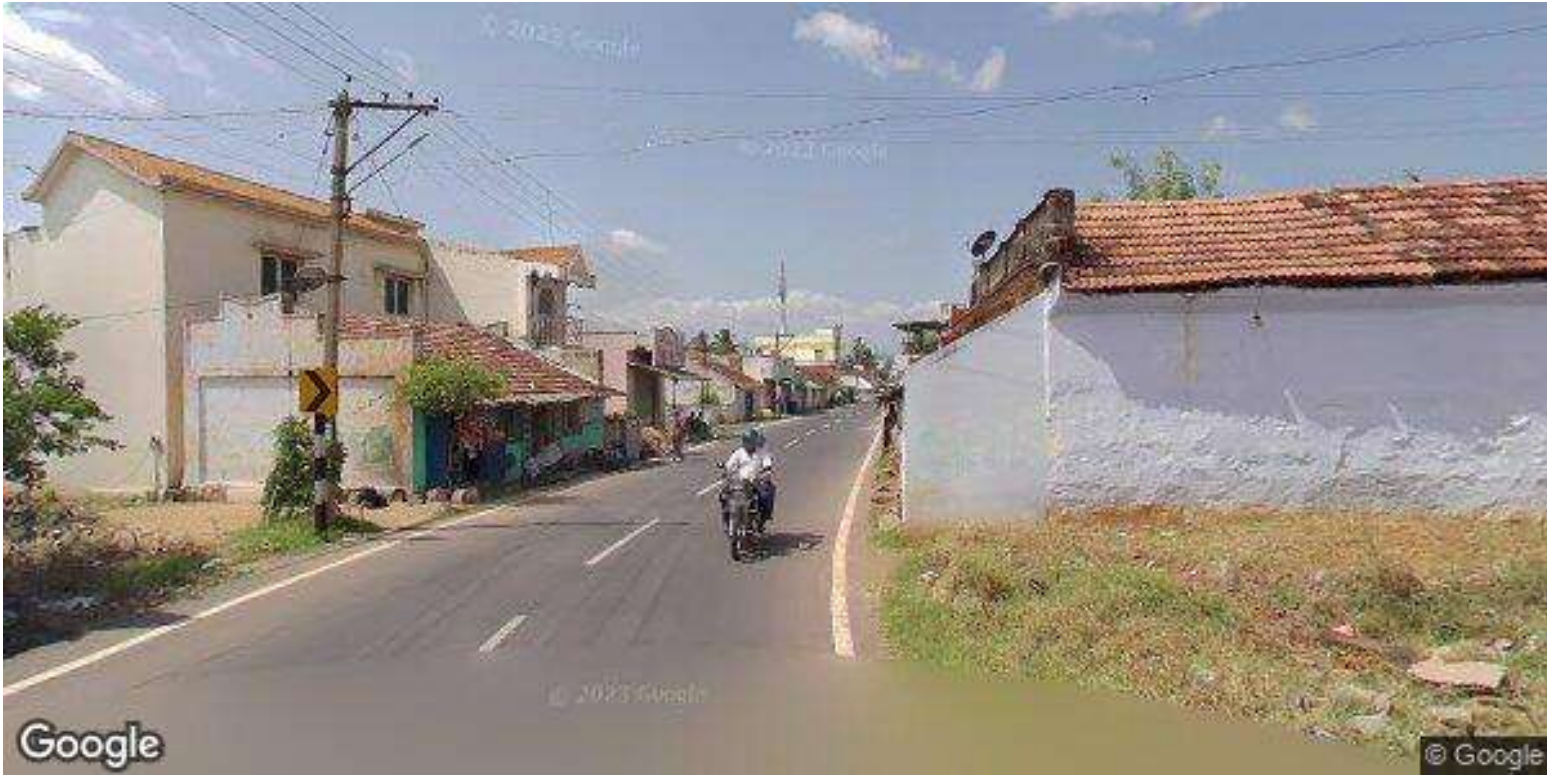
**Risk Type:** Turn  
**Risk Level:** High  
**Speed Limit:** 15 KM/Hr  
**Coordinates:** 11.58768, 78.44445

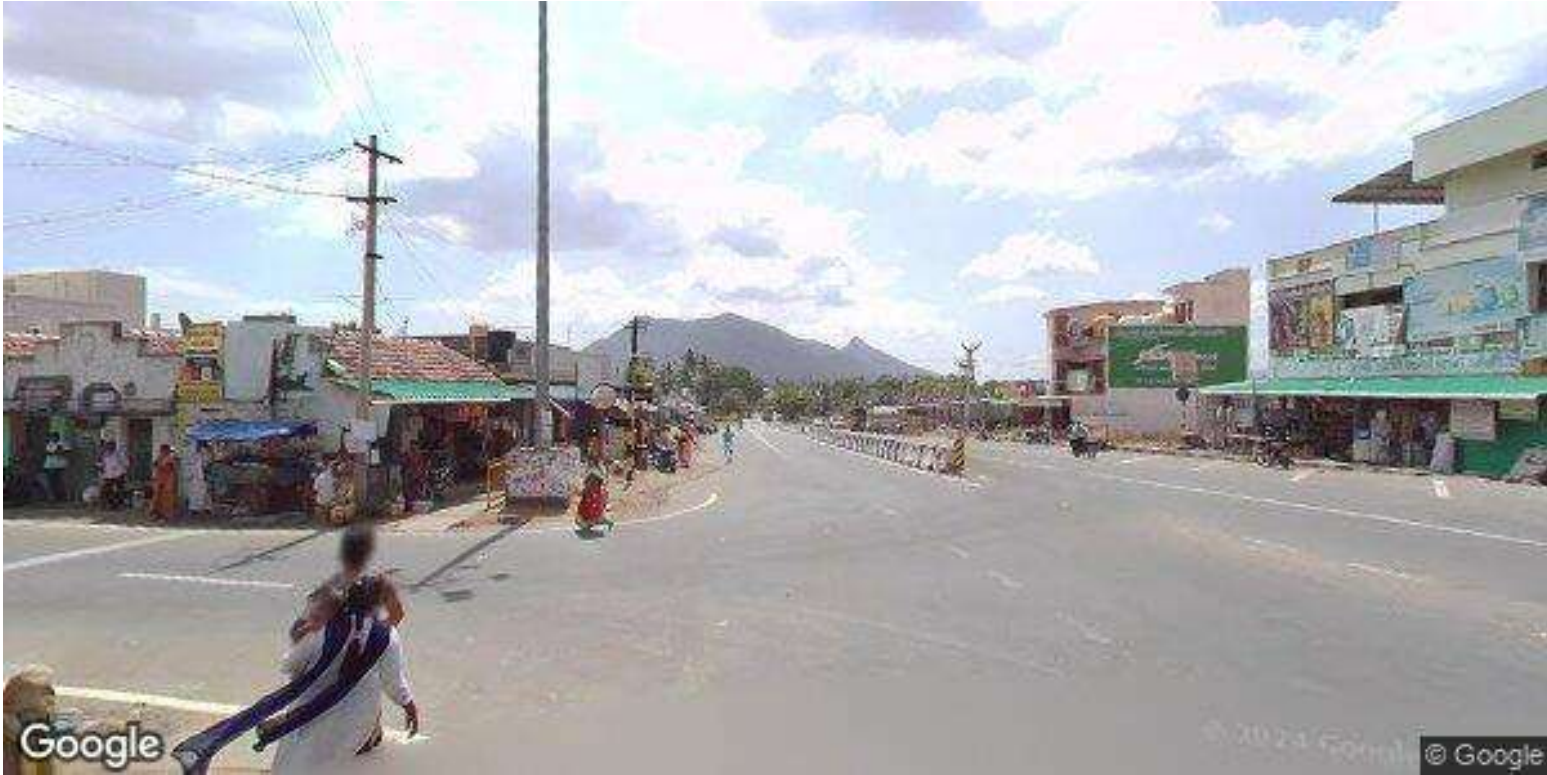
**Risk Type:** Blind Spot  
**Risk Level:** Blind Spot  
**Speed Limit:** 10 KM/Hr  
**Coordinates:** 11.58332, 78.44386

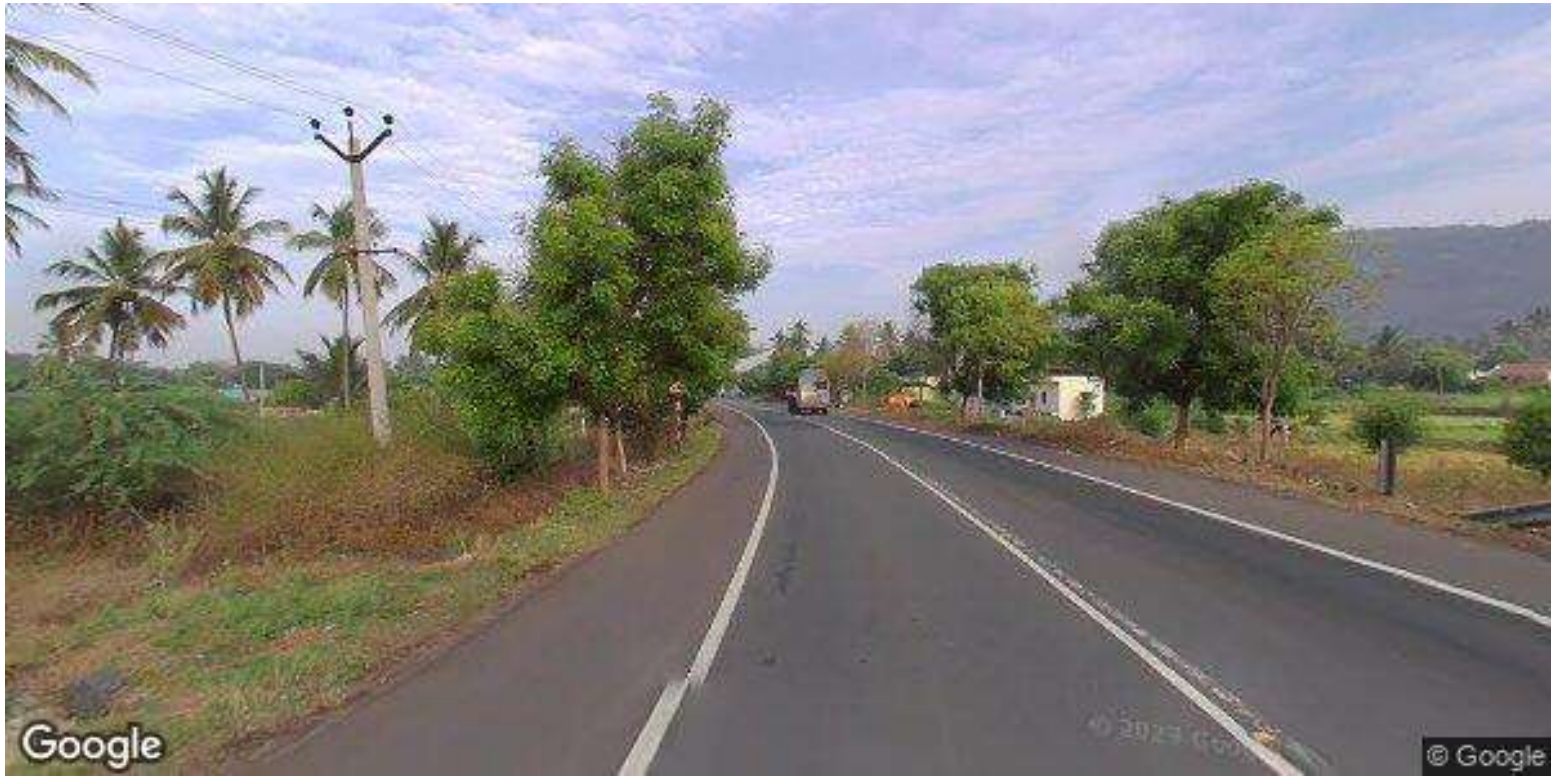
**Risk Type:** Turn  
**Risk Level:** Medium  
**Speed Limit:** 30 KM/Hr  
**Coordinates:** 11.57494, 78.49402

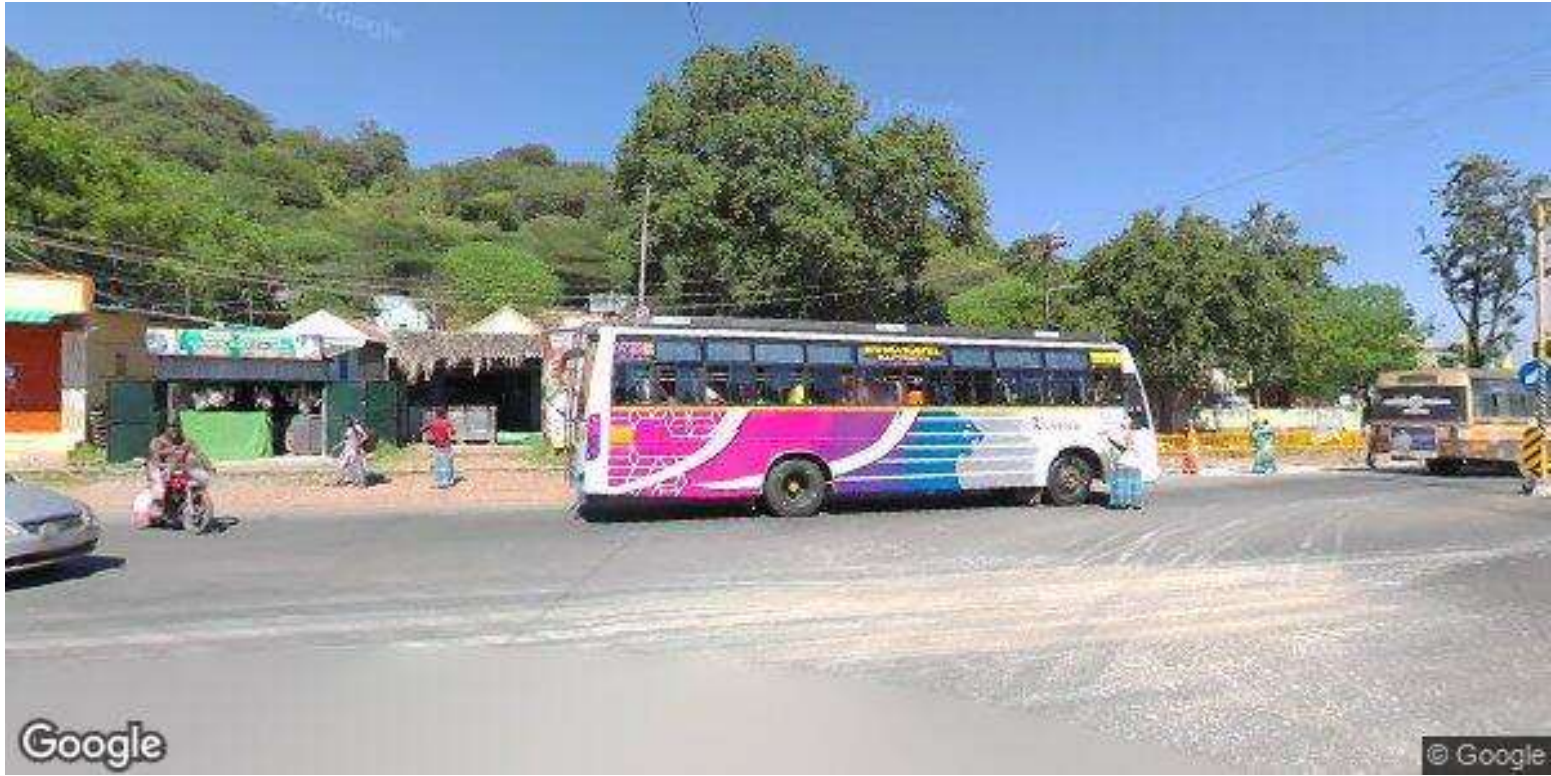
**Risk Type:** Blind Spot  
**Risk Level:** Blind Spot  
**Speed Limit:** 10 KM/Hr  
**Coordinates:** 11.57100, 78.49943
