# IndianOil

## JOURNEY RISK MANAGEMENT (JRM) STUDY

### Salem Terminal to CHERAN PETROLEUMS

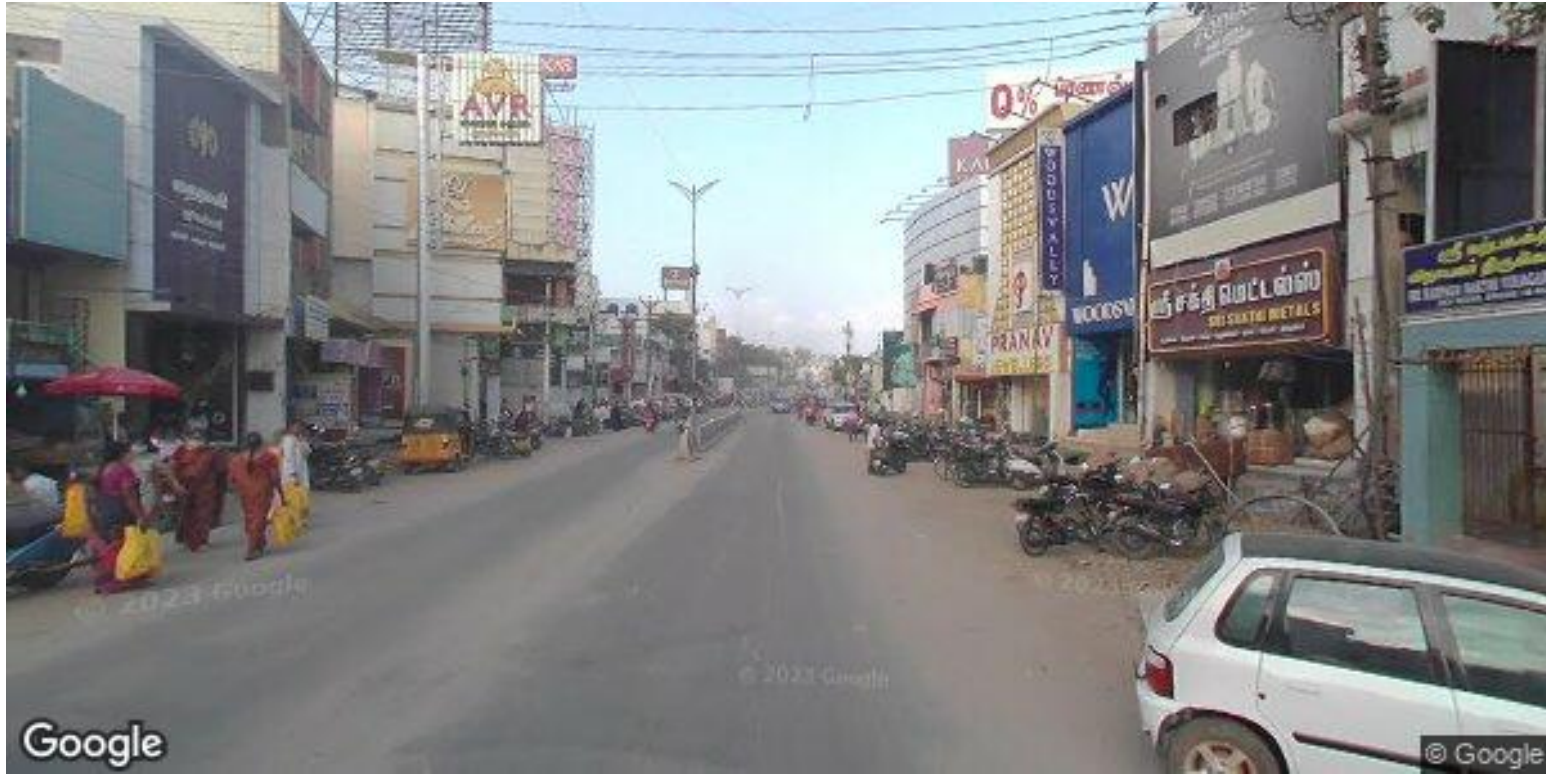
**Coordinates: 11.3453211, 77.7304652**

**Risk Type: U-Turn**

**Risk Level: High**

**Speed Limit: 10 KM/Hr**

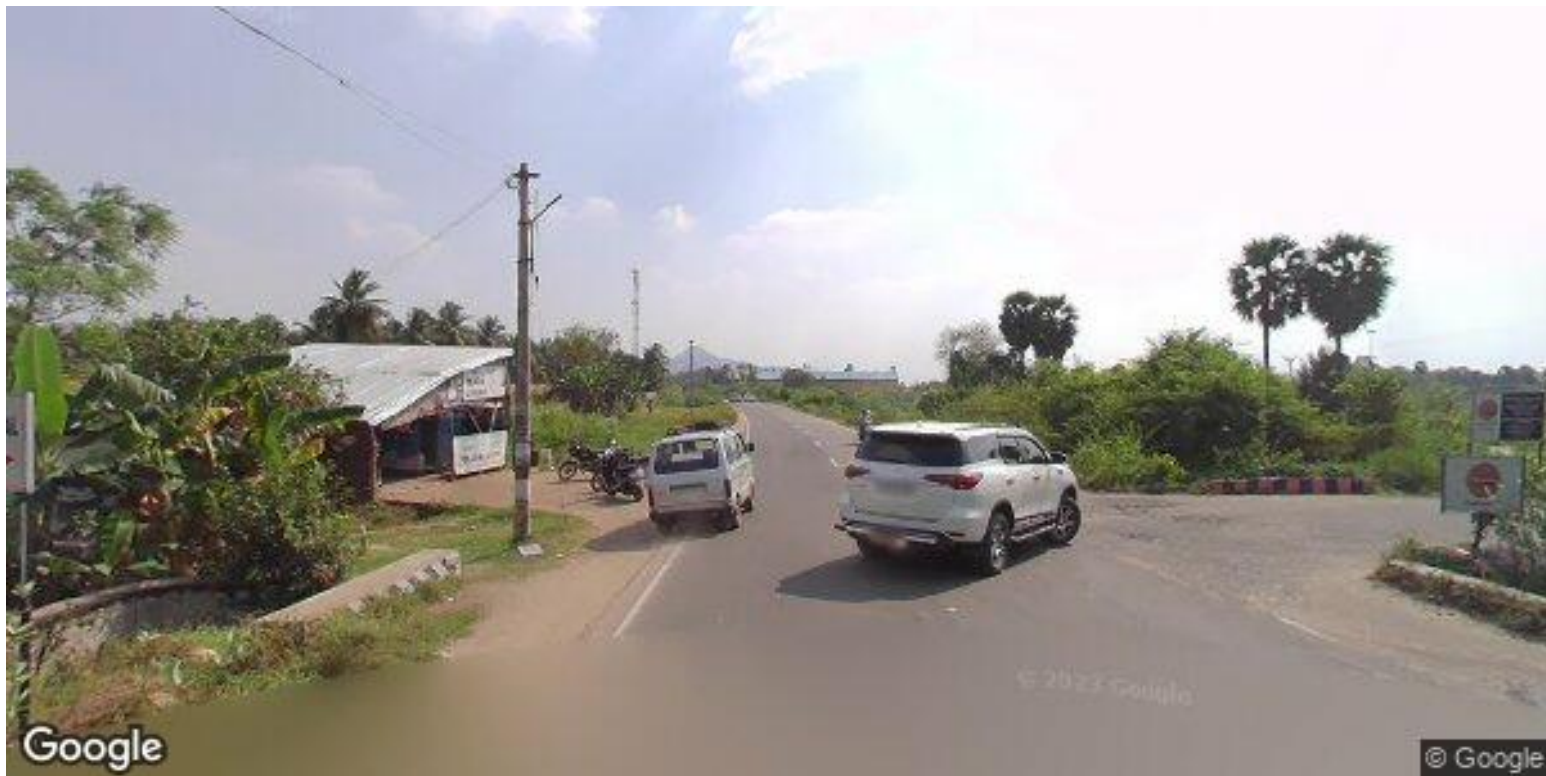
**Coordinates: 11.44029, 77.87544**

**Risk Type: Turn**

**Risk Level: High**

**Speed Limit: 15 KM/Hr**

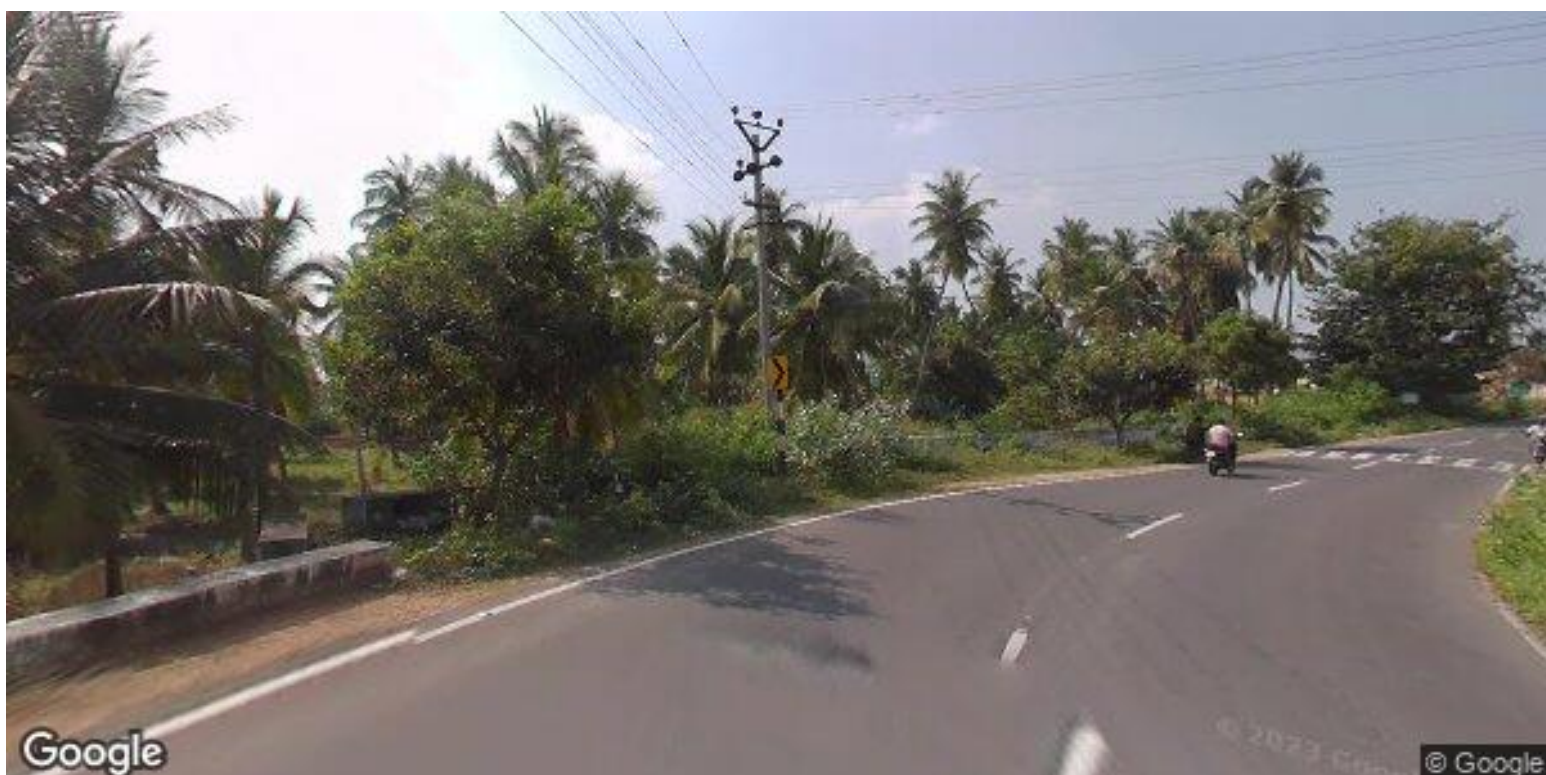
**Coordinates: 11.45348, 77.85706**

**Risk Type: Turn**

**Risk Level: Medium**

**Speed Limit: 30 KM/Hr**

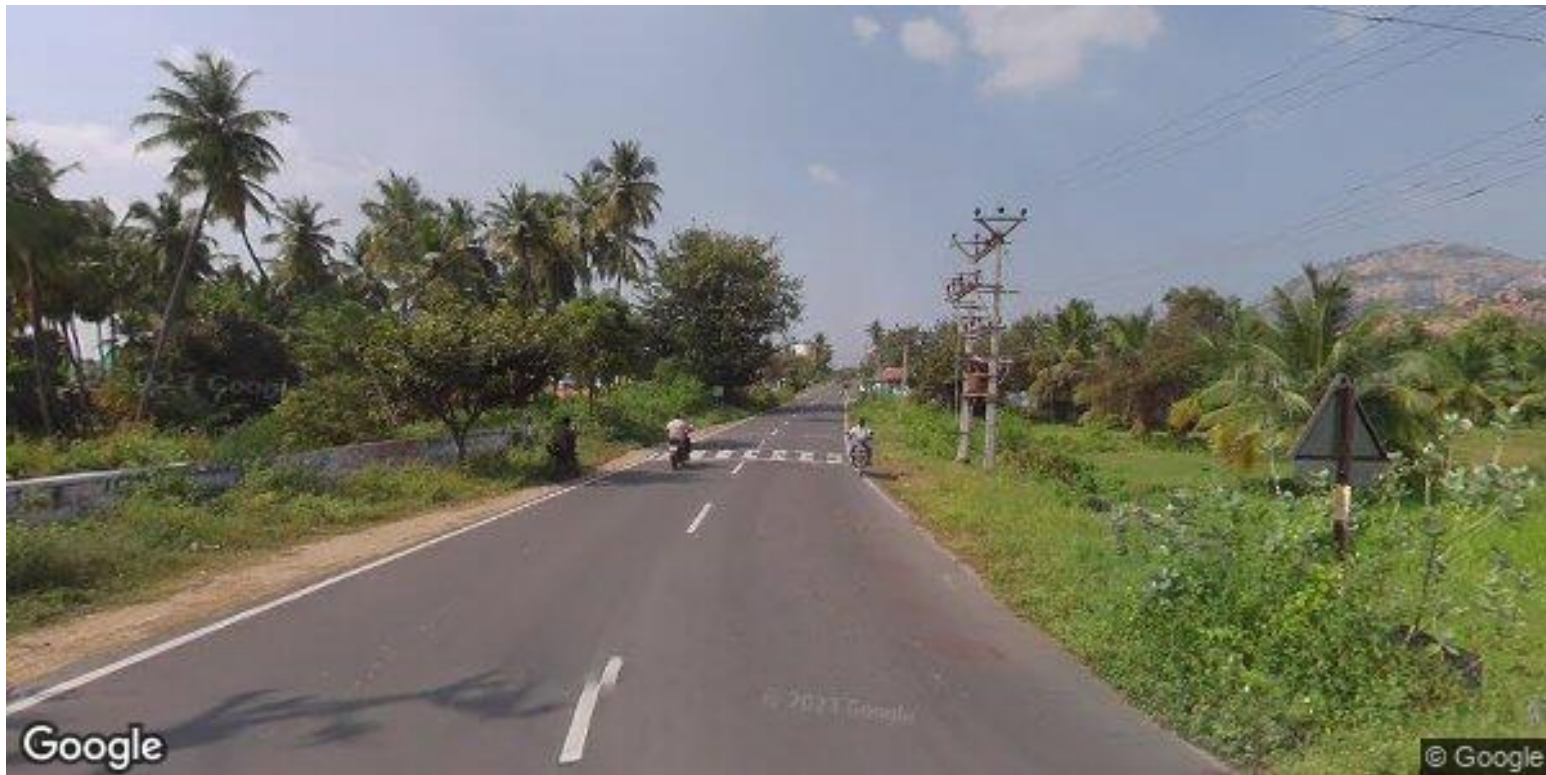
**Coordinates: 11.45352, 77.85698**

**Risk Type: Turn**

**Risk Level: Medium**

**Speed Limit: 30 KM/Hr**

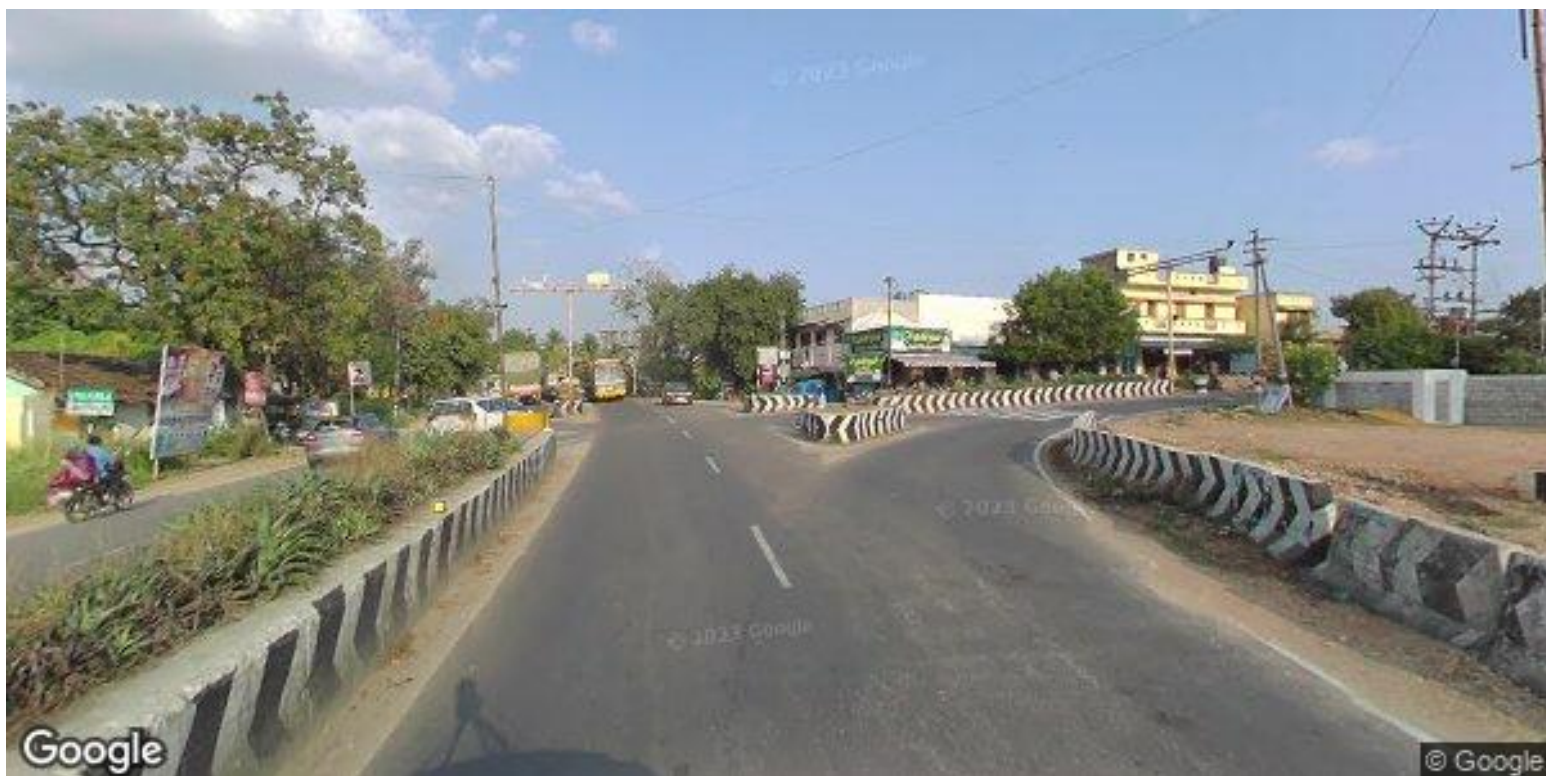
**Coordinates: 11.46318, 77.84913**

**Risk Type: Turn**

**Risk Level: Medium**

**Speed Limit: 30 KM/Hr**

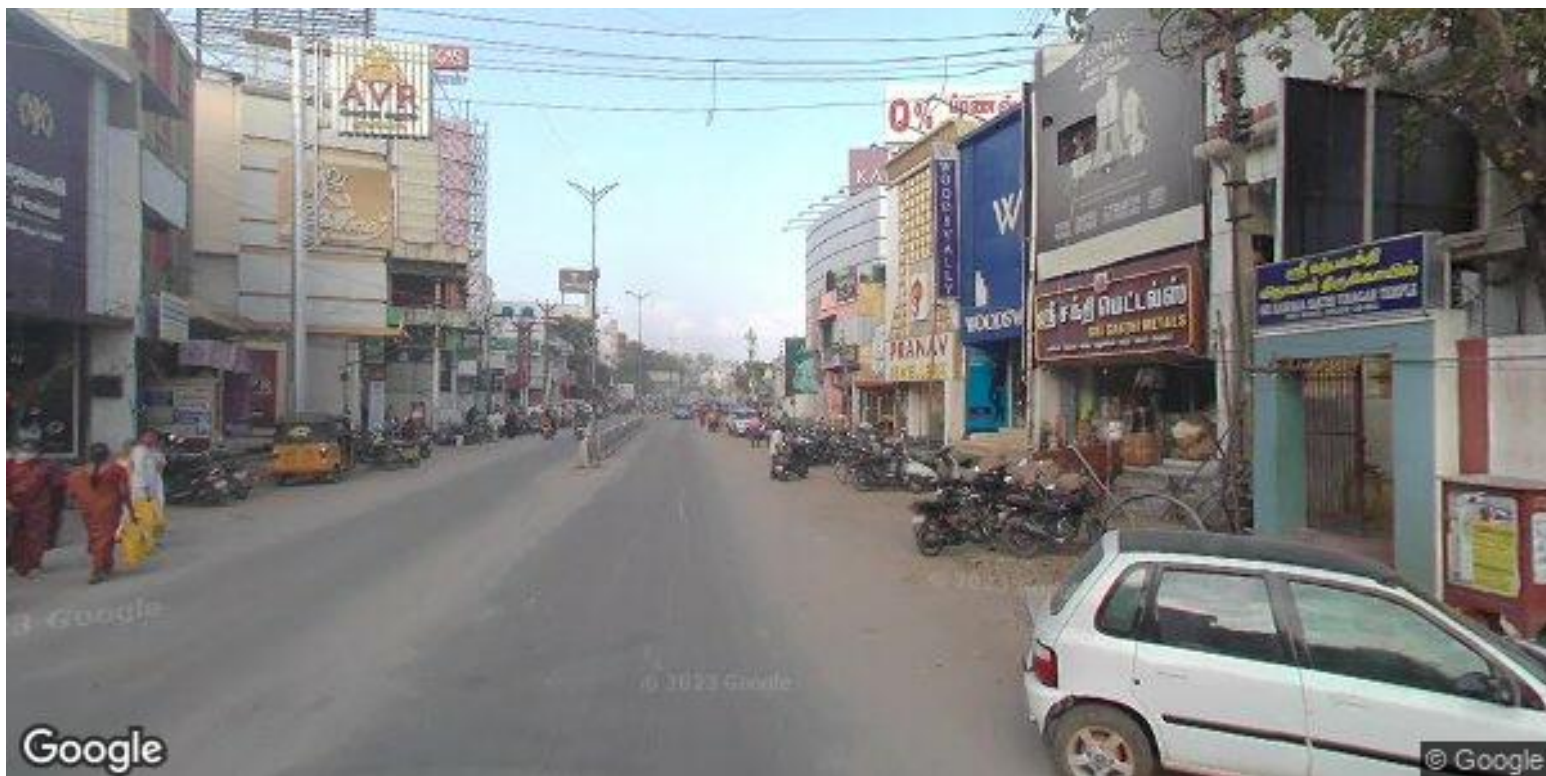
**Coordinates:** 11.34532, 77.73047

**Risk Type:** Turn

**Risk Level:** High

**Speed Limit:** 15 KM/Hr

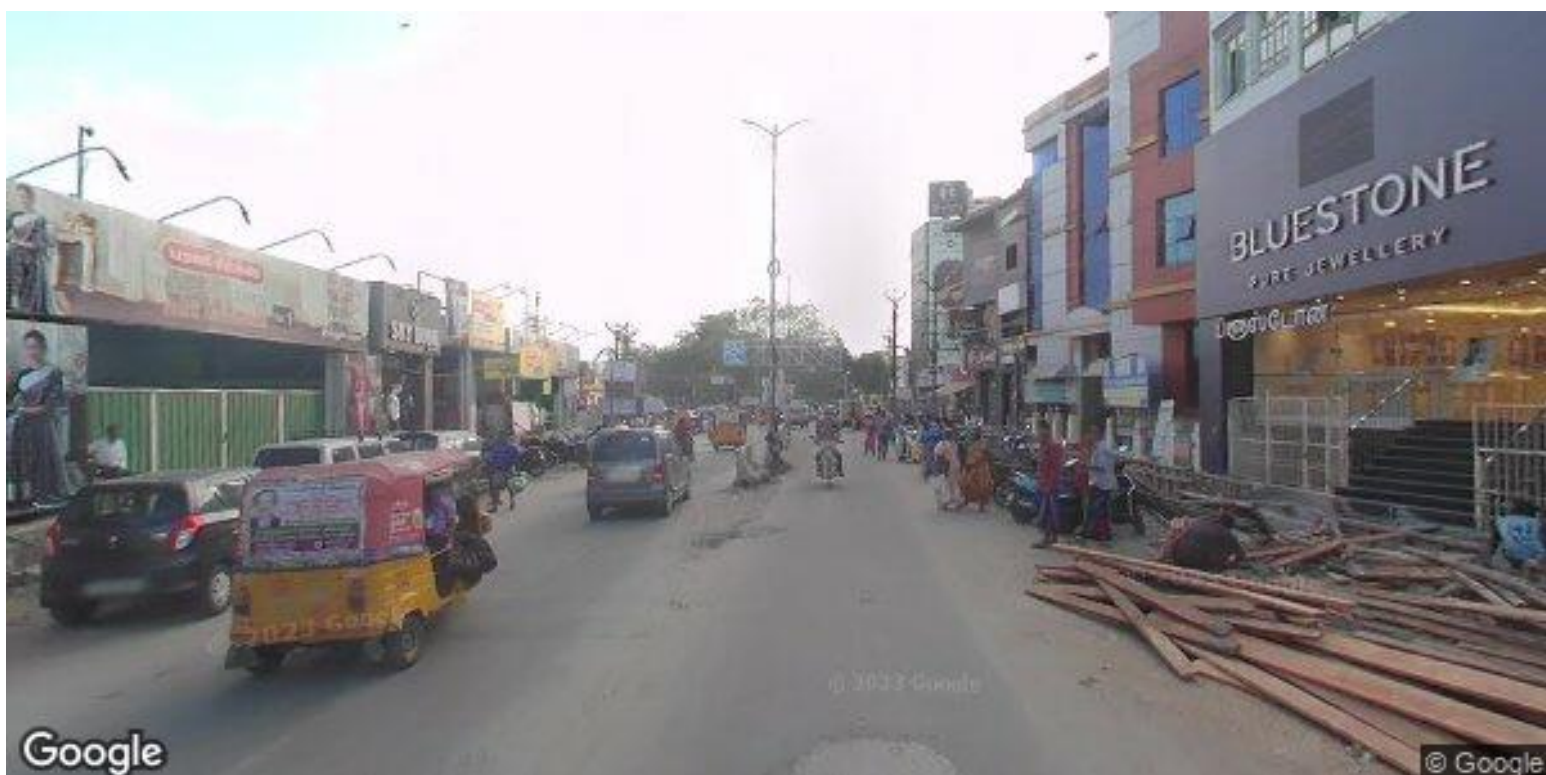
**Risk Type:** Blind Spot  
**Risk Level:** Blind Spot  
**Speed Limit:** 10 KM/Hr  
**Coordinates:** 11.34535, 77.73036

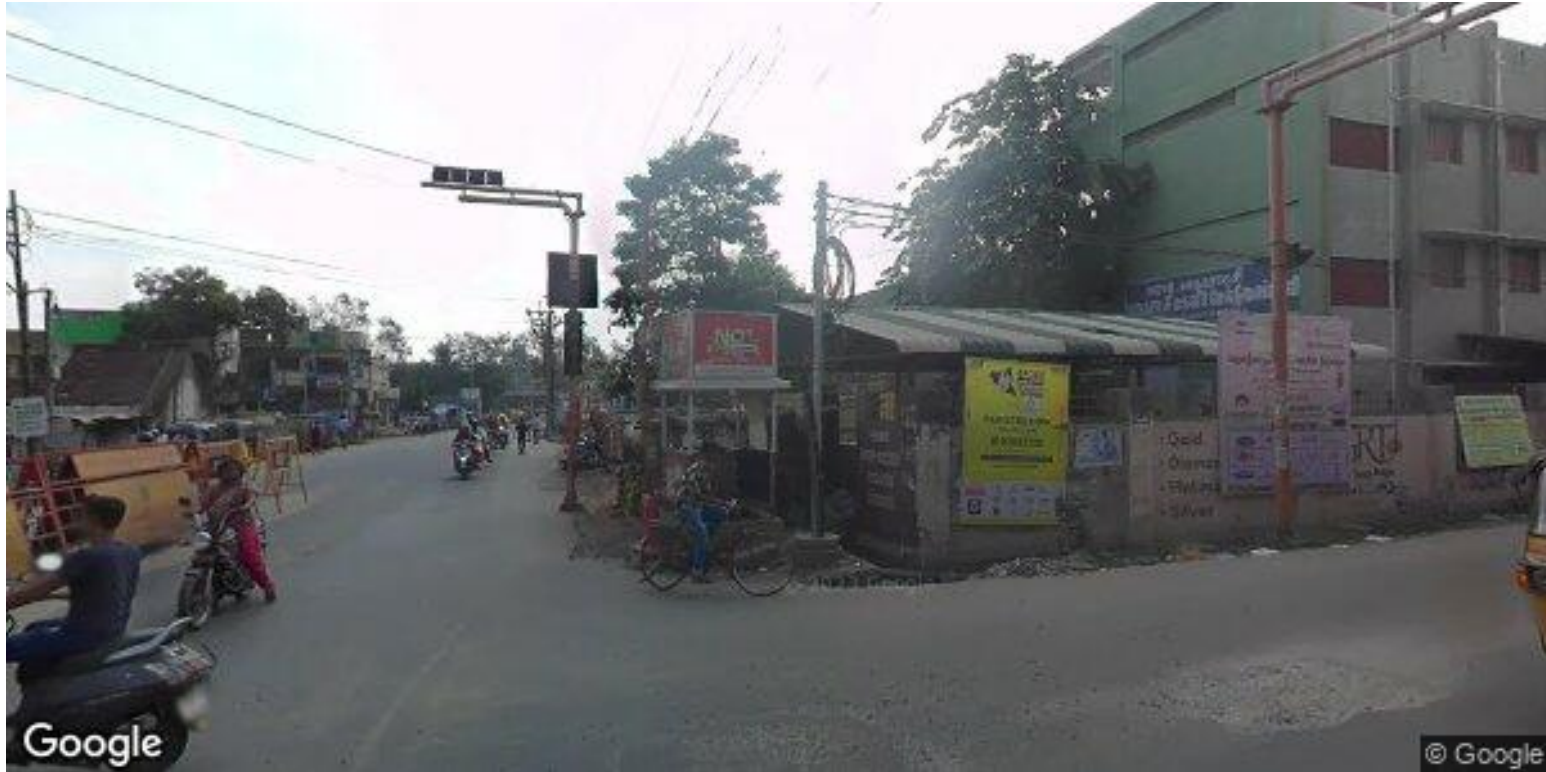
**Risk Type:** Blind Spot  
**Risk Level:** Blind Spot  
**Speed Limit:** 10 KM/Hr  
**Coordinates:** 11.34964, 77.73257

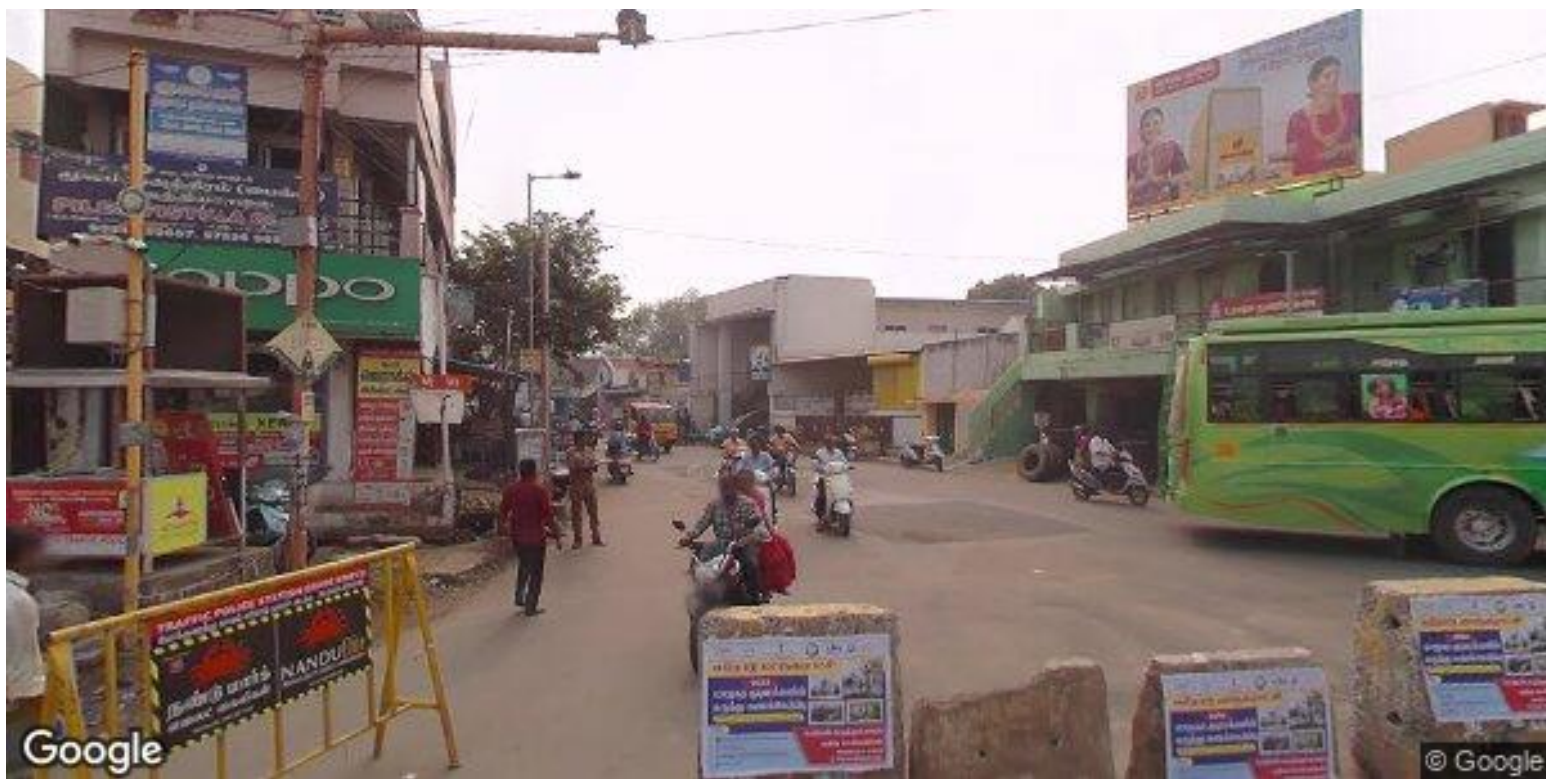
**Risk Type:** Turn  
**Risk Level:** High  
**Speed Limit:** 15 KM/Hr  
**Coordinates:** 11.35072, 77.72261

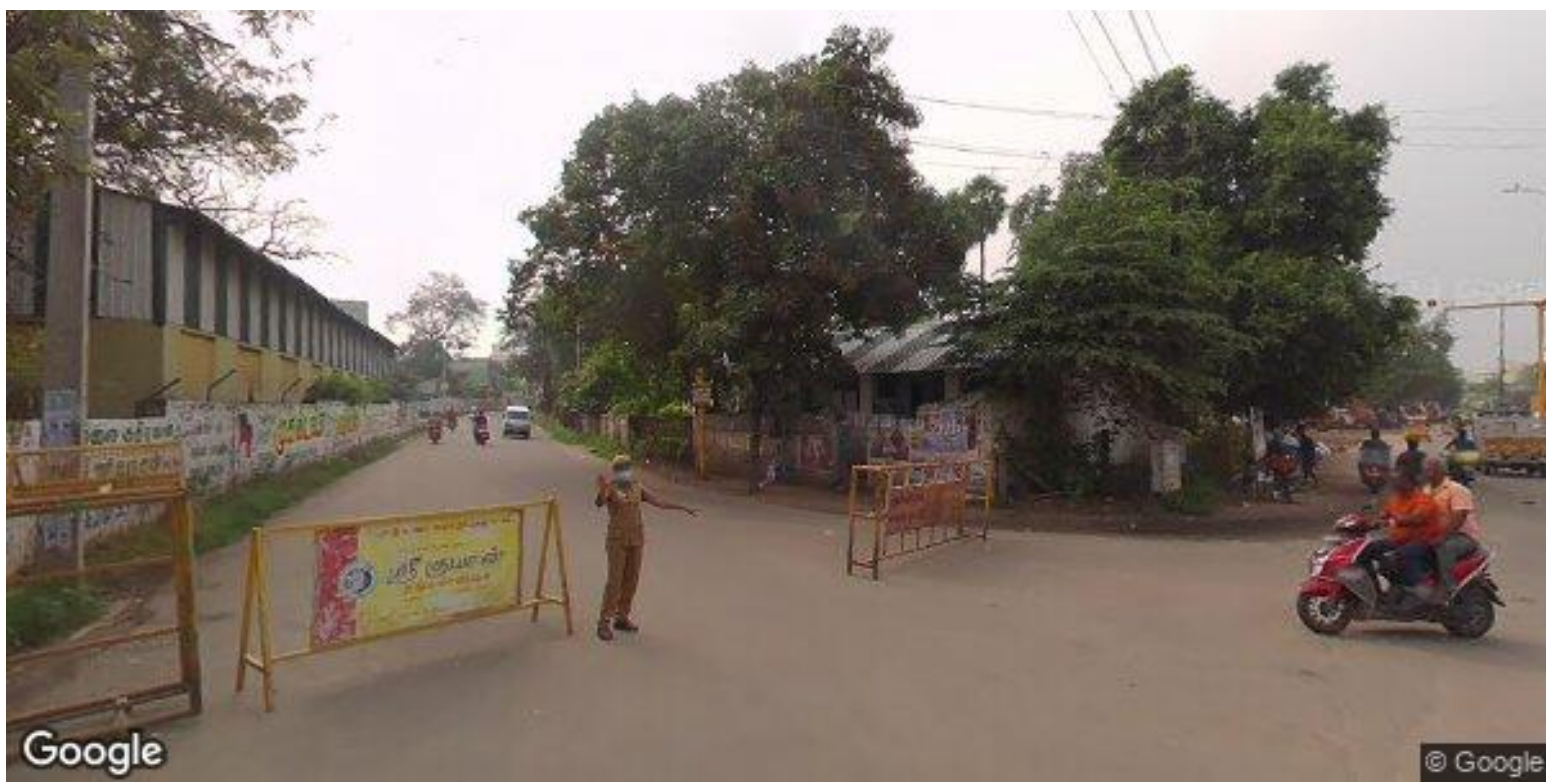
**Coordinates:** 11.35306, 77.71961

**Risk Type:** Turn

**Risk Level:** High

**Speed Limit:** 15 KM/Hr

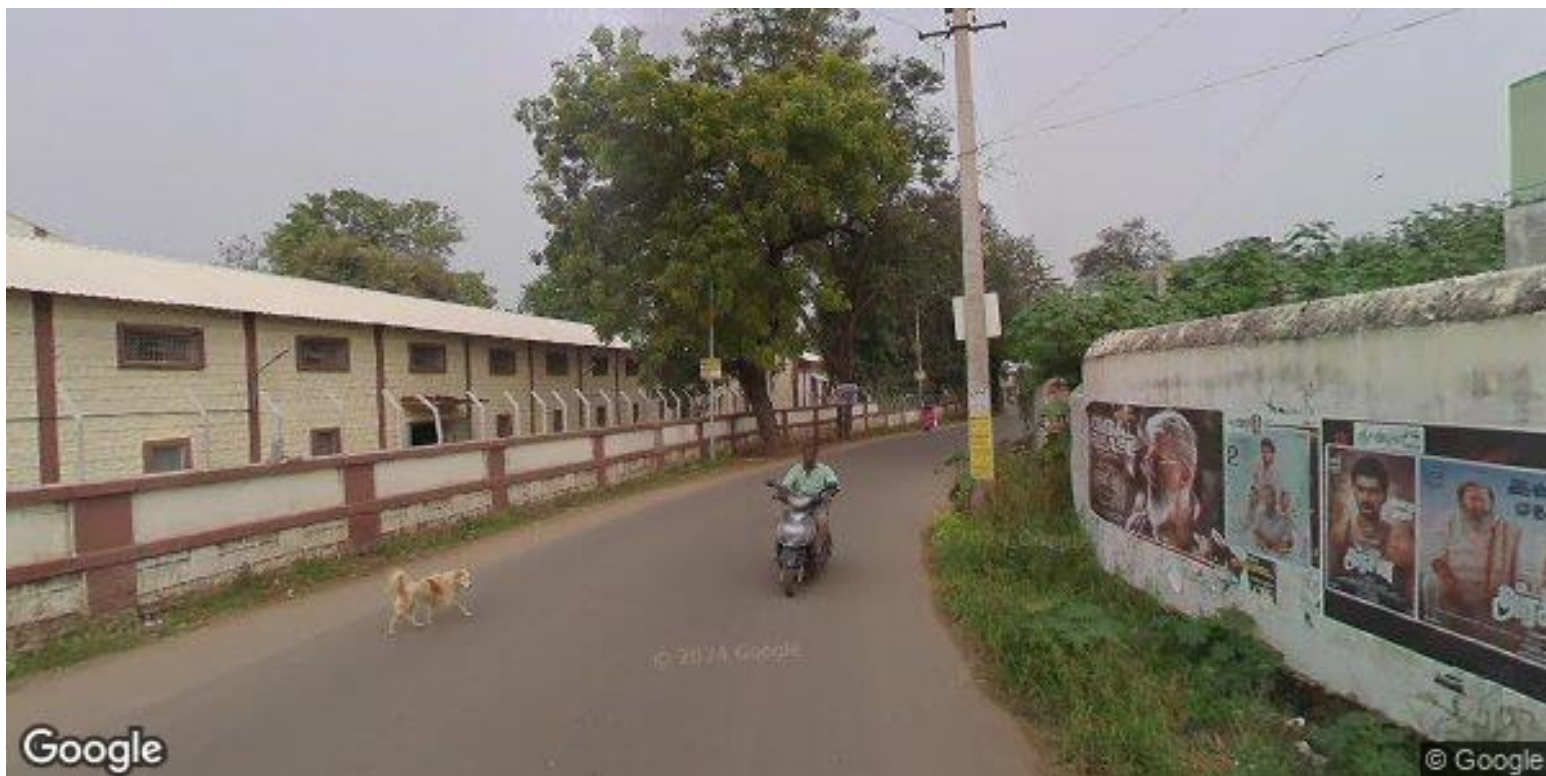
**Coordinates:** 11.35269, 77.71811

**Risk Type:** Turn

**Risk Level:** Medium

**Speed Limit:** 30 KM/Hr

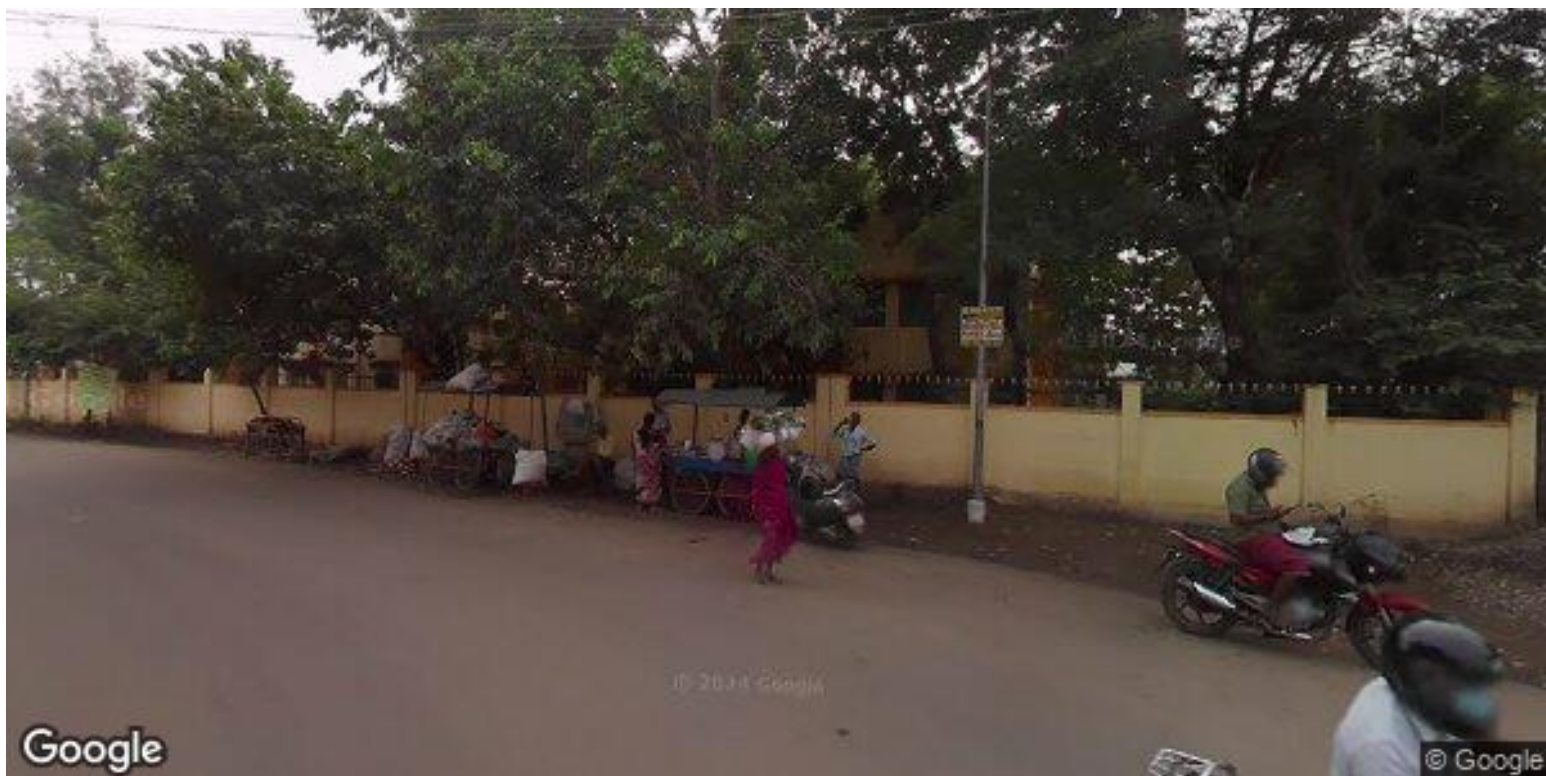
**Coordinates:** 11.35173, 77.71753

**Risk Type:** Turn

**Risk Level:** Medium

**Speed Limit:** 30 KM/Hr

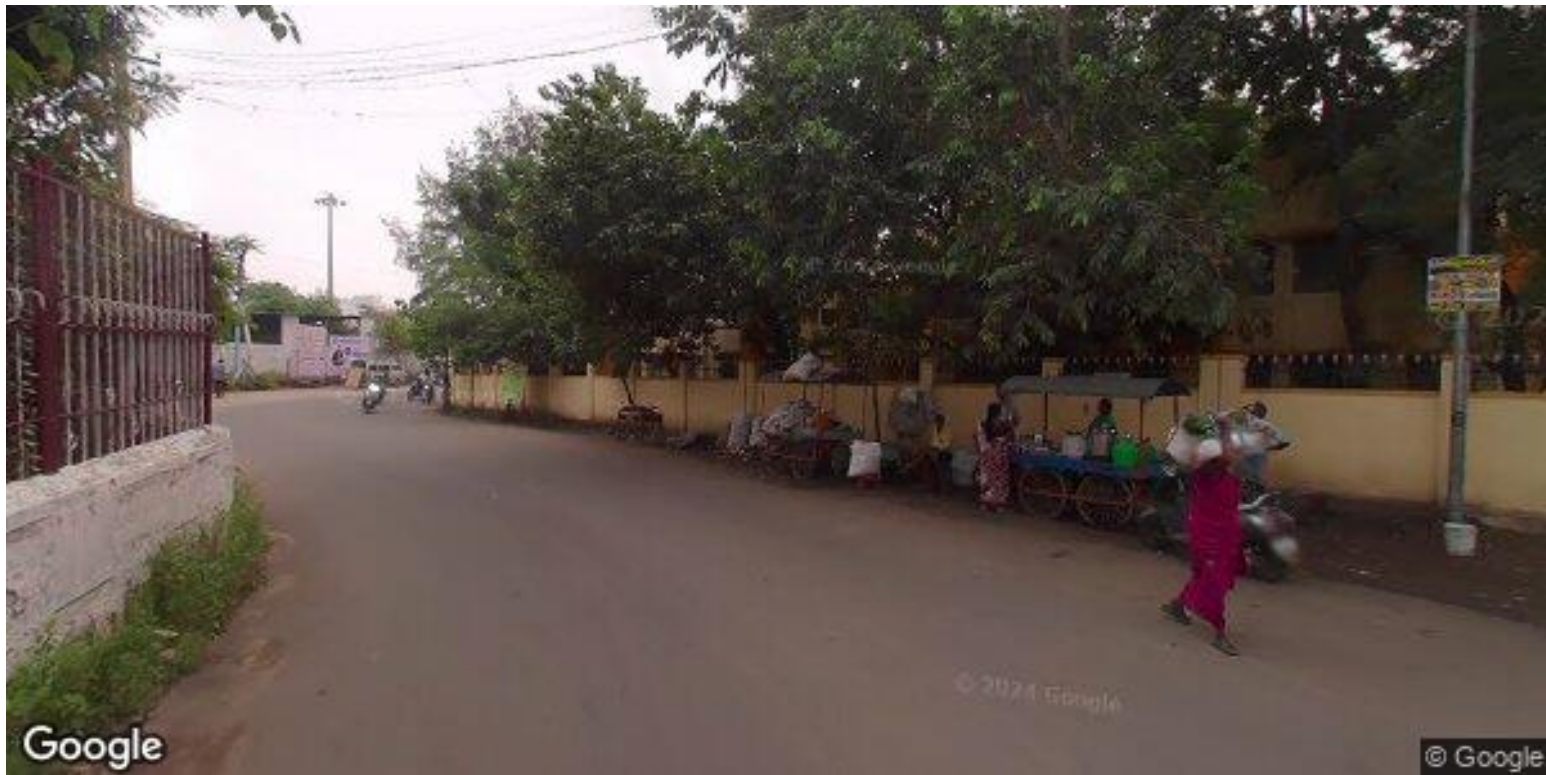
**Coordinates:** 11.35167, 77.71753

**Risk Type:** Turn

**Risk Level:** Medium

**Speed Limit:** 30 KM/Hr

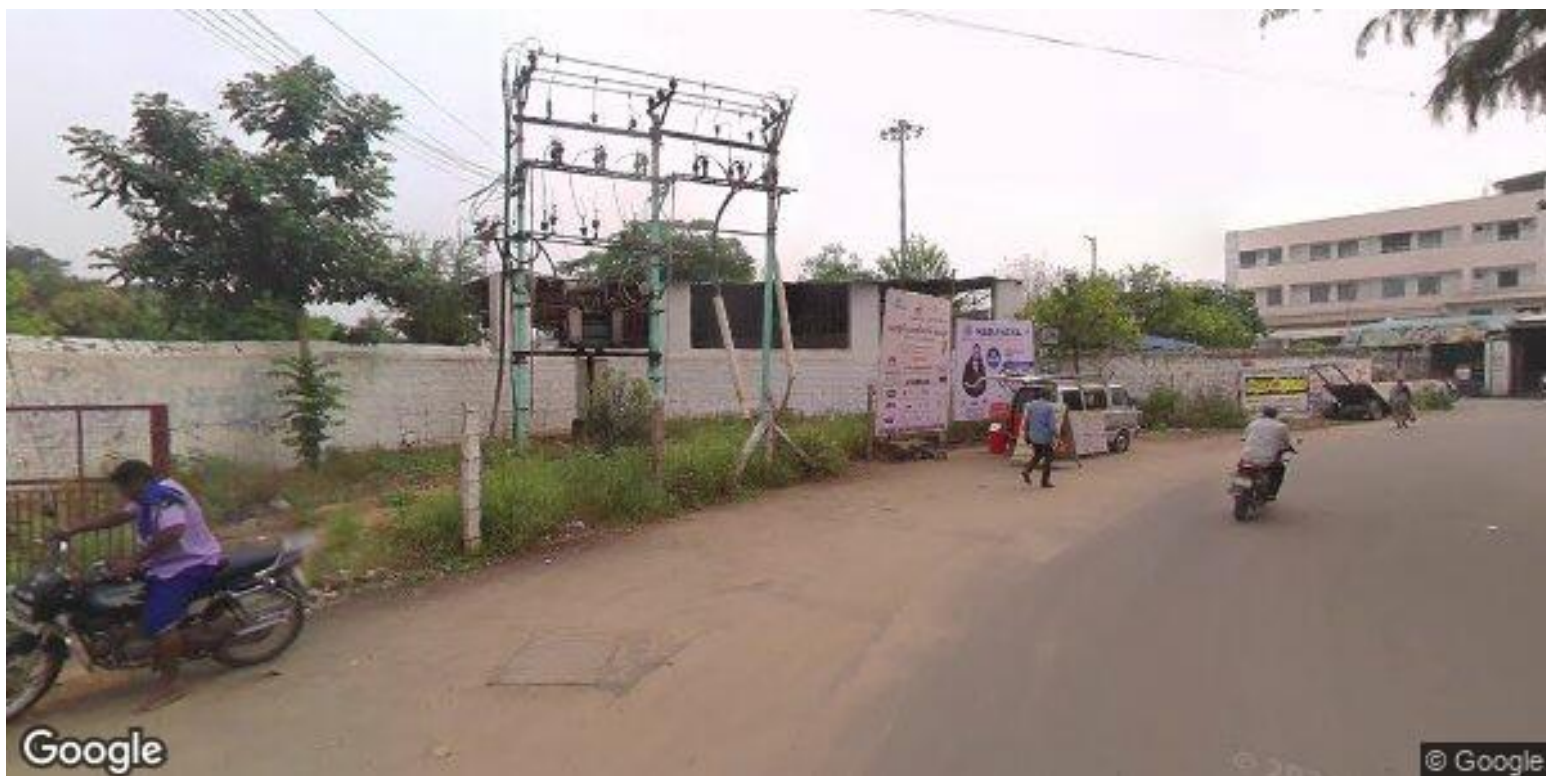
**Coordinates:** 11.35138, 77.71774

**Risk Type:** Turn

**Risk Level:** Medium

**Speed Limit:** 30 KM/Hr

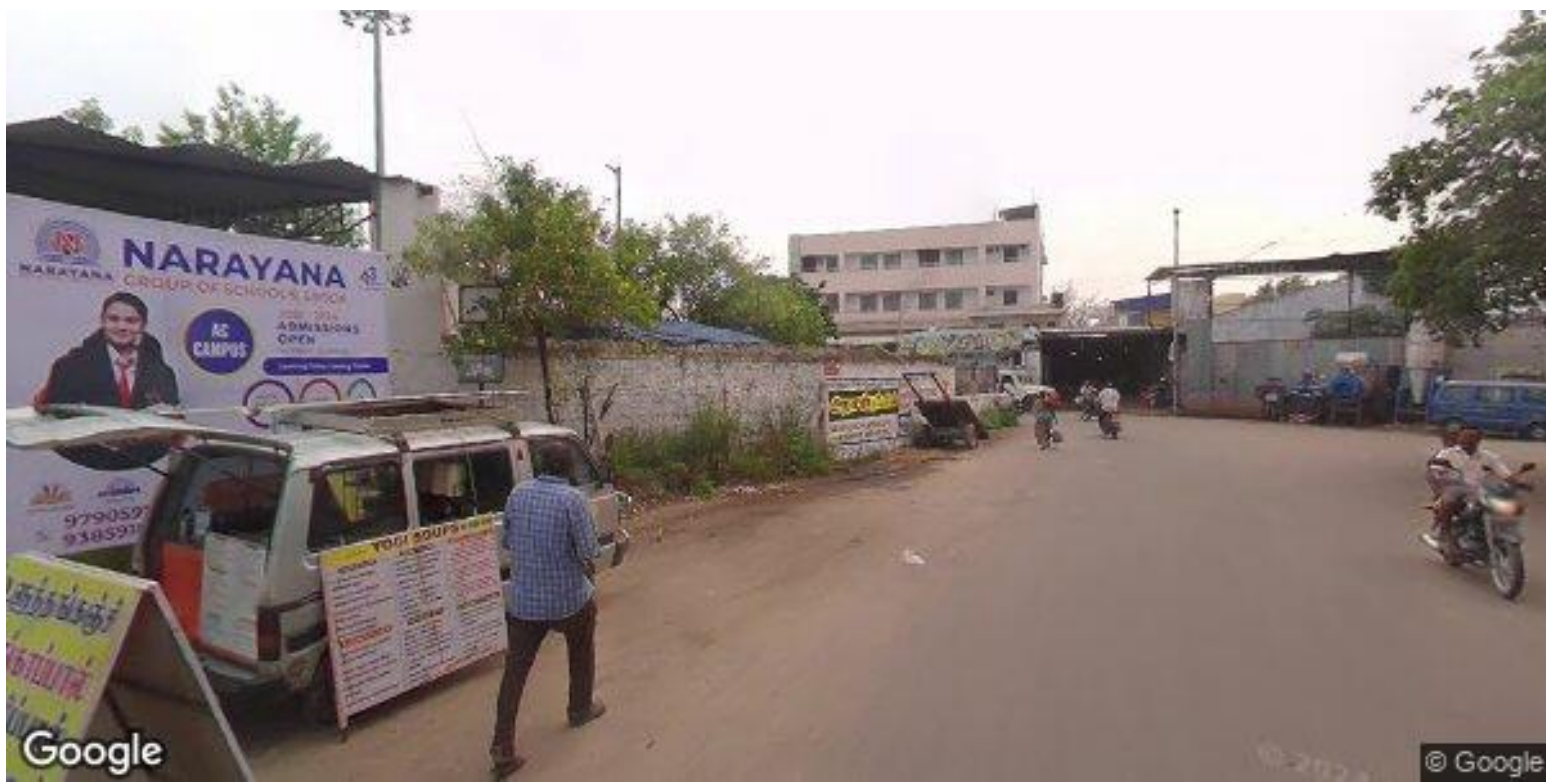
**Coordinates:** 11.35129, 77.71775

**Risk Type:** Turn

**Risk Level:** Medium

**Speed Limit:** 30 KM/Hr

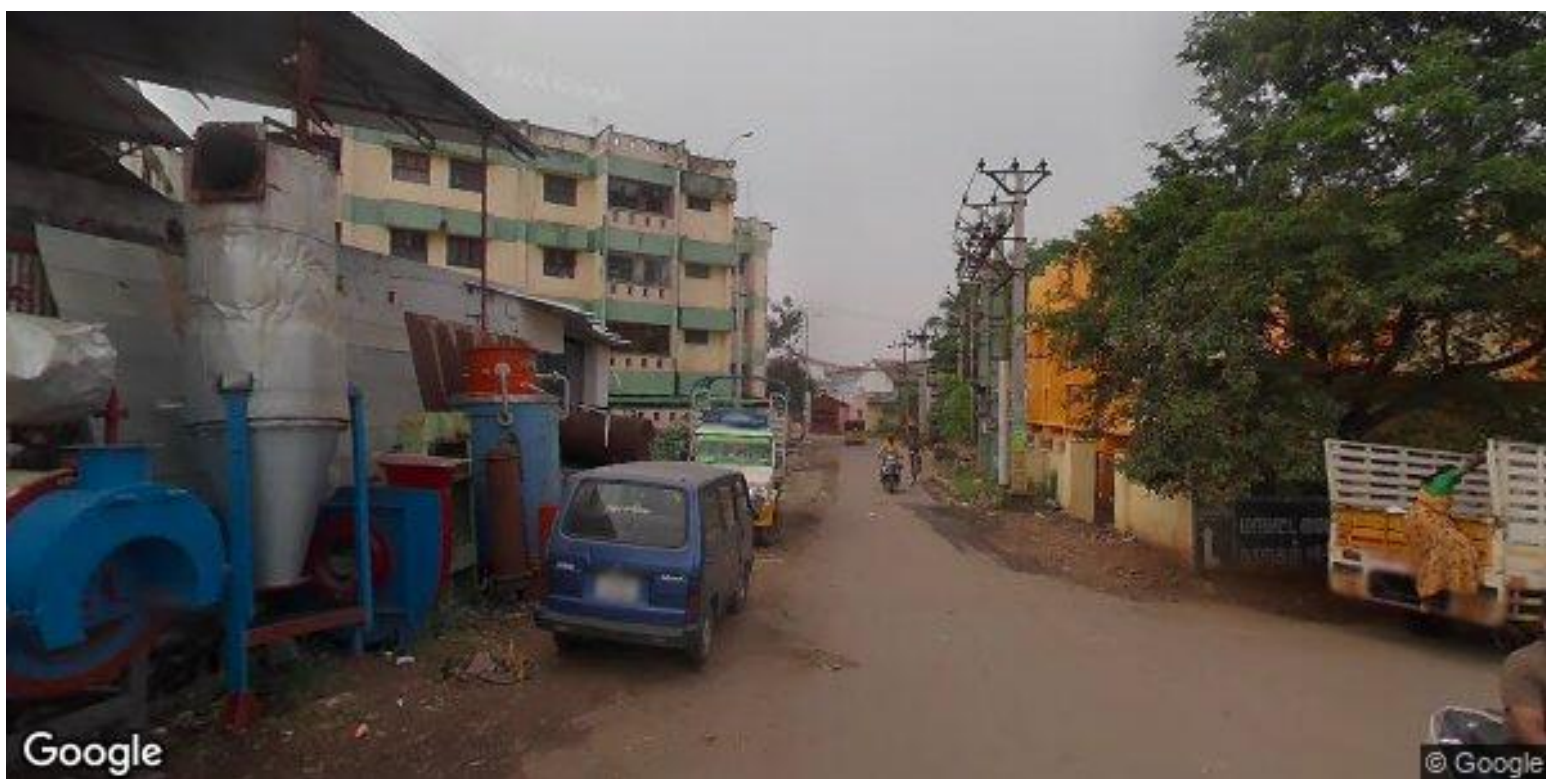
**Coordinates:** 11.35101, 77.71764

**Risk Type:** Turn

**Risk Level:** High

**Speed Limit:** 15 KM/Hr

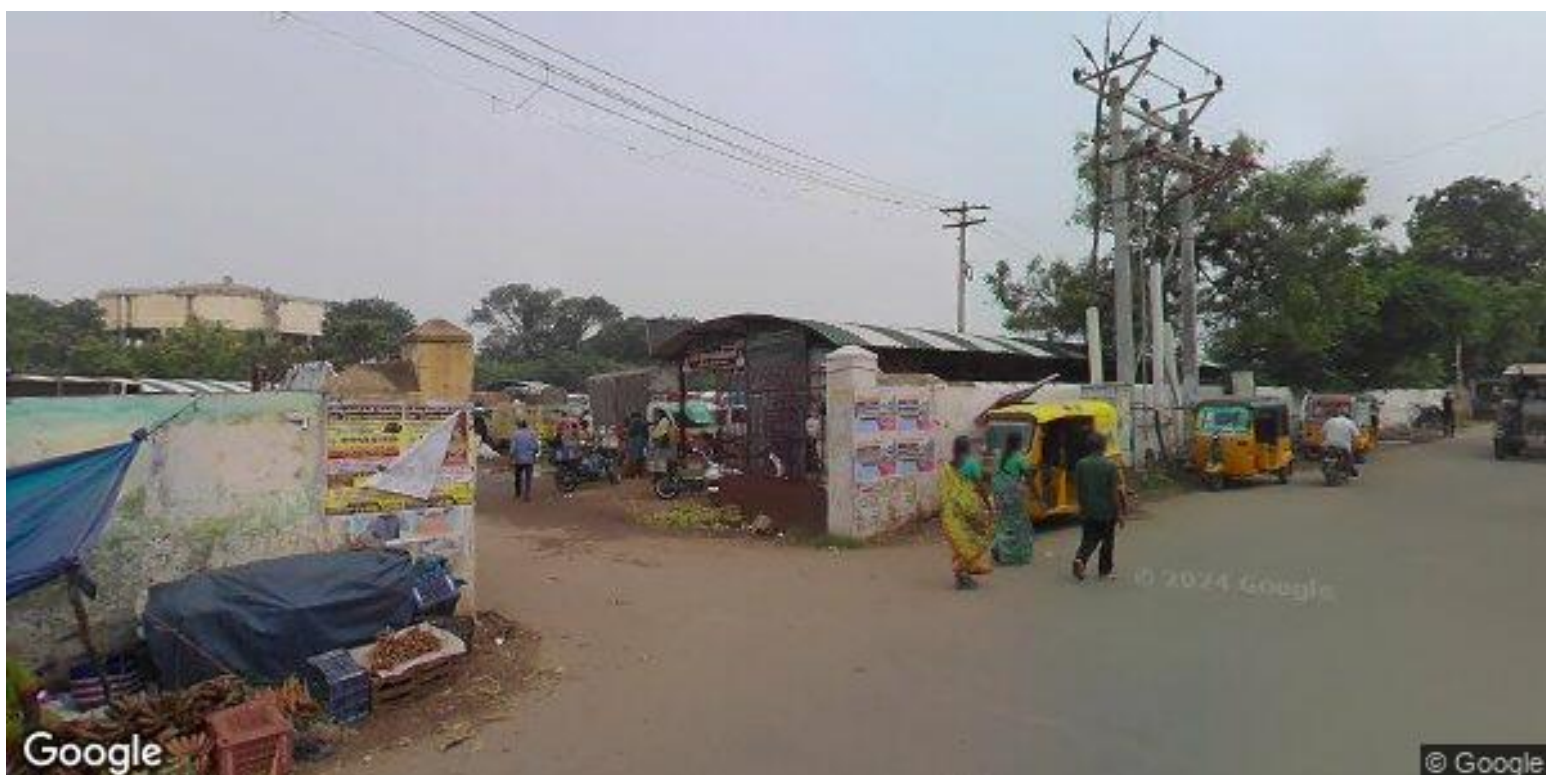
**Risk Type:** Turn  
**Risk Level:** High  
**Speed Limit:** 15 KM/Hr  
**Coordinates:** 11.35076, 77.71790

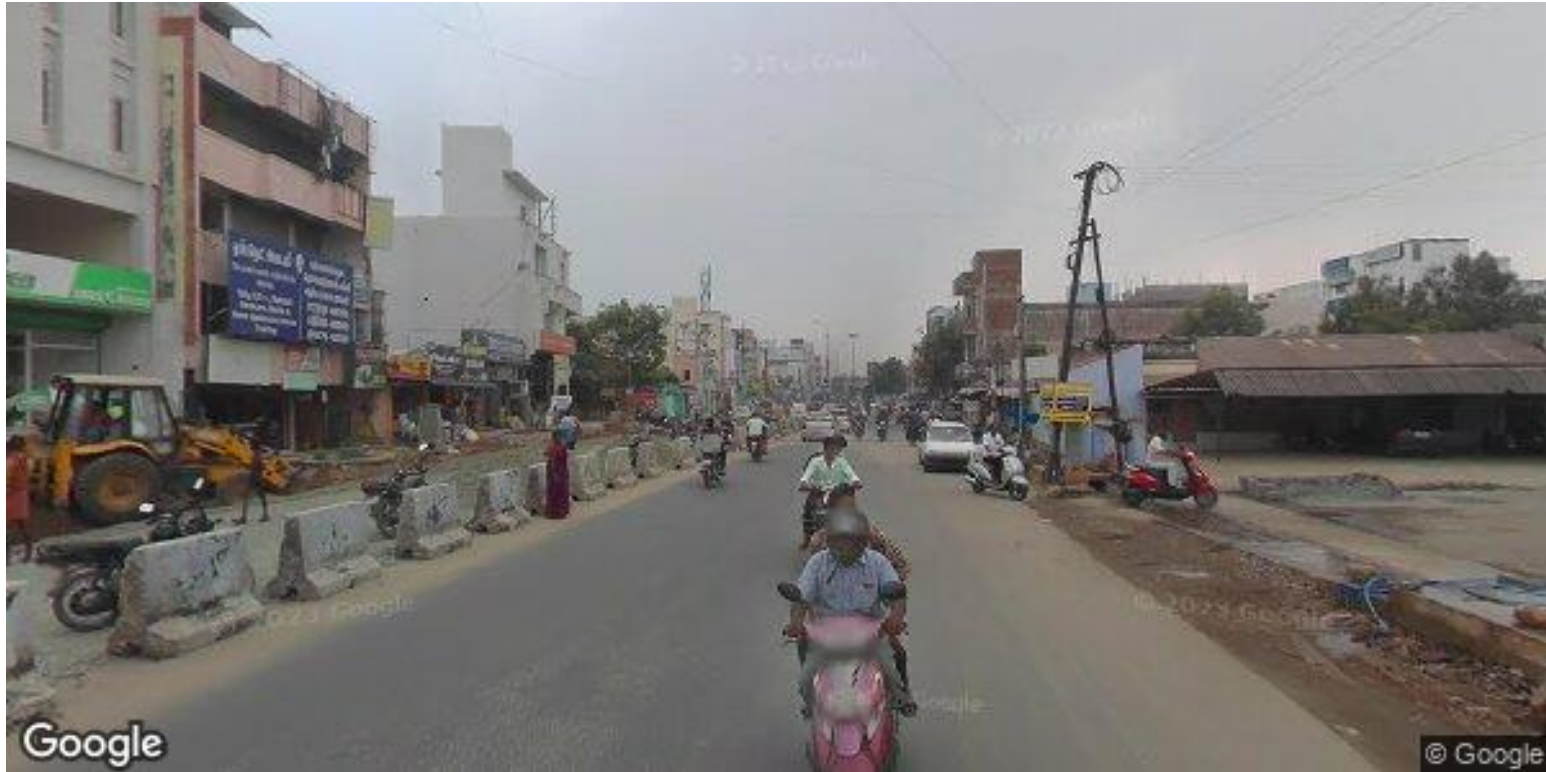
**Risk Type:** Turn  
**Risk Level:** High  
**Speed Limit:** 15 KM/Hr  
**Coordinates:** 11.34859, 77.71744

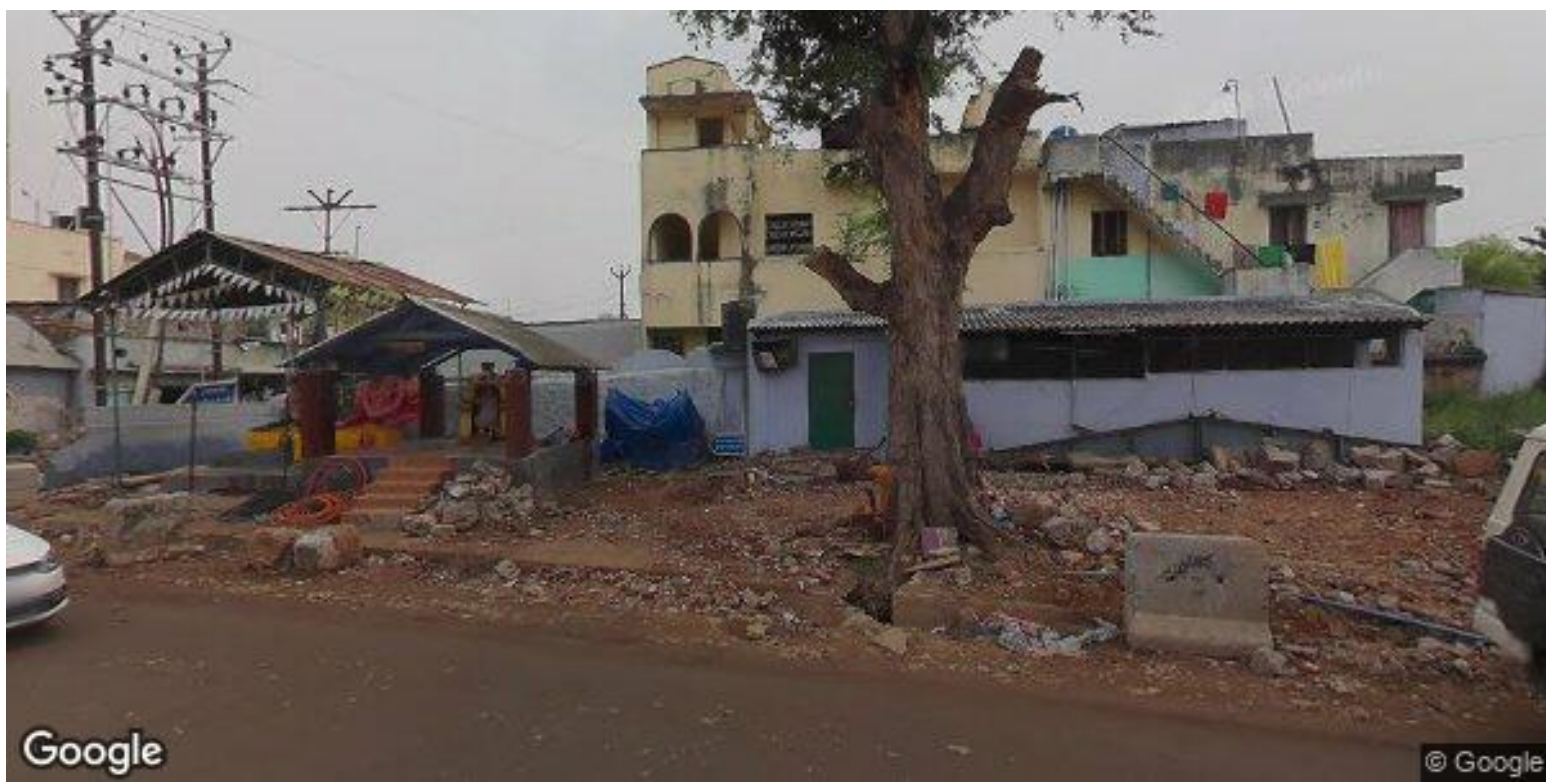
**Coordinates:** 11.35249, 77.71072

**Risk Type:** Turn

**Risk Level:** Medium

**Speed Limit:** 30 KM/Hr
